Pascoe's Shaft Pumping and Winding
Engine Houses, South Wheal Frances,
Piece, Cornwall
Historic Building Record

Cornwall Archaeological Unit

Report No: 2022R022

Historic Building Record

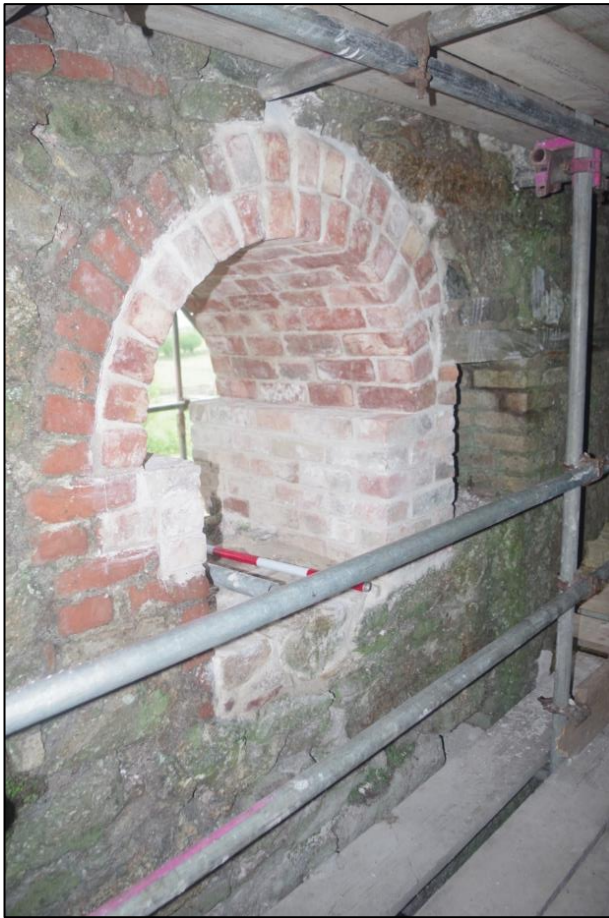
Fig 103 Interior south-west wall, reconstruction of arch.

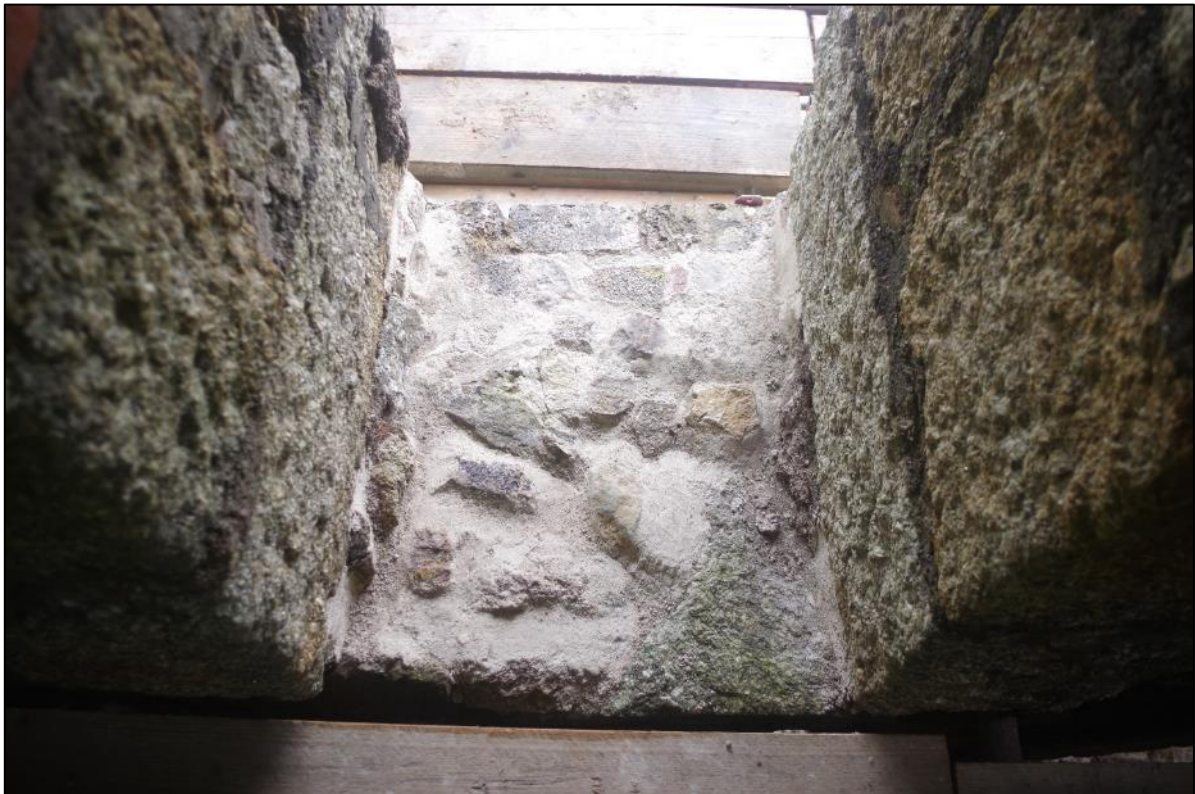
Fig 104 Interior south-west wall, small patch repair to window sill.

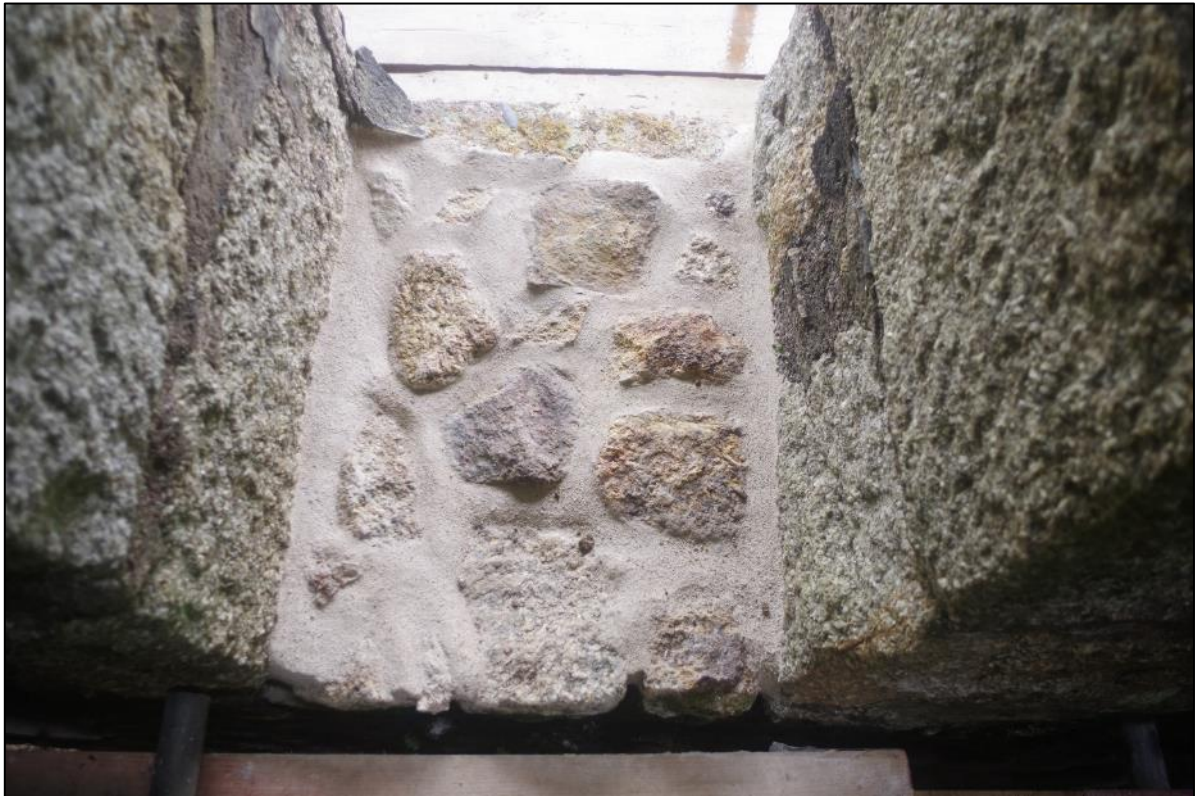
Fig 105 Interior south-west wall, small patch repair to window sill.
