Trevaney farm buildings, Constantine, Cornwall

Historic Buildings Record

Client	Mr Hamish Mcleod
Report Number	2010R131
Date	October 2010
Status	Final
Report author(s)	Eric Berry
Checked by	Nigel Thomas
Approved by	Peter Rose

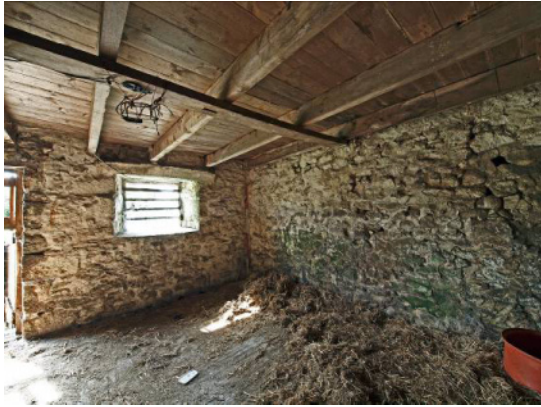
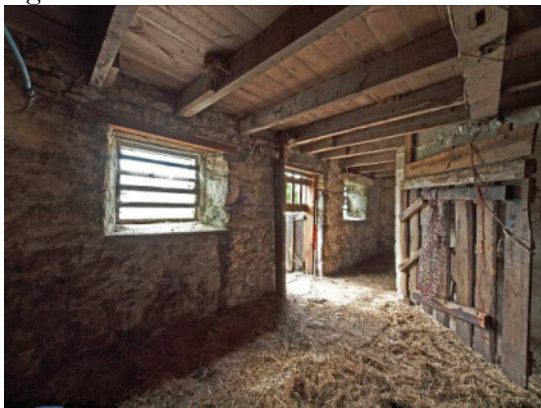
Fig 13 Barn west corner

Original internal fittings have long been removed. Cobbled flooring on the ground floor survives to the south corner area of the barn extending from an area inside the doorway to the south-east wall and from a former drain at the south-west end of the former stalls to the south-west wall (Figs 13 and 14). A wooden hayrack fitted to the rear wall of the south-east room space is part of fitting out for later use of the shippon as a loose box. The 10-bay floor structure above appears to be original with close-spaced joists and tongue-and groove boards. The barn loft (Fig 18) has a modern ceiling between its probable original six bays of tie-beam roof trusses.
