Wreck of the Barque *Antoinette* Camel Estuary, Padstow, Cornwall

Undesignated Site Assessment and Emergency Recording

Client	English Heritage
Report Number	2010R101
Date	14/03/2011
Status	Final
Report author(s)	Charles Johns, Kevin Camidge and Peter Northover
Checked by	Peter Rose
Approved by	Helen Keeley

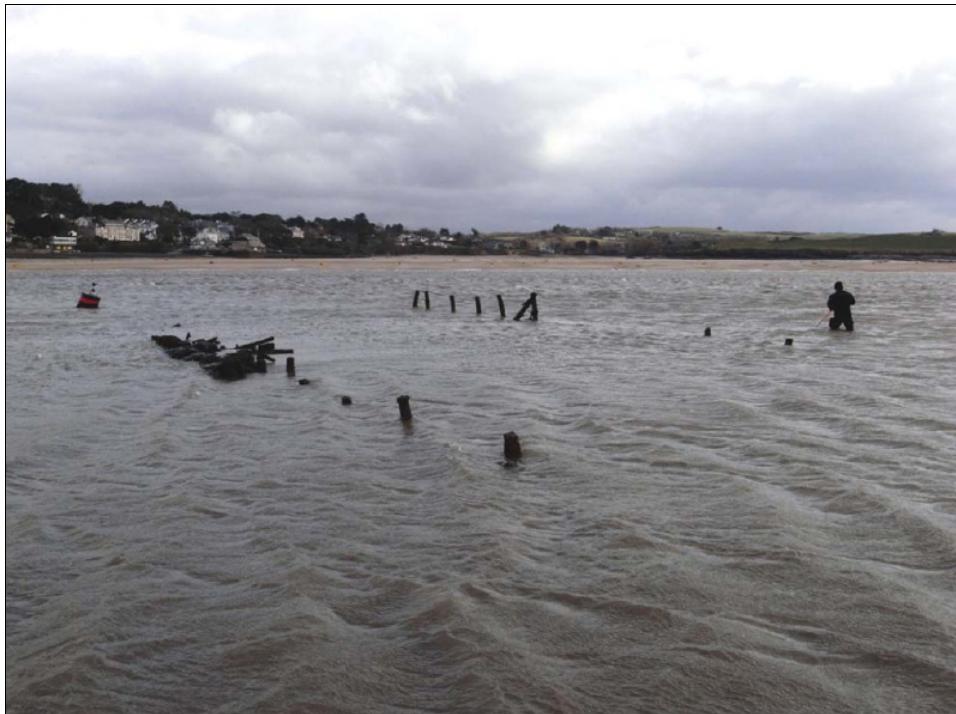
Fig 5 The exposed wreckage just before low tide, the wading figure gives an indication of the water depth around the wreckage (photo: Kevin Camidge)

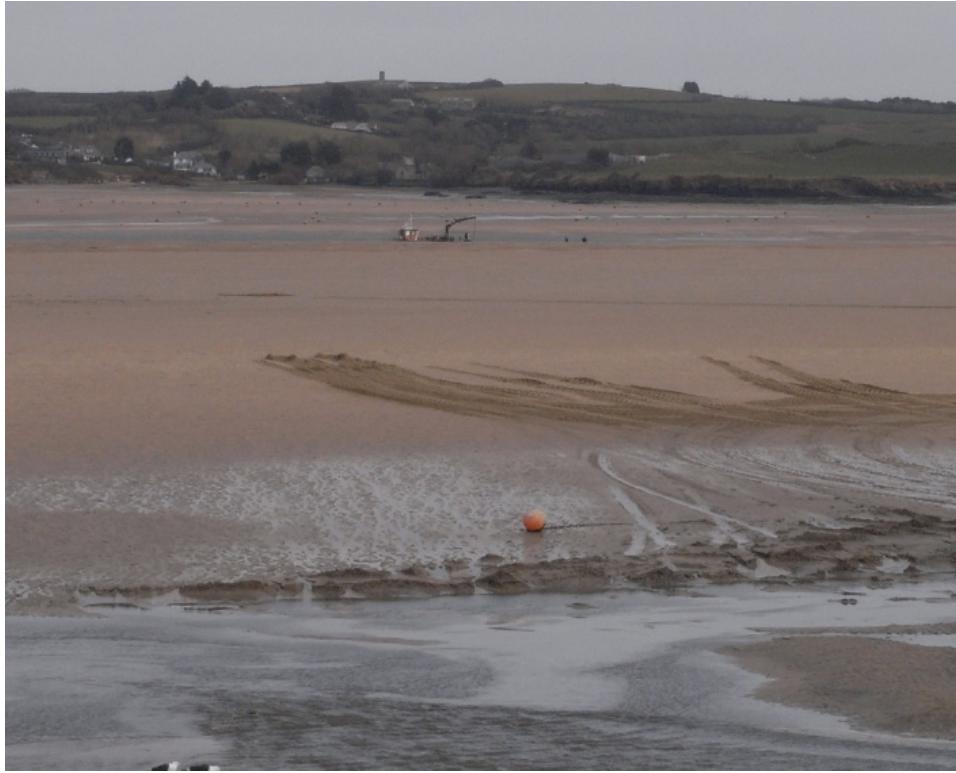
The wreck was broken up with explosives by the Royal Navy bomb disposal team from Plymouth on the 1 and 2 March (Fig 7). Apparently this was not as successful as anticipated and further work to break up the wreck has been scheduled for the next extreme spring tides in September 2010.

Fig 8 Removing elements of the wreck after use of explosives Seen here, a mechanical excavator on the site at low tide on 2 March lading timbers on to one of the harbour launches (photo: Kevin Camidge)

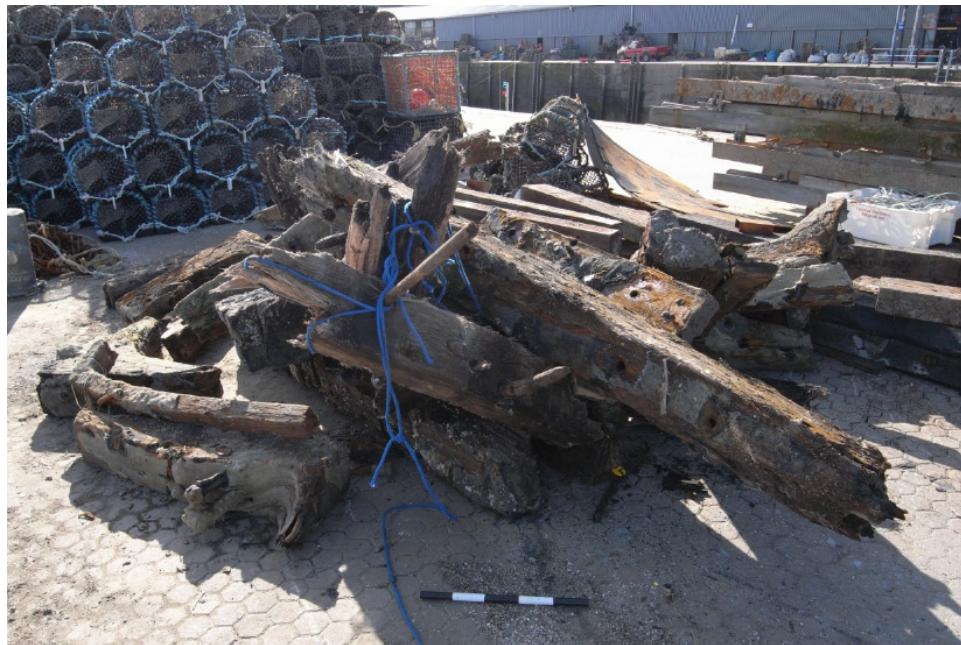
Material recovered from the wreck by the harbourmaster was recorded on the quay in Padstow harbour. A total of 23 items were recovered. These were placed in a large pile on the quay; the items on the bottom of the pile could not be examined properly as many of them were too heavy to move manually (Fig 9). A catalogue of all the items was made and selected items were drawn. Tentative identification of the timbers suggests that they comprise eight lodging knees, seven beams (probably deck beams but possibly hold beams), four fragments of frame timbers, one plank and two other structural elements – a possible deck ledge and a possible stringer. In addition to the timbers there was a single iron knee fragment and an unattached iron bolt (see Figure 10).

Fig 9 The items recovered from the wreck on the quay in Padstow harbour Note: the stacked timbers in the background are modern railway sleepers (photo: Kevin Camidge)
