Hallgarden Farm outbuildings, Otterham, Cornwall

Historic building record

Client	Mr and Mrs D Thompson
Report Number	2011R024
Date	February 2011
Status	Draft/2nd draft/Final
Report author(s)	Eric Berry
Contributions from	Jo Sturgess and Nigel Thomas
Checked by	
Approved by

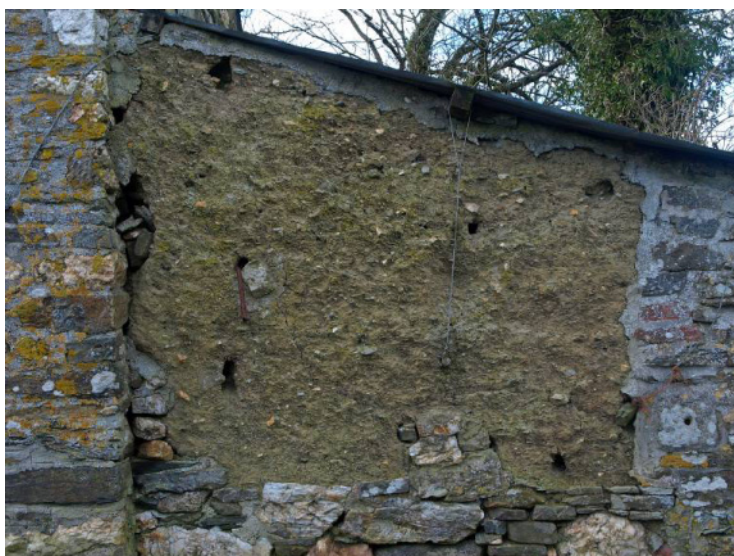
Fig 11 Building 1: lean-to E wall detail

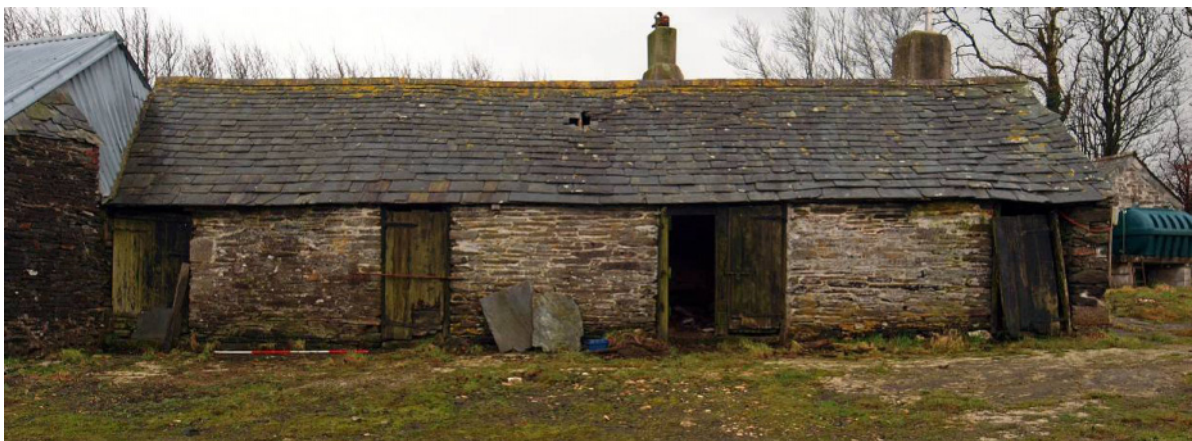
The north front (Figure 15) has four doorways, as described in plan (section 6.6.4). Old planked and ledged doors open outwards. The left-hand doorway incorporates a rebated granite jamb-block at its closing side plus granite blocks in the left-hand jamb to support pintails.

Fig 15 Building 5: north front (single-phase probable pigsties)

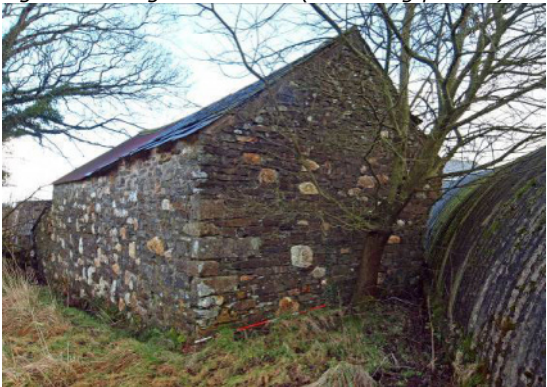
Fig 17 Building 1 from SW (rebuilt end wall)

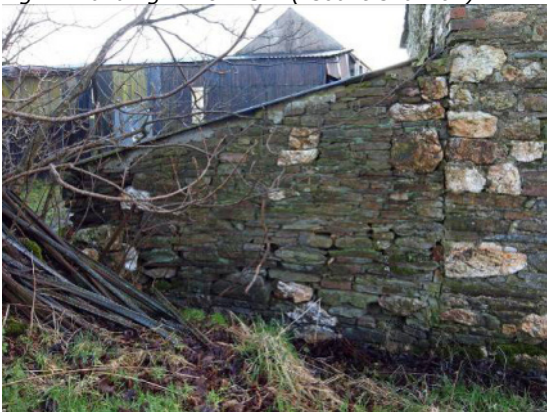
Fig 18 Building 1: lean-to (phase joint)

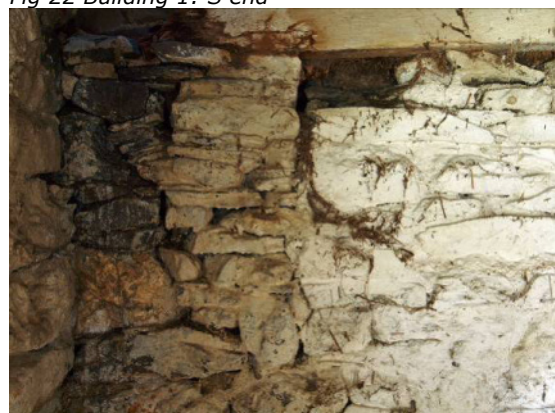
Fig 23 Building 1: S end blocked vent detail

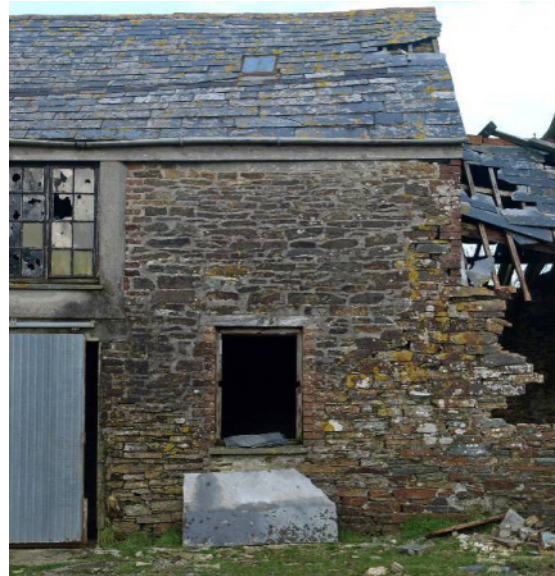
(Figure 50). Left of this is the original right-hand (east) jamb of a doorway, probably widened to the left since rebuilt. Directly above this doorway at first-floor level the right-hand (east) jamb of the former loading doorway also survives. All the other openings are within the rebuilt part of the front wall but many of the present openings may be in the position of former openings. The east wall (Figures 52-54) has a large doorway fitted with ledged and braced doors with offset hinges, designed so that the doors can fold back against the wall when opened.

Fig 50 Building 2: front wall towards right

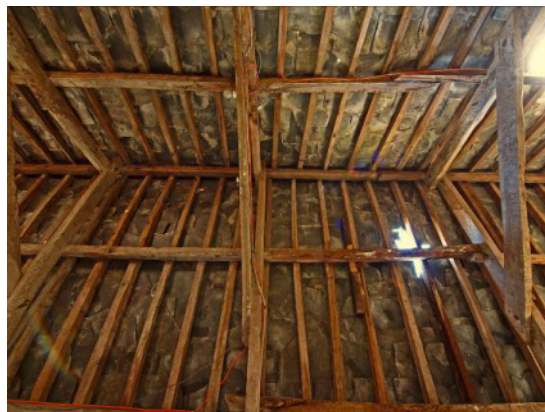
Fig 99 Building 5: rear doorway from NE

The interior of Building 5 (Figures 95-103) has lime-washed walls. Cobbled floors have been damaged when original slate slab partitions relating to the pig pens have been robbed-out of their foundations, now leaving cobbles loose on the surface where the slate monoliths formerly stood. A single vertical slate monolith (figure 95) survives at the south-west corner of the western sty. The original roof structure has asymmetrical trusses with longer rafters to the north side. This design exploits the existing slope of the land and allows greater headroom for the feeding passage. Where the roof runs lower there is still plenty of headroom for the pigs! Original purlins and common rafters also survive, some of the purlins staggered where they meet over the trusses. The trusses are nailed at their joints and also bolted, the bolts probably added later. There are five trusses to the 6-bay roof at the long end of the building and one truss to the 2-bay roof over the feed store.
