## **Kilvickeon Church, near Bunessan, Isle of Mull**

### **Photographic and Measured Surveys**

**2013-14/KVC13**

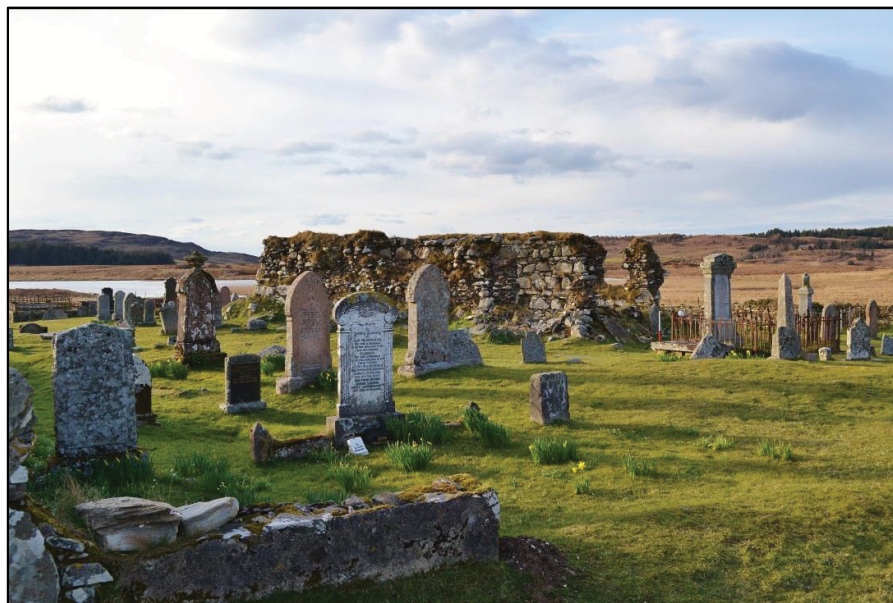
The church is a rectangular building aligned east-west, measuring 13.15m x 5.6m internally. It is surrounded by graves of varying ages (Plate 1), with the graveyard being enclosed by a Post-Medieval wall. The remnants of a former extent to the east-southeast enclosure wall and an earlier sub-circular enclosure were also recorded (Figure 3). The church is in a ruinous condition. The north and south walls stand approximately to their original height (about 3.5m from the current ground level internally), while the east and west walls now only stand to approximately 0.6m high (Plate 2).

**Plate 1:** Church surrounded by gravestones
