ROSS & CROMARTY ARCHAEOLOGICAL SERVICES

Craft House, Plockton

Building Survey

CHP13: Building Survey of Craft House, Plockton

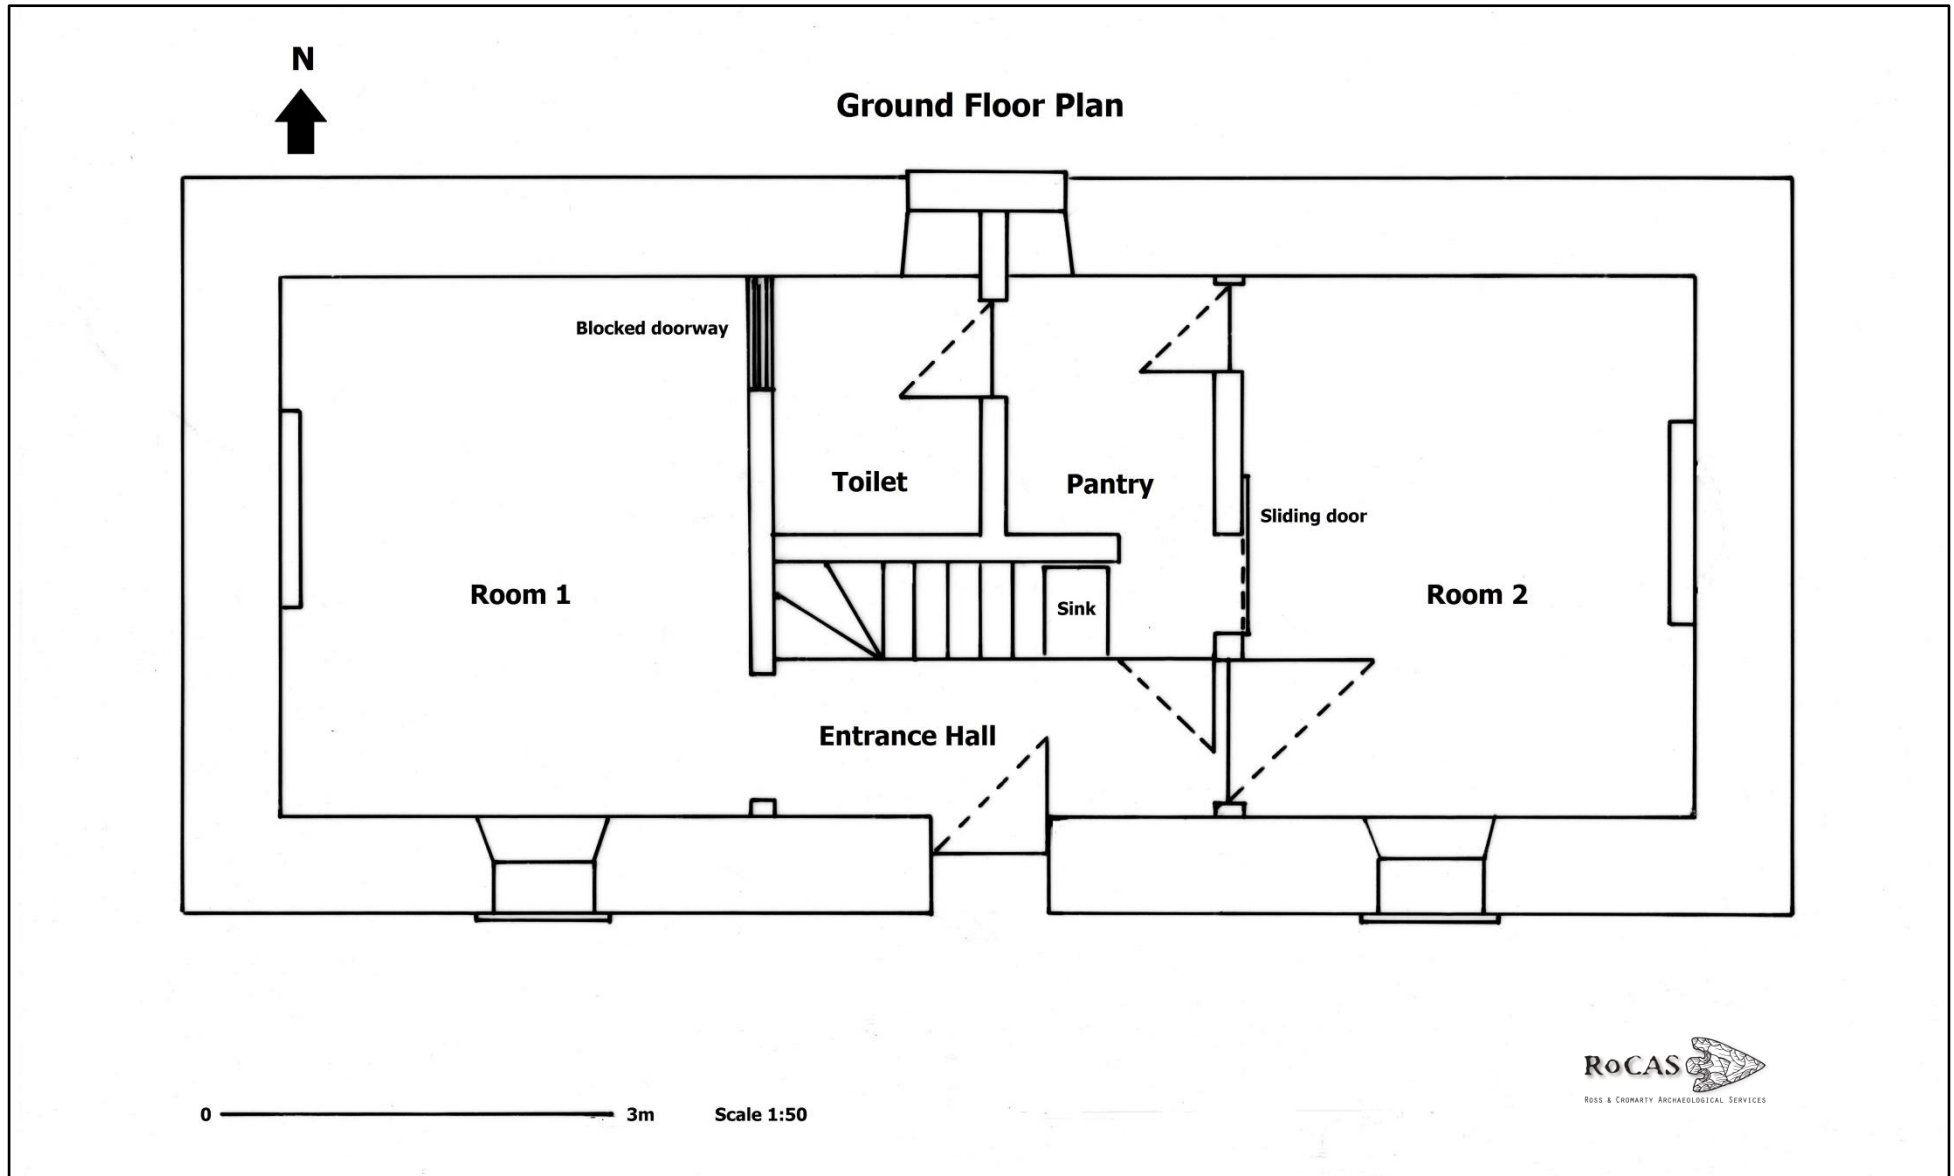
Figure 3: Ground floor plan

The ground floor consists of an entrance hall and staircase, two public rooms and a small rear pantry and toilet. Reference should be made to the ground floor plan (Figure 3) for orientation purposes. The floor throughout consists of poured concrete, which probably replaces an earlier wooden or beaten earth floor of which no trace remains. The floor to ceiling height is 2.1m.

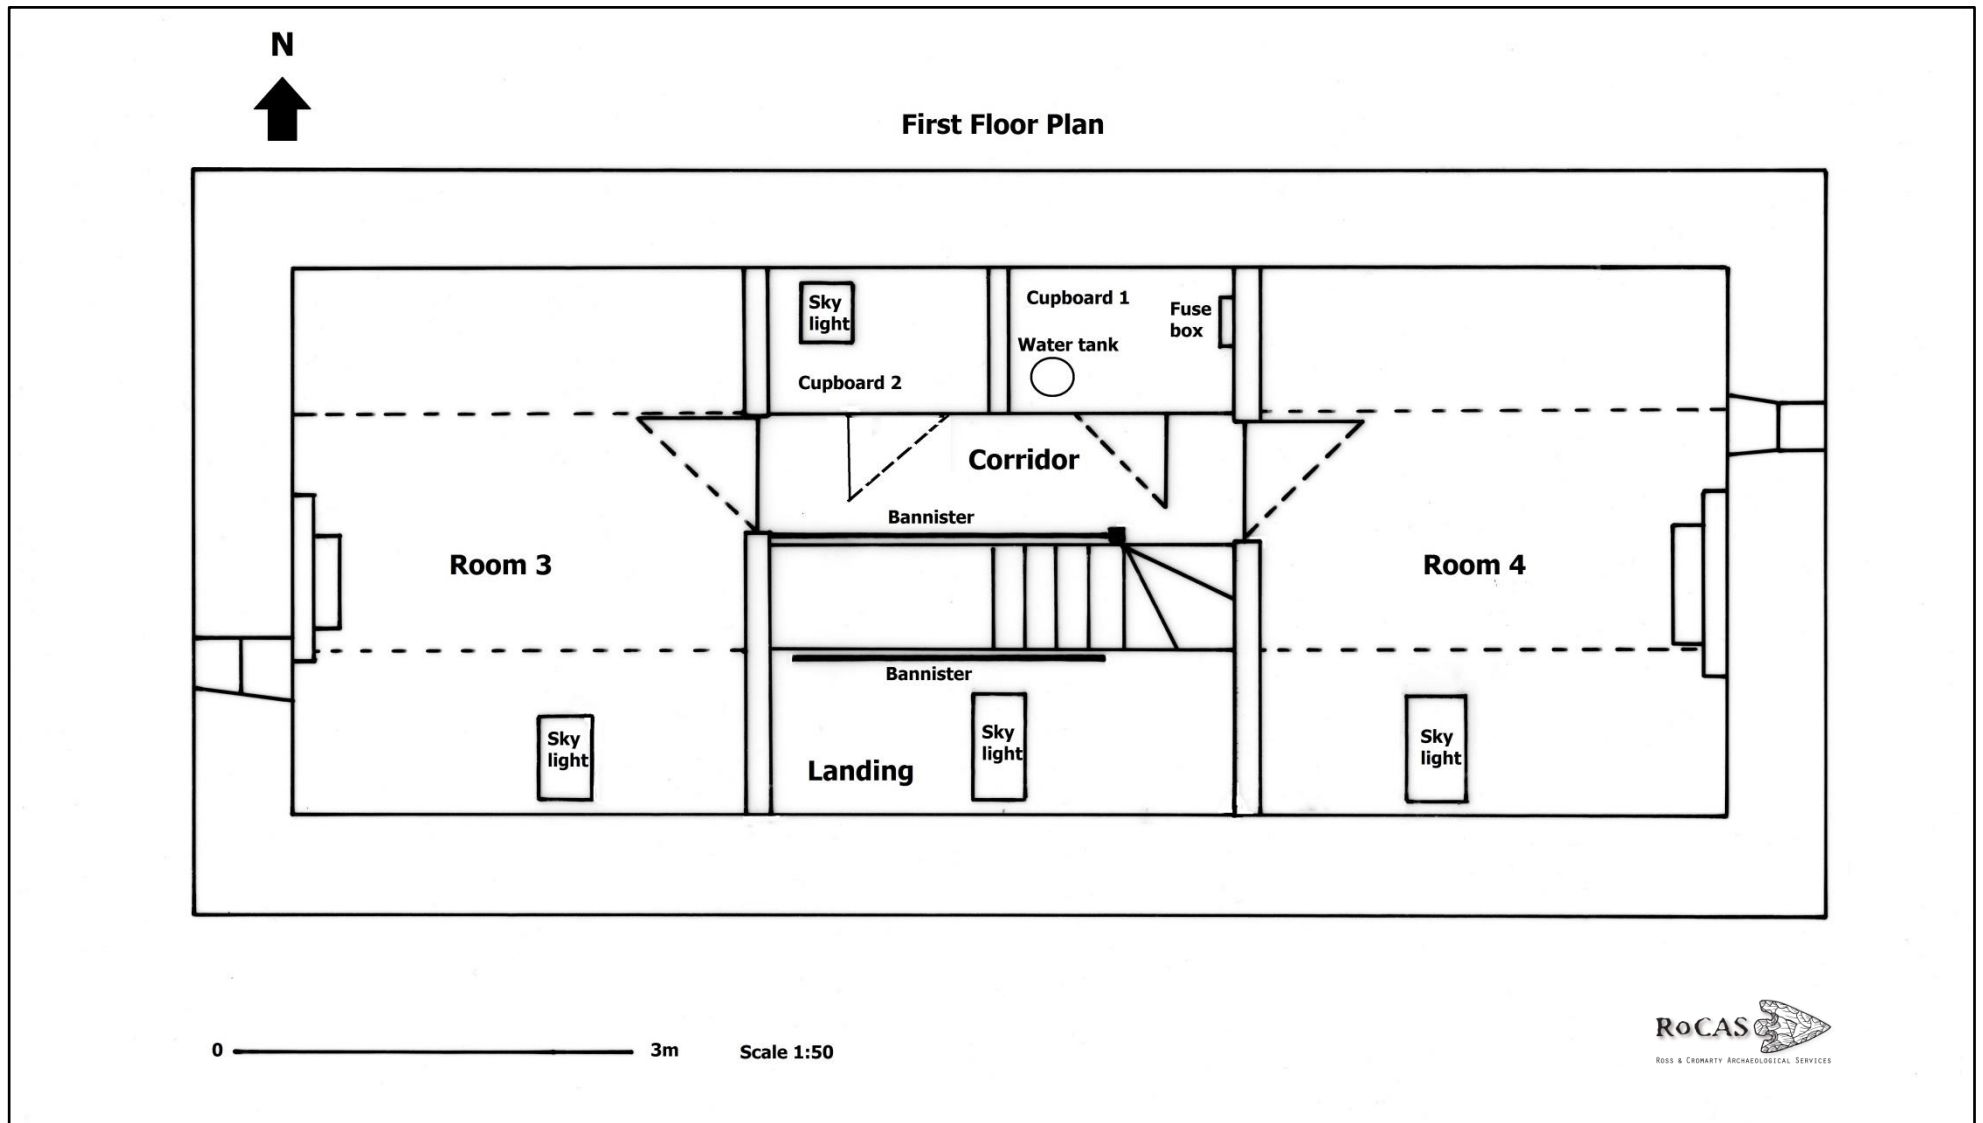
Figure 4: First floor plan

The first floor consists of a split landing, two public rooms and two walk-in cupboards. Reference should be made to the first floor plan (Figure 4) for orientation purposes. The flooring throughout most of the first floor is dark brown, close-grained wood, which changes outside Room 3 to much more open-grained, paler boarding suggesting it is a later replacement.
