A Report to G. R. Merchant Ltd, Architectural and Planning Consultants on behalf of Mr and Mrs Hartfill

AGRICULTURAL BUILDINGS ON LAND ADJACENT TO ABENDBLOEM, TOWN DAM LANE, DONINGTON, LINCOLNSHIRE

Historic Building Recording

Site Code: TDLD12
LCCM Accession No.: LCNCC 2012.112
OASIS ID: withamar1-132339
South Holland Planning Application No.: H04-0626--09
NGR: TF 2054 3505

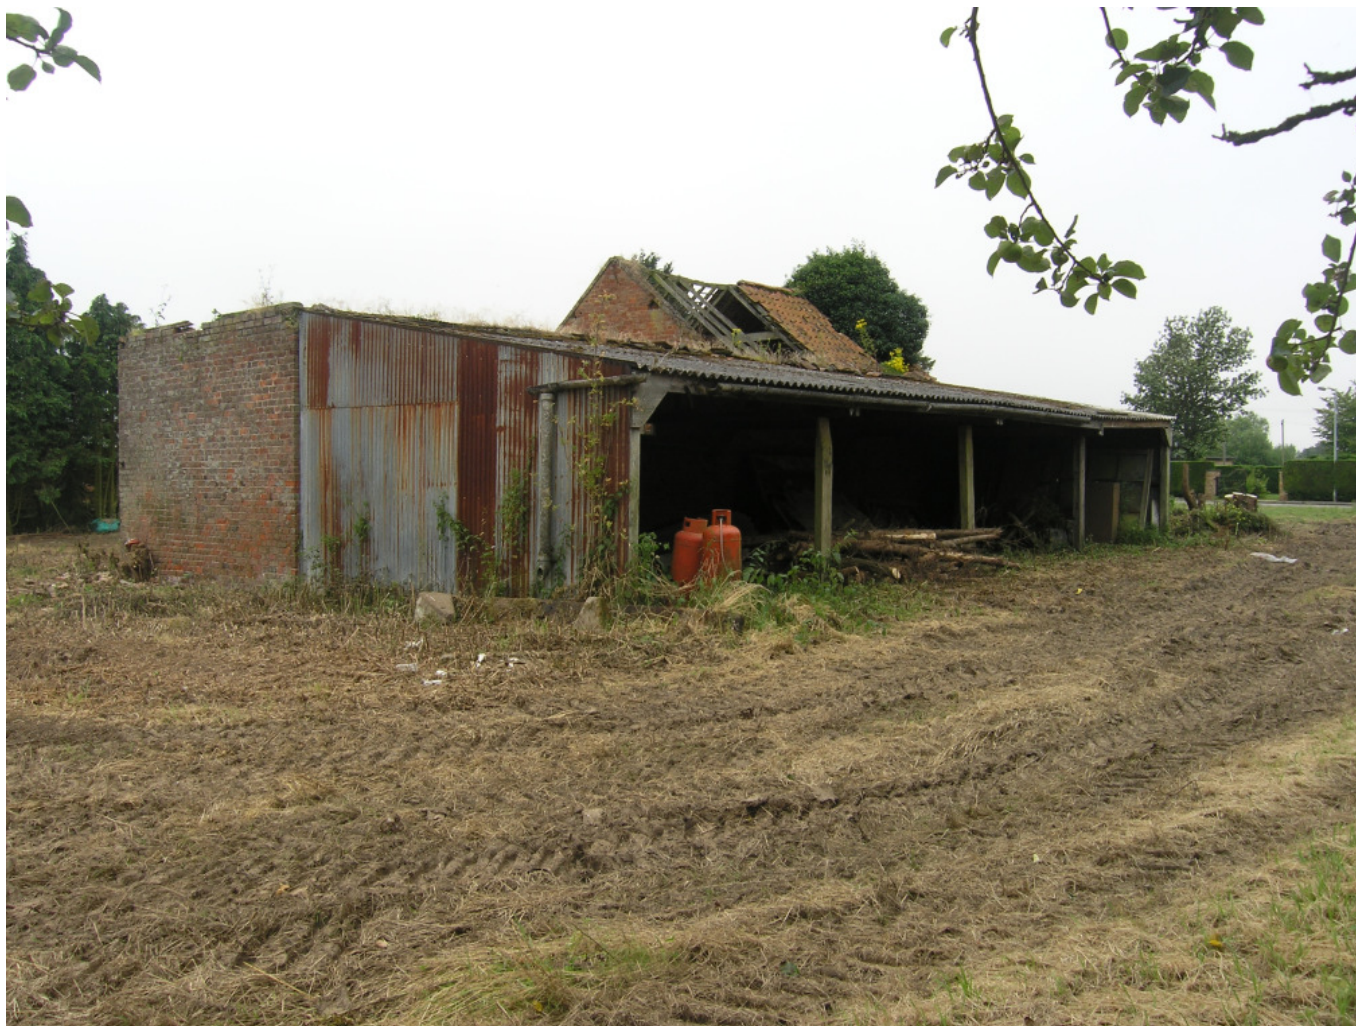
Plate 2: Buildings viewed from the east, looking west

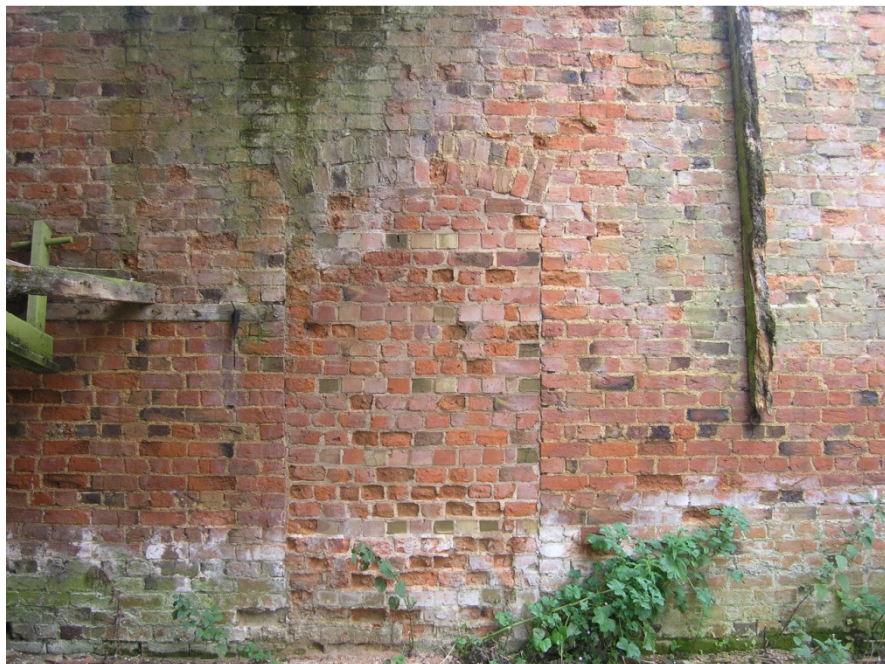
The large door in the main elevation is opposed by a much narrower door in the rear wall. The latter, which is bricked up, can be seen from the interior of Building 3 (Plate 5). It is consistent in style with the barn door, with a shallow arch and identical brick detail, and is clearly an original feature. There are four ventilation slots in the rear wall, arranged symmetrically in pairs either side of the door.

Plate 8: Blocked in doorway seen from the inside of Building 1

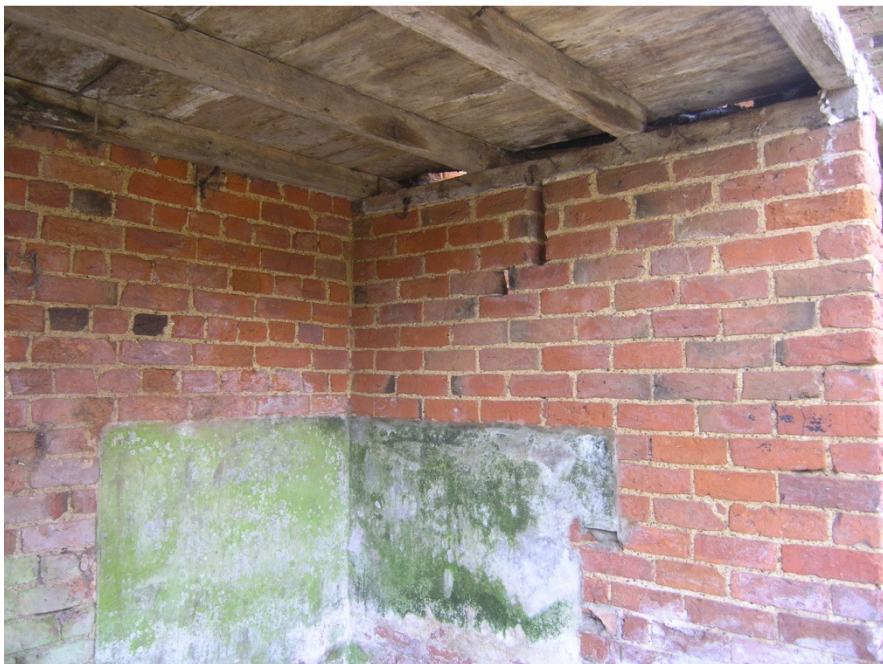
A chimney (see *Plate 9* and chimney on *Plate 1*) rises through the mezzanine floor at the western corner of the building. The lower extent of the structure has been demolished but dark staining on the walls indicates the position of the flue. Built from machine made bricks, the structure does not appear to be an original feature and is not keyed into the wall. The most likely function of the feature would have been as the flue for equipment used in fodder preparation, probably located in the adjacent area where the walls are lined with cement (*Plates 9 & 10*).

Plate 10: Lined area adjacent to the chimney in Building 1

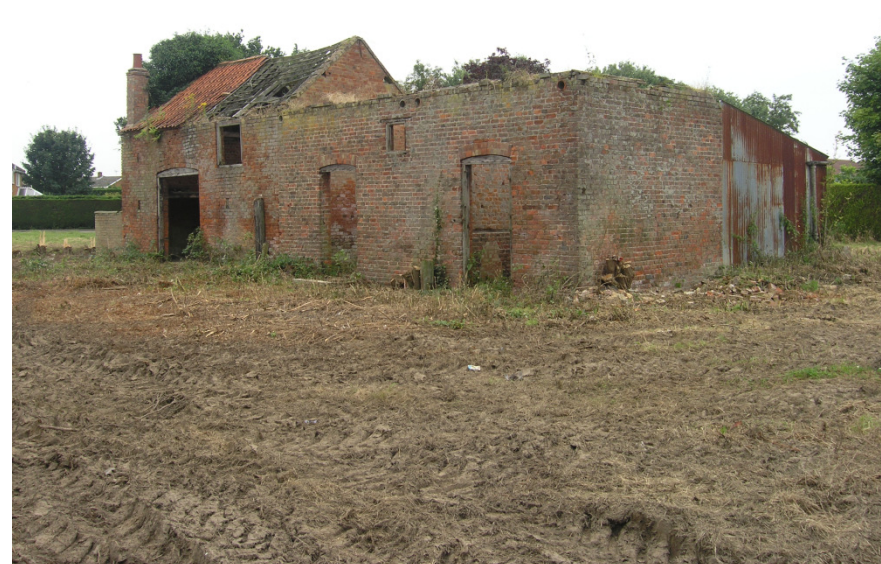
Plate 12: Building 2 in the foreground, viewed from the south

Building 2 is 8.65m long x 4.75m wide (external dimensions), abutting the southeast end of Building 1. The walls are built from handmade brick (slightly darker in colour than Building 1) averaging 235 by 70mm in size, bonded by light grey mortar with frequent hard, black inclusions. The bricks are arranged in irregular courses featuring occasional $\frac{3}{4}$ bricks and randomly distributed runs of headers. The building is divided by an internal brick wall into two units, the larger on the northwest side.

The roof of the building 2 has been completely removed but appears to have been gabled to the southeast (as seen on the 1971 aerial photograph).

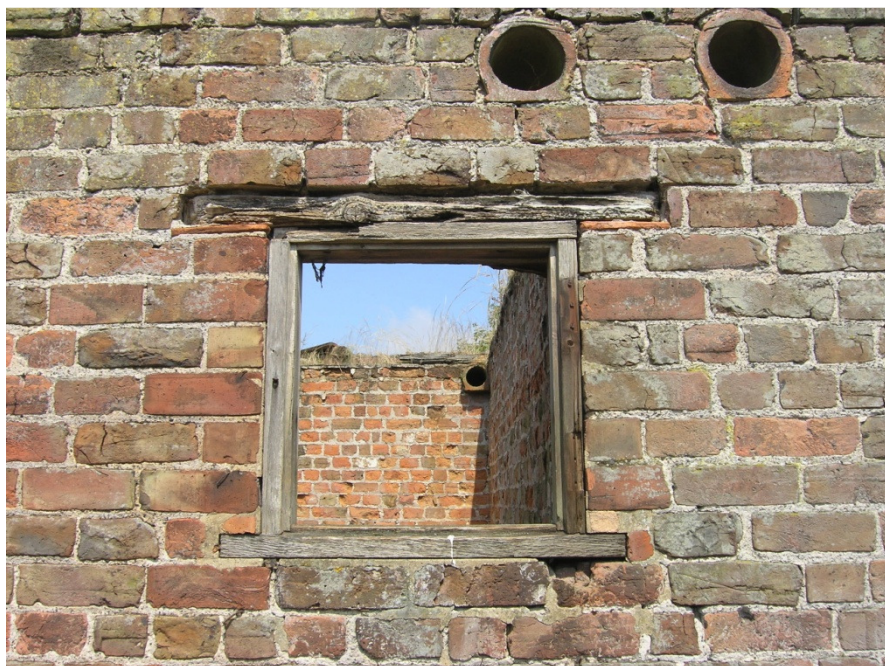
Plate 13: Building 2 – high level opening to Unit A

There are separate doors into the two units (hereafter the larger unit is designated A, the other B), both with shallow arches detailed in brick (*Plate 14*). There is a small, high level opening in the front elevation of Unit A, immediately adjacent to the internal wall (*Plate 13*). Cylindrical, ceramic vents are present at the corners of each unit, at high level just beneath the wall plates.

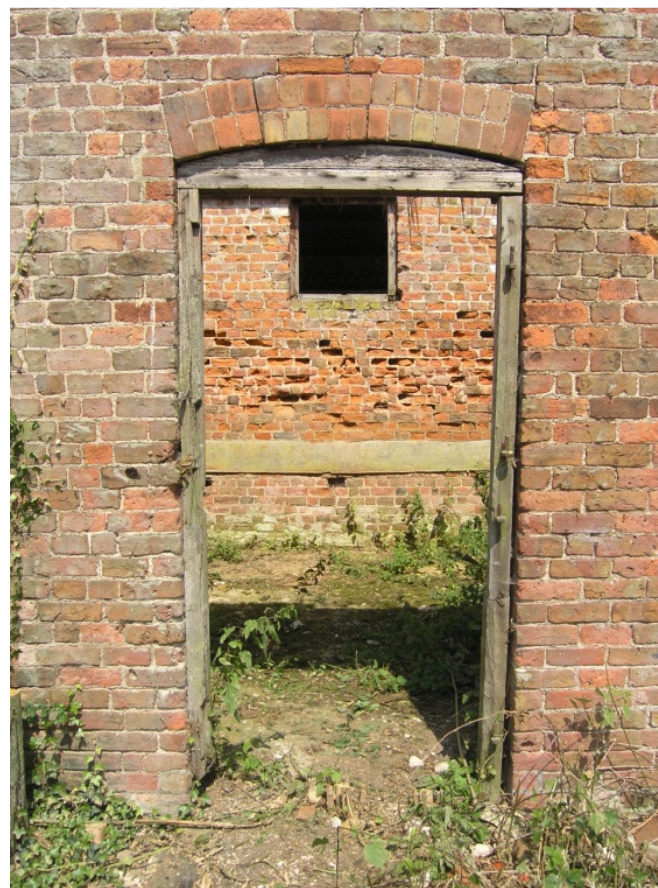
Plate 14 – Building 2 – door to Unit B

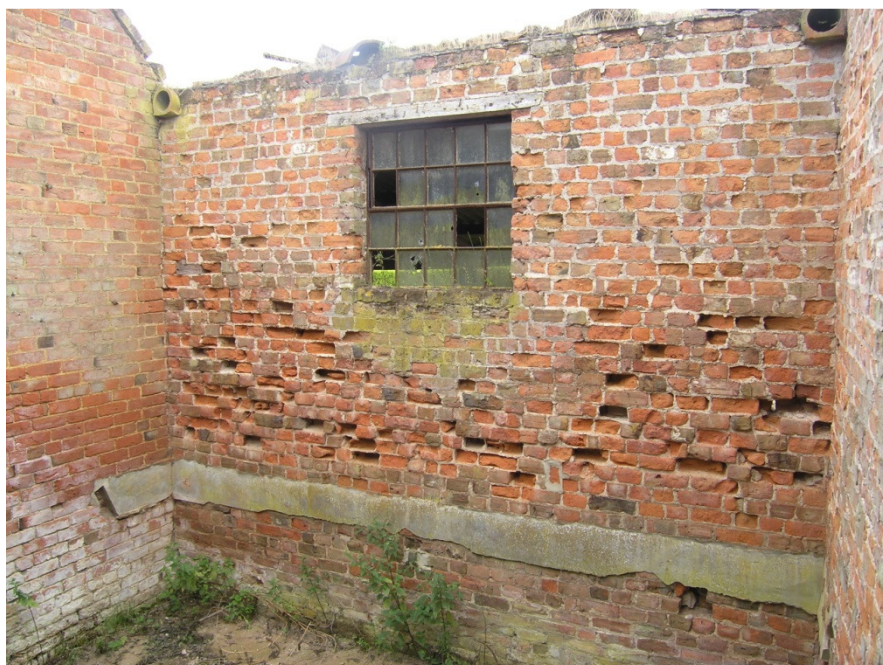
Plate 15: Building 2 – rear of Unit A

In Unit A the manger was approximately 0.75m above floor level, resting upon supports indicated by three sockets beneath; two of the sockets contain the sawn off ends of timbers. Sloping recesses in the adjacent walls (*Plate 15*) mark the position of the front of the manger while three sockets in the concrete floor indicate the positions of upright supports (one shown in *Plate 16*).

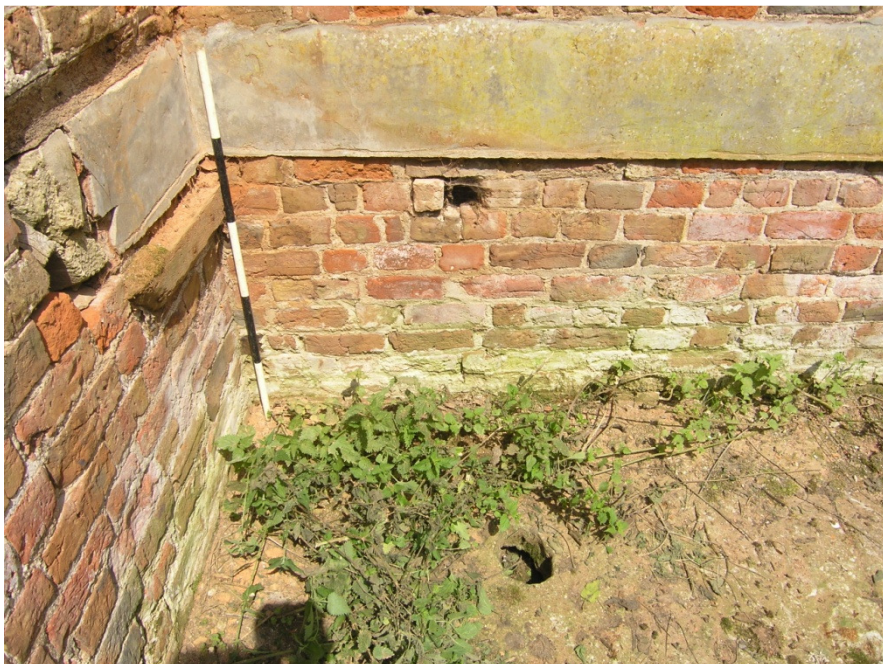
Unit B has a similar arrangement for a manger, differing only in the number of upright supports (two in Unit B, see *Plate 20*) and the survival in Unit B of timbers components let into the walls at the side (also *Plate 21*).

Plate 21: Building 2, Unit B – northwest end of manger (1m scale)

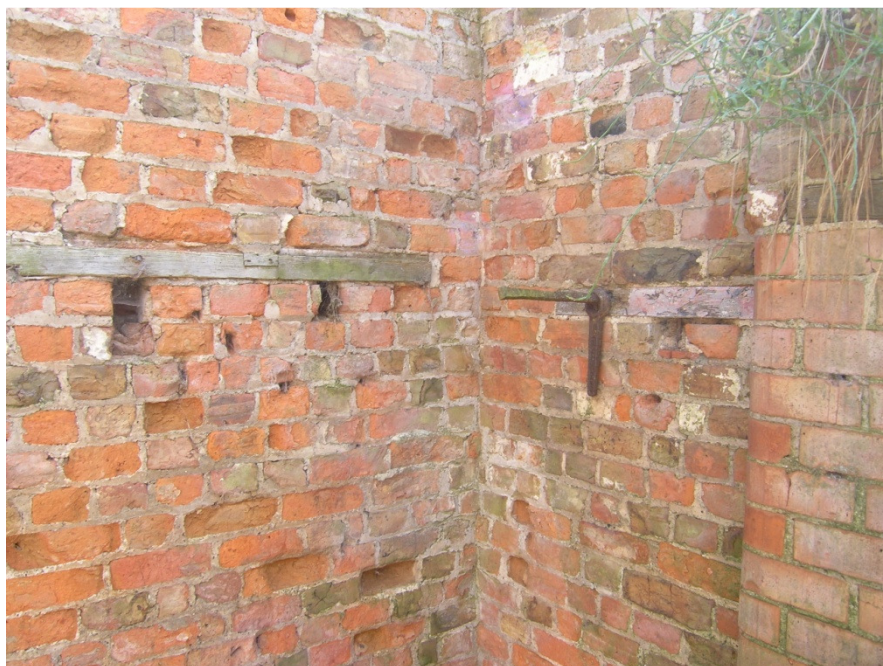
The door in Unit B (Plate 22) is identical to Unit A and there are similar arrangements of timbers let into the walls (Plate 23). There is, however, an iron peg projecting from the timber southeast of the door and a spanner looped over the peg (Plate 24). The timber in the end wall had two sockets below - presumably for supports to a timber structure - and a hinge on its face.

Plate 23: Building 2, Unit B – detail adjacent to the doorway

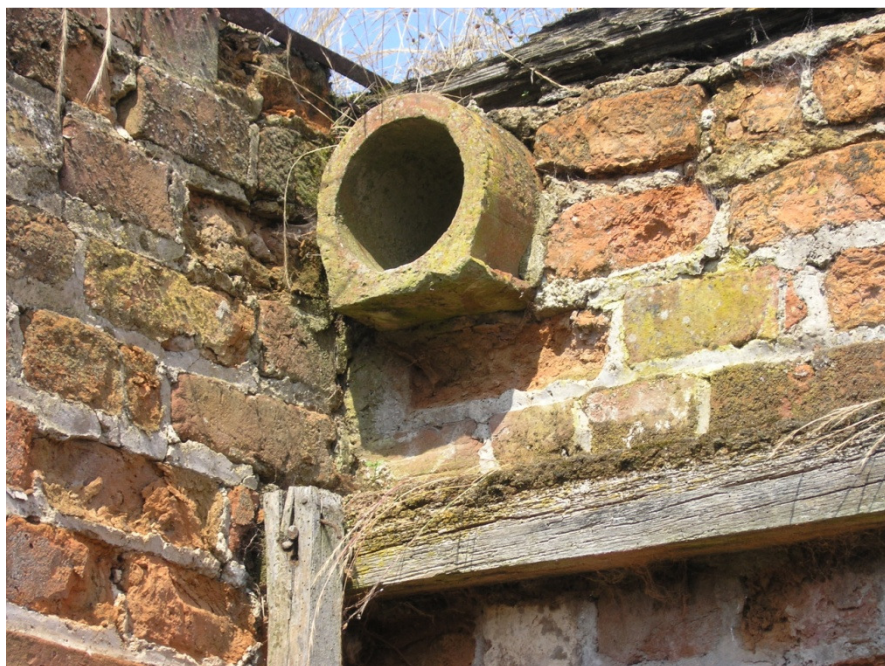
Plate 25: Vent at in the rear wall of Unit B

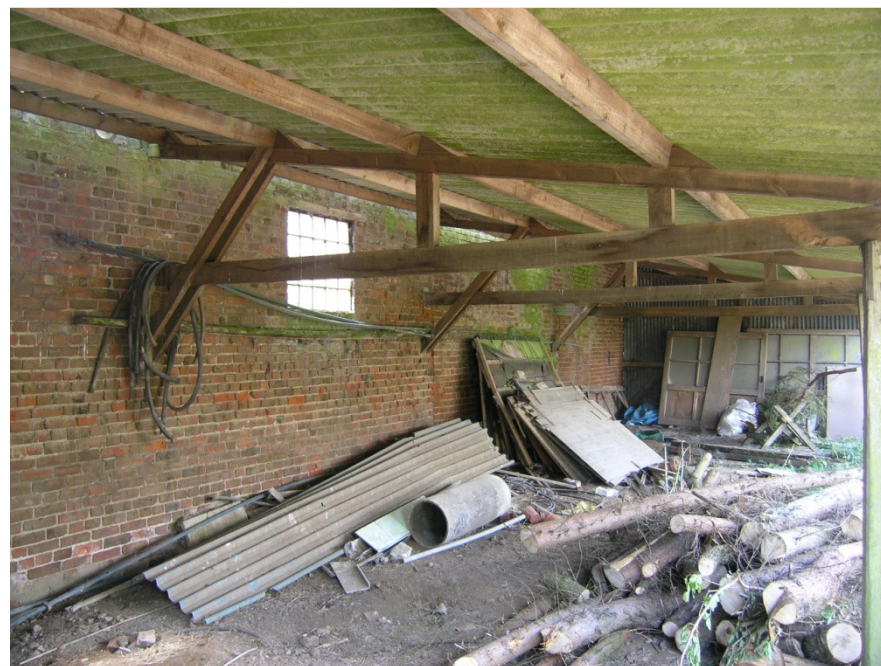
Plate 28: Building 3 – interior, looking west

Building 3 is an open sided shed or lean-to constructed against the rear walls of Buildings 1 and 2 (*Plate 27*). The roof covering of corrugated asbestos sheets rests upon three trusses attached to rear wall of brick structure at one end and carried by timber post at the other (*Plate 28*). Sheets of corrugated iron enclose the ends of the structure.
