A report to Hereward Homes Ltd.

September 2014

## **MANOR FARM, MANOR FARM LANE, ESSENDINE, RUTLAND**

### **Historic Building Recording**

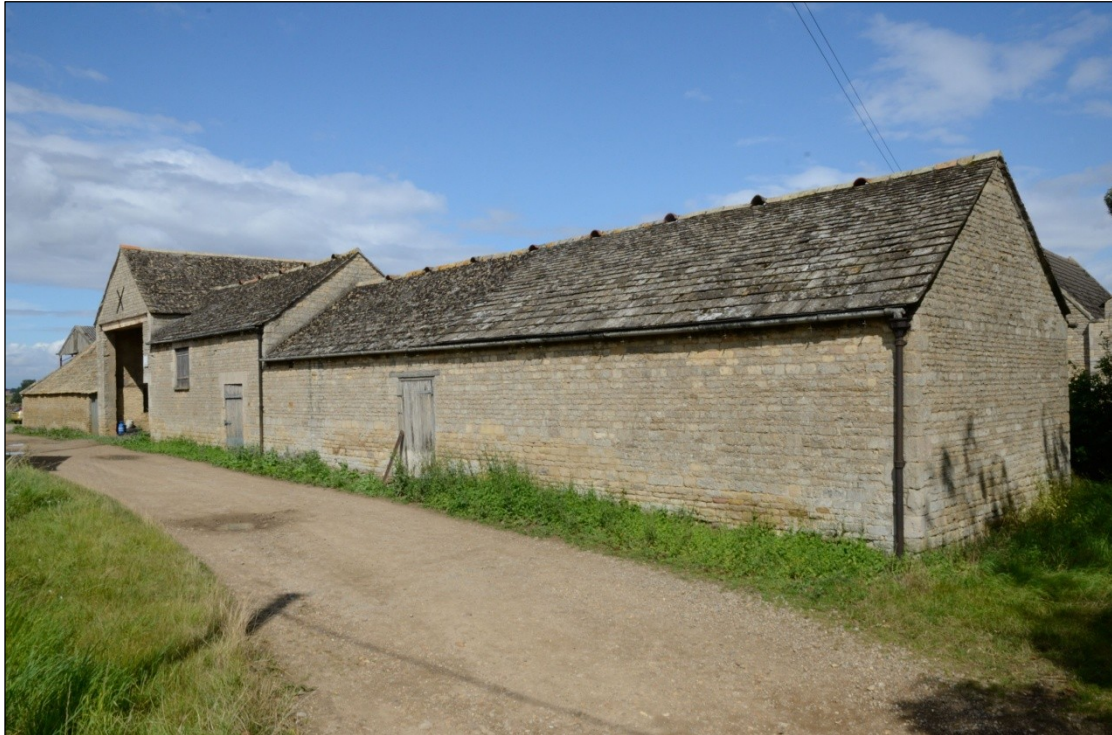
Commencing at the northern end of the west elevation, the gable of the two-storey structure (*Plates 2 and 57*) features a large opening inserted for access by modern farm machinery. The gable above is supported by a steel girder. Part of an original doorway survives at ground floor on the south side of the opening, defined by detailing in dressed stone and a stone lintel (*Plate 3*). The treatment is identical to that seen around the openings elsewhere in Unit 5.

*Plate 2: Buildings east of the access track; west facing elevations, looking north*

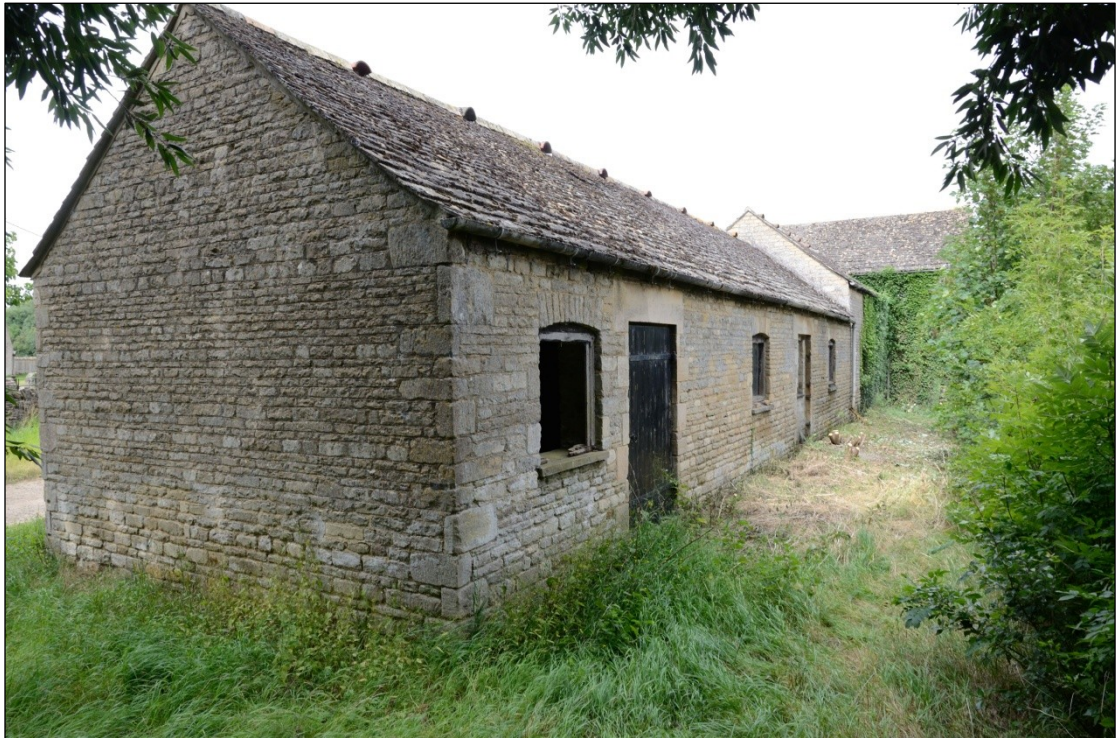
The southern elevation of the tack room is plain (*Plate 7*). The door to the room is on the east side of the building (*Plates 7 and 8*), detailed in finely dressed stone and flanked to the south by a window or vent.

*Plate 7: Building 5 (B, C and D), east and south facing elevations; looking northwest*

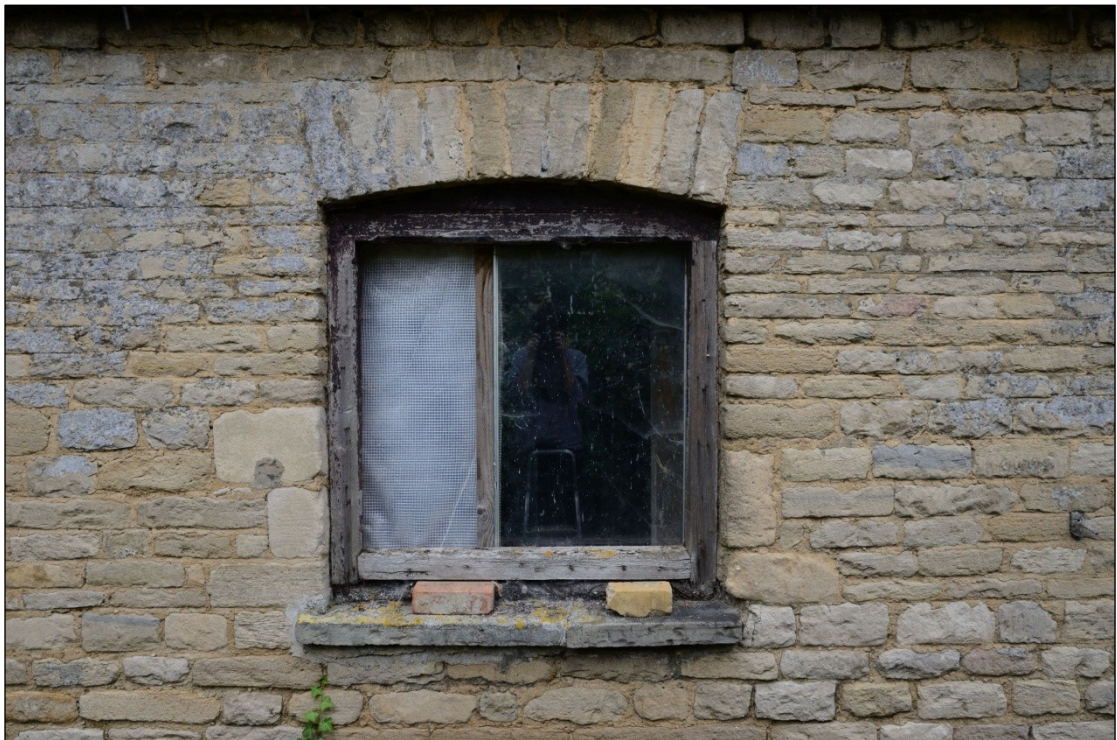
The door to the stable is positioned centrally in the wall to the area (*Plate 10*) with windows/vents placed symmetrically to either side (*Plates 9 and 11*). Although the door has been bricked up and a window inserted, the hooks for split stable doors are intact.

*Plate 9: Window in the east wall, south of the door, of Building 5C, looking west-southwest*

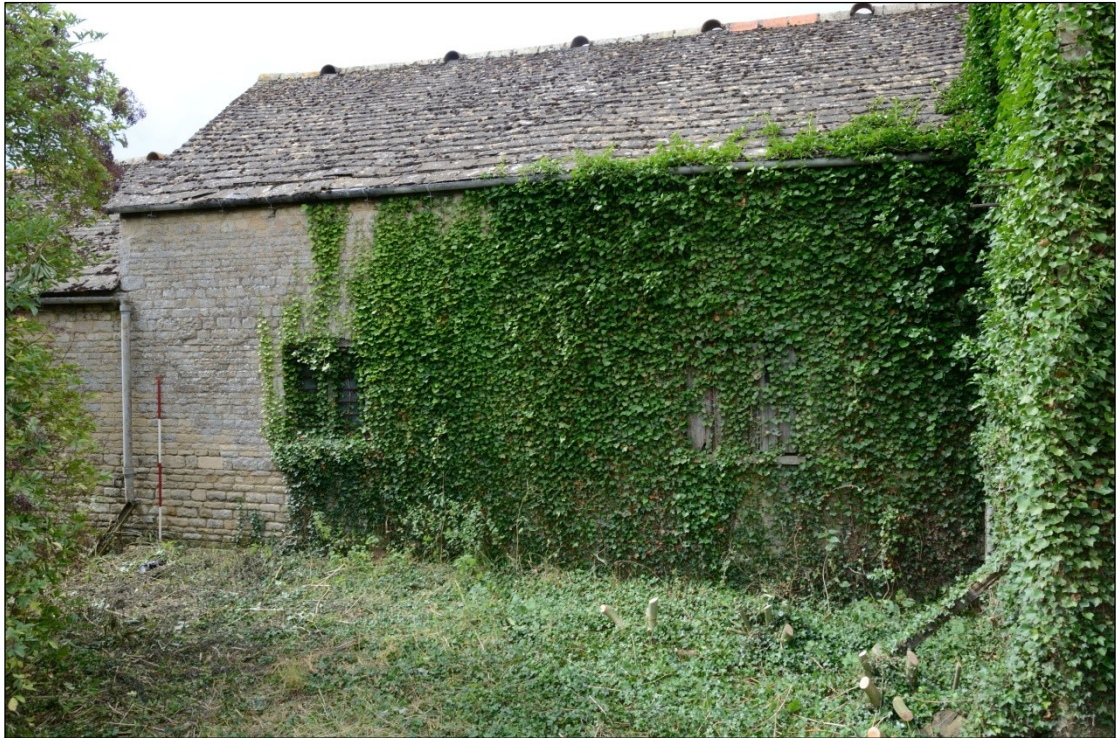
The east elevation of 5B (the chaff house) is heavily obscured by vegetation (*Plate 12*) but appears to be plain except for two windows/vents at ground floor. The southernmost vent (*Plate 13*) contains horizontal iron bars while the northernmost retains a wooden plank shutter (*Plate 14*).

*Plate 12: East side of Building 5B, looking southwest (2m scale)*

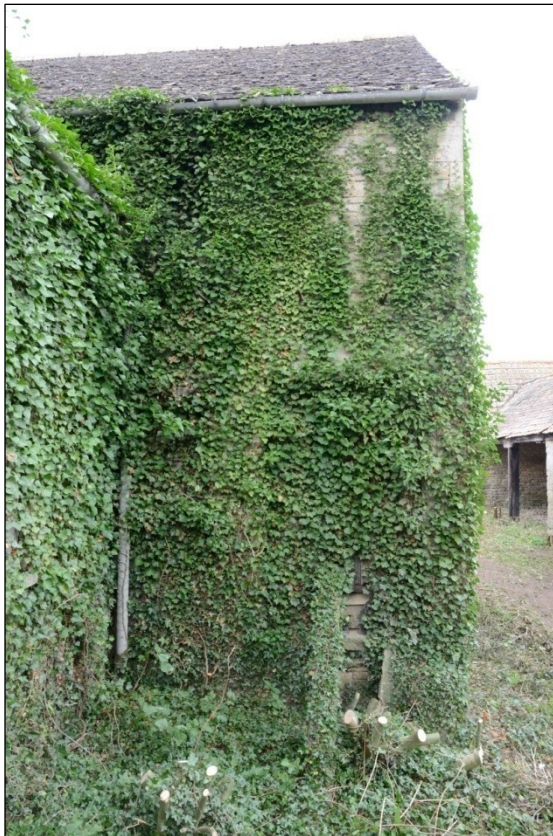
The south wall of building 5A is also heavily obscured by vegetation (*Plate 15*) and little can be seen of the openings for a door and windows which are visible in the interior of the building (see *Plates 24 and 25* as well as descriptive text below).

*Plate 15: South facing elevation of Building 5A, looking north-northwest*

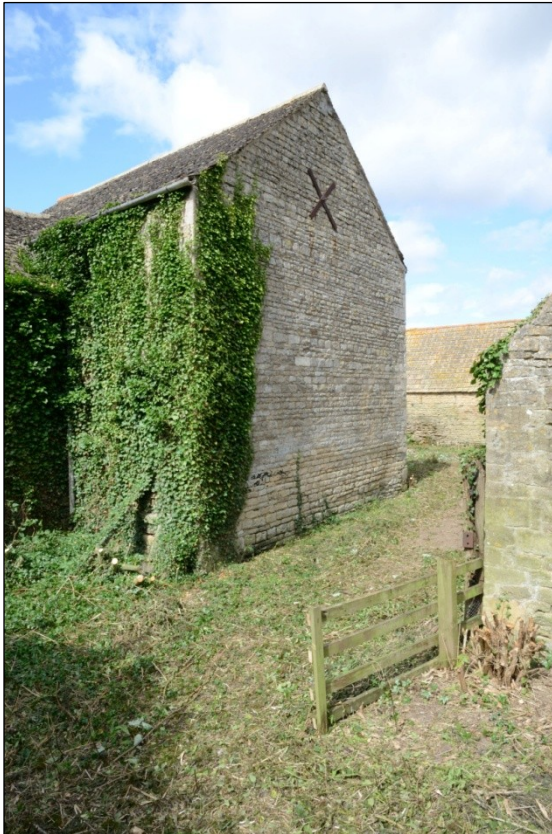
The east gable is plain, except for a tie-plate at approximately eaves level (*Plate 16*). The north elevation (*Plate 17*) contains four openings for windows/vents arranged symmetrically on ground and first floors. The windows are barred in similar fashion to those in 5B (*Plate 18*) and a wooden plank shutter survives in the westernmost ground floor example (*Plate 19*).

*Plate 16: East facing elevation of Building 5A, looking northwest*

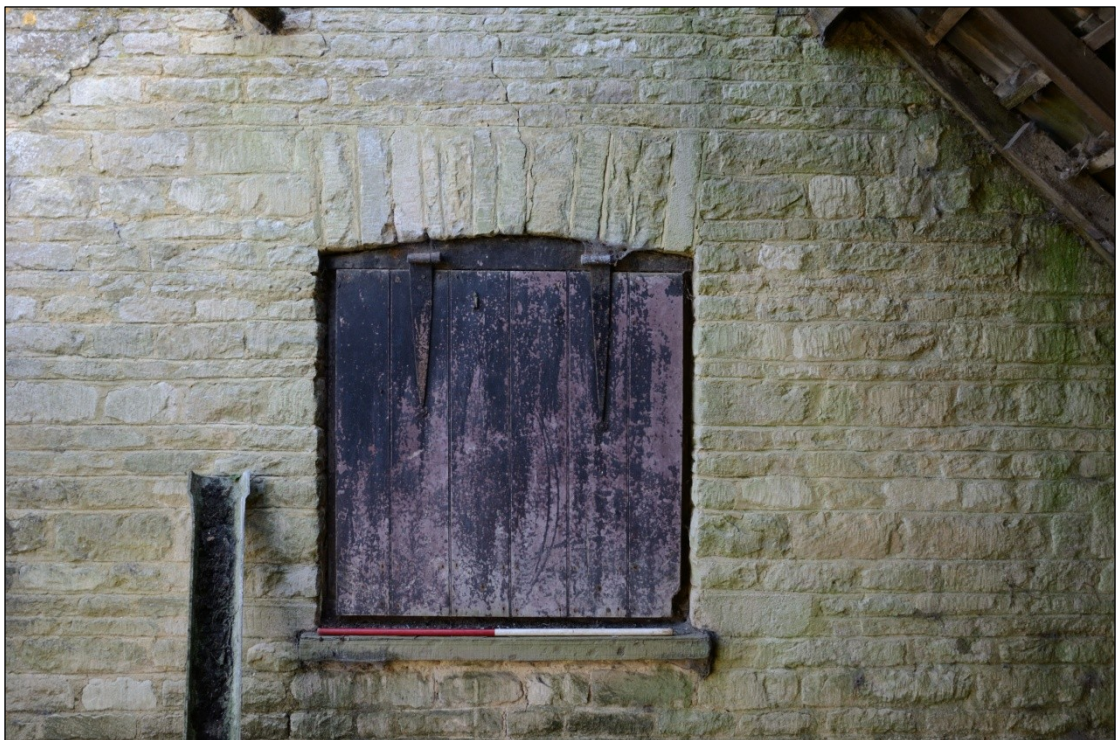
*Plate 19: Window in the north facing elevation of Building 5A, looking south-southeast (1m scale)*

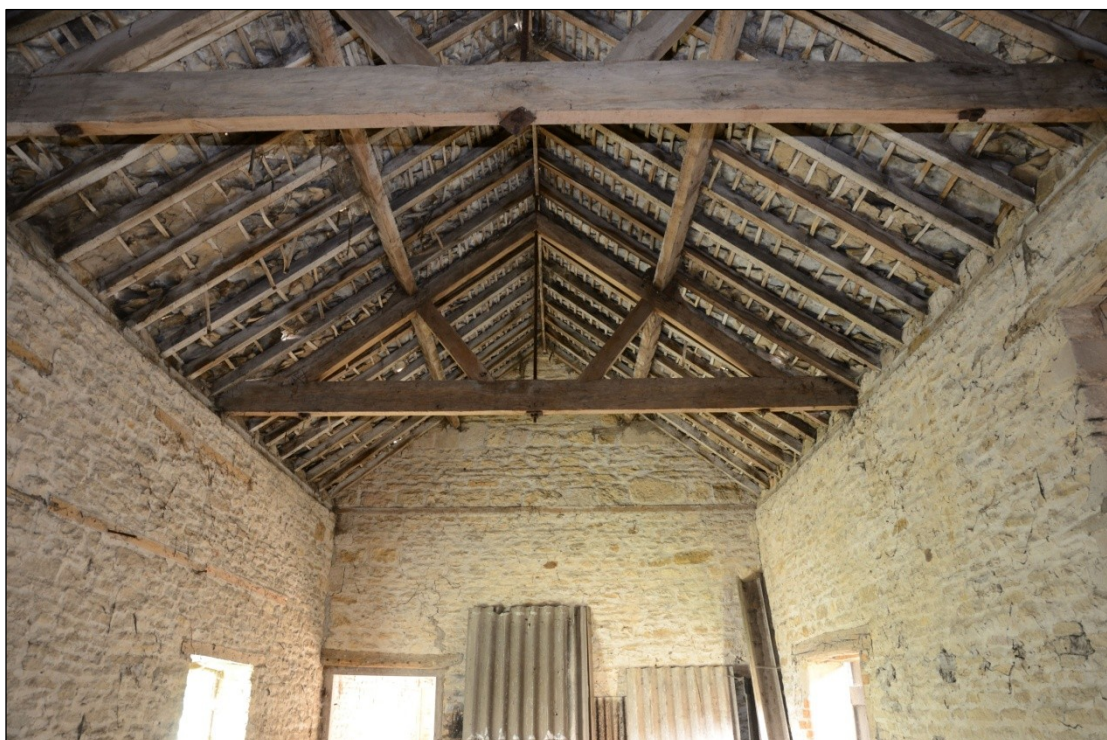
Building 5B – presumably a chaff house – features high walls and is open to the roof (*Plate 26*). At the southern end there is a doorway providing access to and from the stable (5C). The doorway features a timber lintel above and has a wooden frame (*Plate 28*) but the door is missing. The door in the west wall (*Plate 29*) has rounded edges formed by dressed limestone and bull-nosed bricks, similar to the door in 5A. There is graffiti on both inside faces of the doorway including the date ‘1915’ on the south side (*Plates 30 and 31*). There is a pitching door high in the west wall (*Plate 32*) and two windows/vents in the east wall (*Plate 33*). The roof is identical in construction to 5B, having two trusses (*Plate 34*). A modern concrete floor extends throughout the unit.

*Plate 34: Roof structure in Building 5B, looking south-southeast*

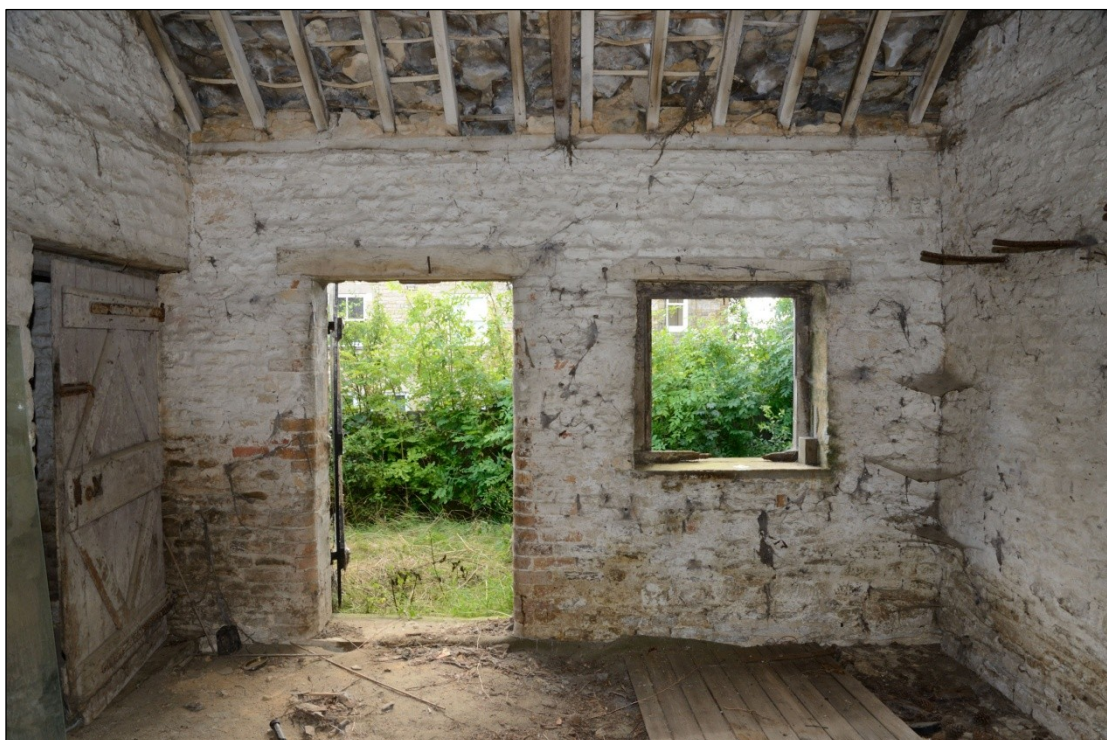
A small unit at the southern end of the range would appear to have served as a tack room. The door in the east wall is original and in keeping with treatment elsewhere in the building (*Plate 44*), while a door in the north wall provides access to the stable (*Plate 45*). Harness pegs are present on three sides of Unit 5D (*Plate 46*) and the floor is of large cobbles (*Plate 47*) which may be original. There is graffiti on the sides of the doorway (*Plate 48 and 49*) but no particular initials or dates could be discerned.

*Plate 44: Interior of Building 5C, looking east-northeast*

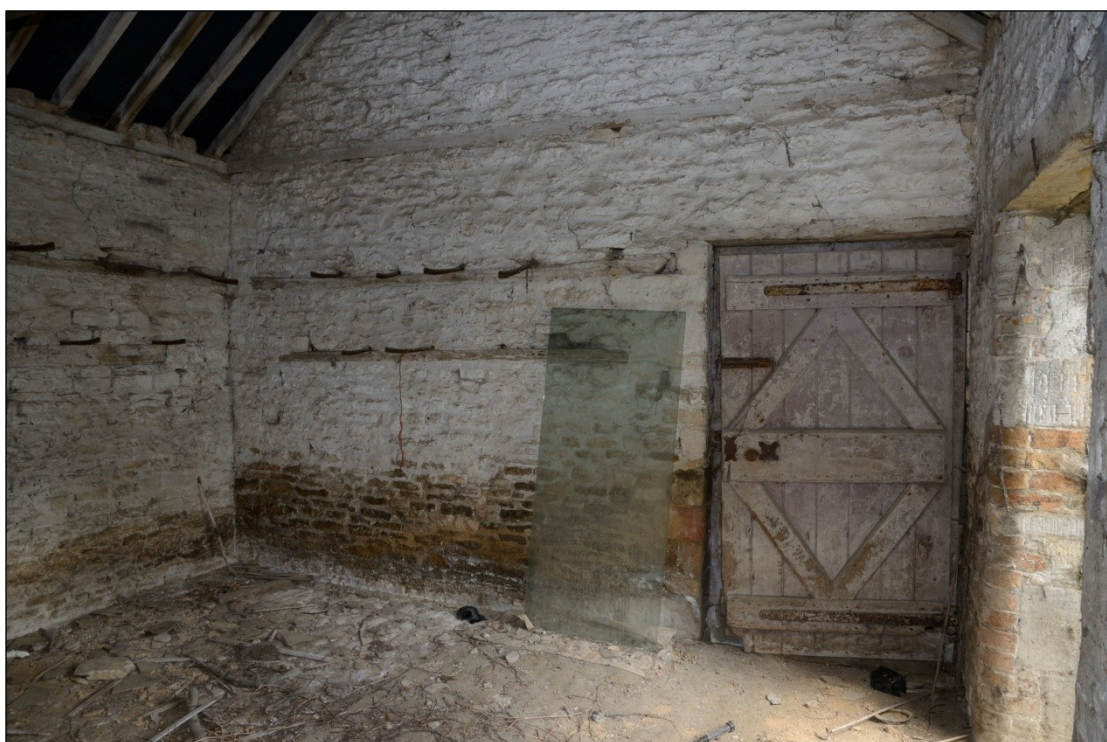
*Plate 45: Interior of Building 5C, looking north-northwest*

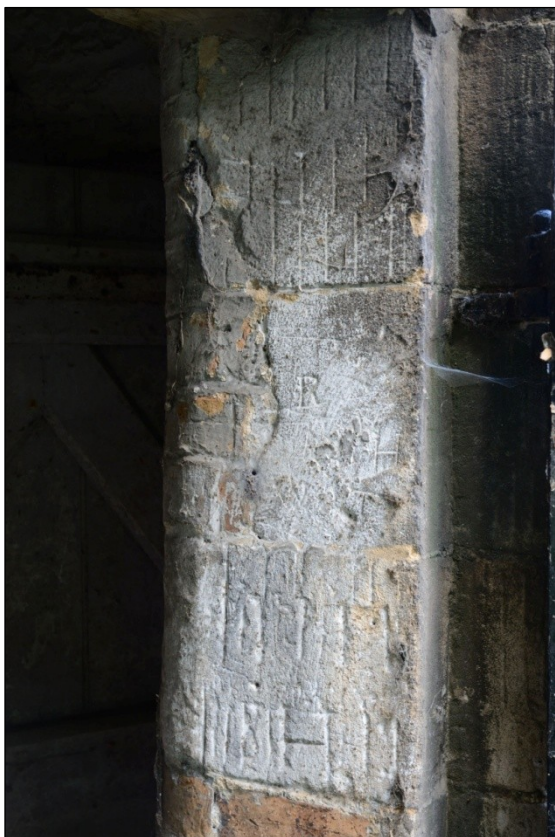
*Plate 48: Graffiti on the north side of the door to Building 5D, looking north-west*

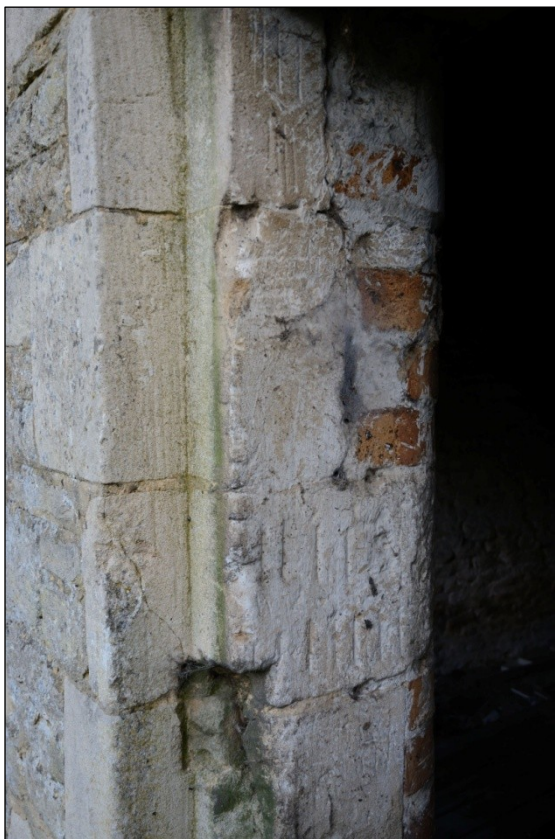
*Plate 49: Graffiti on the south side of the door to Building 5D, looking southwest*

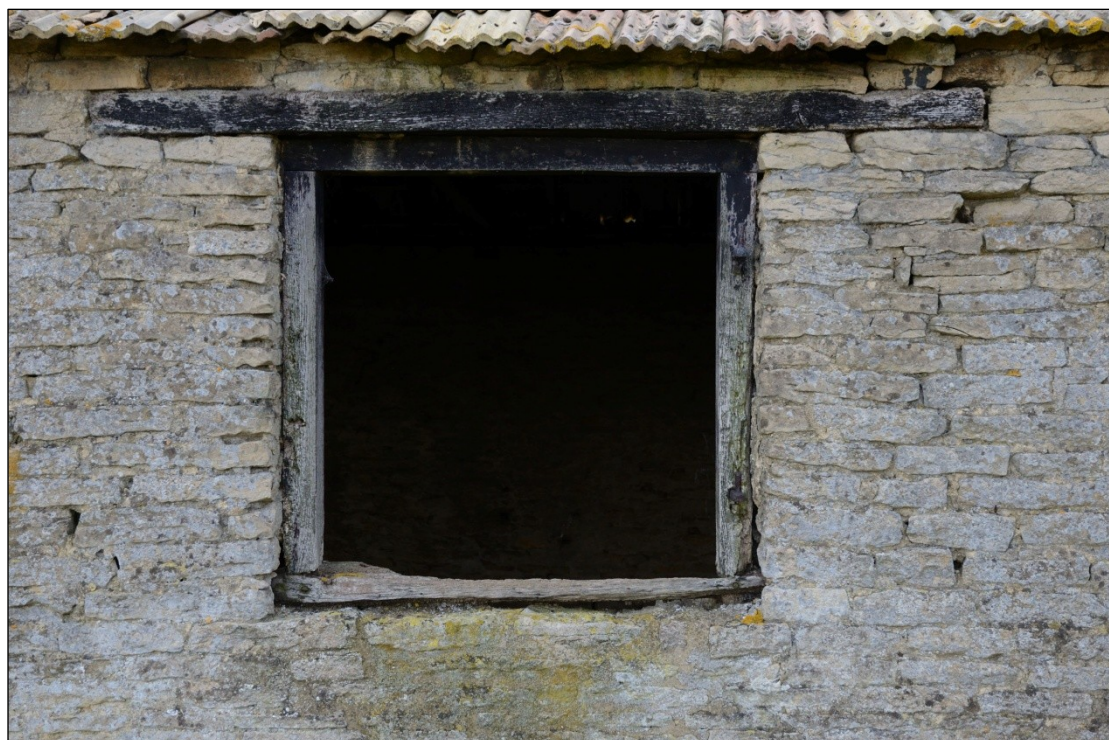
Building 1 features a large ‘barn’ type doorway in the north elevation flanked by a pitching door to the west (*Plate 51*). Both openings have timber lintels and frames but the doors are missing from both (*Plates 51 and 53*). There is a gap between Buildings 1 and 2 bridged by wooden beams to support a continuous roof across (*Plate 54*). The buildings are gabled to either side of the opening (*Plates 55 and 56*) and an offset stone at the northwest corner of Building 1 incorporates a lead setting for the pin of a door or gate. There is also a groove in the side of the stone, which may have received a wooden shutter used to close the opening.

*Plate 53: Pitching door in the north wall of Building, looking south-southeast*

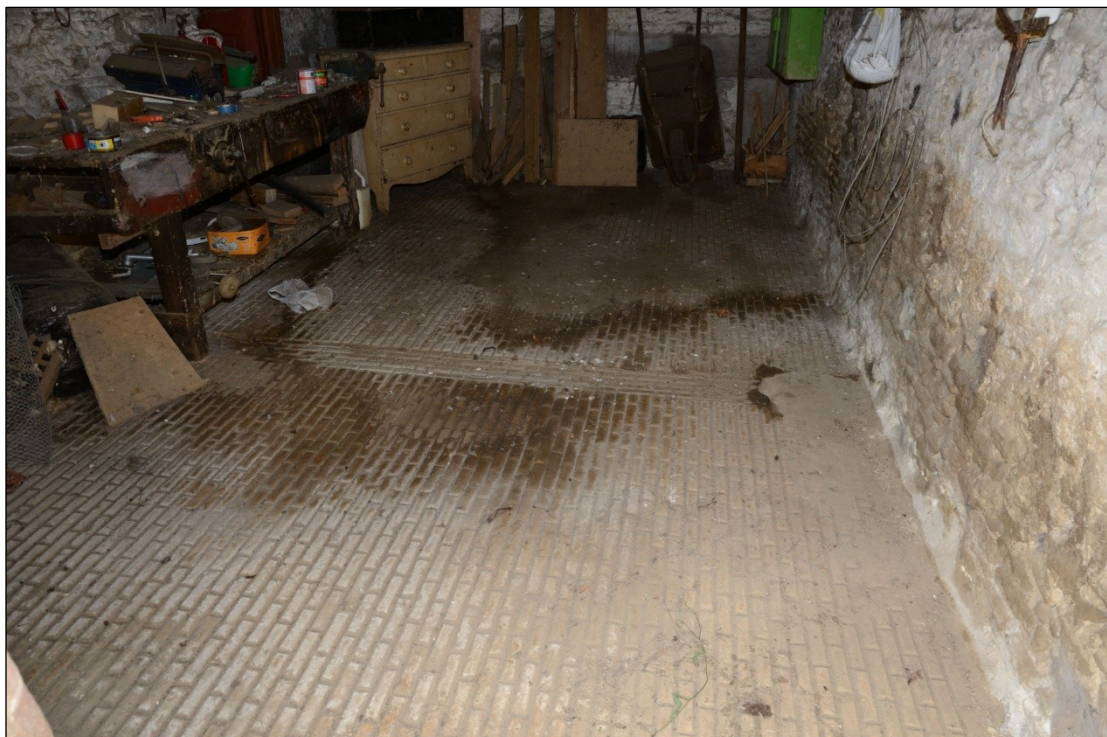
The interior of Unit 6E is now used as a workshop (*Plate 98 and 99*) but would clearly have been an animal house or loose box. A concrete repair on the rear wall may indicate the former position of a manger, while wooden slats in the vent and the tile floor with a central channel for manure (*Plate 100*) provides further indication of use as animal housing.

*Plate 100: Floor in Building 6E, looking west-southwest*

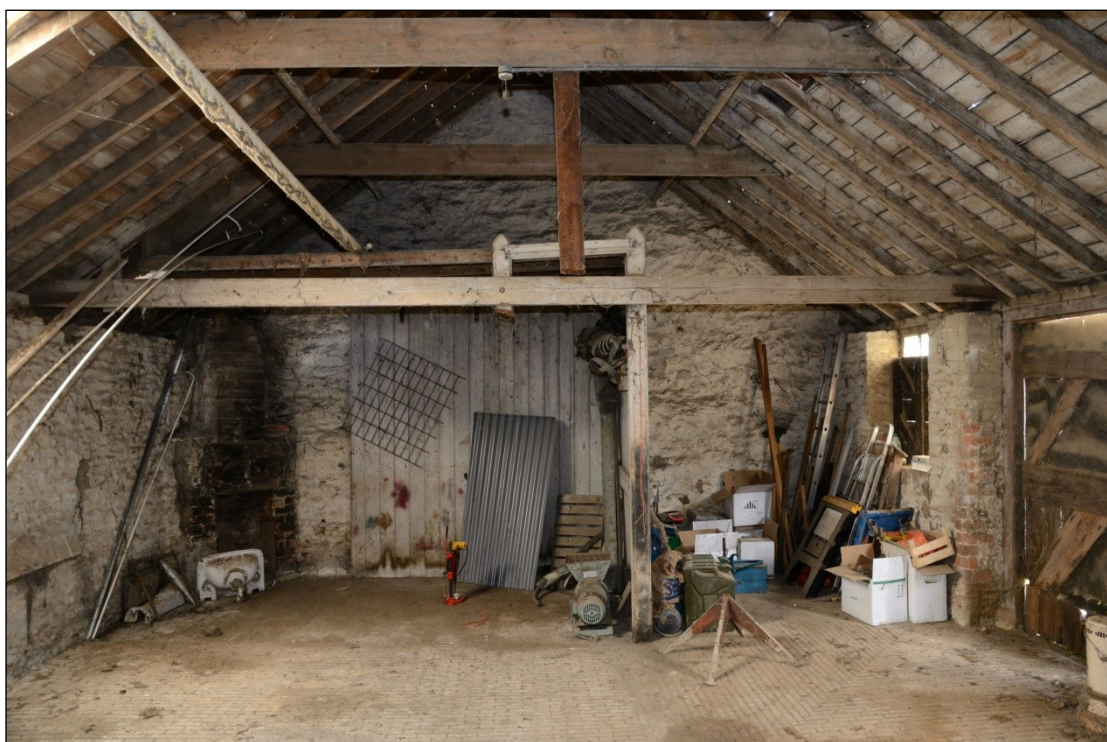
Building 6D (now a lock-up store) would also have functioned as an animal house. Originally there was a partitioned area at the northwest corner of the room (*Plates 101 and 102*) whose extent is defined by brick flooring (*Plate 106*). The tongue and groove partition is intact on the east side, meeting a wooden corner post, and fragmentary remains of the south wall indicate a doorway immediately west of the post. Tongue and groove cladding survives on the north wall. There is a fireplace in the northwest corner of the room containing an eighteenth century cast iron hour-glass hob-grate below a brick chimney stack (*Plate 103*). In view of the layout of the space and the presence of facilities such as the fireplace, the area may be regarded as a tack room and possibly a rest area for the groom.

*Plate 101: Interior of Building 6D, looking north-northwest*

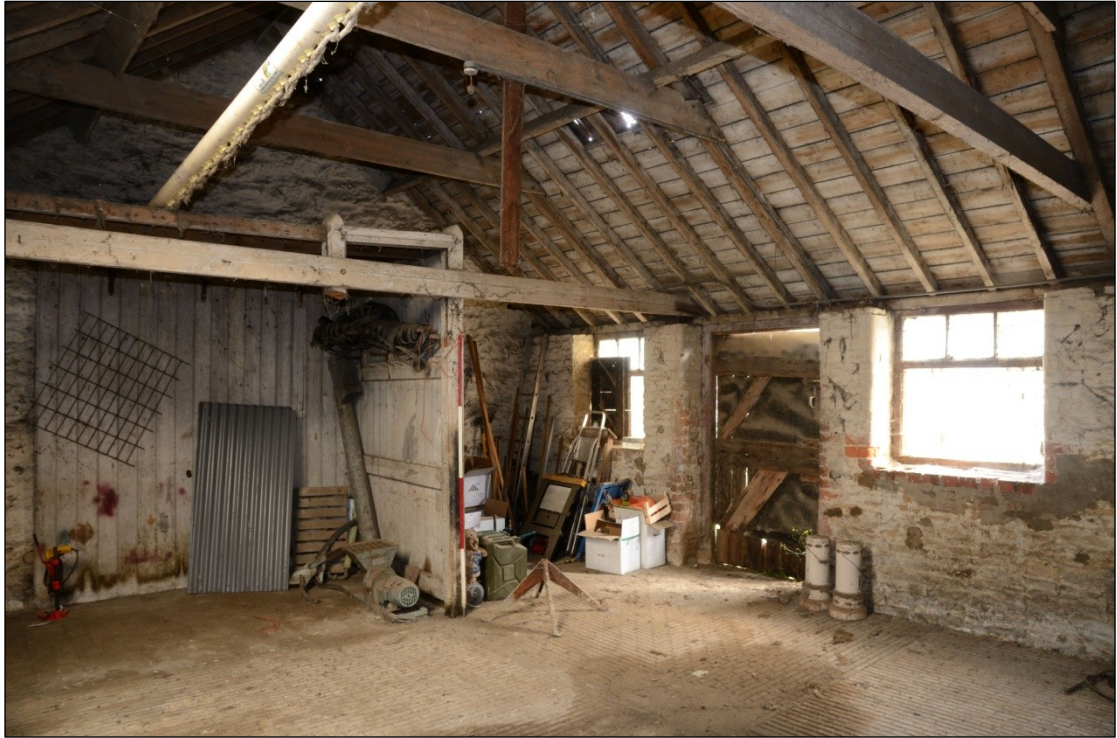
*Plate 102: Interior of Building 6D, looking north (2m scale)*

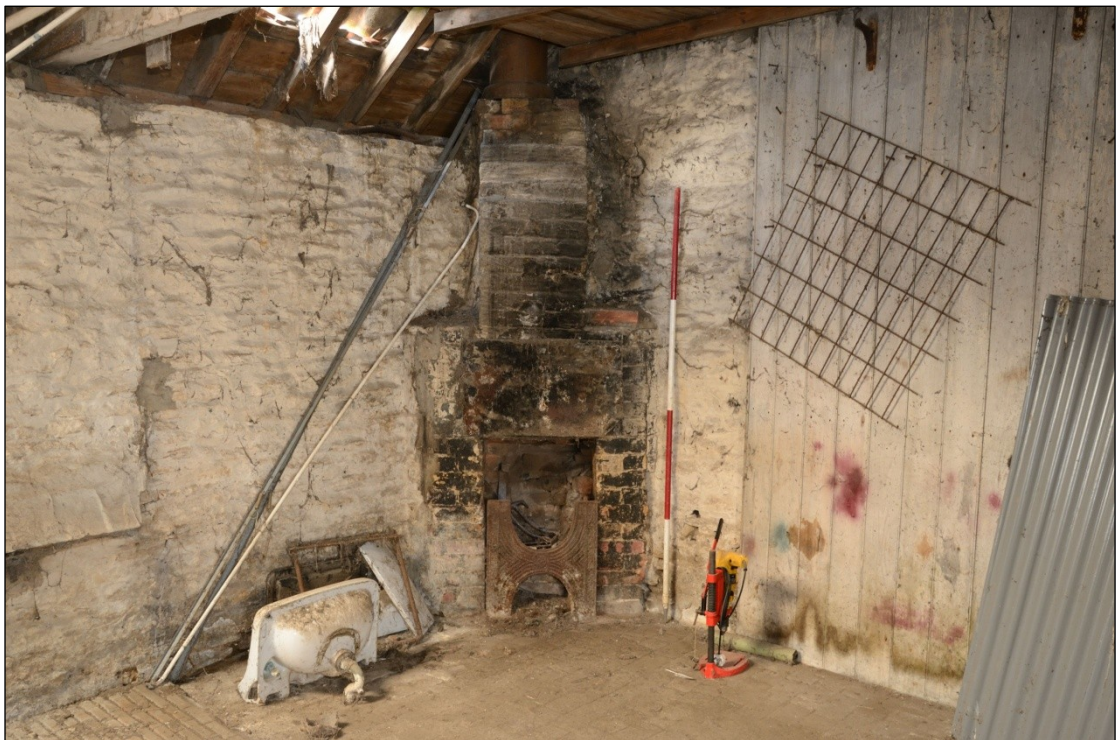
*Plate 103: Fireplace in Building 6D, looking west-northwest*

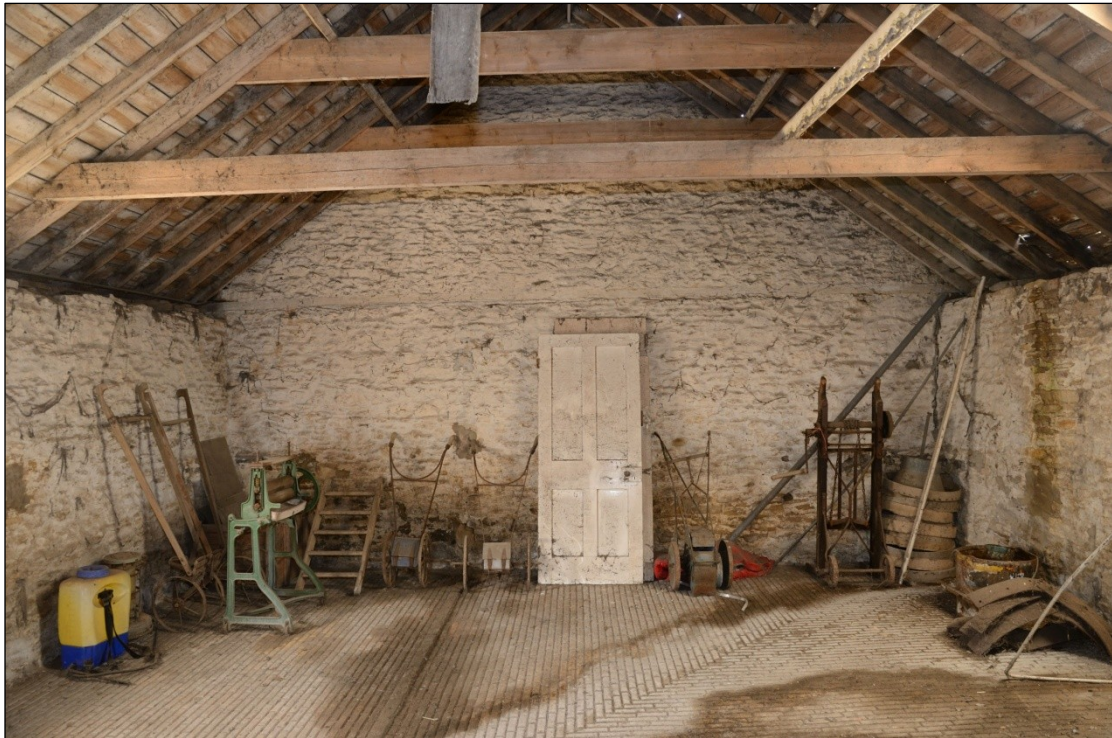
*Plate 104: Interior of Building 6D, looking south-southeast*

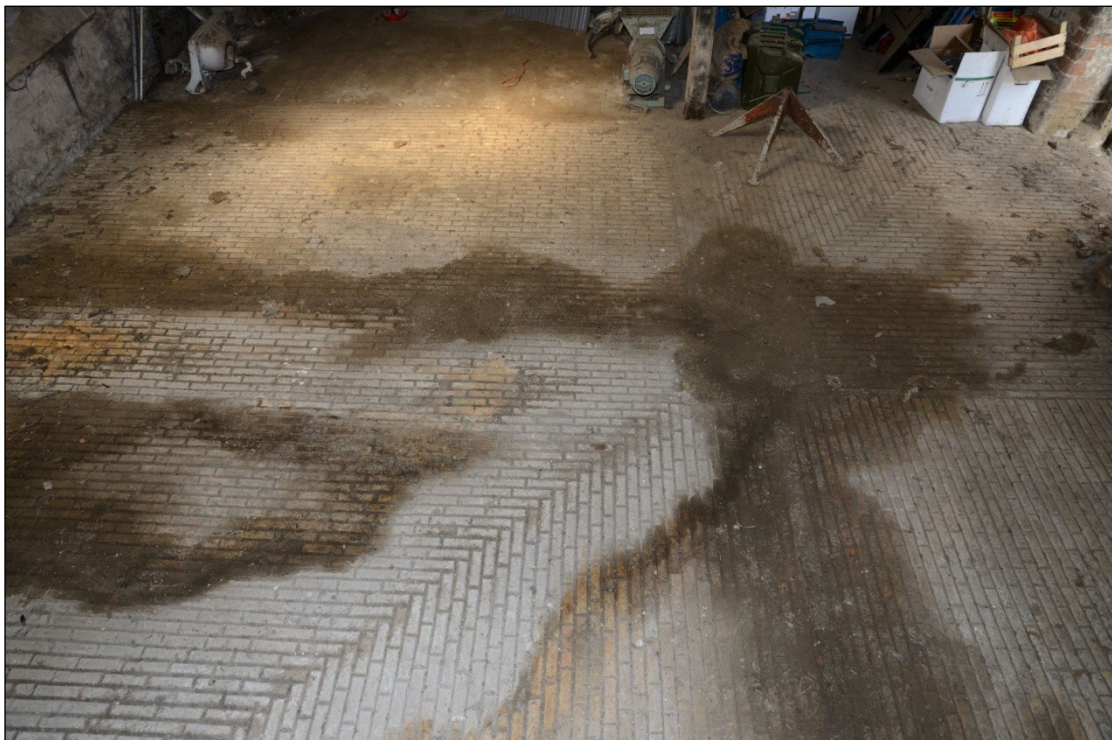
A floor of terracotta tiles set on edge extends throughout the greater part of Unit 6D, divided into four quadrants draining towards a central point (*Plate 105*).

*Plate 105: Floor in Building 6D, looking north-northwest*

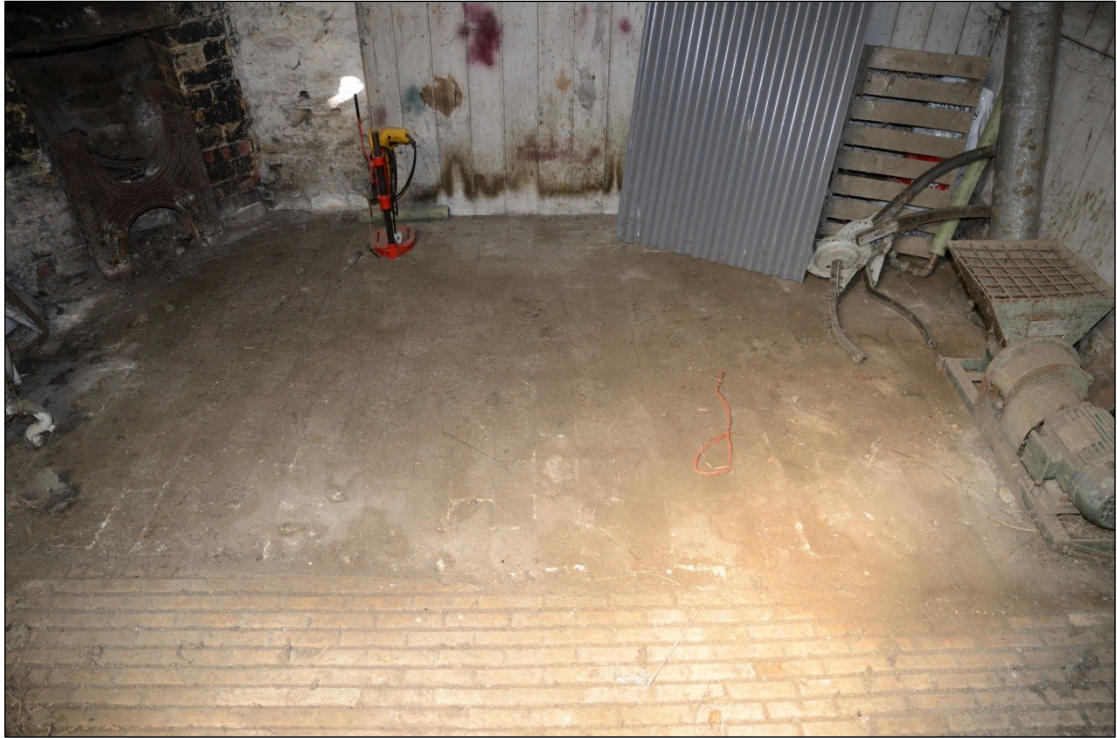
*Plate 106: Floor on the north side of Building 6D, looking north-northwest*

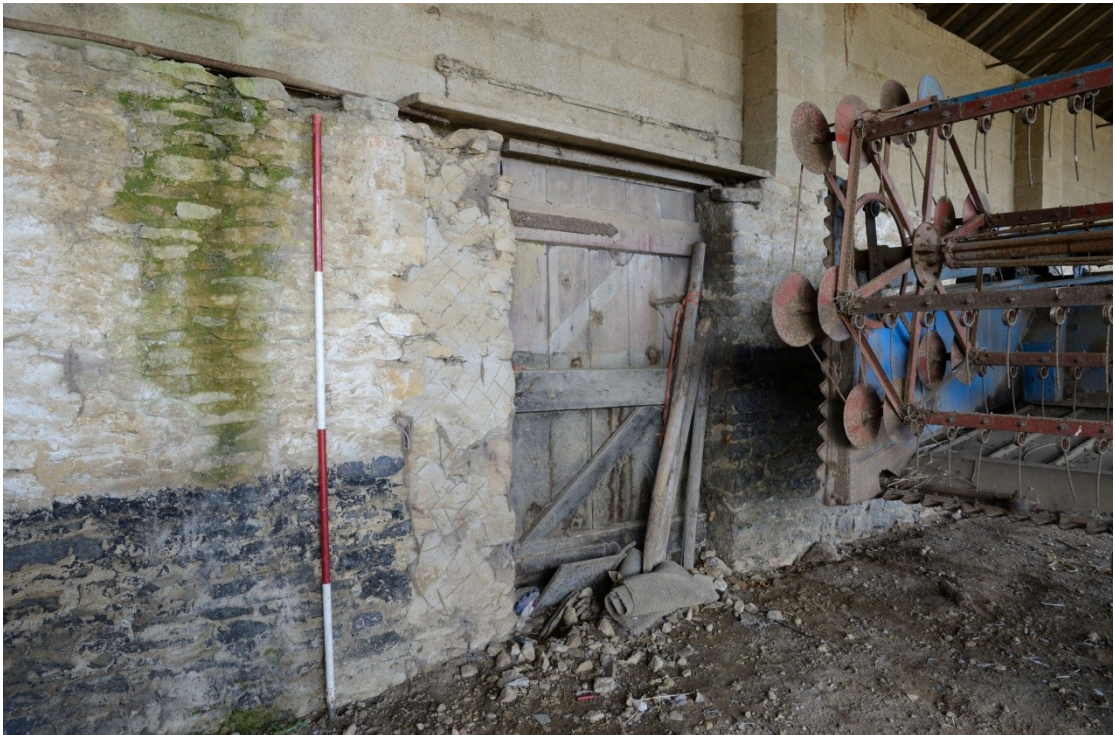
The interior of Unit B is painted black to around 900mm above ground level. The door in the rear wall (*Plate 111*) is flanked by a plaster repair indicative of the removal of an internal dividing wall. A similar repair further to the south (not photographed) may relate to a second internal division.

*Plate 111: Door in the west wall of Building 6C, looking west-northwest*

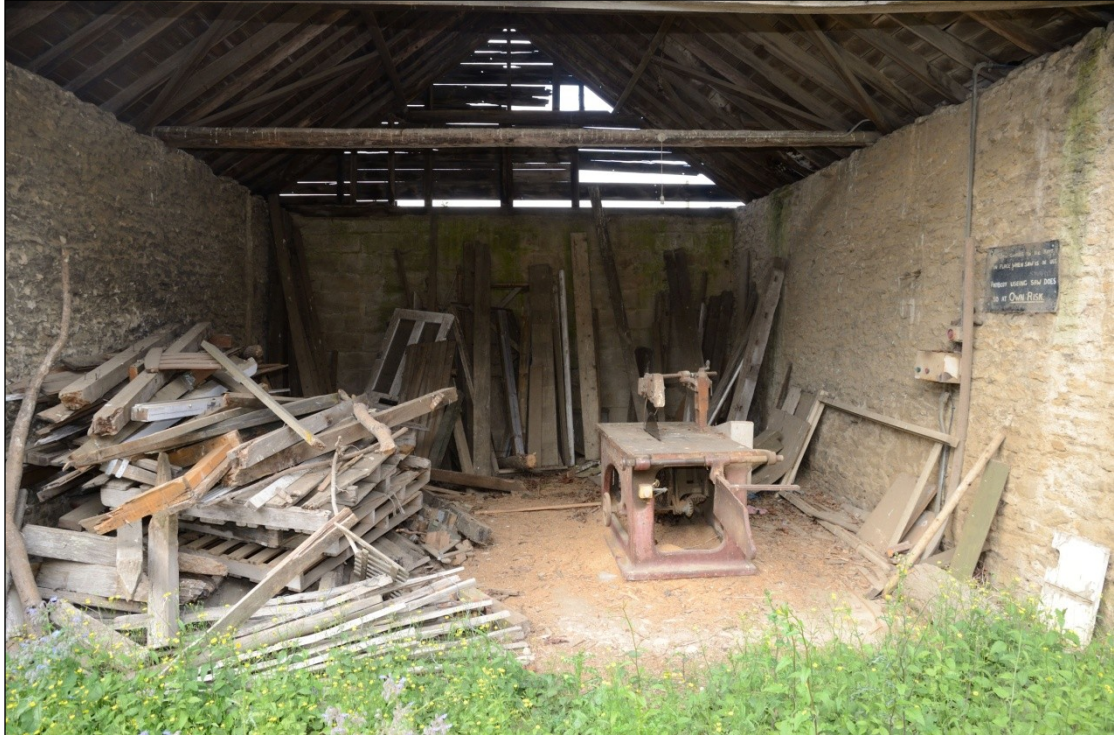
Building 7 currently serves as a woodcutting shed (*Plates 112 and 113*), but might originally have been constructed as a wagon hovel. The latter interpretation would fit with the buildings position in relation to the stables.

*Plate 112: Interior of Building 7, looking west-southwest*

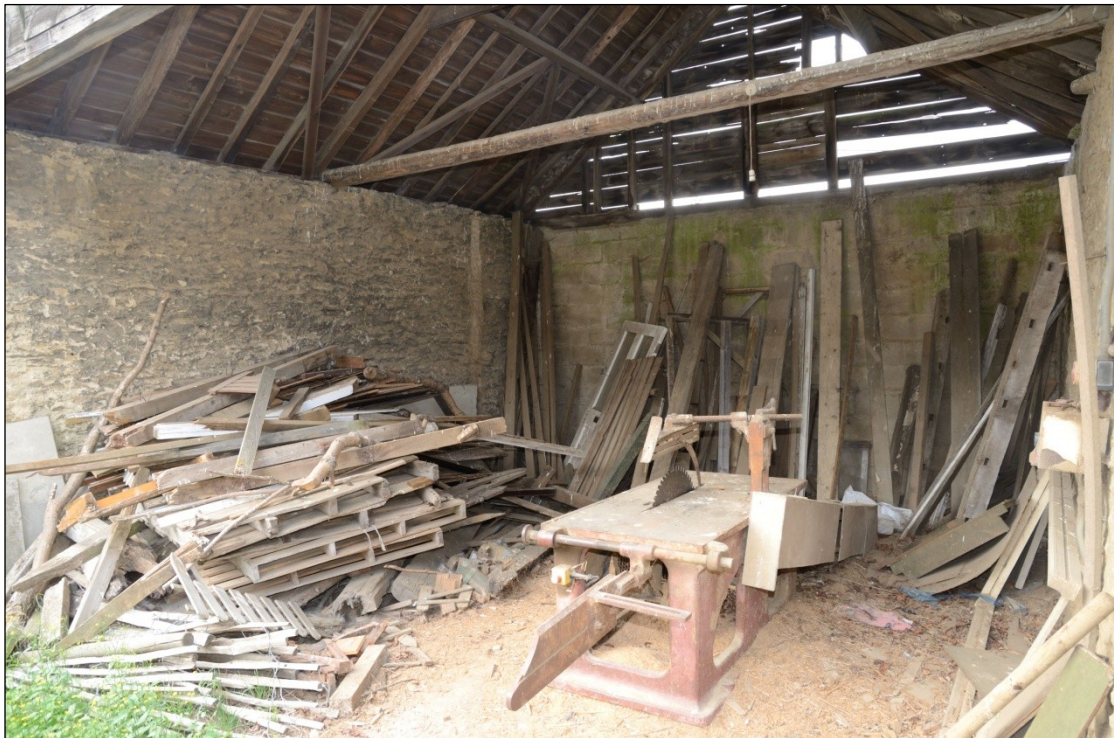
*Plate 113: Interior of Building 7, looking southwest*
