BARNS AT PARK HOUSE, GOREFIELD ROAD LEVERINGTON, CAMBRIDGESHIRE

Historic Building Recording

BARNS AT PARK HOUSE, GOREFIELD ROAD, LEVERINGTON, CAMBRIDGESHIRE

CHER Event No. ECB3841
Museum Accession No.: TBC
OASIS ID.: withamar1-189800
Planning Application Nos.: F/YR11/0259/LB & F/YR110258/F
NGR: TF 4352 1199

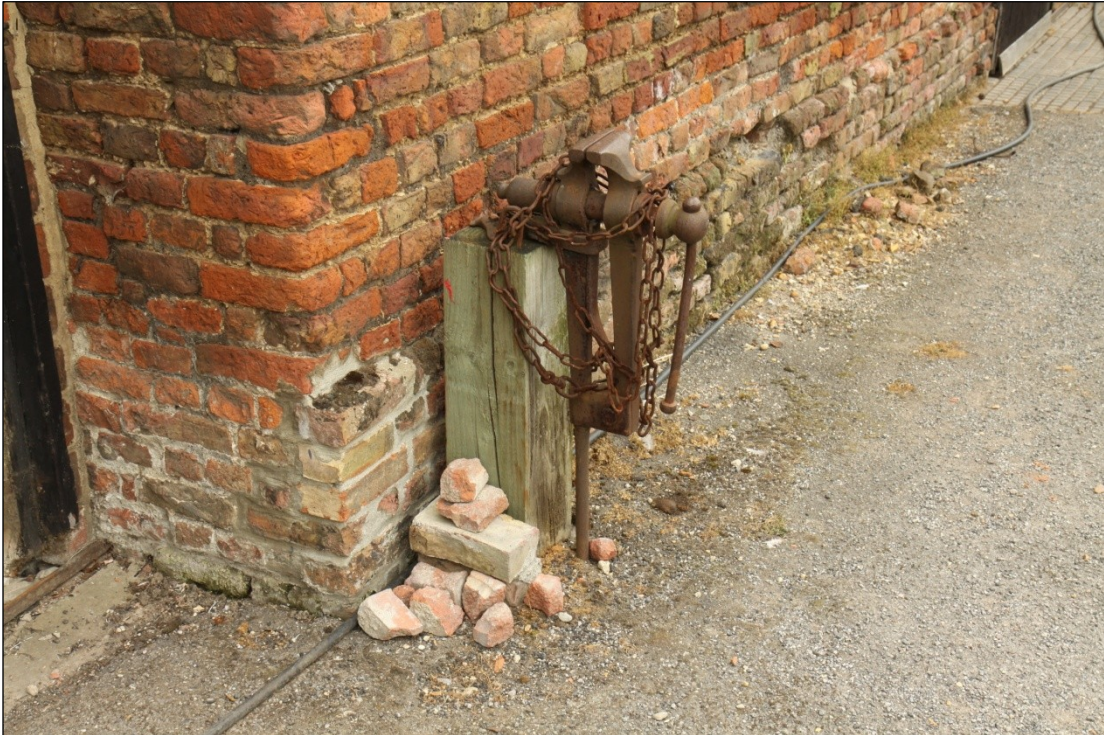
Plate 5: Vice positioned near the southwest corner of Barn 1, looking northeast

A vice (*Plate 5*) is situated at the southwest corner of the threshing barn, indicating that the abutting structure to the west was used as a workshop.

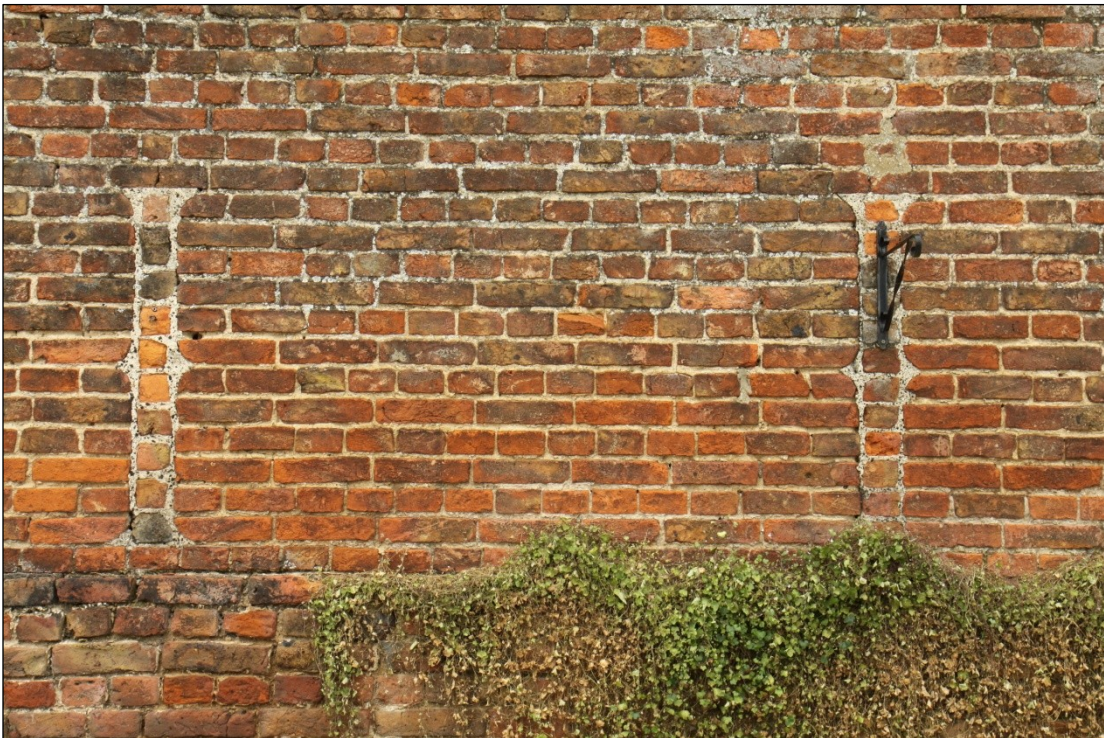
Plate 6: Ventilation slots in the south facing elevation of Barn 1, looking north

Two bricked up ventilation slots (*Plate 6*) relating to original use as a threshing barn are visible in the south facing elevation (*Plate 4*) of the building, while a wide opening in the centre of the elevation marks the position of the original south door. The west side of the door has been substantially rebuilt (probably as part of alterations to form the stables) and may have resulted in an alteration to the original width.

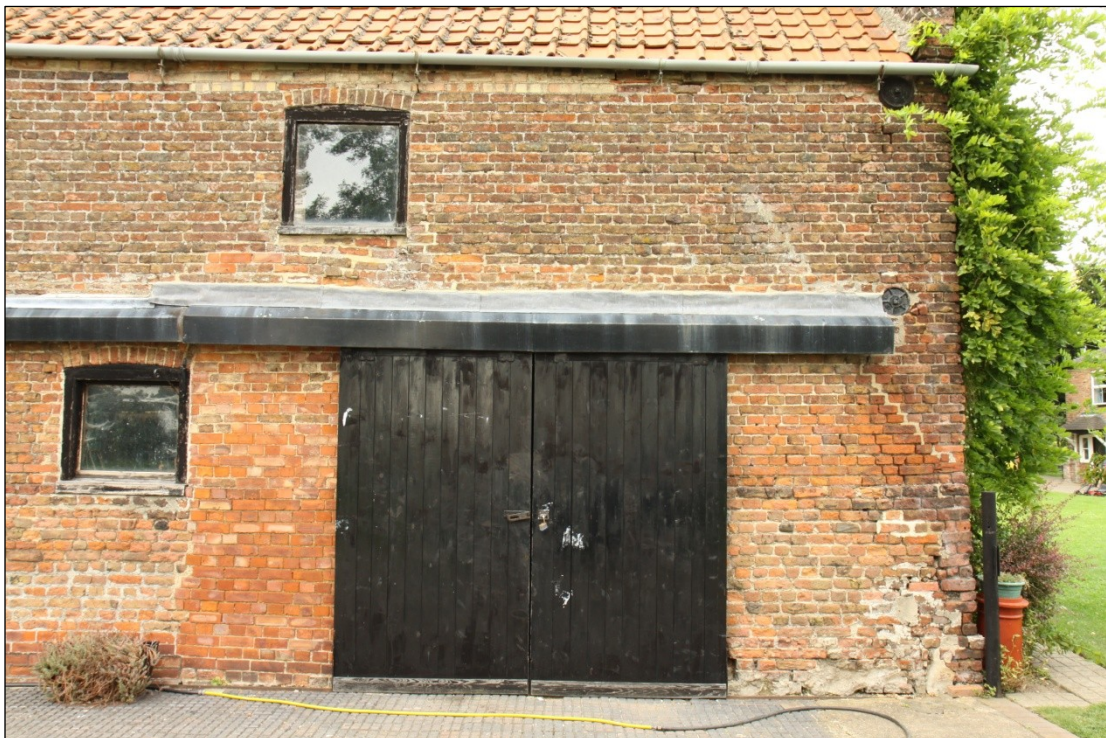
Plate 9: Ground floor window and modified doorway in the south facing elevation of Barn 1

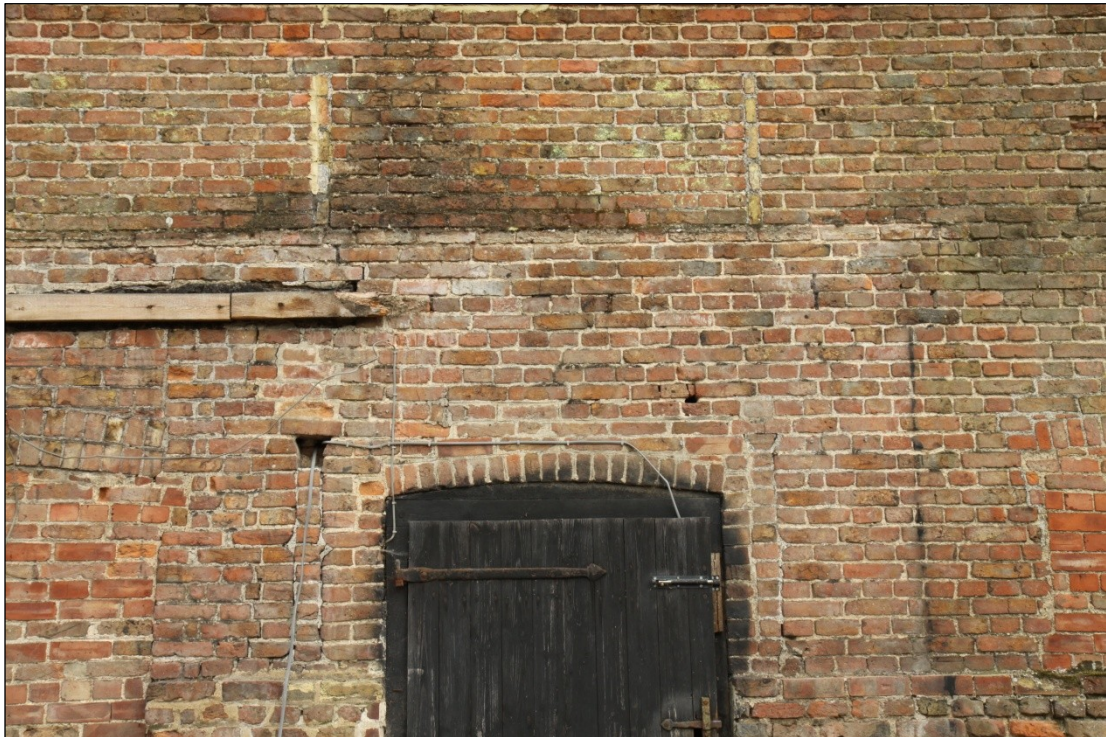
Plate 18: Ventilation slots around the existing door in the north elevation of Barn 1, looking south

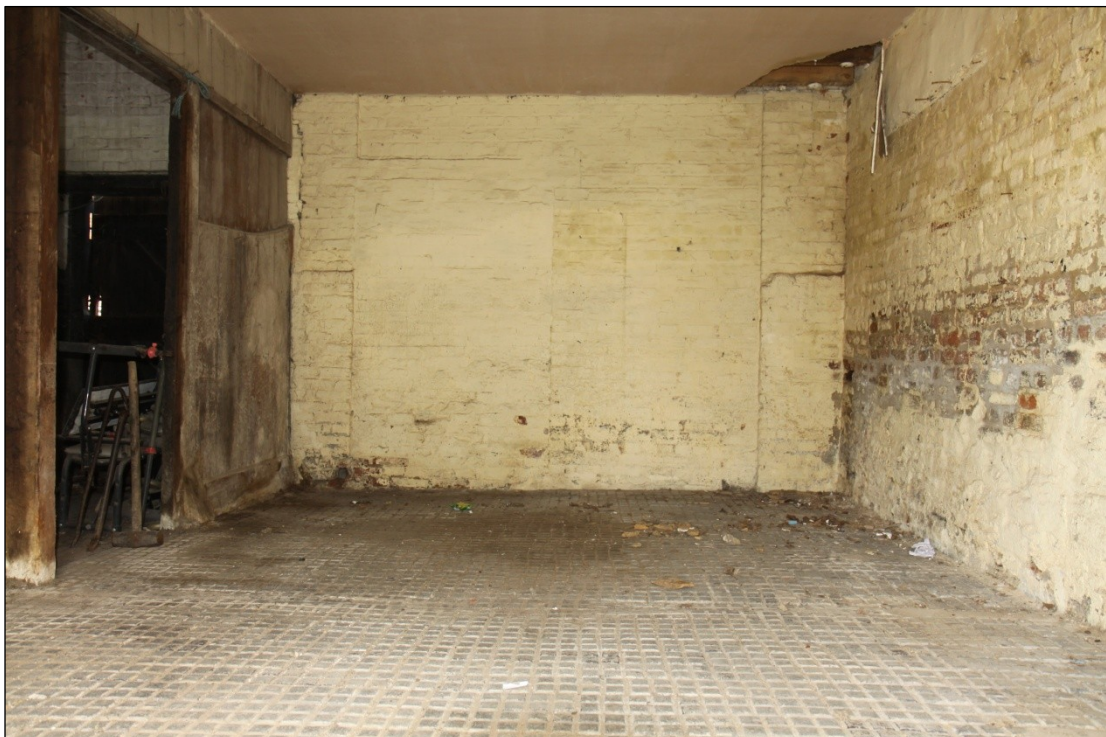
Plate 27: Area east of the stables and blocked in doorways in the north wall of Barn 1, looking north

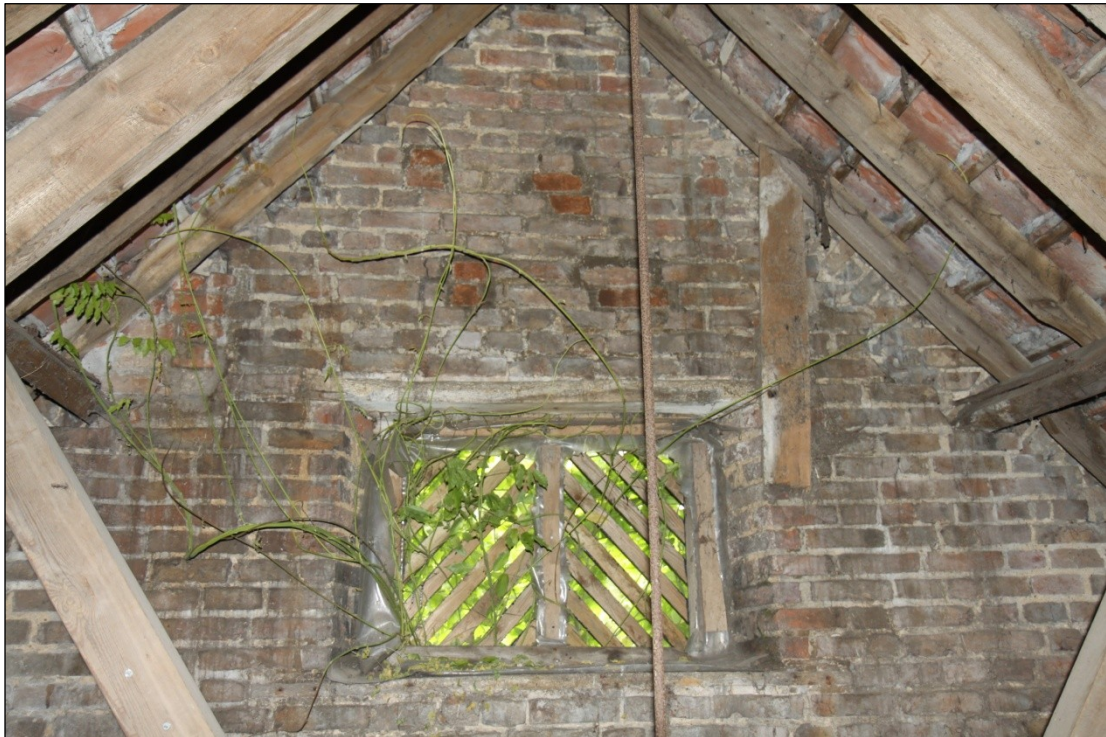
Plate 43: Bricked up window or vent in the east wall of the probable granary in Barn 1, looking east

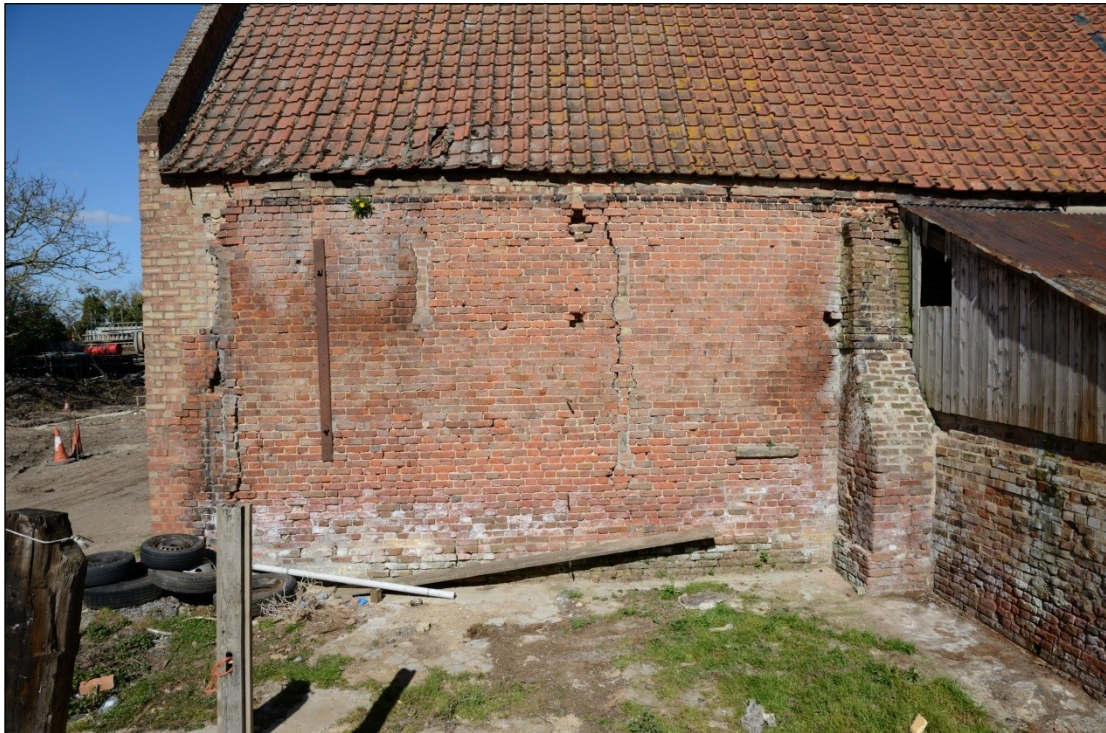
Plate 51: South facing elevation of Barn 2 (lean-to removed), west side, looking north

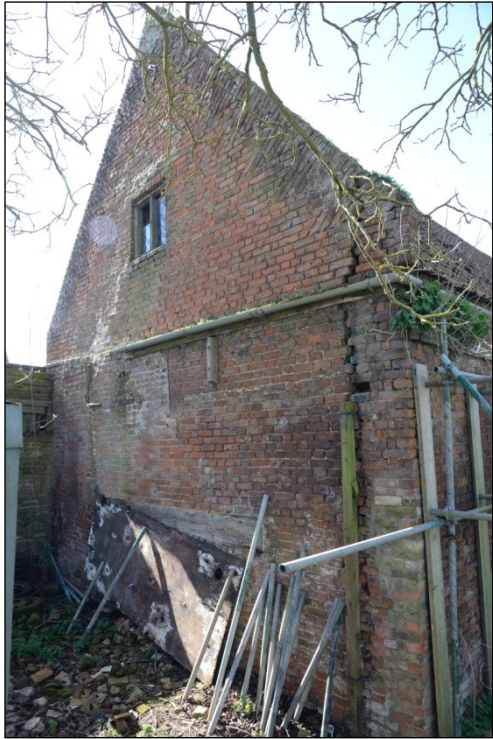
The east facing elevation has a low door at ground floor, bricked up openings for a door and window/vent at first floor, and a window/vent higher in the gable (*Plate 55*). The door at ground floor is positioned centrally in the elevation and has a substantial reused wooden lintel above (*Plate 56*). Paired peg holes are visible on the exterior face of the lintel and corresponding mortises on the underside (*Plate 59*). The opening contains two phases of brick infill, the first in hand-made red brick (partly collapsed) to form a much narrower opening offset to the south, the second in modern brick to close most of the remaining opening. The bricked up door at first floor level is located on the south side of the elevation, extending to just beneath a stringcourse, while the window or vent is located centrally in the elevation (*Plate 57*). The surviving opening at higher level in the gable (*Plate 58*) contains a timber frame with remnants of glazing.

Plate 55: East end of Barn 2, looking southwest

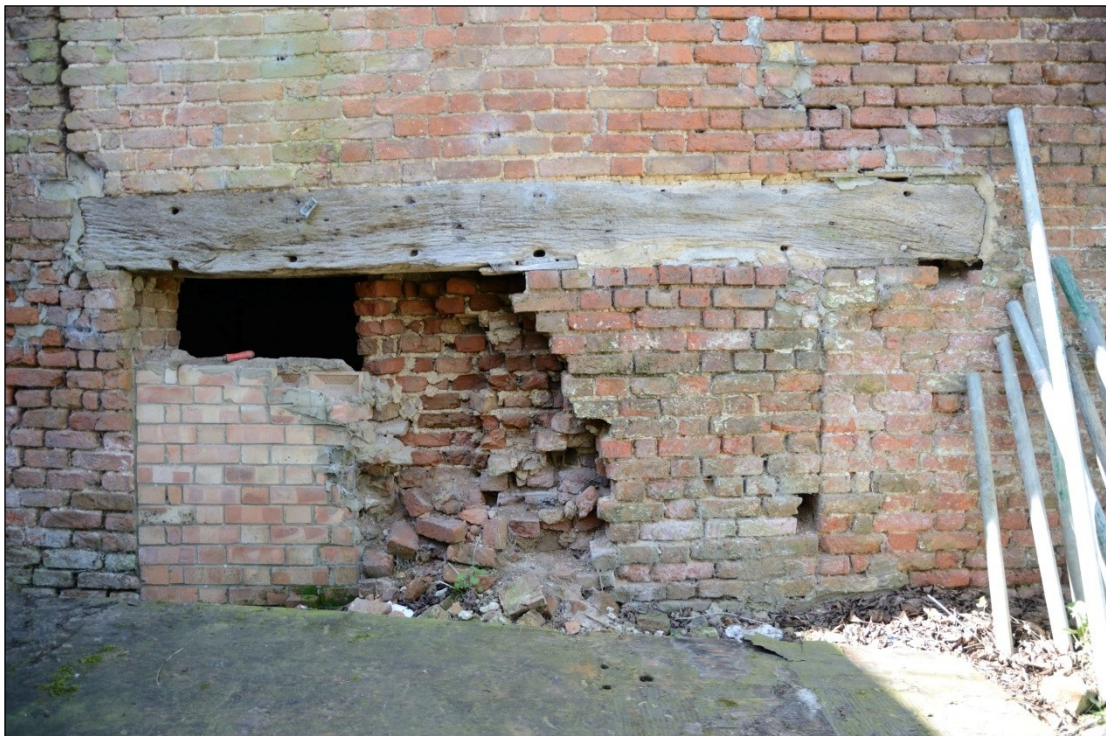
Plate 56: Ground floor opening, east end of Barn 2, looking west

The ground floor space had a low ceiling carried by joists running between the long walls of the building (*Plate 74*). A straight join and substantial wooden lintel (*Plate 75*) in the east wall corresponds to the opening seen externally in *Plate 56*. There are three ventilation slots in the north wall, arched at the top and either partly or fully brick up (*Plate 76*), and two slots in the south wall (*Plate 77*).

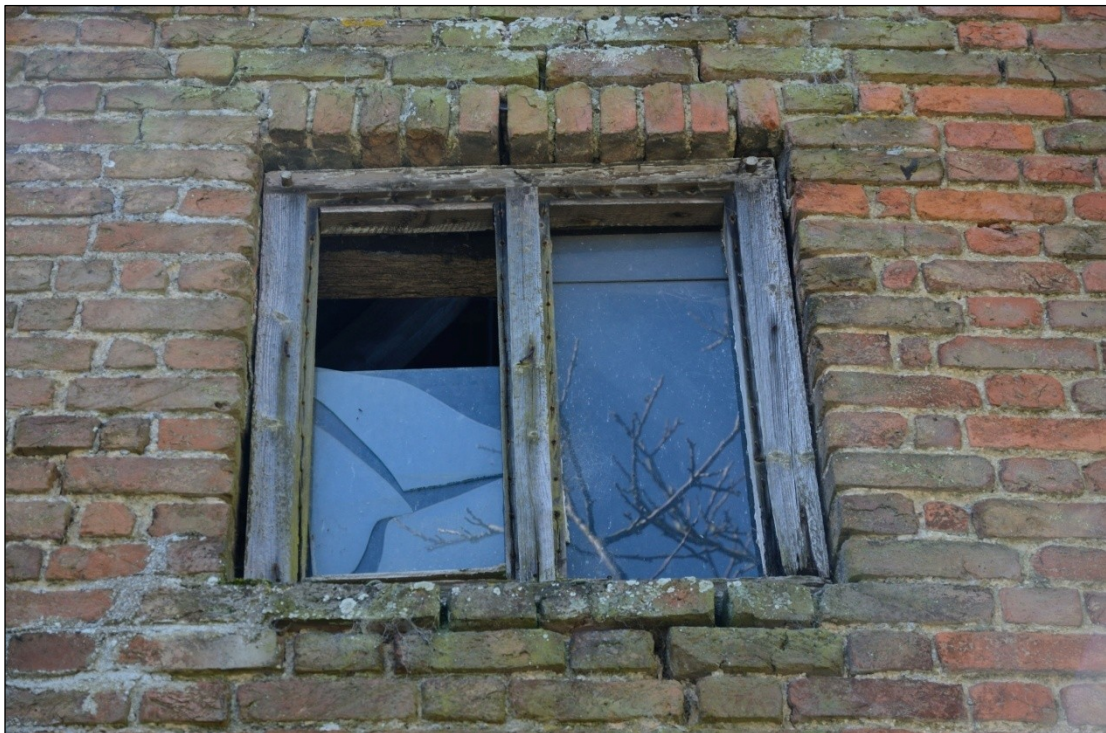
Plate 58: East facing elevation of Barn 2, opening in gable, looking west

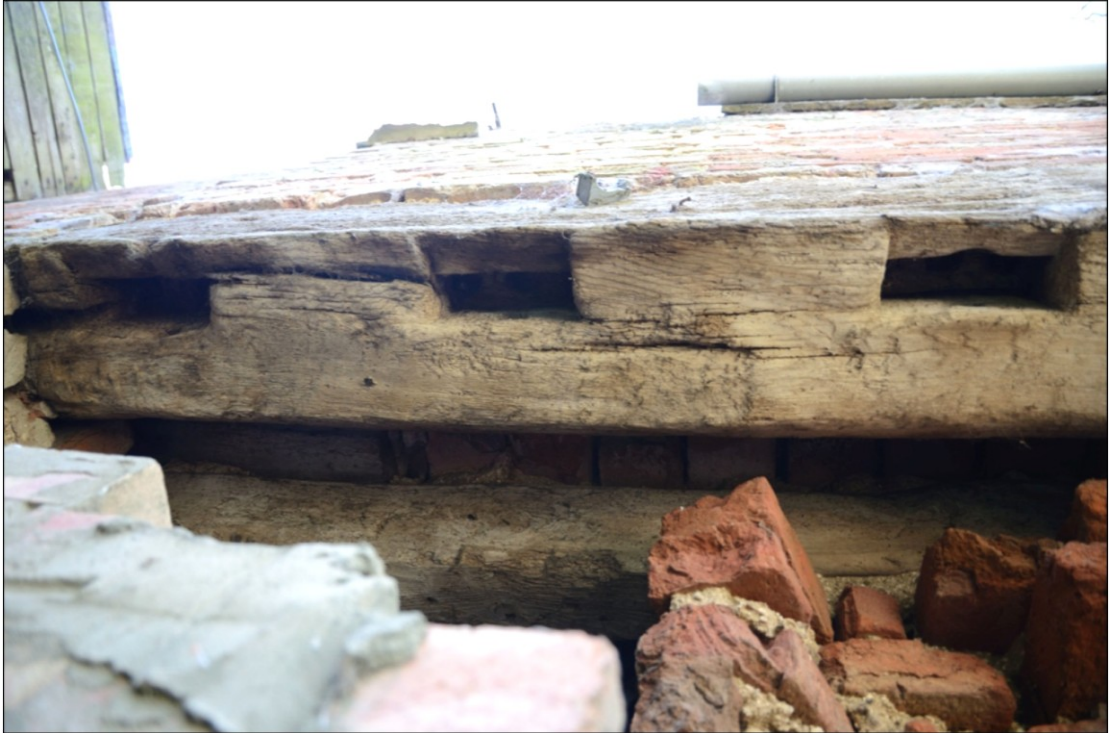
Plate 59: Underside of reused timber lintel, east facing elevation of Barn 2, looking up

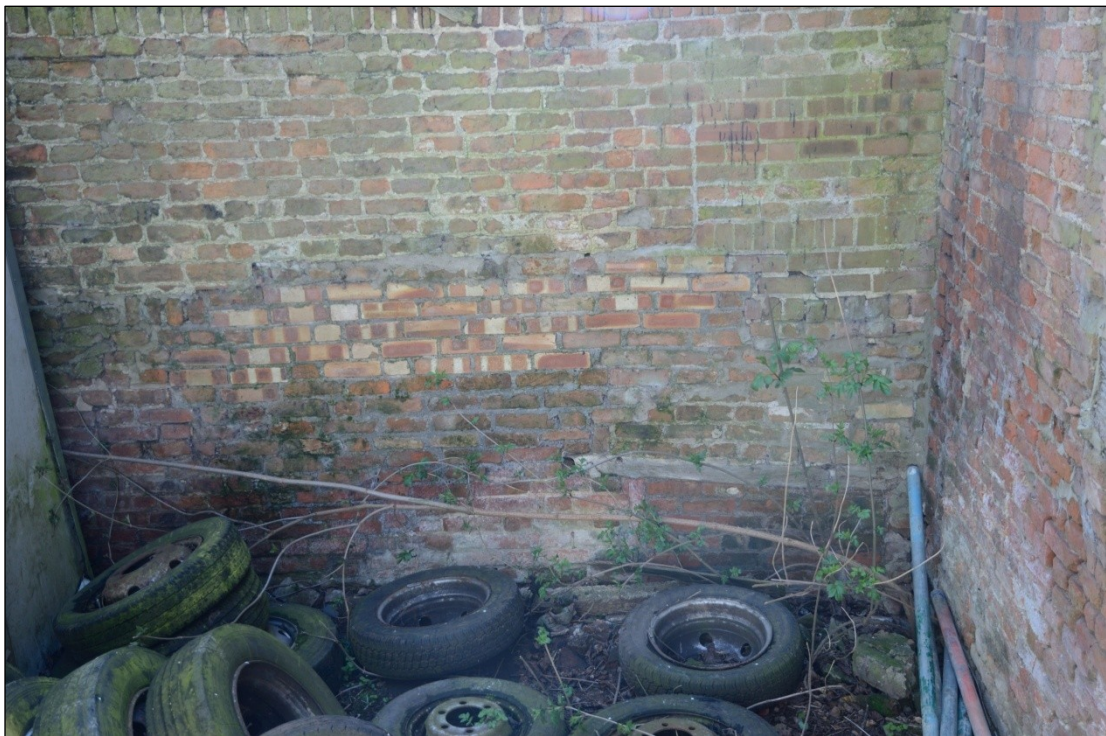
Several areas of brick infill are visible in the yard wall (*Plate 60*) extending east from Barn 2, including a low-level opening defined by a wooden lintel.

Plate 60: Yard wall at east end of Barn 2, looking south

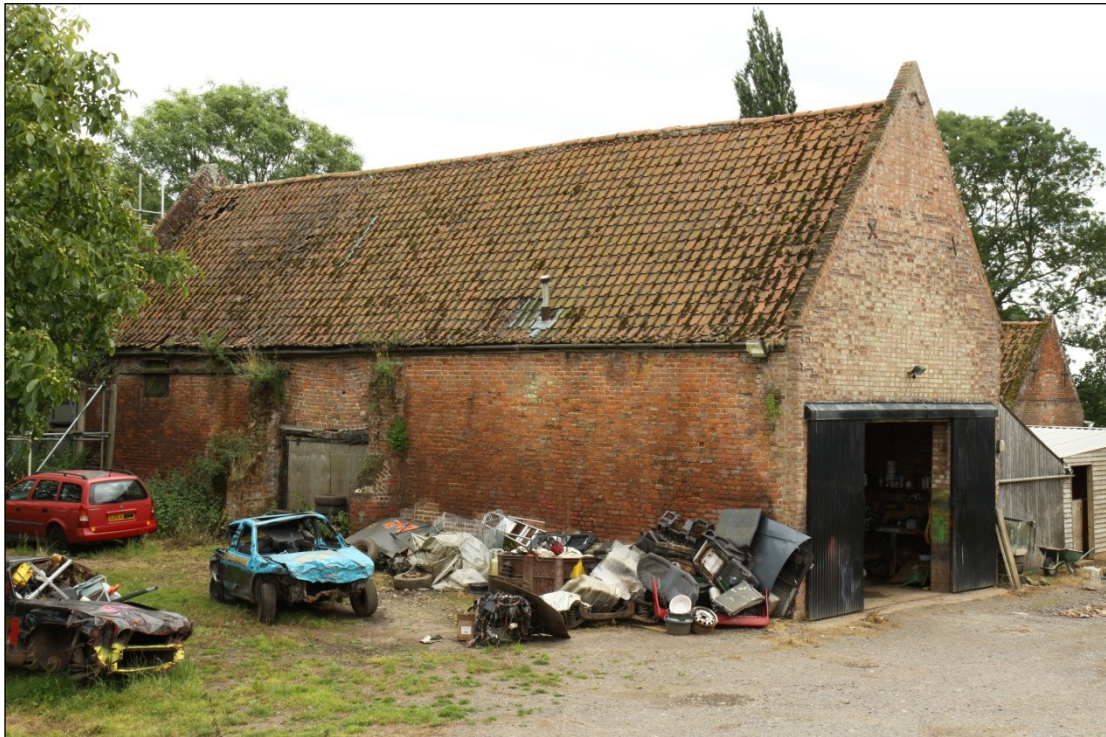
A plank attached to the north elevation (*Plate 61*) east of the north door denotes the former position of a lean-to structure shown on historic maps. The north door (*Plate 62*) is lower than the south door, which extends the full height of the wall (see above). It has a substantial timber lintel (*Plate 64*), but the original doors are missing and the opening is filled by modern ply boards. Stepped buttresses in brick are situated to either side of the door, extending to almost the full height of the wall. The buttress on the east side includes comparatively late fabric but the one on the west side appears to be wholly original. The lintel over the door has bowed under the weight of the overlying brickwork, leading to slumping in the wall.

Plate 61: General view of Barn 2, looking southwest

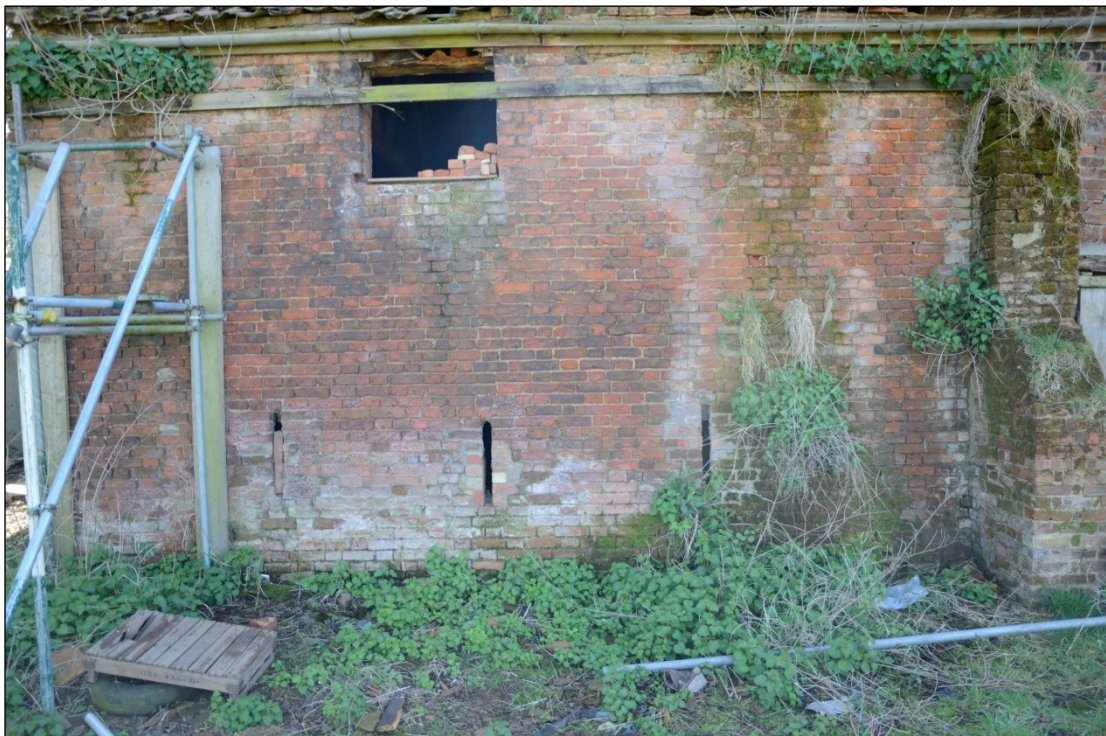
East of the north door are three ventilation slots (*Plate 62*), opening from the ground floor unit, while higher in the wall, there is a square opening (originally a vent?) opening from first floor. The latter contained a wooden frame overlain with diagonally aligned slats (*Plate 63*), which was later removed.

Plate 62: Ventilation slots in the north facing elevation (east end) of Barn 2, looking south

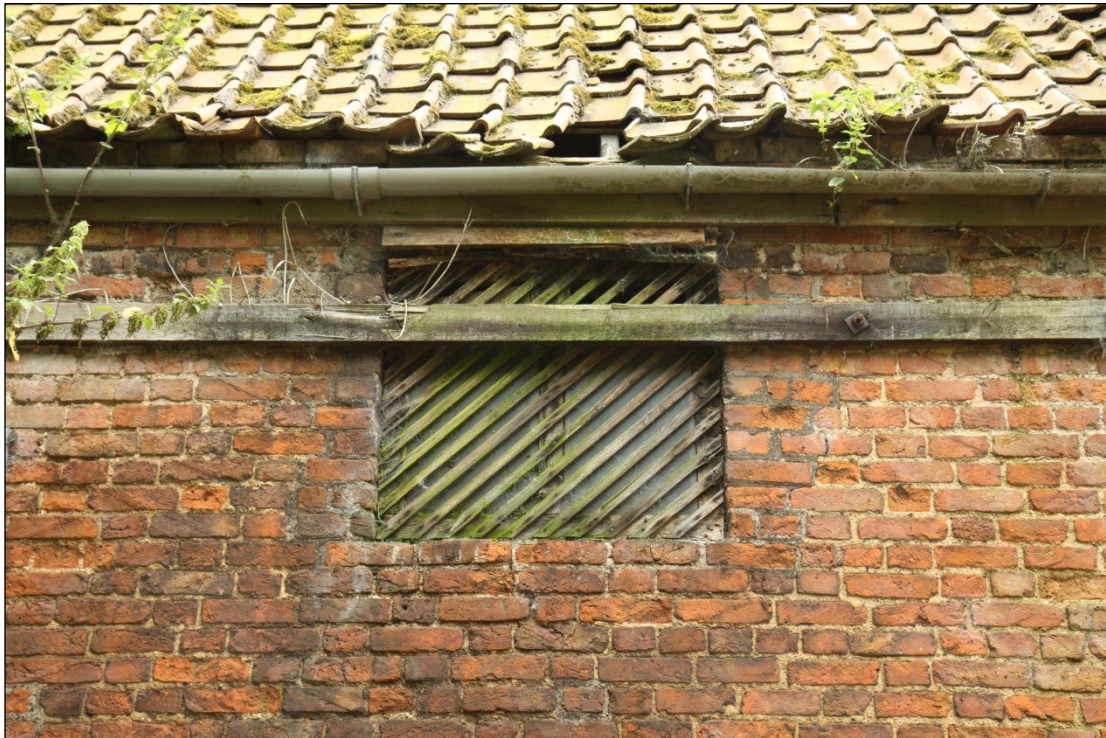
Plate 63: Vent or window to first floor in the north facing elevation of Barn 2, looking south

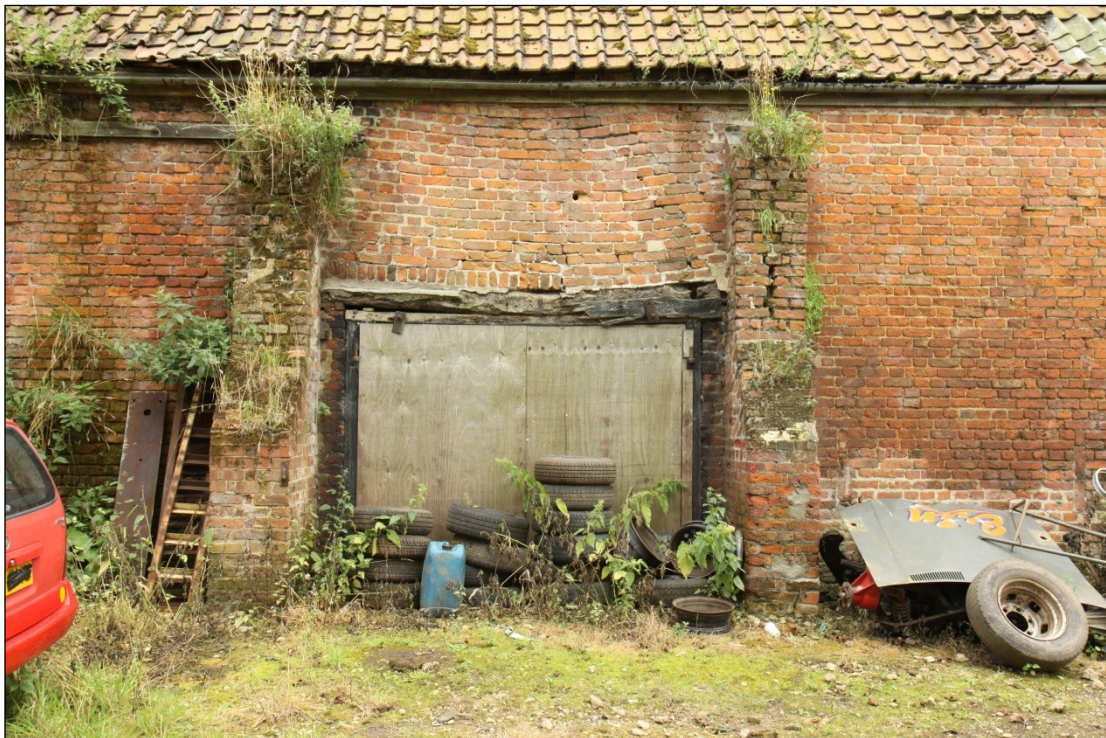
Plate 64: Doorway in the north facing elevation of Barn 2, looking south

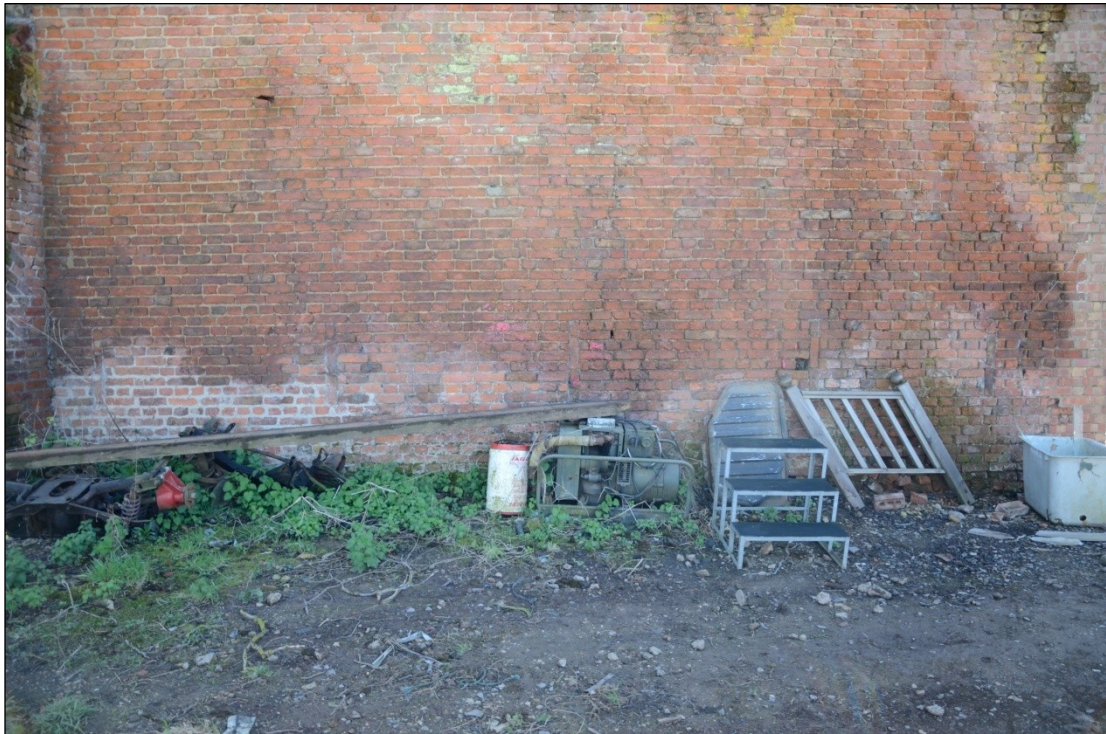
Four ventilation slots (all blocked with brick) are present, low in the wall, west of the north door (*Plate 65*).

Plate 65: Ventilation slots in north facing elevation of Barn 2 (west side), looking south

Three ventilation slots are visible in the south wall (*Plate 68* and *Plate 69*), two above and one below, corresponding to the easternmost of the features seen externally in *Plate 51*. Five more slots (all bricked up) are visible at low level in the north wall (*Plate 71* and *Plate 72*), corresponding to features seen externally in *Plate 65*.

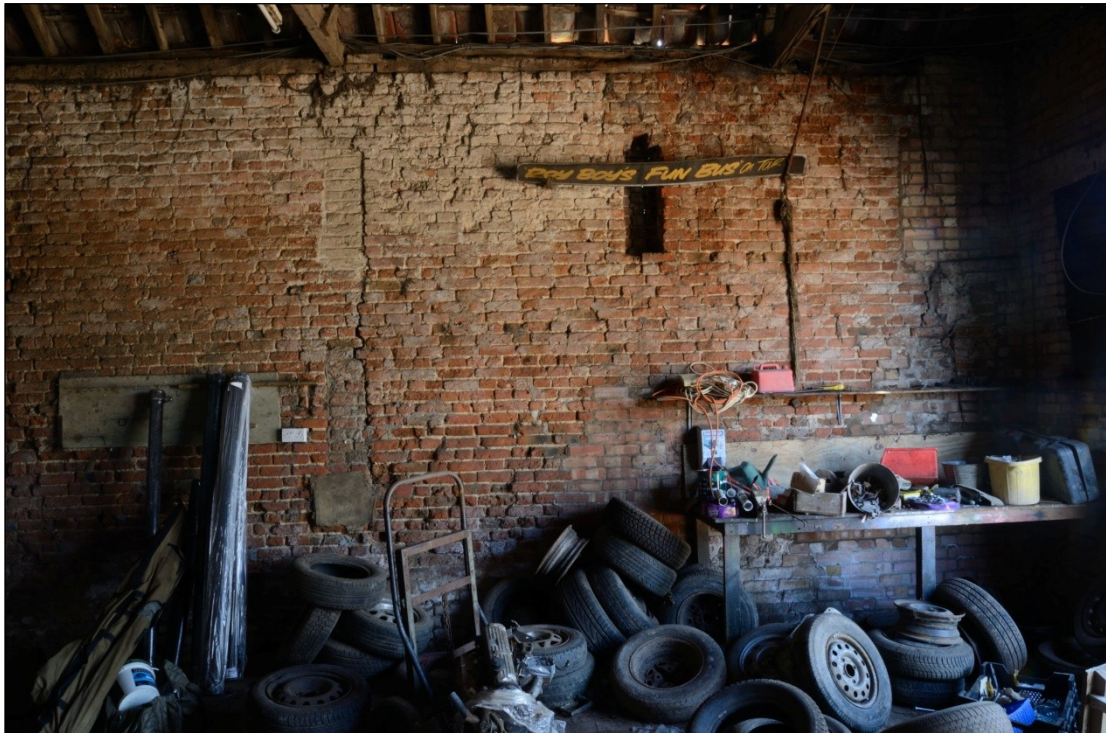
Plate 69: Interior of Barn 2, ventilation slots in the south wall, looking south

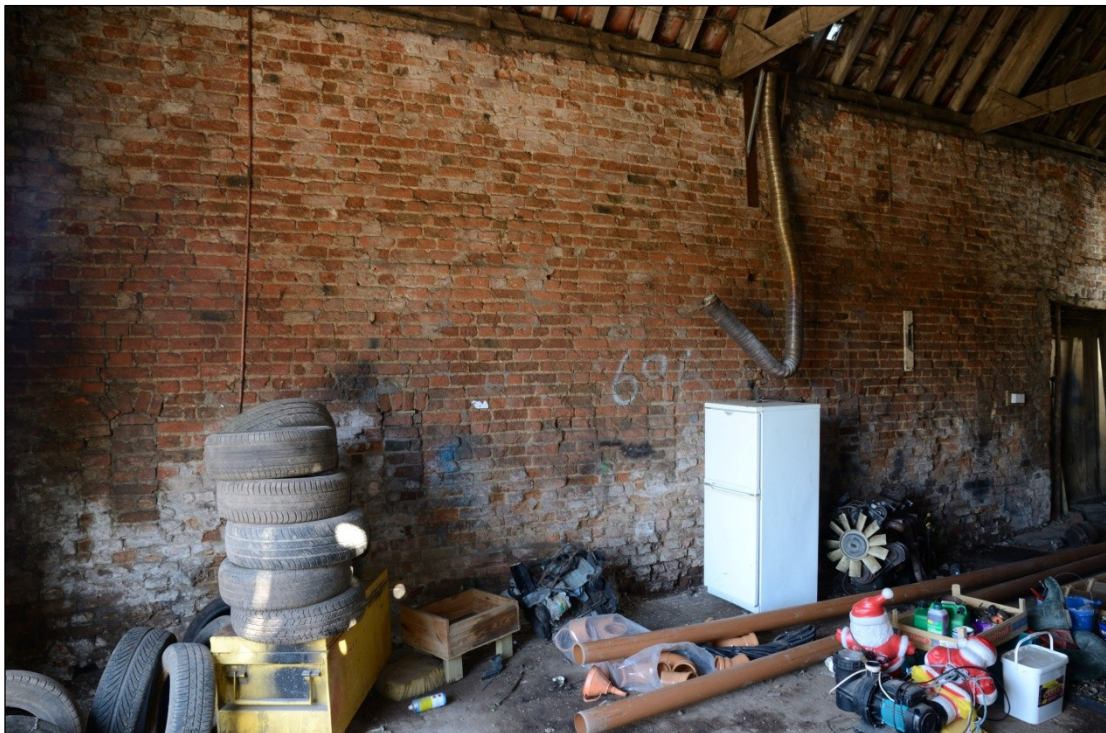
Plate 72: Interior view of ventilation slots in the north wall of Barn 2, looking northeast

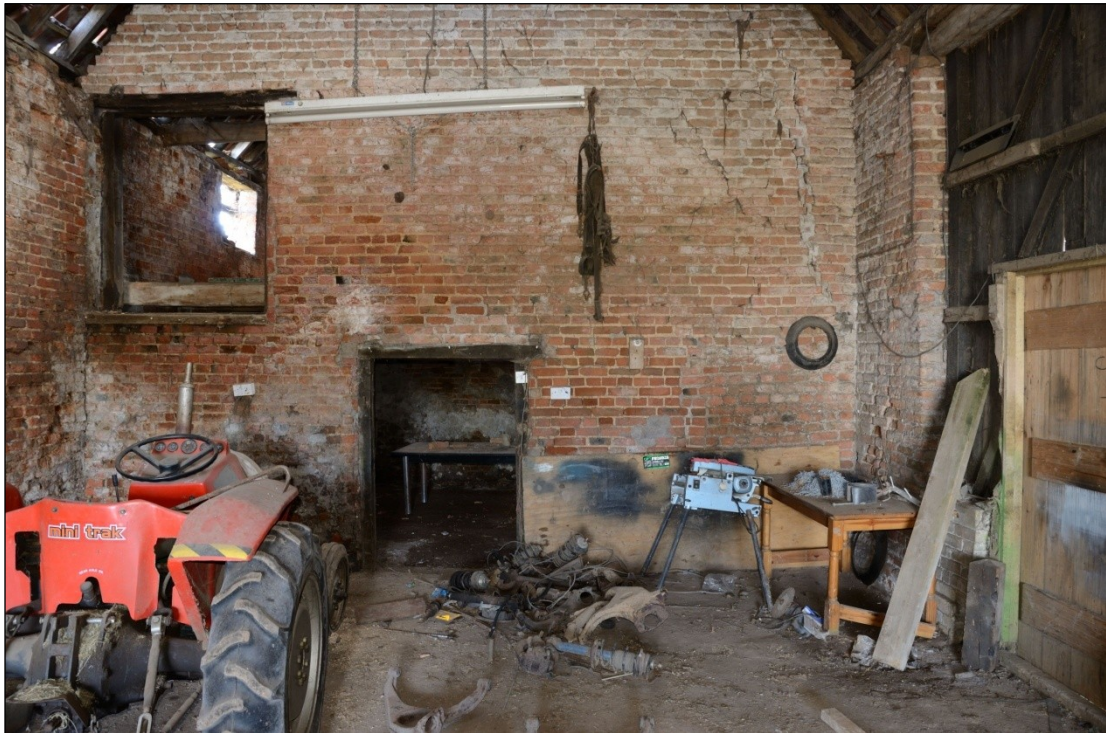
There are two openings in the internal wall (*Plate 73*), providing access to ground and first floor units occupying the area east of the opposing barn doors.

Plate 73: Internal wall in Barn 2, looking east

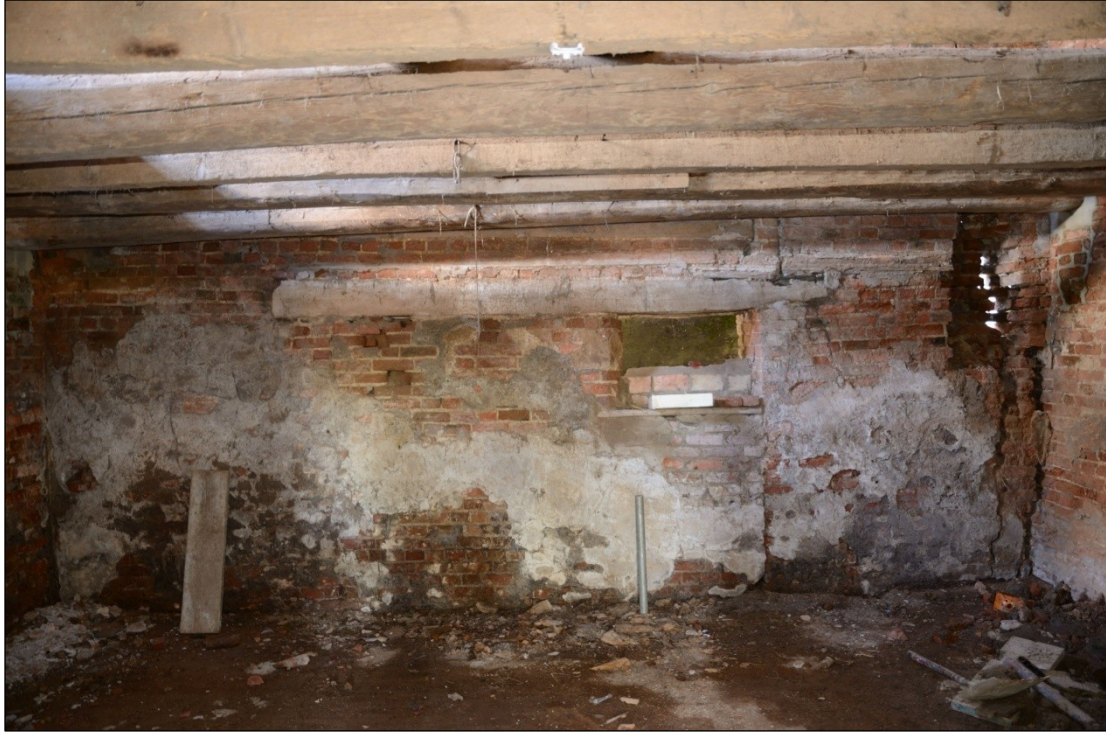
Plate 75: Ground floor area at the east end of Barn 2 (emptied), looking east

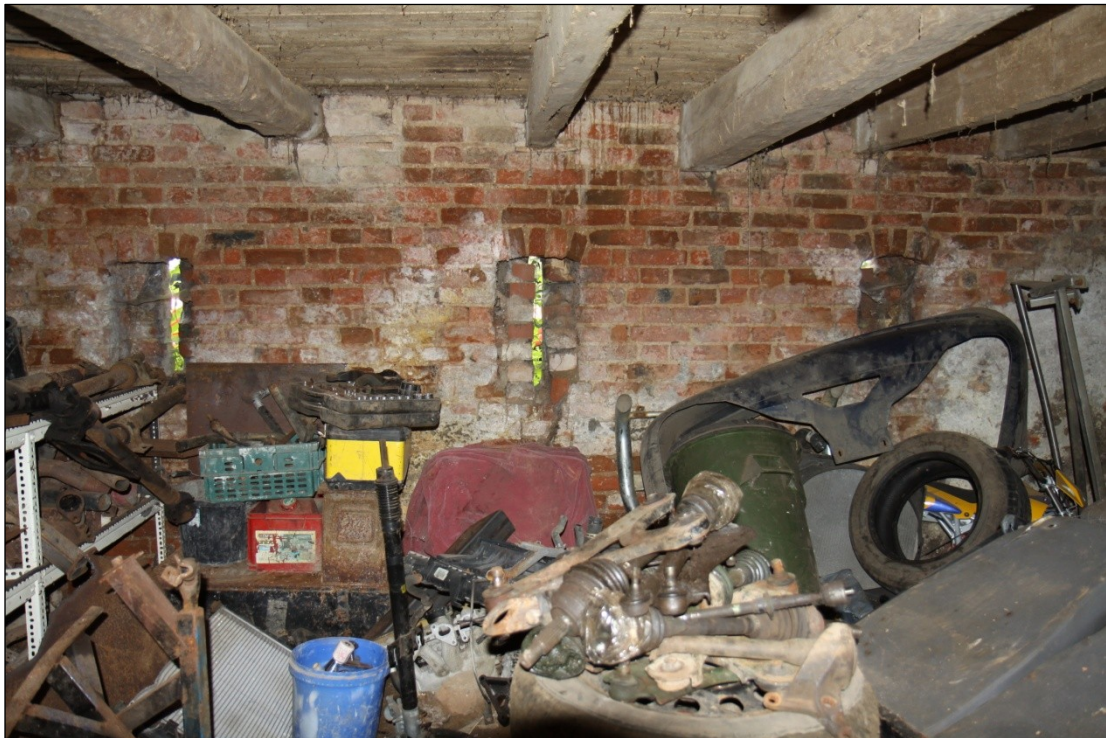
Plate 76: Interior view of ventilation slots in the north wall (east end) of Barn 2, looking north

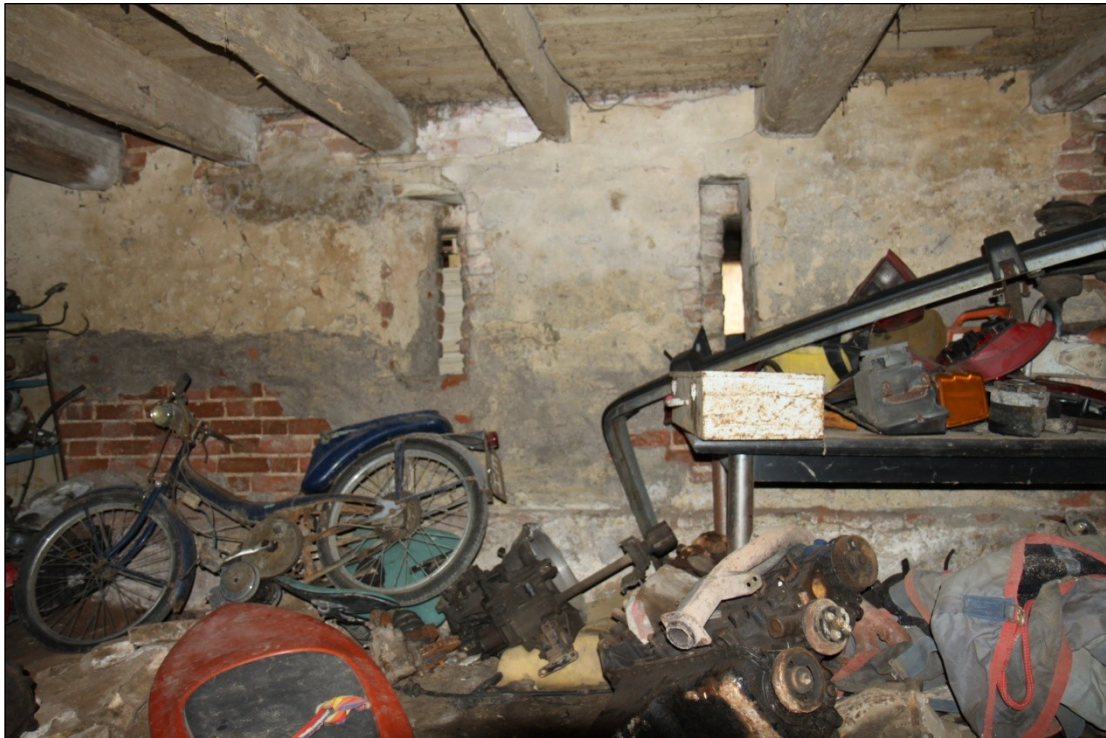
Plate 77: Interior view of ventilation slots in the south wall (east end) of Barn 2, looking south

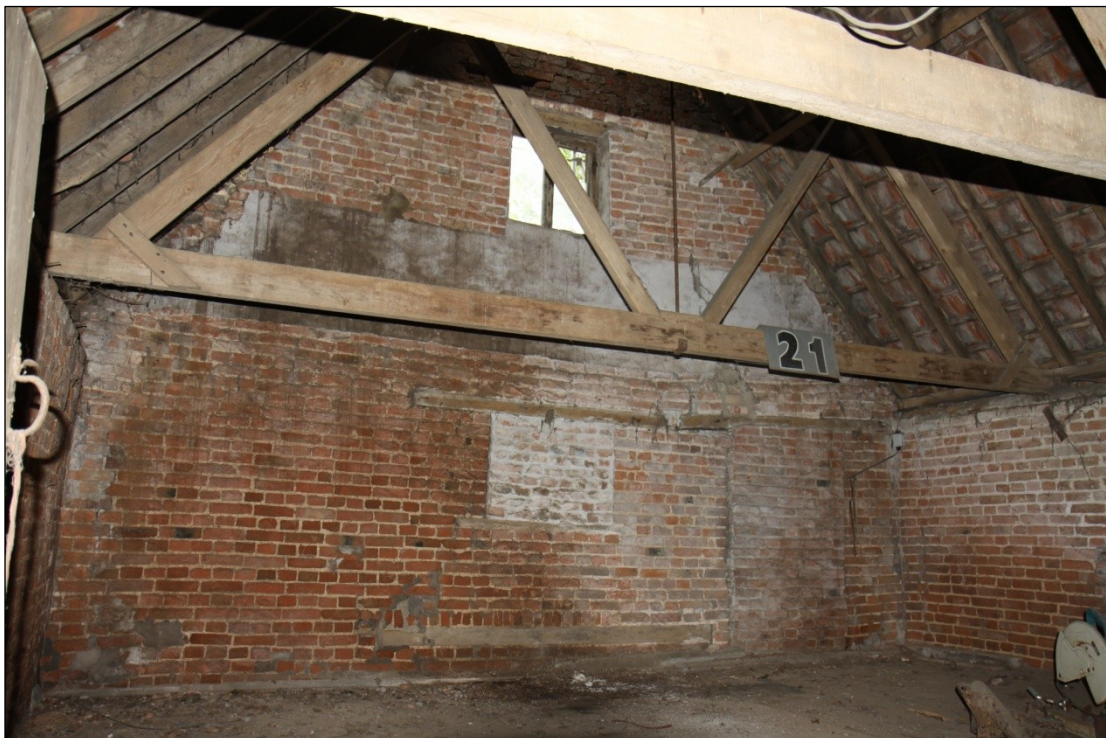
Access to the space at first floor is provided by a door on the north side of the dividing wall, reached via wooden steps; the door is constructed from vertical planks (*Plate 80*). There are two blocked openings for a door and a window or vent in the east wall (*Plate 78*), as well as a window or vent at high level and a lintel (related to the ground floor door) is visible at just above floor level (*Plate 83*). The door (*Plate 82*) and window/vent (*Plate 81*), both with wooden lintels above, correspond to features seen externally in *Plate 57*. Additional windows or vents are present in the south (*Plate 79*) and north (*Plate 80*) walls. Wooden casements are currently in place in both openings, with diagonal wooden slats surviving on the exterior (see above – *Plate 54* and *Plate 63*).

The roof in Barn 2 comprises six trusses of the king-rod type seen in Barn 1 (see *Plate 67* and *Plate 78*).

Plate 78: Interior of first floor unit (granary?) at the east end of Barn 2, looking southeast

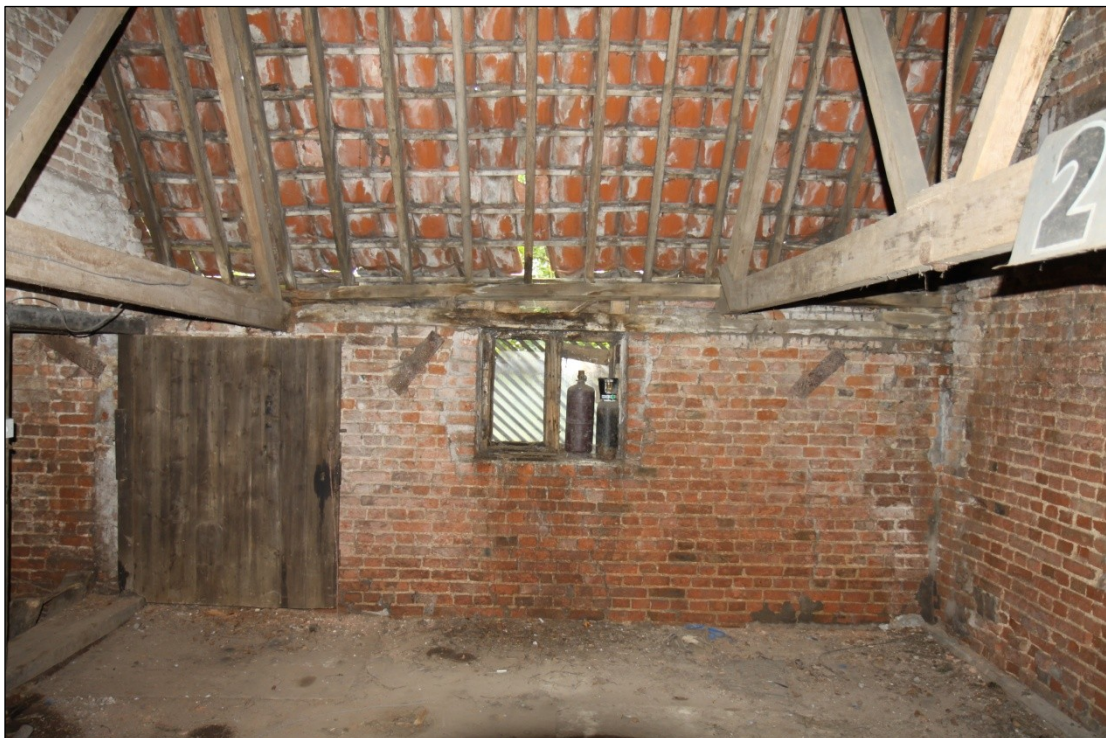
Plate 80: Interior of probable granary at the east end of Barn 2, looking north
