The Workhouse, Southwell:  
Archaeological Survey  
Survey and assessment for the National Trust  
ArcHeritage 2017

**The Workhouse, Southwell, Nottinghamshire:  
Archaeological Survey**

## Key Project Information

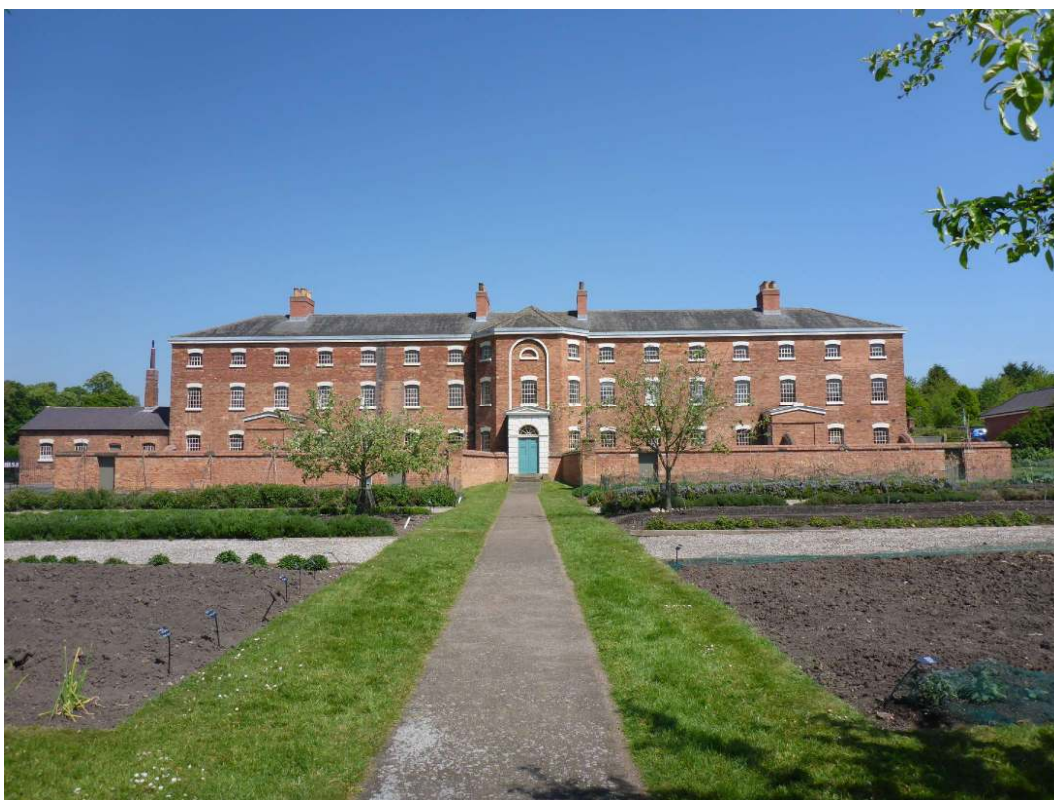
Plate 1: South front of The Workhouse (asset 101), looking towards the formal entrance

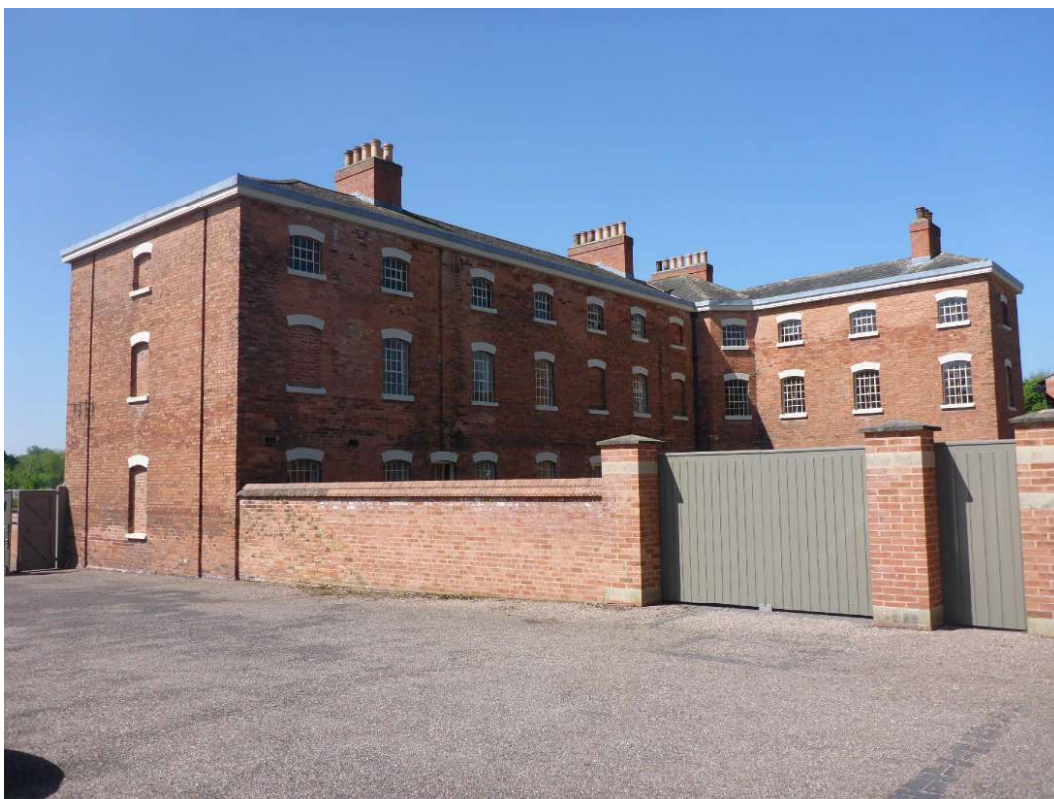
The east and west gables both have a single blind window in each storey, to the same dimensions of those in the north and south faces. The gable walls each have two incised grooves, arranged to either side of the windows (Plate 5), though the grooves in the west gable have been truncated by the construction of the later schoolroom abutting the accommodation block. There are four brick ridge stacks on the roof, each with multiple chimney pots (Plate 1).

Plate 5: East gable of accommodation block and restored work yard wall, facing southwest

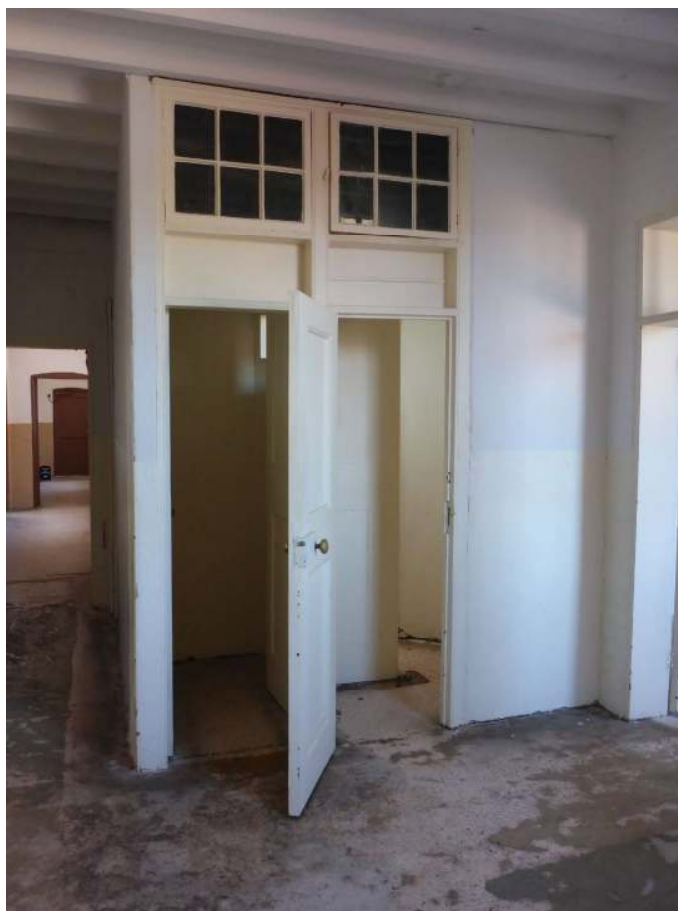
The first and second floors have concrete floors; it is uncertain whether this was the original flooring material. The site manager reported that there are potential problems with the load capacity of these floors. The residents' dormitories and bedrooms again have bare brick walls and plain fireplaces, whilst the governor's bedroom has plastered walls, skirting and a mantelpiece, and a painted-over light above the door. There are large walk-in cupboards in the corridor area of the central hub, and small internal privies with curving walls blocking the view in (Plate 8).

Plate 8: First floor privies, viewed facing west

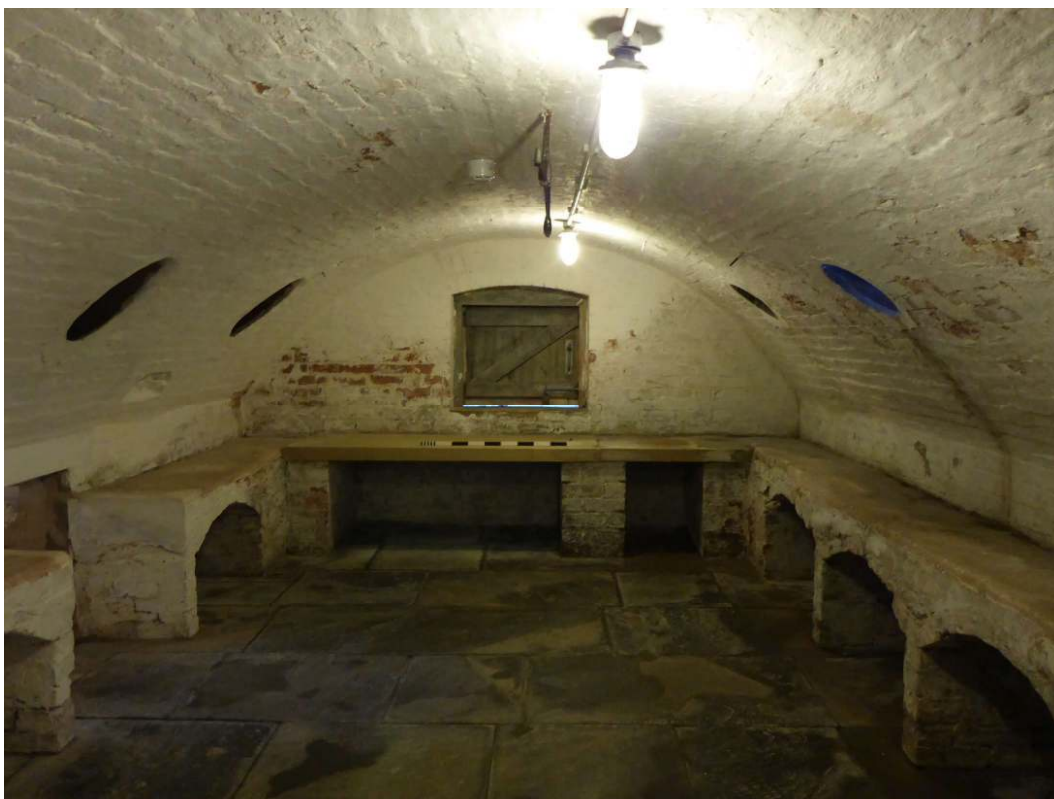
There is a basement below the western half of the building, with arched ceilings to the corridor and rooms. The rooms have raised stone benches around the sides, and low-height access openings between them, as well as circular light wells running through the walls in the central room (Plate 9). There is a square hatch in the western wall of the central room, with access via an external staircase adjacent to the west gable. There are lightwells into the cellar set into the ground to either side, with windows at basement level and iron grilles raised slightly above the yard surfaces.

Plate 9: Basement room in main accommodation block, viewed facing west

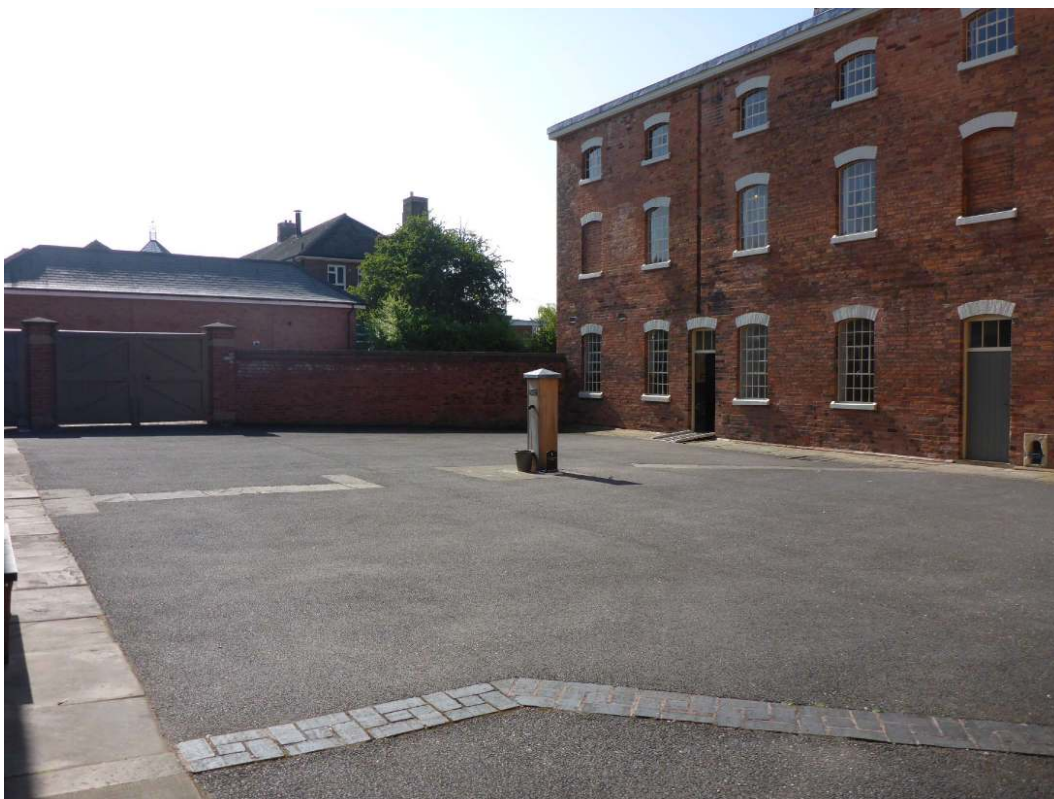
The work yards are located to the north of the accommodation block, and are defined on the north side by the range of outbuildings, and on the east and west sides by walls of a very similar design to those surrounding the exercise yards. There are gates set into the east and west walls, with the gatepiers of brick with stone courses at hinge level, surmounted by shallow pyramidal stone caps (Plate 11). A further outbuilding interrupts the western wall of the yard. The yards

Plate 11: View west across the men's work yard (asset 107)

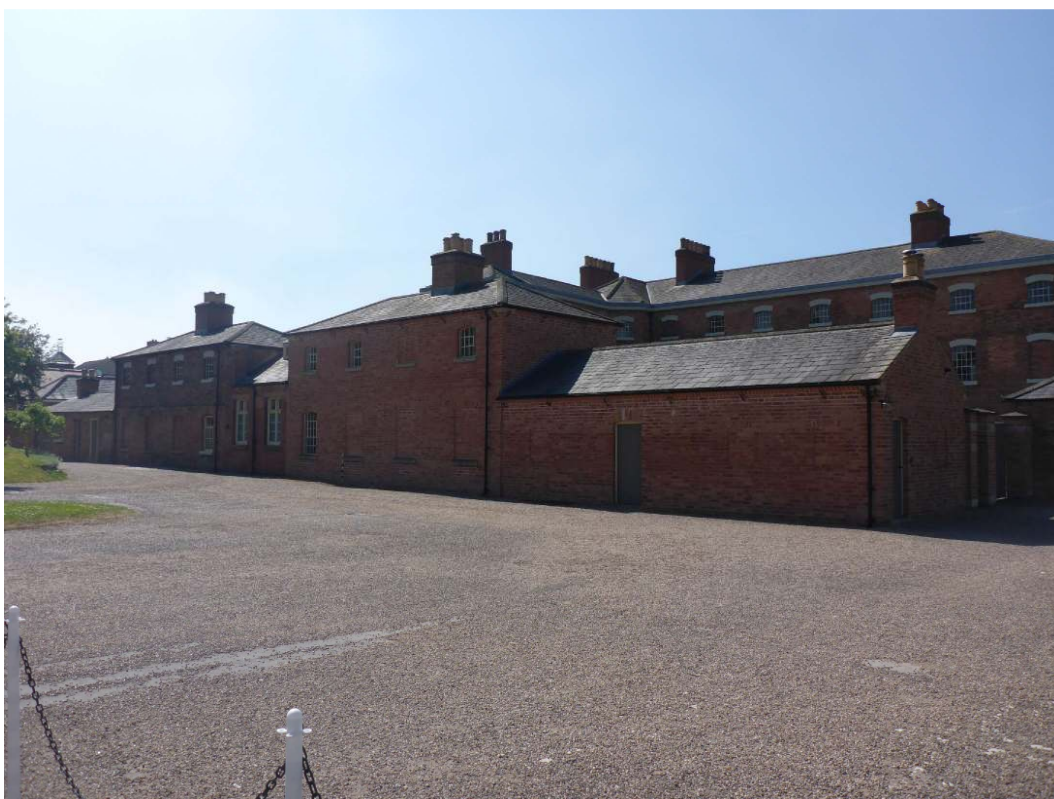
The outbuildings along the northern side of the work yards consist of several elements, and can be largely broken down into three segments. The western range (asset 103) was rebuilt in 2001, having been demolished between 1955 and 1967. It has been reconstructed in a mirror image of the eastern range (asset 102), which contains a single storey block at the east end, and a two-storey structure adjacent to the west (Plate 12). The two ranges are separated by a one and a half-storey structure that is clearly of more recent date. This is shown as a wash house on the 1930s plan, which replaced a walled coal yard depicted in 1828 that was progressively built over in the late 19<sup>th</sup> and first half of the 20<sup>th</sup> centuries. Stylistically, the wash house appears to be of early 20<sup>th</sup>-century date. This structure is in a different brick to the original range, and has flat, plain stone window lintels rather than the usual rounded brick arches, though the sills are similar moulded stone common to the workhouse buildings (Plate 13). The pitched slate roof has a central ridge dormer skylight. This element has no doorway and must be accessed internally from one or both of the two-storey blocks. The interior was not inspected. There is a bricked-in repair in the north elevation that may be a removed vent-hole.

Plate 12: North face of northern outbuilding range (assets 102-103)
