Exton Park, Rutland Lidar analysis and archaeological survey

ArcHeritage 2017

# Archaeological Survey and Lidar Analysis

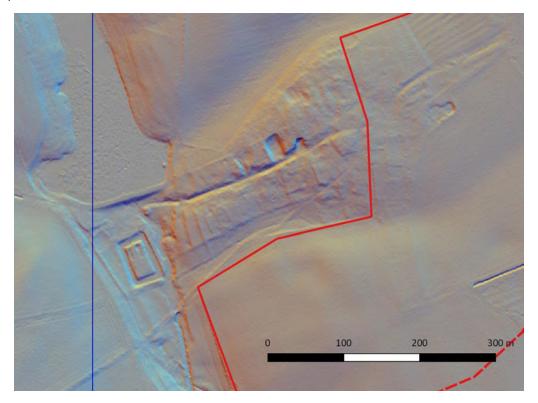
The most significant earthworks within the survey area comprise the well-preserved remains of the deserted medieval village of Horn, at the eastern side of the park (asset 2; Figure 12; Plate 1). These are designated as a scheduled monument, and include house and toft boundaries and trackways, as well as the site of a moated manor house (asset 25). The earthworks have previously been plotted from aerial photographs (Hartley 1983), though it is likely that more detail is visible from the Lidar data. Further deserted village remains are visible in the southwest part of Exton Park, south of the hall (asset 19), associated with buildings cleared during an expansion of the ornamental park in the early 19<sup>th</sup> century. Remains of earthworks associated with the 17<sup>th</sup>- to 18<sup>th</sup>-century terraced gardens around Exton Old Hall are also preserved within this part of the park (asset 23). Within the 19<sup>th</sup>-century walled kitchen garden (asset 20),

Plate 1: Lidar imagery of Horn deserted medieval village and moated site

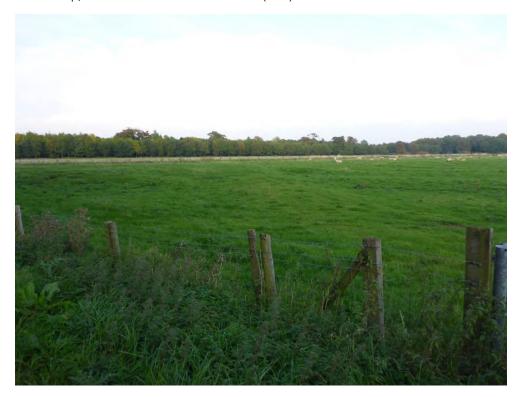
map (181), with earthwork ridge 316 continuing an extant track across ridge and furrow towards Tunneley Wood. A former trackway along the eastern side of the survey area, shown on the 1885 map, survives as a terraced feature (176).

Plate 2: View northeast along raised trackway 316, ridge and furrow to either side

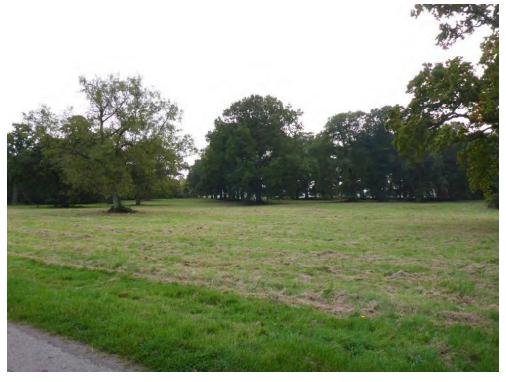
Plate 3: View southeast along tree line 320, northeast of Tunneley Wood

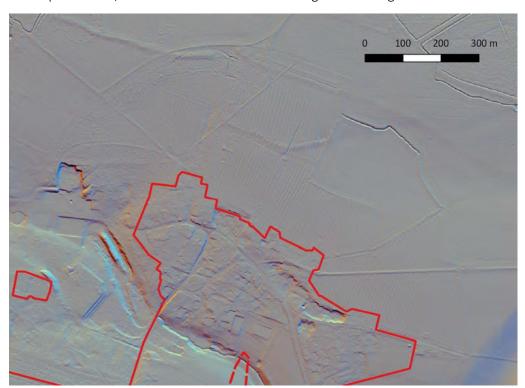
Plate 4: Lidar imagery showing ridge and furrow earthworks north of Exton

The majority of surviving earthwork ridge and furrow is found in the area around Exton Hall, with significant groupings in pasture fields to the immediate north of Exton village (assets 242, 259-262, 264-5, 267-8), and in the grassland/pasture part of the parkland to the west and southwest of the hall (243-244). There is also a small area at the west edge of the survey area, extending into the buffer, around Hall Farm (asset 245) and possibly around Barnsdale Grange (asset 258). The predominant alignments of the ridges are north-south and Northeast-southwest, with occasional small patches of east-west aligned ridges. An extensive area of strips is shown on the 1730 map between Exton village and Tunneley Wood, and to the west and south of the park. The map indicates that cultivation in the open field method was still

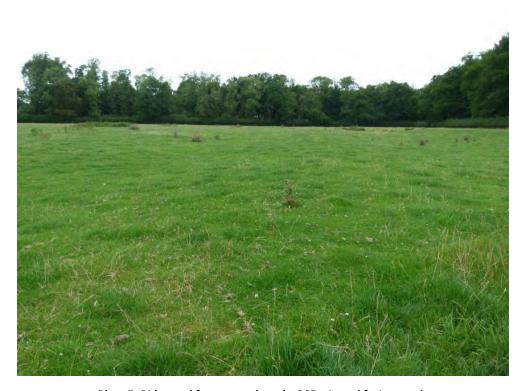
Plate 5: Ridge and furrow earthworks 265, viewed facing north

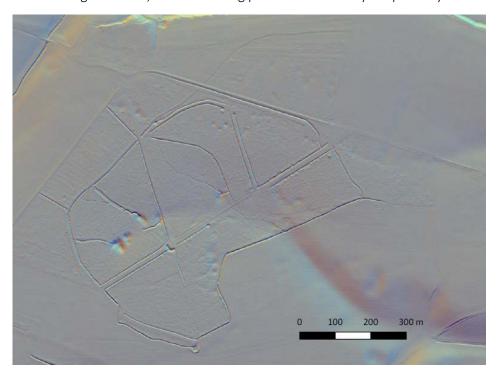
Plate 8: Lidar image of Tunneley Wood showing drainage and possible park pale

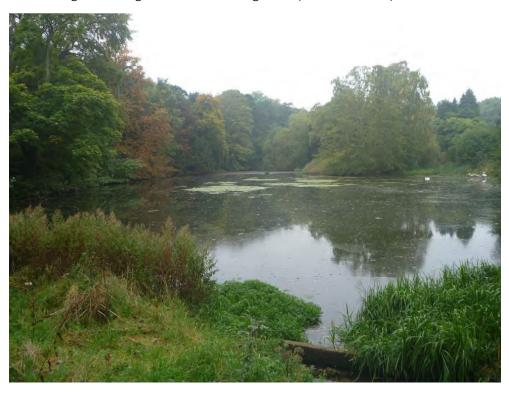
Plate 9: View west over fishpond 307 in Exton Park

A small pond to the east of pond 229 (asset 306) was first shown in 1826. This appears to have been dry by 1885, with a channel running through it crossed by a footbridge (asset 118). The pond has since been reinstated and is in a good condition, though the footbridge is no longer extant. The southeast pond, asset 227, was first shown on the 1807 map, as more extensive than its current form. At that date, the northern half formed a loop around a central island, with the south half forming a partial loop. By 1885, the northern half had been reduced in size, with only the western arm being extant; the eastern arm was shown as a dry valley, which still survives as a substantial earthwork, partly vegetation choked. The southern half now forms a loop around a narrow island, accessed on the northeast side by a plain modern footbridge (asset 119). The pond is in a good condition, though there is some vegetation growth and silting.

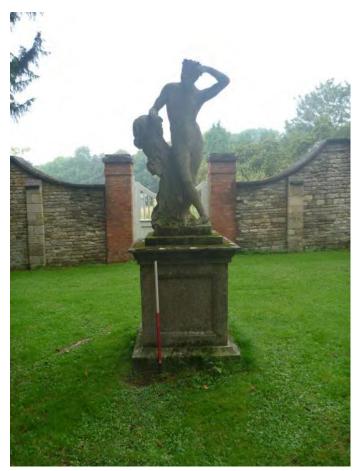
Plate 13: Statue with kitchen garden walls and gate to rear, viewed facing west

Six boundary walls have been recorded, including the grade II listed boundary around the southeast part of the inner park (asset 297). Further boundary walls within the park include the walls surrounding three sides of the former kitchen garden (asset 20). The walls are of brick and stone, and over 2m in height, with tall brick gatepiers. A further wall associated with a garden feature is the north-south aligned wall (asset 312) along the east side of a lawned terrace south of Exton Hall, with steps down to a walkway at either end. The terrace formerly held a parterre, created in the 19<sup>th</sup> century. At the eastern side of the park, a partially collapsed stone boundary wall (asset 292) survives along the southern edge of the field containing Horn DMV, extending west across the valley. Part of this wall forms the park boundary, and it is shown on 18<sup>th</sup>-century

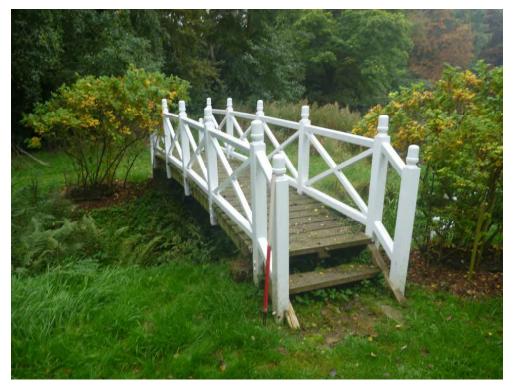
Plate 15: Modern wooden footbridge 310, crossing leat between ponds 307 and 229

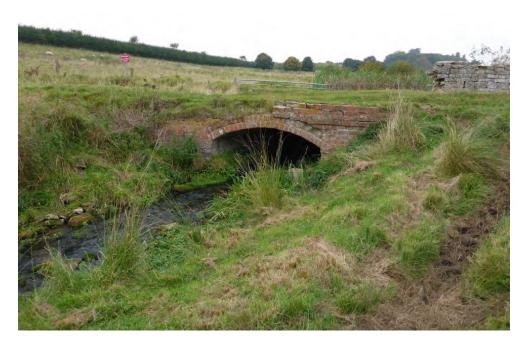
Plate 16: Brick footbridge 116 over North Brook, south of wall 292

southeast edge of the survey area. The bridge is in a moderate to good condition, though it appears that the southern parapet may have been rebuilt in places. The bridge has two large moulded stones in the coping of the northern parapet, the remainder having flat copings. A footbridge (asset 116) over the North Brook to the south of Lower Lake is of red brick construction with an arch over the brook. There is no parapet, and it is unclear if this has been removed or was never extant. It is in a moderate condition. A road bridge over a brook in the buffer to the southeast of Exton (asset 315) has mortared stone parapet walls and triangular coping stones. Vegetation and access restrictions mean that the main part of the bridge structure could not be observed.

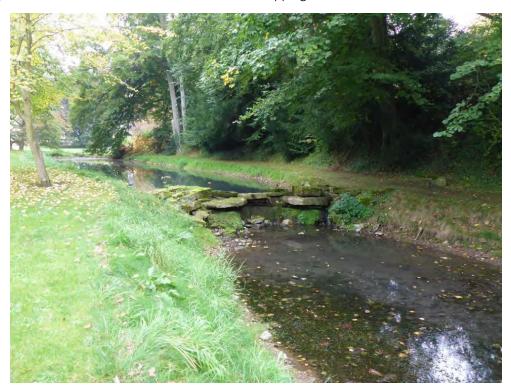
Plate 18: Rustic stone weir 276 over fishpond 227 in Exton Park, viewed facing north

Two rustic weirs of rough, large stones cross pond 227, one linking the bank to the southern island. These features appear designed to look fairly natural, and may be entirely decorative

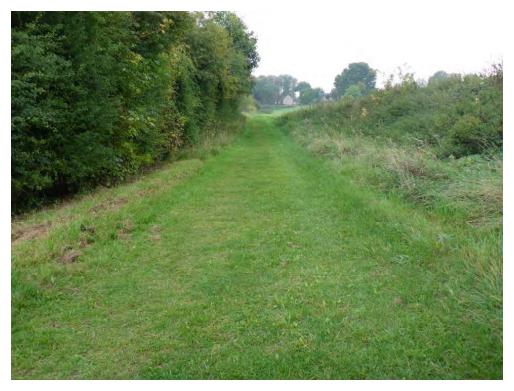
Features associated with transport (excluding bridges, mentioned above) include the former mineral railway, a trackway, and five 19<sup>th</sup>-century guide posts on the roads in the buffer around the survey area (Figure 18). The mid-20<sup>th</sup>-century mineral railway (asset 27) formerly ran in a loop around the edge of the park, constructed largely in cuttings. After its removal in the 1970s, the cuttings were infilled, and Lidar analysis and field survey suggest that this was effectively done, as there are very few visible features surviving. The exception, apart from the road bridge over the railway on Cottesmore Road (asset 305), is a small section of the former trackbed that currently forms part of a public footpath to the southeast of Exton (asset 27). There are no visible remains of railway features within the path. A cart or vehicle track (asset 213) marked by two rows of bricks spaced 1m apart is located at the western side of the park, aligned north-south. It is marked as a track on the 1885 map, but the date of the brick surfacing is uncertain. The guide posts (assets 187-191) are all in an identical style, a white-painted faceted post with wooden boards labelled with raised, black-painted lettering. The posts are incised 'RCC' for Rutland County Council (established 1889), and are therefore likely to be 20<sup>th</sup>-century replacements of the posts shown on the 1885 map.

Plate 19: View west along line of former mineral railway 27 to southeast of Exton

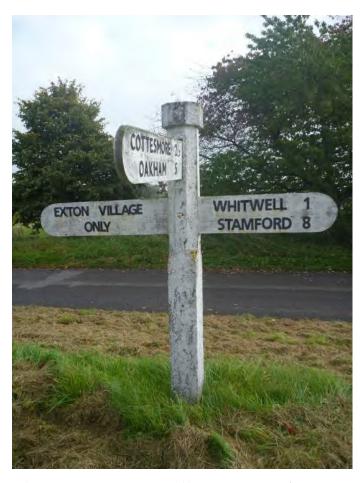
Plate 20: Guide post 189 on Oakham Road, viewed facing east
