**A DETAILED BUILDING SURVEY OF
THE ROOF AND THE ATTIC OF THE
EAST RANGE, APETHORPE HALL,
NORTHAMPTONSHIRE**

A Report for English Heritage

OS Grid Ref. SK 022 952
TPA Project Code: AHN.1
File Name: AHN1-Rept.doc
July 2007
Amended October 2007

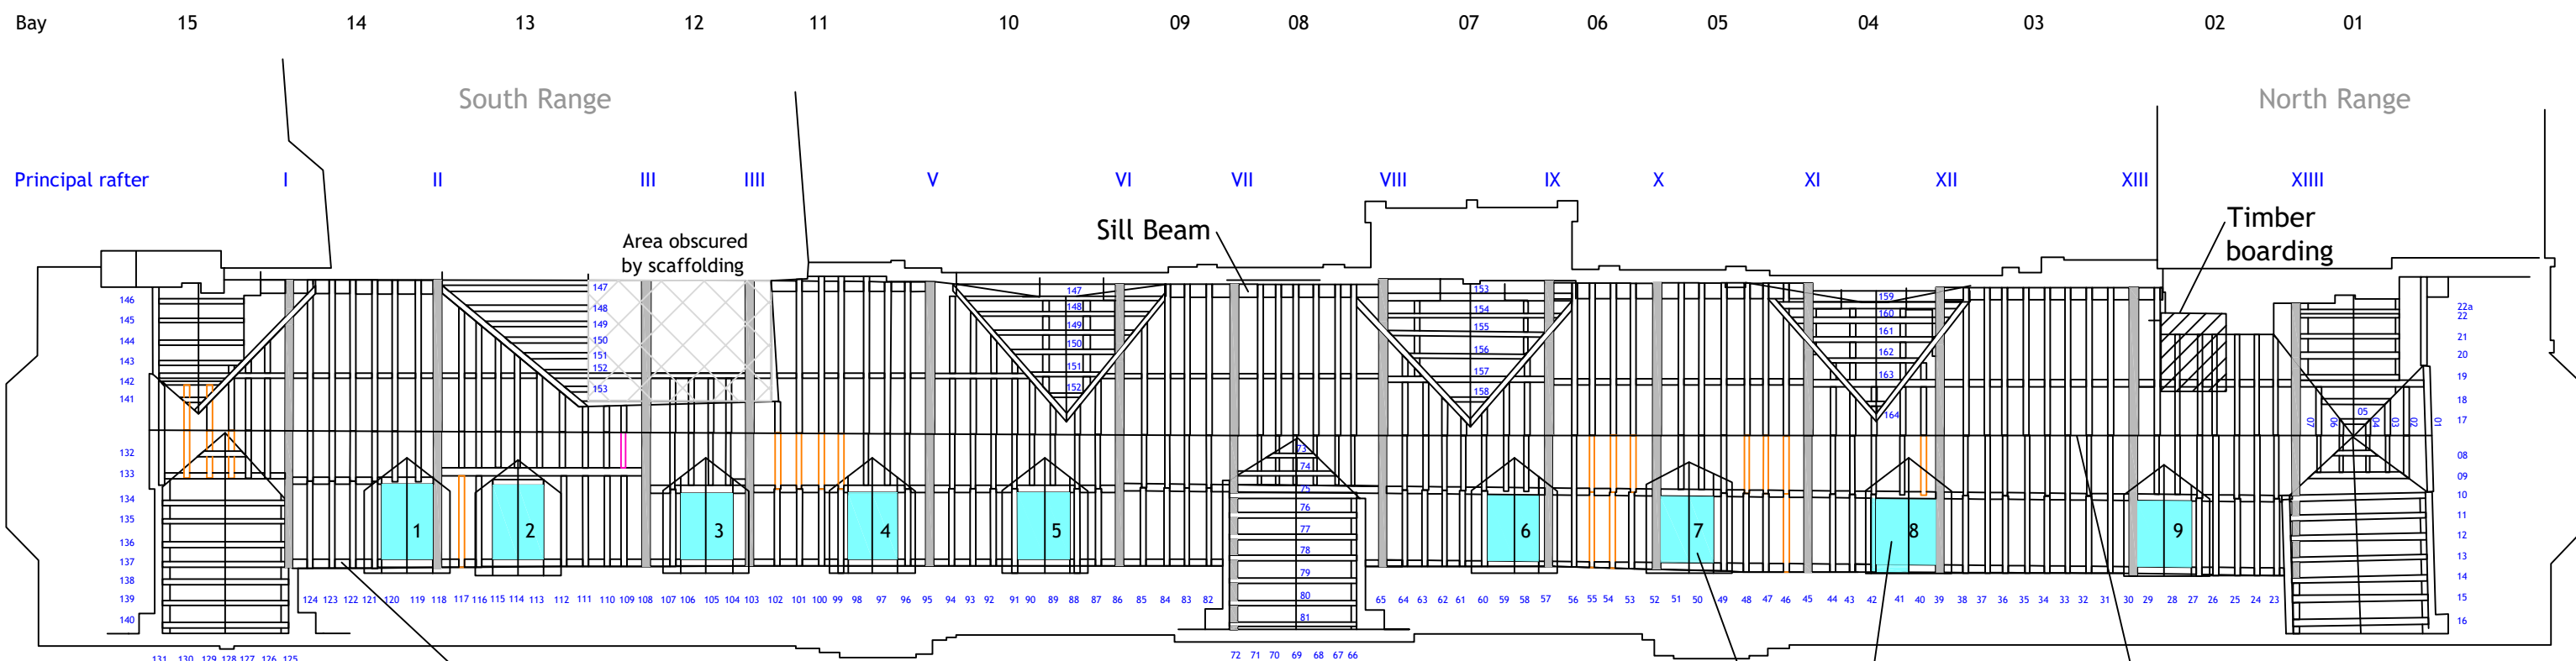
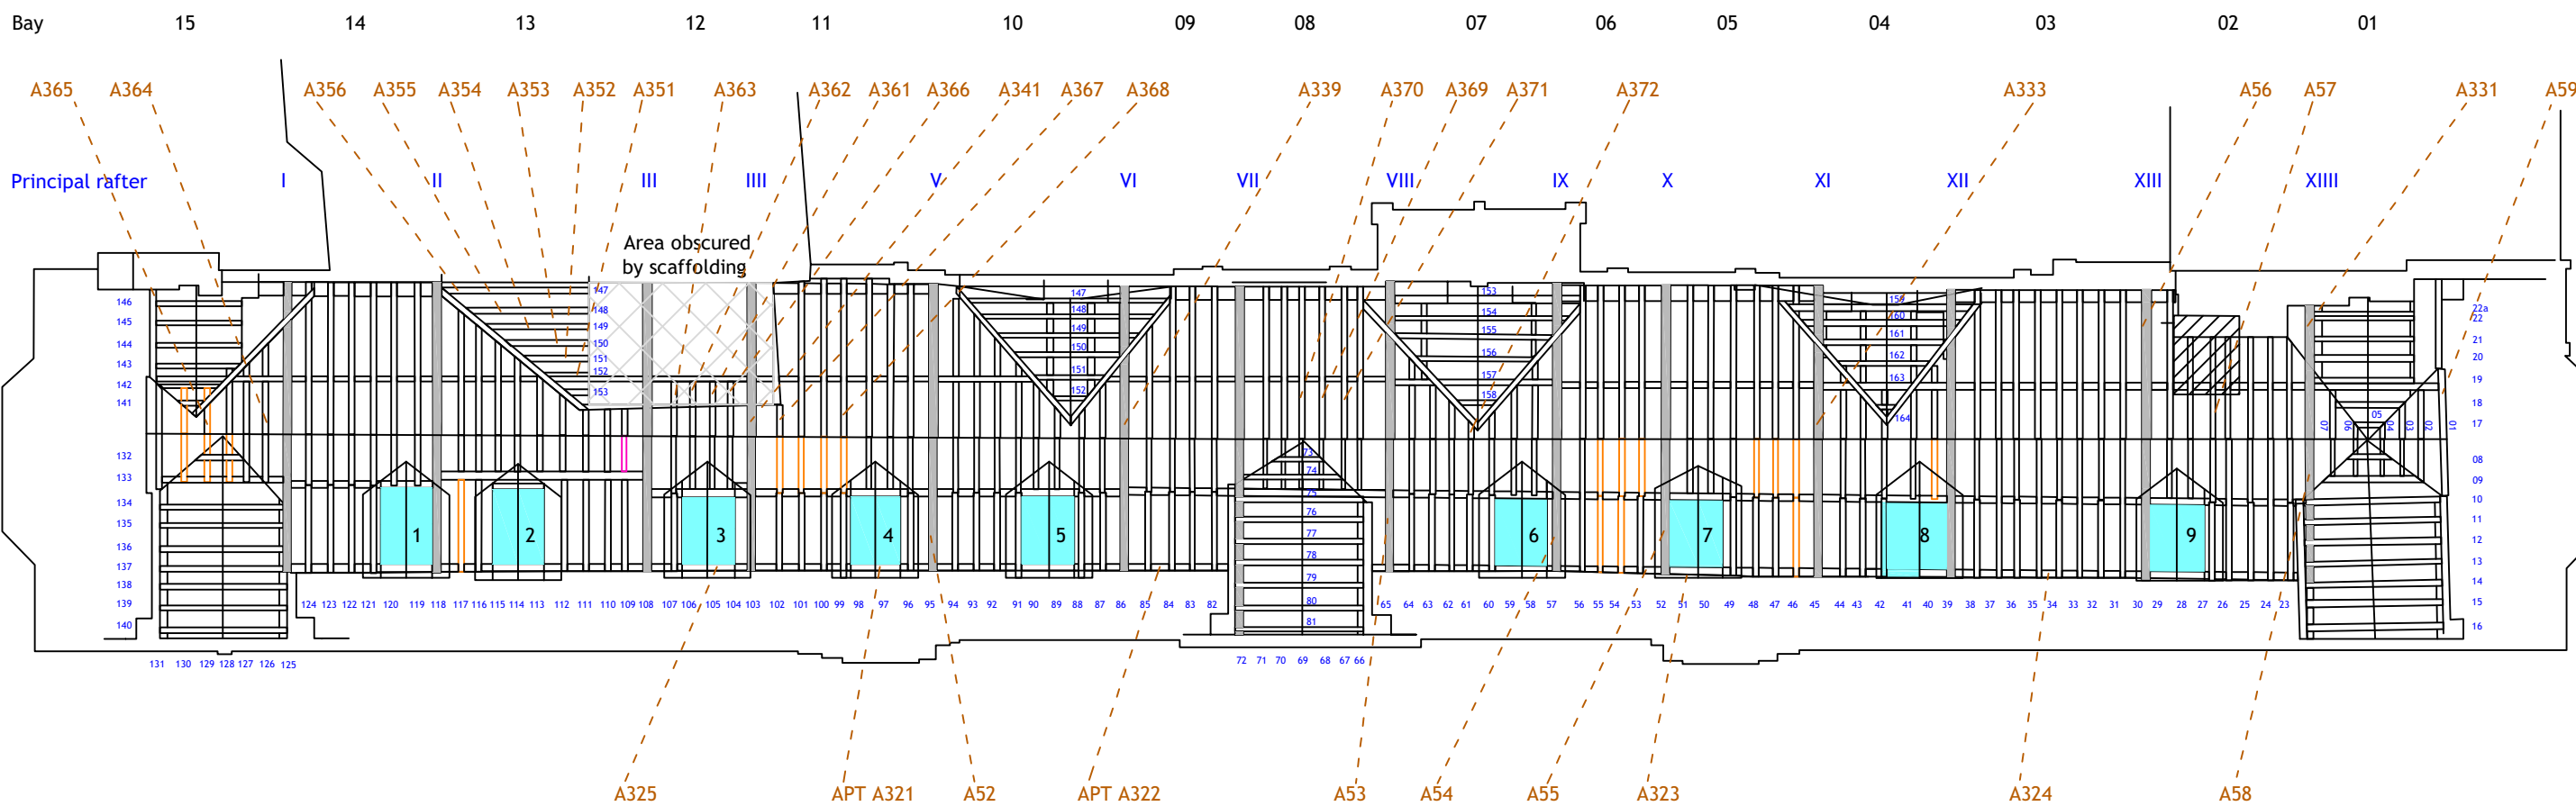
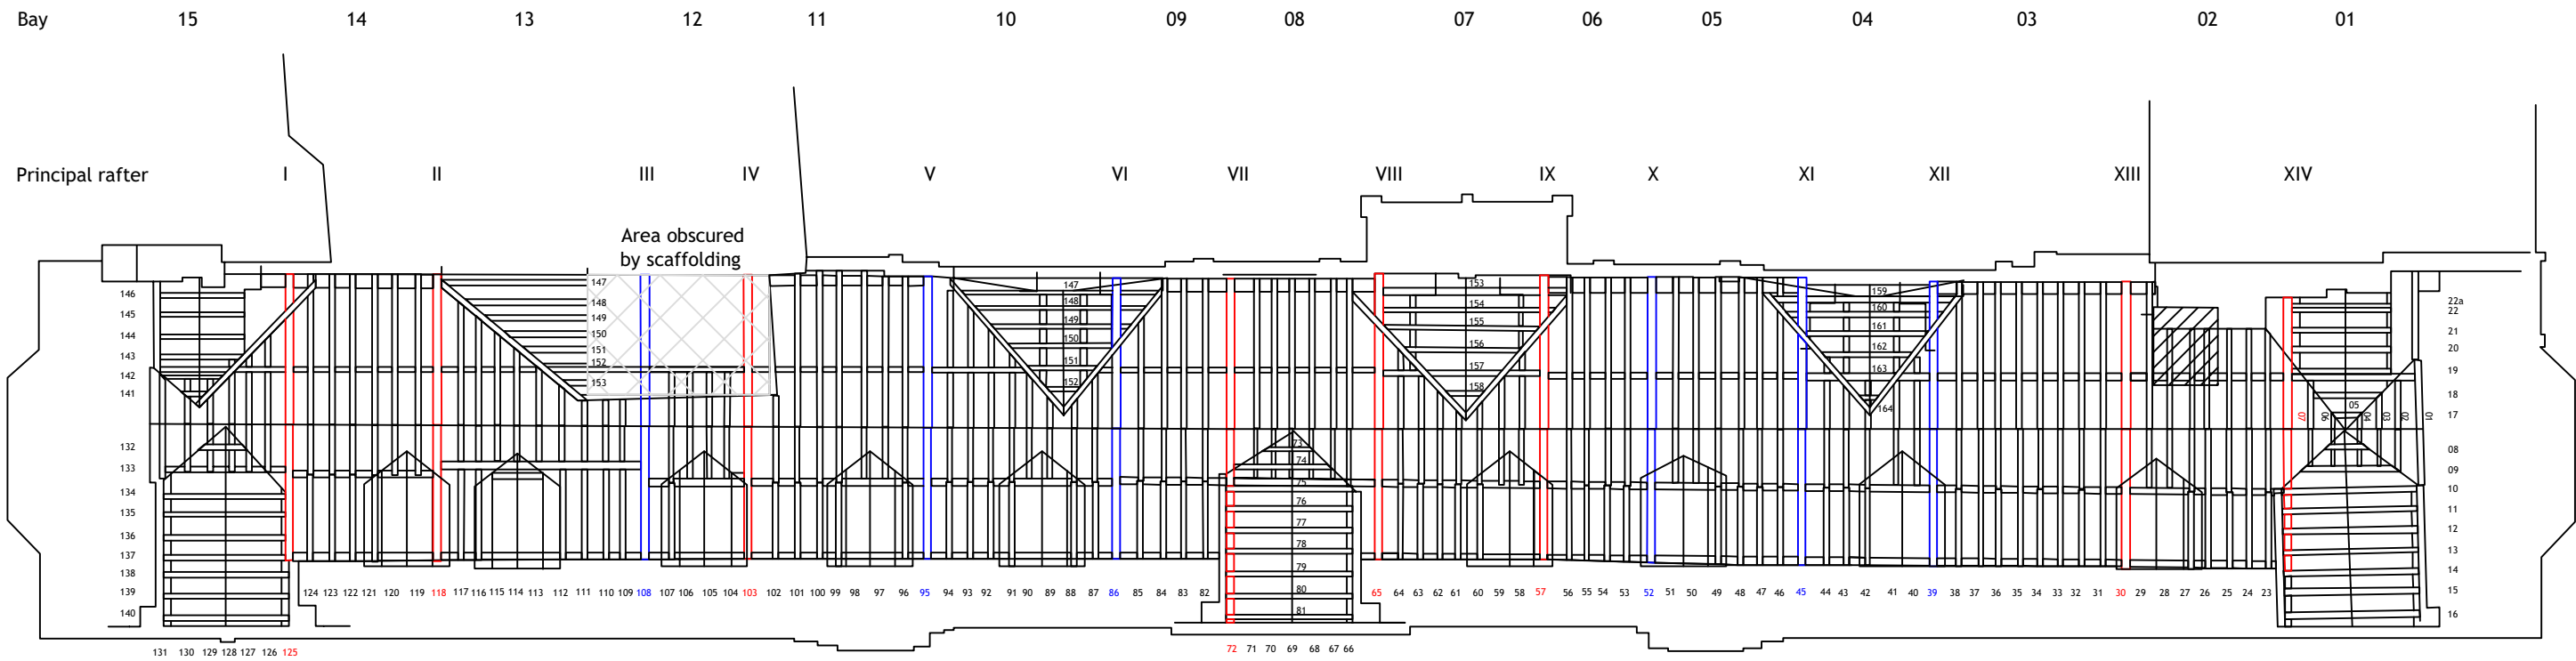
Figure 2: Apethorpe Hall, Northamptonshire
Plan of roof timbers of East Range: Principal rafters
1:200 at A4 RS/DW 11/07/07

- Principal rafters corresponding with floor bridging beams
- Principal rafters not corresponding with floor bridging beams

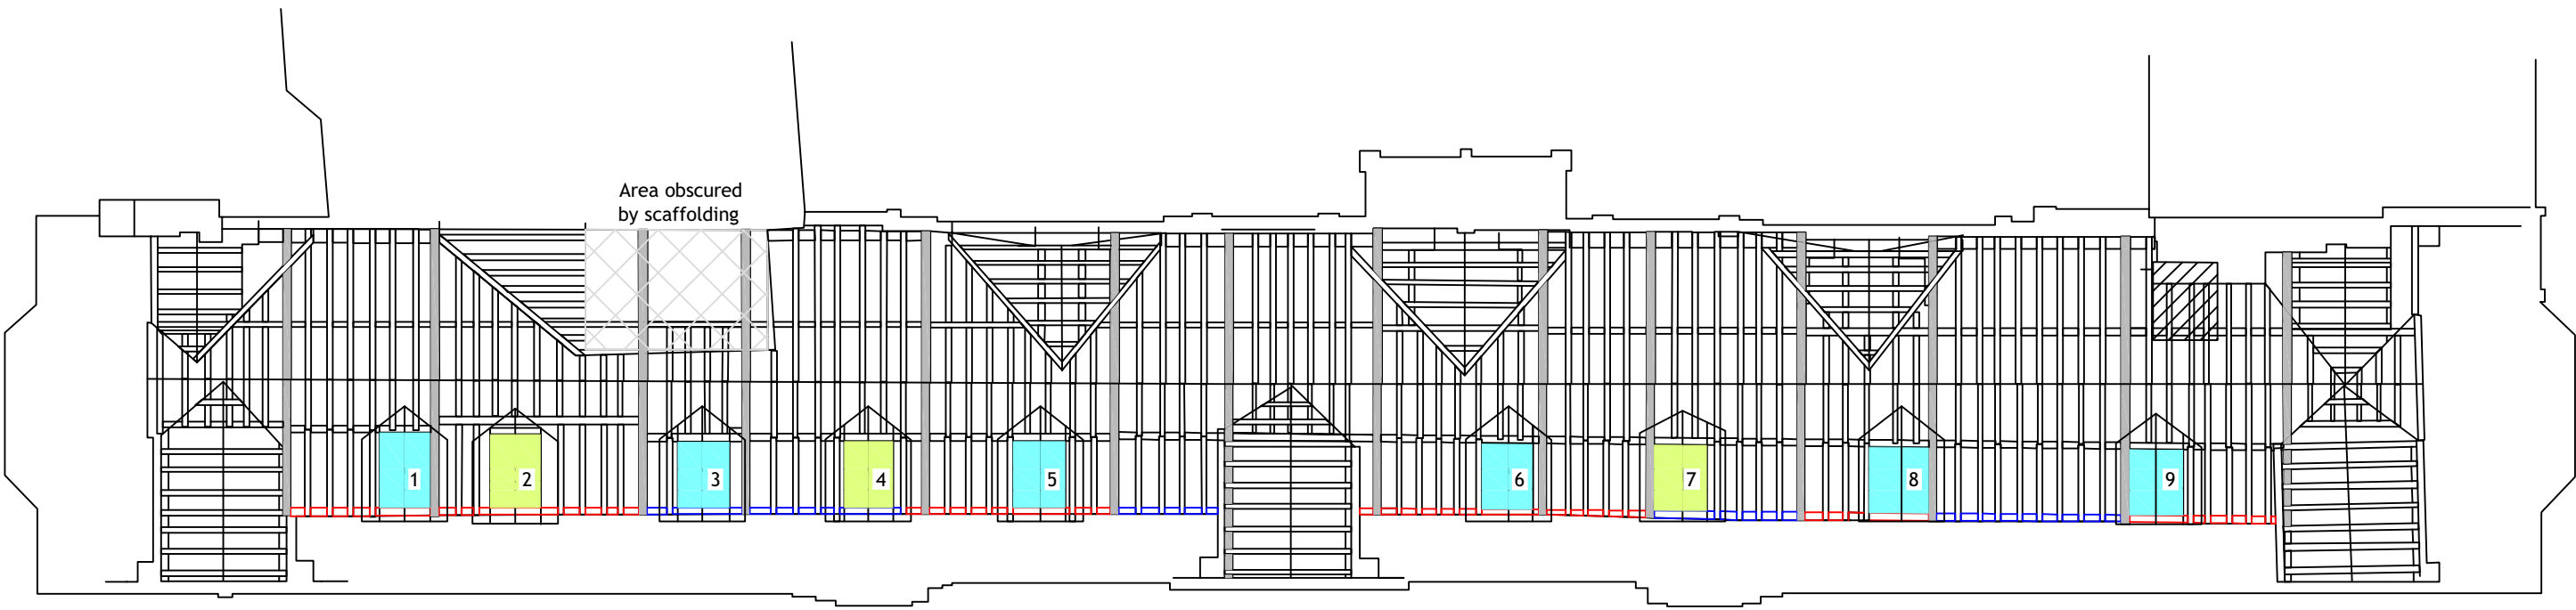
Figure 6: Apethorpe Hall, Northamptonshire
Plan of roof timbers of East Range: East side upper sill beams and dormer windows
1:200 at A4 RS/DW 11/07/07

Bay 13 was probably rebuilt later when a new dormer window (dormer 2 - Fig. 6) was inserted. Neither dormers 1 or 2 are shown on Neale's view of the East frontage of 1830, perhaps because they looked incongruous together. The first time that dormer 2 appears is on the plan of 1858, presumably to help light the first room north of the main staircase. The east side of bay 13 was carefully rebuilt using existing Type A timbers, one reused rafter with mortices with rounded ends, one new rafter and a softwood purlin with the stamped initials S.F.H. Although the meaning of the initials could not be traced, their typography suggests a late 18th - early 19th century date.

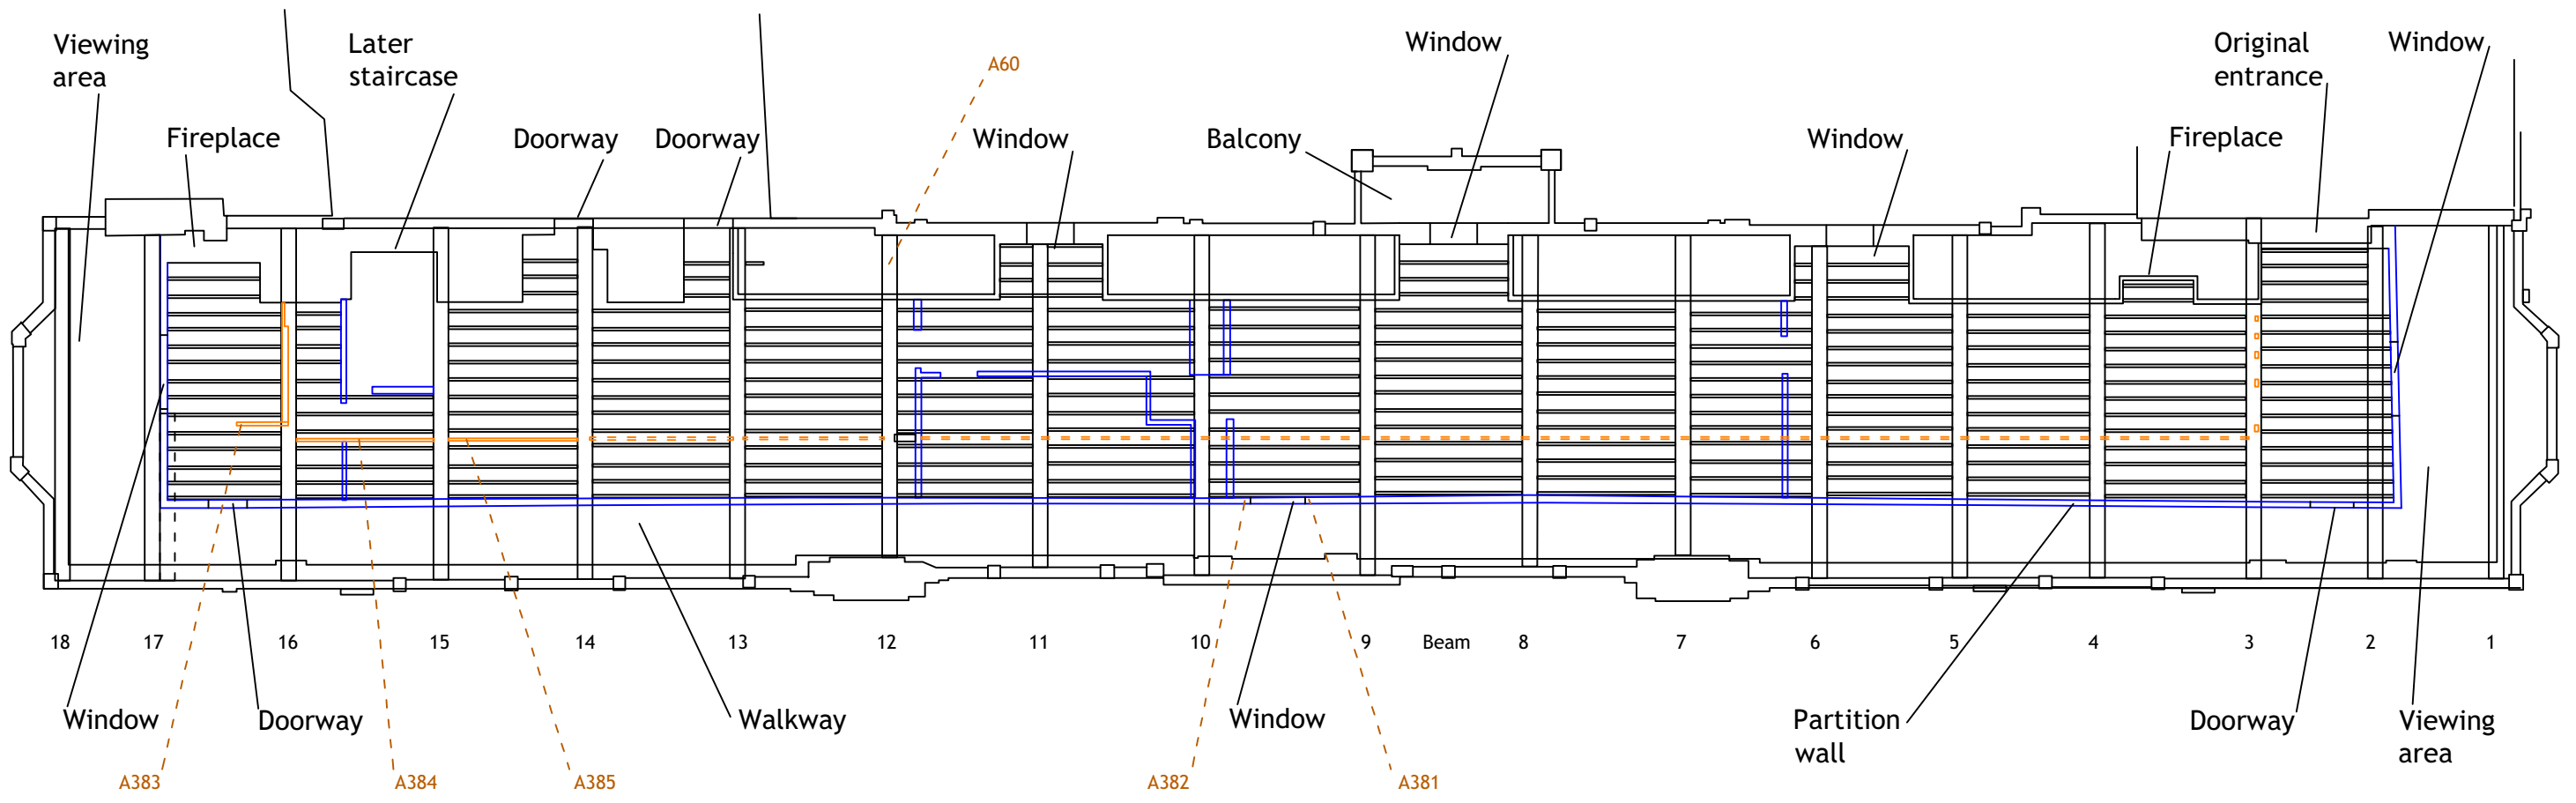
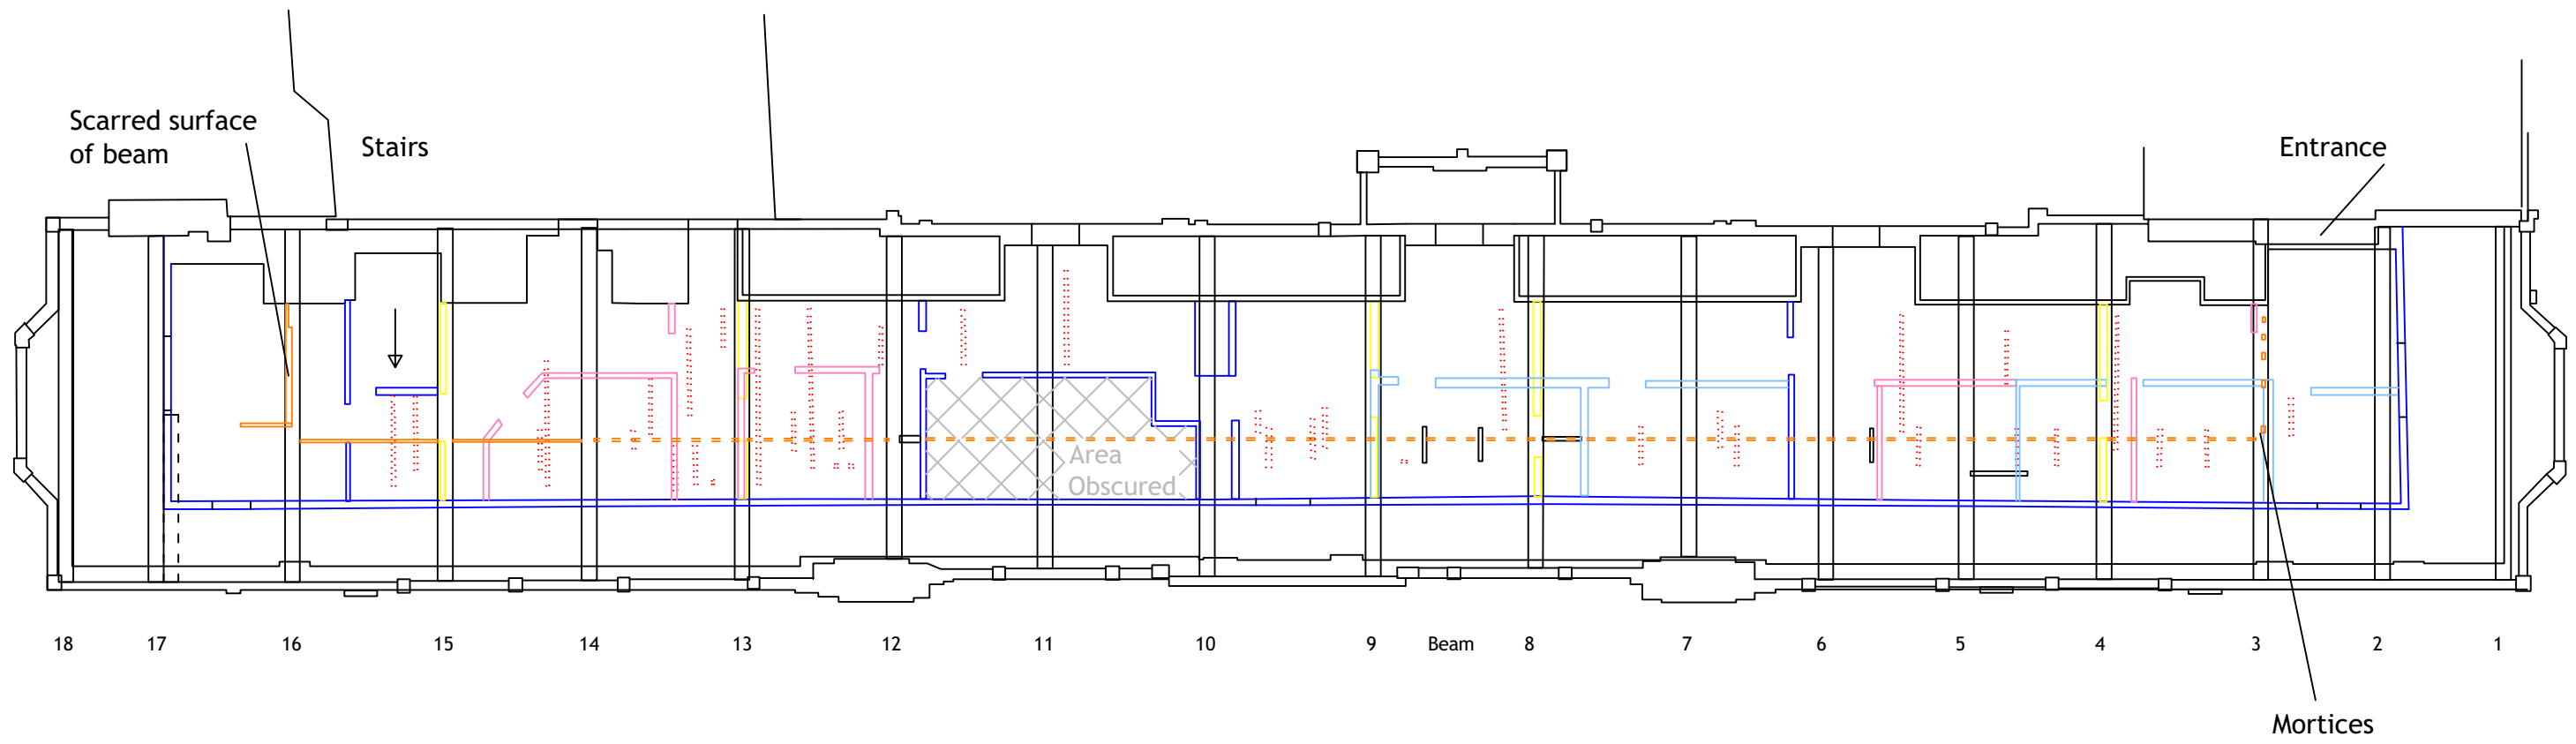
Figure 15: Apethorpe Hall, Northamptonshire
 Plan of bridging beams, joists and remaining partitions in the attic of the East Range
 1:200 at A4 RS/DW 29/09/07

The attic was floored with mainly softwood boards and a few oak ones. Most of these were removed early on for safety reasons and replaced with large boards. With the bridging beams and floor-joists exposed (Fig. 15) the opportunity was taken to look for evidence of former partitioning. Many long and short lines of notches cut into the tops of the joists and some in the bridging beams were recorded. These were mostly straight cuts of differing widths, but some were angled cuts (Plate 46).

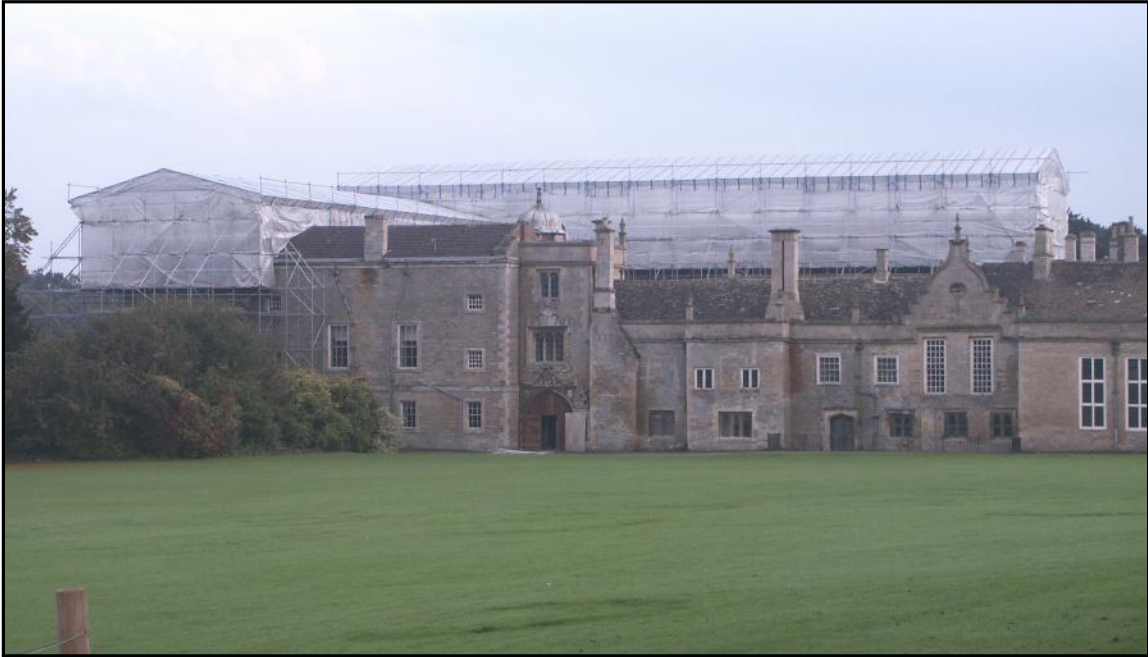
1

Plates of the East Range of Apethorpe Hall. 1: part of the north frontage with the covered roofs of the East Range (left) and the South Range (right) showing in the background **2:** view of the northern end of the roof of the East Range, with slates removed and battens and timbers beginning to be exposed (photo 38).

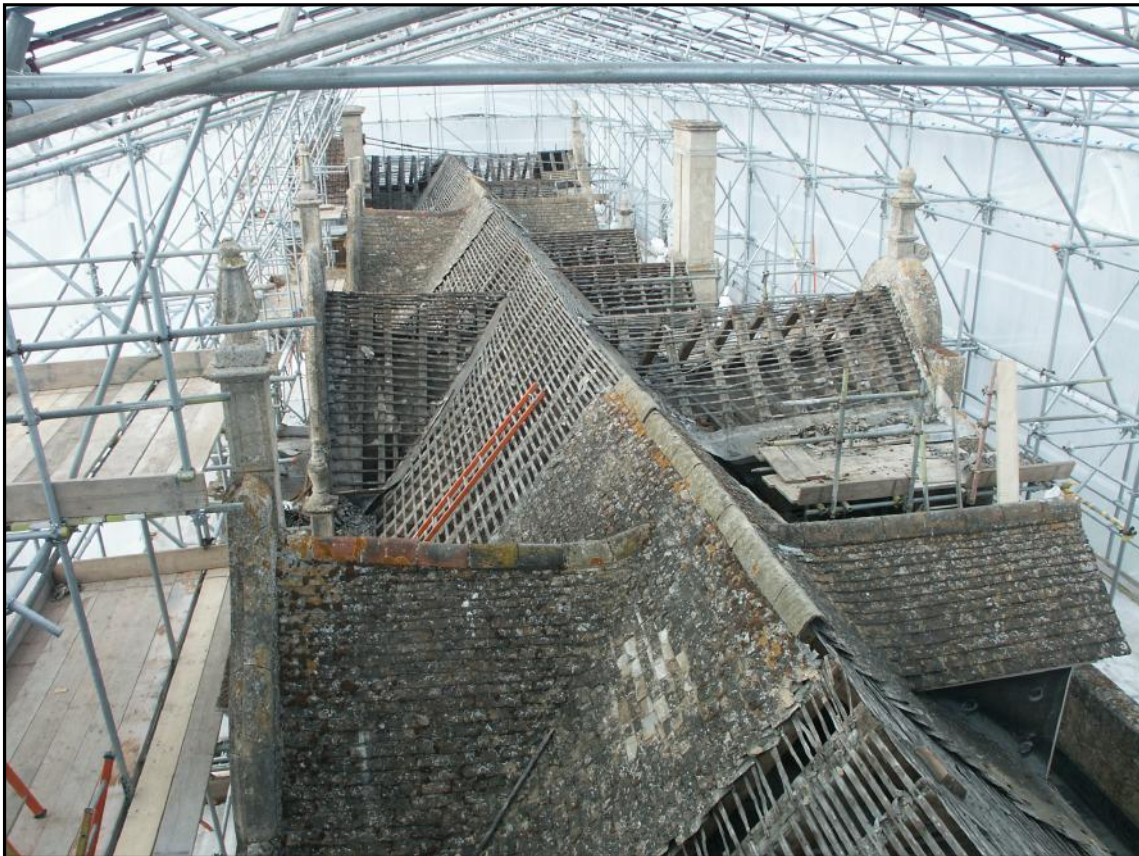
2

The full area at the top of the East Range is largely covered by a north-south running timber roof that is over 45 metres in length and just over 5.5 metres in width. This is covered by Collyweston slate roof tiles set on timber battens (Plate 2). The roof structure is built of oak rafters that join at the roof apex, without ridge pieces having been used. The roof is divided into 15 bays of varying length by larger principal rafters, the majority of which are seated onto bridging beams under the floor of the attic beneath the roof (Fig. 2). In cross-section (Fig. 8a) the roof slopes straight down on the west side but on the east side the principal rafters each include a natural kink which is supported by an angle-brace. These unusual one-piece timbers are shaped to allow for a low wall which has raised sill beams that support the lower ends of the common rafters. This wall divides the attic from a long external walkway that runs the length of the east side of the roof area to viewing area at the north and south ends of the building.

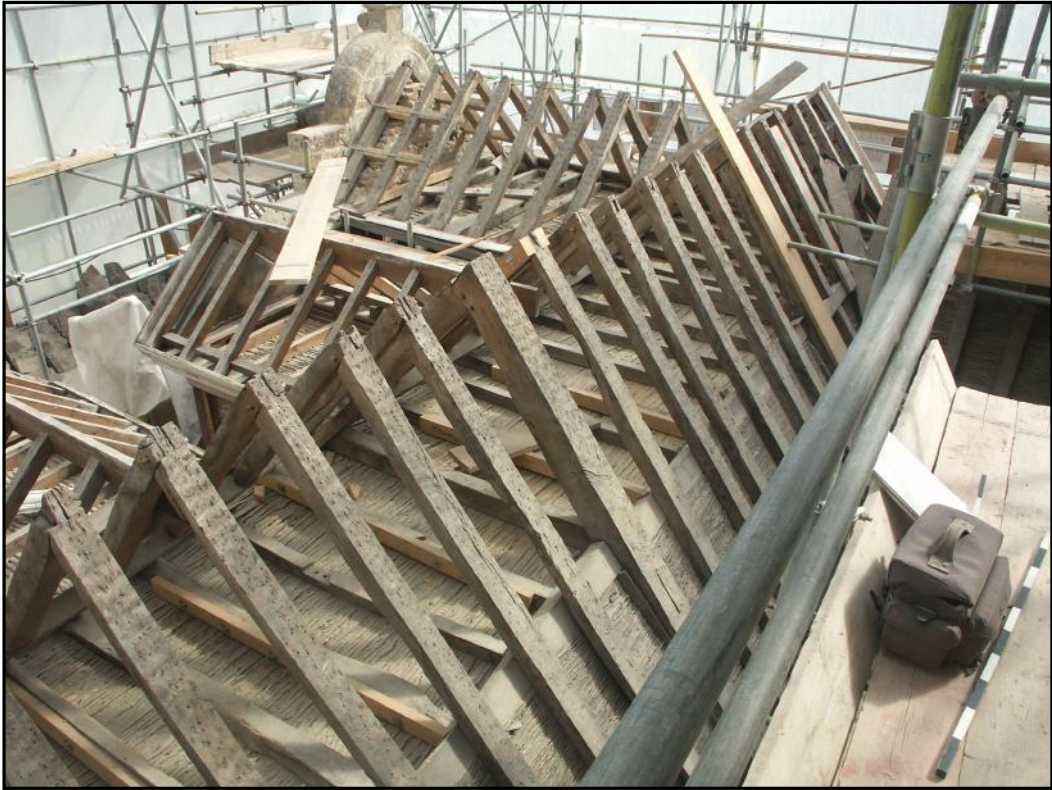
3

Plates of the East Range of Apethorpe Hall. 3: view of the west side of the main roof showing similar sized common rafters between bays 13-15 (photo 246); **4:** evidence of a former inserted dormer window in bay 14, on the west side of the roof (photo 253).

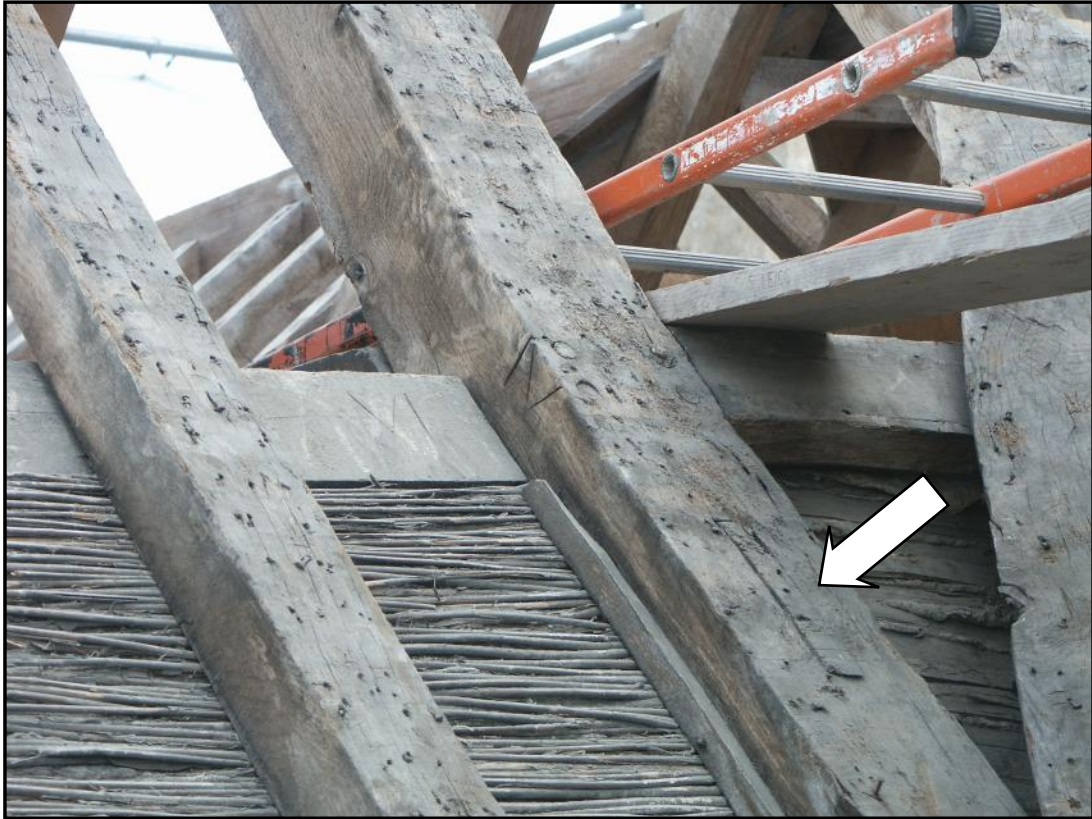
5

Plates of the East Range of Apethorpe Hall. 5: similar carpenters' marks where rafter 86 (principal VI) adjoins a purlin on the west side of the roof. An intact tenon is indicated by the arrow (photo 554); **6:** an instance of where a principal rafter is somewhat oddly seated on a much smaller sill beam rather than one of the comparably-sized bridging beams beneath the attic floor (photo 684).

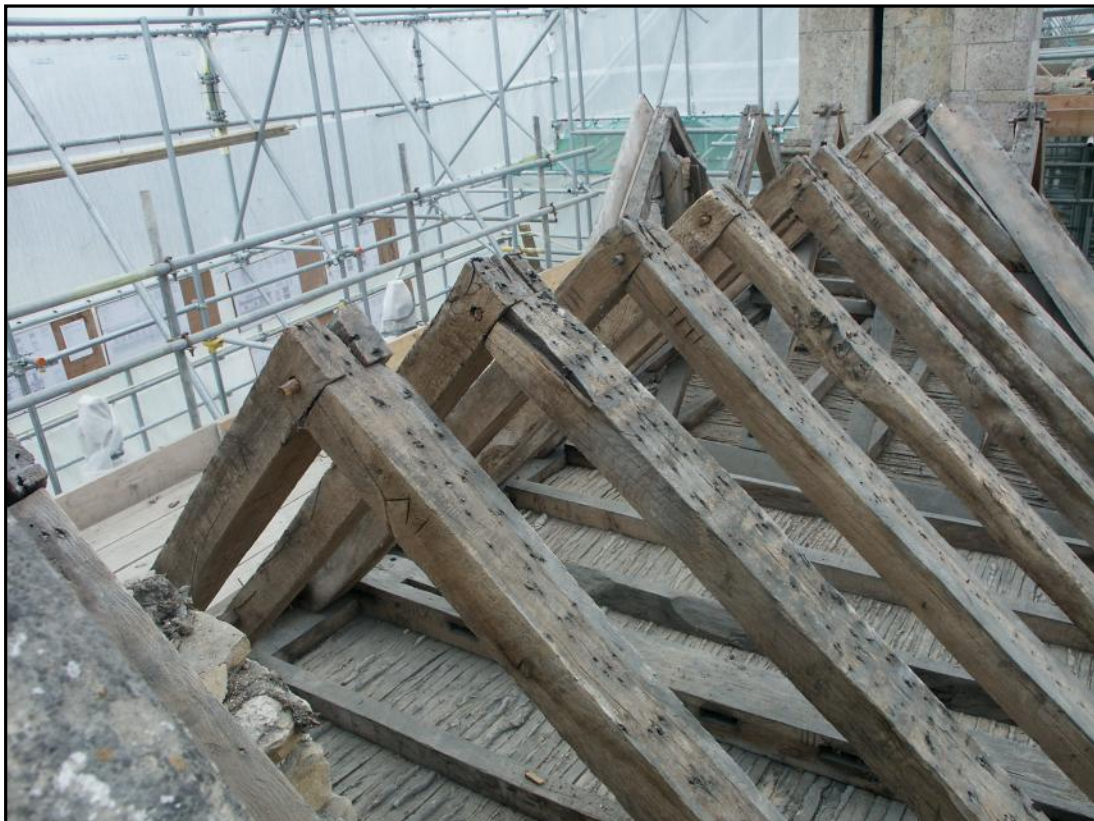
10

Plates of the East Range of Apethorpe Hall. 9: paired carpenters' marks at the roof apex in bay 13 (photo 479), the only place on the main north-south roof where this occurs; **10:** paired carpenters' marks and similar-sized and jointed rafters in one of the side-roofs (west roof, bay 15, south end of building - photo 511).

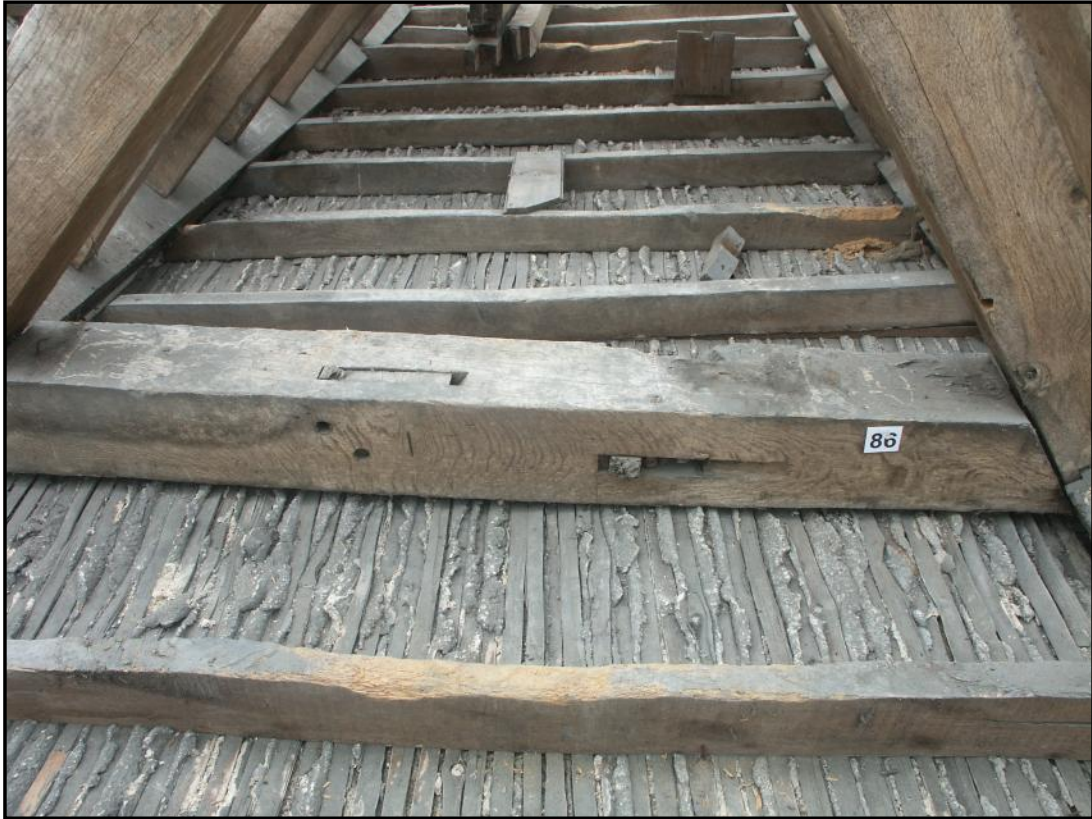
27

Plates showing Apethorpe Hall. 27: one of a sequence of ten large collars set between principal rafters with mortices that indicate reuse from elsewhere (photo 625); **28:** an example of close-set mortices in one of the larger collars. The acute angle of the mortice with the intact tenon is indicated by a projecting pencil (photo 611).

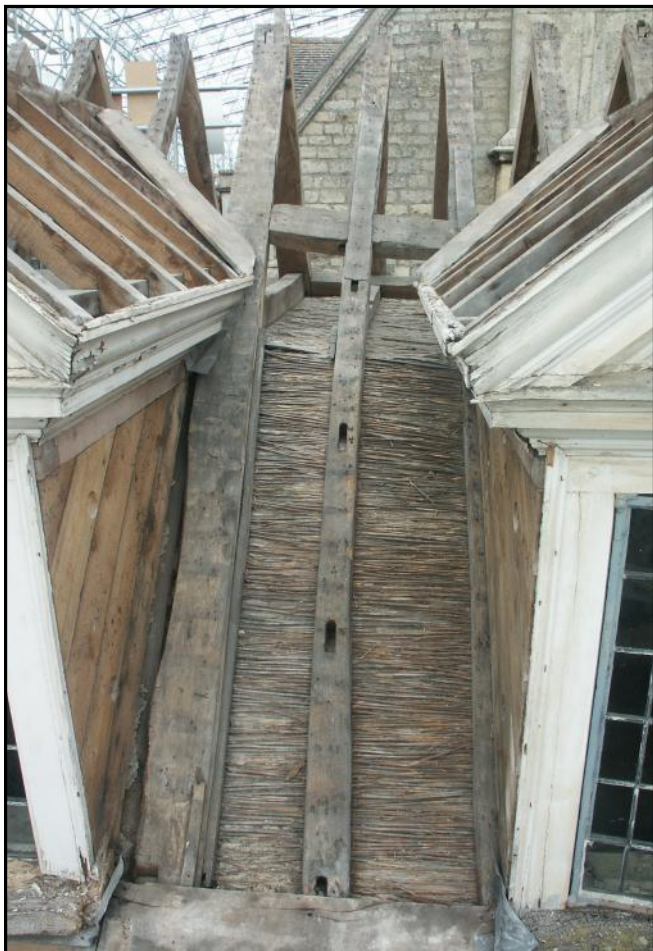
30

Plates of the East Range of Apethorpe Hall. 29: a large wall-plate with mortices showing in three planes, reused as a collar (photo 646); **30:** a smaller wall-plate reused as a rafter on the east side of the roof (Photo 485); **31:** possible rafter-braces reused as replacement collars towards the south end of the main roof (photo 634).

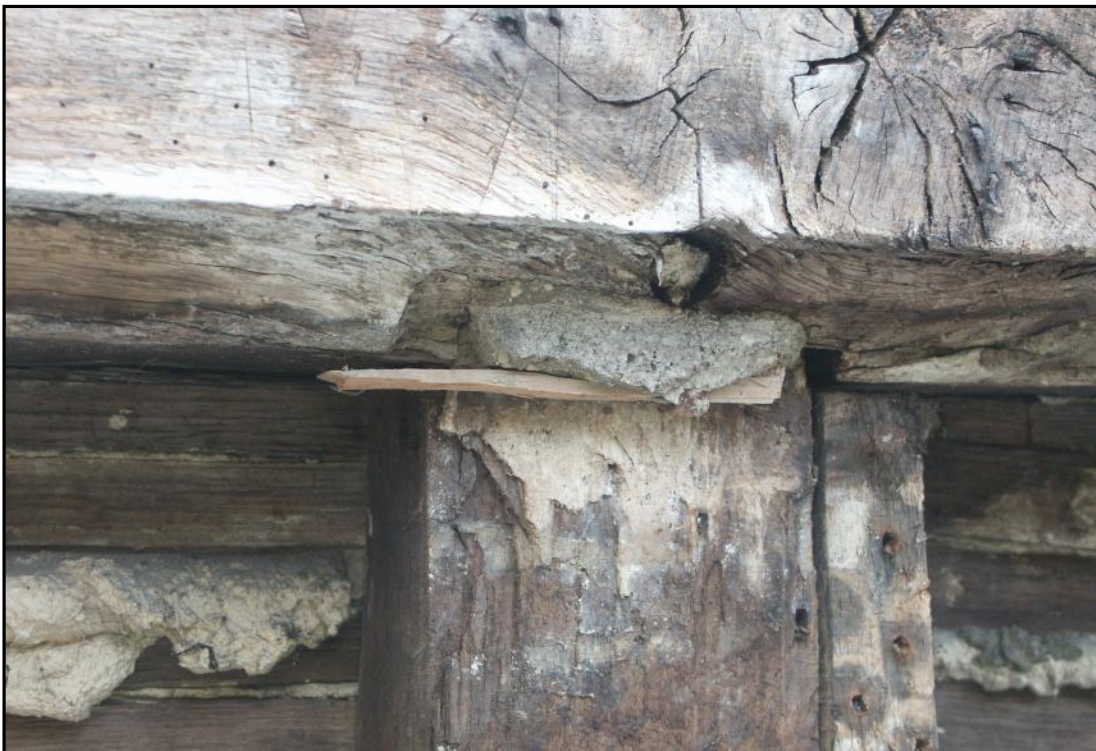
33

Plates of the East Range of Apethorpe Hall. 32: the low wall on the east side of the roof with upper sill beams showing. Seatings for the rafters show in the sill beneath the dormer window in bay 4, whilst the sill to the right in bay 3 lacks them and the rafters are nailed on instead (photo 186); **33:** one of the empty or infilled peg-holes showing on the underside of those sills with rafter seatings (photo 214).

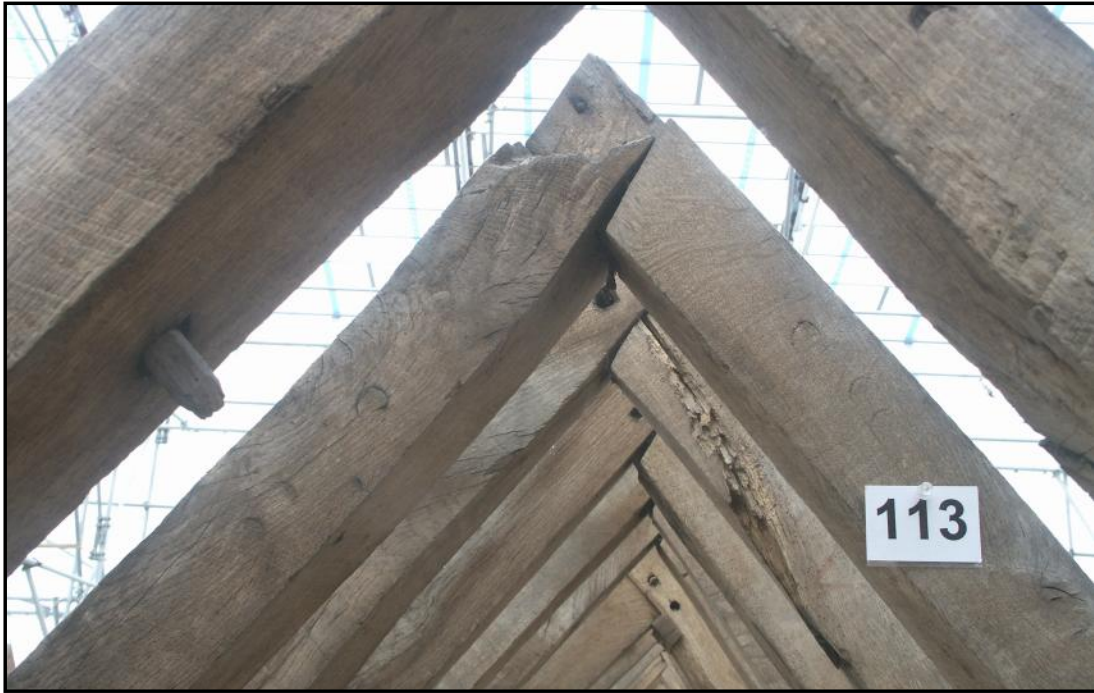
34

Plates of the East Range of Apethorpe Hall. 34: looking southwards along bay 13 of the main roof structure, with all of the west side Type A rafters jointed into the underside of the east side Type A rafters). Principal rafters, arranged the other way, show in the background (photo 481). 35: rafter 33 in bay 3 showing the acute angle of the top of the west side rafter (to right), and behind it , rafter 34, which is set differently with the west rafter uppermost and the carpenter's mark upside down (photo 386).

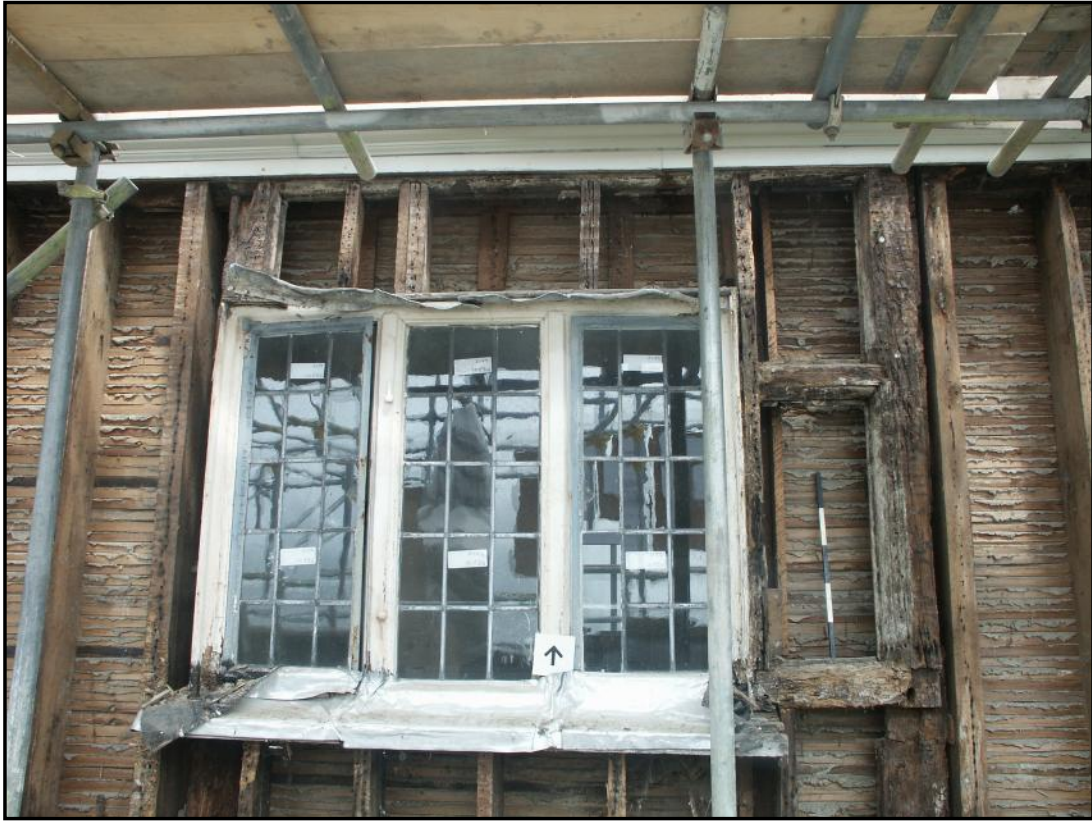
39

Plates of the East Range of Apethorpe Hall. 39: wooden-framed window in the south end-wall of the attic, with part of the frame of an earlier larger 6-light window showing to the right and above (photo 284); 40: a 6-light wooden-framed window in the north-end wall of the attic (photo 265).

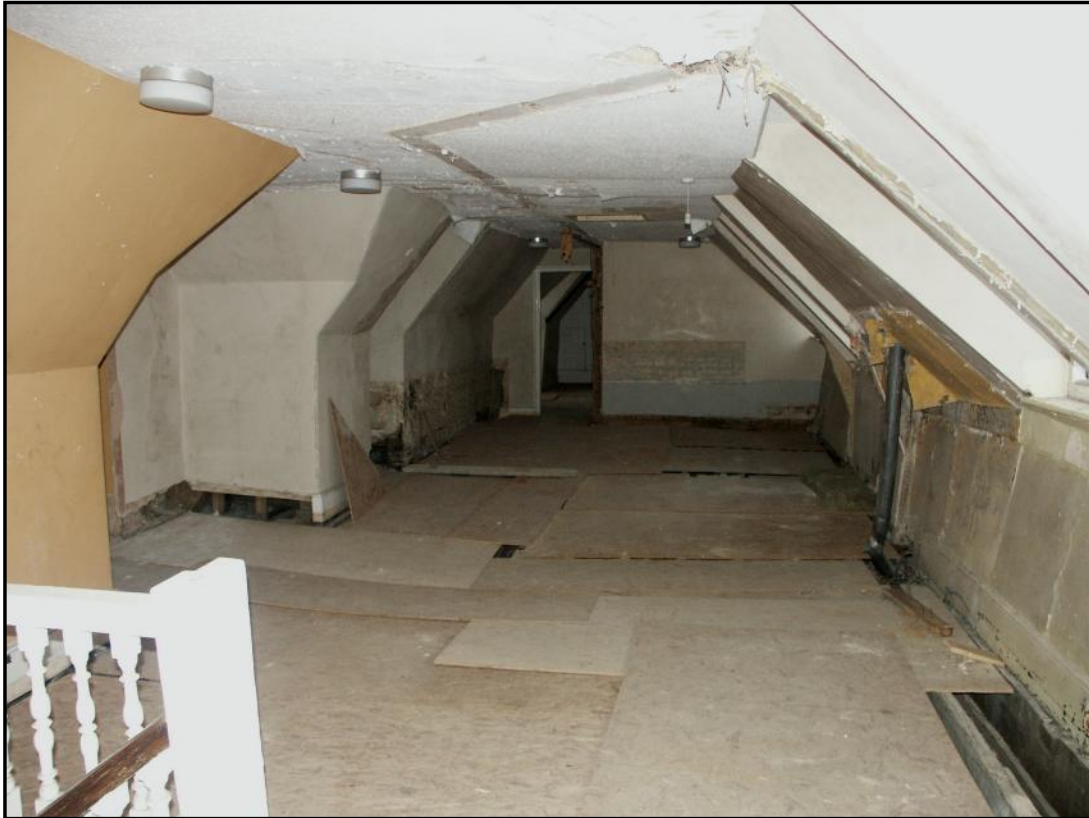
41

Plates of the East Range of Apethorpe Hall. 41: view of the south end of the attic after floor-boards and some partitioning had been removed. To the right the side wall can be seen bowing (photo 020); **42:** interior view by a dormer window showing one of the knee-angled principal rafters with an knee-brace, and the upper sill-beam (photo 024).

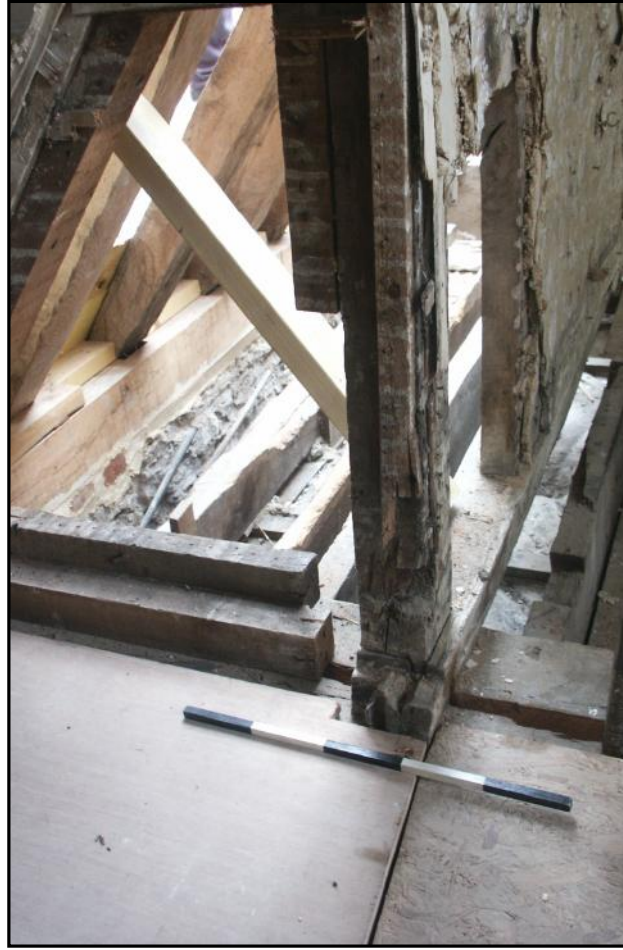
44

Plates of the East Range of Apethorpe Hall. 43: repair work by one of the knee-angled principal rafters, showing that the knee-brace was nailed on (photo 686); **44:** construction details of the partition on the west side of the attic (photo 670); **45:** dismantling in progress of the inserted fireplace in the west side of bay 2, showing the flue above it (photo 333).
