**A DETAILED BUILDING SURVEY OF
THE ROOF AND THE ATTIC OF THE
EAST RANGE, APETHORPE HALL,
NORTHAMPTONSHIRE**

A Report for English Heritage

OS Grid Ref. SK 022 952
TPA Project Code: AHN.1
File Name: AHN1-Rept.doc
July 2007
Amended October 2007

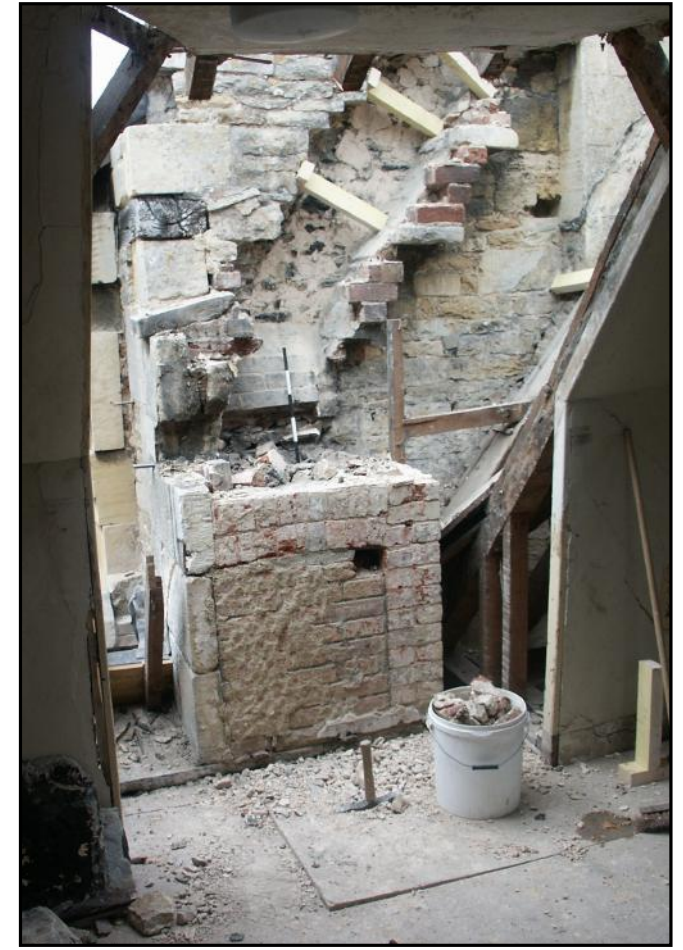
45

Plates of the East Range of Apethorpe Hall. 43: repair work by one of the knee-angled principal rafters, showing that the knee-brace was nailed on (photo 686); **44:** construction details of the partition on the west side of the attic (photo 670); **45:** dismantling in progress of the inserted fireplace in the west side of bay 2, showing the flue above it (photo 333).
