# Wollaton Park Walled Garden

## Structural Recording and Condition Survey

For Nottingham City Council Museums & Galleries

TPA Report code: 144/2014

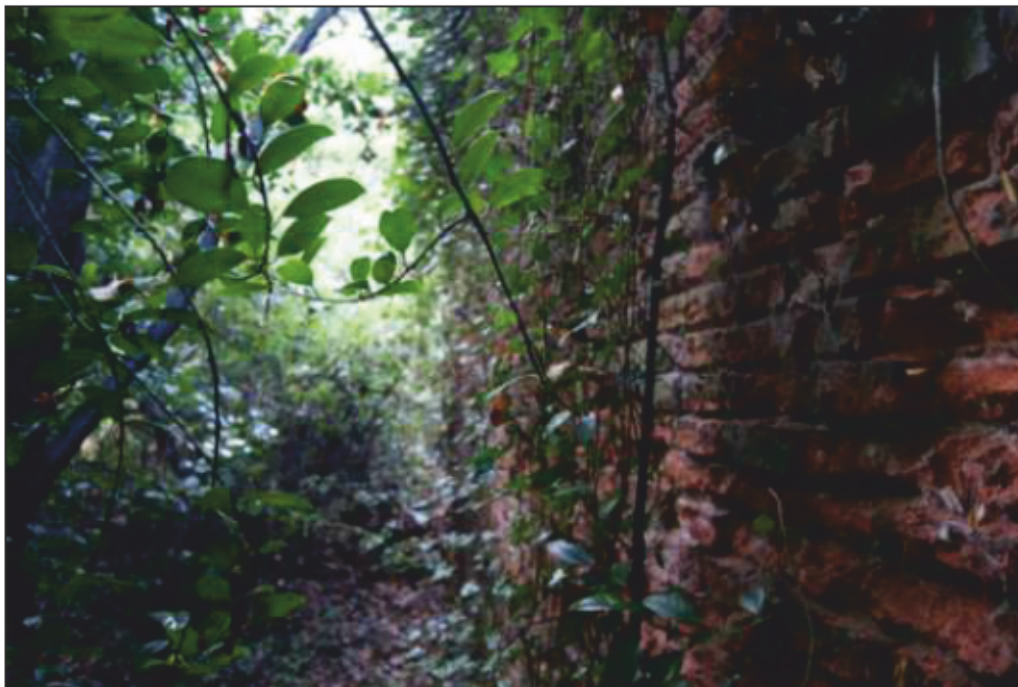
Plate 9: Wall face 4 showing soiled brickwork, looking north-west.

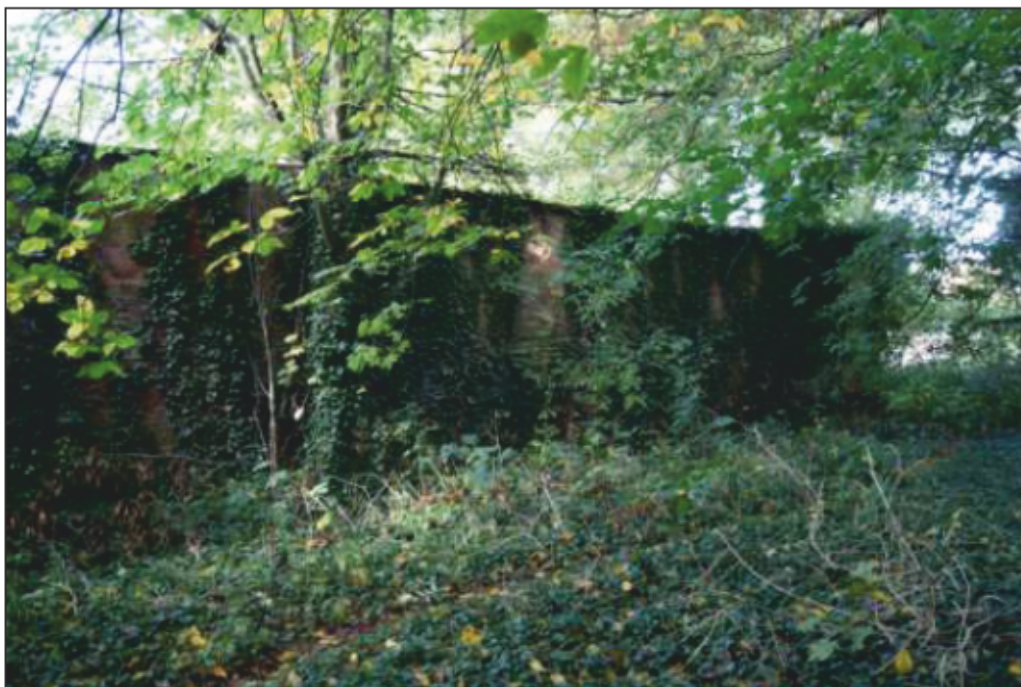
Plate 14: Wall face 6 showing ivy, looking north-east.

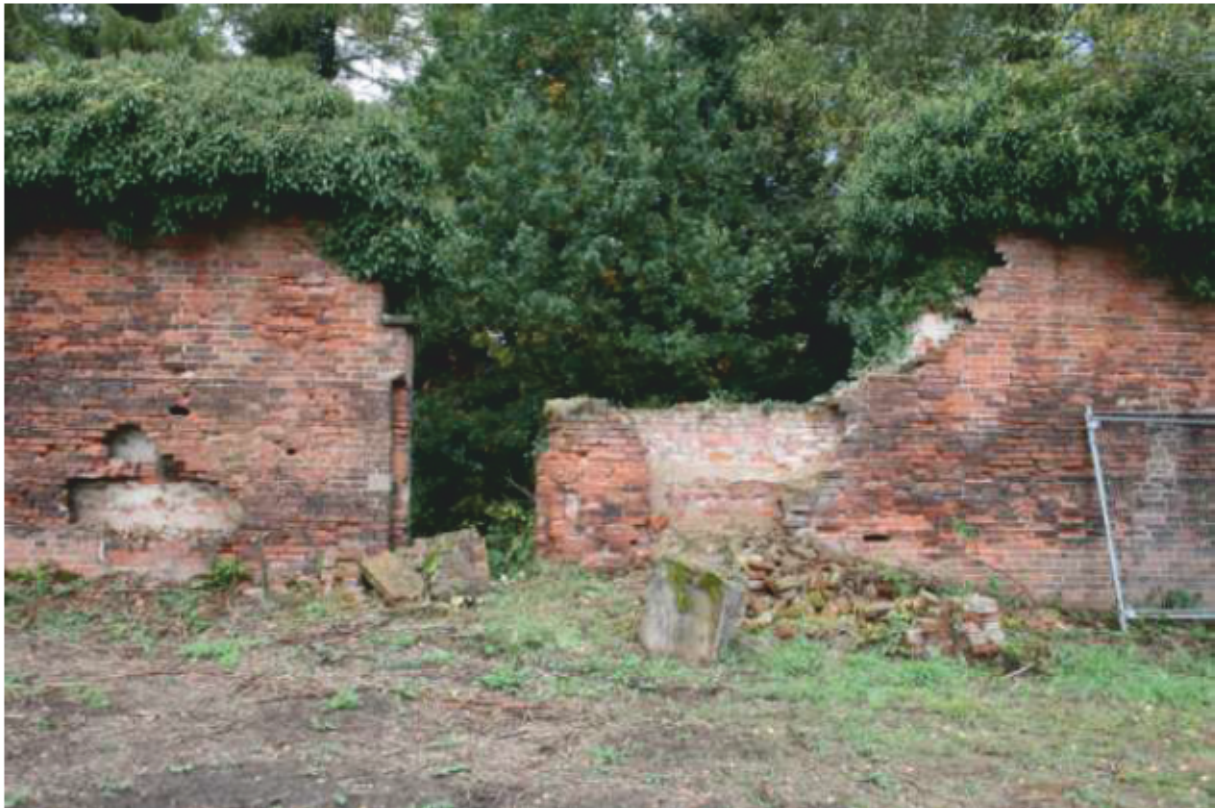
Plate 15: Wall face 7, northern end, showing the collapsed walling and gate pillar. Looking east.

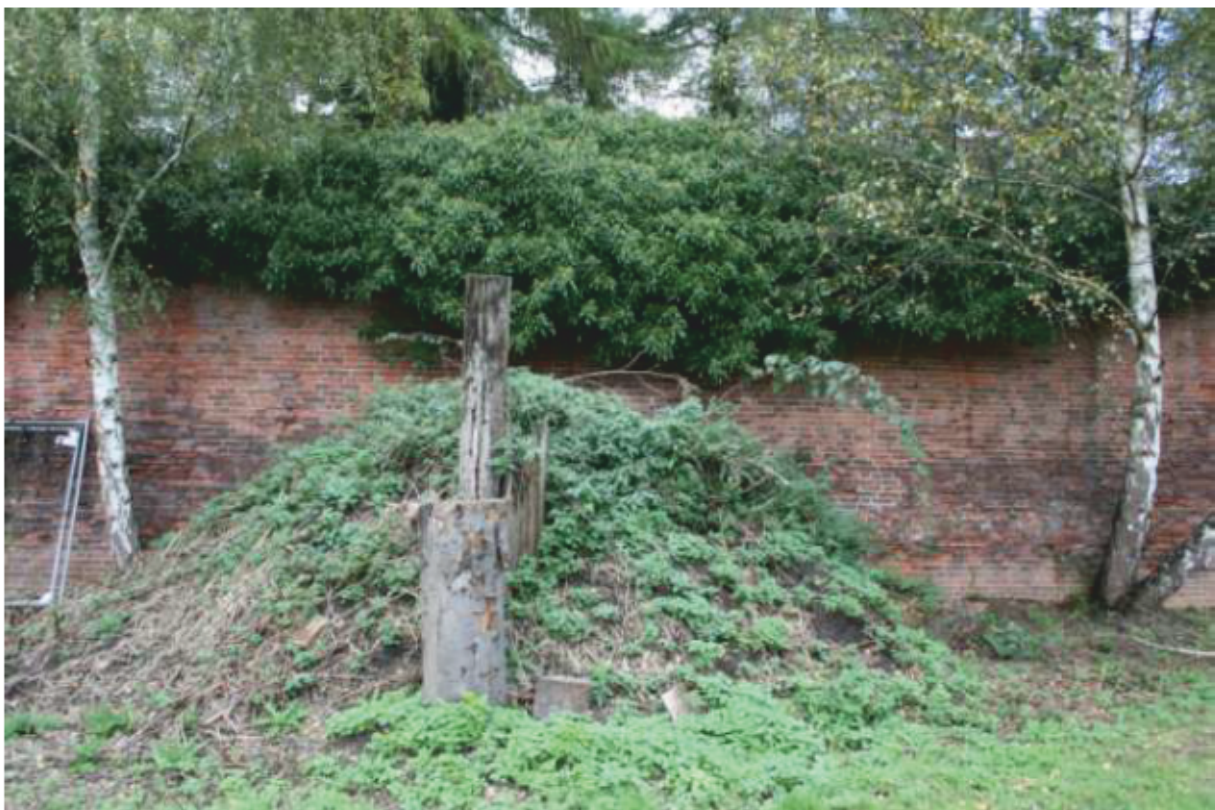
Plate 16: Wall face 7, showing the shooting butt and badger sett, and silver birches. Looking east.

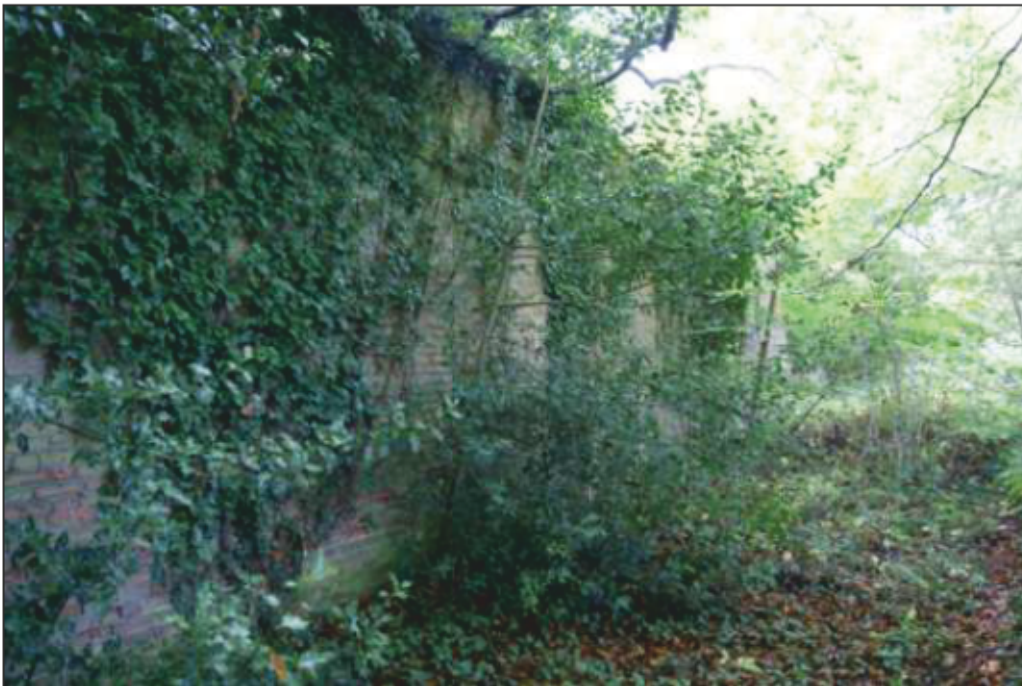
Plate 18: Wall face 8 showing ivy, looking north-west

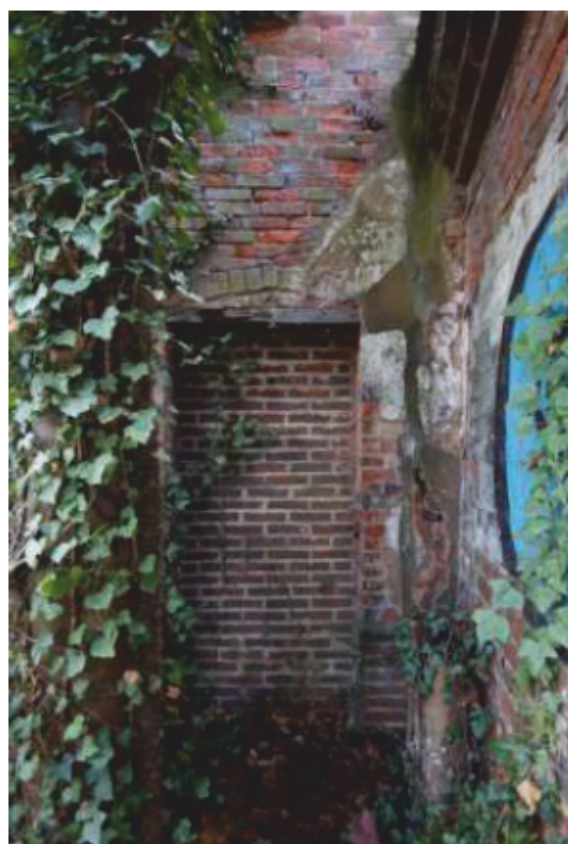
Plate 24: Wall face 13, blocked pedestrian entrance at northern end of wall face. Looking west.

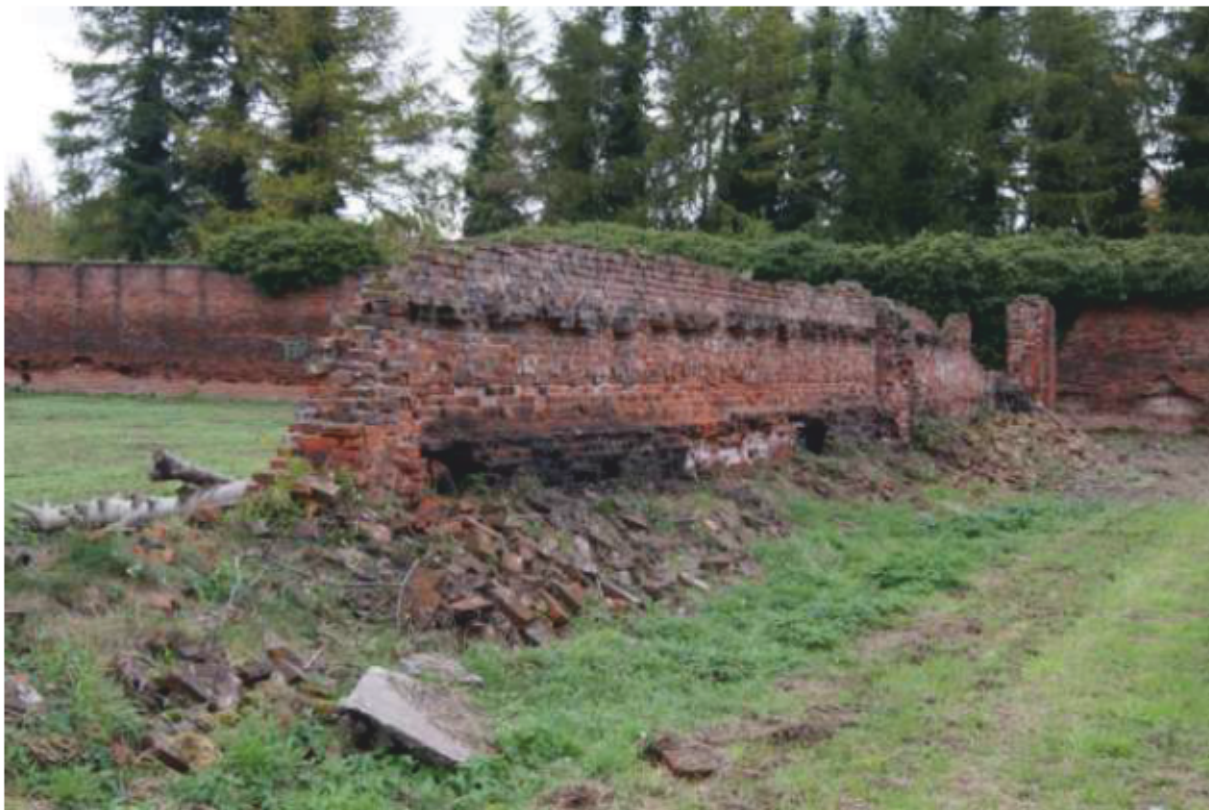
Plate 26: Wall face 15, showing exposed core of double-skinned wall. Looking north-east.

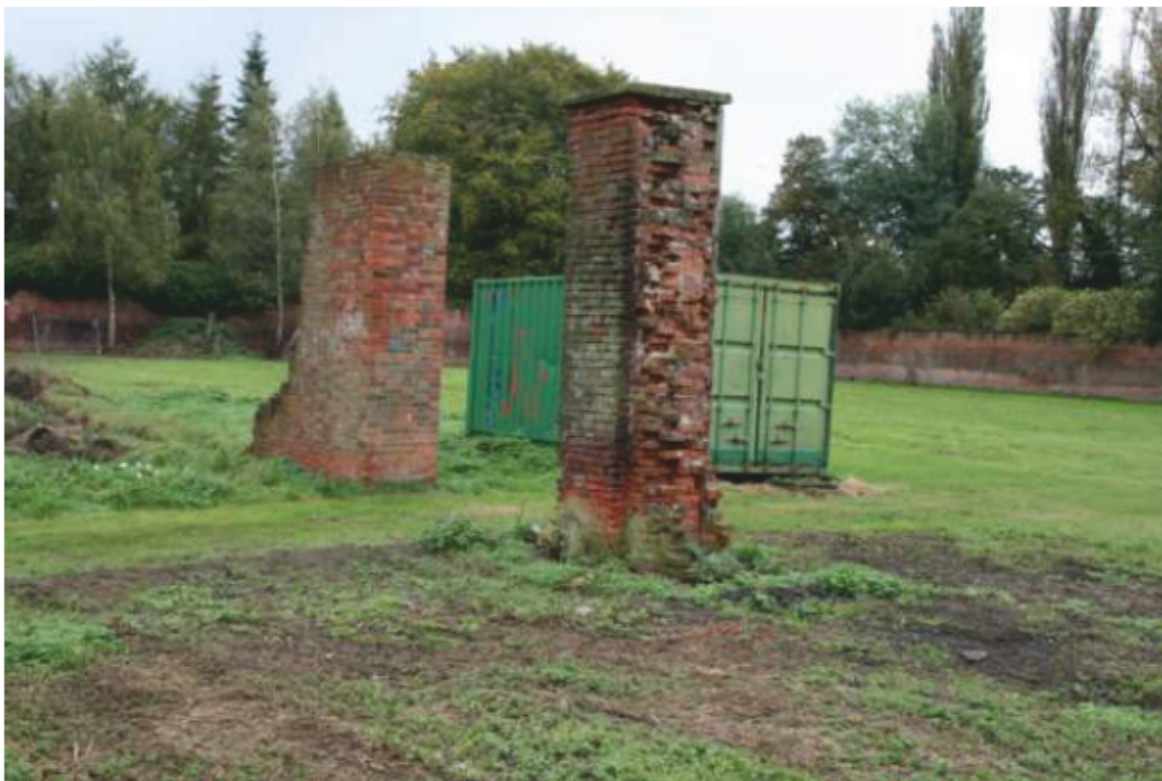
Plate 30: Wall face 21, surviving pillar. Looking south-east.

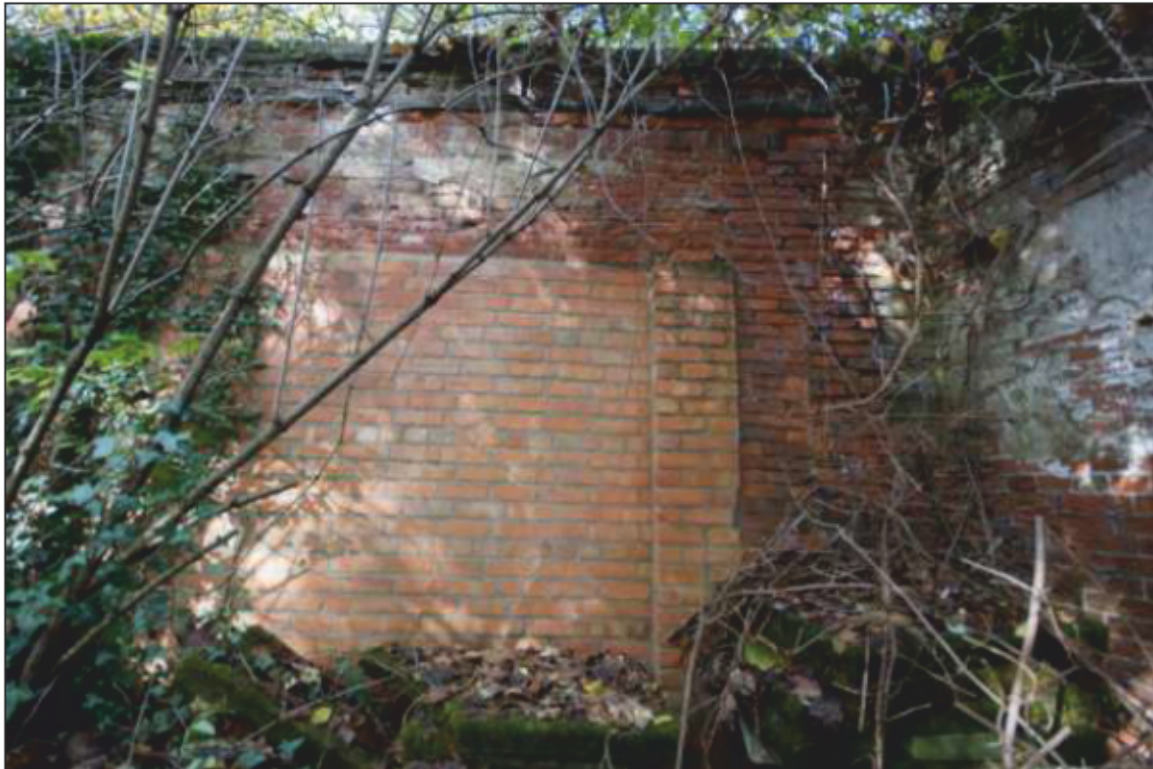
Plate 33: Wall face 11 showing infilled brickwork, looking north.

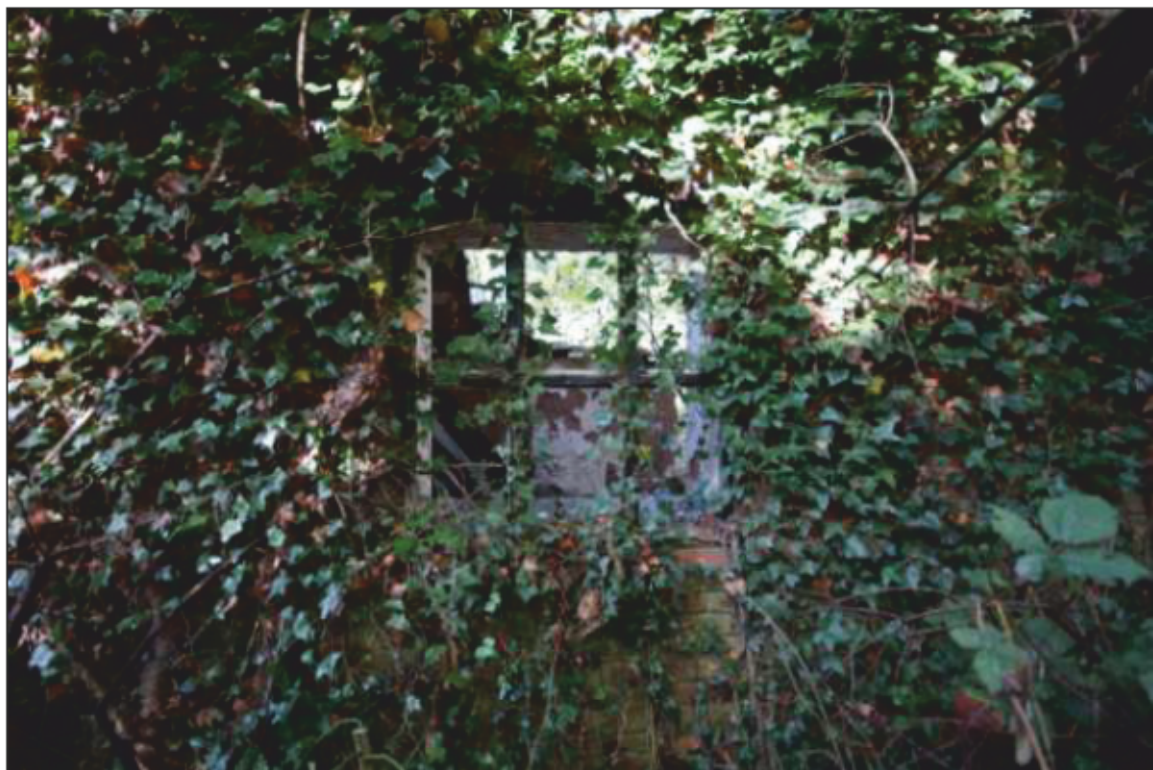
Plate 34: Wall face 11 showing window opening, looking north.

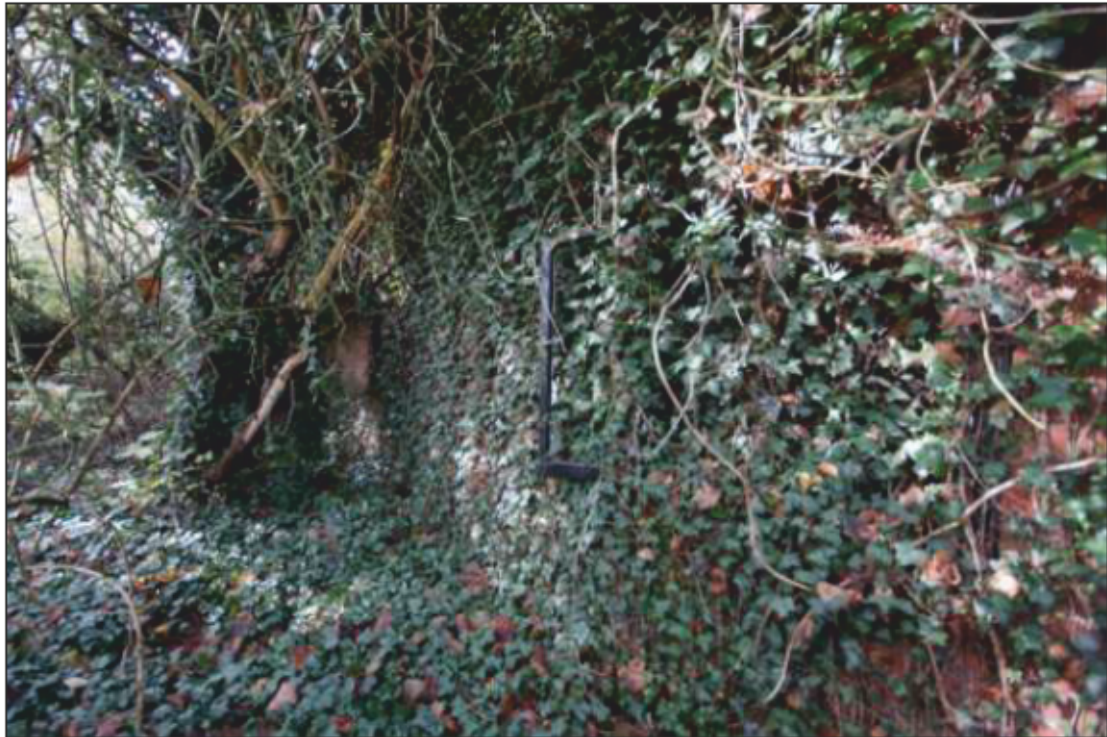
Plate 35: Wall face 11 showing window opening. looking north-west.

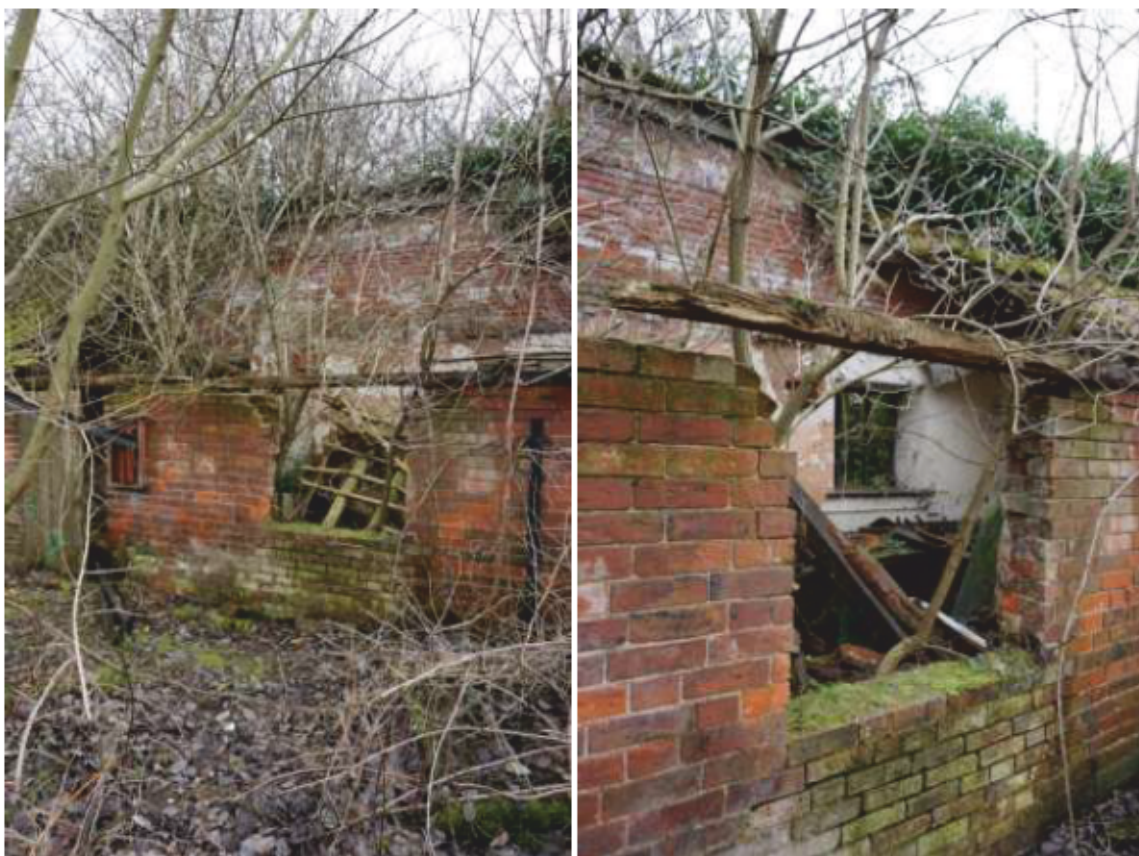
Plate 38, left, and Plate 39, right: views of Shed Phase 2, showing collapsed roof, self-set trees and the window shown in Plate 34. Looking south-east and south-west.

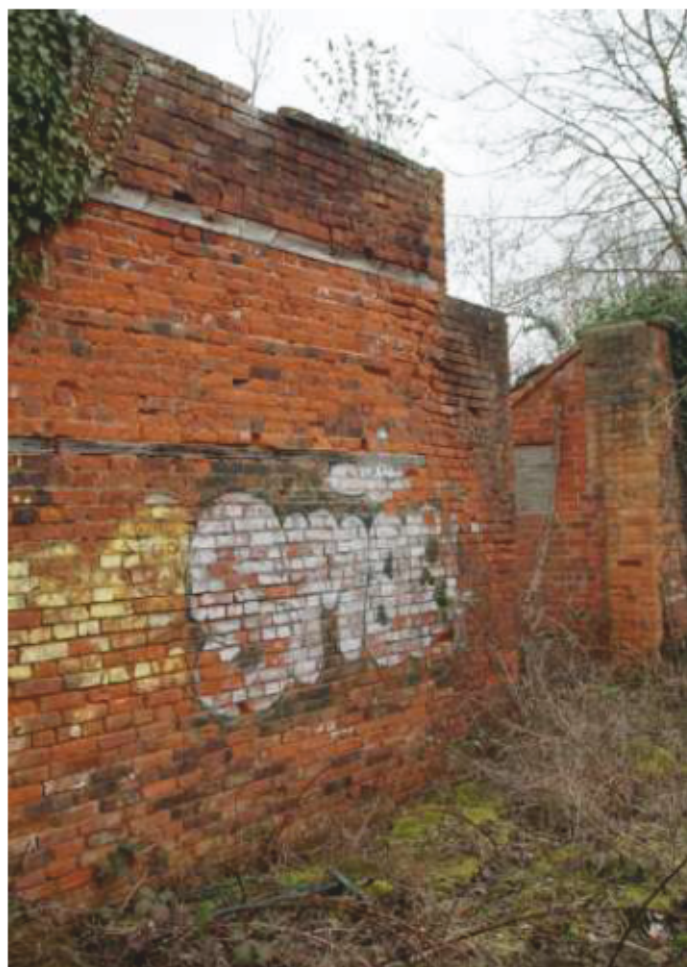
Plate 43: Wall faces 17 and 11 showing north-eastern entrance, graffiti, and inset wooden beams. Looking north-east.

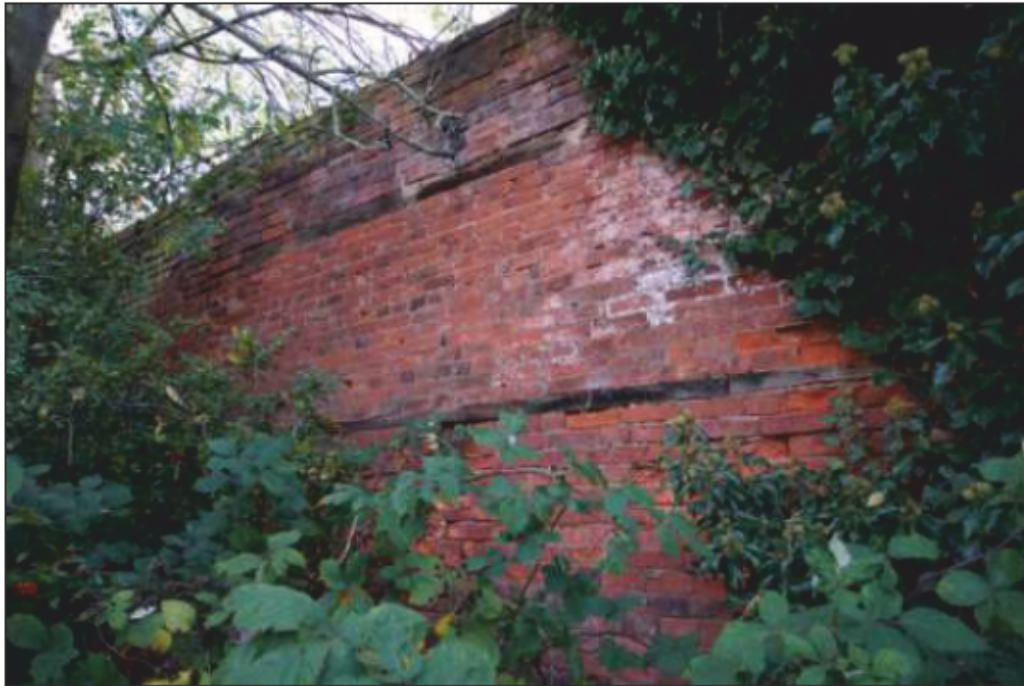
Plate 44: Wall face 17 showing wooden beams, looking north-west.

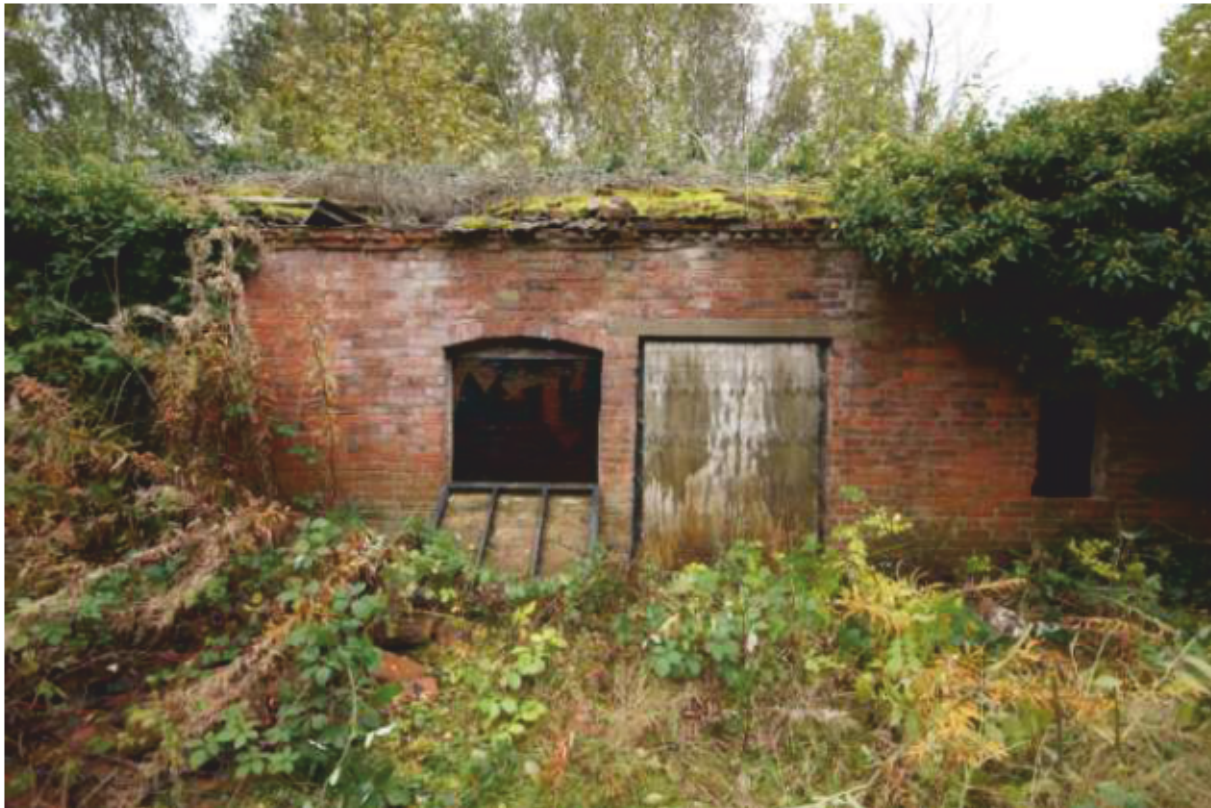
Plate 46: Wall face 18, Shed Phase 1, showing roof collapse, graffiti, boarded doors and architectural detailing. Looking south.

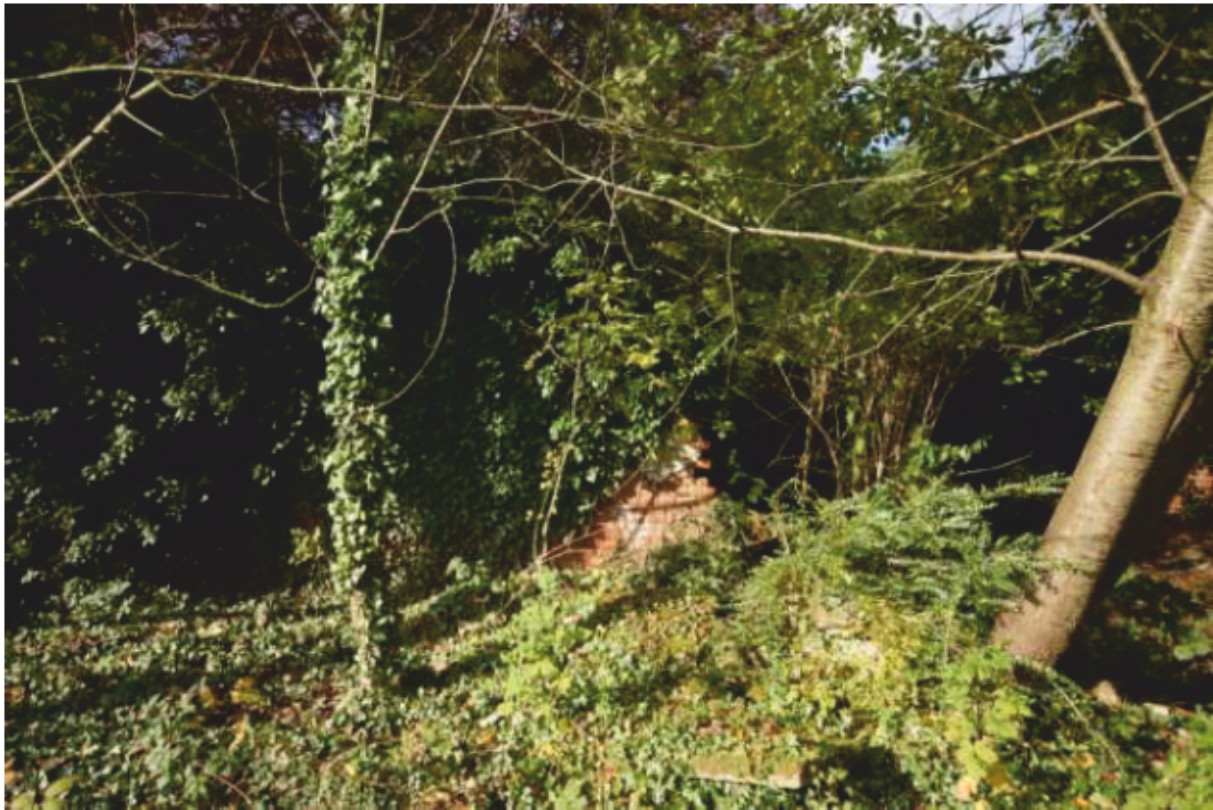
Plate 52: Wall face 19. Eastern end of wall, showing collapsed pillar. Looking north.

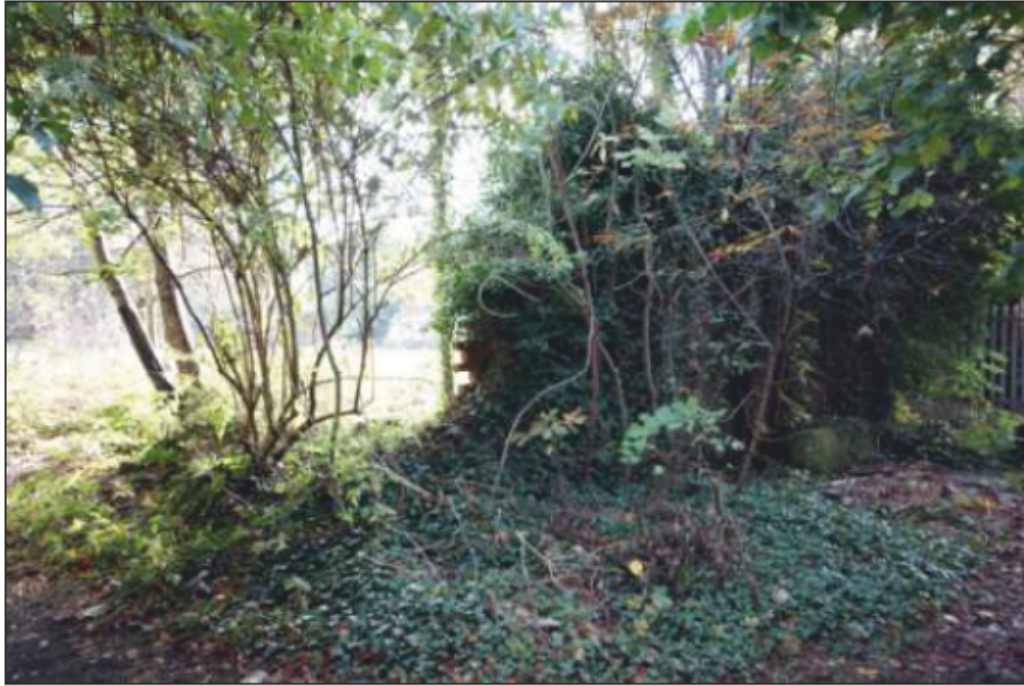
Plate 54: Wall face 20 showing ivy growth, looking south west.
