**HISTORIC BUILDING APPRAISAL
OF THE FORMER CHAPEL AT
STANCLIFFE HALL, DARLEY DALE,
NEAR MATLOCK, DERBYSHIRE**

*by
Richard Sheppard*

OS Grid Ref. SK 2677 6400
TPA Project Code: SHA.2
February 2013
TPA Report No. 023/2013

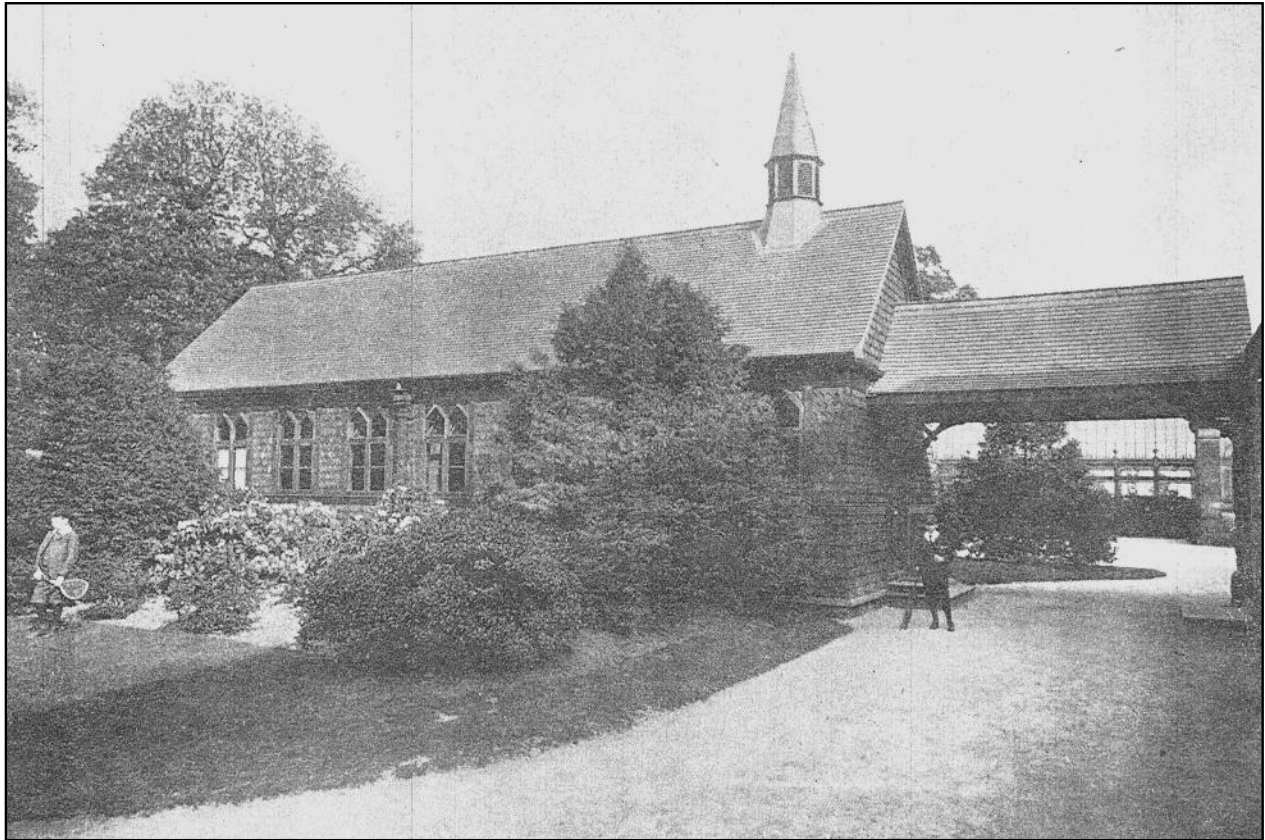
Plate 1: Early 20th century view of the chapel at Stancliffe Hall, Derbyshire with two school pupils showing in the foreground.

The roofing is composed of a chequer-board pattern of reddish asbestos tiles (Plate 3) although early views of the building show it originally had horizontal bands of small reddish tiles on the roof (Plate 1). The roofline is broken by a single spire with a lower grill, its function having been to act as a ventilation outlet for the by-products of combustion for internal gas lighting. Water was removed along cast-iron gutters feeding into a centrally-placed down-pipe on either side of the building (Plate 10).

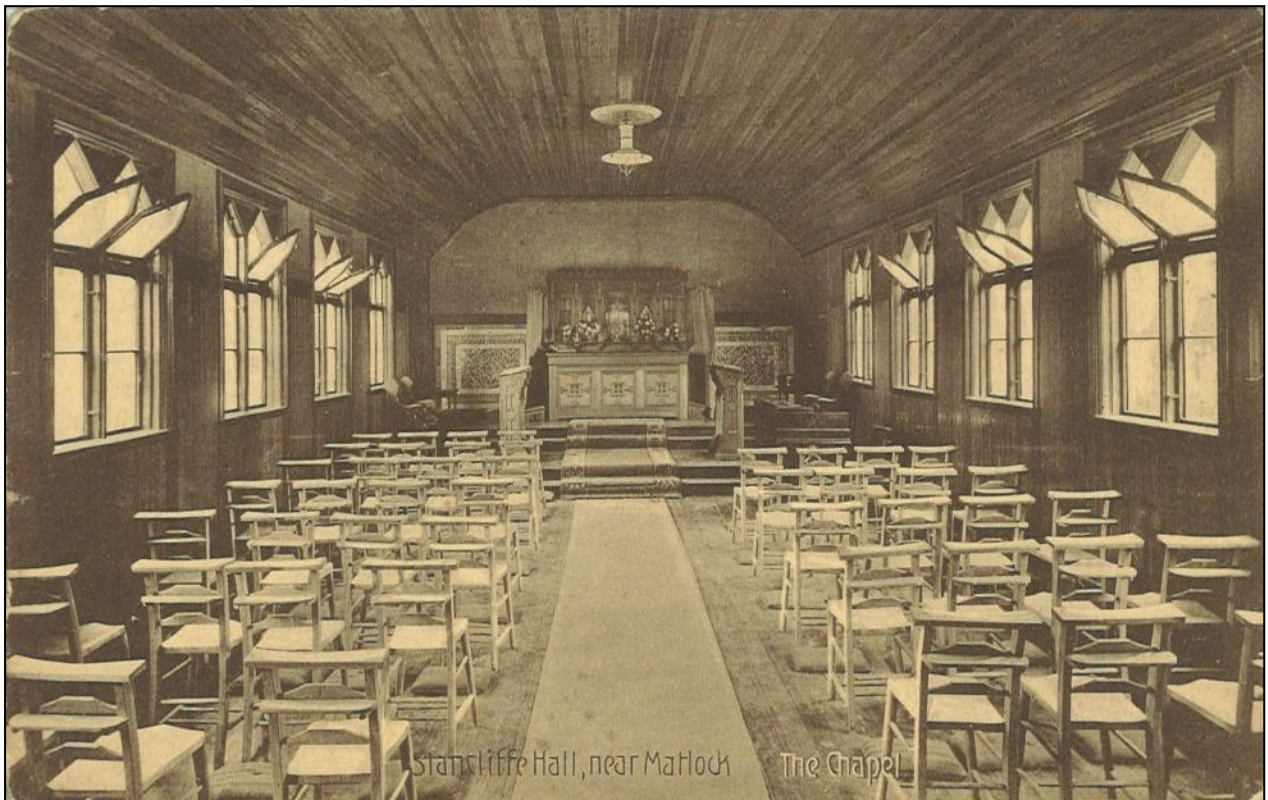
Plate 2: Early 20th century postcard view of the interior of the chapel at Stancliffe Hall with the altar and decorative panels still in place at the far end.

Internally, the chapel is of single-room rectilinear plan 5.33m (17½ feet) x 14.65m (48ft), a ratio of 1:2.75. There are two rises at the north-east end towards where the altar one stood. The still intact altar and surrounding panels are shown on an early view of the interior (Plate 2); this also shows a former gas fitting in the ceiling and the upper windows are shown open. The chapel's side walling has vertical panelling and has rails and window surrounds that are decorated with detailed mouldings (Plates 16, 17). The ceiling is composed of long narrow timber strips and the ceiling curves down toward the side walls (Plates 14, 15). There are still two circular openings in the ceiling that formerly opened into flues to remove gases given off from gas lights immediately below (Plate 18). The building has no added heating system.

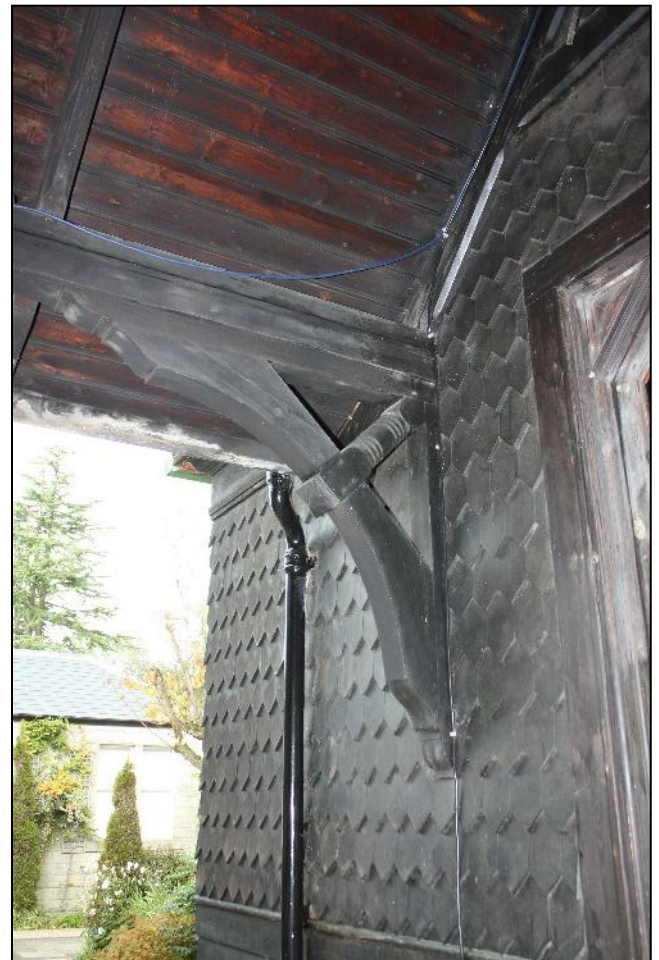
Plate 7: Decorative bracket beneath the walkway canopy.

The south-west end has a decorative partly paneled double-door entry beneath a covered way that served as a sort of porch (Plate 6). The latter is held in place by some decorative brackets (Plate 7). There are seven windows with pointed tops along each of the long sides (Plate 9) but no openings in the north-east end of the building.
