**MARY ROSE NEW MUSEUM
PORTSMOUTH HISTORIC
DOCKYARD
PORTSMOUTH
HAMPSHIRE**

**ASSESSMENT OF CONSTRUCTION
PHASE ARCHAEOLOGICAL
WATCHING BRIEF**

PCA REPORT NO: 11279

SITE CODE: PMRP08

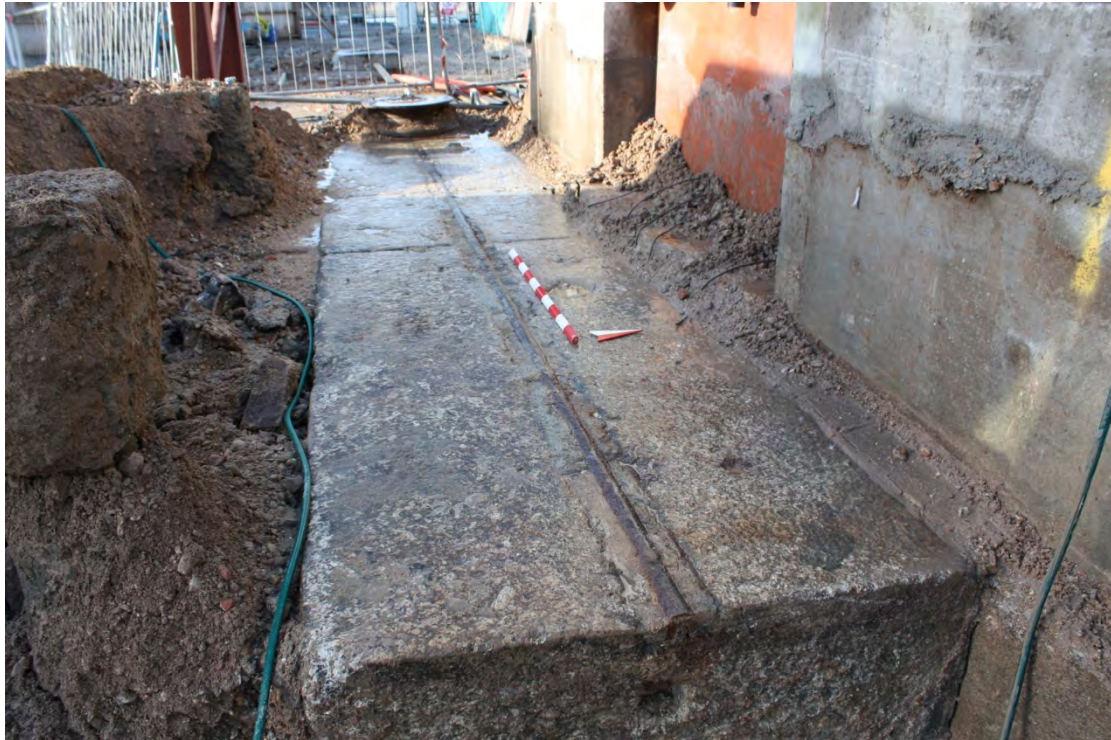
Plate 13. D300/96. 1920s outer facing dockside crane rail, south side Dry Dock No. 3. Scale 1m looking W.

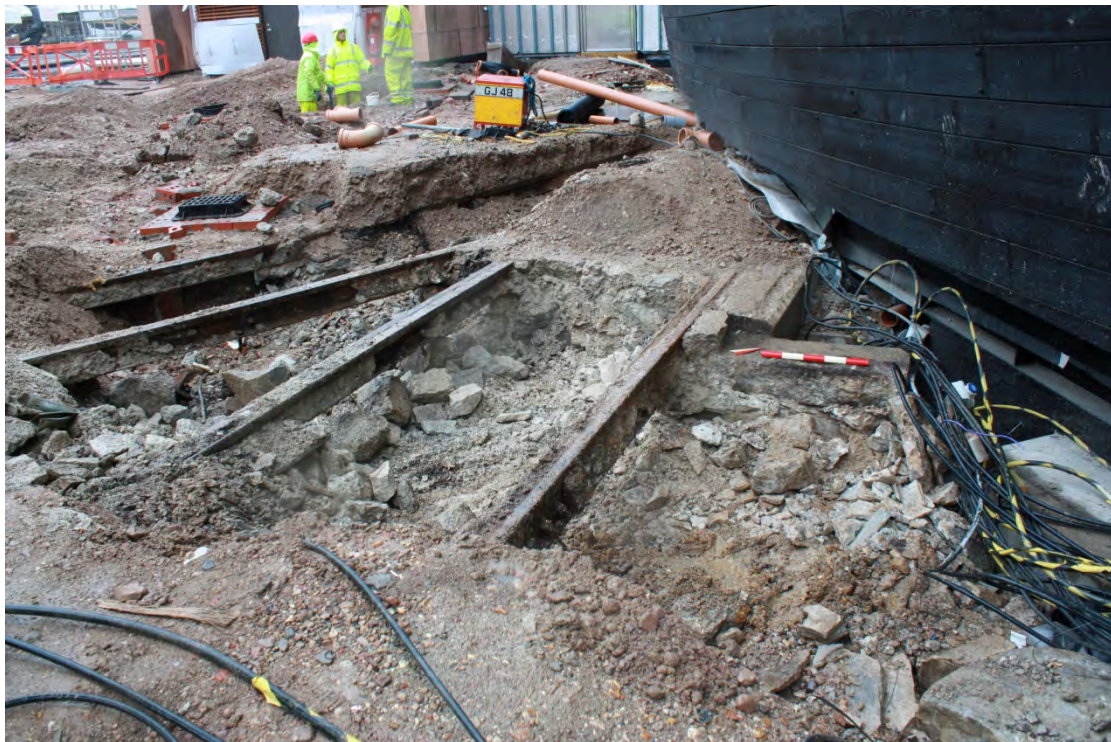
7.9.2 Much of the upper levels of the Georgian stepped stonework of the south side of Dry Dock No. 3 had been in-filled and levelled off with concrete in 1924. This was to provide a platform to carry rail tracks for a dockside rail mounted crane. To construct the new Context Galleries for the museum the rail needed to be removed and the concrete needed to be cut away by diamond sawing. As part of the Scheduled Monument Consent a photographic record of the 1924 dockside crane rails (photo. refs: D300, D302, D304) was made and the concrete cutting monitored to insure none of the original 19th-century stonework was inadvertently damaged (Plates 13 & 15). Later on in the programme of works parts of the rail track, where it curved in east from the dockyard complex back to the edge of Dry Dock No. 3, was exposed at the south-east corner of the dock during the excavation of TR3. This section of the dockside rails remained *in-situ*, but overlain by the landscaping surface finishes (Plate 14). The rails were recorded photographically (photo ref: D320).

Plate 14. D320/26. 1920s crane rails at SE end of Dry Dock No. 3. Scale is 0.50m looking W.

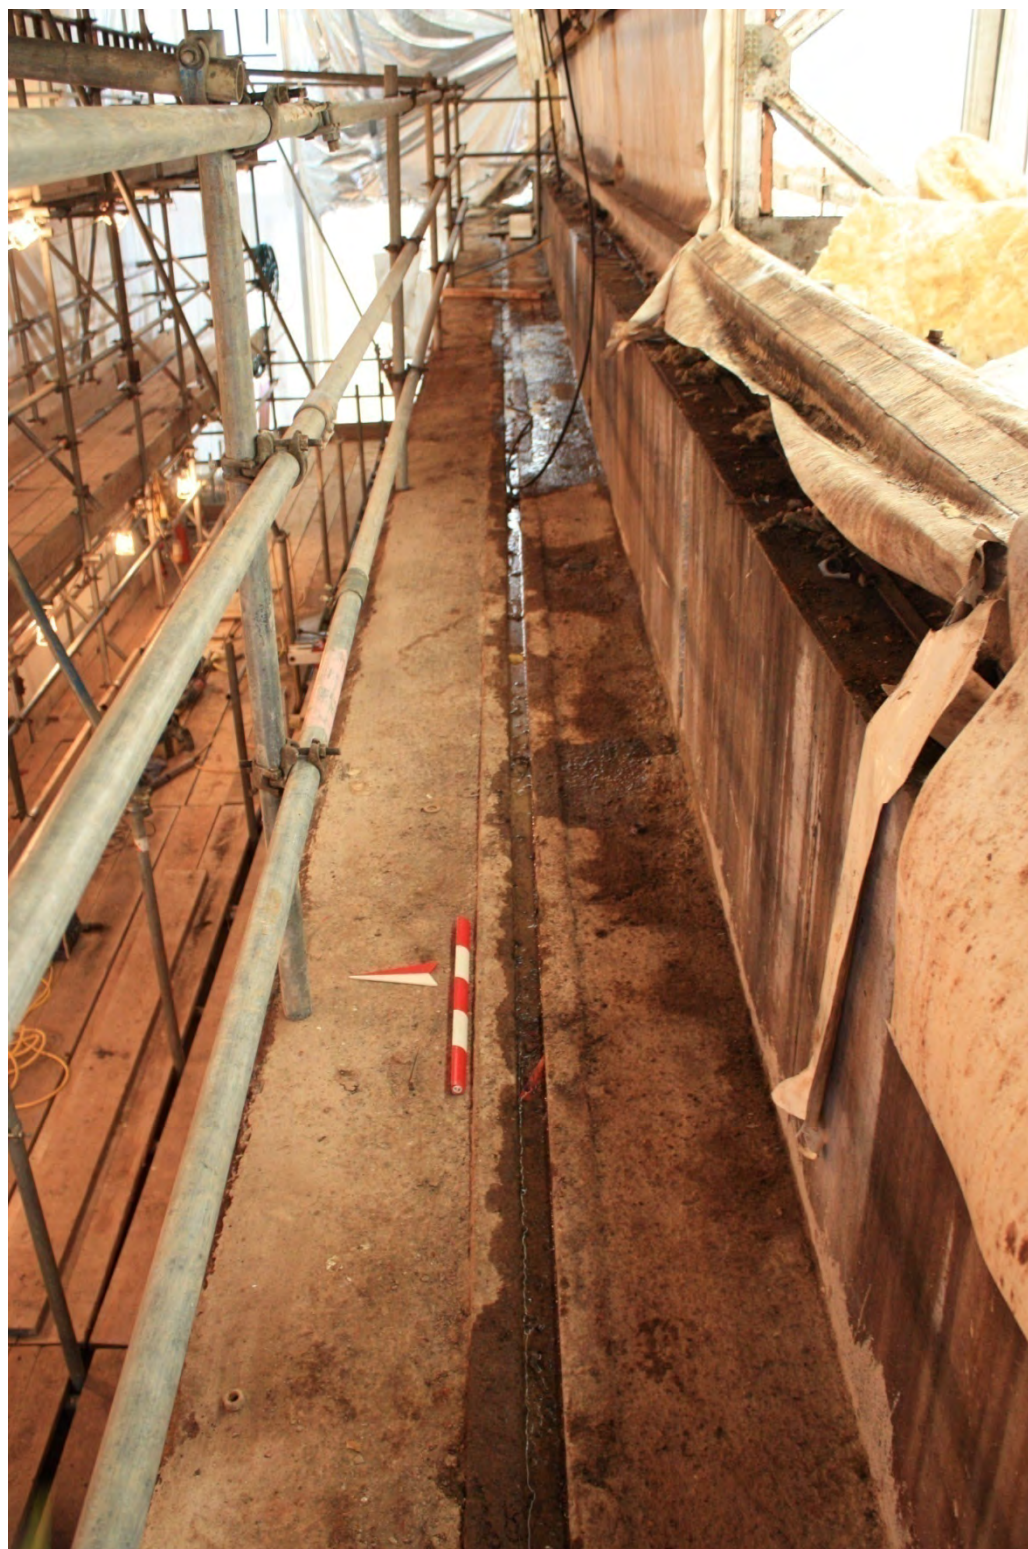
Plate 15. D304/19. 1920s inner facing dockside crane rail, inside the Weymes building, set into concrete along southern side of the dockside. Scale 0.5m looking E.

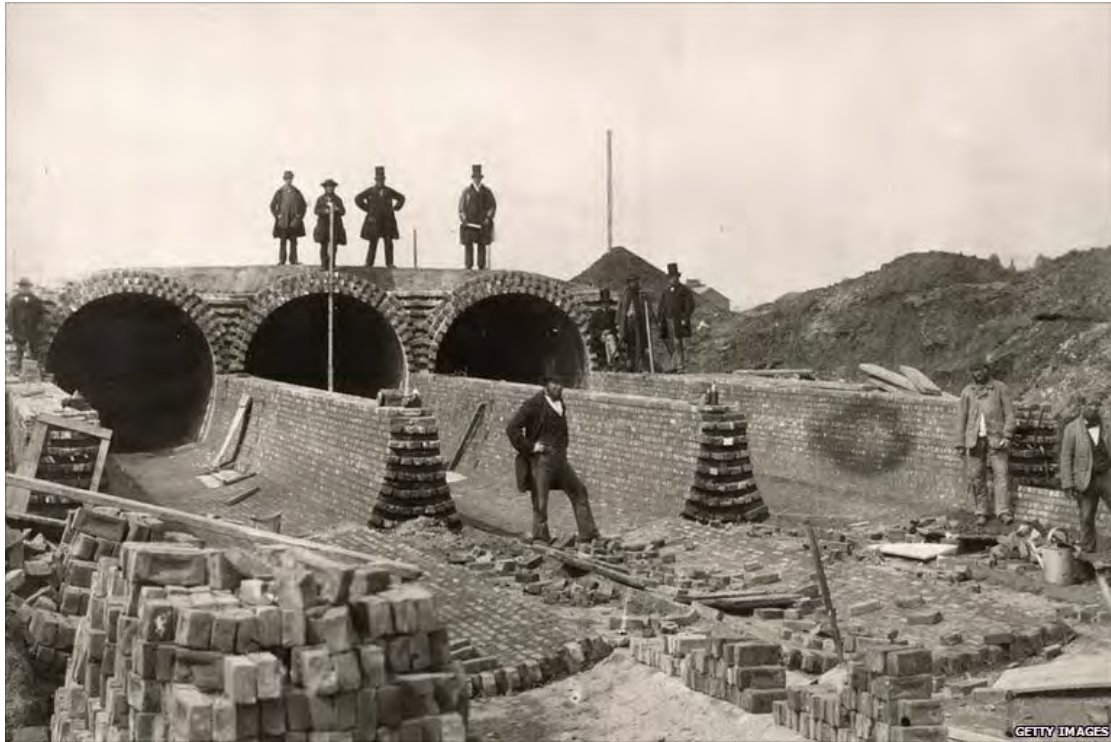
Plate 19. Joseph Bazalgette's northern outfall sewer, London, c. 1860s. Compare with Plate 17 above.

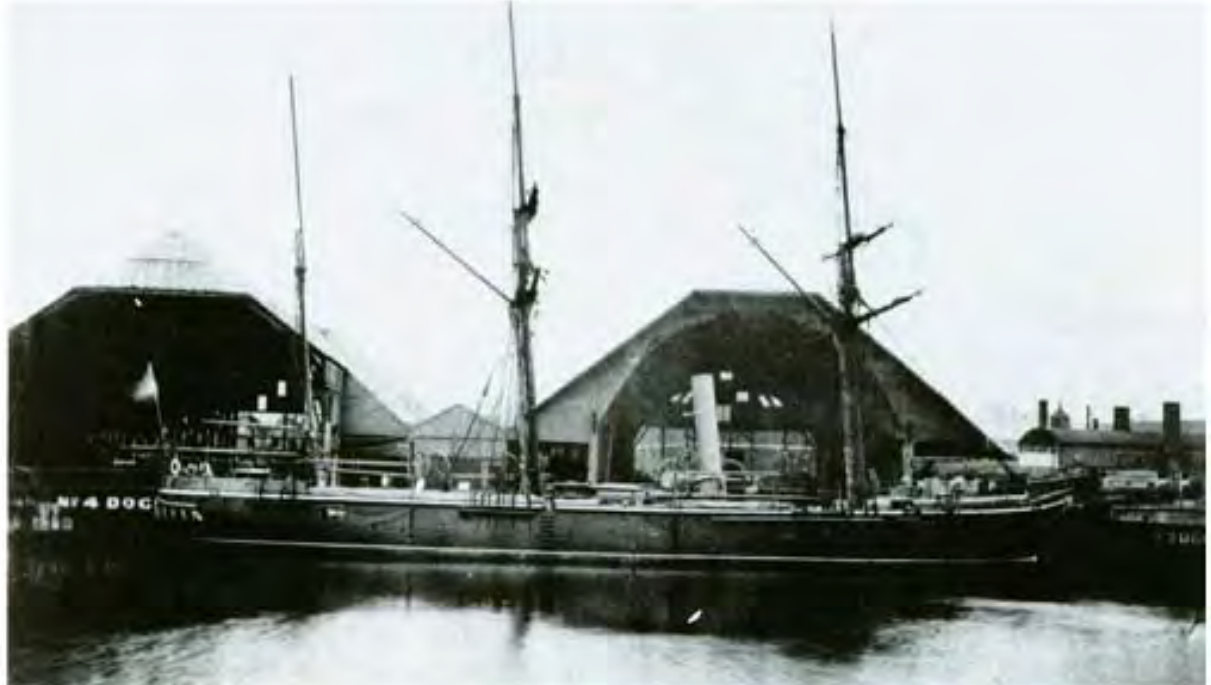
Plate 22. Photograph taken 1872. Looking E towards Dry Docks Nos. 4 and 3 (3 on the right) showing timber sheds built over the docks. [145] may be corner foundation for posts supporting this structure.
