**HISTORIC BUILDING
RECORDING OF FARM
BUILDINGS AT NEWHOUSE
FARM, WARESIDE, WARE,
HERTFORDSHIRE**

PCA REPORT NO. R11243

JUNE 2012

Historic Building Recording

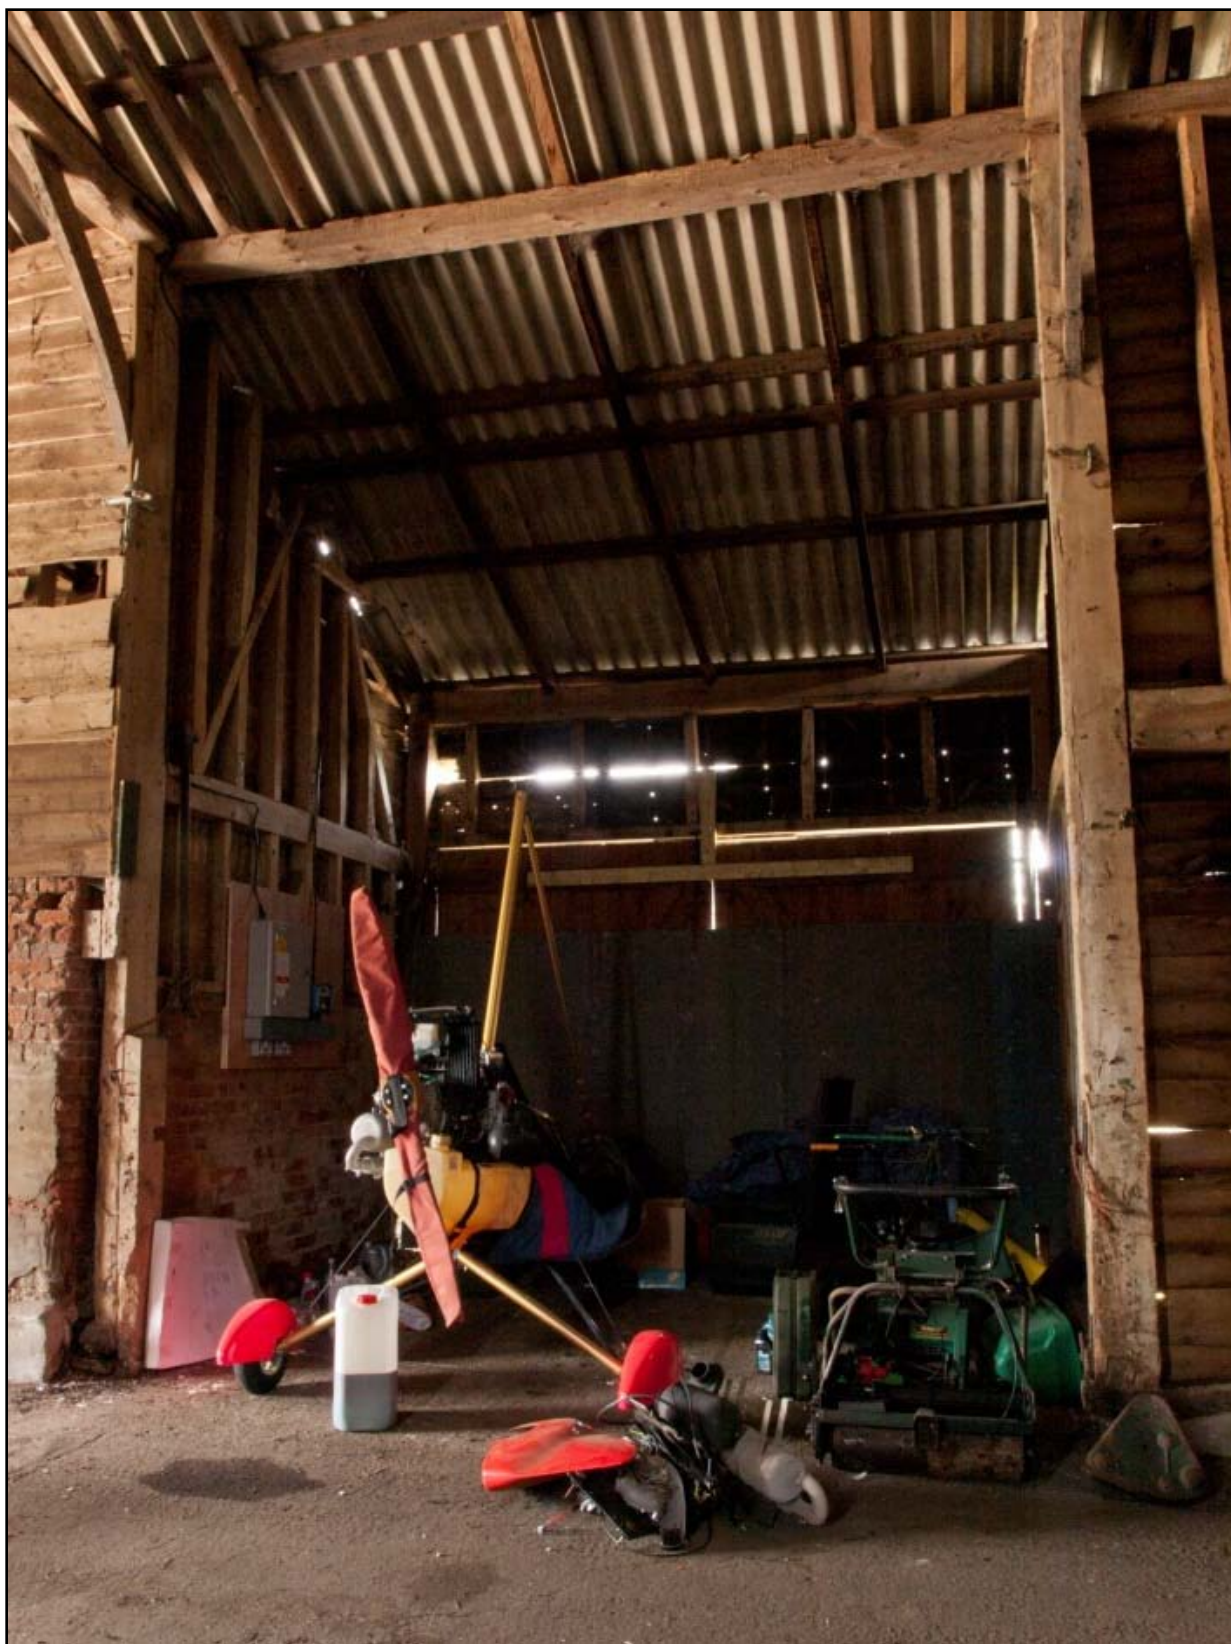
Plate 20: Entrance porch on west side of Building 3, viewed from the east

- 6.3.3 The interior is in good condition with some hand hewn timber beams but predominantly machine cut pine studwork and common rafters. The floor is covered with 20th century poured cement. The exterior weather-boarded east elevation of Building 4 is visible within the interior of Building 3 and is weather boarded above a brick wall (**Plate 21**). The roof has four timber trusses with raking queen struts supporting a single row of clasped purlins. The roof has been replaced and lowered, with the raking queen struts shortened and the ridge lowered in the late 20th century. Numerous slender common pine rafters descend from a thin ridge board to the wall plate (**Plates 21**). The roof of the west entrance porch also appears to have been rebuilt.

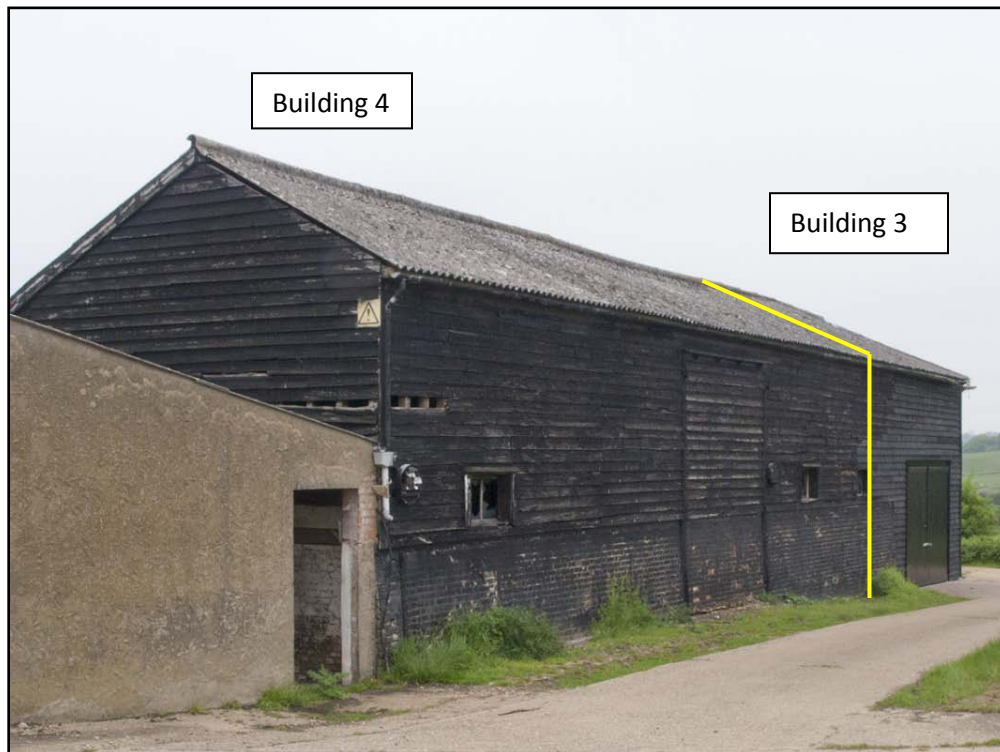
Plate 22: West elevation (left) of Building 4 and south elevation of Buildings 6 (left), 4 (centre) and 3 (right), viewed from the south-west

- 6.4.1 Building 4 has five bays, with an aisle on its north side. Its low brick walls are built in Flemish bond and support a timber superstructure and weatherboarding. Externally the brickwork and weatherboarding are both painted black. The barn has a pitched roof, covered by asbestos sheeting (**Plates 22 to 24**).

- 6.4.2 The south elevation has a blocked double door opening, which would have originally provided cart access into the barn (**Figures 11; Plates 22 and 23**). Three small windows located at intervals along this elevation are 20th century insertions (**Plate 22**). The north elevation faces the farm yard and has three heck doors. Two vertical timber posts in this elevation align with roof trusses (**Figure 11; Plate 24**).

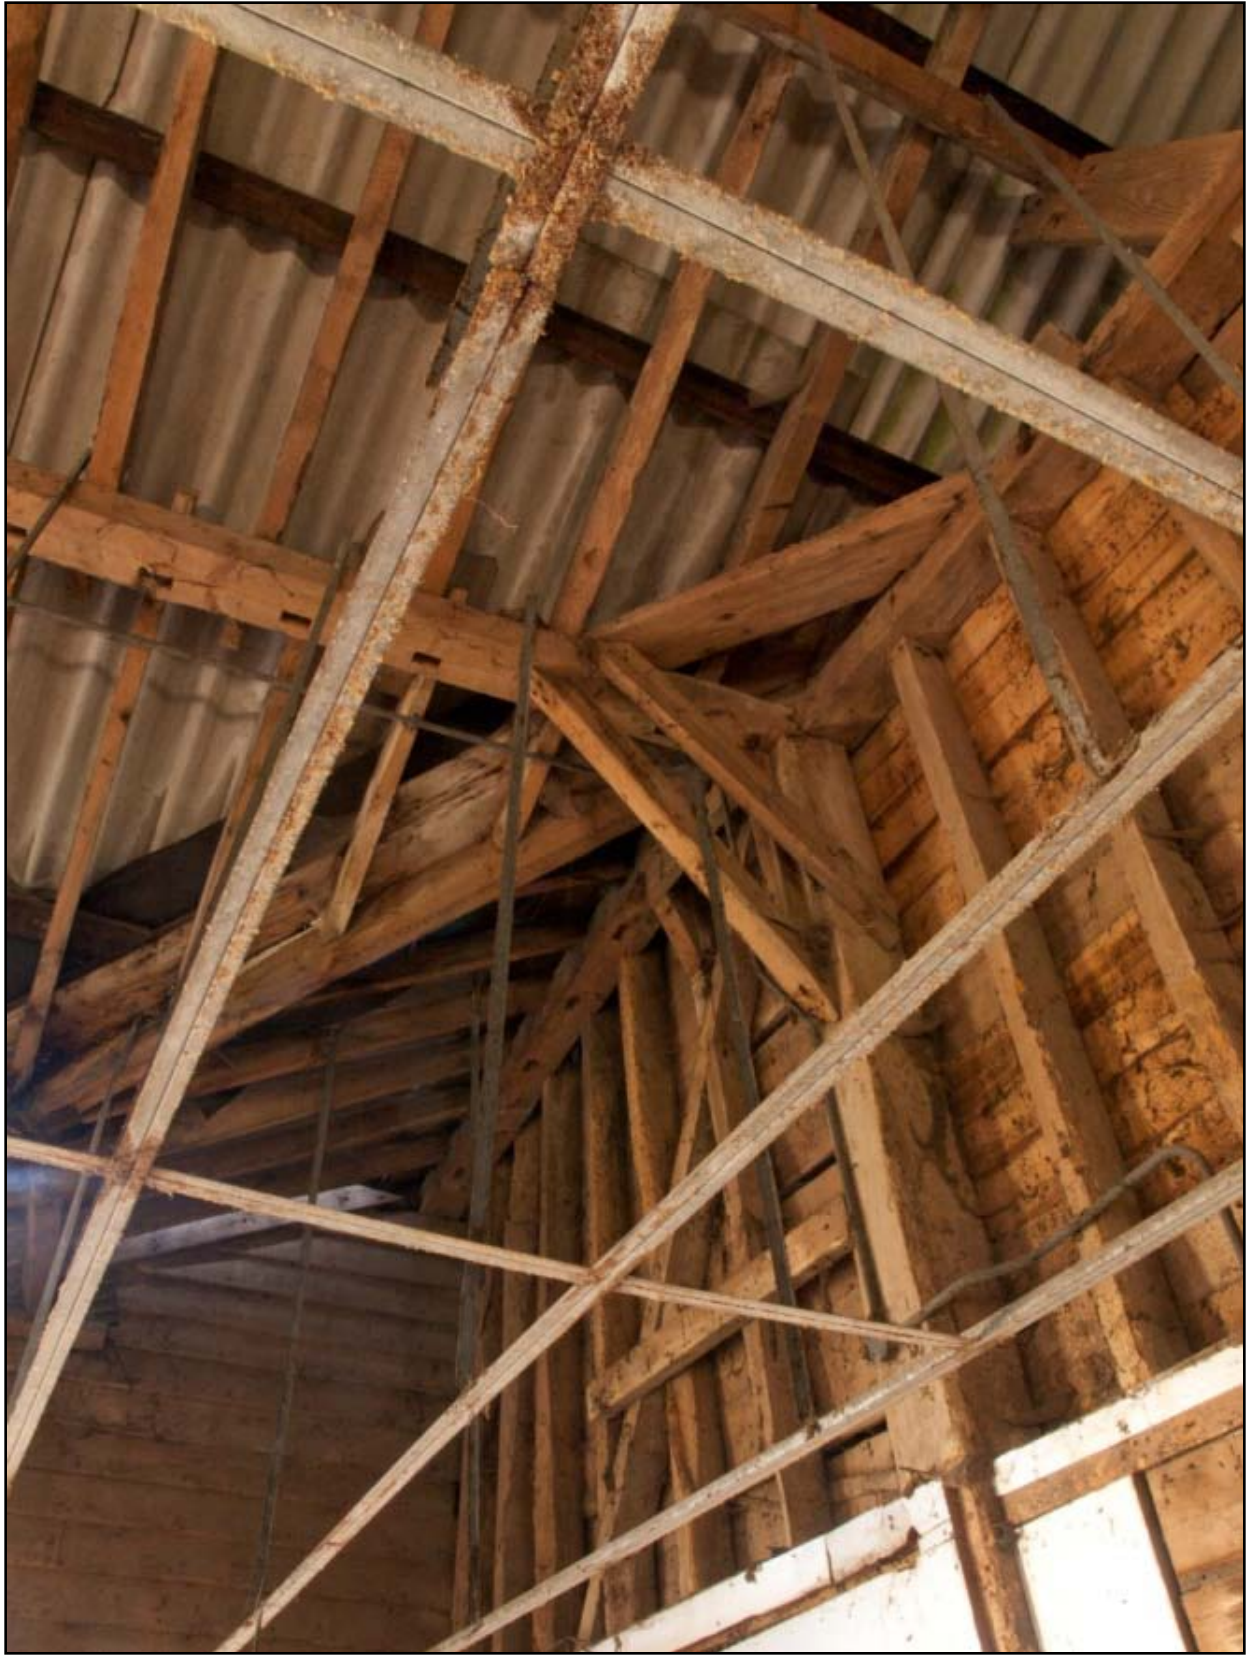
Plate 27: North-east corner of Building 4, viewed from the south-west

- 6.4.4 The timber-framing in the north-east corner of the building had been rearranged presumably when the roof of both Building 3 and its porch were altered (**Plate 27**). One or more timbers with empty mortices in this part of the building show that some of the timbers had been reused. Numerous timbers had been used as additional braces. The south external elevation of the entrance porch of Building 3 is visible internally at high level at the north-east corner of Building 4 and is weather boarded (**Plate 27**).
- 6.4.5 The surviving original timber-framing in the barn is late 18th or early 19th century in appearance. The barn is shown on the 1845 Tithe map and would appear to have been built before the 1831 fire (see Section 5.2.2).

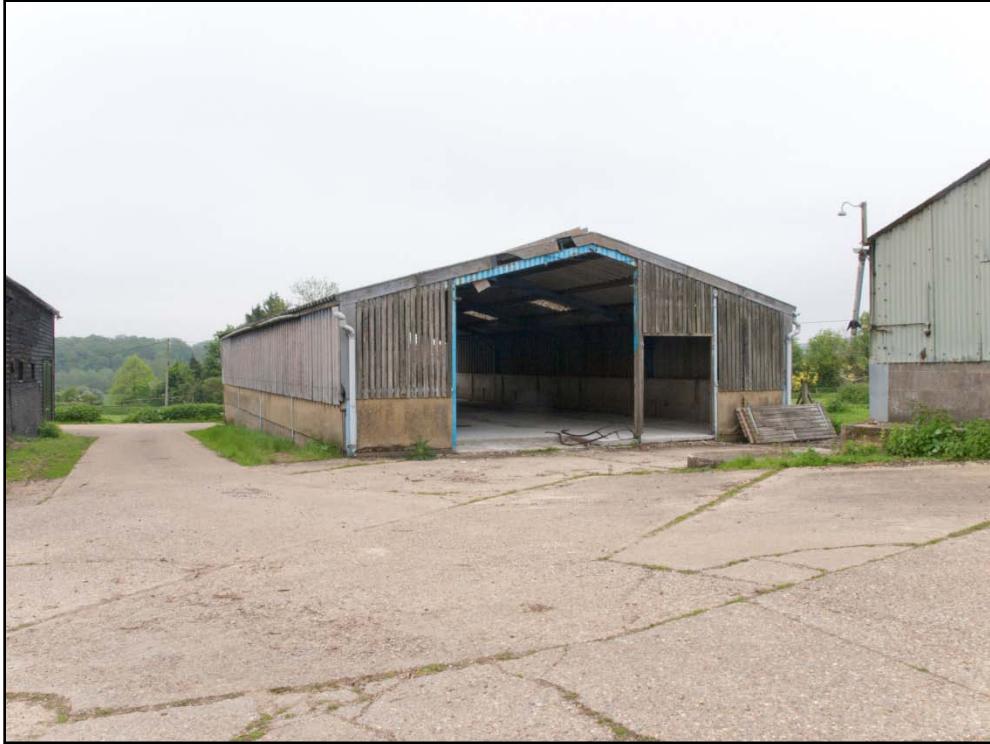
Plate 28: West and north elevation of Building 5, viewed from the north-west

- 6.5.1 Building 5 is a large rectangular barn located at the south-east corner of farmyard complex immediately south of Building 3 and running parallel with Building 4 (**Figure 2; Plates 28 and 29**). The building is aligned east-west with a low pitched roof and gables at the east and west ends. It is constructed with low walls of concrete block, which in turn support a metal superstructure. Externally the building is clad with corrugated metal cladding on the south and north elevations, with the east and west elevations covered with evenly spaced vertical timber planks. The roof is also clad in corrugated metal sheeting which contains several opaque skylights (**Figure 12**).

- 6.5.2 The entrance to the building is in the west elevation (**Plate 28**), while the east elevation contains four openings (**Plate 29**). The interior of the building has a level concrete floor. The low concrete block walls are capped by small timber strips internally (**Plates 30 and 31**). The building is first shown on the 1977 Ordnance Survey map (**Figure 7**).

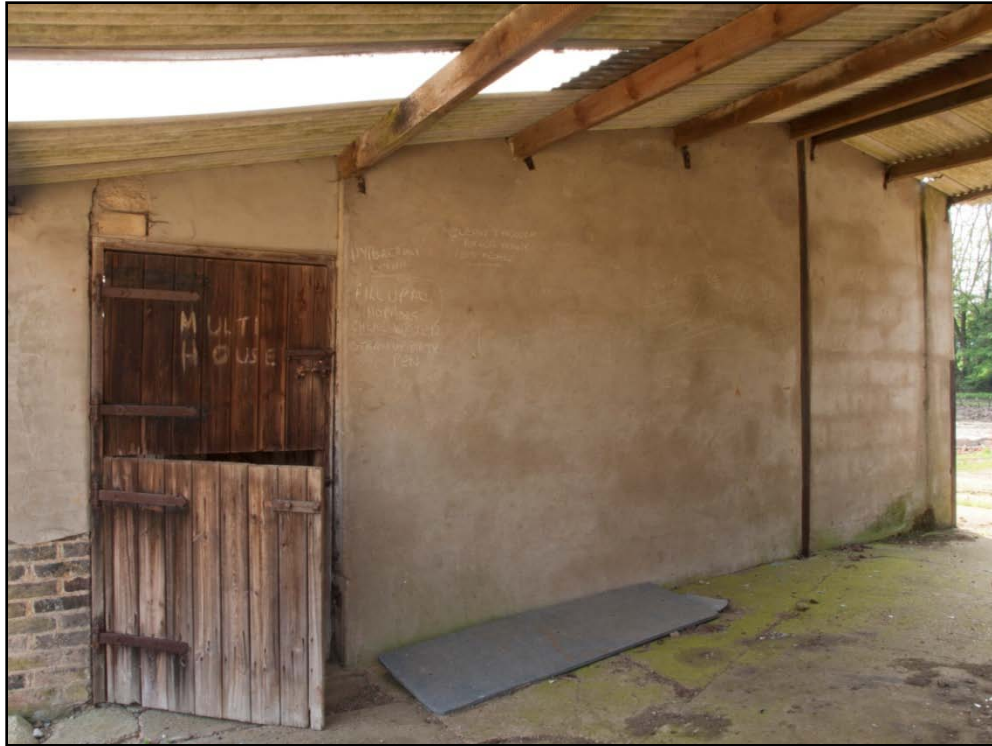
Plate 32: North elevation of Building 6, viewed from the north-east

- 6.6.2 The north elevation of the building is covered with cement render with brick exposed at the east end of the wall and concrete block visible under the render on the west side (**Plate 32**). The south elevation of the building is also covered with cement render with some red brick exposed on the east side (**Plate 33**). The east elevation is constructed of brickwork in stretcher bond at low level. Doorways in this elevation have been infilled with concrete block and concrete block has been used to form the upper part of the wall. The wall appears to have been reduced in height to the level of the brickwork and then built up in concrete block. Brickwork forms the door surrounds. The west side of the building is open apart from a line of 13 wide, side hung metal gates which allowed access in and out of the pig pens inside (**Plate 35**). The building has a steel frame roof structure supported by vertical RSJs (rolled steel joists) (**Plates 36 to 39**).

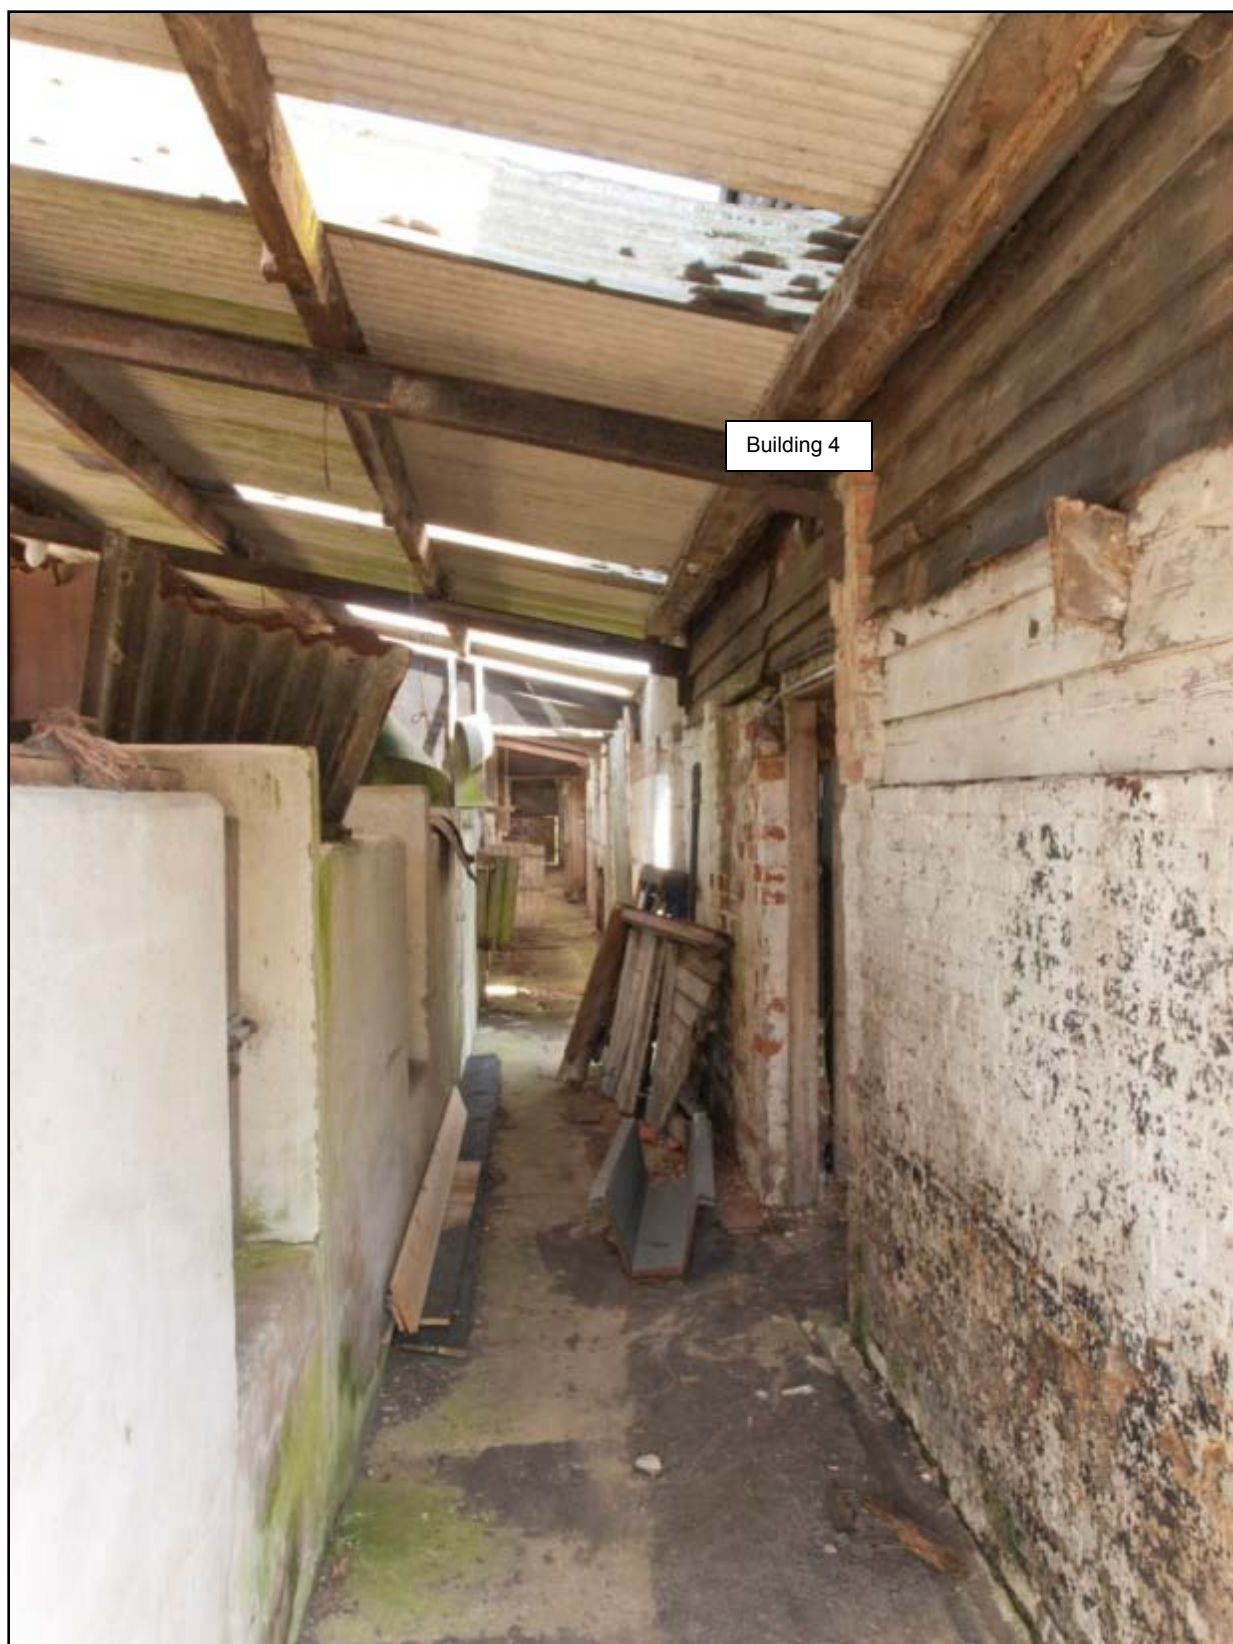
Plate 36: Southern end of the access corridor along the east side of Building 6, viewed from the south

- 6.6.3 A narrow corridor runs along the east side of the building giving access to the 13 pig pens on the west side as well as the farmyard to the east and Building 4 (**Figure 13; Plate 36 and 37**). Each pen is identical with a wide metal gate on the west side leading into an outer area with a small water trough on the south side. An inner area is situated toward the back (east side) of the pen and is slightly raised, with a shelter on the south side covered by a timber hatch roof, operated with rope and pulleys (**Plates 38 and 39**).
