**AN ARCHAEOLOGICAL WATCHING BRIEF AT  
16 SOUTH BAILEY, DURHAM,  
COUNTY DURHAM**

**ASSESSMENT REPORT**

**SEPTEMBER 2013**

Pre-Construct Archaeology Limited Quality Control	
<i>Project Number</i>	K3020
<i>Site Code</i>	SBD 13
<i>Report Number</i>	RN11028

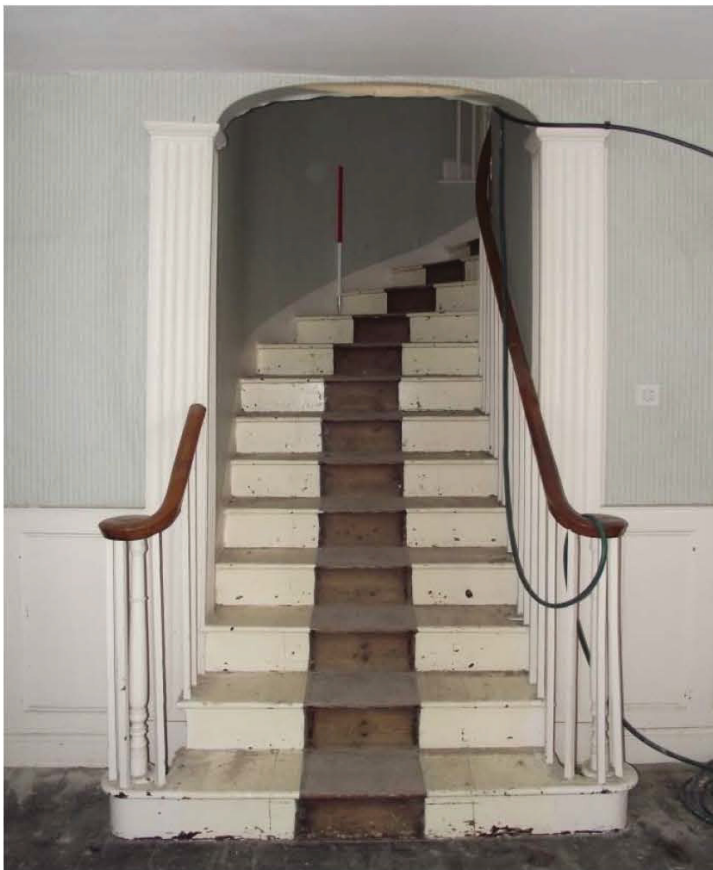
Plate 34: Front element, ground floor, staircase from main lobby (1m scale)

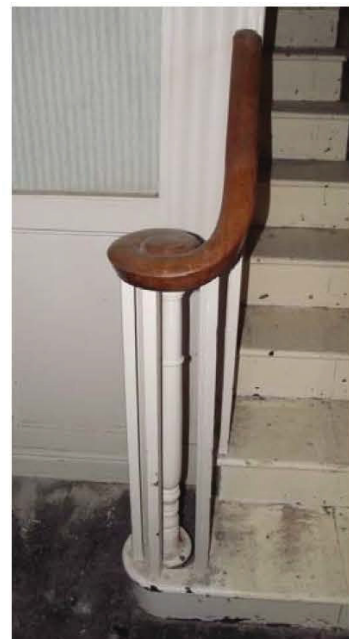
Plate 35: Front element, ground floor, staircase from main lobby, balustrade detail (view, no scale)

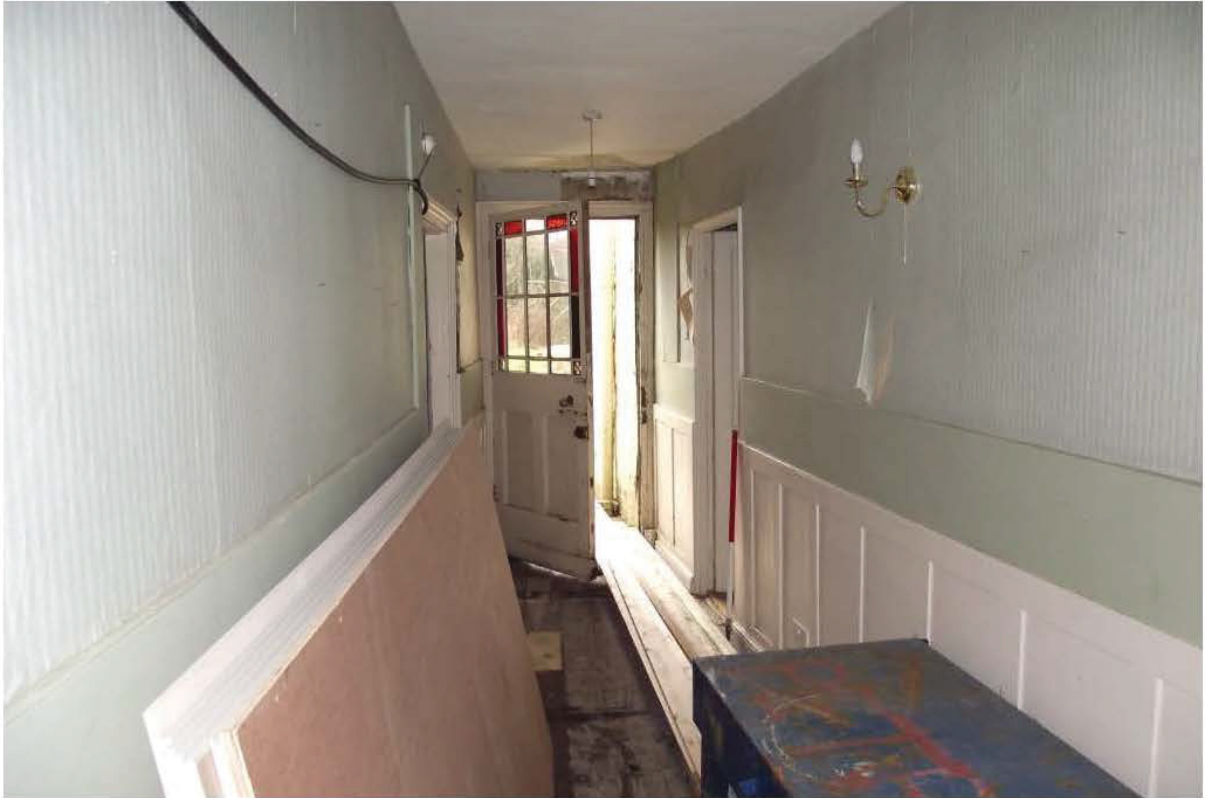
Plate 38: Southern rear element, ground floor, central hallway (1m scale)

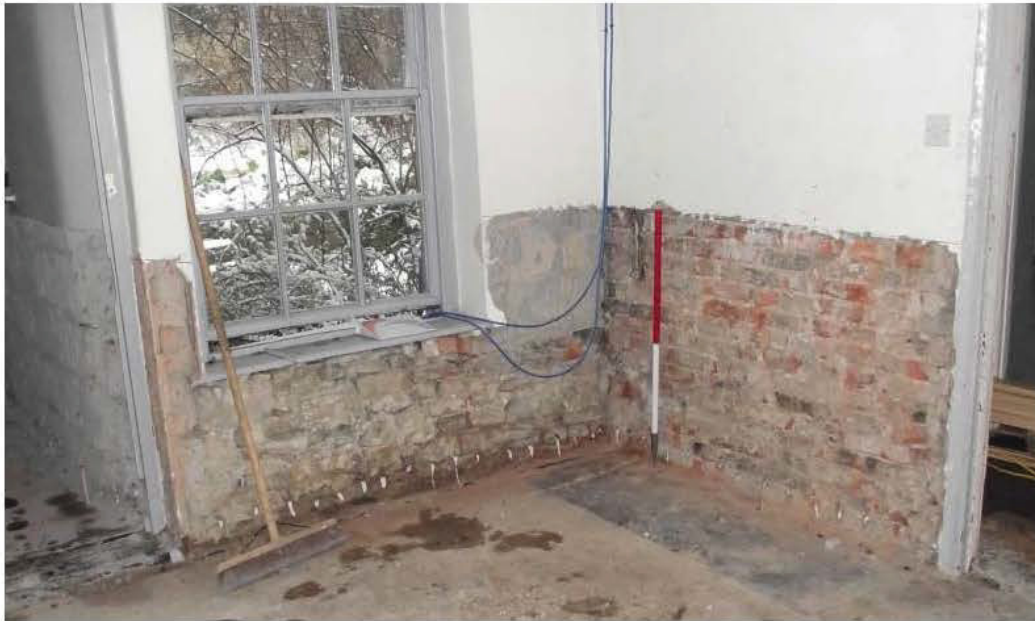
Plate 40: Southern rear element, ground floor, Reception Room 2, exposed masonry in north-west corner (1m scale)

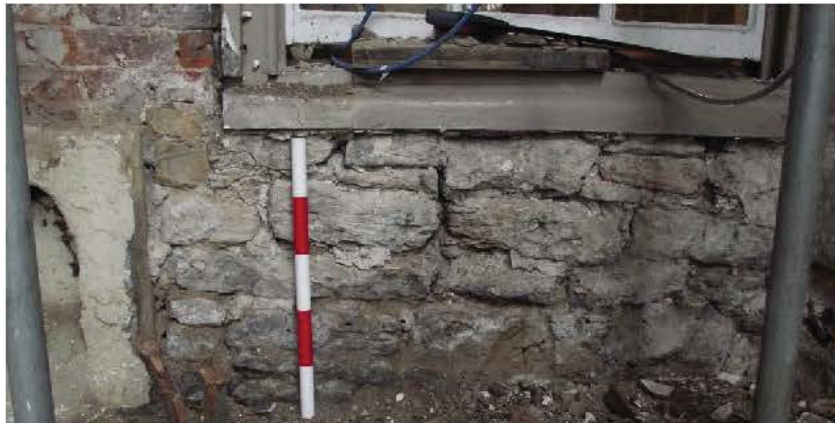
Plate 41: West-facing (rear) elevation, southern element, sandstone masonry below ground floor window (0.5m scale)

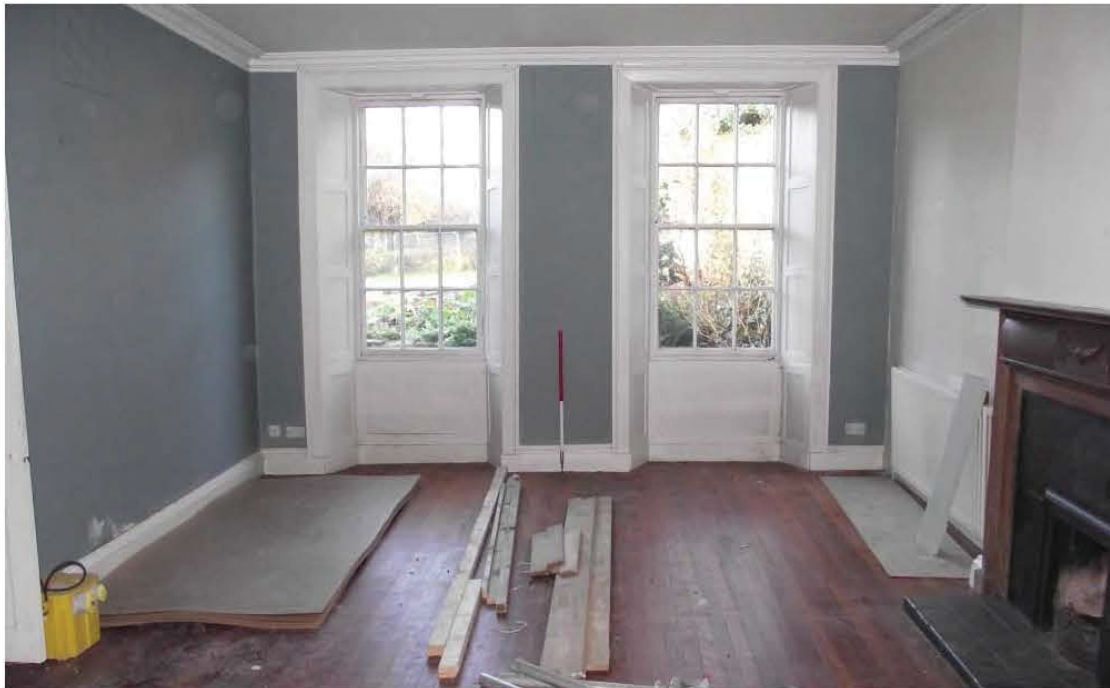
Plate 43: Northern rear element, ground floor, Reception Room 1 (1m scale)

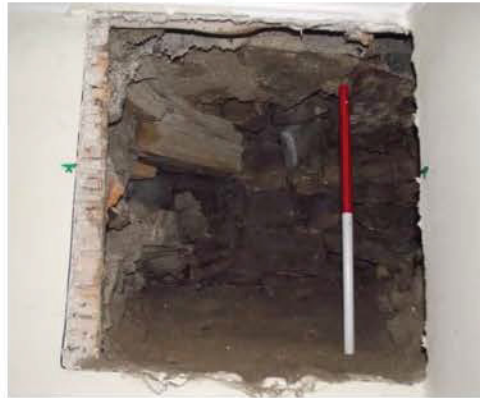
Plate 46: Reception Room 1, easternmost enabling hole in north wall, detail (0.5m scale)

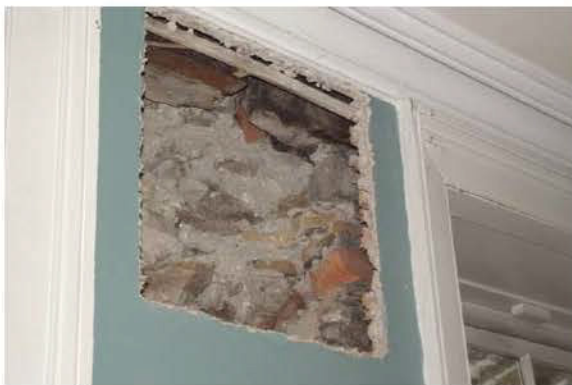
Plate 47: Reception Room 1, enabling hole in west wall, detail (view, no scale)

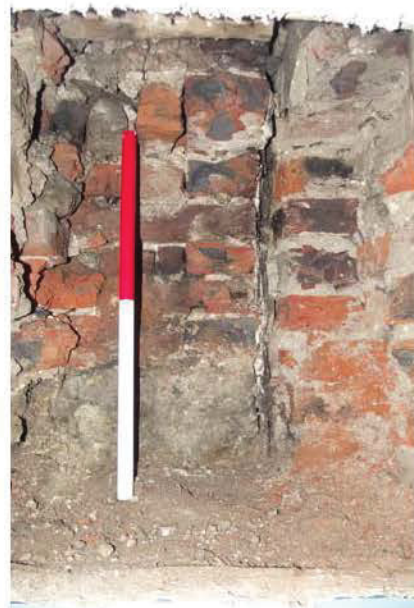
Plate 48: Reception Room 1, westernmost enabling hole in south wall, detail (0.5m scale)

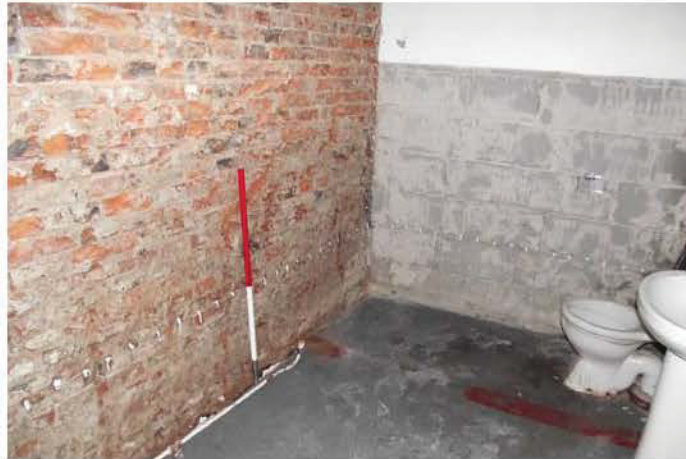
Plate 51: S-shaped rear extension, utility room/WC range, brickwork exposed in east wall (1m scale)

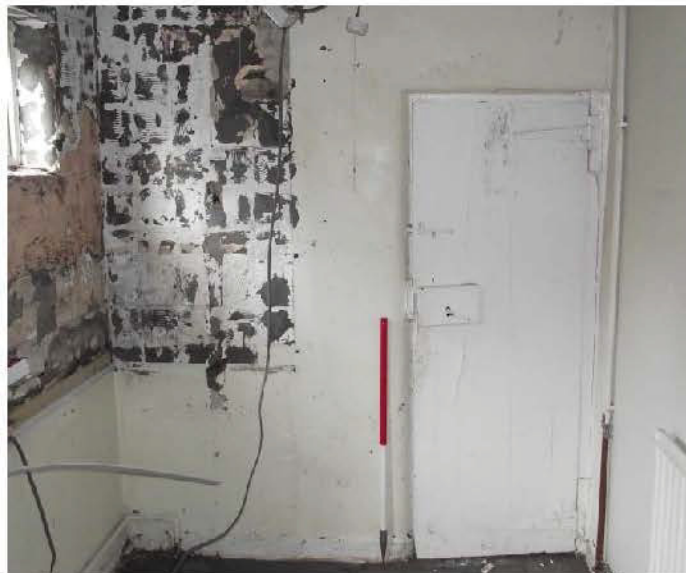
Plate 52: S-shaped rear extension, utility room/WC range, door in north wall (1m scale)

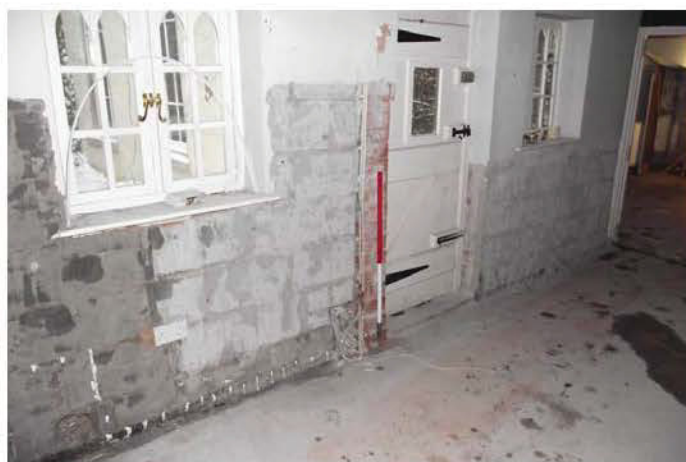
Plate 53: S-shaped rear extension, kitchen range, north wall (1m scale)

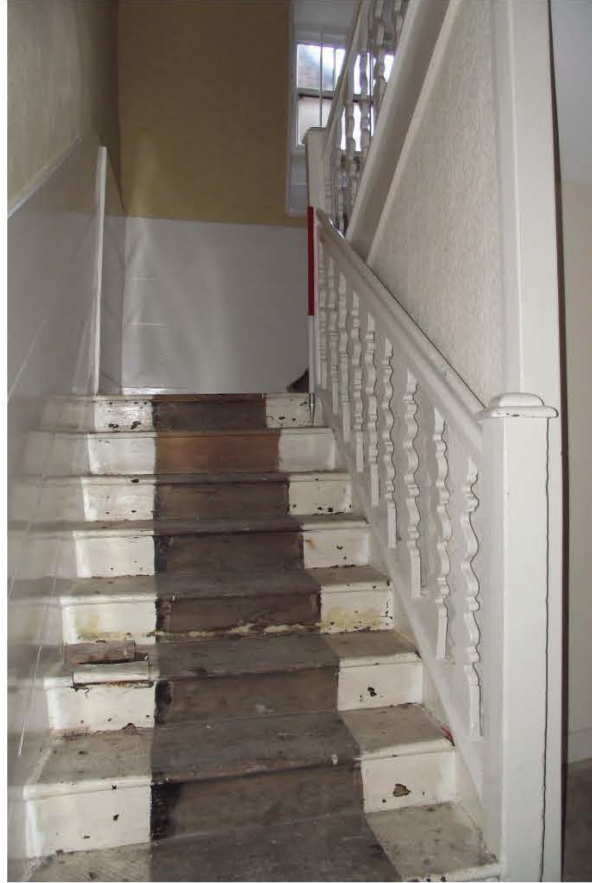
Plate 54: Northern rear element, staircase, rising from ground floor (1m scale)

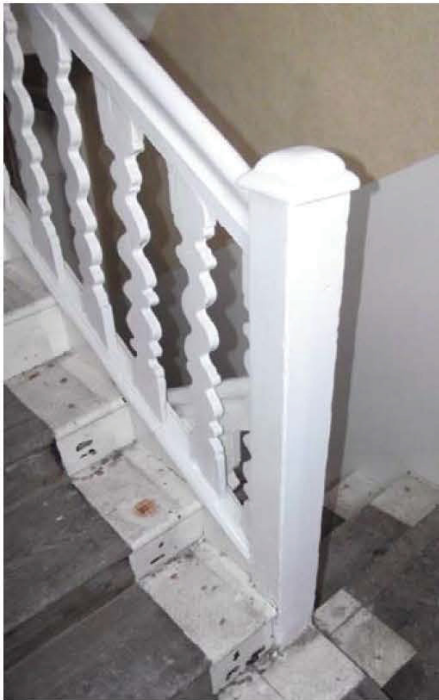
Plate 55: Northern rear element, staircase, balustrade at half-landing between ground and first floor (view, no scale)

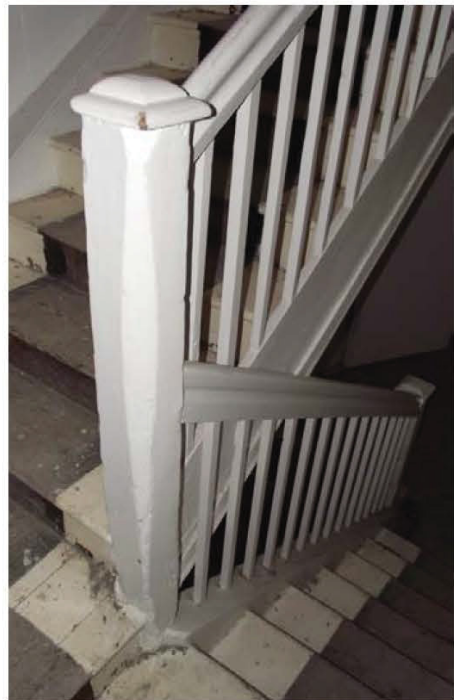
Plate 56: Northern rear element, staircase, balustrade at half-landing between first and second floor (view, no scale)

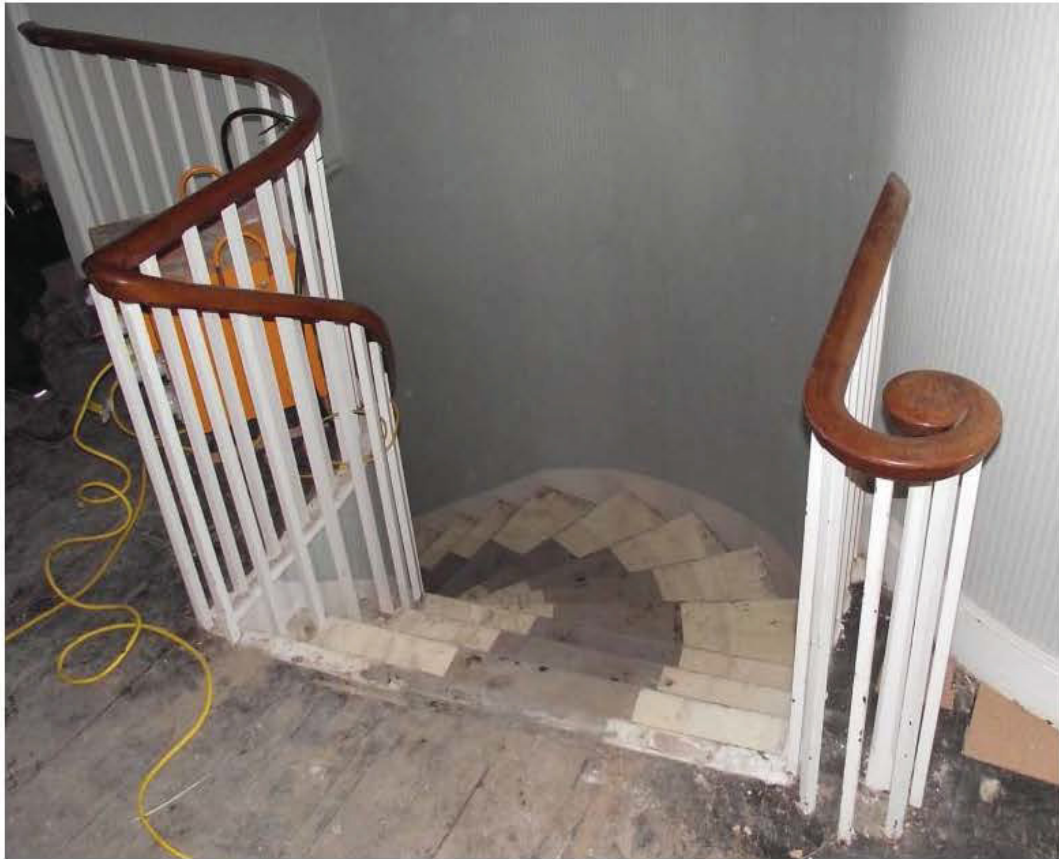
Plate 57: Southern rear element, main staircase, from first floor landing (view, no scale)

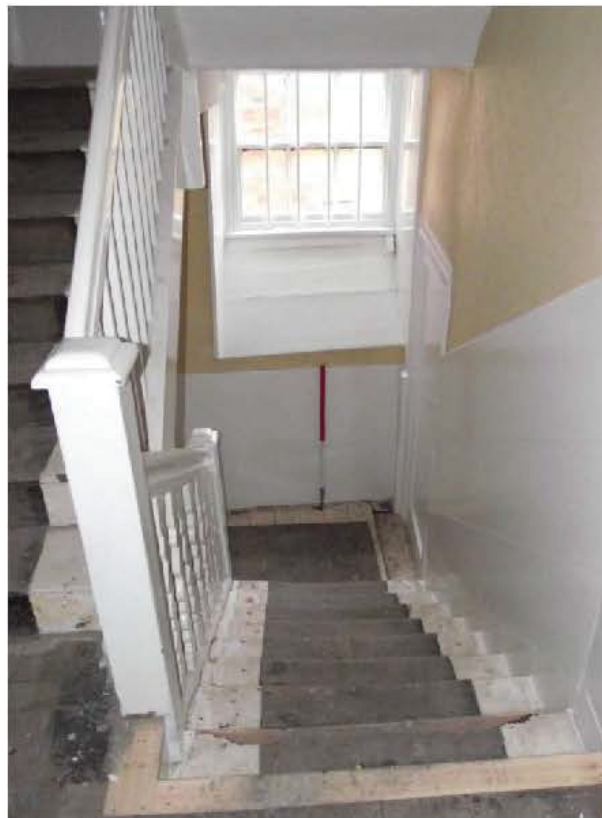
Plate 58: Northern rear element, staircase, from first floor landing (1m scale)

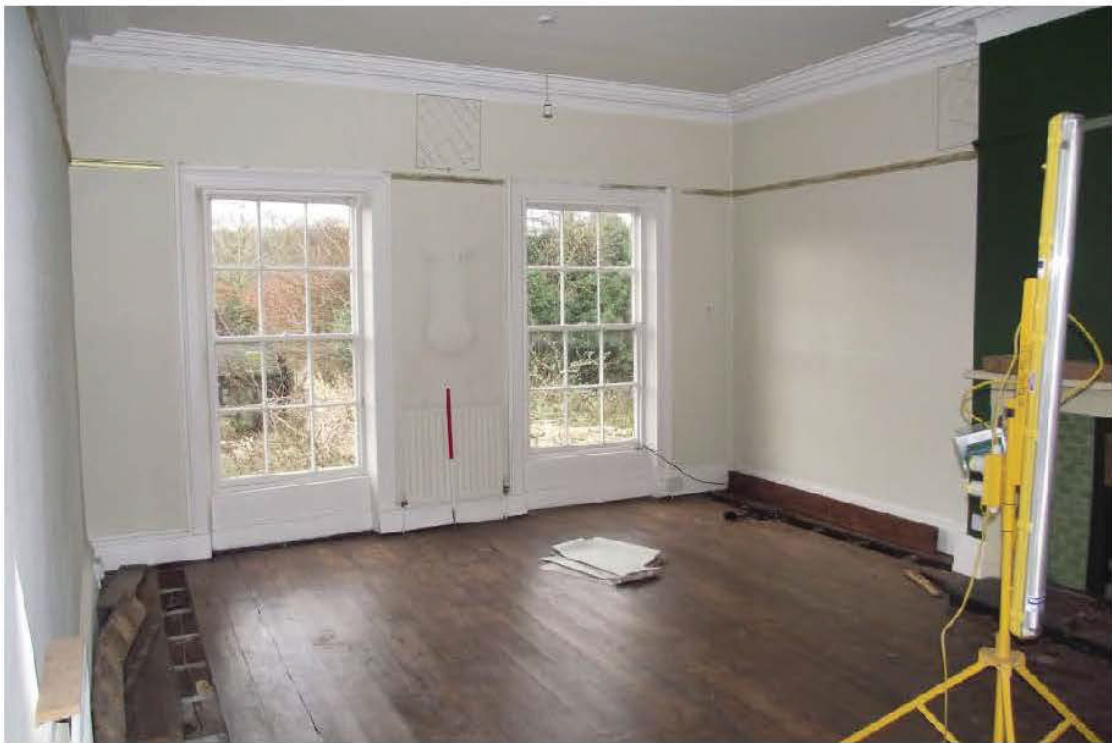
Plate 60: Northern rear element, first floor, Bedroom 1 (1m scale)

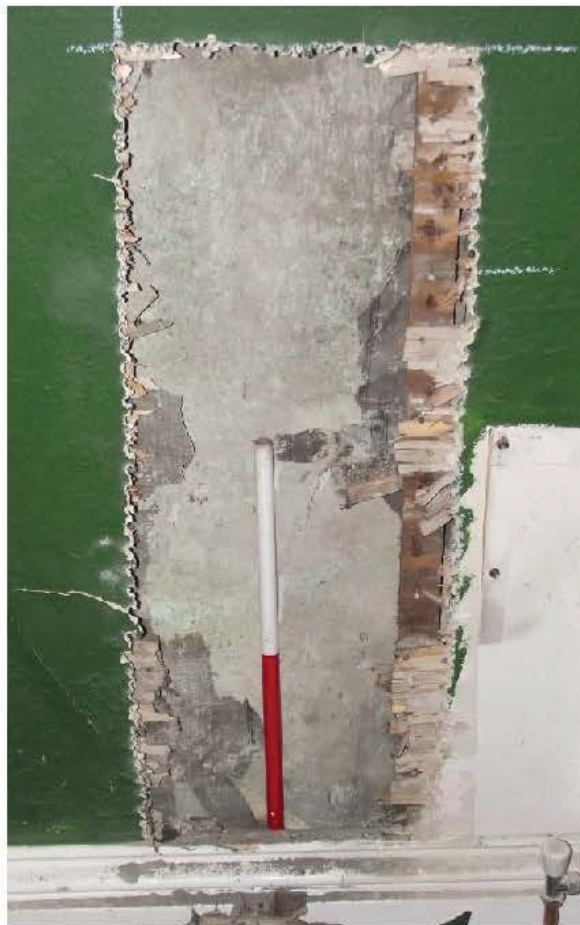
Plate 62: Northern rear element, first floor, Bedroom 1, service installation area in north wall (0.5m scale)

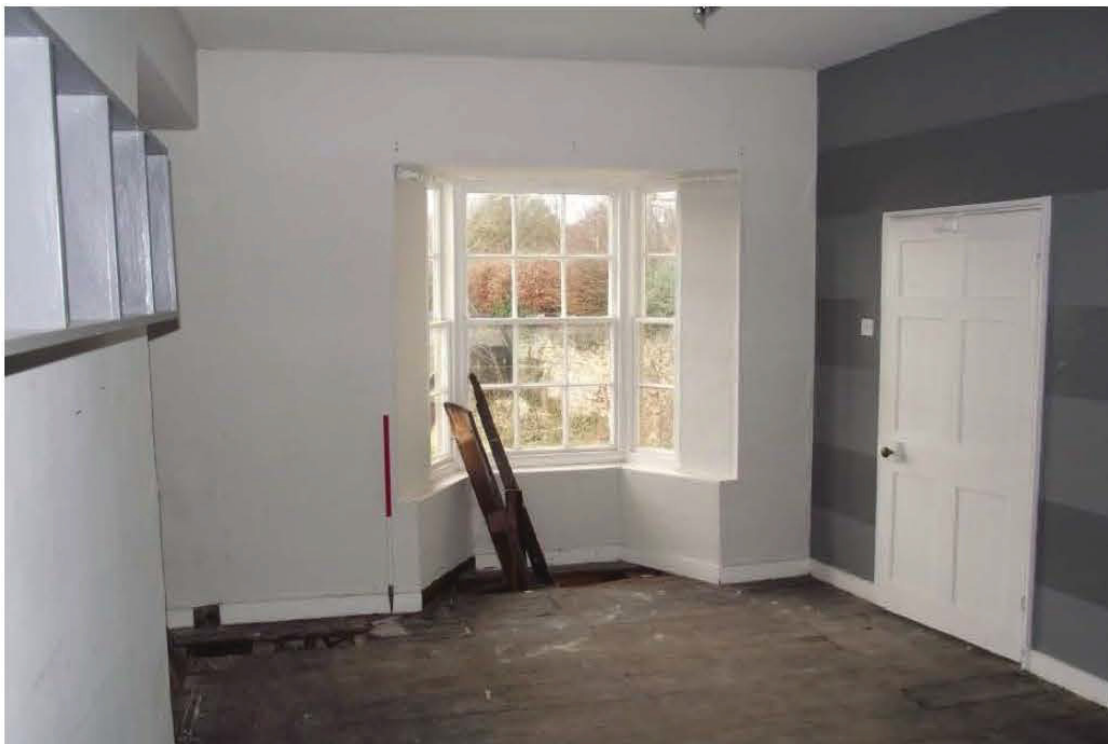
Plate 64: Southern rear element, first floor, Bedroom 2, western part (1m scale)

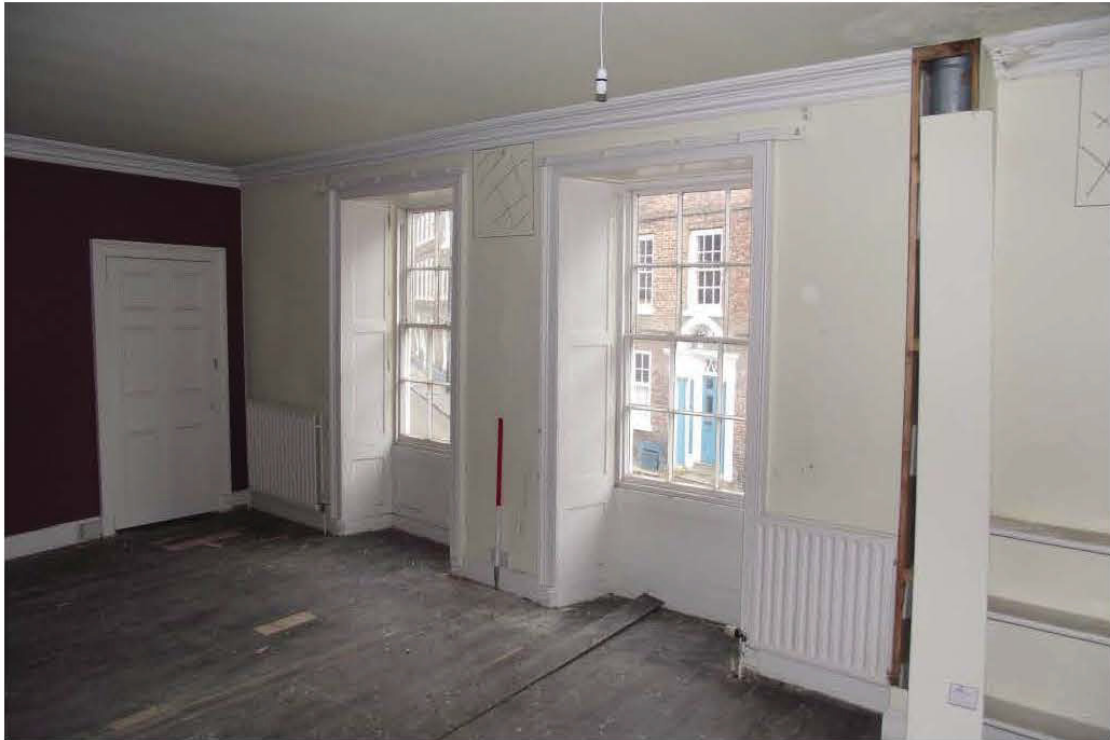
Plate 65: Front element, first floor, Bedroom 3, eastern part (1m scale)

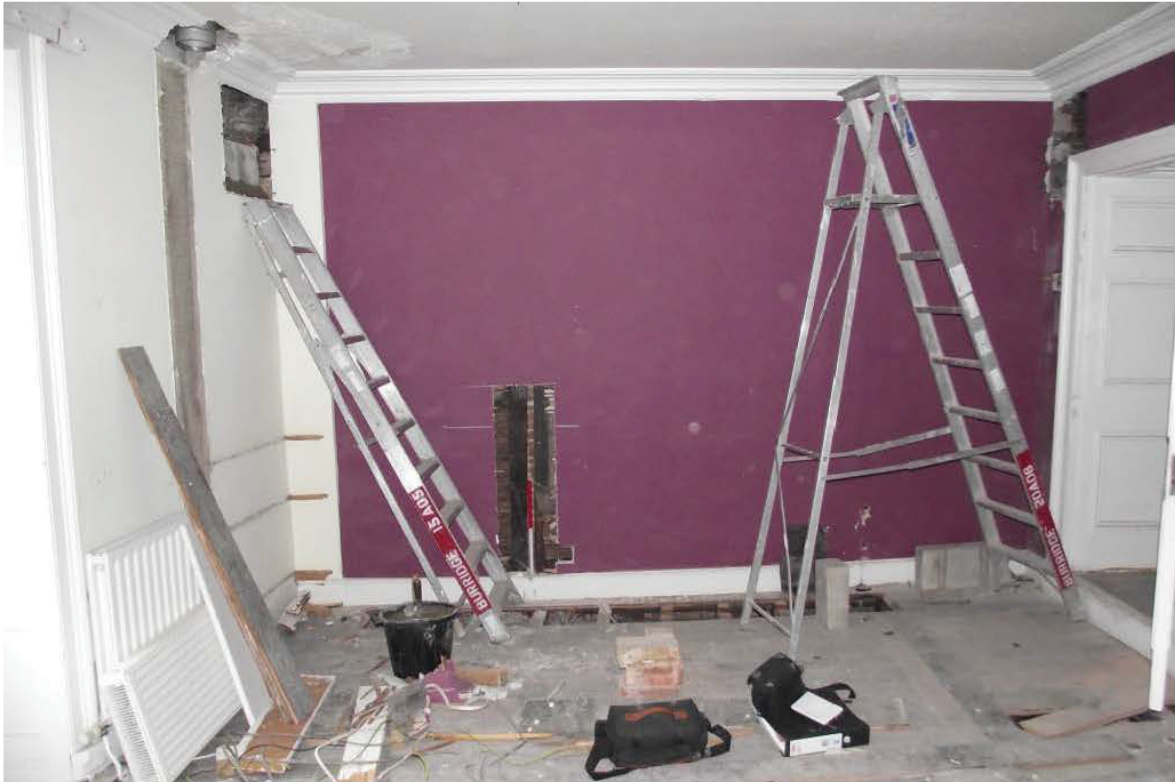
Plate 67: Front element, first floor, Bedroom 3, south end, during works (1m scale)

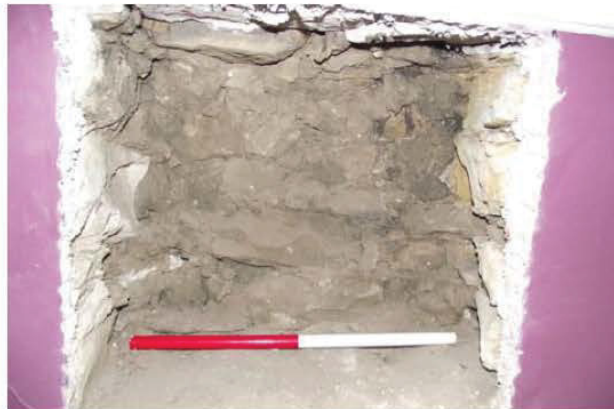
Plate 68: First floor, Bedroom 3, enabling hole in north wall (0.5m scale)

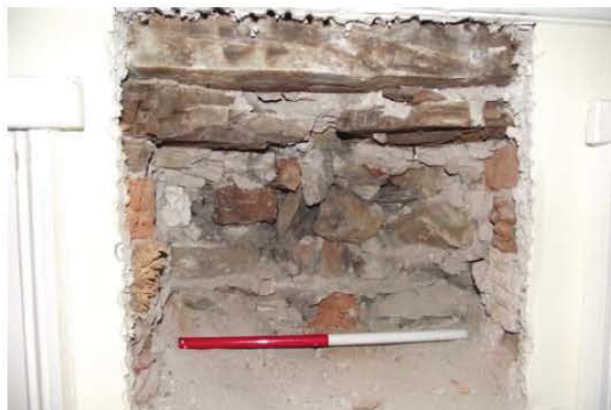
Plate 69: First floor, Bedroom 3, central enabling hole in east wall (0.5m scale)

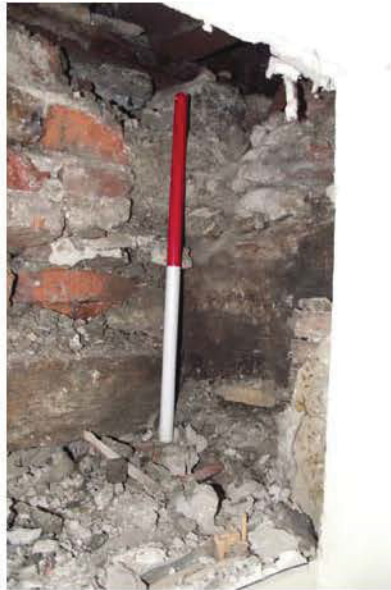
Plate 70: First floor, Bedroom 3, southern enabling hole in east wall (0.5m scale)

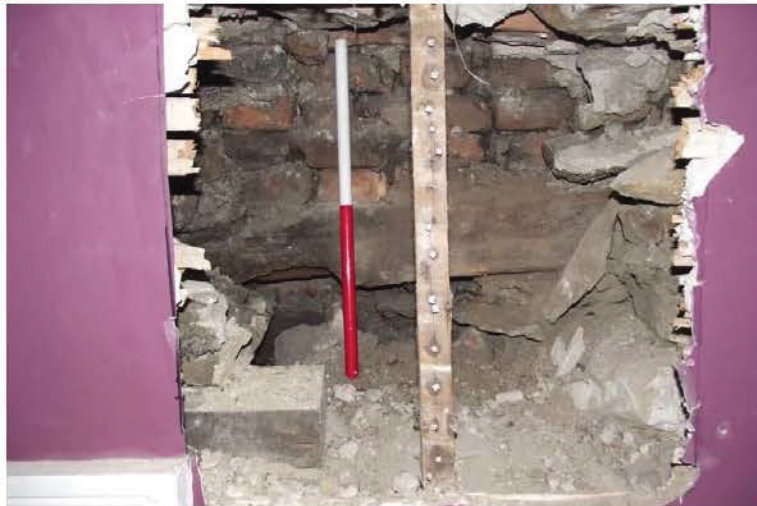
Plate 71: First floor, Bedroom 3, central enabling hole in west wall (0.5m scale)

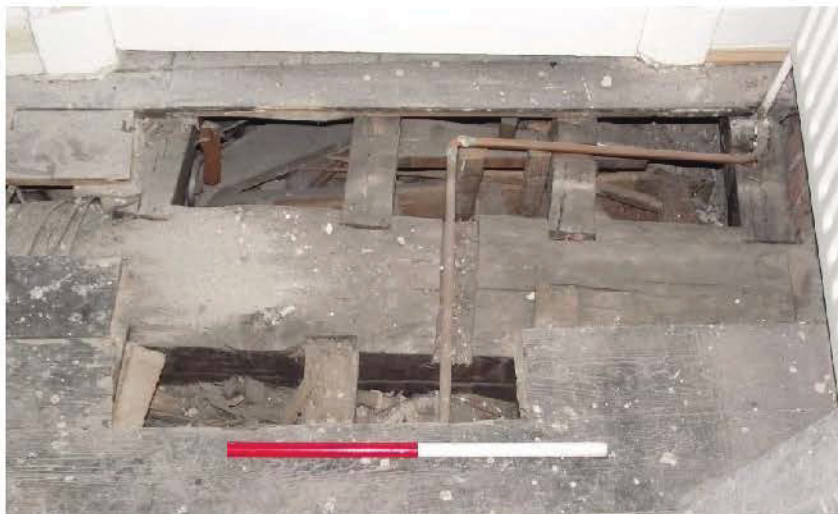
Plate 72: First floor, Bedroom 3, removed floorboards showing timber beam (0.5m scale)

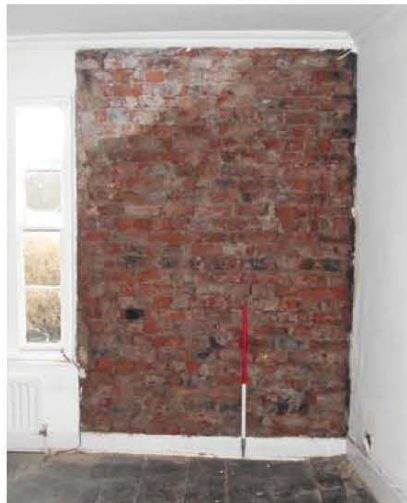
- 6.3.35 In the north-west corner of the living room in the southern rear element, the west wall was stripped of plaster north of the window aperture to expose an area of brickwork (average brick dimensions 230mm by 110mm by 70mm) the full (c. 2.50m) height of the room, comprising 24 courses in English Garden Wall bond, bonded by lime mortar (Plate 74).

Plate 74: Southern rear element, second floor, living room, exposed brickwork in west wall (1m scale)

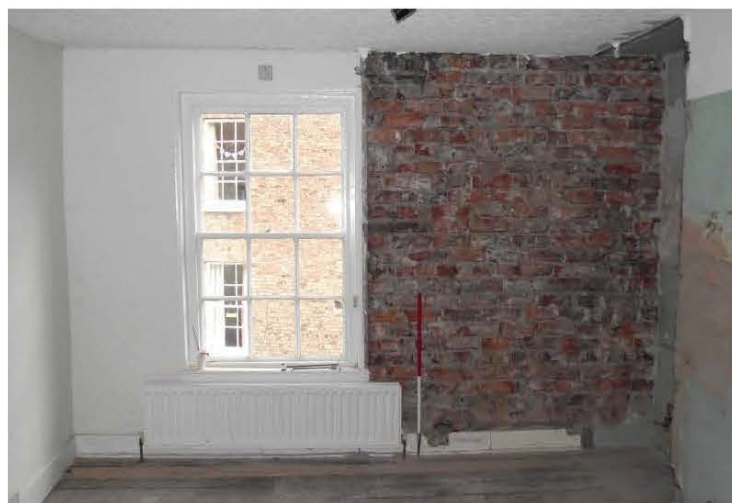
- 6.3.36 In the bathroom and kitchen in the frontage element, refurbishment work comprised removal of existing fixtures and fittings including a corner cupboard in the bathroom. New partition walls were built to the west. Areas of brickwork were exposed across portion of the south and east walls of the kitchen. This comprised up to 30 courses of bricks (average brick dimensions 240mm by 110mm by 70mm) in English Garden Wall bond, bonded with lime mortar, with, both areas probably 19th century in date (Plate 75).

Plate 75: Front element, second floor, kitchen, exposed brickwork in east wall (1m scale)
