**BUILT HERITAGE  
RECORDING OF A PANEL  
OF THE PARAPET OF  
CHISWICK BRIDGE, GREAT  
CHERTSEY ROAD, LONDON  
BOROUGH OF HOUNSLOW**

**PCA REPORT NO. R11474**

**JULY 2013**

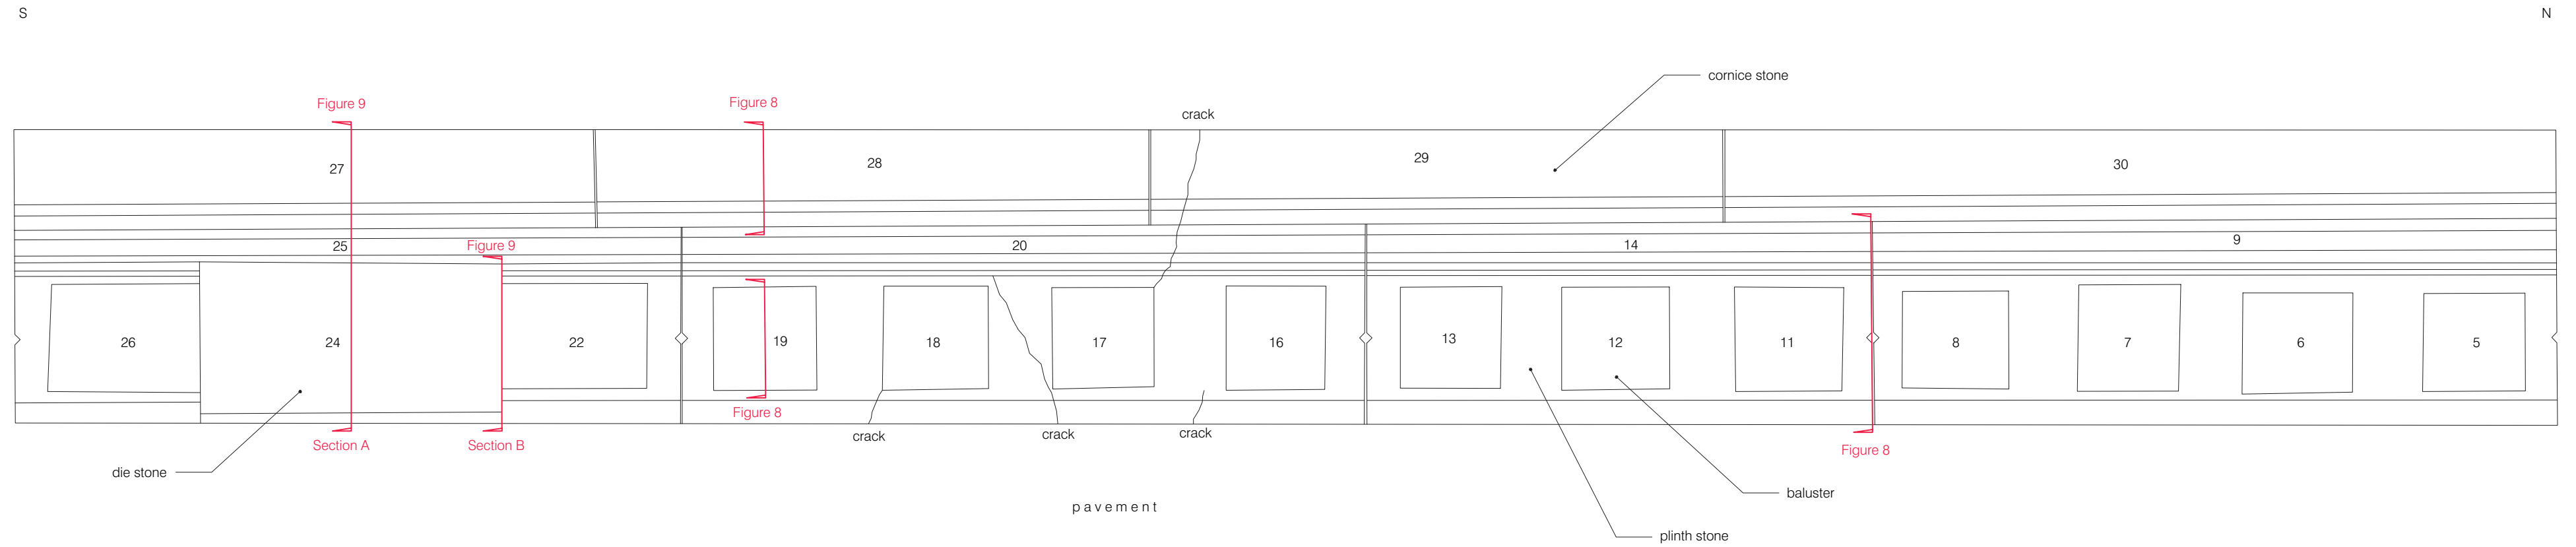
Figure 6  
Plan of plinth  
CIS13 Chiswick Bridge  
1:10 at A2

Area of severe weathering

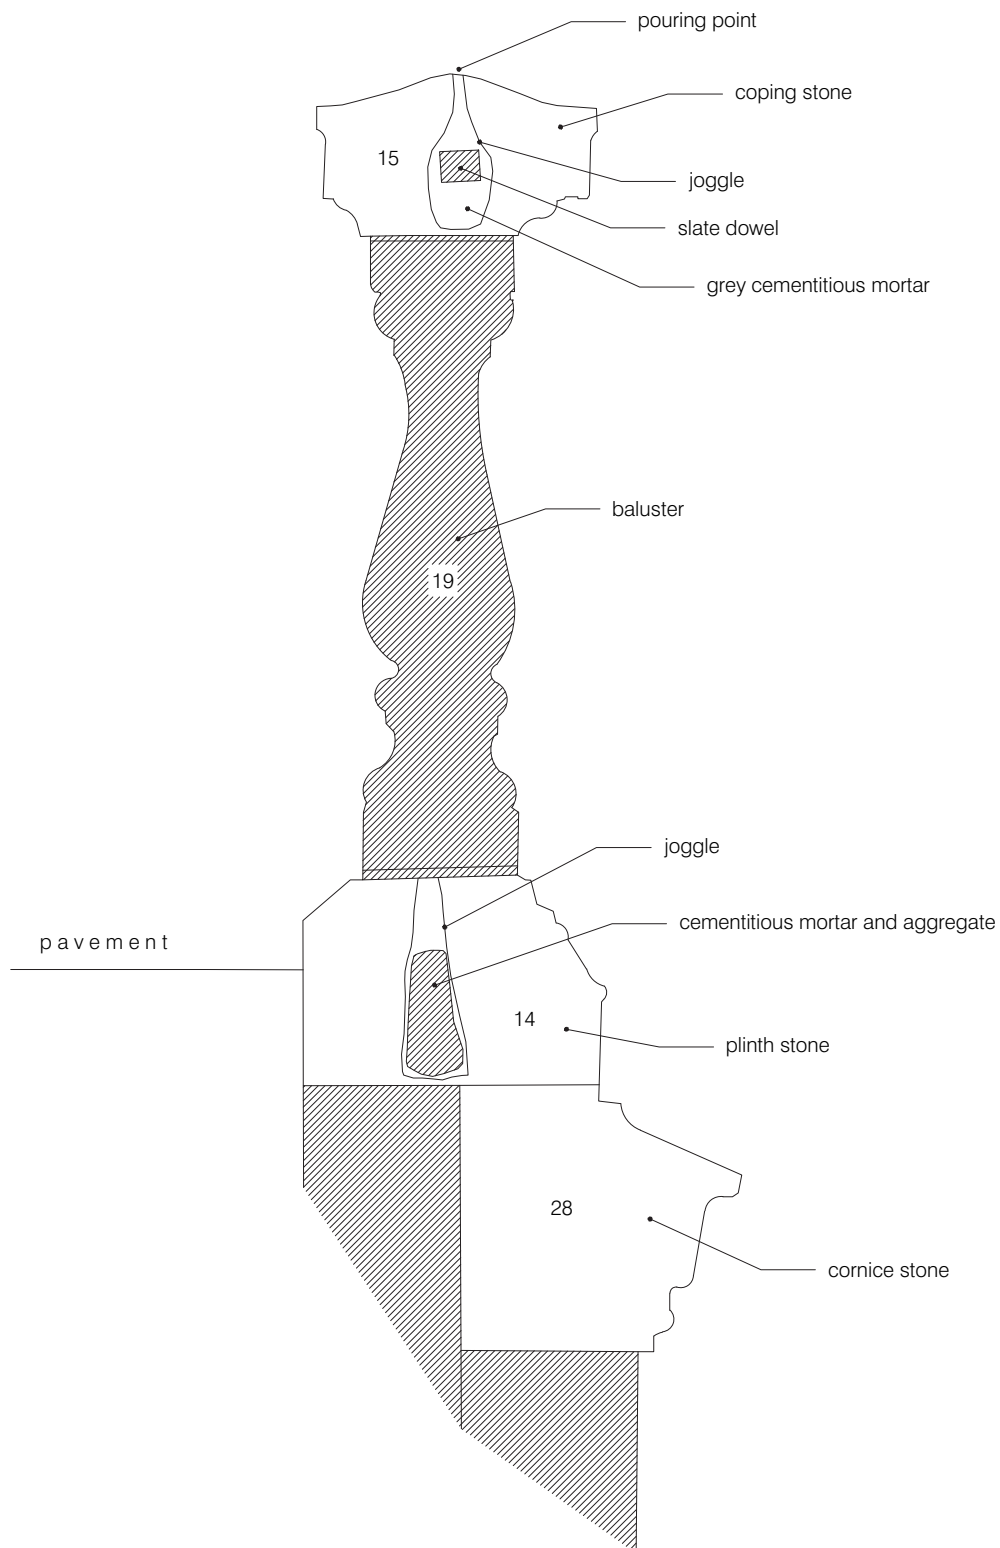
Figure 8  
Section through Baluster 19, looking South  
CIS13 Chiswick Bridge  
1:10 at A4

coping stones, however instead of using a slate dowel to reinforce the joint, flint aggregate has been added to the mortar (**Figure 8; Plate 23**). When plinth stone 9 was lifted it was possible to see the rear (east side) of the upper surface of the cornice stone 30 and its abutting join with the concrete which forms the main part of the bridge structure (**Plate 22**)

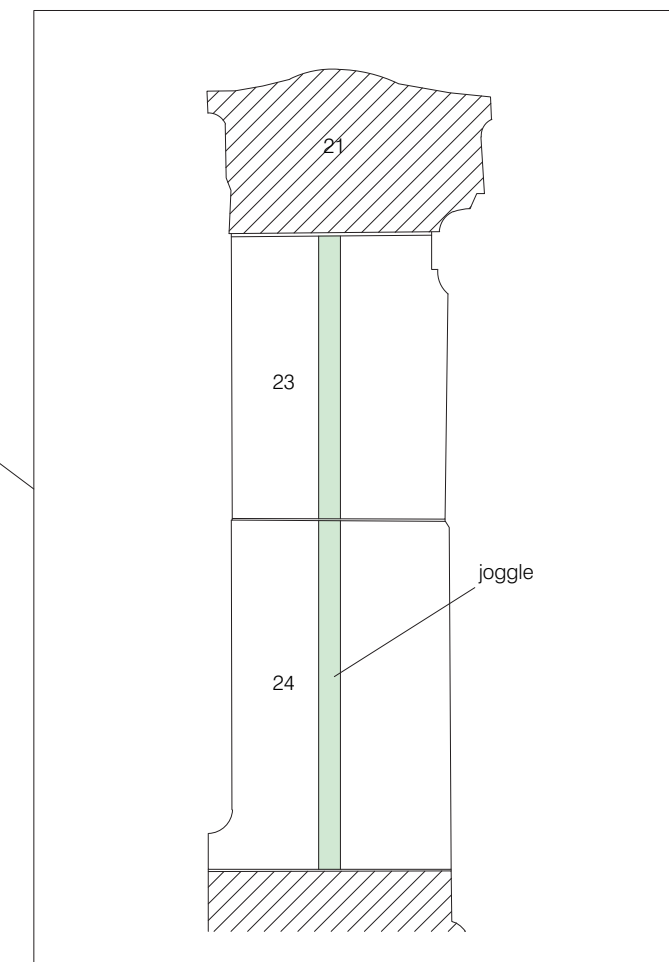
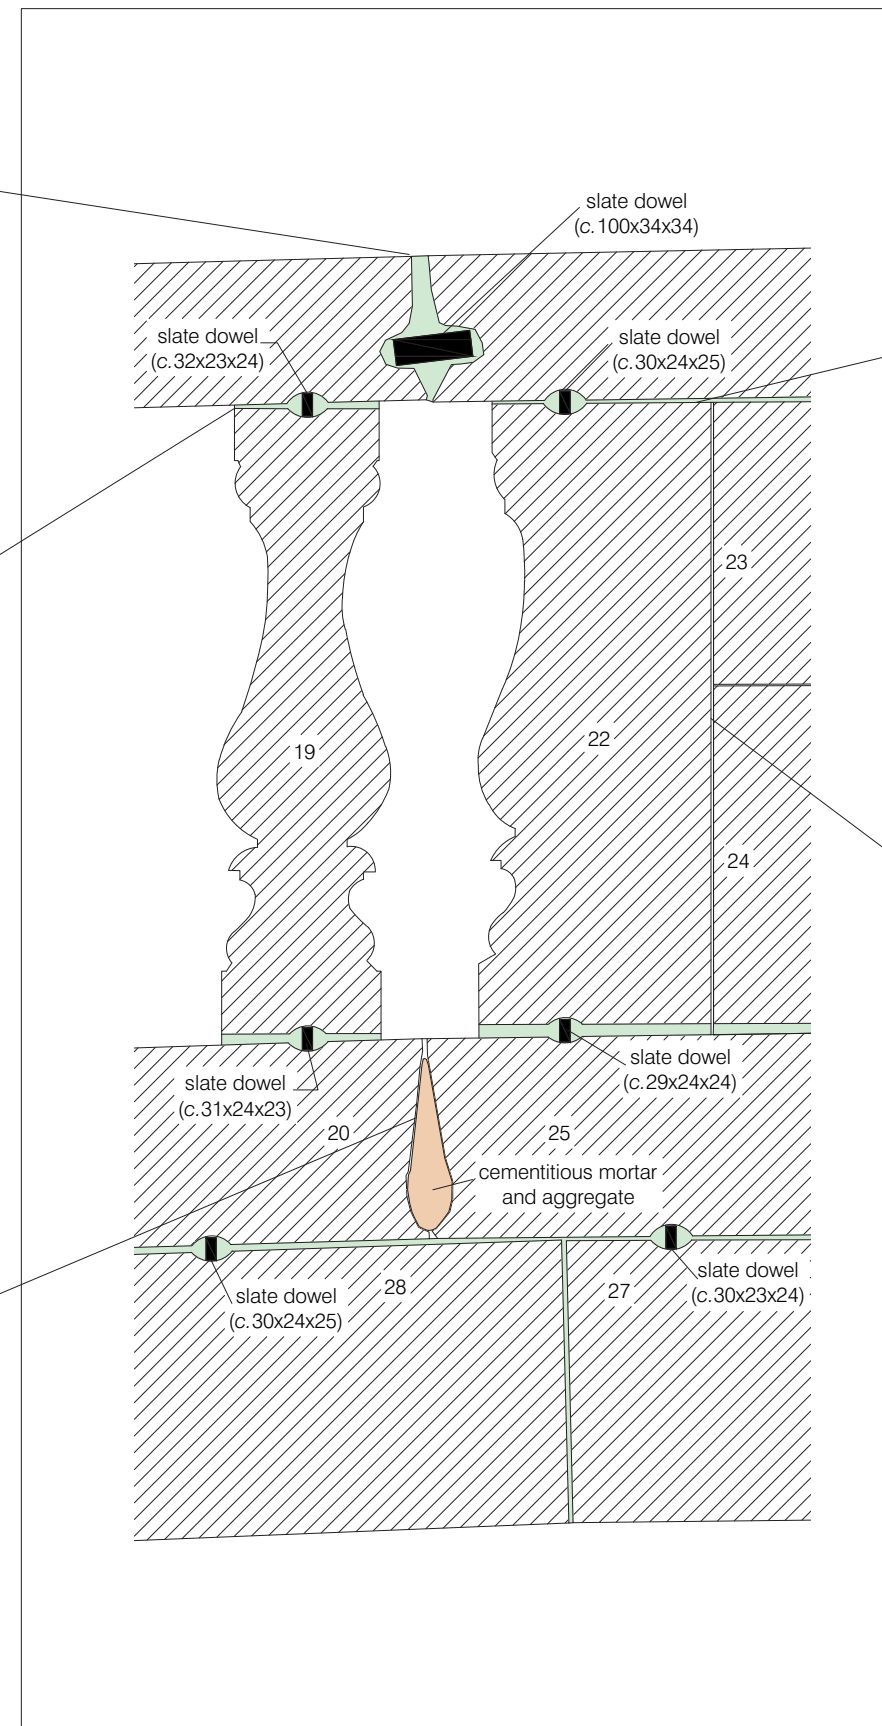
Figure 10  
Longitudinal Section through baluster 19 and half baluster 22  
(all dimensions in mm)  
1:10 at A2

- 6.2.5 The joint between half baluster 22 and die stones 23 and 24 (**Figure 10; Plate 24**) again uses a joggle with poured cementitious mortar which contains aggregate with the slight difference that half baluster 22 appears to have been set and rendered prior to the pouring of the aggregate filled cementitious mortar, presumably in order to create a suitable cavity. Although half balusters 22 and 26 each appear to comprise two stones (the half baluster and the stone behind), these two elements are one stone.

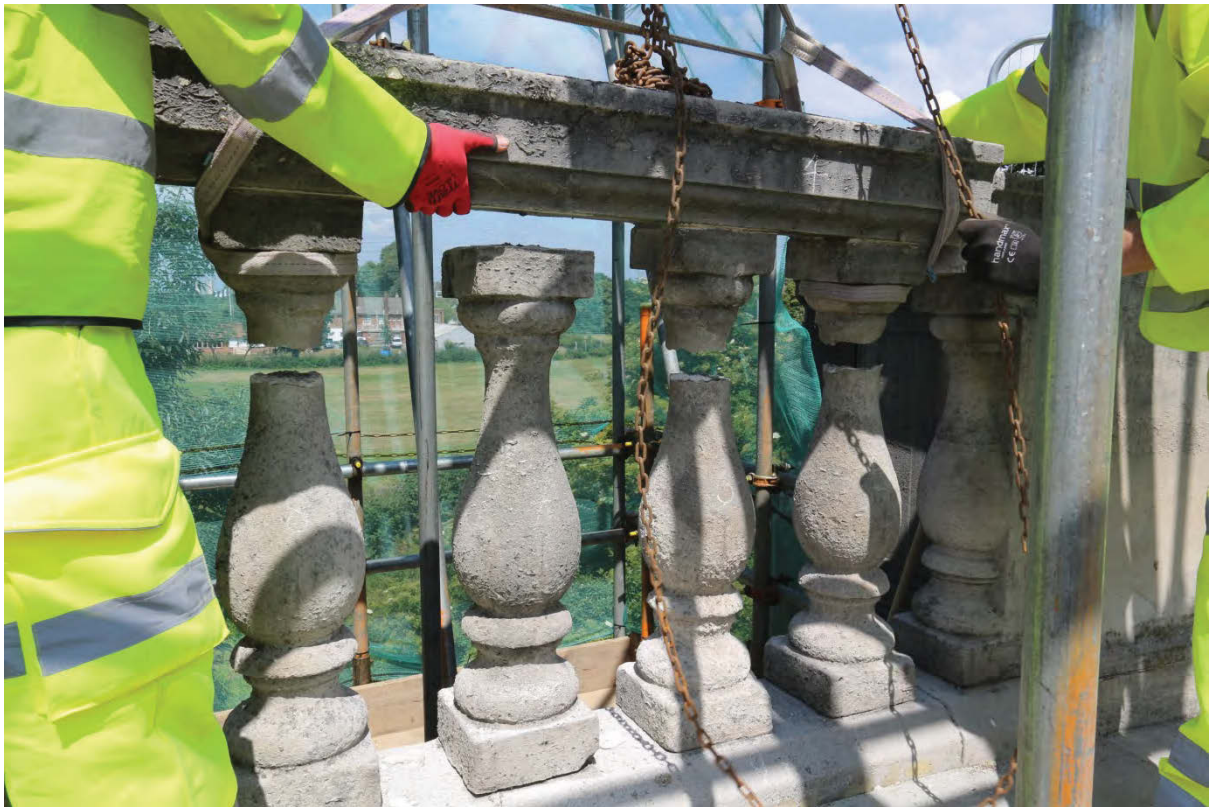
Plate 14 Lifting of coping stone 4, internal (east) elevation, looking west (CIS13 D1 3205)

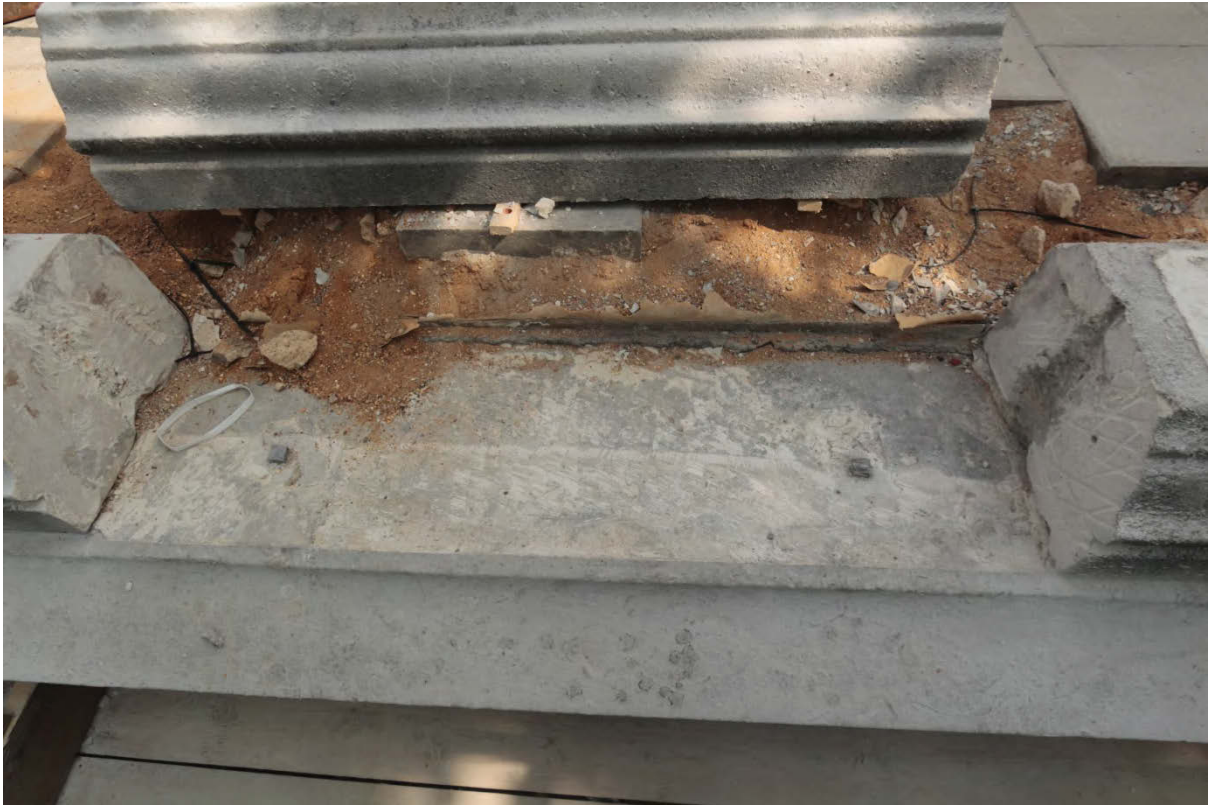
- 6.2.4 Removal of plinth stone 9 showed that it was joined to the cornice stones below by two small slate dowels as well as being set on a base of poured grey cementitious mortar (**Plate 22**). The joint between the plinth stones is similar to those between the

Plate 22 Removal of plinth stone 9 exposing upper surface of cornice stones 31 (left) and 30 (centre) and north end of plinth stone 14 (right), looking east (CIS13 D1 3297)

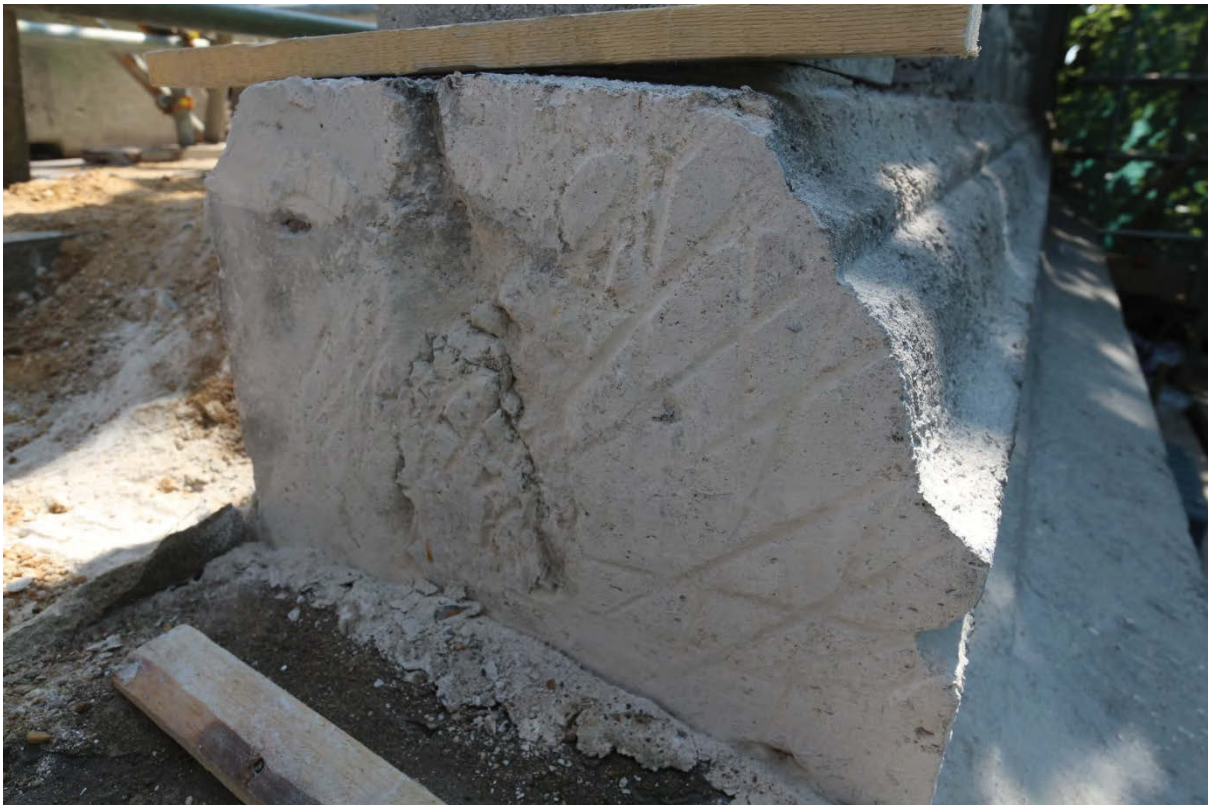
Plate 23 Joggle and poured cementitious mortar with aggregate in the north end of plinth stone 14, looking south-east (CIS13 D1 3279)

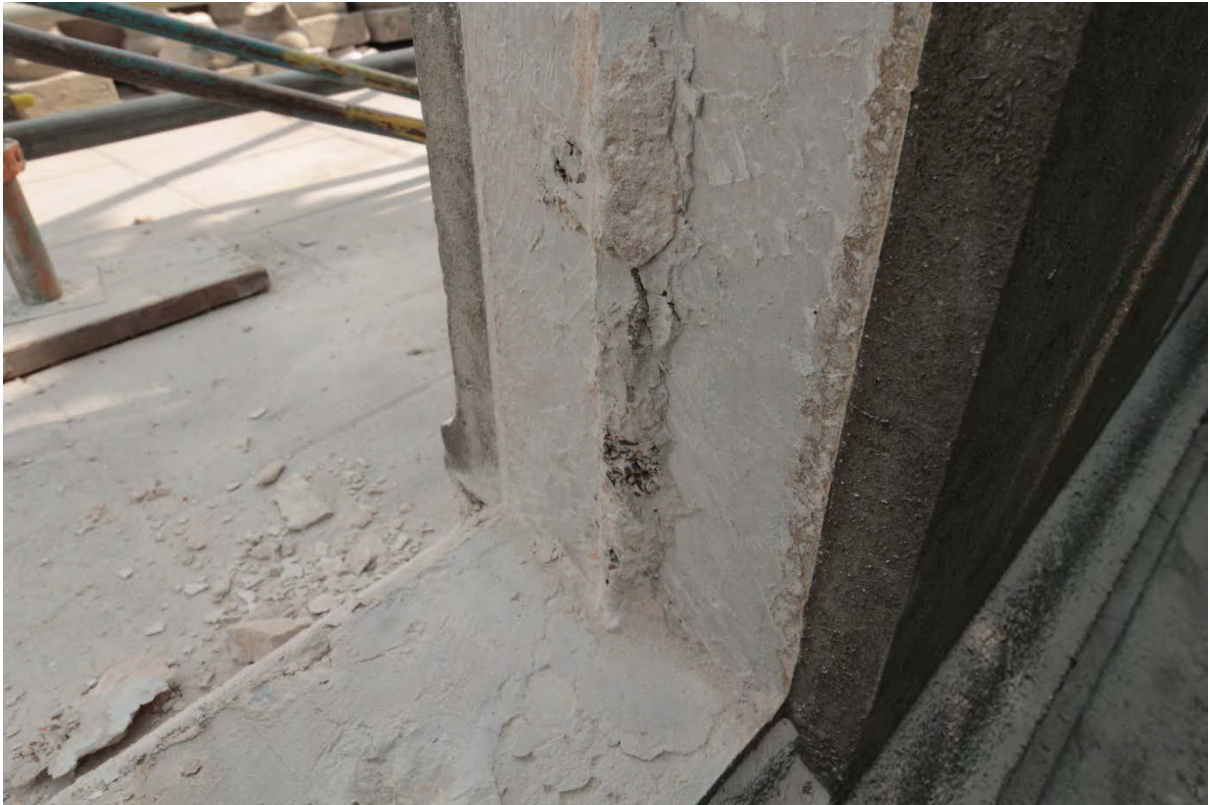
Plate 24 Removal of half baluster 22 exposing the upper surface of plinth stone 25 (left) and the north end of die stones 23 and 24 (right), looking south-east (CIS13 D1 3293)

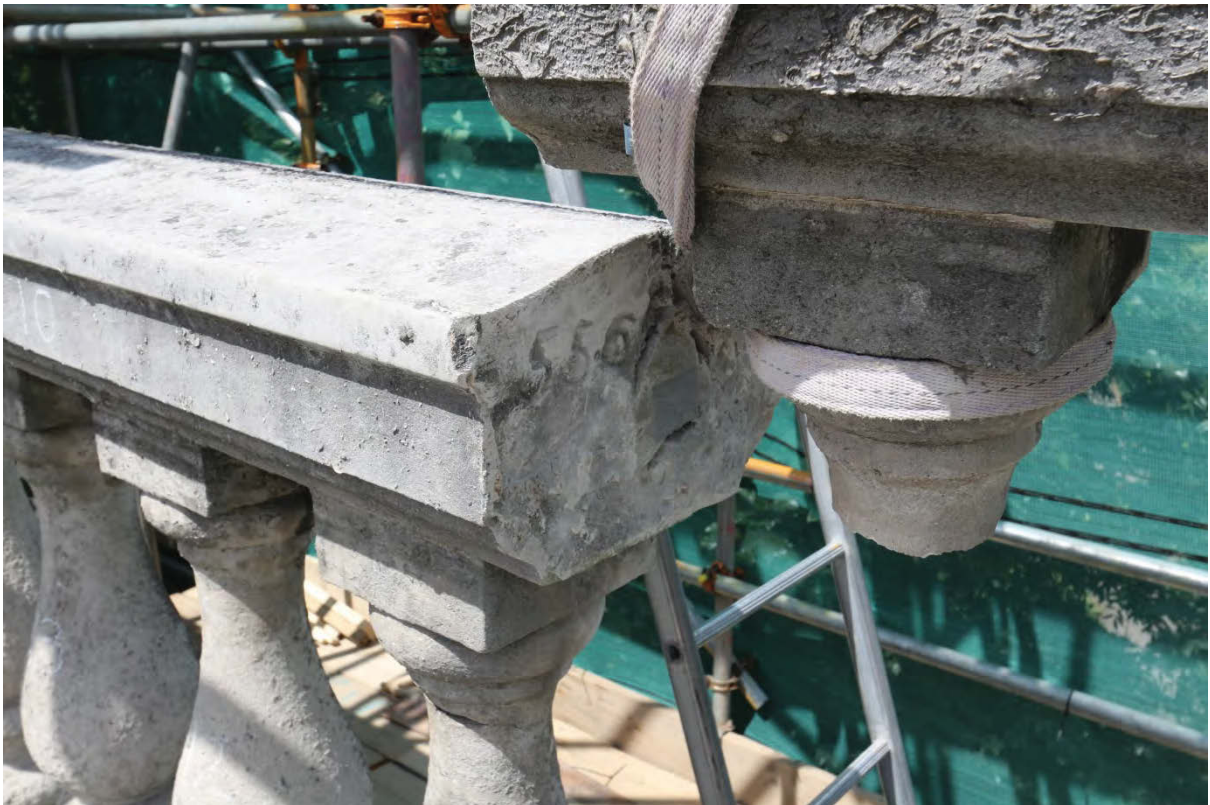
- 6.2.6 At least two of the coping stones have, what appear to be, unique numbers carved into their north ends (**Plates 25 and 26**). This is presumably related to the original construction of the bridge. As coping stones 10 and 21 were numbered 556 and 558 respectively, coping stones 4 and 15 were presumably 555 and 557 respectively. No numbers were observed on any of the balusters, which would seem to suggest that the balusters were fairly uniform and as such had no specific locations, whereas the coping stones had been cut to fit at pre-specified locations within the parapet.

Plate 25 Lifting of coping stone 4 exposing the number on the north end of coping stone 10, looking south-west (CIS13 D1 3267)

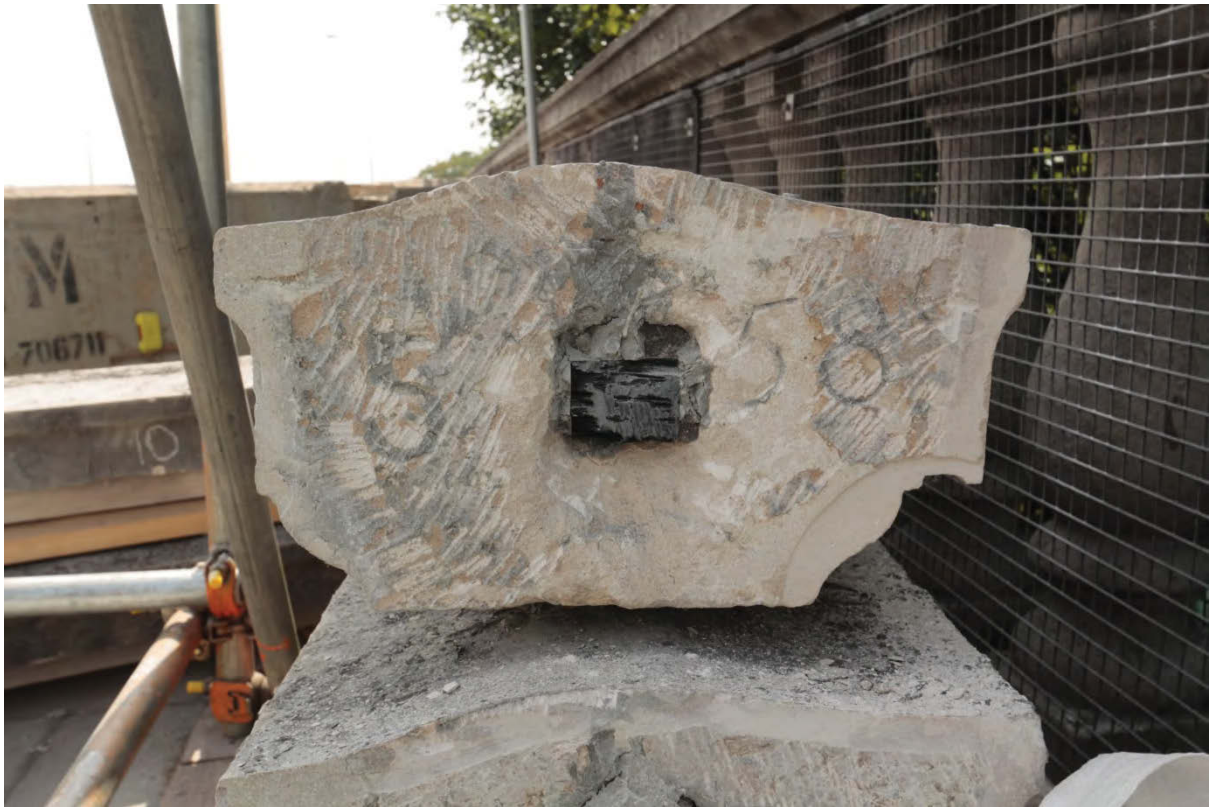
Plate 26 Number on north end of coping stone 21, looking south (CIS13 D1 3291)
