**HISTORIC BUILDING SURVEY OF
FORMER STABLE BUILDING AT
BREEDON HALL, BREEDON-ON-
THE-HILL, LEICESTERSHIRE**

PCA REPORT NO: 11491

SEPTEMBER 2013

**Historic Building Survey of former Stable Buildings, No. 8 the Delph, Breedon Hall,
Breedon-on-the-Hill, Leicestershire.**

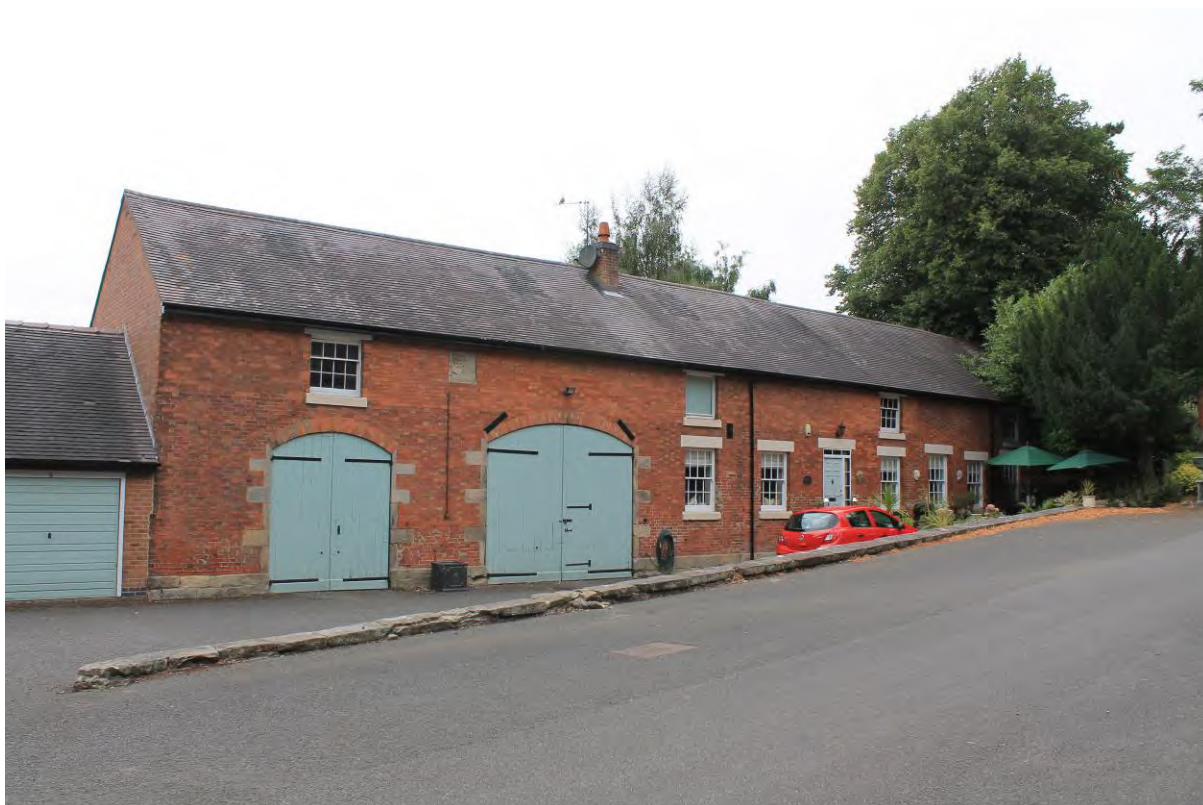
Plate 1 Curzon House Looking North-west

- 2.2.5 Coach-house and stable range, converted to flats 1986 (**Plate 1**). Mid-late C18, raised C19, with left gable rebuilt C20. Red and buff brick, ashlar plinth, C20 plain tile roof, one brick chimney to left of centre. 2 storeys. Long range. To left are 2 coach-house bays with double doors. Doors have bonded stone jambs and segmental brick arches. Left doors are slightly smaller and have 4-pane sash above. Below eaves between bays is a square tablet of moulded stone inscribed 'John Curzon, Anne Dorn 1690', re-sited. To right are 4 window openings and 3 doorways. One window has 4-pane sash; the others await C20 glazing. 2 doorways have board doors with barred rectangular fanlights; one doorway is empty. 3 square loft openings, the left with board door, 2 to right with 4-pane sashes. C20 4-bay garage extension at left end. Included for group value.

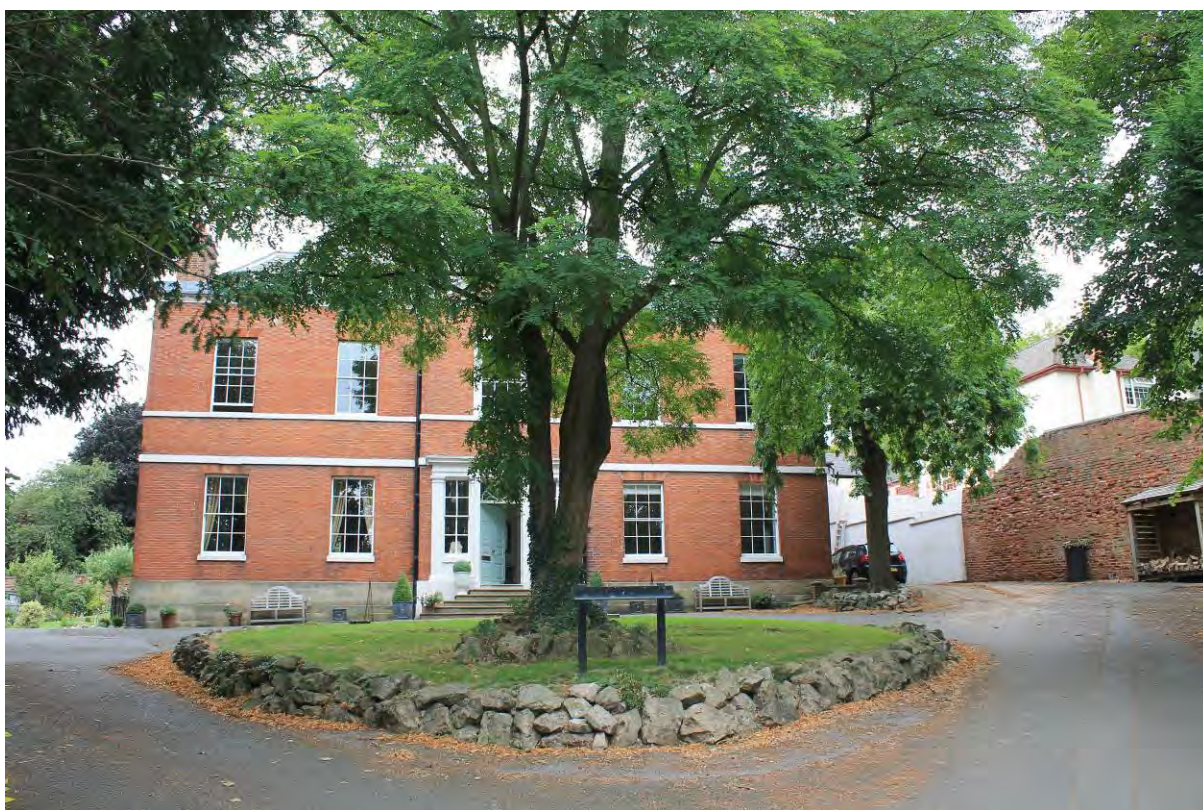
Plate 2 Breedon Hall Looking North

- 2.2.7 Former house, now 4 apartments (**Plate 2**). Early C18 part survives, at rear NE corner; extended mid C18; refronted 1777 as dated on rainwater heads, which also bear initials NC for Curzon family. Refurbished and converted to apartments c.1970-80. Brick, with ashlar plinth and moulded stone eaves, the front of better quality red brick with fine white mortar joints and some stone dressings. Hipped slate roof, brick chimney to left rebuilt C20. Double pile block, the front of 2 storeys, the rear of 3 storeys with cellars. 5-bay front has stone band courses at first floor and first floor sill level, and modillion eaves with leaded blocking course, all stone dressings painted. Centre bay is slightly advanced and pedimented. 3-pane sashes with narrow glazing bars and fine gauged heads. Centre bay has painted stone architrave surround to first floor window. 8-panelled door below with ornamental rectangular fanlight and flanking 2-pane sashes, all in painted stone surround with Doric pilasters, entablature and architrave frame to door. Door is approached by 6 spreading stone steps. Above door is a metal lantern. Downpipes with dated rainwater heads flank central bay. Rear has 3 mid C18 bays with 3-pane sashes and gauged heads to right, and 2 earlier C18 bays to left. These bays have rendered plinth, dentilled brick band courses and boxed 3-pane sashes, renewed C20. 2-storey extension to far left is C18 in origin but much altered. C20 interior said not to contain any original features of note.

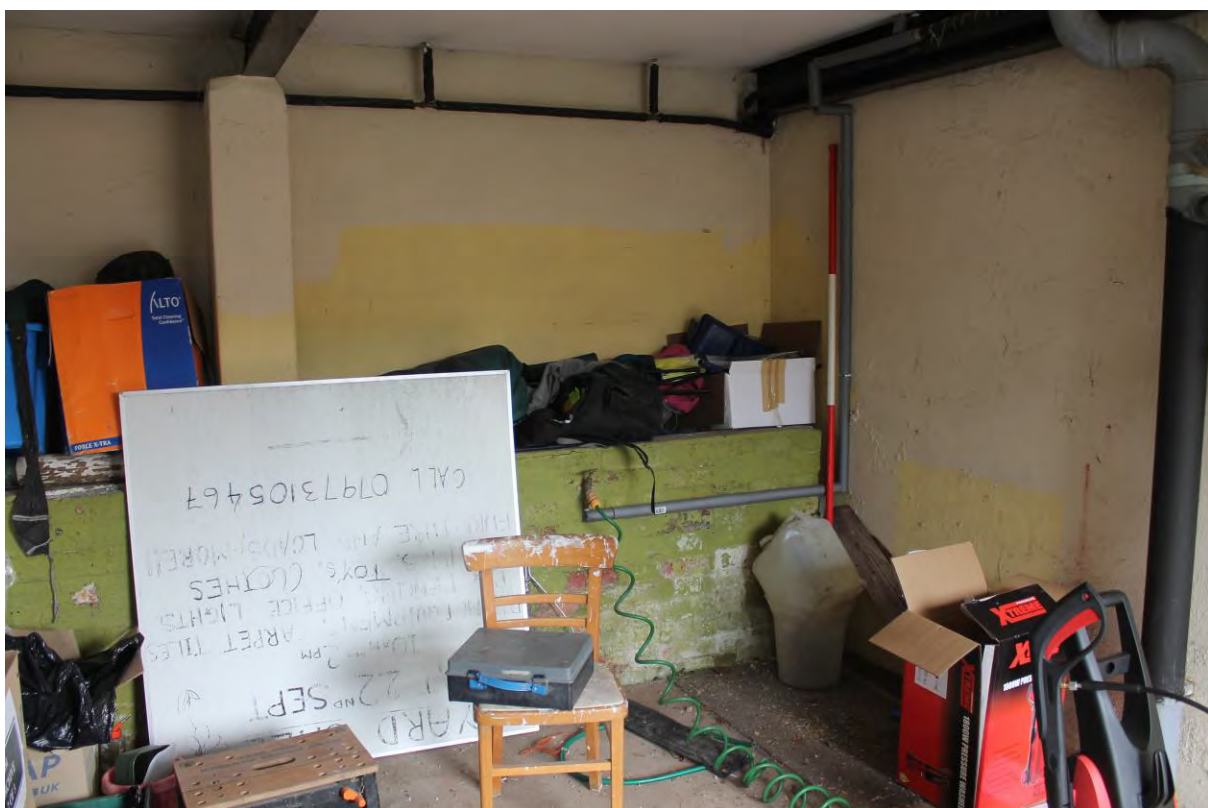
Plate 18 Extant Brick Built Trough along rear wall

6.7.8 A notable feature that remained within the stable was the survival of an integral brick-built food trough backing onto the eastern (rear) flank wall (**Plate 18**). The trough extended the full width (N-S) of the stable but was divided centrally by the pier that supported the ceiling joists. This pier, though modern, was probably built in the same location as a stall partition or divider. The height of the trough at c.0 90m from the floor confirms that it was a horse feed trough as feed troughs for cattle are usually lower.

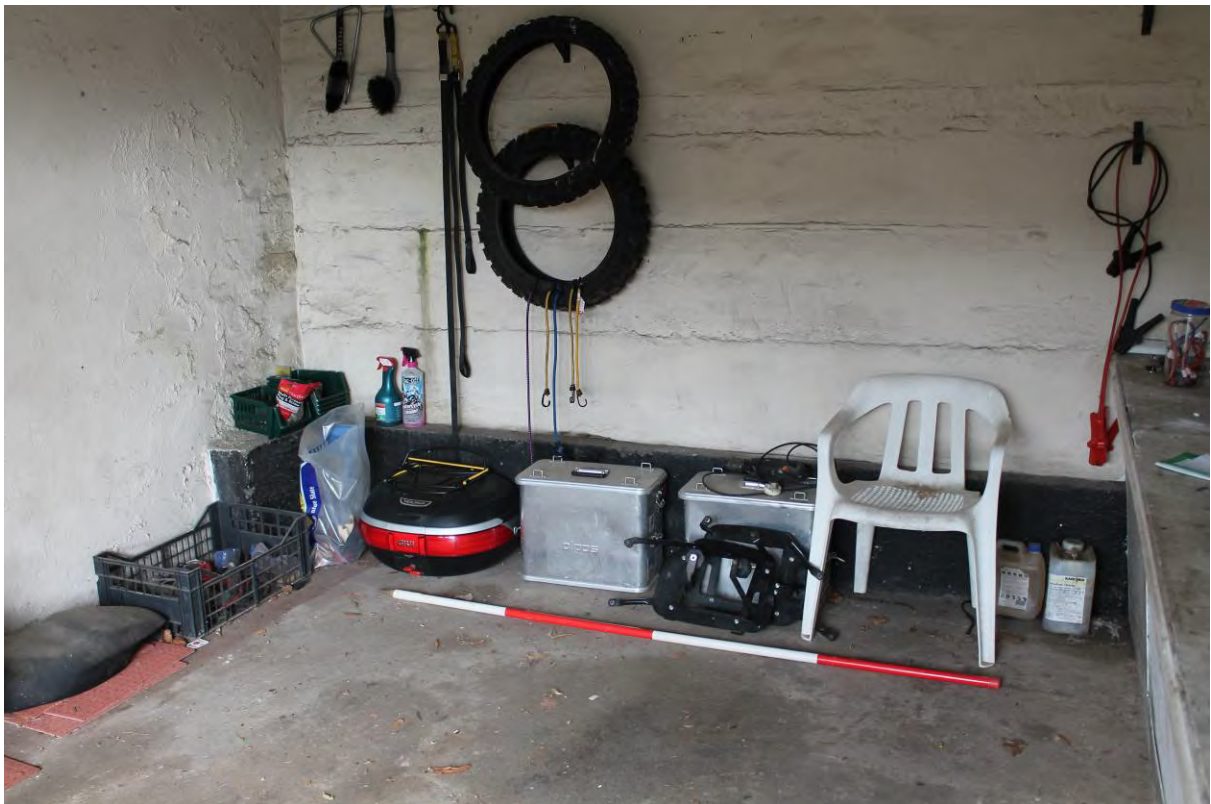
Plate 20 Base of Feed Trough in Room (4)

6.7.11 A notable feature present along the rear wall was the remains of a food trough, comprising just the lower brick courses of presumably a trough similar in form to that present in the adjacent room (4) (**Plate 20**). The brickwork of half a brick thickness, survived to a height of 16 inches and extended 24 inches from the rear wall. No other features were present.
