**HISTORIC BUILDING  
RECORDING AND  
ARCHAEOLOGICAL  
MONITORING AT POND  
HOUSE, NO. 162 LOWER  
CLAPTON ROAD, LONDON  
BOROUGH OF HACKNEY**

**PCA REPORT NO. R11599**

**JANUARY 2014**

**Site Code: POH12**

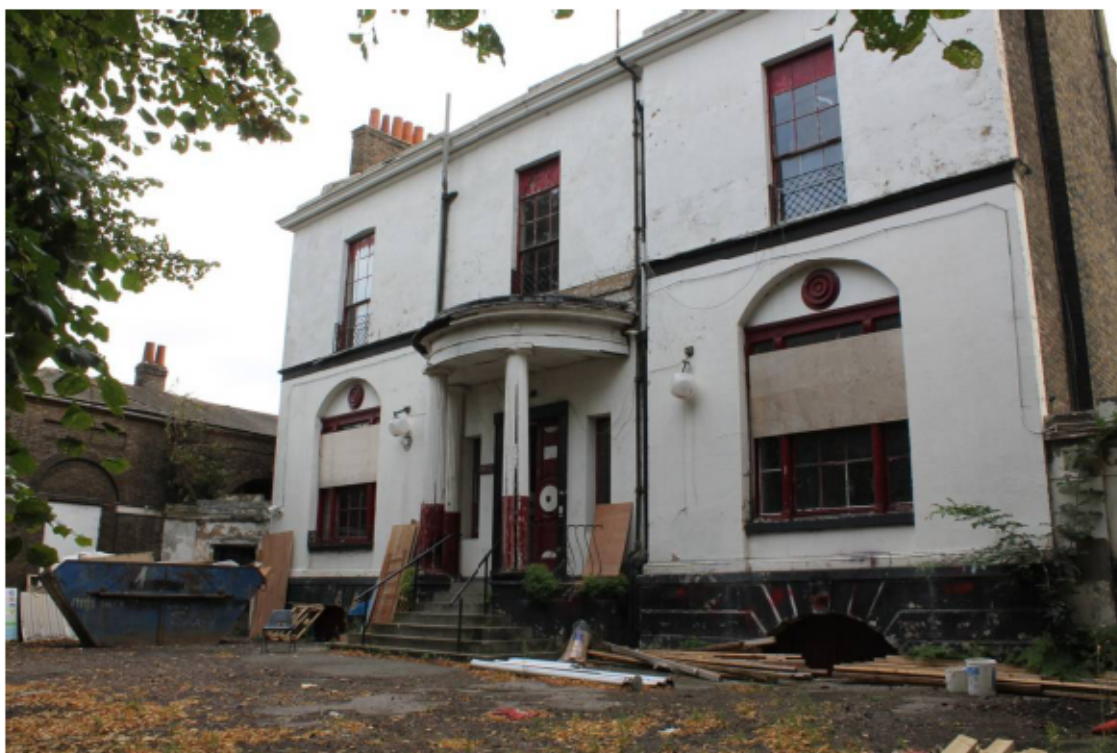
**Plate 1** Pond House west facing principal elevation, looking north-east

- 6.2.1 Pond House is an early 19<sup>th</sup> century 'double fronted' later Georgian Villa built over two-storeys plus basement and attic storeys (**Plates 1 and 2**). The principal facade facing Lower Clapton Road is symmetrical in form and laid out over three roughly equal sized bays with a slightly recessed central bay. The principal entrance is central to the facade and is sheltered below a raised semi-circular tetra-style portico with fluted Doric columns and an entablature with Bucranium motifs. The house has a stucco frontage, which rises from a rusticated basement storey with large lunette windows. A plain parapet with stone copings, above a modest cornice over the first floor windows, partly obscures three flat dormer windows in the attic storey and a low slate covered double pile Mansard roof. The house is flanked by ornate concave quadrant walls in stucco plaster which butt up to the stable block (north) and the adjacent terrace (south) respectively. The large tripartite windows of the ground floor are set below arched tympanum each containing a single patera. The first floor windows are simpler with tall sashes and a blind upper light. The rear, garden elevation is much plainer and dominated by a central full height bow fronted bay and a single storey, full width, modern extension.

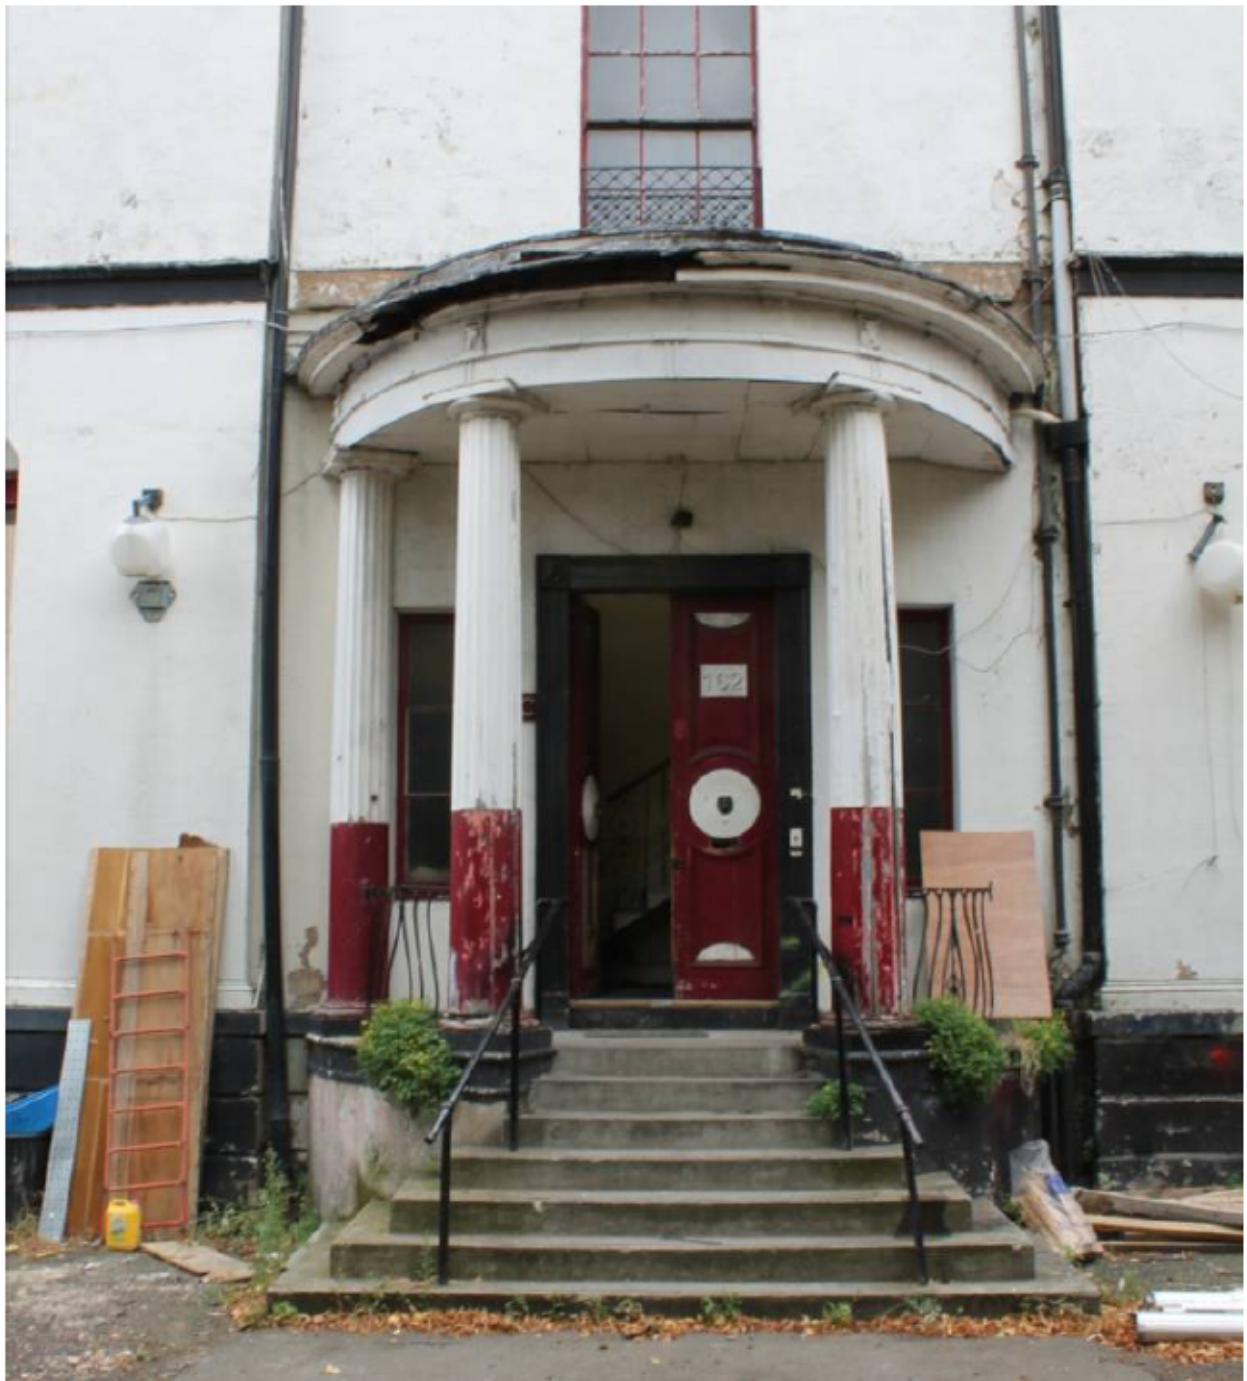
- 6.3.3 Central to the facade is a raised, semi-circular tetra-style portico with fluted Doric columns and an entablature with Bucranium motifs (**Plate 4**). The portico, reached by a flight of modern steps with simple handrails (replacing a more elegant semi-circular flight of steps), retains many original features, including ornate balustrades and fluted Doric columns with simple capitals and bases and an entablature of timber

construction. It has however lost the southernmost column of the circuit, but all four square Portland stone plinths on which the columns rest, remain. The floor of the portico is stone flagged, with rounded, over-sailing edges. The entablature has Bucranium (ox-head) motifs set above each pillar and an over-sailing flat canopy above. The principal entrance doorway is flanked by a pair of narrow sidelights (with replacement obscure glazing) and is surrounded by an ornate moulded architrave with raised lion head decoration on each of the upper angles (**Plate 45i**). The main door has two leafs with recessed shaped panels with lunette designs. Each leaf has a central moulded patera with a brass lion head door knocker (**Plate 5**); both are now missing their striking rings.

**Plate 4** Raised tetra-style portico in the principal (west) elevation, looking east

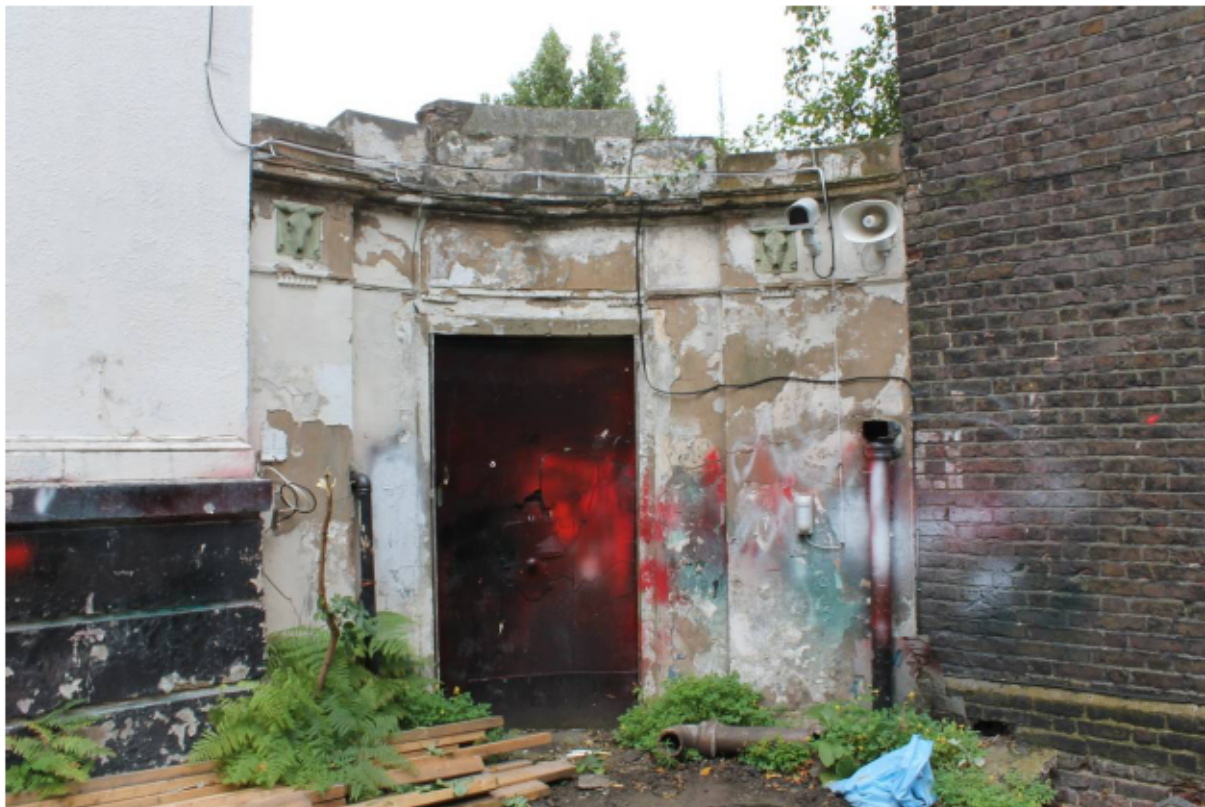
**Plate 6** South quadrant wall, looking south-east

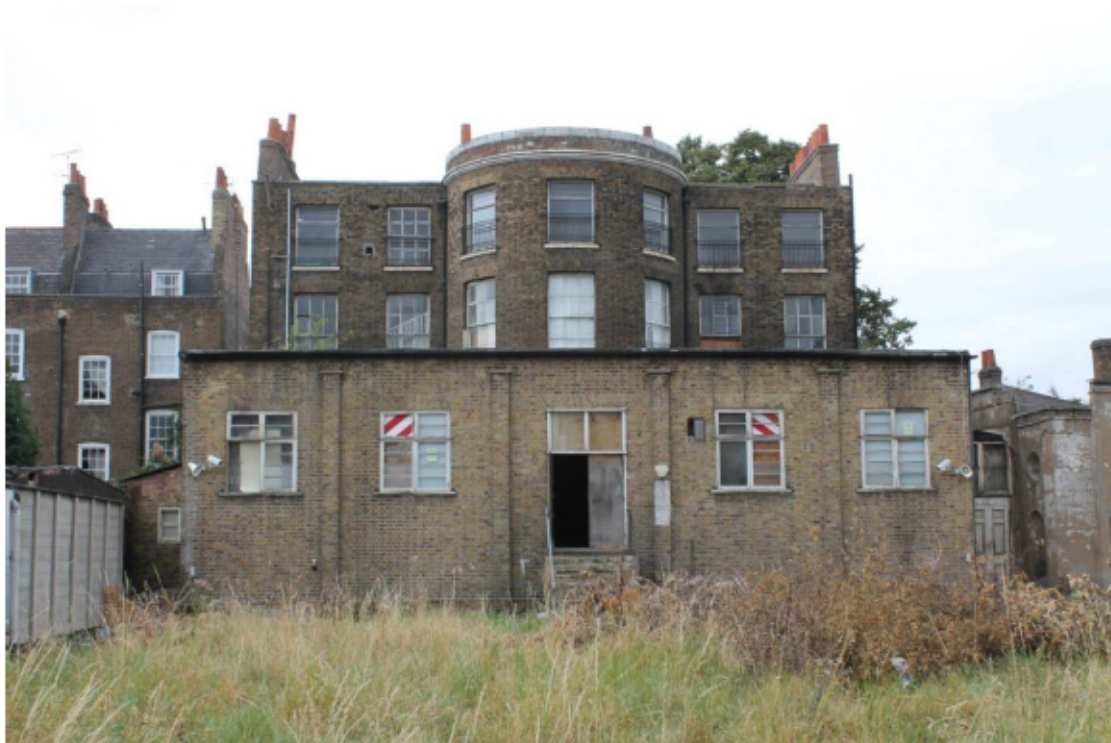
**Plate 7** Rear (east) elevations, looking west

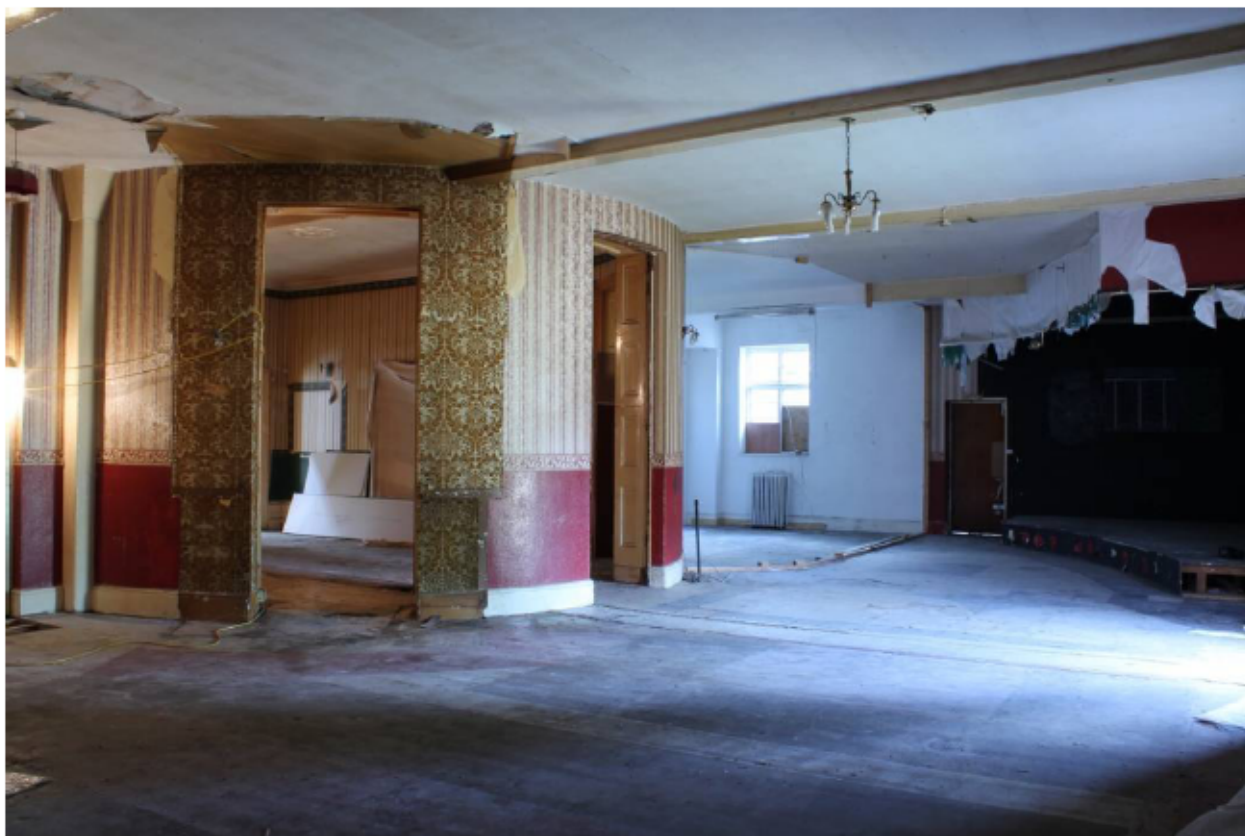
**Plate 17** Extension (G5) enclosing bow fronted rear bay, looking north-west

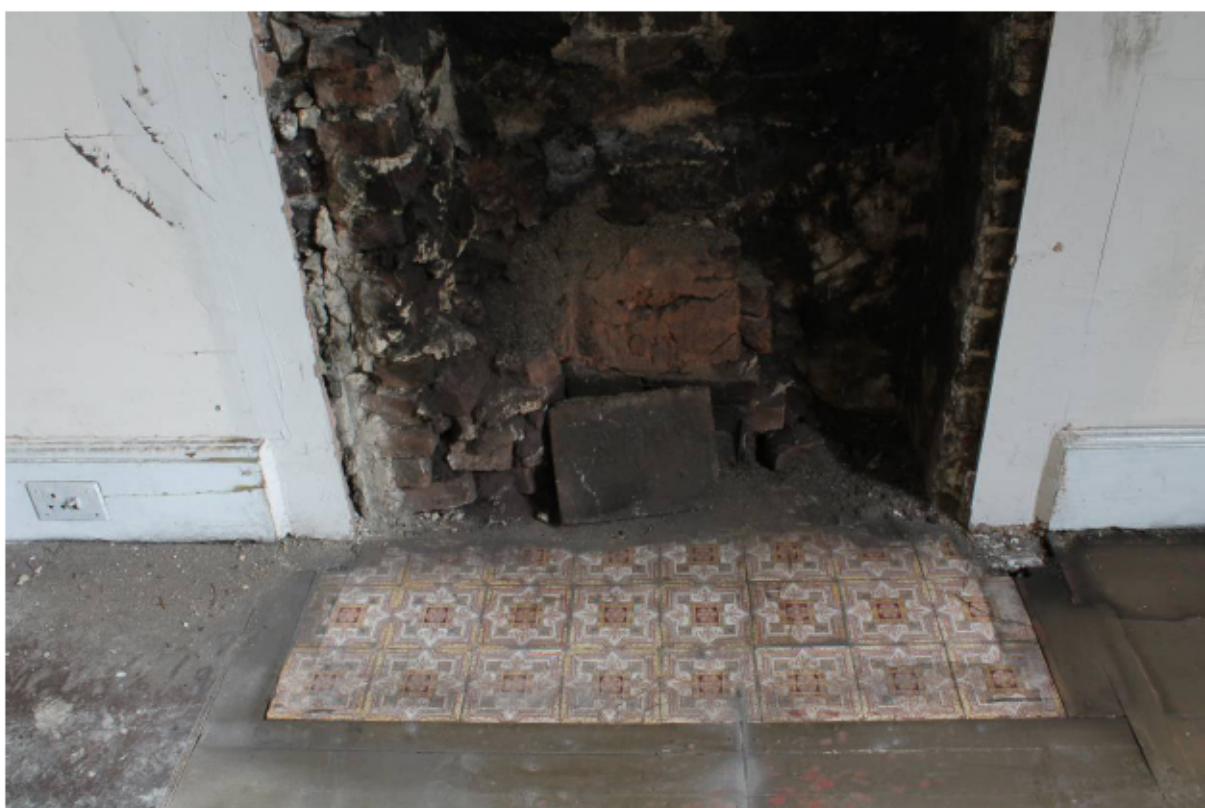
**Plate 26** Tiled hearth in Bedroom (F8), looking south-west

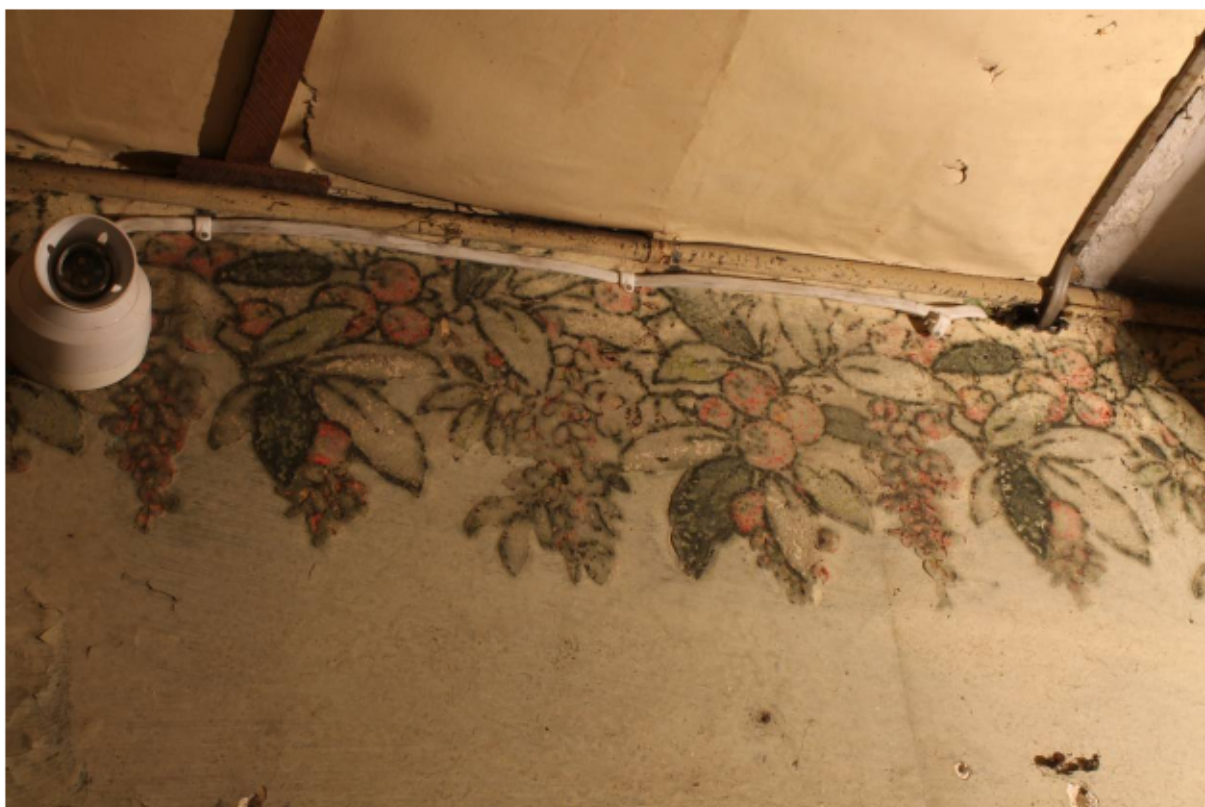
**Plate 40** Decorative frieze in (B18), looking north-east

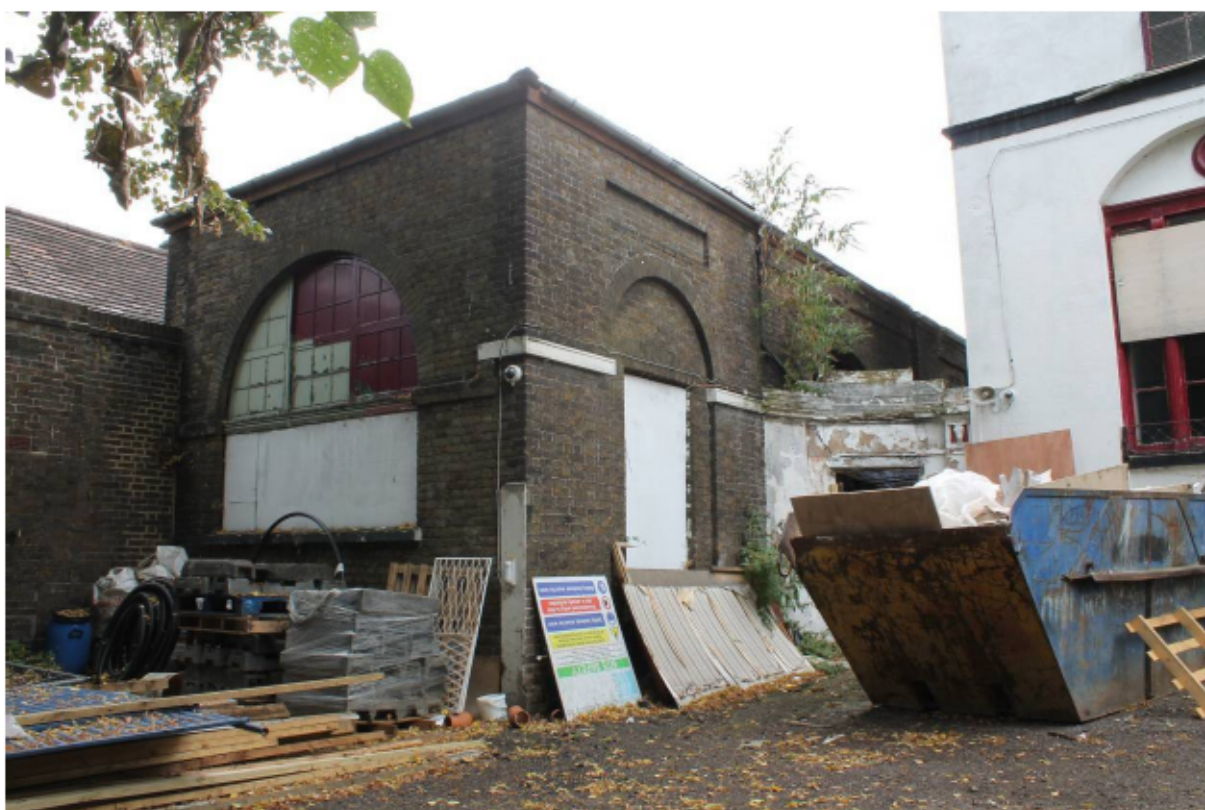
**Plate 41** Stable/Coach House, looking north-east

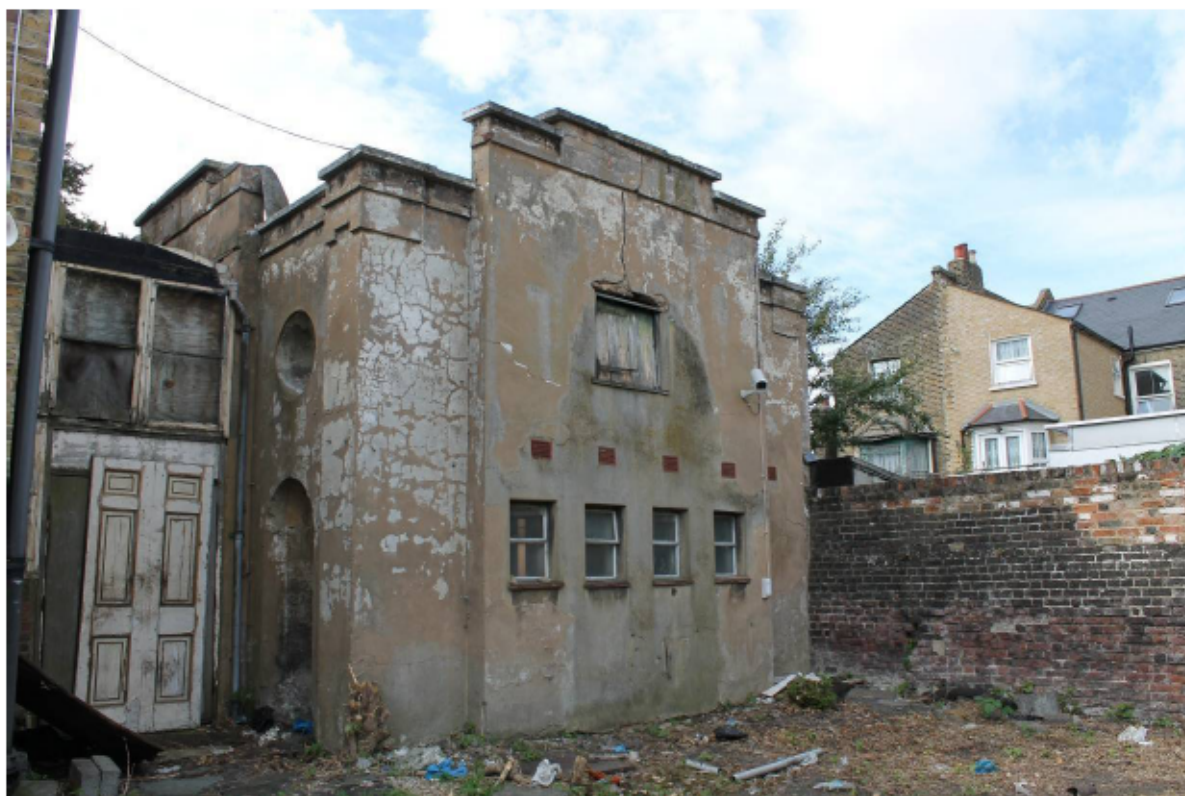
**Plate 42** East end of the Billiard Room, looking north-west

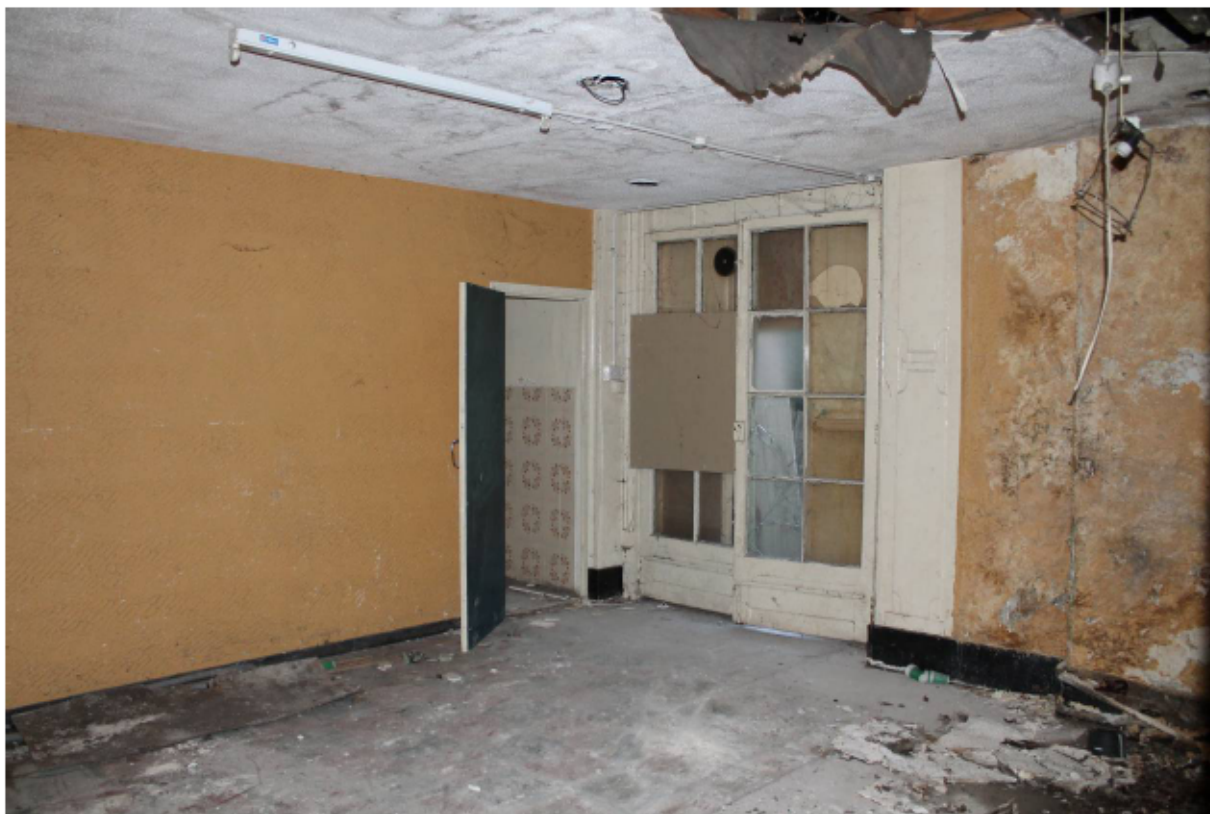
- 7.4.2 The two leaf southern garden door, only partially viewed internally prior to the removal of the modern ceiling (**Plate 44**), is a particularly ornate and well preserved original feature. It is a two leaf door of 8 lights, using fine glazing bars with a lambs tongue detail. The two doors sit below a fixed glazed panel of 5 lights which in turn are below the top rail of the architrave. Above the architrave is an ornate half round fan-light with fine radiating glazing bars. The door architrave is deeply moulded with shafts rising from a plinth to a squared flush panel at the upper angle (similar to the architraves to the stone hall, but without the lions head detail). The architrave, which continues above the fan light using the same moulded detail, survived mainly intact, though part of the eastern architrave had been removed following the addition of the modern toilets.

**Plate 44** Billiard Room (23), looking south-east

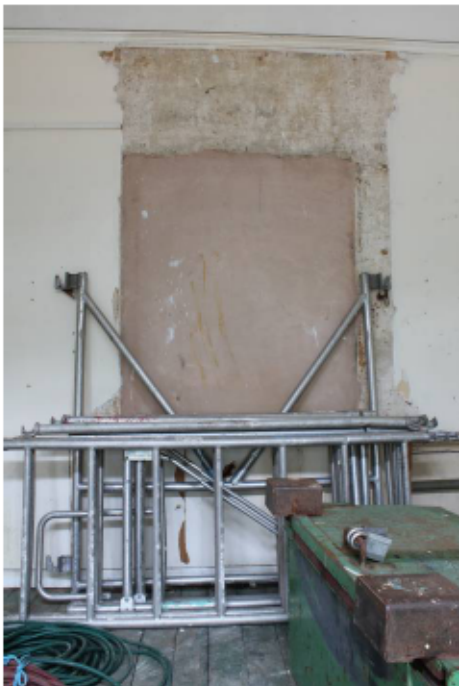
removed), probably from the adjacent fireplace, was relocated there after the door was blocked (**Plate 47xii**).

xii) Blocked door and overmantle scar (G2)

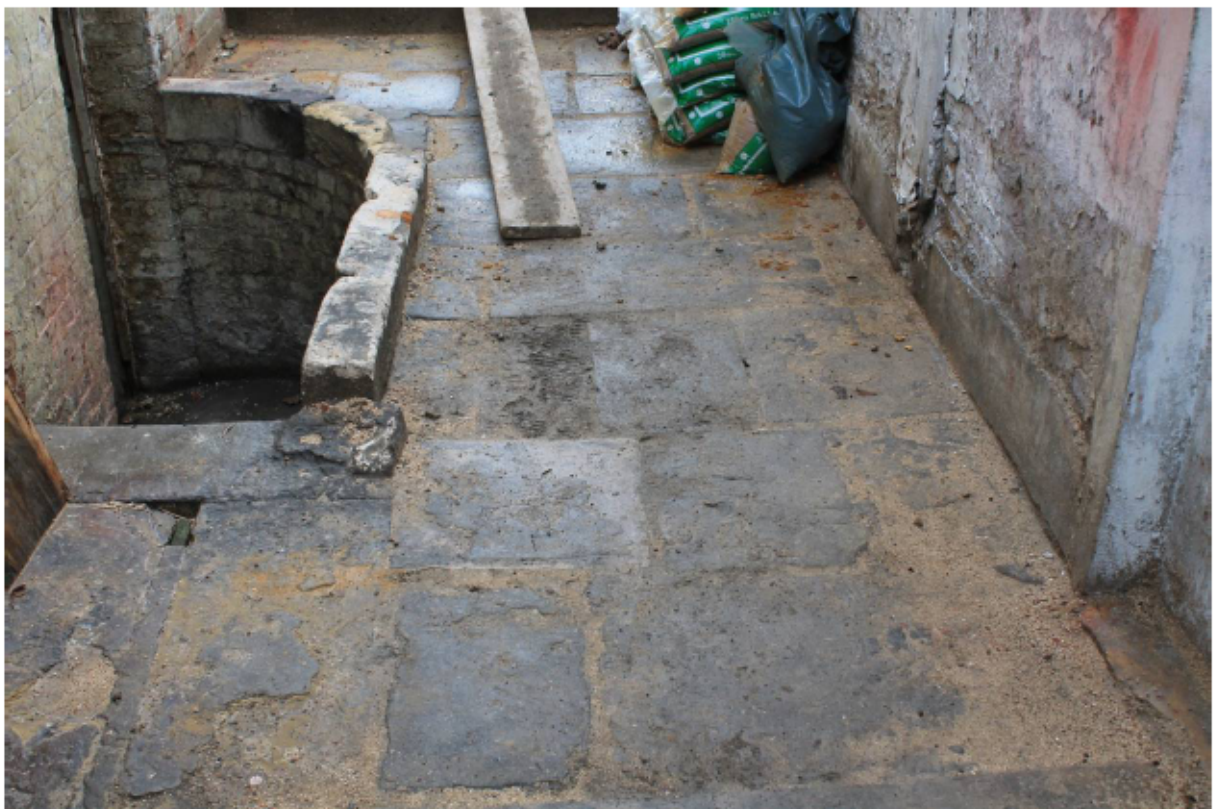
- 7.3.1 The surface within the area adjacent to the south elevation was paved with large stone flags laid in a random course using irregular sized flags (**Plate 51**). The flags probably originally extended along the full width of the main house (side wall) but the eastern end had been removed following the construction of the toilet block serving the club house extension. At present the stone surface extends c.1m to the east of the short flight of stone steps into the kitchen (B16). These steps were retained within a well which terminated with an elegant curve (echoing the theme of the quadrant wall) to the east of the basement door. The stair well is edged with a stone coping (0.16m wide) that sits proud of the stone flags and includes empty rebates, coinciding rebates in the opposite wall show that the well was formerly enclosed by a handrail or short balustrade.

**Plate 51** Stone flag floor surface in Southern Quadrant, looking east

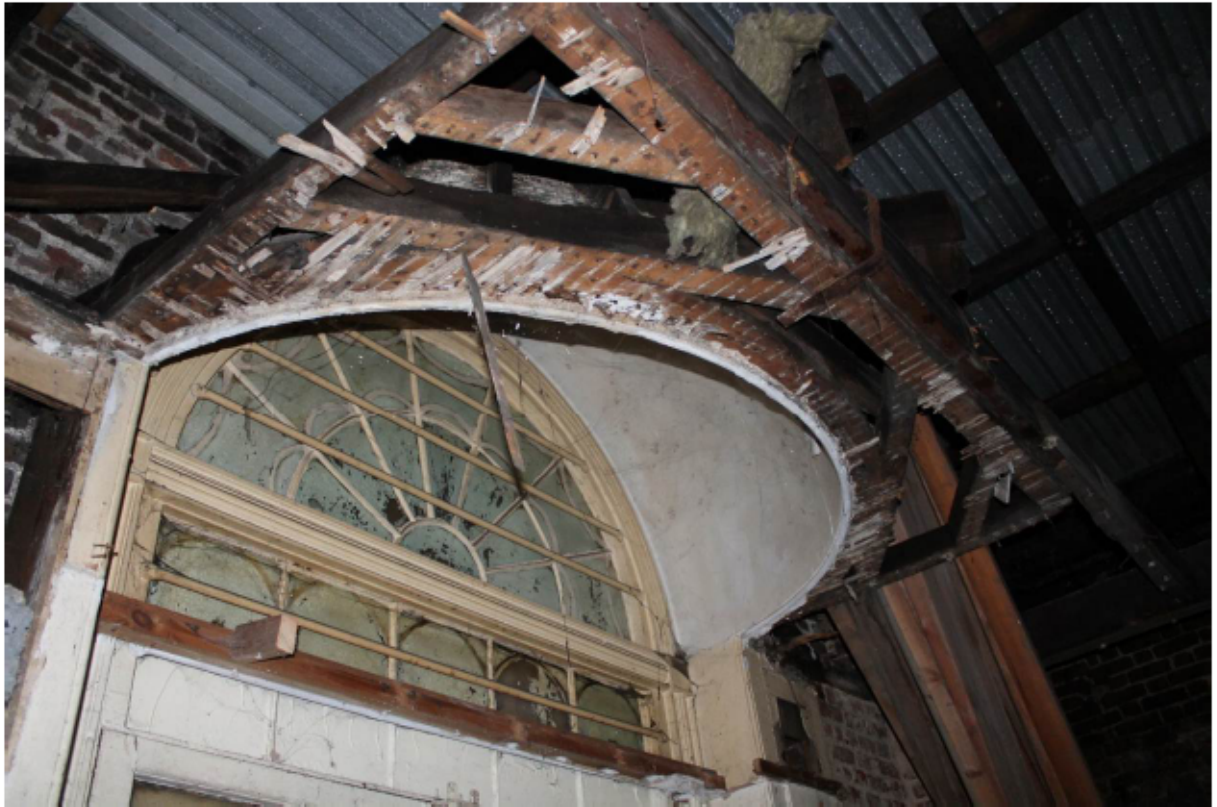
wall plates on the flank walls and corner braces or dragon beams bracing the north and south-eastern corners. Most significant was the survival of the supporting form structure and the original plaster dome built to the rear of the glazed fanlight over the principal garden door in the southern wall (**Plate 52**). The dome is clearly a substantial structure which is supported on its own framework, tied into the main bridging beams. The dome is original to the building and was constructed using laths nailed to a frame or form comprising shaped and curving timber battens. It clearly protruded above the level of the ceiling to provide additional light to the entrance and into the billiard room. This feature was retained in the last scheme.

**Plate 52** Fan light and dome structure in Billiard Room (G23), looking south-west

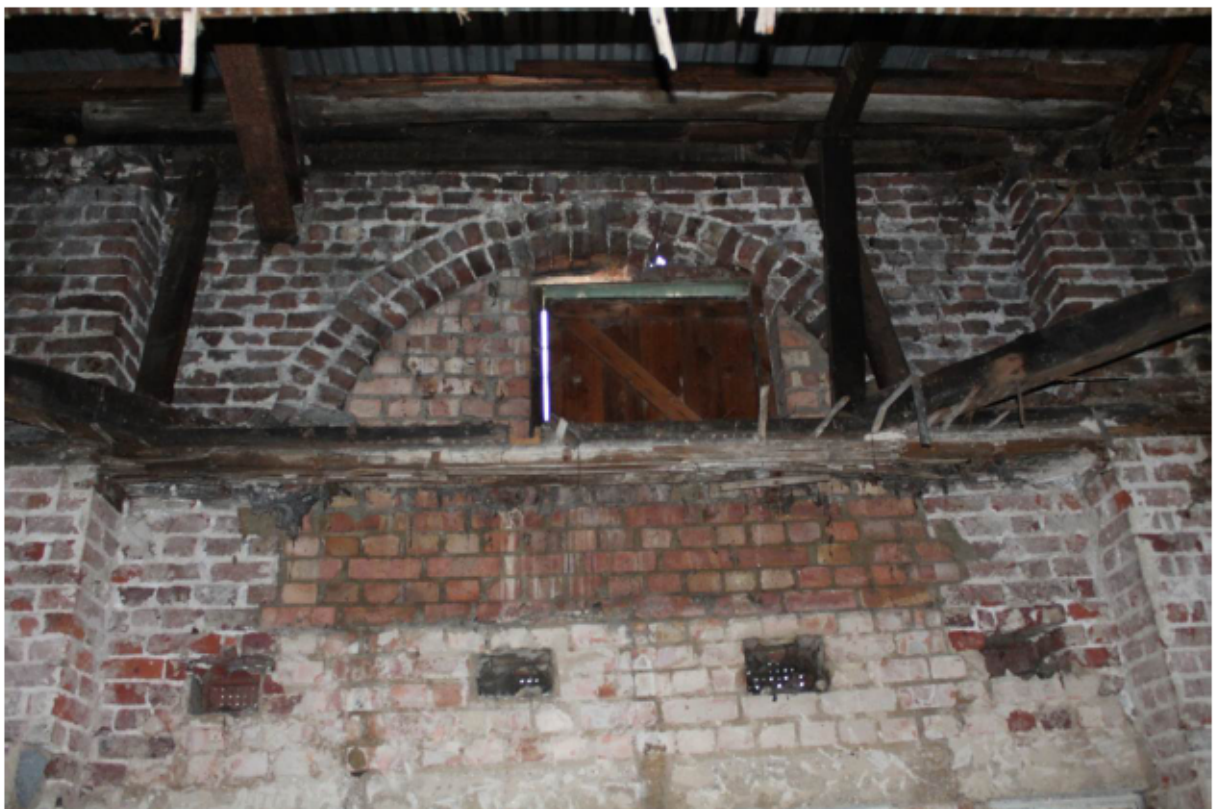
- 7.4.3 A blocked former arched door opening (1.95m wide) lies in the centre of the eastern wall. It was built with a half round arched head of two on-edge courses of brick and was blocked, when the former toilets were added, using modern Fenton brickwork (**Plate 53**). This blocking extended from the arch to the floor level and was interrupted by a later off-centre hatch door, added to gain access to a loft area above the ceiling structure. Given its relationship with the ceiling level, it is possible that this door opening also incorporated an internal dome, similar to the door in the adjacent, southern wall. As part of the renovation works this door opening was re-established and now forms one of two original door openings into the former billiard room (**Plate 59**).

**Plate 53** Blocked arched opening in the east wall of the Billiard Room (G23), looking east

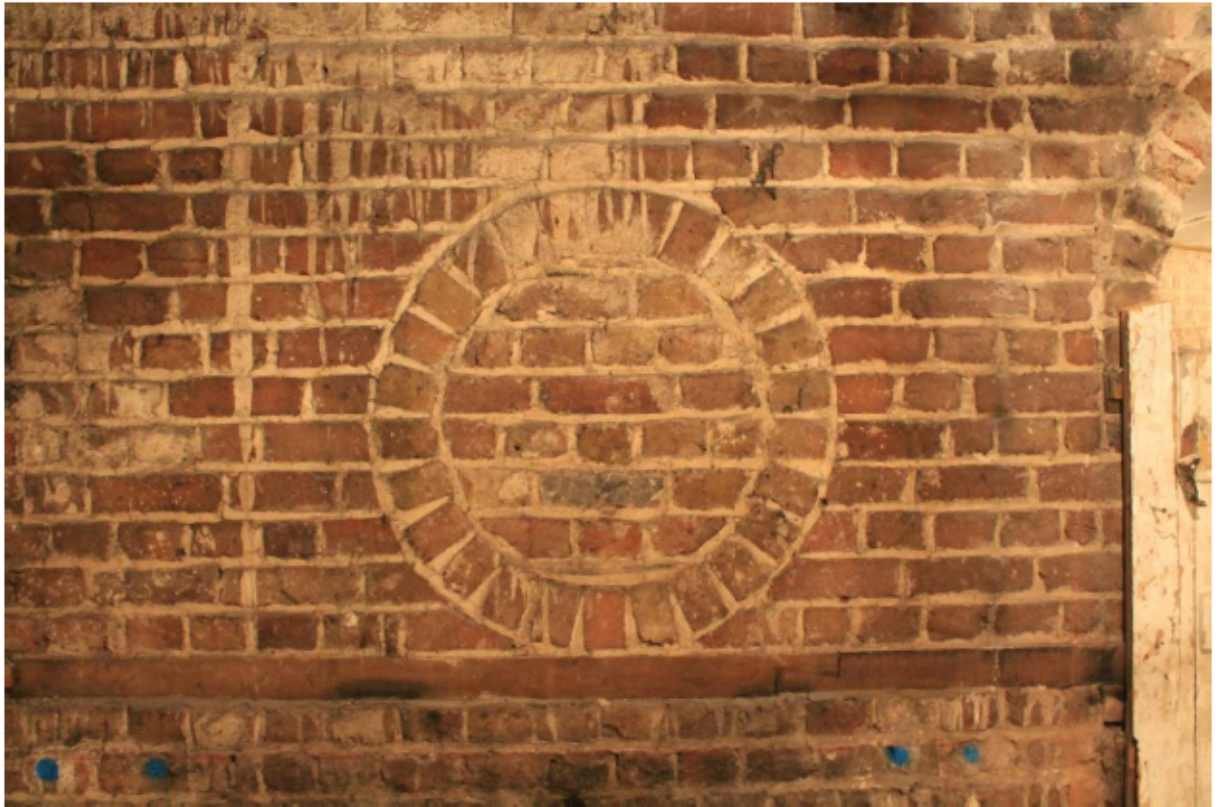
- 7.5.2 Following the removal of the plaster within (B17) it became apparent that the western wall of (B17) was originally interrupted either side of the central door by a pair of circular openings (0.85m diameter) turned in brick with a single on-edge course (**Plate 54**). The brickwork of their blocking was of a similar character to that used in

**Plate 54** One of two blocked circular windows in (B17), looking west

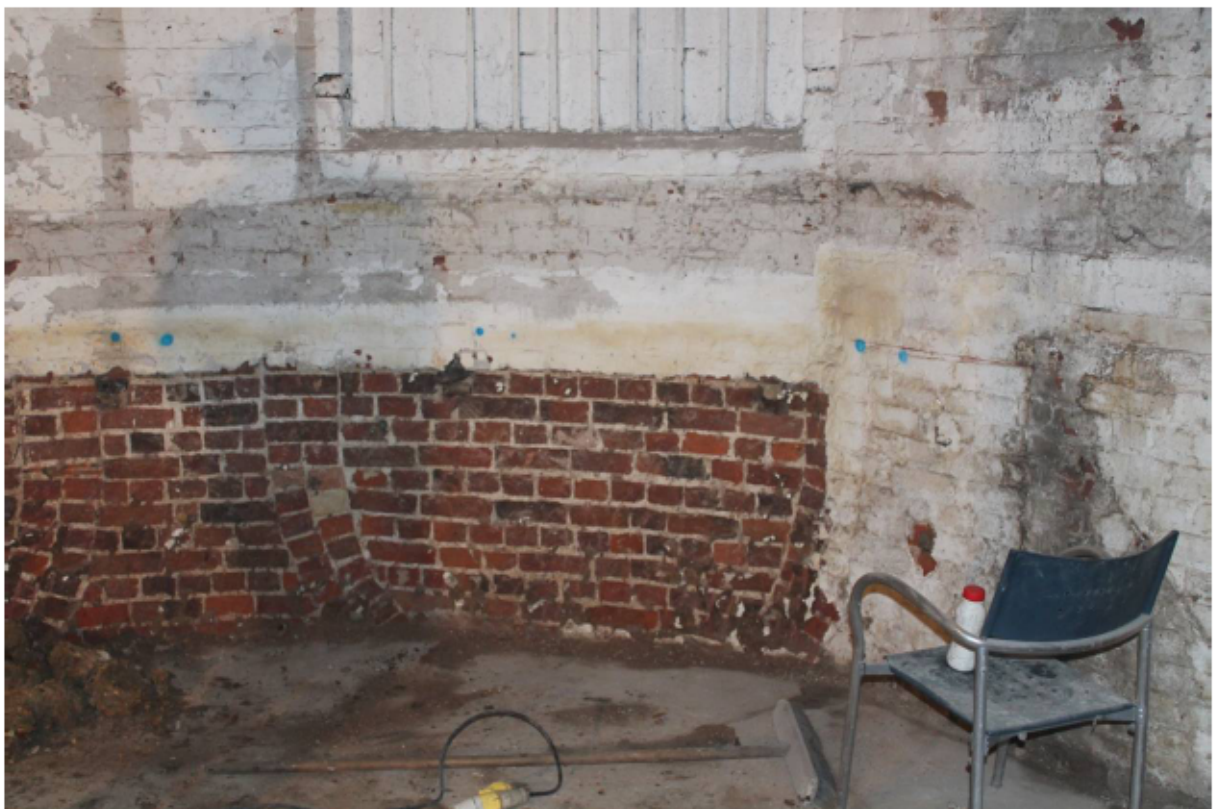
- 7.5.4 The removal of wall plaster also revealed that the basement windows of B17 and B24 were both originally built with a deep reverse arch (1.47m wide) below the window and between the sill and the basement floor (**Plate 55**). The arches were built using two courses of on-edge brickwork. A very similar feature was also present below the large arched headed windows along the west-side frontage, into the kitchen and the later rooms B18 and B19. They also incorporate a brick arch of alternating stretcher and headers.

**Plate 55** Reverse arch of below window in Basement (B17), looking south-east

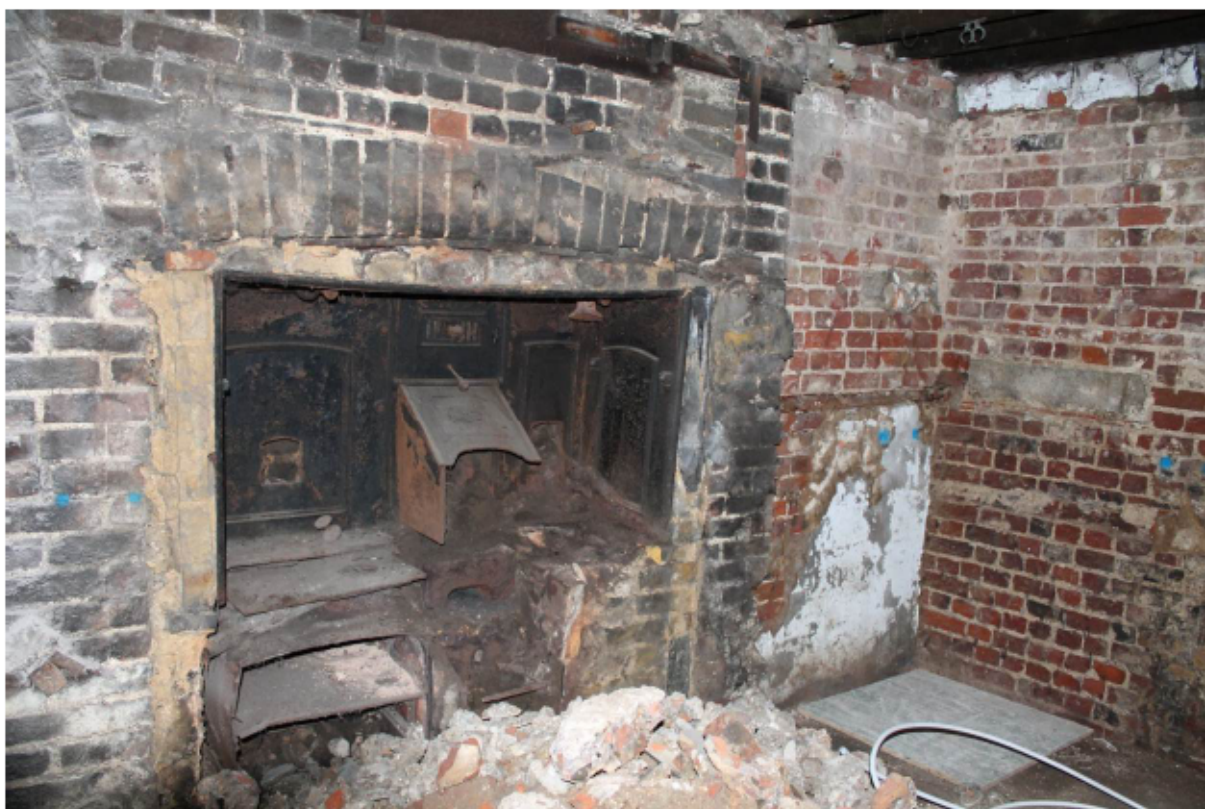
- 7.5.6 The remains of an extant cast-iron kitchen range (**Plate 56**) were revealed in room (B16) following the removal of modern boarded panel in front of the kitchen hearth. The range was inserted into an opening built with a segmental arch head and appeared to be a secondary, later addition, possibly added during the second half of the 19th century.

**Plate 56** Kitchen range (B16), looking south-west

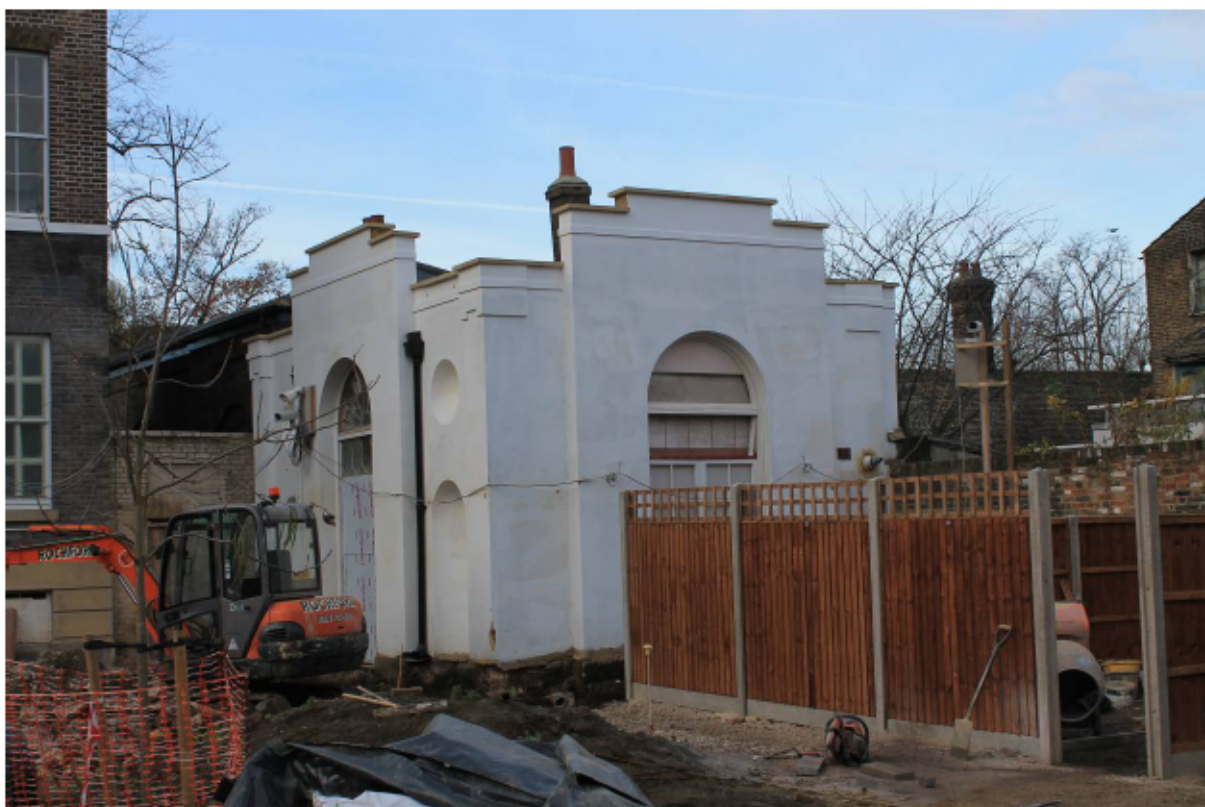
**Plate 59** Re-established door in east wall of former Billiard Room., looking north-west

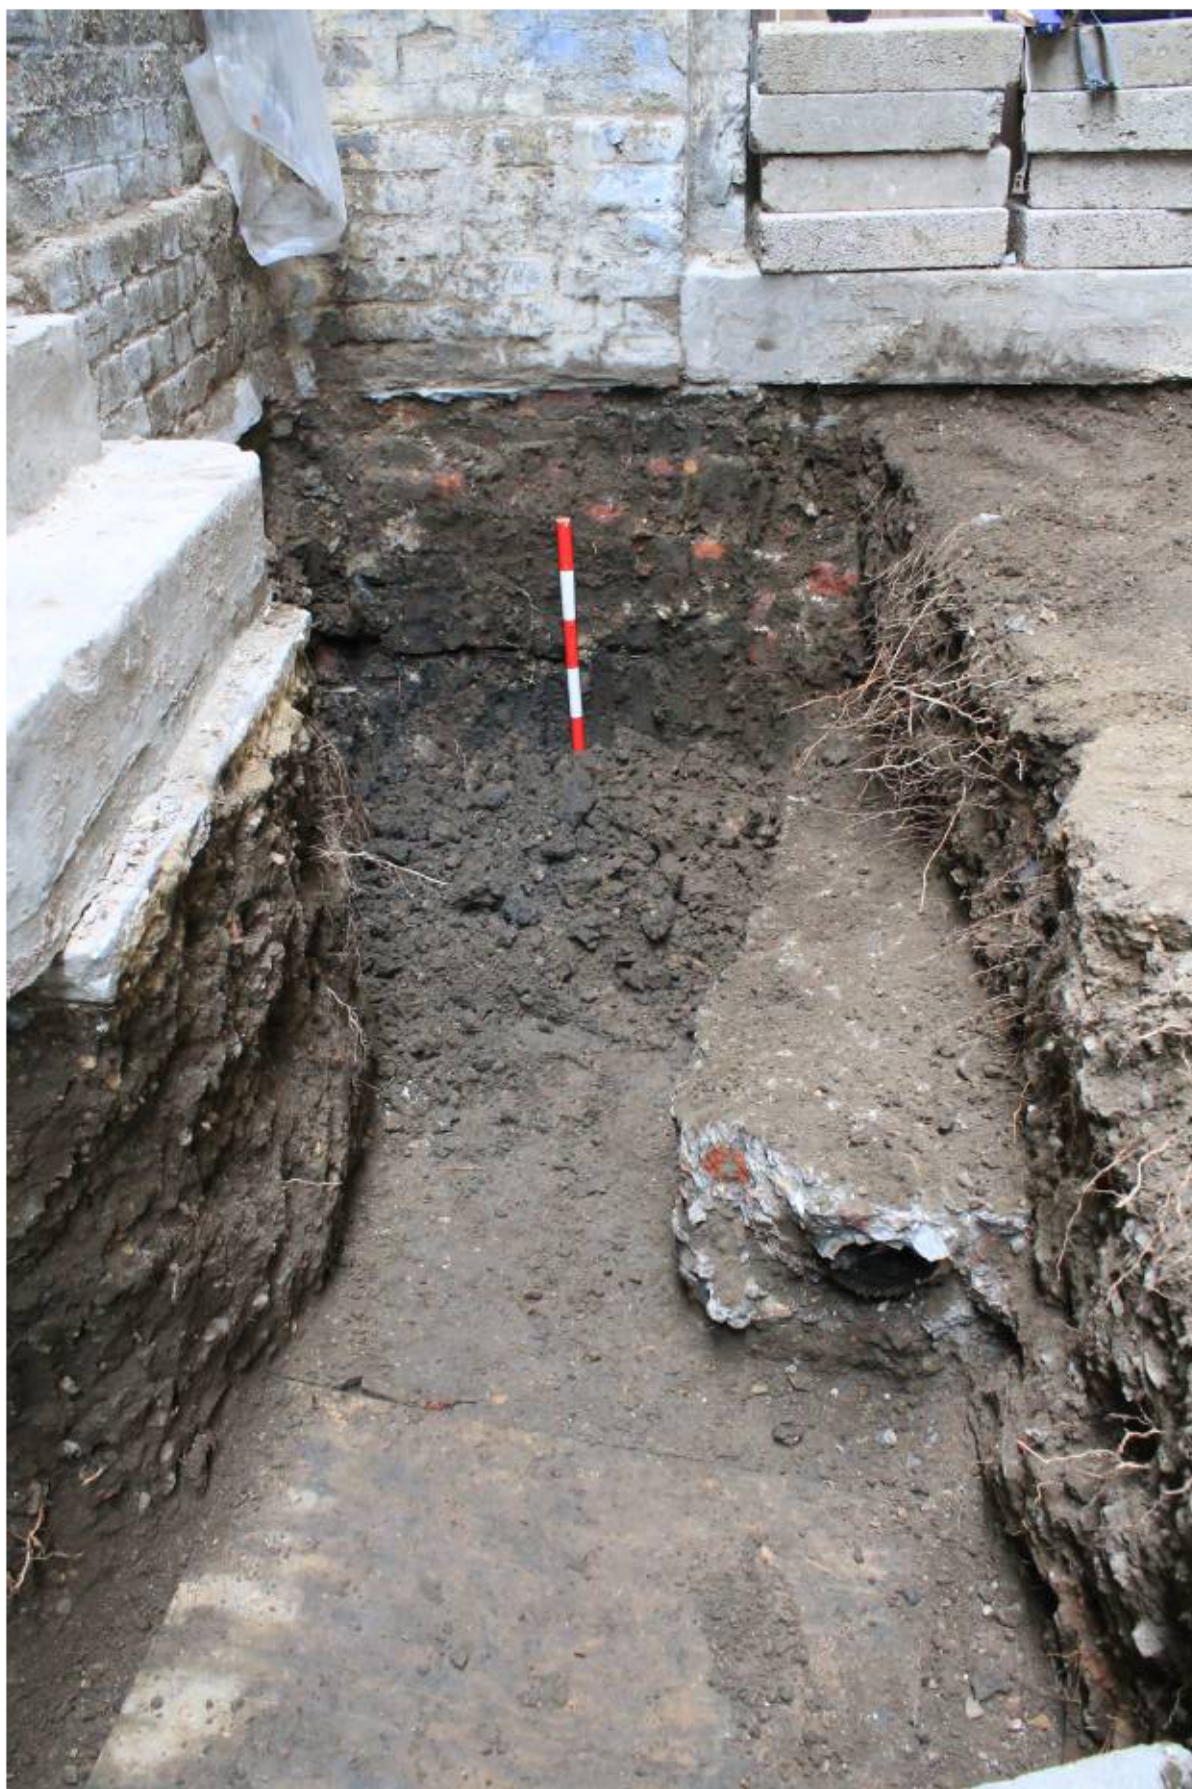
- 7.10.1 The hand excavation of a drainage trench within the area to the north of the north elevation and along the south wall of the stable were monitored on the 6<sup>th</sup> December 2013. The trench measured 1.2m in width and was excavated to a depth of 0.75m below the level of the former yard surface. This revealed a large modern concrete encased sewer, aligned east-north-east to west-south-west extending the length of the trench and a further drain, probably originating from the former toilet block in the billiard room, aligned north-east to south-west and located toward the eastern end of the trench (**Plate 62**). These drainage features had extensively disturbed the ground in this area and no archaeological features associated with a former house were recognised. These works did however reveal the brick footings of the stable which were, in a contemporary sense, quite considerable, built of 8 courses of un-pointed red stock brick and a step-out foundation of a further two courses and possibly more.

**Plate 62** Drainage trench, looking east
