**ARCHAEOLOGICAL
BUILDING RECORDING AND
WATCHING BRIEF OF
THE ROOF LANTERNS AND
LEADED FLAT ROOFS AT
KENSINGTON PALACE,
PALACE AVENUE,
ROYAL BOROUGH OF
KENSINGTON AND
CHELSEA,
W8 4PU**

SITE CODE: KEN29

PCA REPORT NO. R12405

MARCH 2016

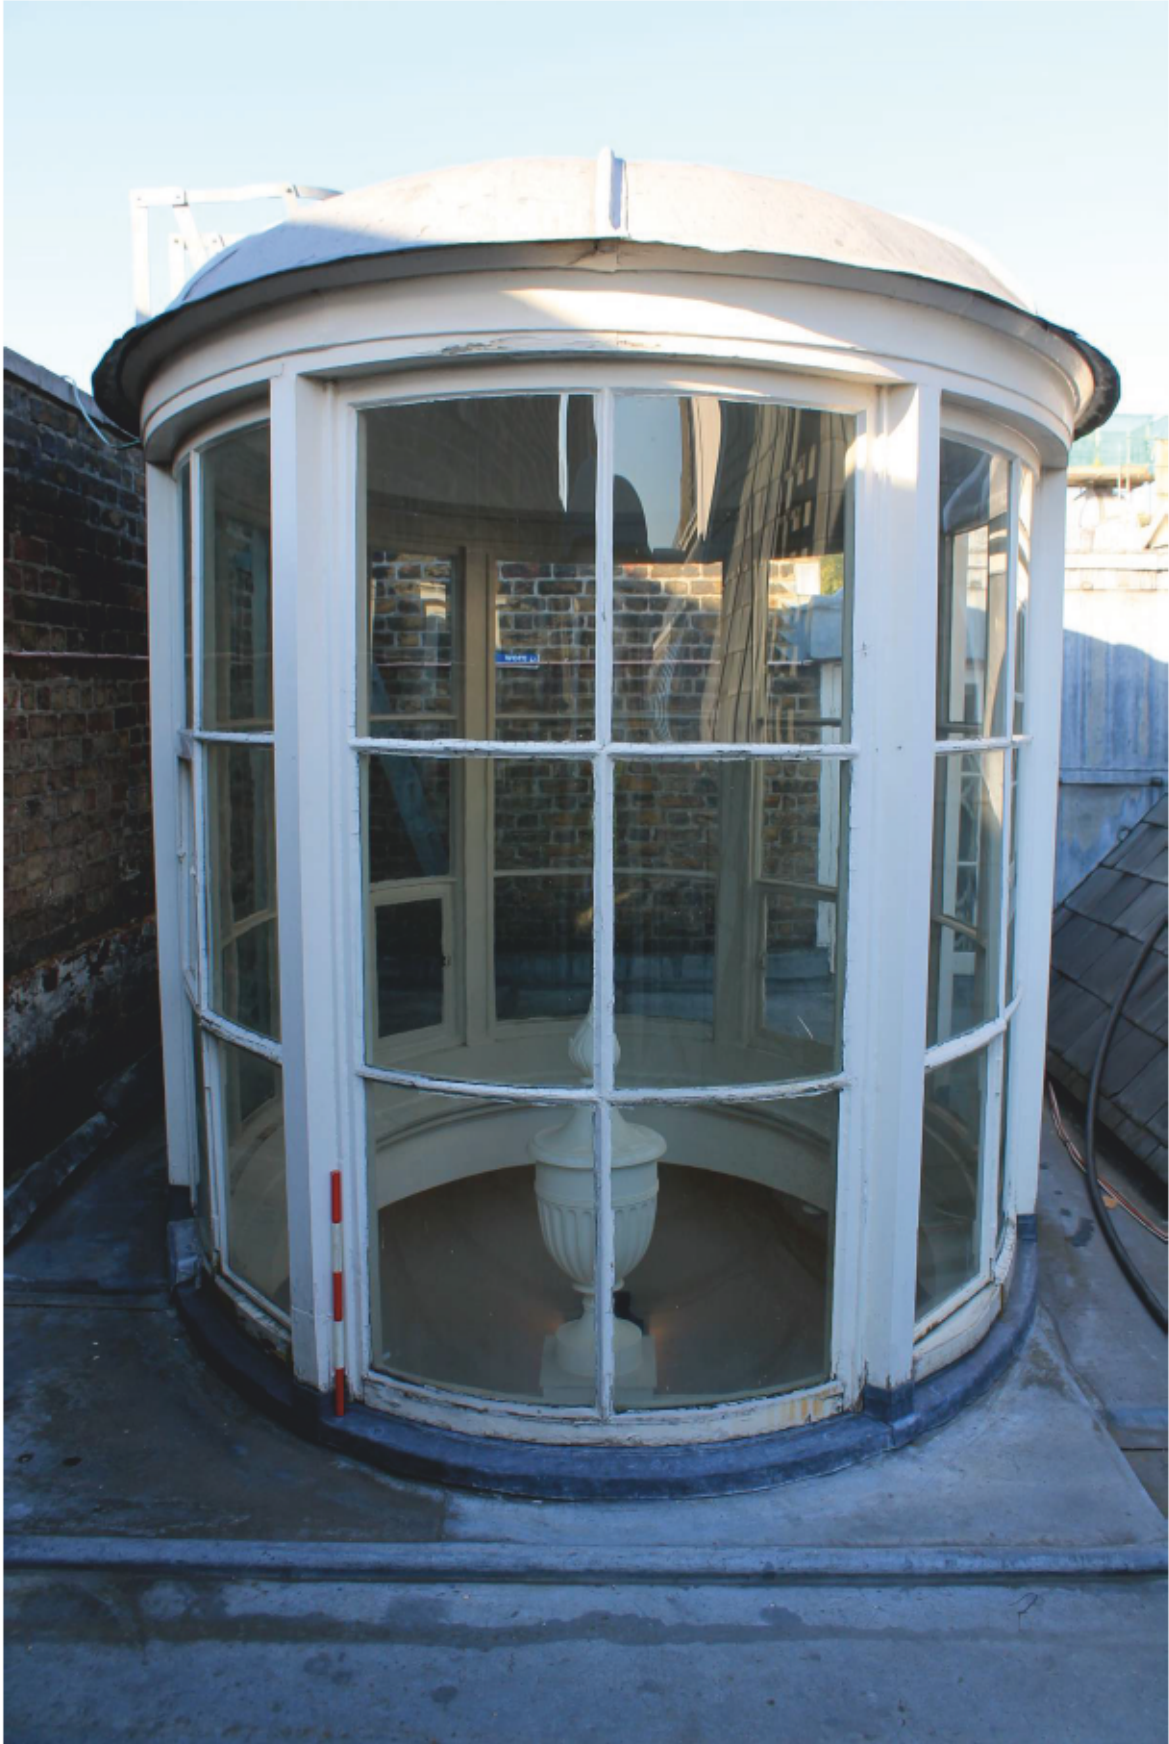
Plate 4 Lantern A looking west

- 5.2.1 External Repair 1: Repair to Sill (Plates 4 and 5): Length of new timber sill extending the full width of the eastern light (c.1020mm). Appears to have been scarfed into the base of the lantern.

- 5.2.2 External Repair 2: ?Repair to entablature (Plate 4): On reflection, whilst this joint was originally thought to be indicative of a repair, it is more likely, given its appearance on all the other lanterns, part of the construction of the band around the top of the window, which is formed from a number of overlapping sections.

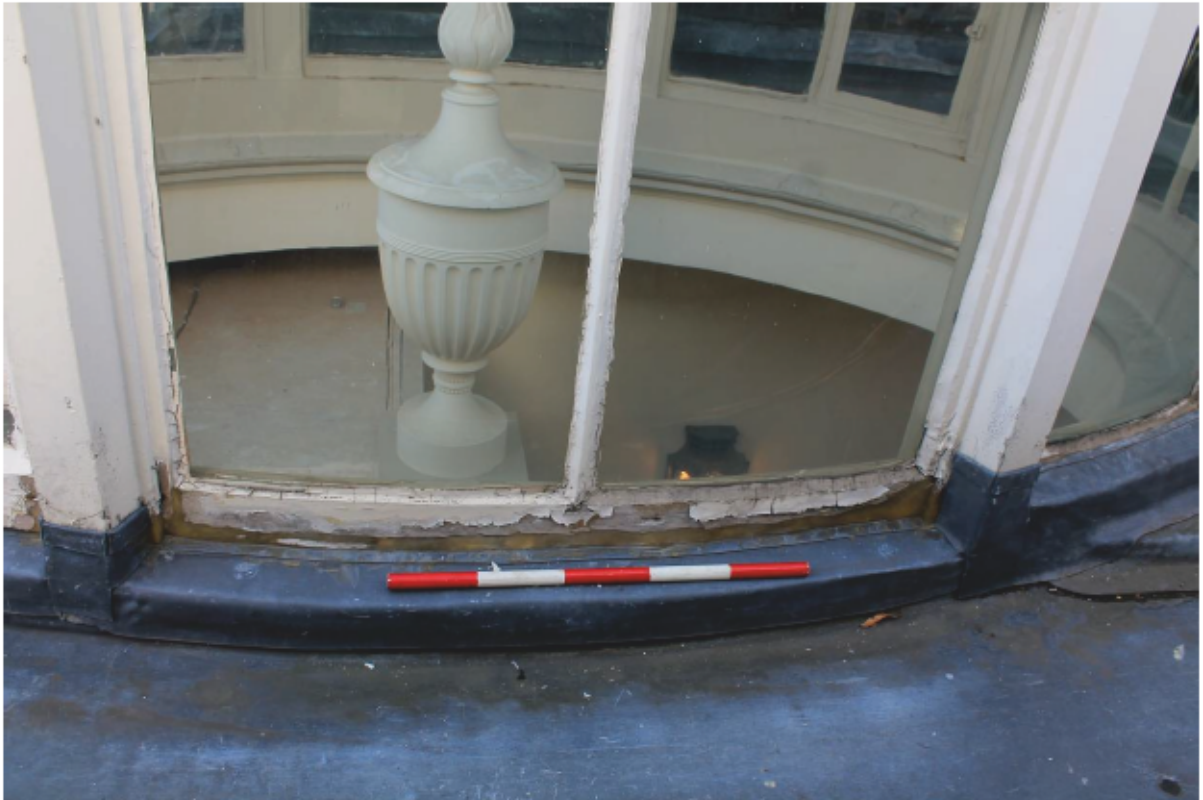
Plate 9 Lantern A: External Repair 6

- 5.2.4 External Repair 4: Repair to sill (Plate 7): Similar insertion of a new section of modern softwood timber sill into the base of the easternmost light. As with (ER3) the inserted sill is much cruder than the original and includes evidence of resin repairs.
- 5.2.5 Casement 5 (Plate 8): Replacement and alteration of glazing bars and insertion of window frame to facilitate introduction of new side hung iron-framed casement window. This also includes the addition of a heavier glazing bar to the top of the casement, which over-sails the window opening to provide a rain drip.
- 5.2.6 External Repair 6: Repair to sill (Plate 9): Resin repair to the sill the window within the central bay/light of the northern elevation, used to consolidate the frame and replace areas of decay within sill.

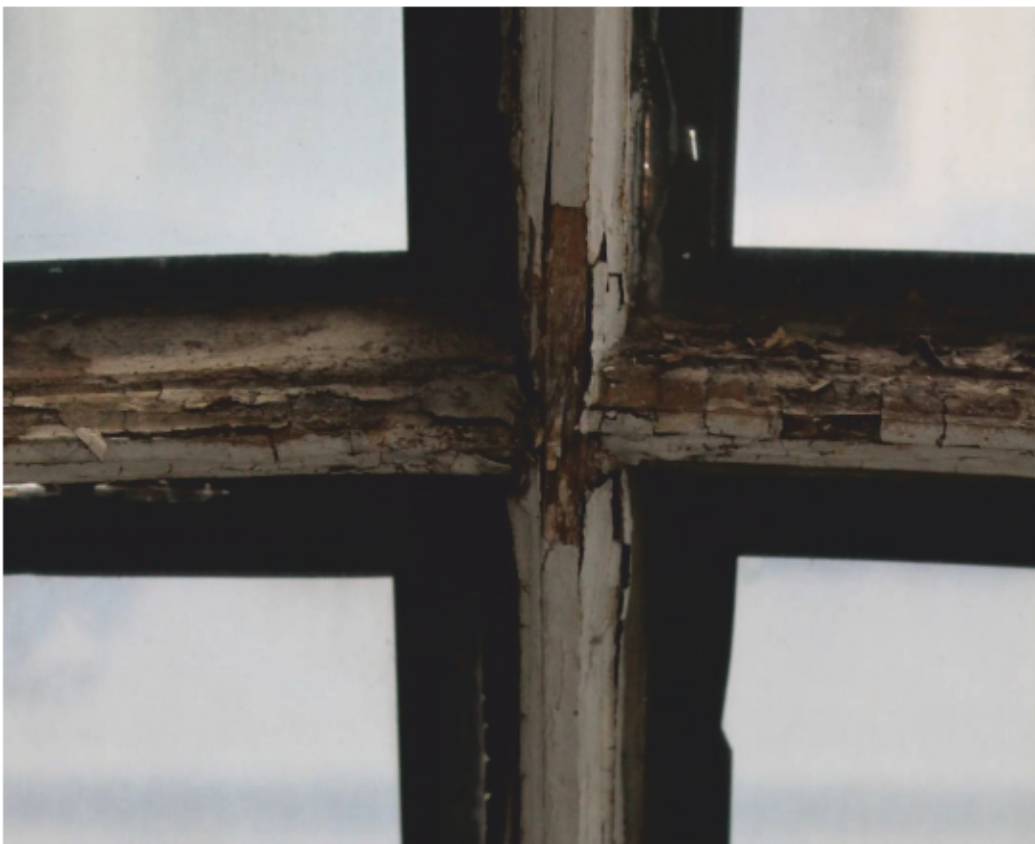
Plate 47 Lantern B: Internal Repair 7

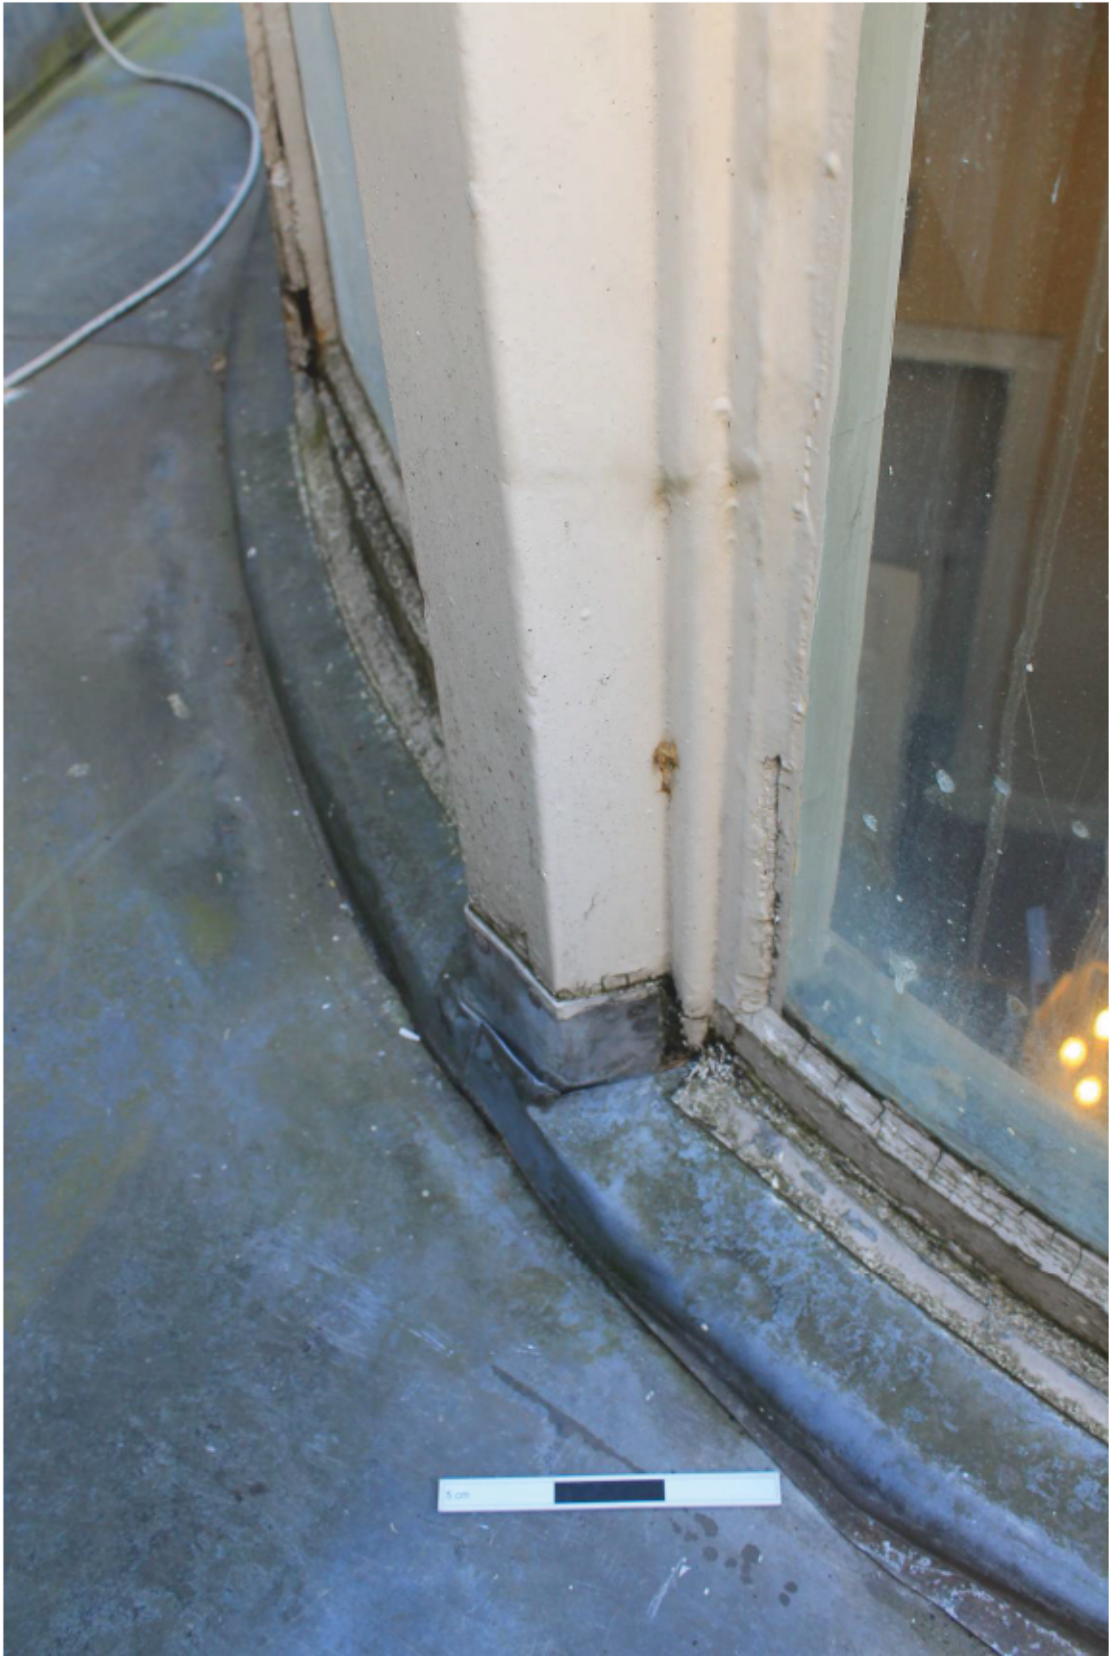
Plate 55 Lantern C: External Repair 29

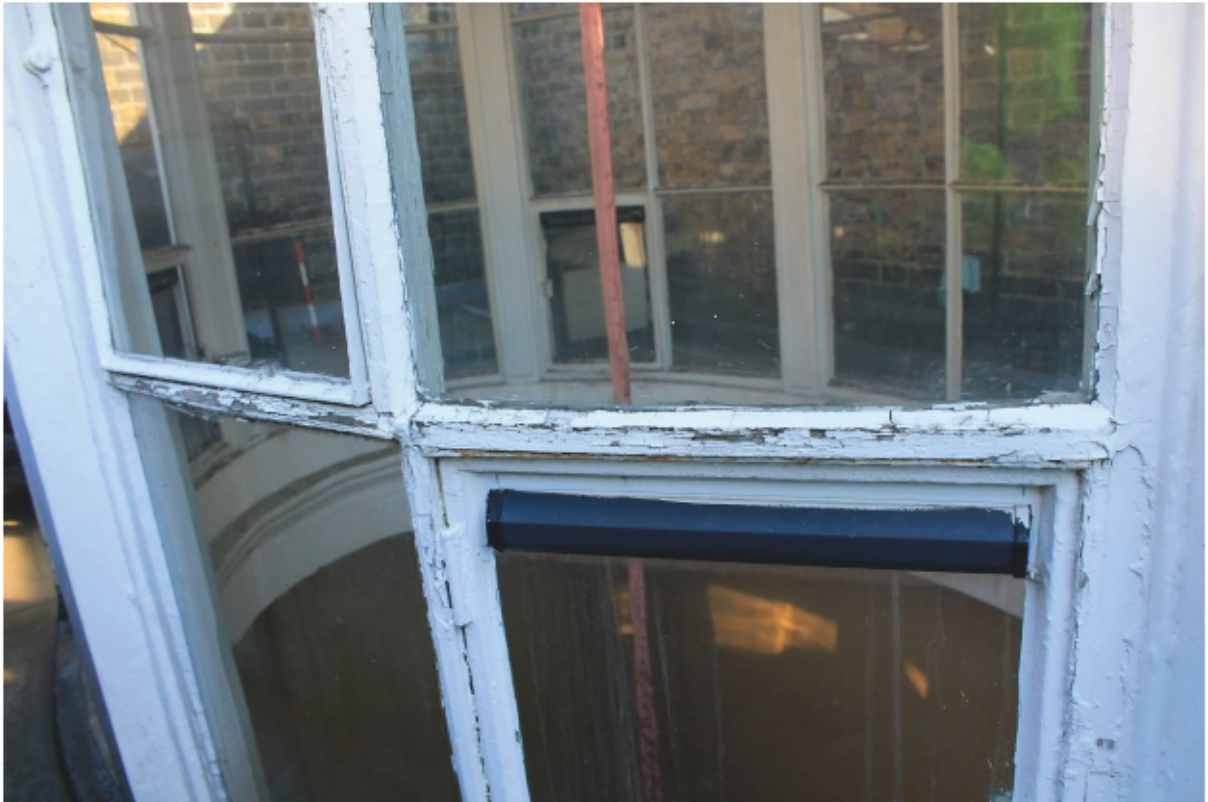
Plate 60 Lantern C: External Repair 34

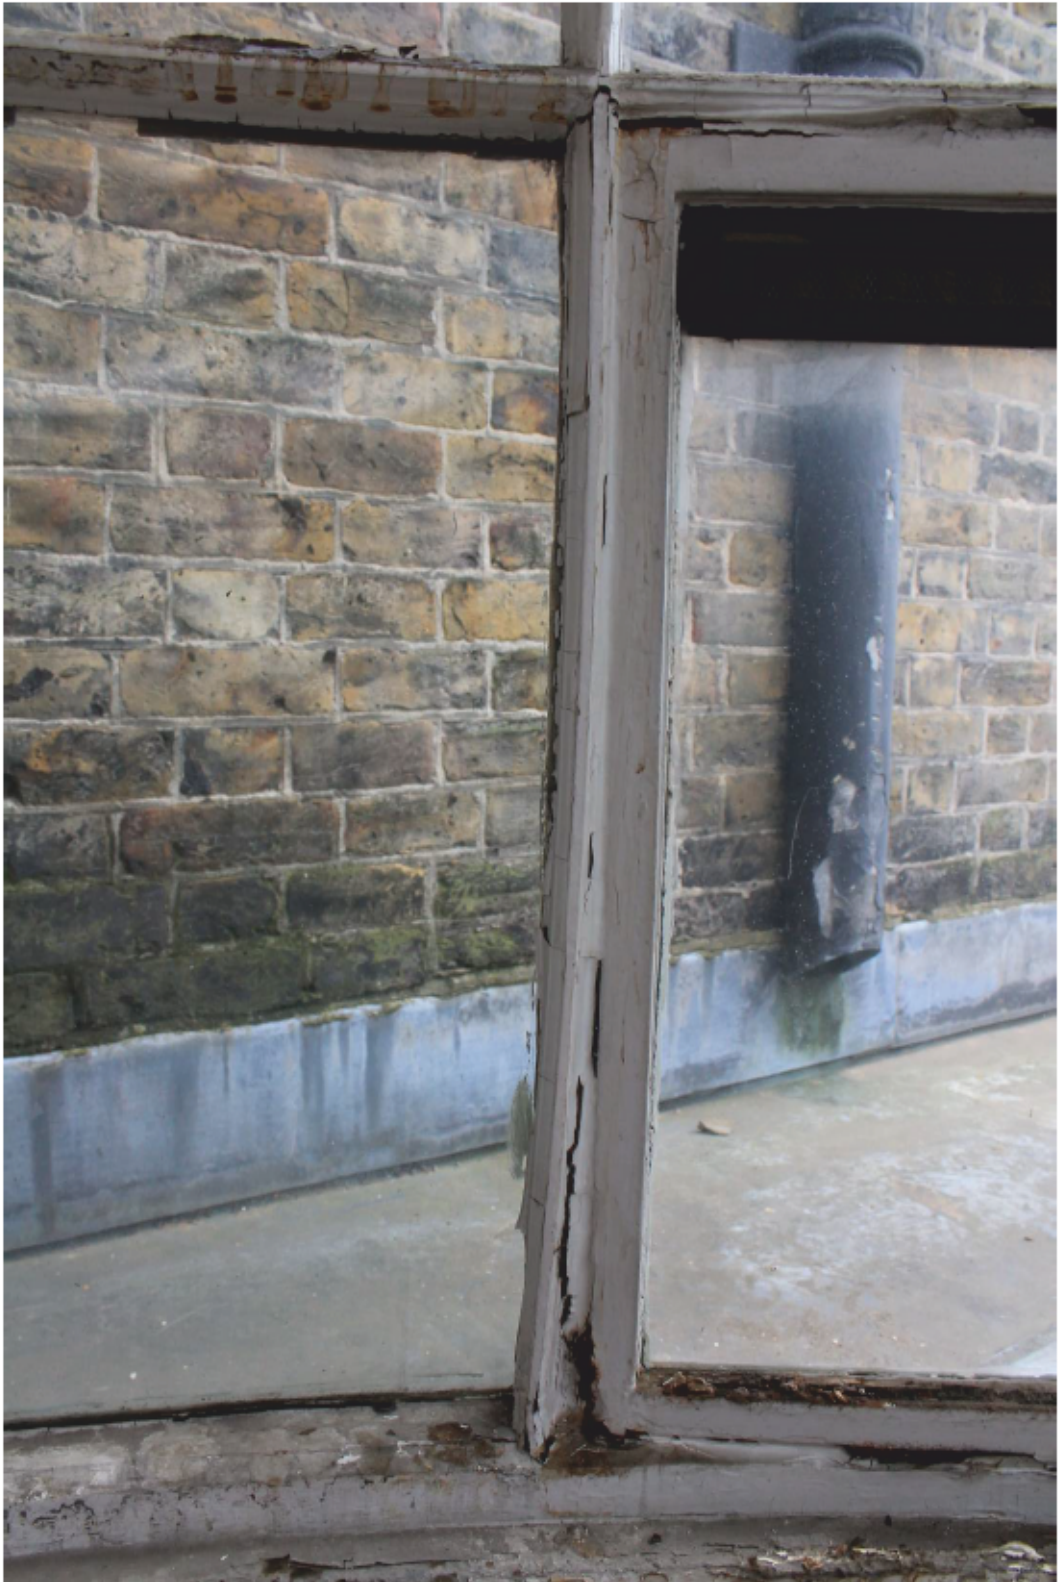
Plate 64 Lantern C: Internal Repair 12

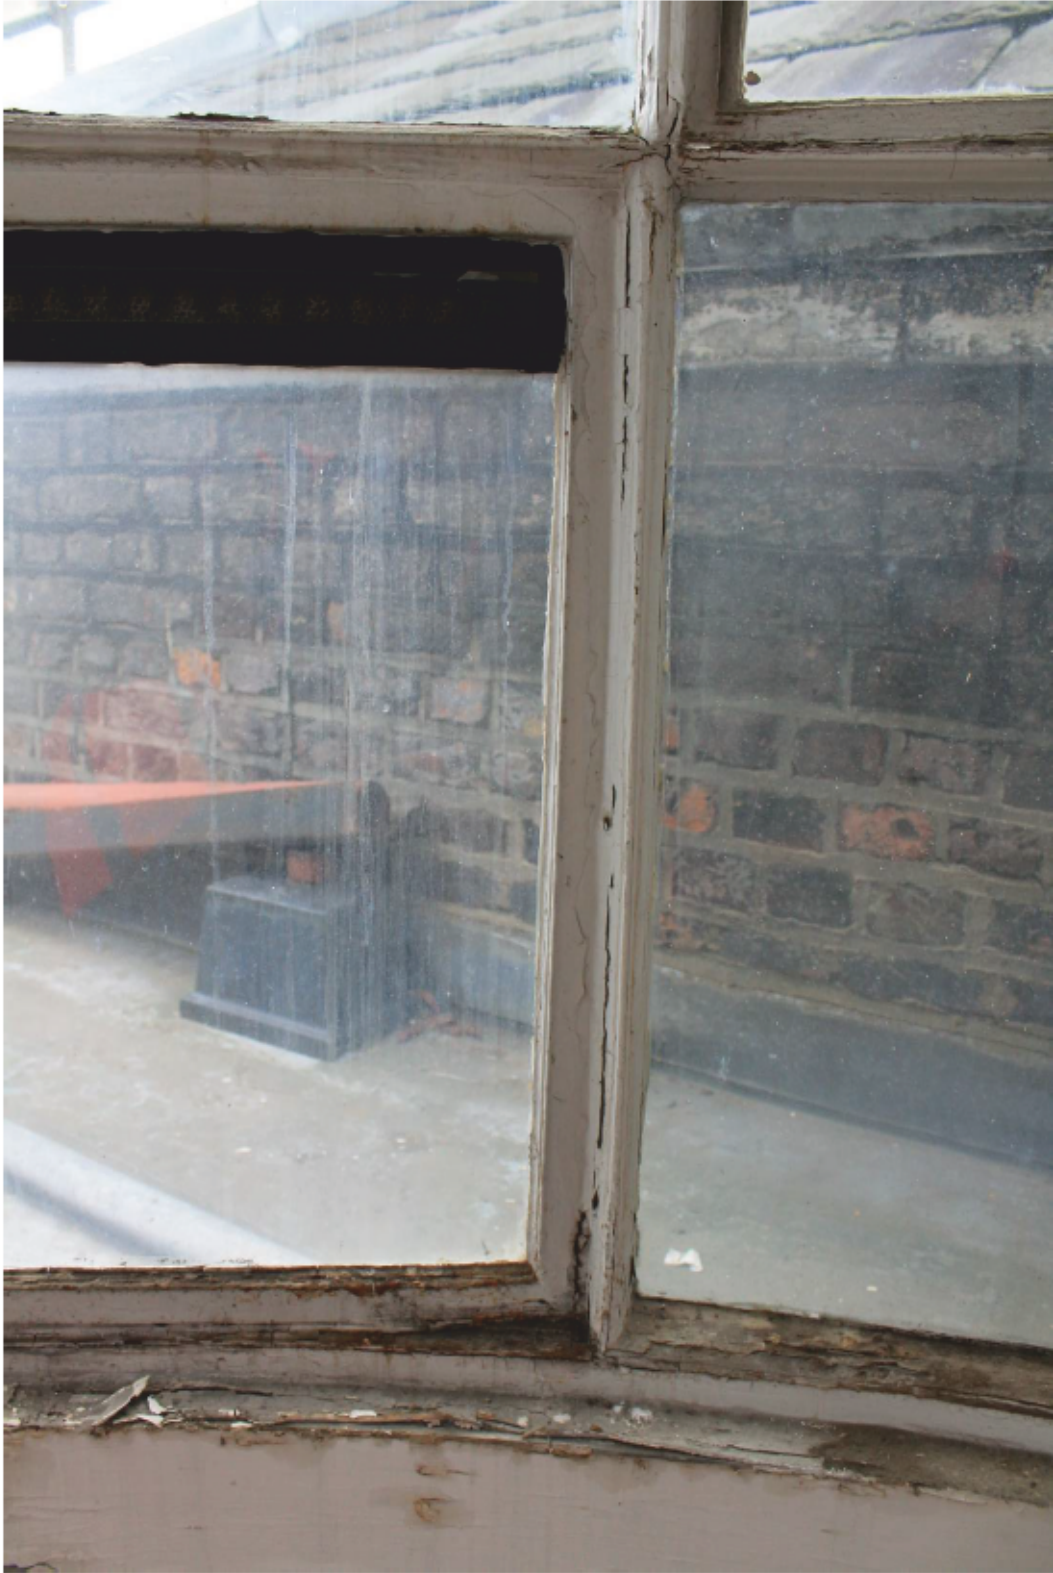
Plate 65 Lantern C: Internal Repair 13

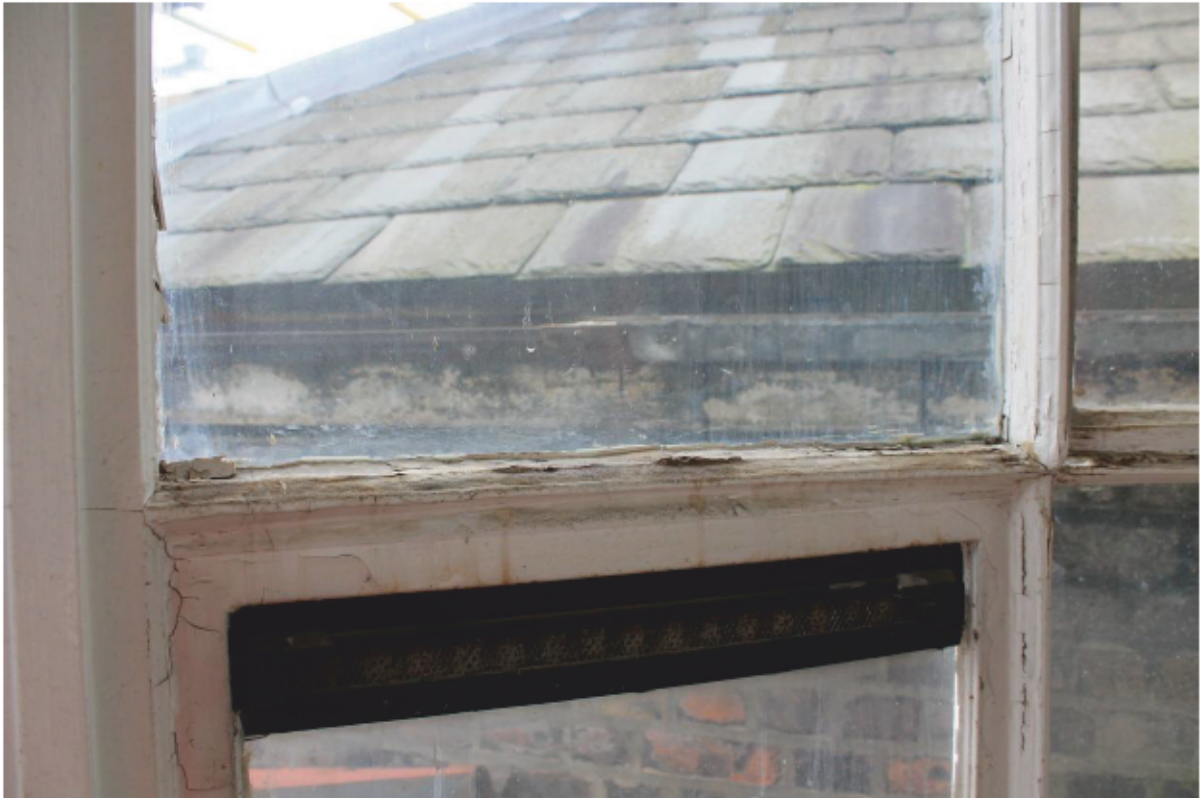
Plate 66 Lantern C: Internal Repair 14

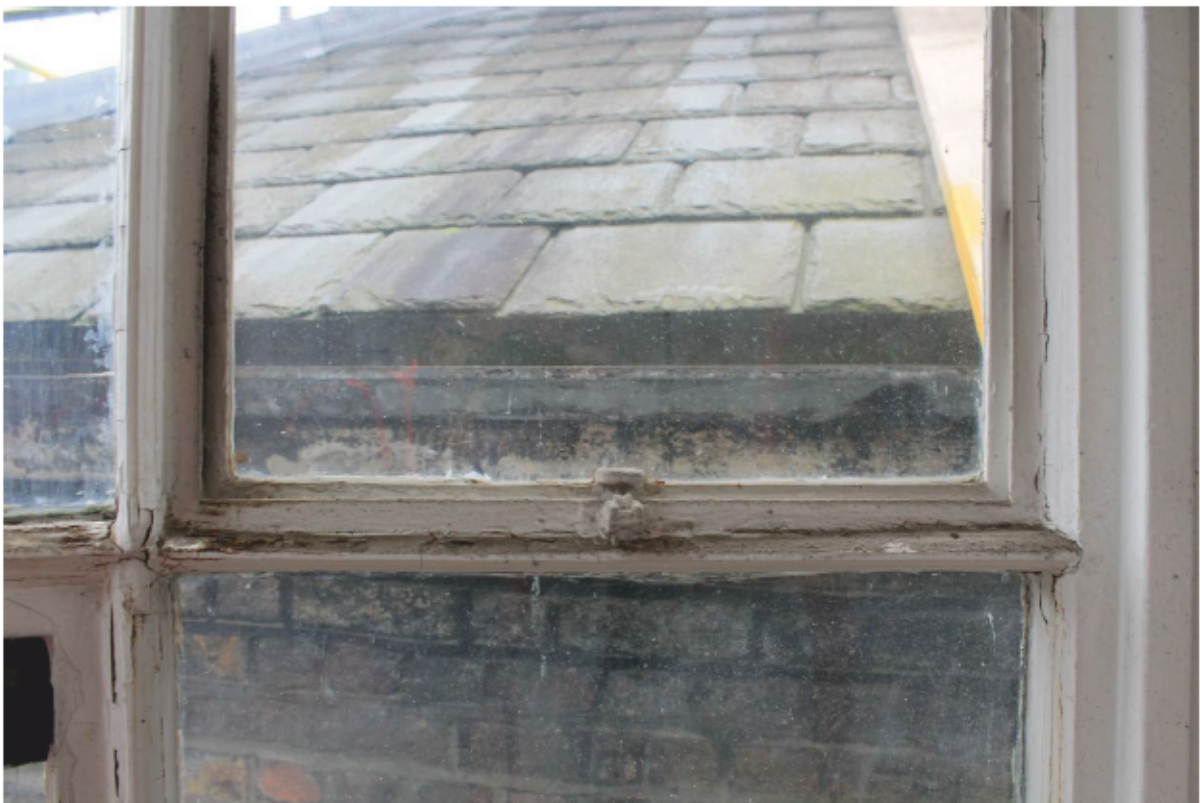
Plate 67 Lantern C: Internal Repair 15

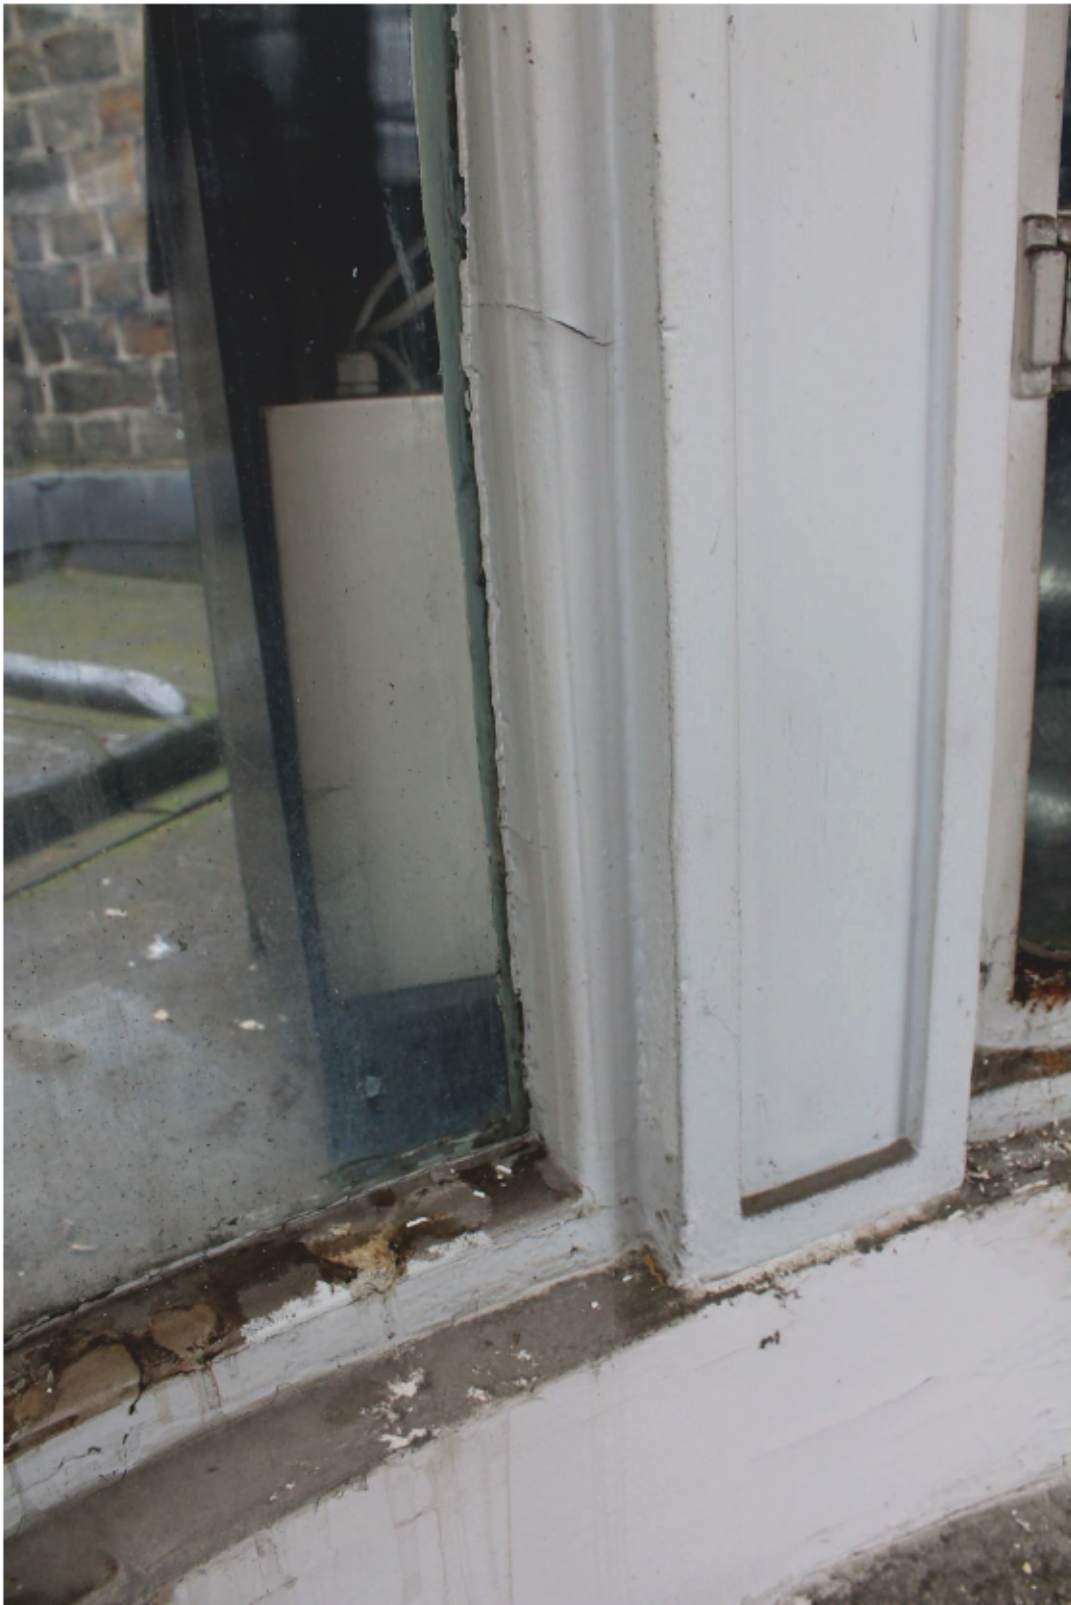
Plate 68 Lantern C: Internal Repair 16

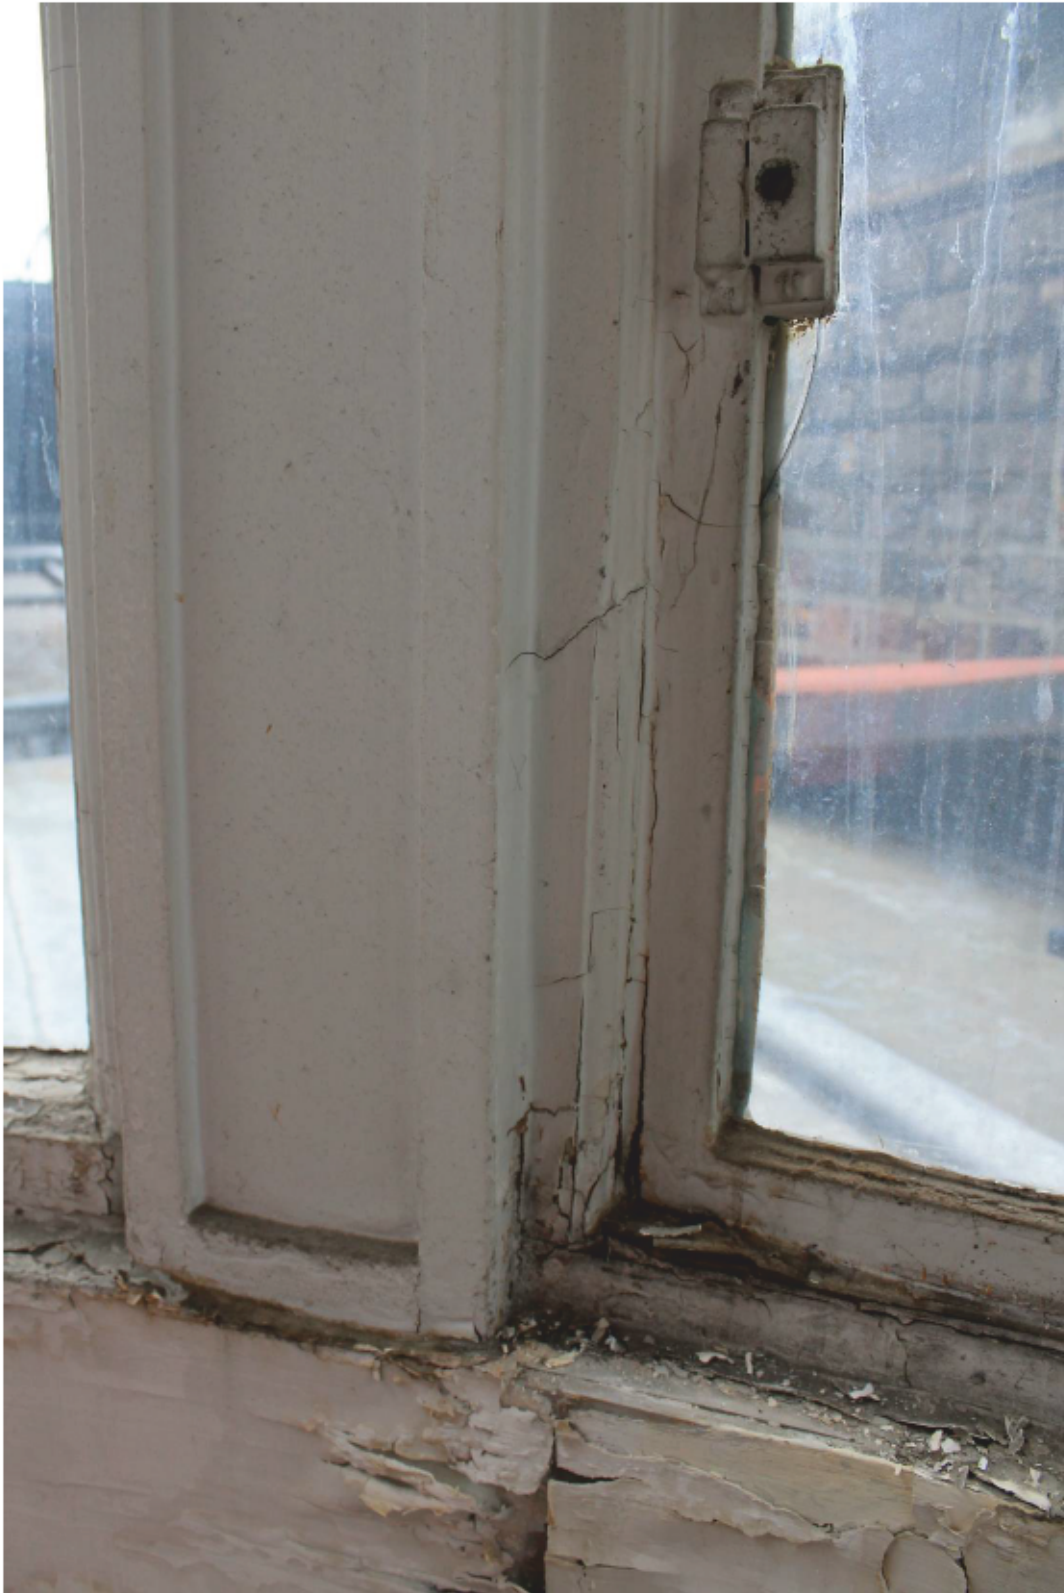
Plate 69 Lantern C: Internal Repair 17

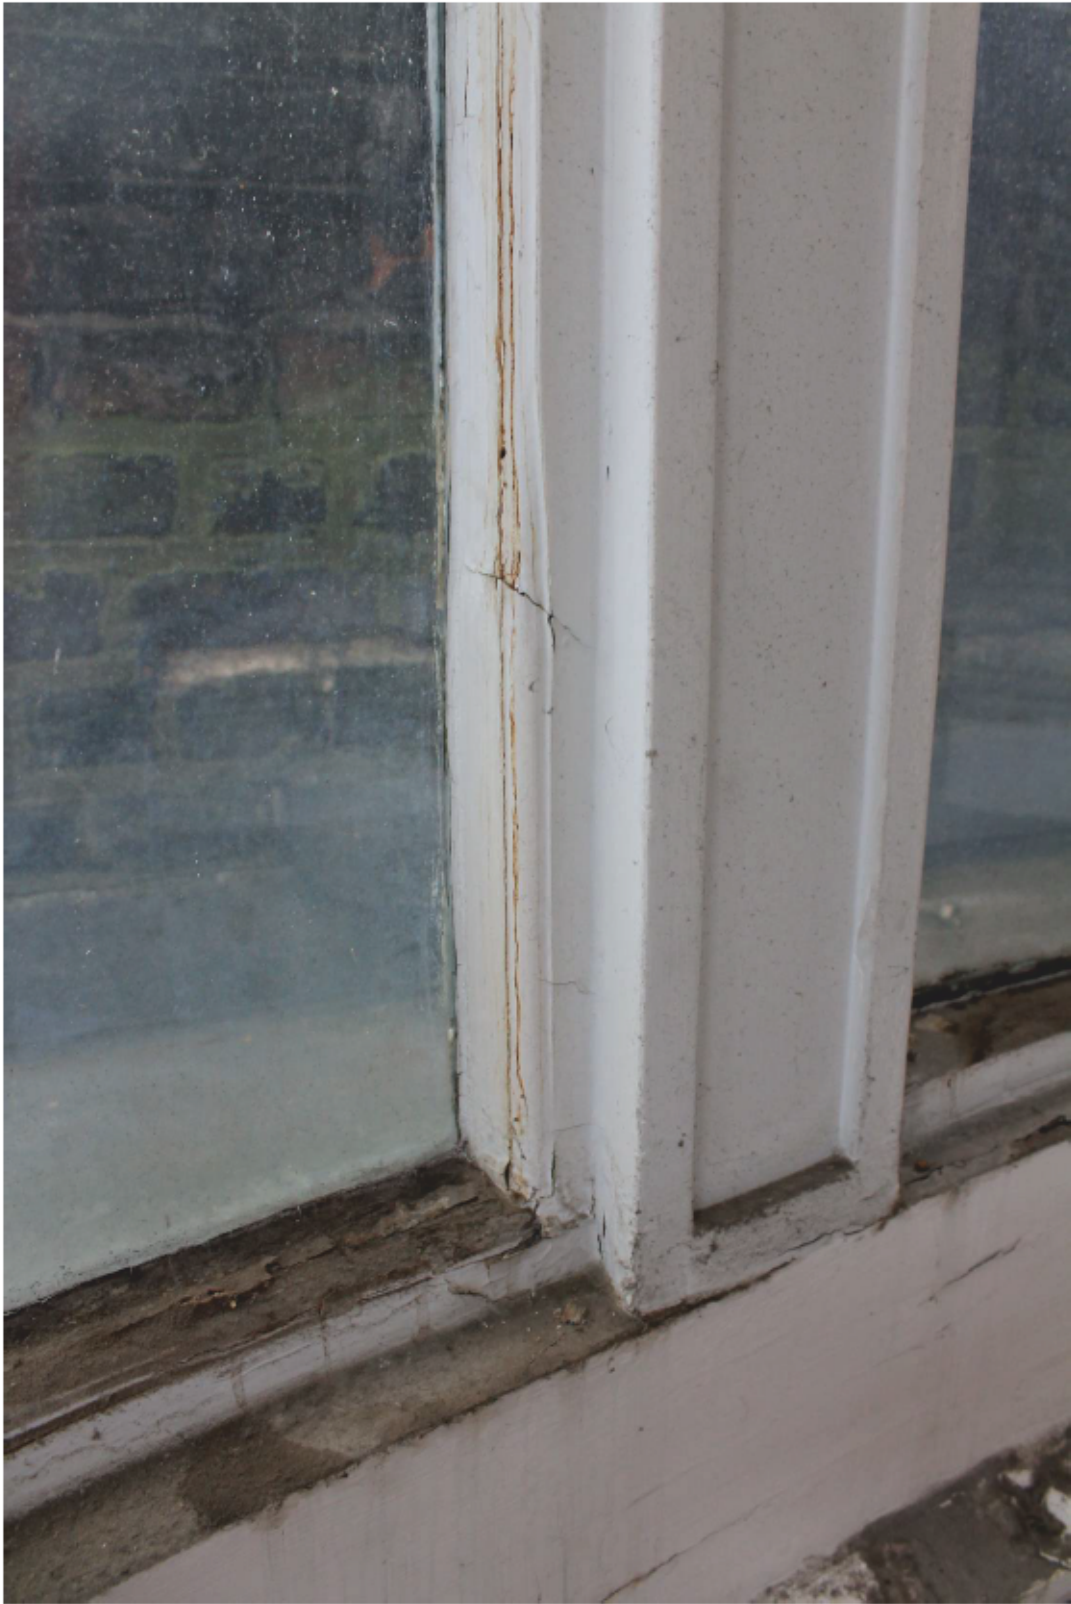
Plate 70 Lantern C: Internal Repair 18

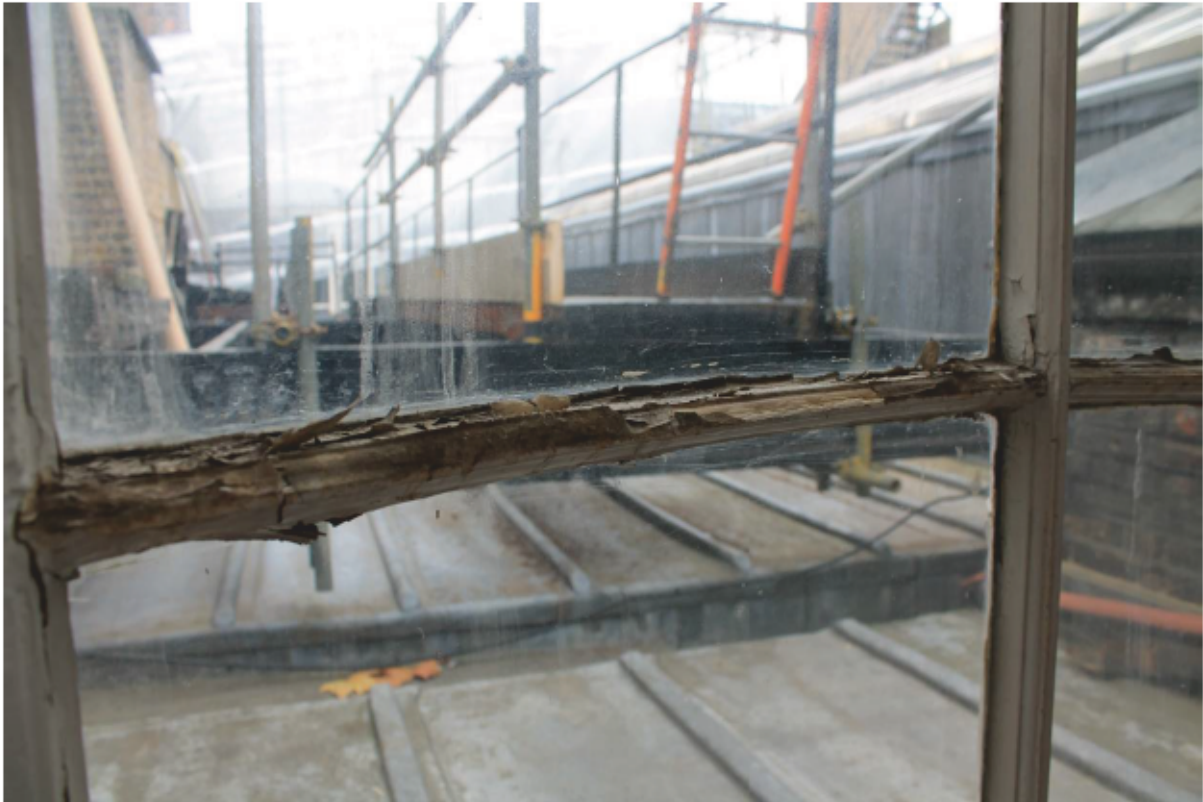
- 5.7.8 **Internal Repair 19: Re-setting of glazing bar (Plate 71):** Replacement or resetting of the horizontal glazing bar between middle and lower panes, central light, eastern elevation. Whilst original, the reset bar is not flush with the adjacent glazing bars, and is most likely

Plate 71 Lantern C: Internal Repair 19

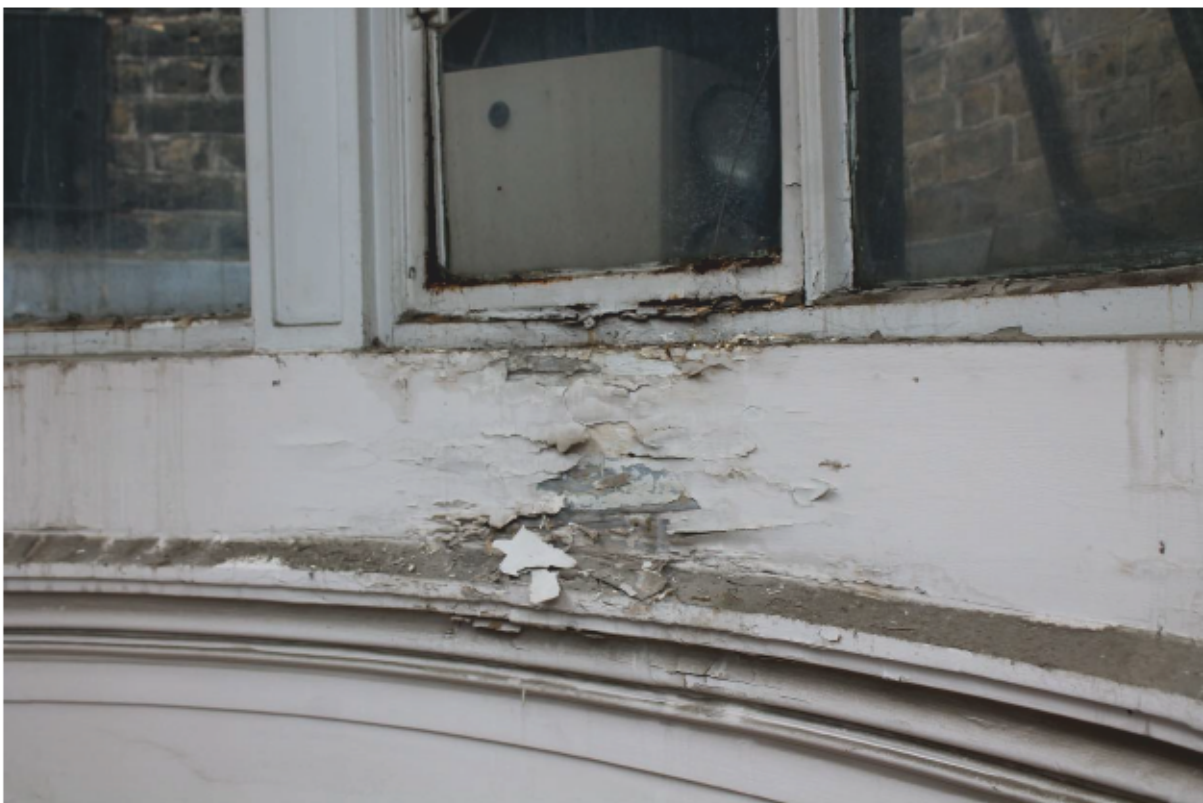
Plate 72 Lantern C: Decay below casement 30

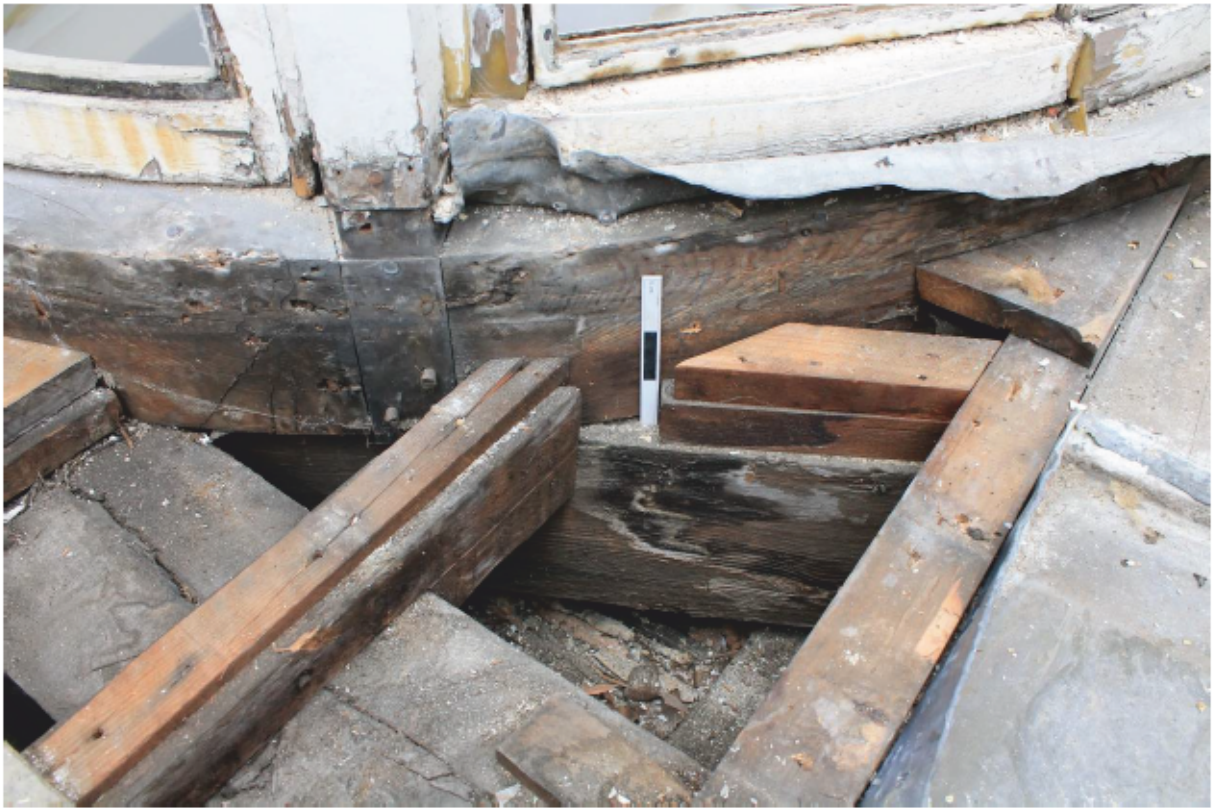
5.9.1 Opening A1 entailed the removal of a 'quadrant' of the roof covering located along the north-eastern side of Lantern A (Figure 10; Plates 73 and 74). This involved the initial removal of the leadwork to the flat roof within this quadrant and the subsequent removal of the underlying softwood boards. The latter, 9 inch boards, butted up against the lantern base/ring beam and were laid north-south, closely cut to follow the curve of the lantern. This was covered in fibrous matting fixed in place using copper nails.

Plate 73 Lantern A: Opening A1 looking south

Plate 74 Opening A1: Detail of sectional sill and supporting sub-structure looking south-west
