**ARCHAEOLOGICAL
BUILDING RECORDING AND
WATCHING BRIEF OF
THE ROOF LANTERNS AND
LEADED FLAT ROOFS AT
KENSINGTON PALACE,
PALACE AVENUE,
ROYAL BOROUGH OF
KENSINGTON AND
CHELSEA,
W8 4PU**

SITE CODE: KEN29

PCA REPORT NO. R12405

MARCH 2016

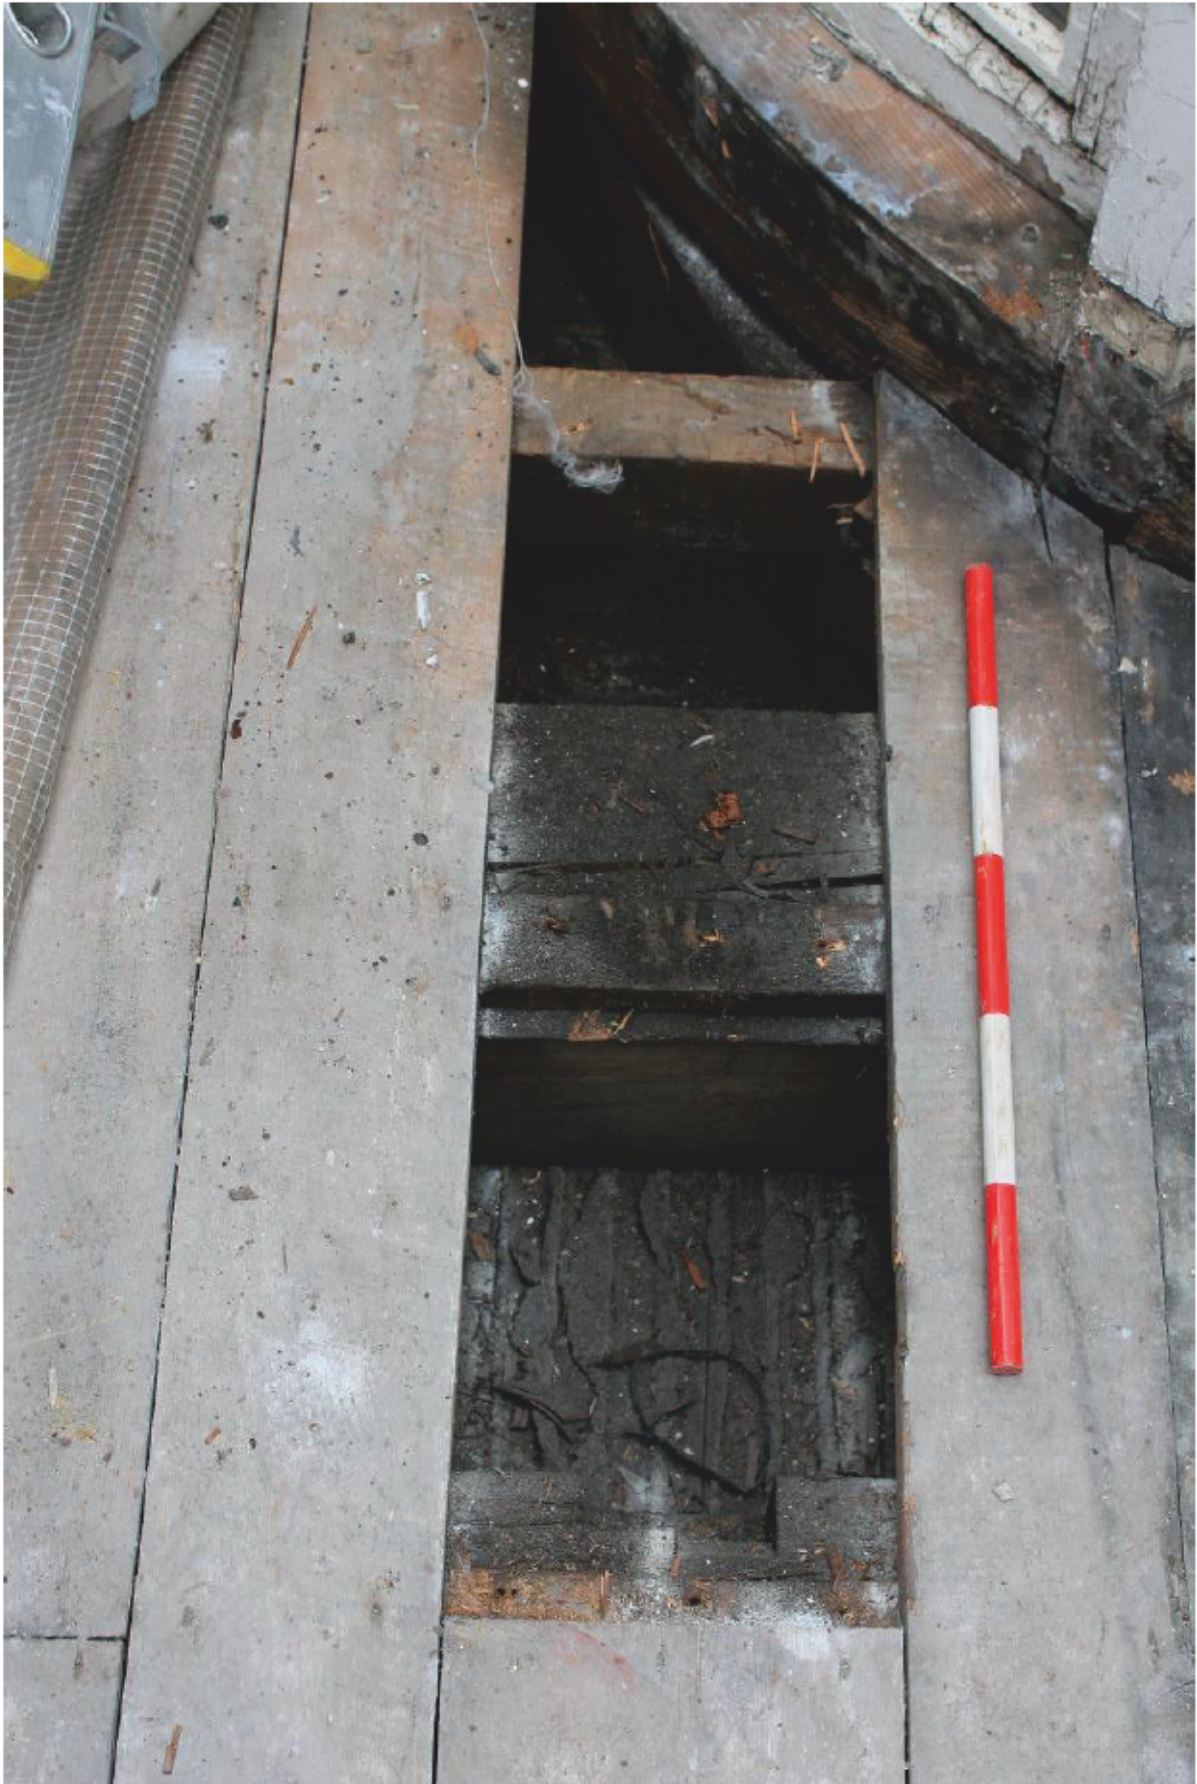
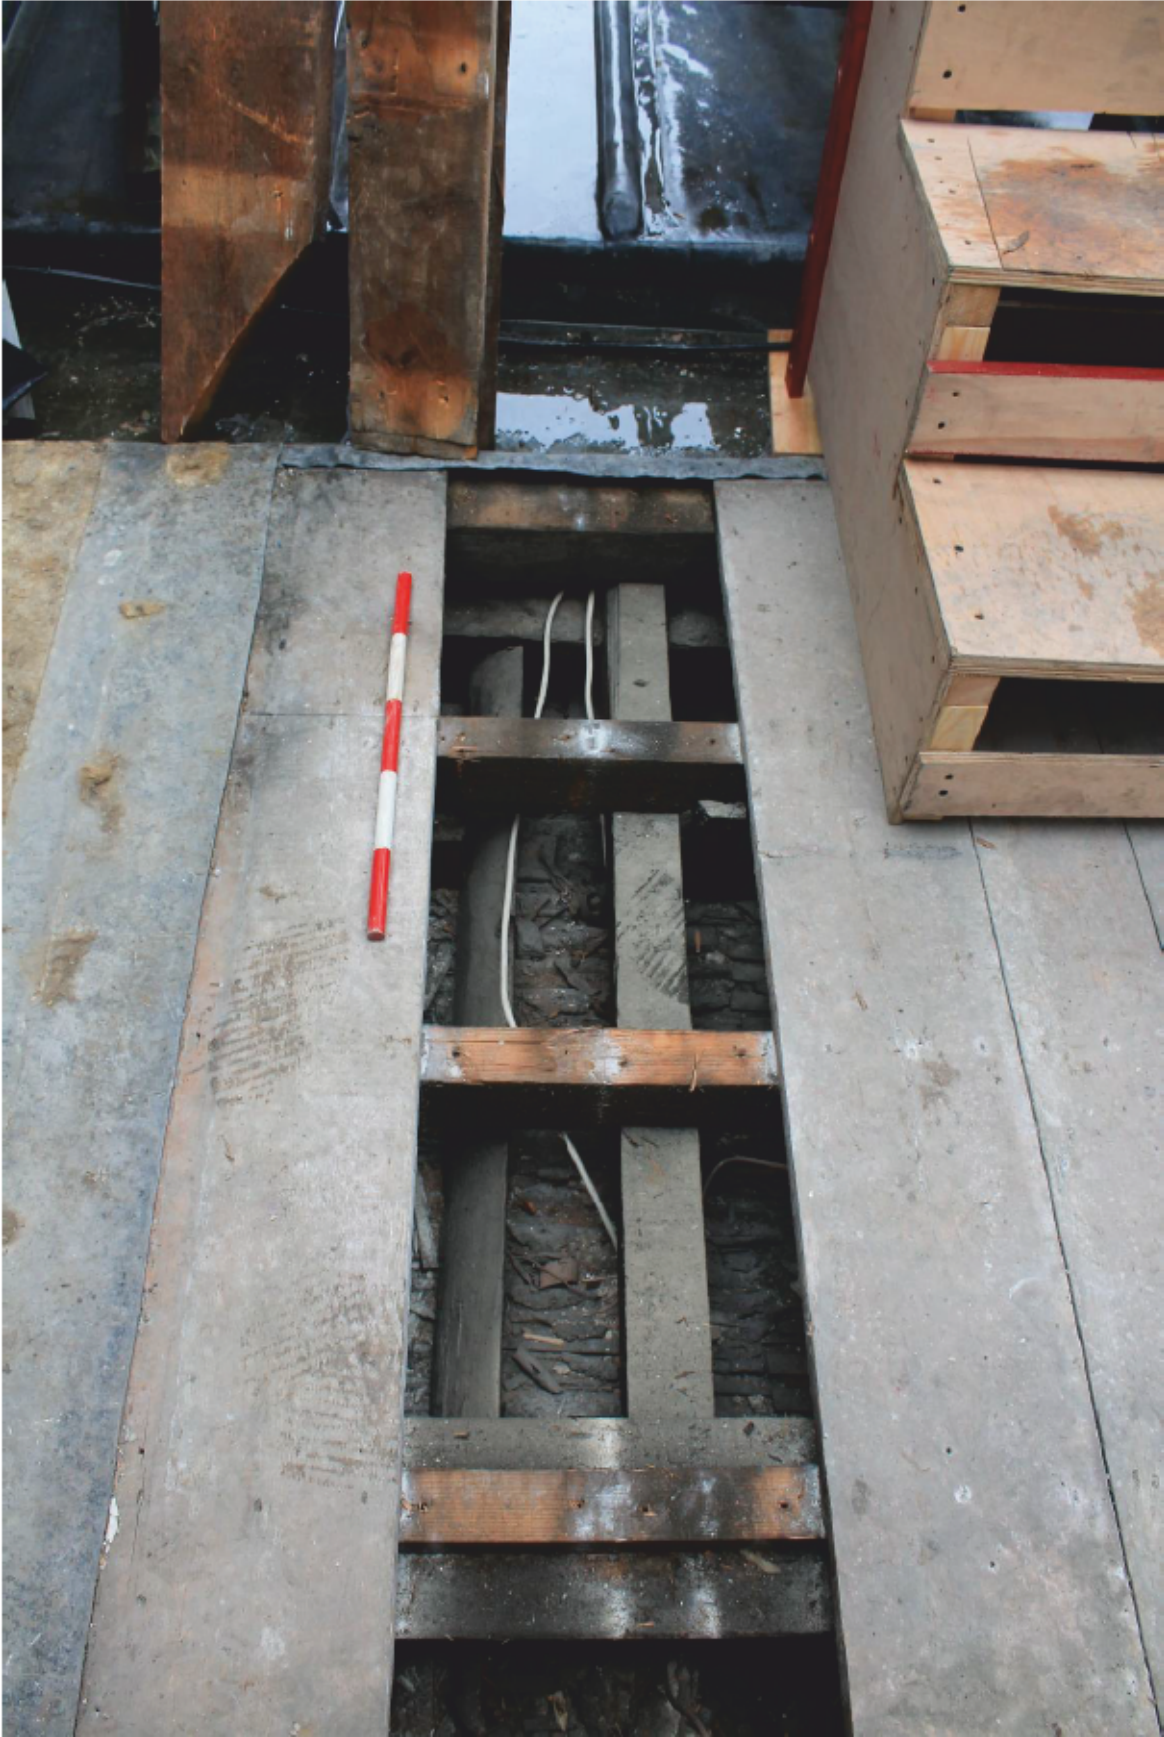
- 5.12.1 Openings C1 and C2 were exposed following removal of east-west aligned roof boards to the western side of lantern C (**Figure 12; Plates 79 and 80**). This exposed the same roof structure adjacent to the lantern, of heavy scantling principal joists aligned north-south and a lighter scantling diagonally set trimmer joists. Another parallel north-south aligned principal joist lay 450mm further to the west. This principal, included evidence of empty mortice holes cut into the top and sides of the joist, but also held a lighter east-west aligned joist pegged into its western side, which in turn was lapped over another north-south joist to the west. The latter formed the structure of the ceiling below which also comprised (visibly) a parallel quarter pole ceiling joist. The principals were overlain by north-south aligned unplanned softwood joists or battens supporting the boards to the flat roof.

Plate 79 Lantern C: Opening C1 looking east

Plate 80 Lantern C: Opening C2 looking west

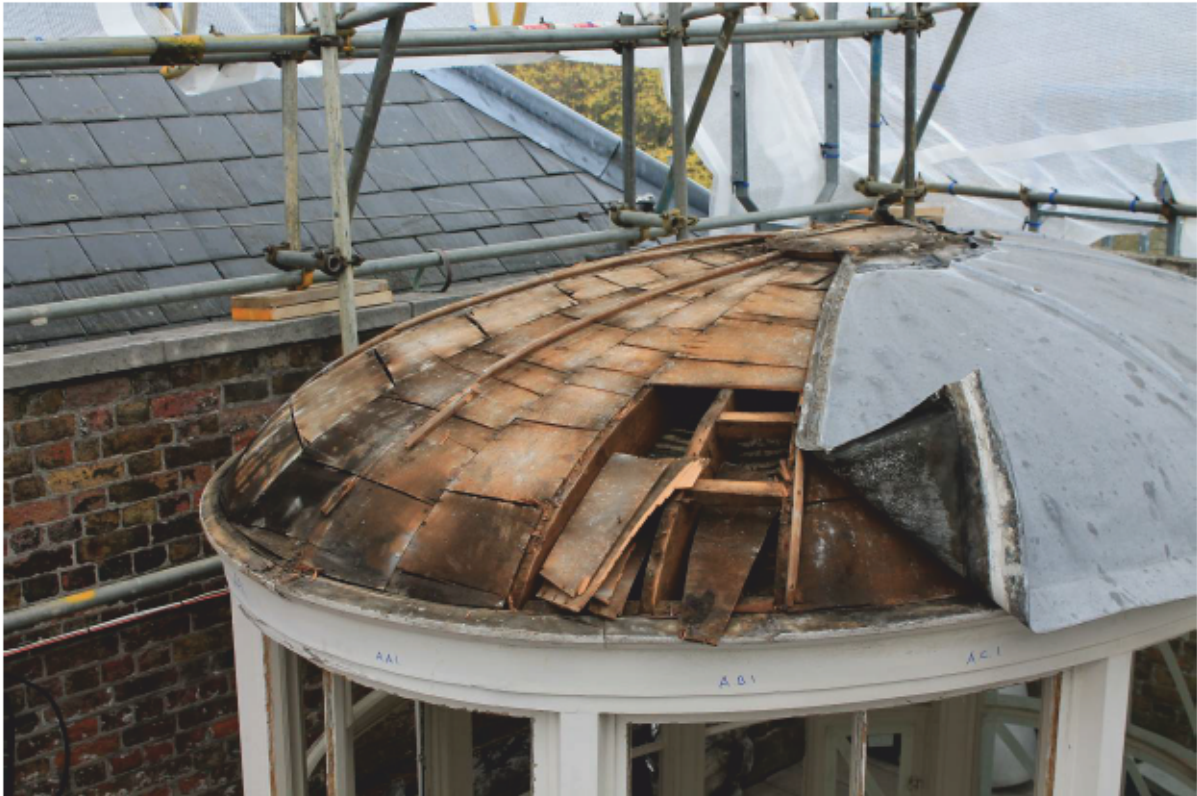
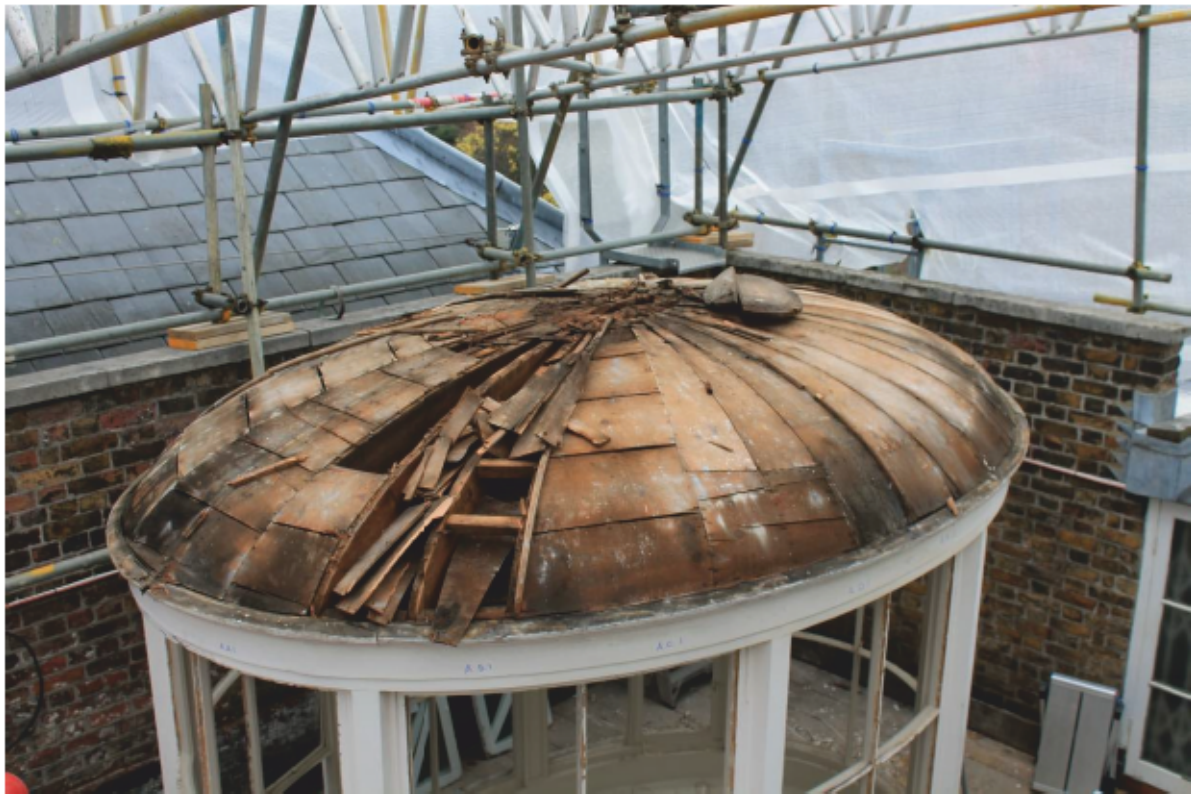
- 5.13.1 The structure of the domed roof over Lantern A was revealed following the removal of the code 8 lead flashings and sections of softwood sarking (**Plate 81**). The latter comprised two different types of covering, either small lengths of softwood boards (typically 9 x ¼ inch) bridging the void between two or three rafters or much longer, tapering segments of boards, formed to the curvature of the dome and extending the full height of the dome from its sill to the apex (**Plate 82**). The boards (of both types) butt against each other and were nailed into the top of the rafters using 1-1½ inch flat-headed handmade nails. An elliptical timber boss covered the apex of the dome (at the convergence of rafters) and a series of 8 softwood ribs, were nailed, using flat section wrought-iron nails, into the underlying rafters, through the boards. These rib features were associated with the lead-work.

Plate 81 Lantern A: Stripping of domed roof exposing sarking boards, looking south-west

Plate 82 Lantern A: Following removal of lead flashings and ribs

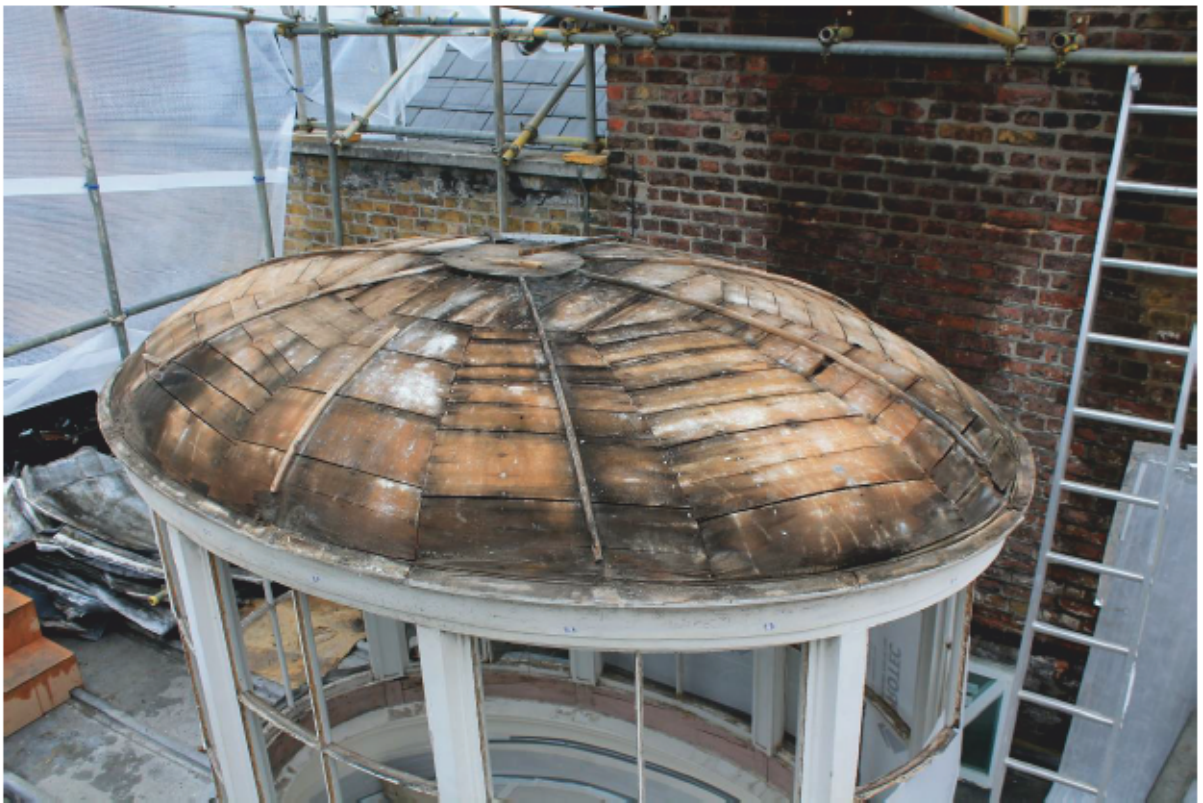
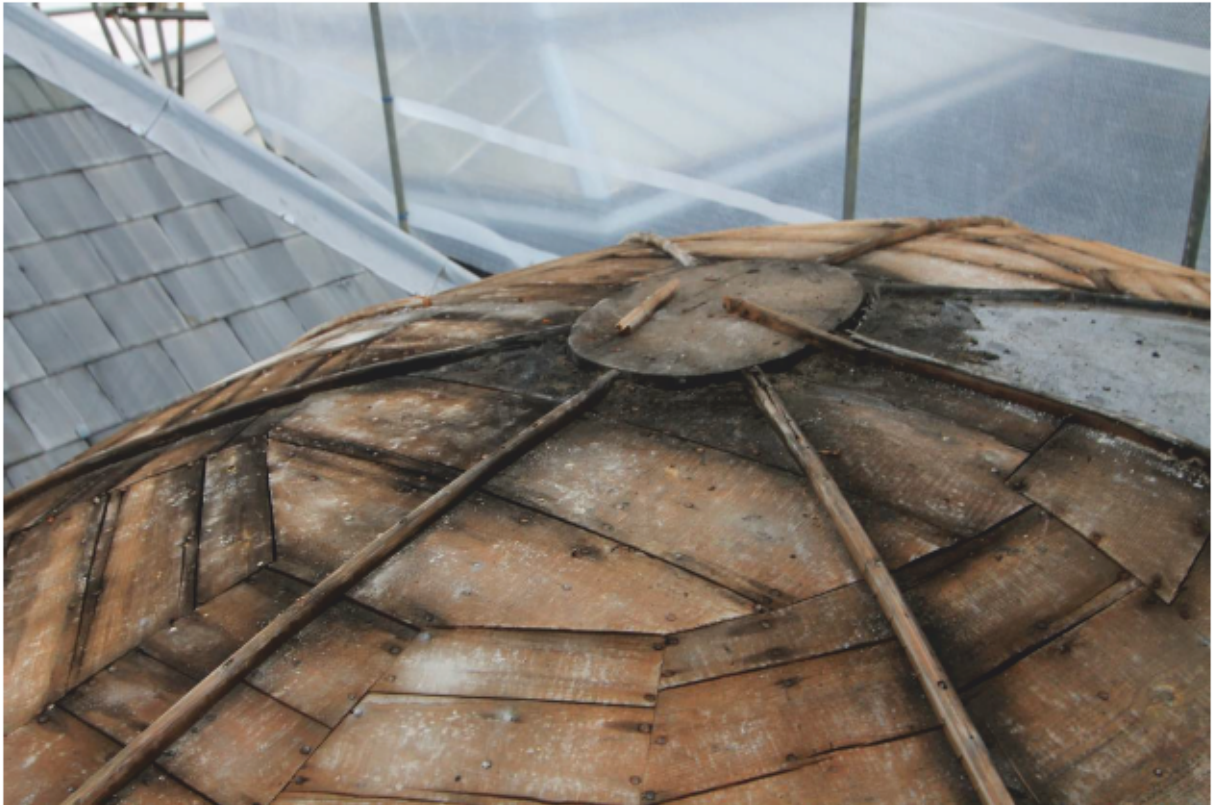
- 5.14 Domed Roof over Lantern B (Plates 84 to 86)**
- 5.14.1 The covering to the roof structure over lantern B was similarly revealed. It was also covered in individual lengths of softwood boards, of a form similar to that present on the eastern side of lantern A (**Plates 84 and 85**). The boards were not a uniform size, with boards spanning three rafters and others, only two. The boards reduced in width as they progressed toward the summit of the dome, at which point they were laid perpendicular (north-south) to the lower boards and within a geometric shaped upper section. The boards are overlain by the same elliptical cap and radiating softwood ribs, located at the junctions of the sections of leadwork covering the dome. Removal of the softwood boards revealed an identical roof structure as present over lantern A (**Plate 86**).

Plate 84 Lantern B: Following removal of lead flashings, looking south-east

Plate 85 Lantern B: Detail of sarking boards and central boss for leadwork

Plate 86 Lantern B: Detail of rafters and eaves

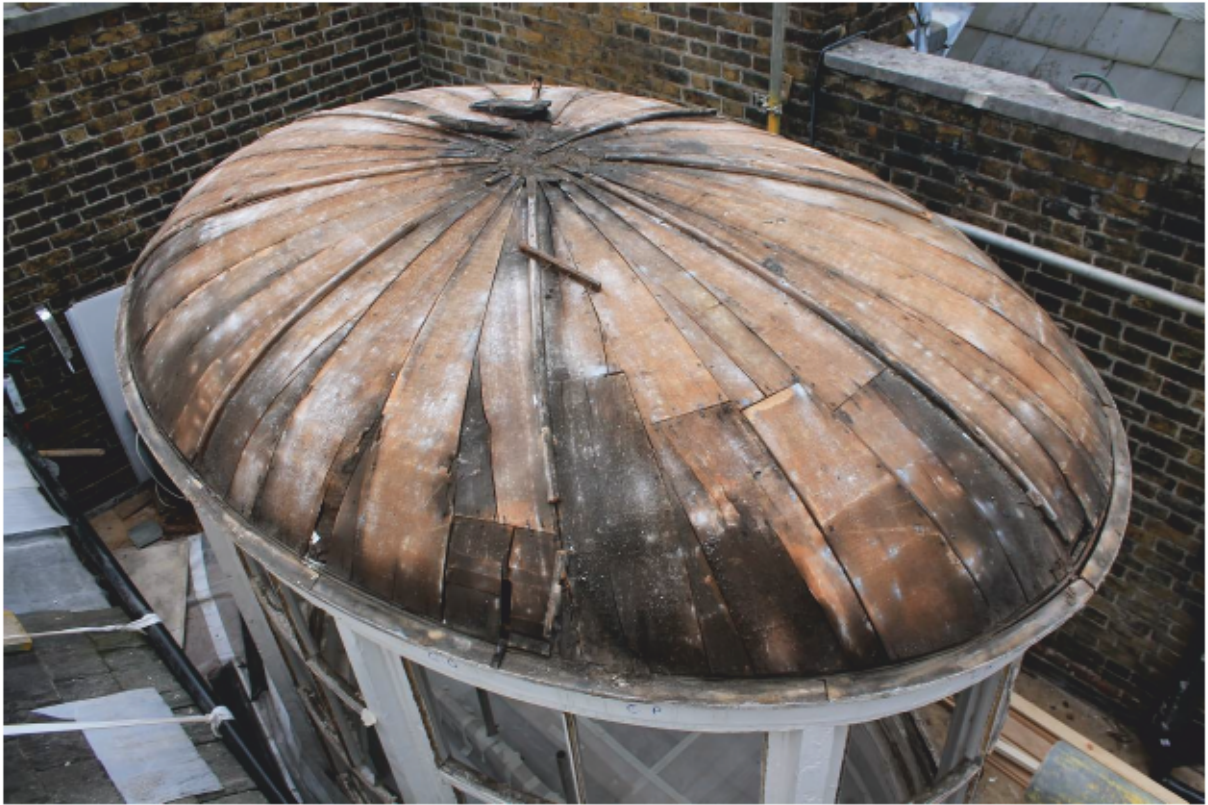
Plate 87 Lantern C: Following removal of leadwork, looking south-east

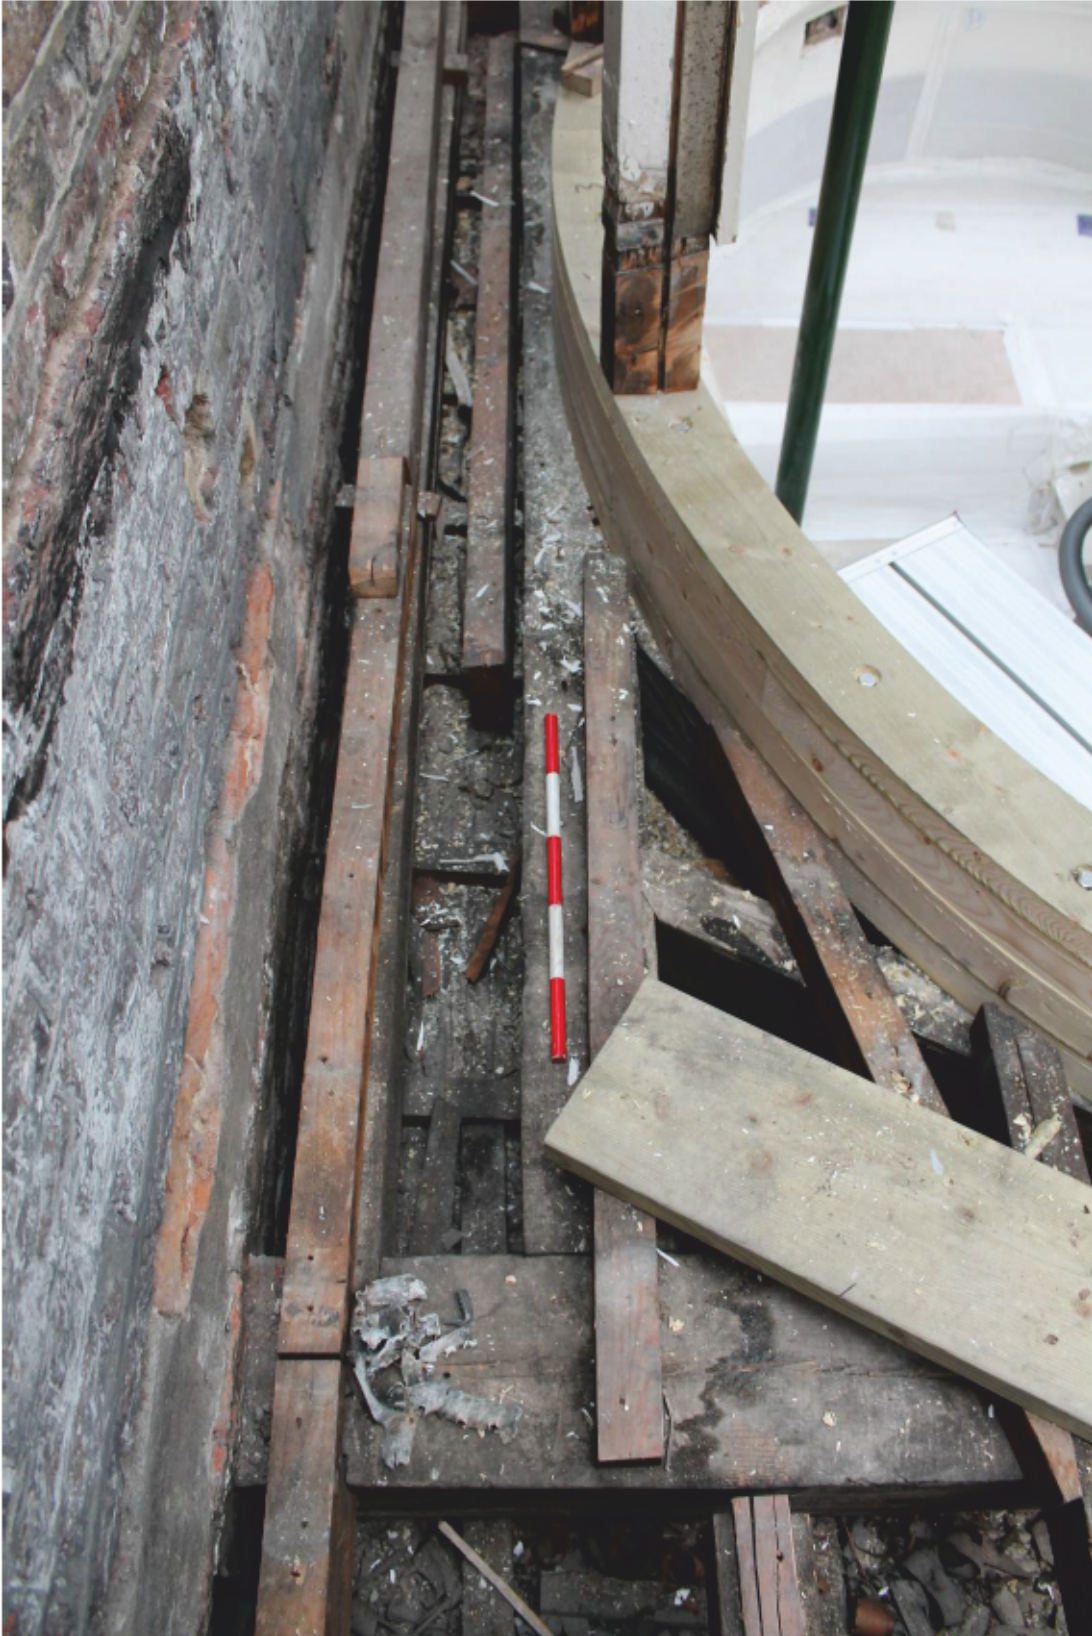
Plate 91 Lantern A: Sub-structure looking west

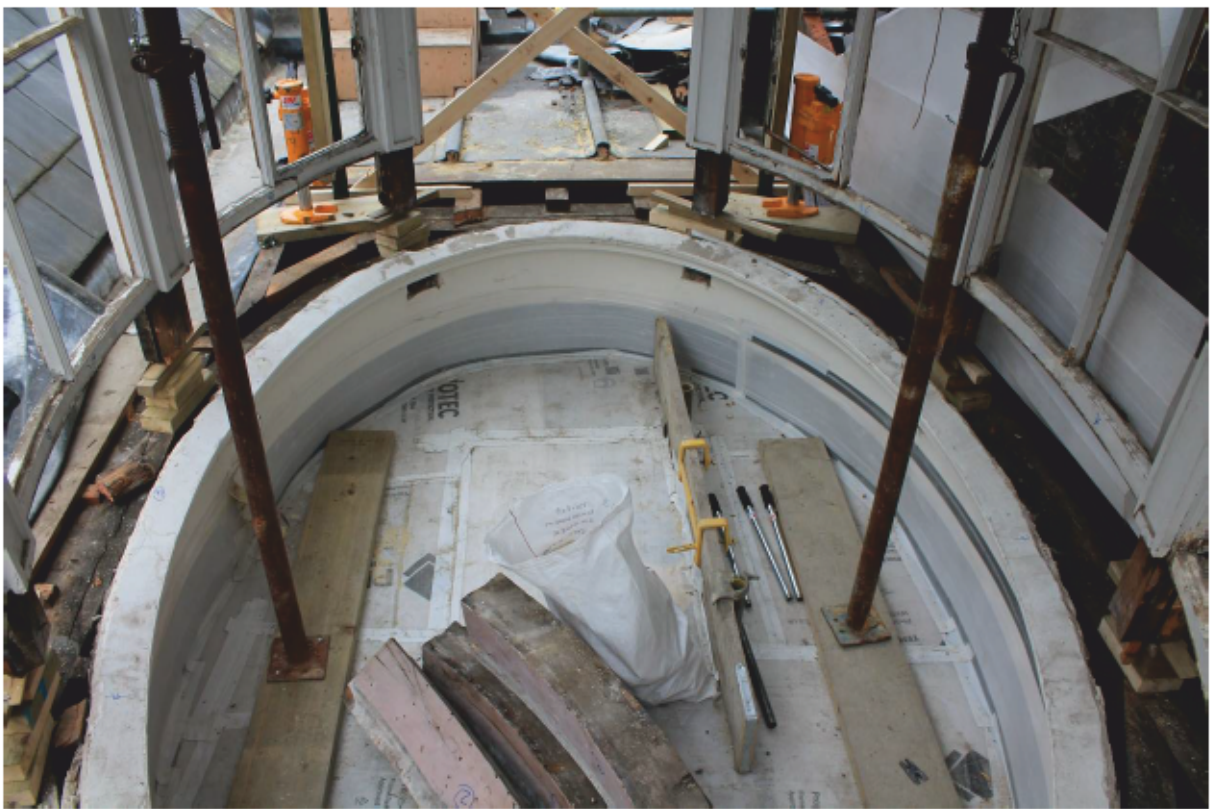
Plate 94 Raising of Lantern B, internal, looking east

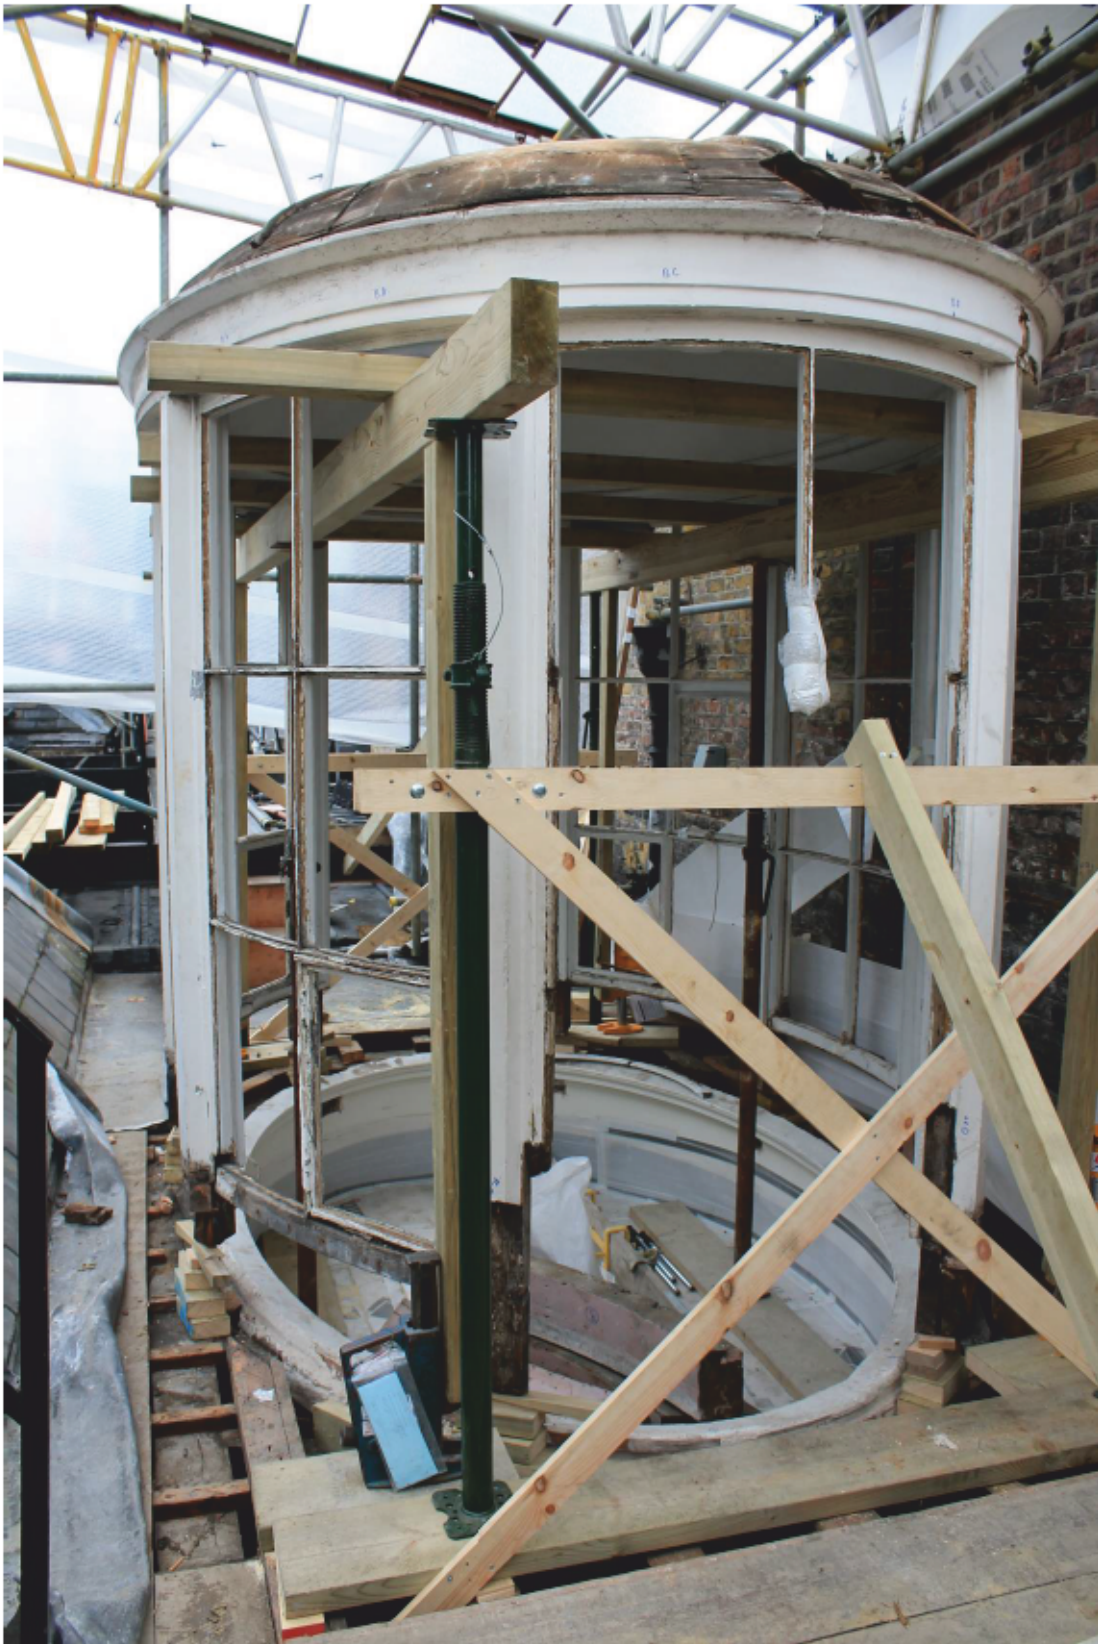
Plate 95 Lantern B, support structure, looking east

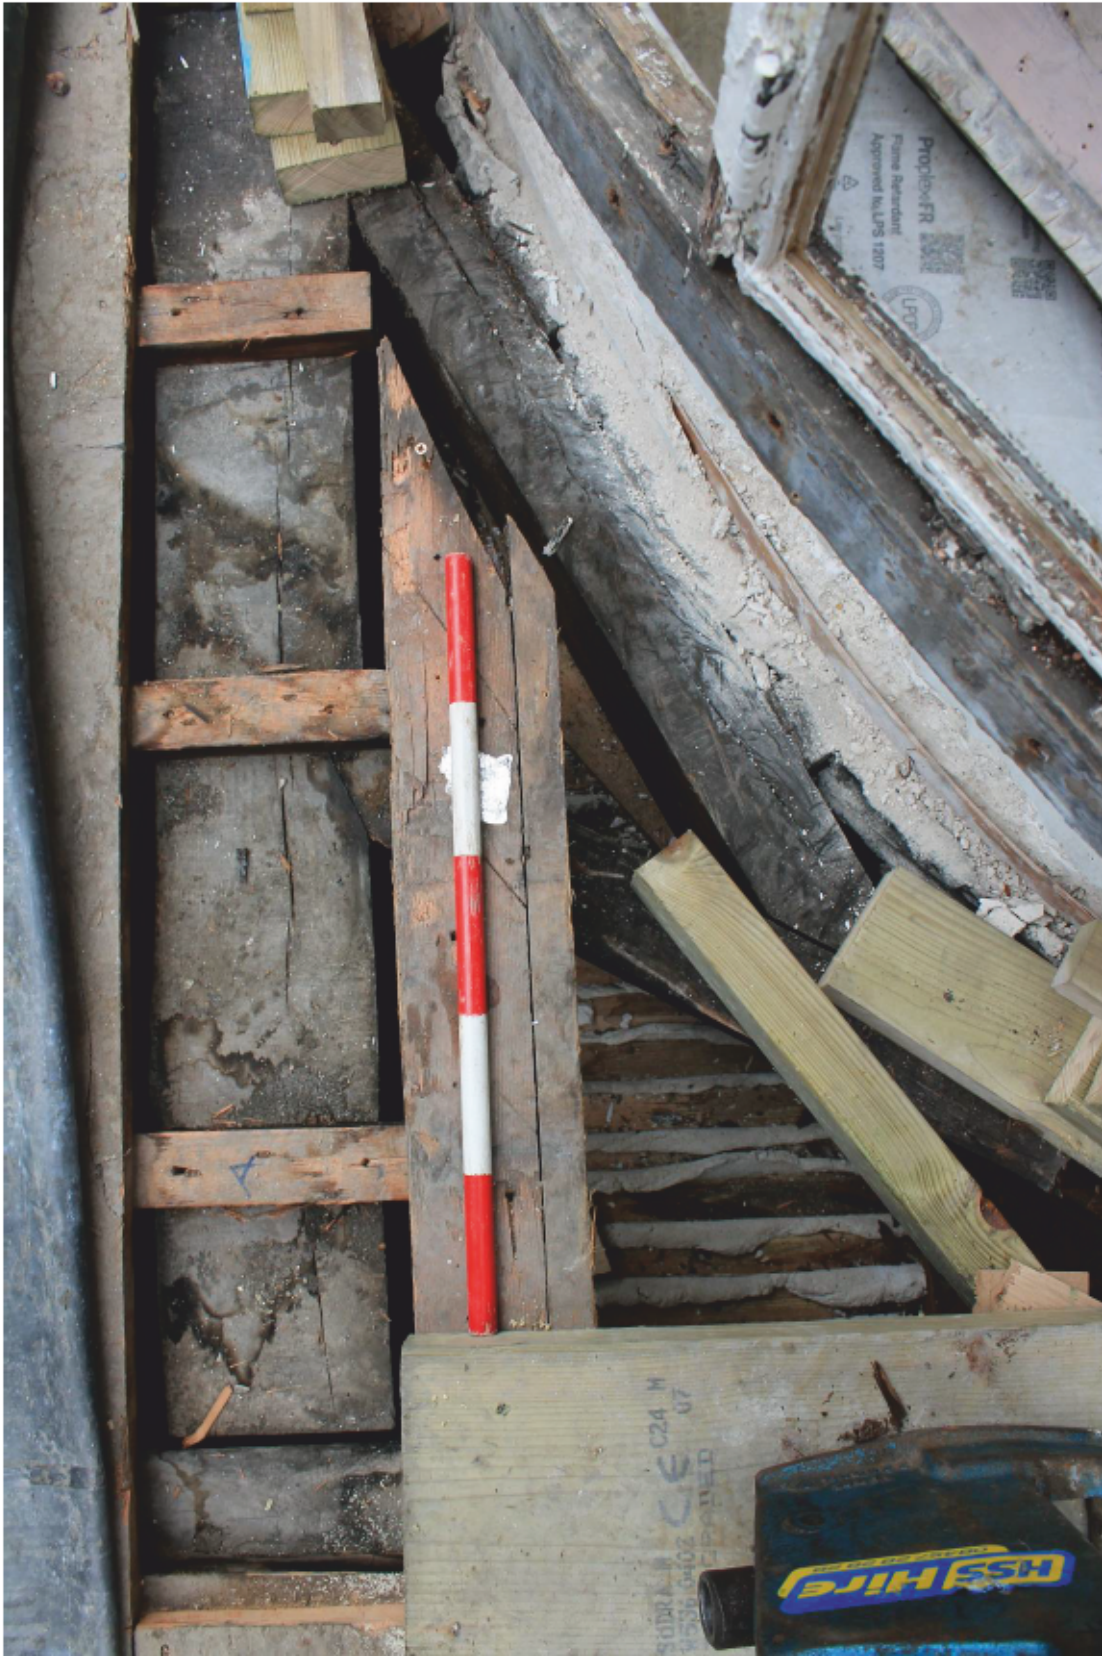
Plate 96 Lantern B: Sub-structure looking east

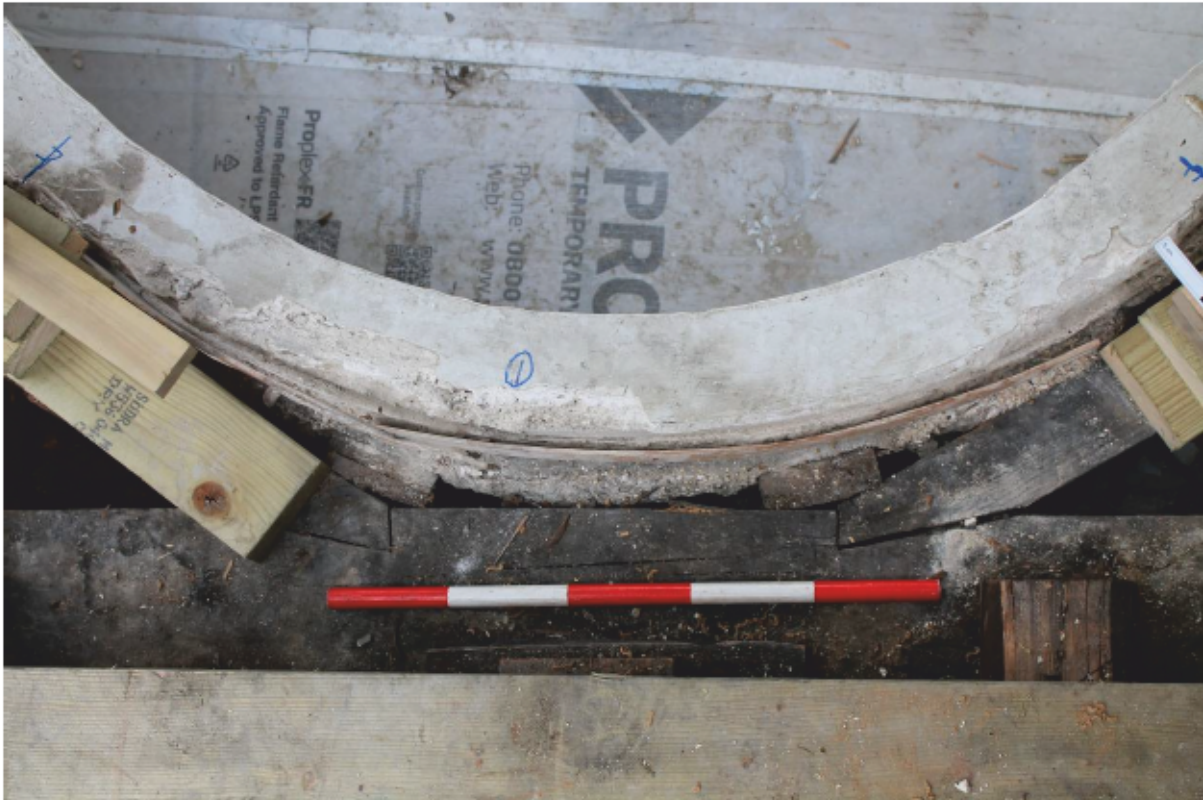
Plate 97 Lantern B: Sub-structure looking east

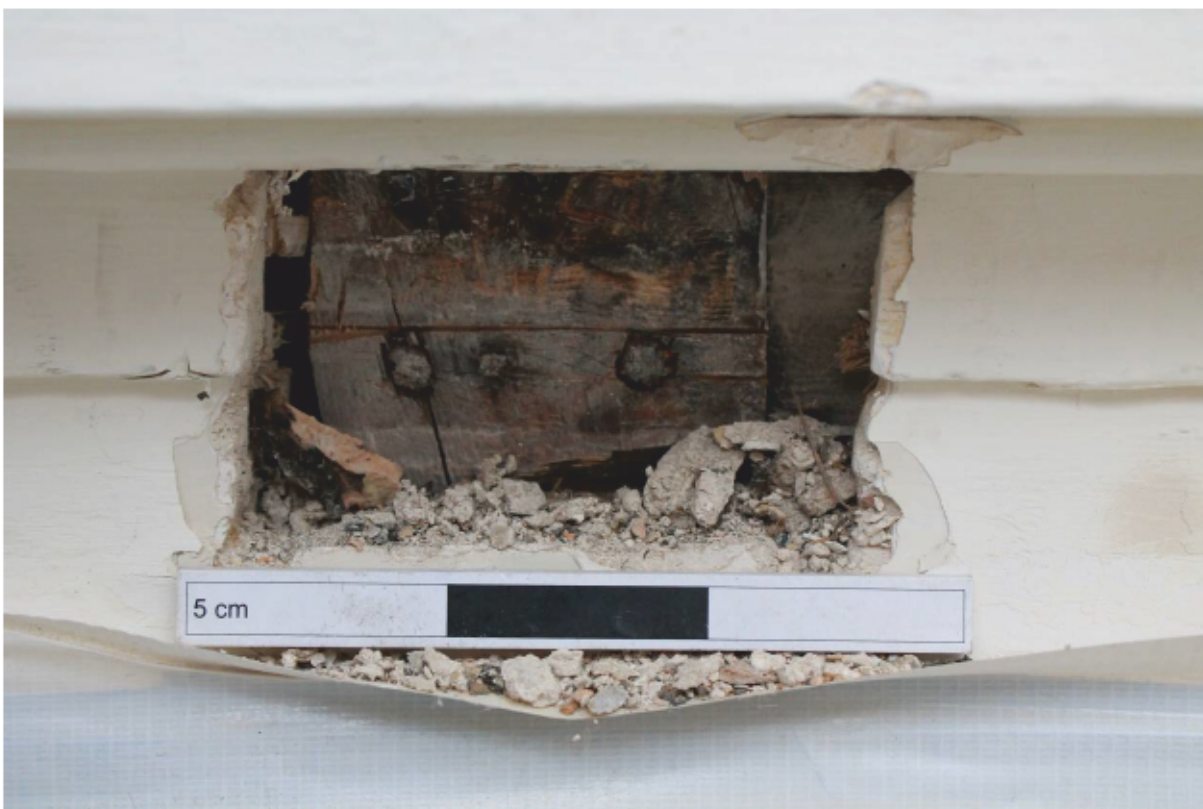
- 5.17.4 It was evident that the structural relationship between the lantern and the sub-structure was accomplished through carpentering the base of the mullions directly into the sub-structure, and not using dowels or pins as previously thought. The foot of each mullion was located and fixed into the sub-structure in two ways; the inner face of the mullion was halved over and nailed into the inner side of the sub-frame (Plate 98), while a tenon cut into the base of the mullion, located within a mortice cut into the upper face of the same sub-structure. This mortice and tenon was also nailed to stop the joint pulling apart.

Plate 98 Lantern B: Mullion foot halved over and nailed into sub-structure (viewed through internal plaster moulding)

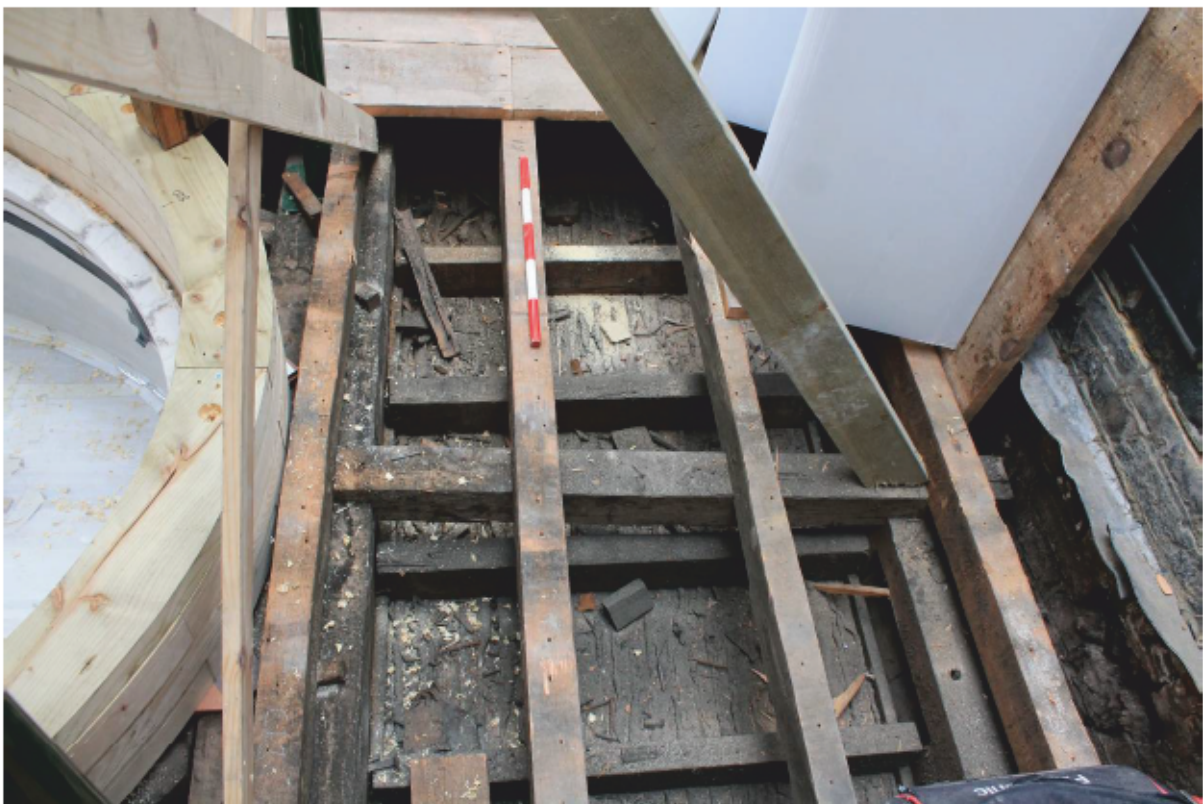
- 5.18.1 Following the exposure of the roof structure recorded in openings C1 and C2, detail of the sub-structure to the lantern was further revealed, in conjunction with the raising of the lantern and the insertion of a composite sill (**Figure 12; Plate 100**). This entailed the stripping back of the flat roof to the east of lantern C, which revealed an identical sub-structure, comprised of a heavy scantling outer frame, with lighter internal trimmers and ties, as described for lanterns A and B. Another heavy scantling beam, aligned (north-south) and present to the east of the lantern and parallel with the parapet wall appeared to be contemporary with the sub-frame. However it was a re-used beam, as two mortices with empty peg holes, were present in its west facing side. These mortices did not coincide with an equivalent in the east facing side of the opposite beam (to sub-frame). A later tie, bracing the sub-frame to this beam had been added, trenched in and held using a wrought iron coach bolt. This was all overlain by lighter scantling joists forming the flat roof structure.

Plate 100 Lantern C: Sub-structure looking north

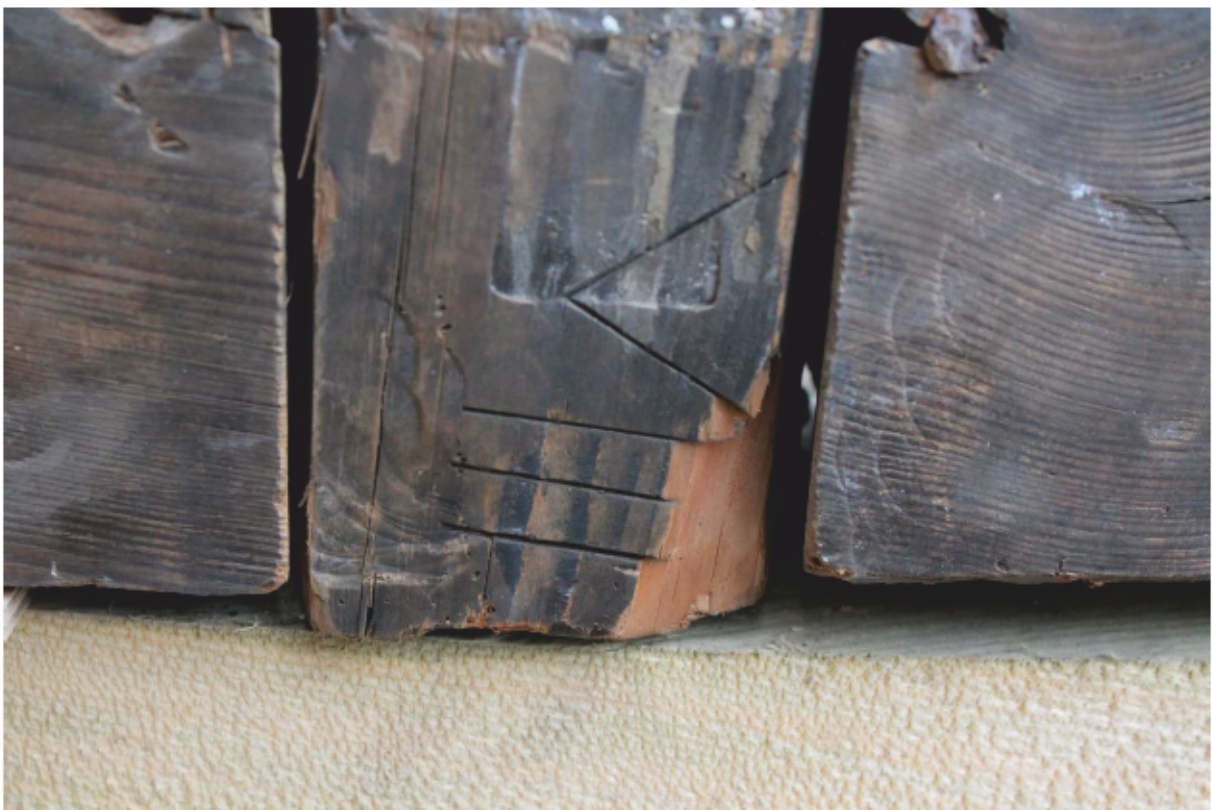
(IIIIV). Whilst the mid-post markings, between lanterns A and B, did not concur, the markings at the post foot, where they survived, did. The eastern post to the south side as marked (I) and that to the west (in a clockwise direction) marked (II), with (VIII; **Plate 104**) and (VII) marked on the posts to the east in an anti-clockwise direction. The three posts which should have been numbered three to five were not marked, as they had been replaced, while post six, though unaltered, was inexplicably unmarked.

Plate 104 Lantern B: Roman marking to mullion foot

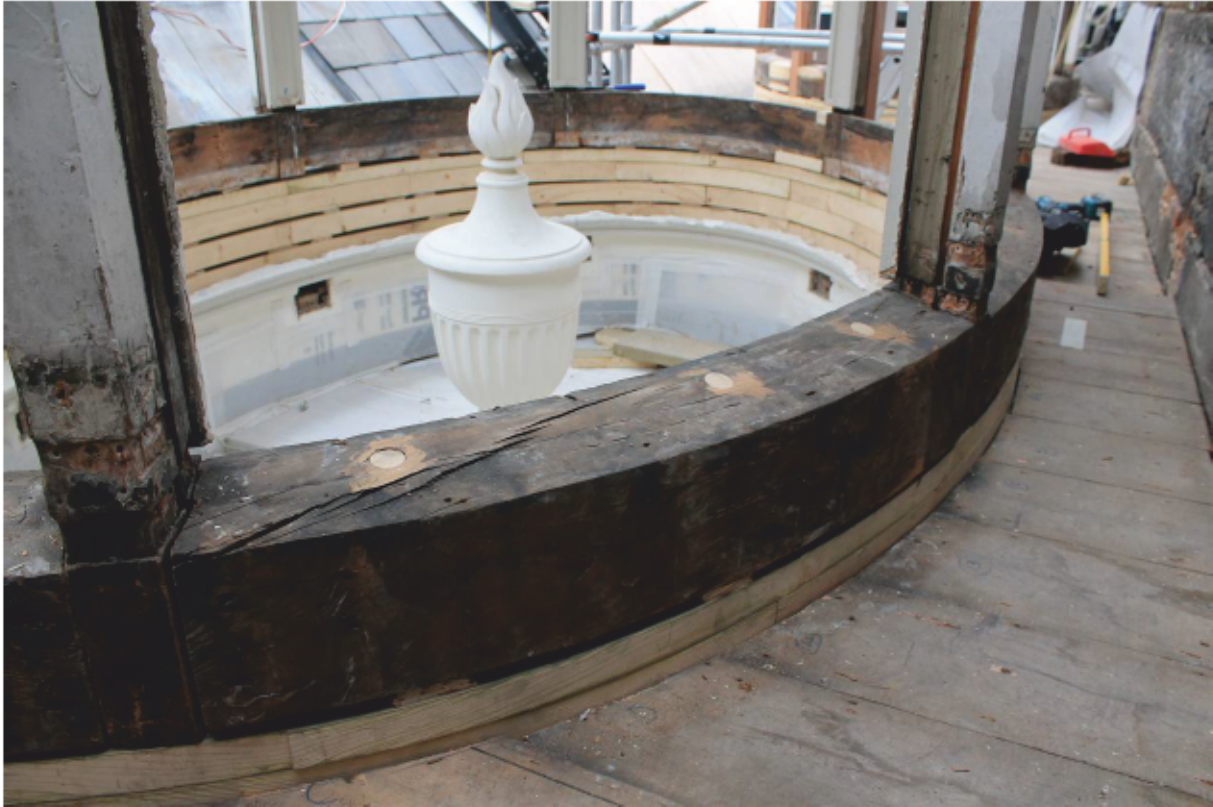
Plate 105 Lantern A: Sectional sill repaired and fixed to new composite sill, looking north-east

5.20.1 The level of the lanterns were raised above the flat roof by the insertion of a new composite softwood sill (c.280mm in height) formed from four tiers of timber sections, through bolted together to form a single composite structure (**Plates 105 and 106**). The foot of the mullions were fixed into this new structure using L-shaped steel brackets and repaired (if needed) using Sapele hardwood. The removed intermediate sill sections, original to the lanterns, were also repaired, where needed, and were drilled and through-bolted into the new composite substructure.
