**ARCHAEOLOGICAL
BUILDING RECORDING AND
WATCHING BRIEF OF
THE ROOF LANTERNS AND
LEADED FLAT ROOFS AT
KENSINGTON PALACE,
PALACE AVENUE,
ROYAL BOROUGH OF
KENSINGTON AND
CHELSEA,
W8 4PU**

SITE CODE: KEN29

PCA REPORT NO. R12405

MARCH 2016

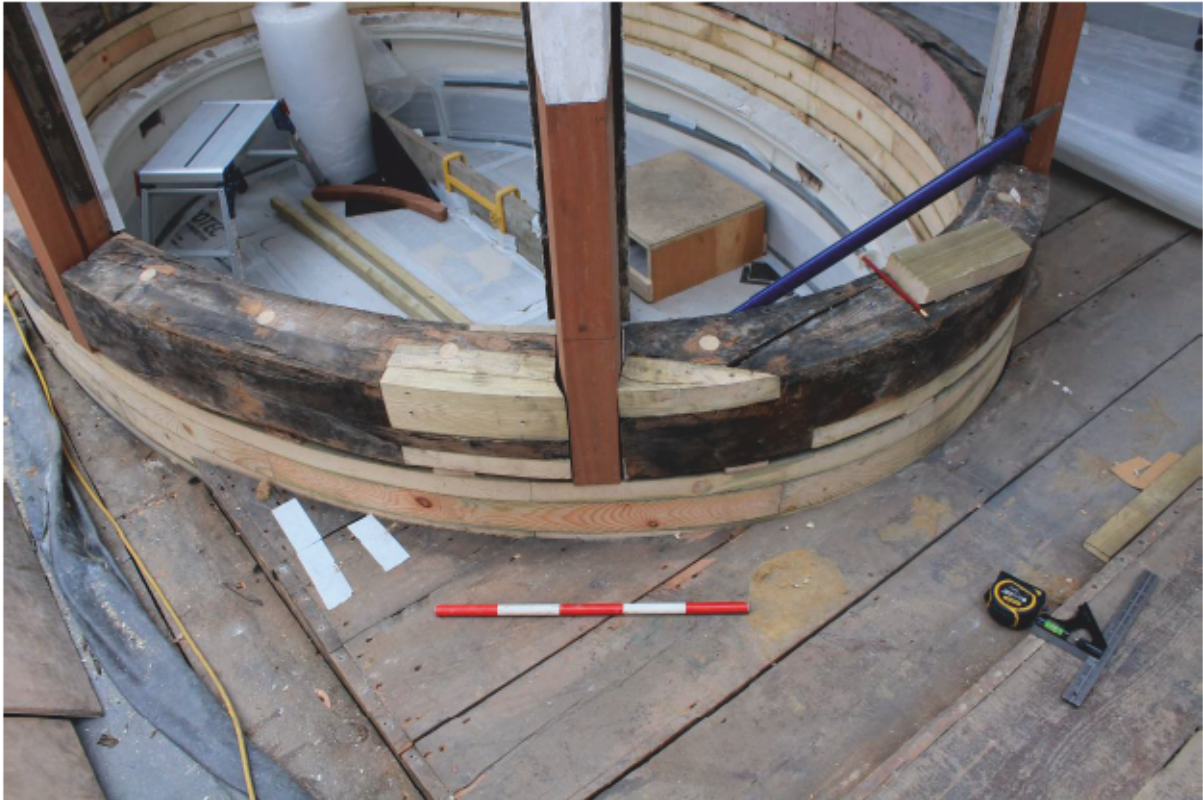
Plate 106 Lantern B: Repaired sill sections and new Sapele hardwood mullion inserts looking south-east

5.20.1 The level of the lanterns were raised above the flat roof by the insertion of a new composite softwood sill (c.280mm in height) formed from four tiers of timber sections, through bolted together to form a single composite structure (**Plates 105 and 106**). The foot of the mullions were fixed into this new structure using L-shaped steel brackets and repaired (if needed) using Sapele hardwood. The removed intermediate sill sections, original to the lanterns, were also repaired, where needed, and were drilled and through-bolted into the new composite substructure.
