A Historic Building Survey at St Nicholas' Church, Deptford, London Borough of Lewisham

Written and researched by Victoria Osborn and Alex Rose-Deacon

Pre-Construct Archaeology Ltd November 2006

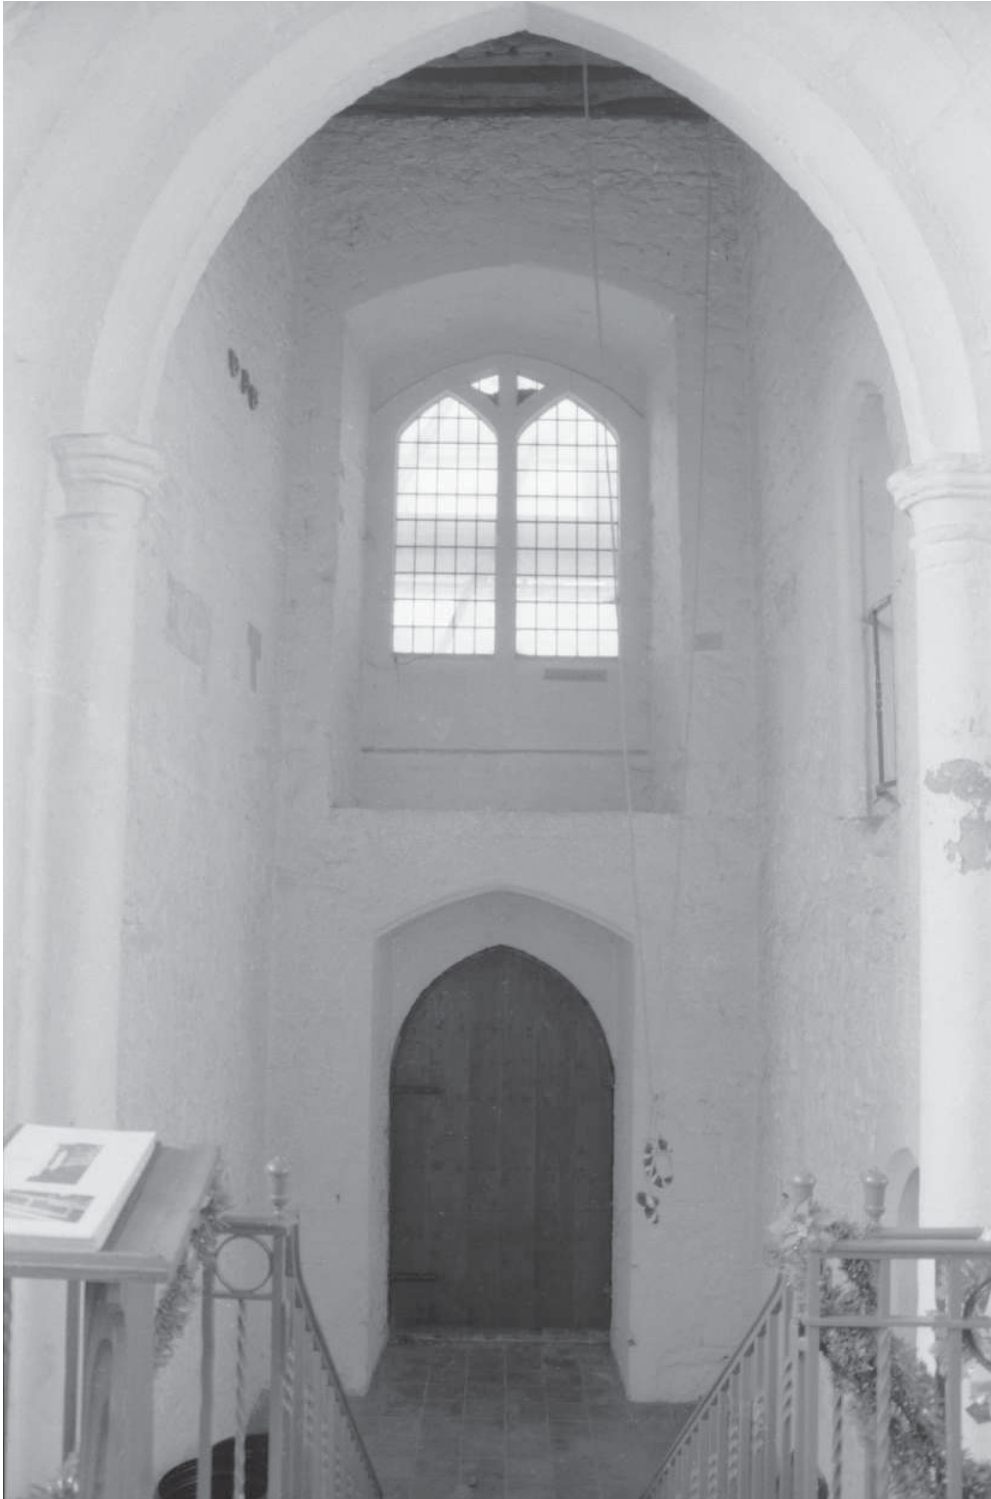
Figure 4:
View Of The Interior Of St Nicholas' Church Tower

- 5.1.4 The ground floor has a 20th century concrete floor covered with tiles, and is visibly lower at a height of 4.50mOD than the nave of the church, which is accessed from the tower space by a flight of 20th century stairs. The flight of stairs leads through a two-centred arch (Figure 4). The first floor is supported by large timber beams laid east to west, at intervals of 0.16m (6"), and has a square floor plan. In the east wall there is a 15th – 16th century squint, behind 17th century timber frames that surround the room. The royal coat of arms is hung on the exterior of the east elevation, where it may be seen from the nave of the church (Figure 4). The second floor is also square in plan and houses the cast iron bell frame with two bells still hanging (Figures 29 & 30).

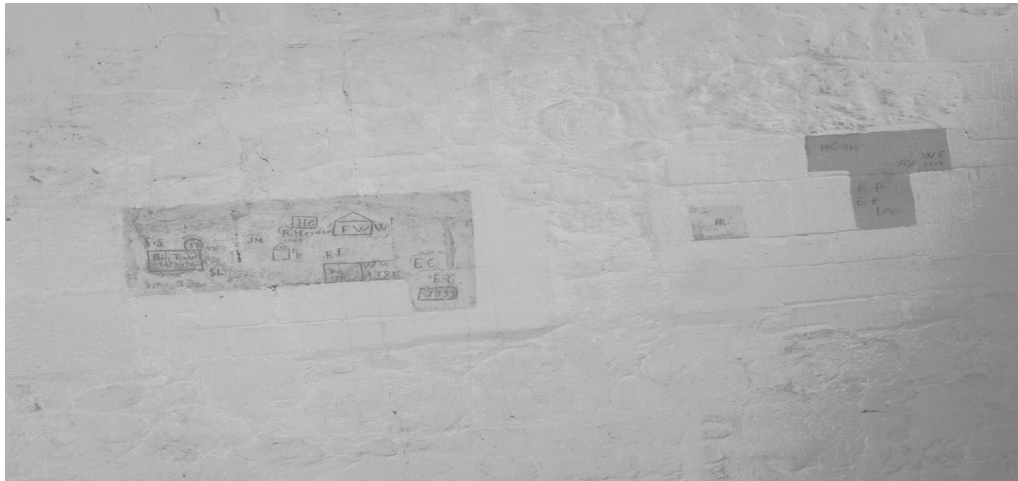
- 6.1.3 The walls of the tower space have been whitewashed, except for patches where names, initials and dates are scratched into the south and west walls. The graffiti is roughly scratched into the stone using a knife and appears in two places, adjacent to the west window and on the south walls. The graffiti on the west window (Figure 6) is later ('E.E.J. FITCH 1877'), than the graffiti on the south wall ('IK 1765') (Figure 7). A row of three small shield shaped plaques with crosses decorate the south wall. Three metres above the ground floor level on the south and north walls are a pair of mortise holes measuring 0.60m x 0.42m. These may have held a floor beam of the former gallery. Concrete inserted underneath the west window has obscured any evidence of further putlock holes or mortises.

FIGURE 7: View of 18th century graffiti on the south wall of the tower space

7.4.3 The well in front of the west door steps was demolished, filled with rubble and capped with old tombstones, one bearing a date of 1789 (P78/NIC/155). Further repairs with Roman cement were made to the exterior fabric, while inside graffiti was scratched into the south walls. The graffiti is level with the ringing gallery, and the eight initials scratched together in one place on the wall suggest some form of initiation of bell ringers (Figure 7).

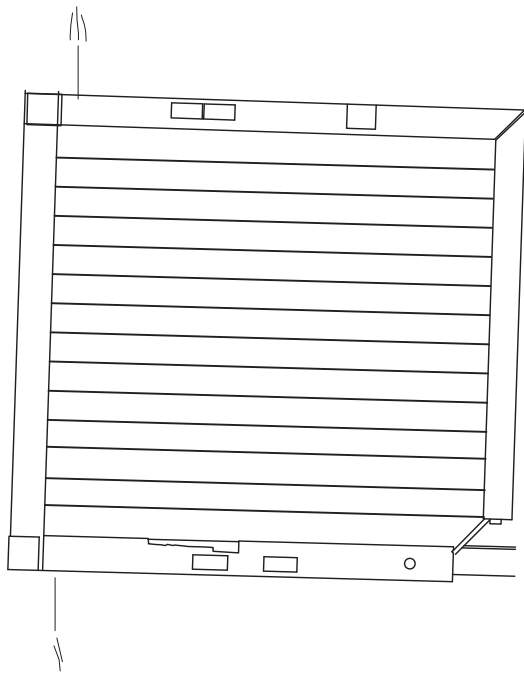
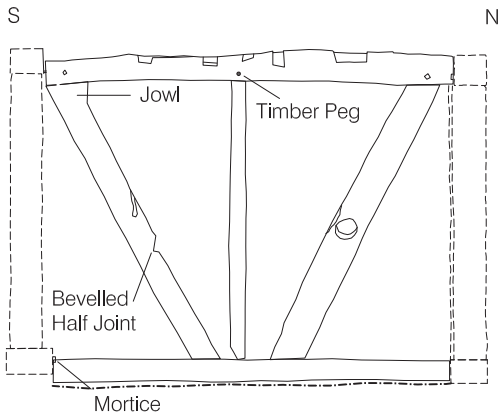
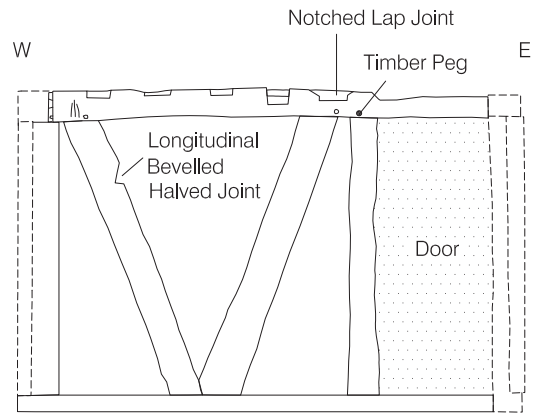
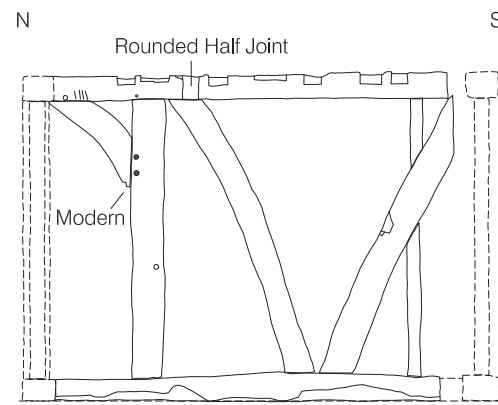
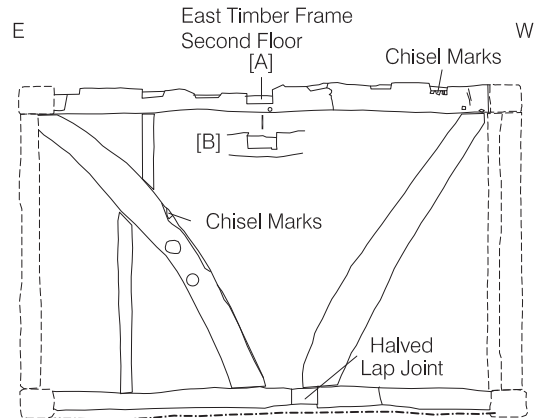
Figure 9
Timber Frames on the First Floor
1:50 at A4

6.1.5 The timber used for the joists is extremely knotty, but in good condition. The roughly square profiles indicate an early late medieval to late post medieval date (Brunskill, 1988). The following table records the first floor timbers as seen in Figure 8:

Joist Number	Type of Joint	Comments
1	Square mortise	Re-used
2	Mullion mortise	Re-used wall/sill plate
3	None visible	Original use of timber
4	None visible	Later addition
5	None visible	Later addition
6	Circular hole & half joint	Old timber building frame
7	Half joints	Re-used beam
8	None	Modern

The staircase doorway is incorporated in the north frame, which is in good condition (Figures 9 & 21). The east post has become the doorjamb, and consequently has a late 20th century lock fitted into it. The sill beam is attached to the east and west frames and runs underneath the door, acting as a threshold. The top plate, which acts as a lintel over the doorway, is attached to the west top plate with a double mortise and tenon joint. It has four single cogged joints and a notched lap joint, which may be associated with the bevelled halved joint in the west frame, and a carpenter's mark with three scratches scored into the west side.

The east timber frame is in front of the squint and is in very poor condition, particularly as it is truncated to the south by the installation of the early 20th century down pipe (Figures 9 & 20). The top plate is heavily jointed from previous uses with seven single cogged joints and a very worn half joint visible above the north brace. The bracing is supported with two modern struts, where the frame has been truncated at its south end, and the southern strut is cut with a dovetail joint. A later arch brace has been added for extra support in the north and is affixed by a round-headed nail to the top plate and by timber pegs to the post.

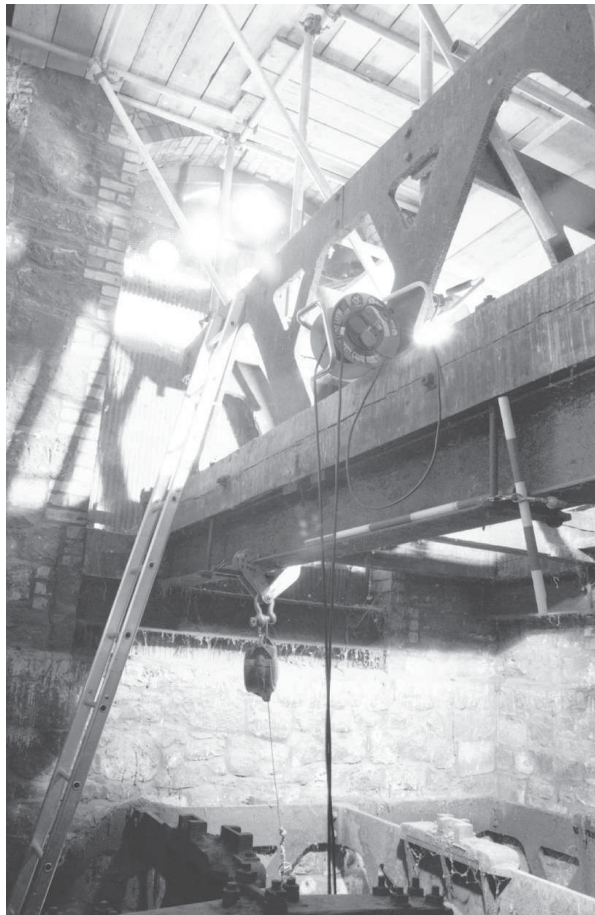
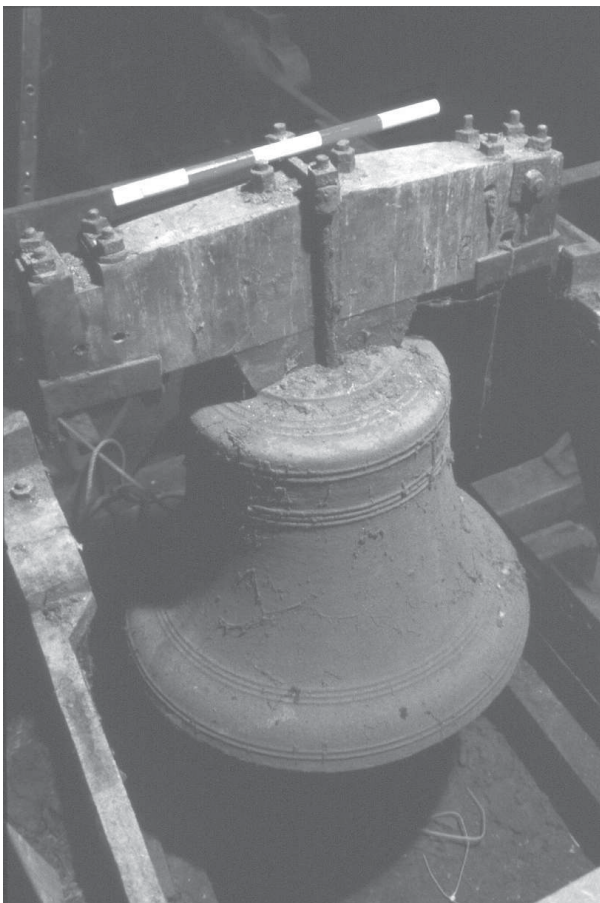
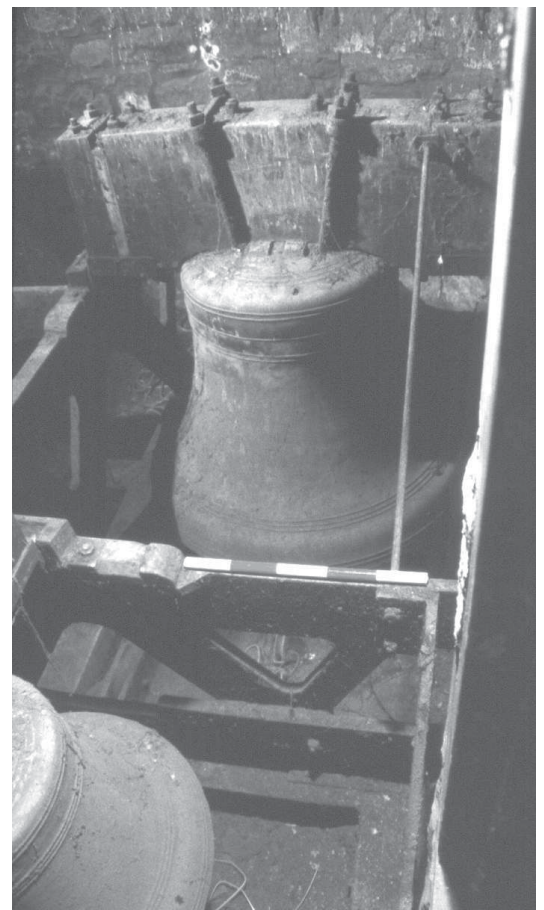
Figure 10a:
The Independent Two Tier
Cast Iron Bell Frame
Second Floor

6.3.2 John Warner and Sons re-installed the cast iron bell frame, consisting of two independent tiers, in 1904. The frame consists of single cast iron Y plate trusses, 1.14m long, 0.89m high and 28.5mm (1 ¼ " thick), bolted together with hexagonal bolts which indicate an early 19th century date. The lower tier is a complex frame consisting of five bell pits with the bells hung to swing in two directions. The main north to south sections are 1.79m long while the east to west sections are 2.32m long. The frame fills the second floor, measuring 3.33m x 3.53m, and is bolted with square bolts to oak beams below. The upper tier is a simple frame consisting of three parallel bell pits 1.65m above the lower frame. The bells in the upper frame would have swung in one direction. The main north to south sections are 3.69m long while the east to west sections are 2.43m long, and consequently the upper tier is only partially suspended over the lowest. The frame is supported on an inserted steel I beam with 8° tapered flanges, dating to the early 20th century. A treble and tenor bell are hung in the lower tier without their wheels, to be rung as tolling bells (Figure 10). There are no bells in the upper tier. The following table describes the bells:

Bell	Weight	Diameter	Cast	Founder	Inscription
1 (Treble)	5 ¼ cwt	30"	1701 Cripplegate	Samuel Newton Isaac Hadley	1701
2 (Tenor)	29 ¼ cwt	49"	1842 Cripplegate	Thomas Mears II	Thomas Mears Founder London 1842 Rev AE Skethchley MA Vicar, Charles Barlee, William Knott

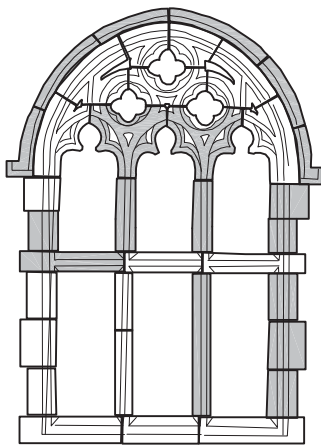
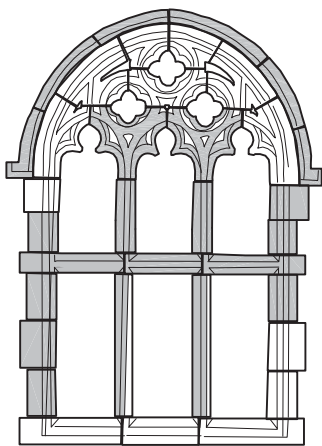
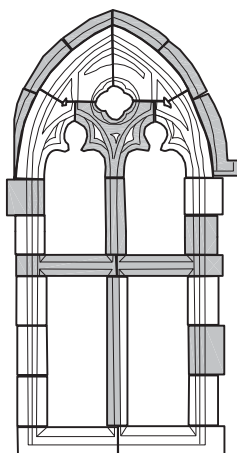
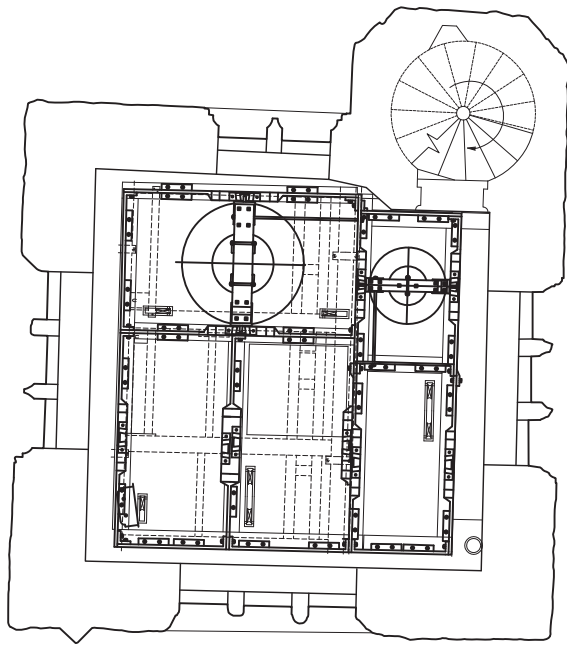
Figure 12
Detail of the second floor opening tracery
1:75 at A4

- 6.4.3 The openings at second floor level were built to transmit the sound of the bells. The north elevation tracery opening has a two centred arch, a central mullion composed of two substantial blocks of limestone and transom covered with timber louvre boards (Figure 12). The tracery consists of simple moulded blocks of limestone forming a central quatrefoil and two foils at the top of the upper lights. It has been built into the west elevation of the stair turret, creating a partial springer and losing the long jamb stones and stop on the east side of the opening. Because of its fairly poor condition, with the centrally moulded stones worn and smooth from weathering, it was replaced during the conservation works.

- 6.4.4 The openings of the west, south and east elevations are larger openings, but of similar construction with two mullions instead of one (Figure 12). The tracery on each of these openings consists of nine moulded blocks of limestone forming three quatrefoils and three foils below. The simple hoodmould is formed of two stops and springers with four voussoirs. The east elevation opening is in good condition and has suffered less weathering than the west and south openings, although one mullion has been replaced during the conservation works and is now composed of two limestone blocks. The south window was in very poor condition and the whole tracery opening was replaced during the survey.

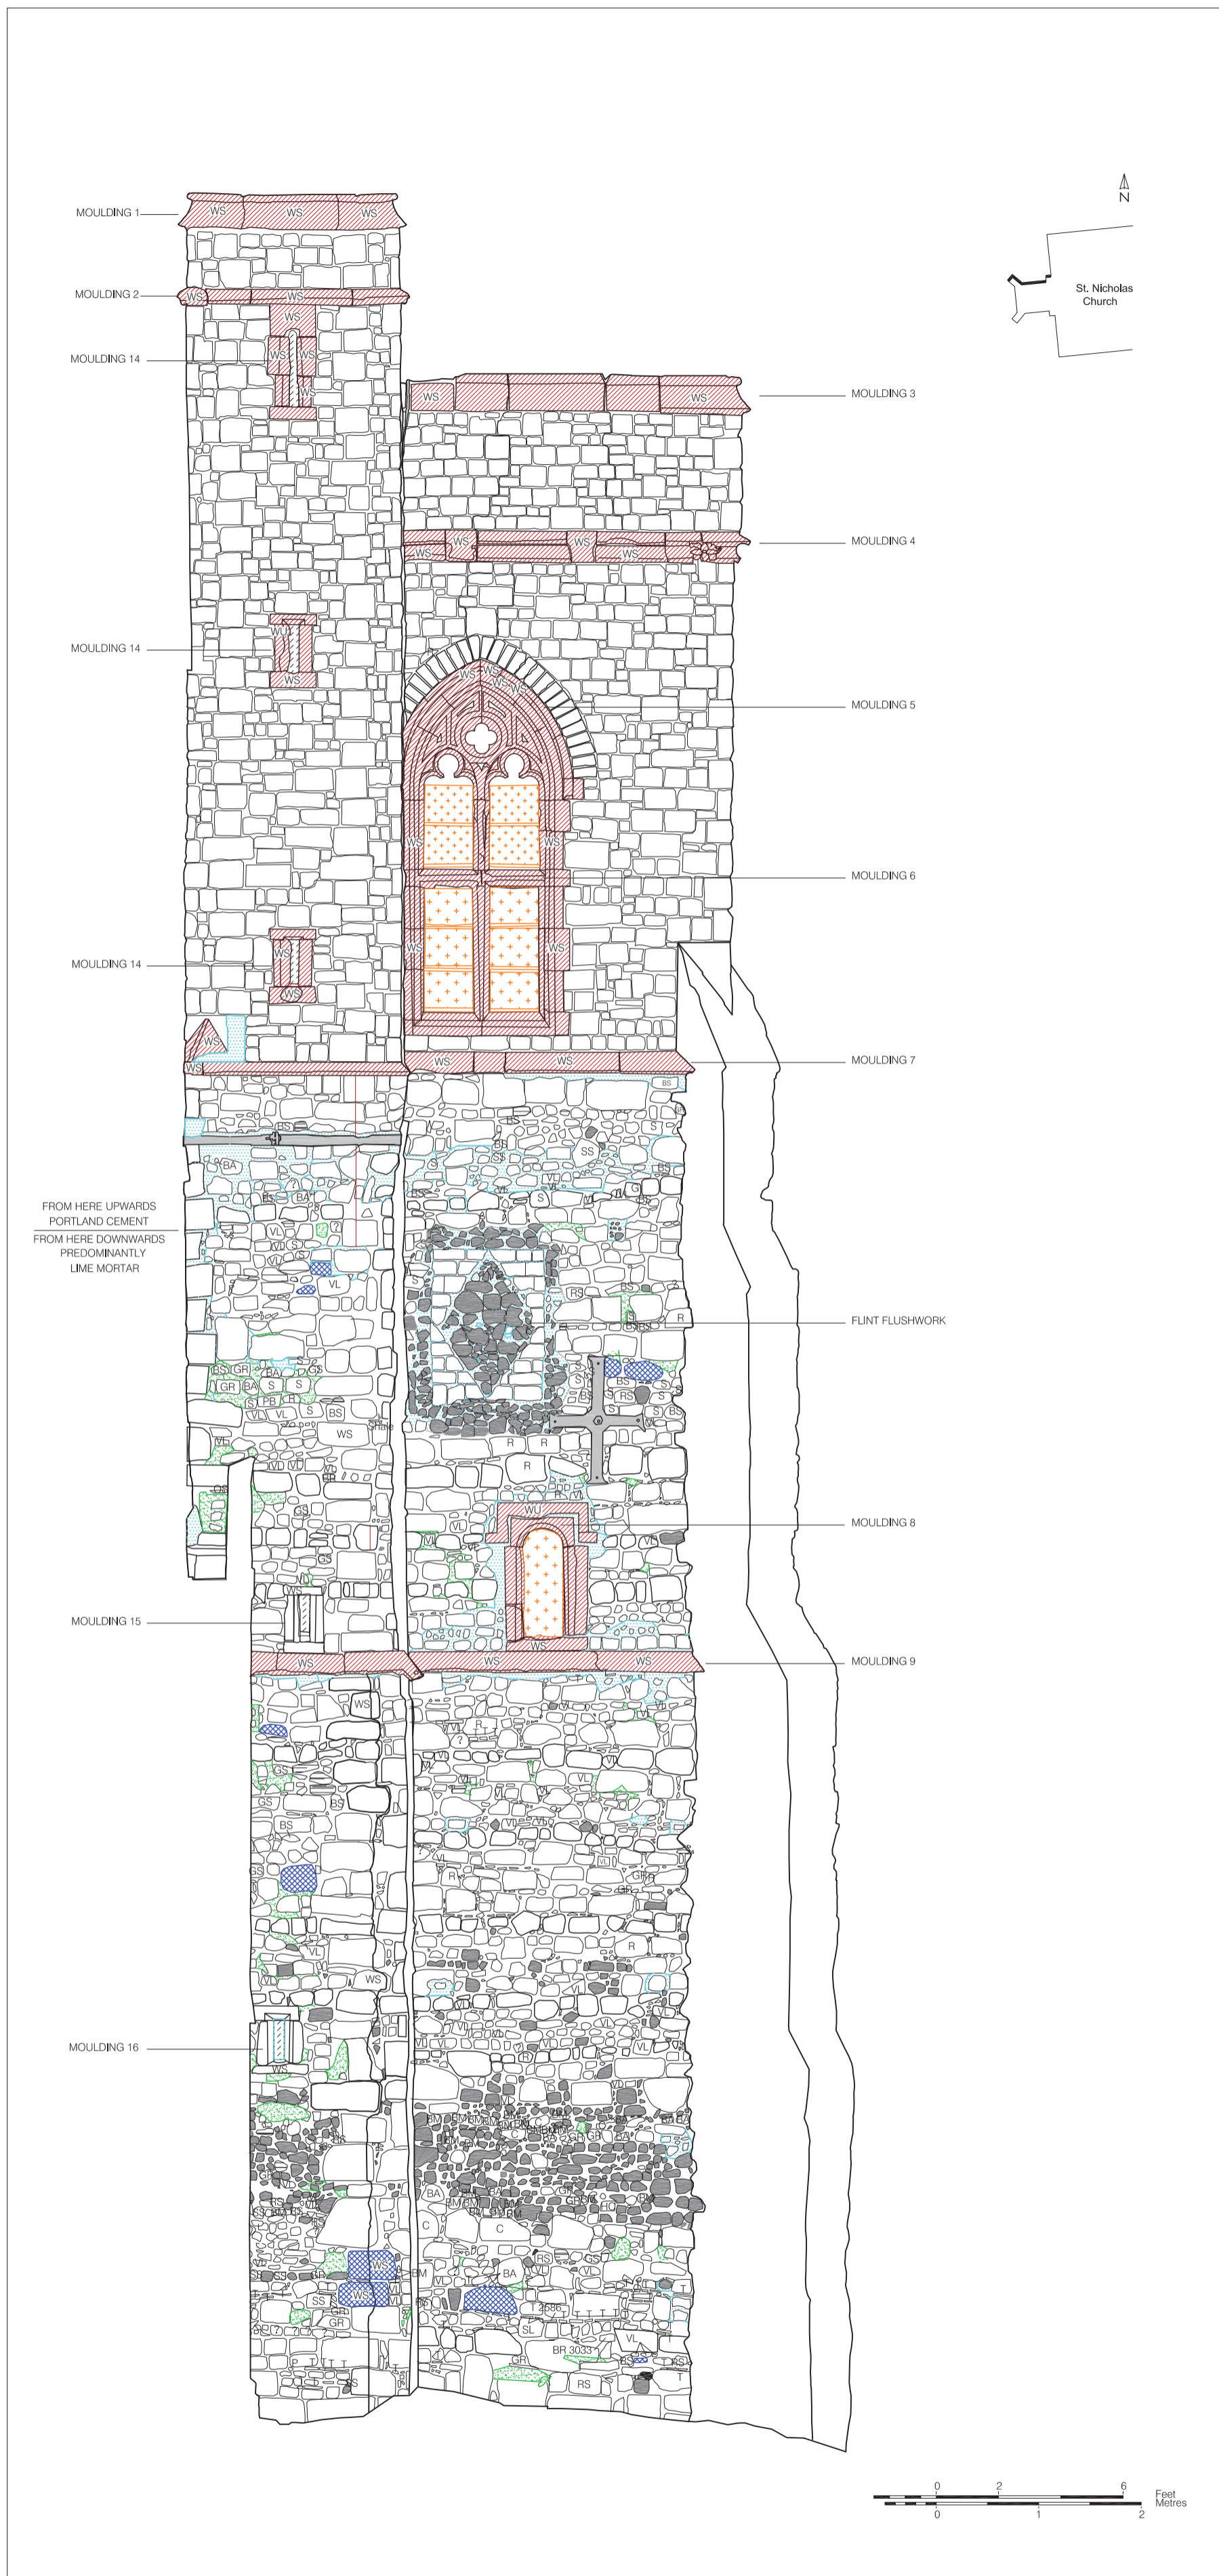
Figure 43
North elevation - pre-conservation survey
(For key to building material see Appendix 1, Figure 16)
1:50 at A2

- 5.1.8 The stair turret fenestration consist of small rectangular windows formed with a surround of large blocks of laminated limestone set in oyster shell mortar and partially re- pointed with Roman cement. The lowest window is 2" away from the 1697 church wall, with its stone lintel partially hidden behind it. The window above the first floor stringcourse is level with the opening in the north elevation. It is set further away from the church wall at 0.32m. There is no evidence that the windows were originally glazed, though they are currently glazed with modern glass. Above the second floor stringcourse the openings are characterised by gothic tracery decorated with simple moulded blocks of laminated limestone in the form of foils (Figure 43).

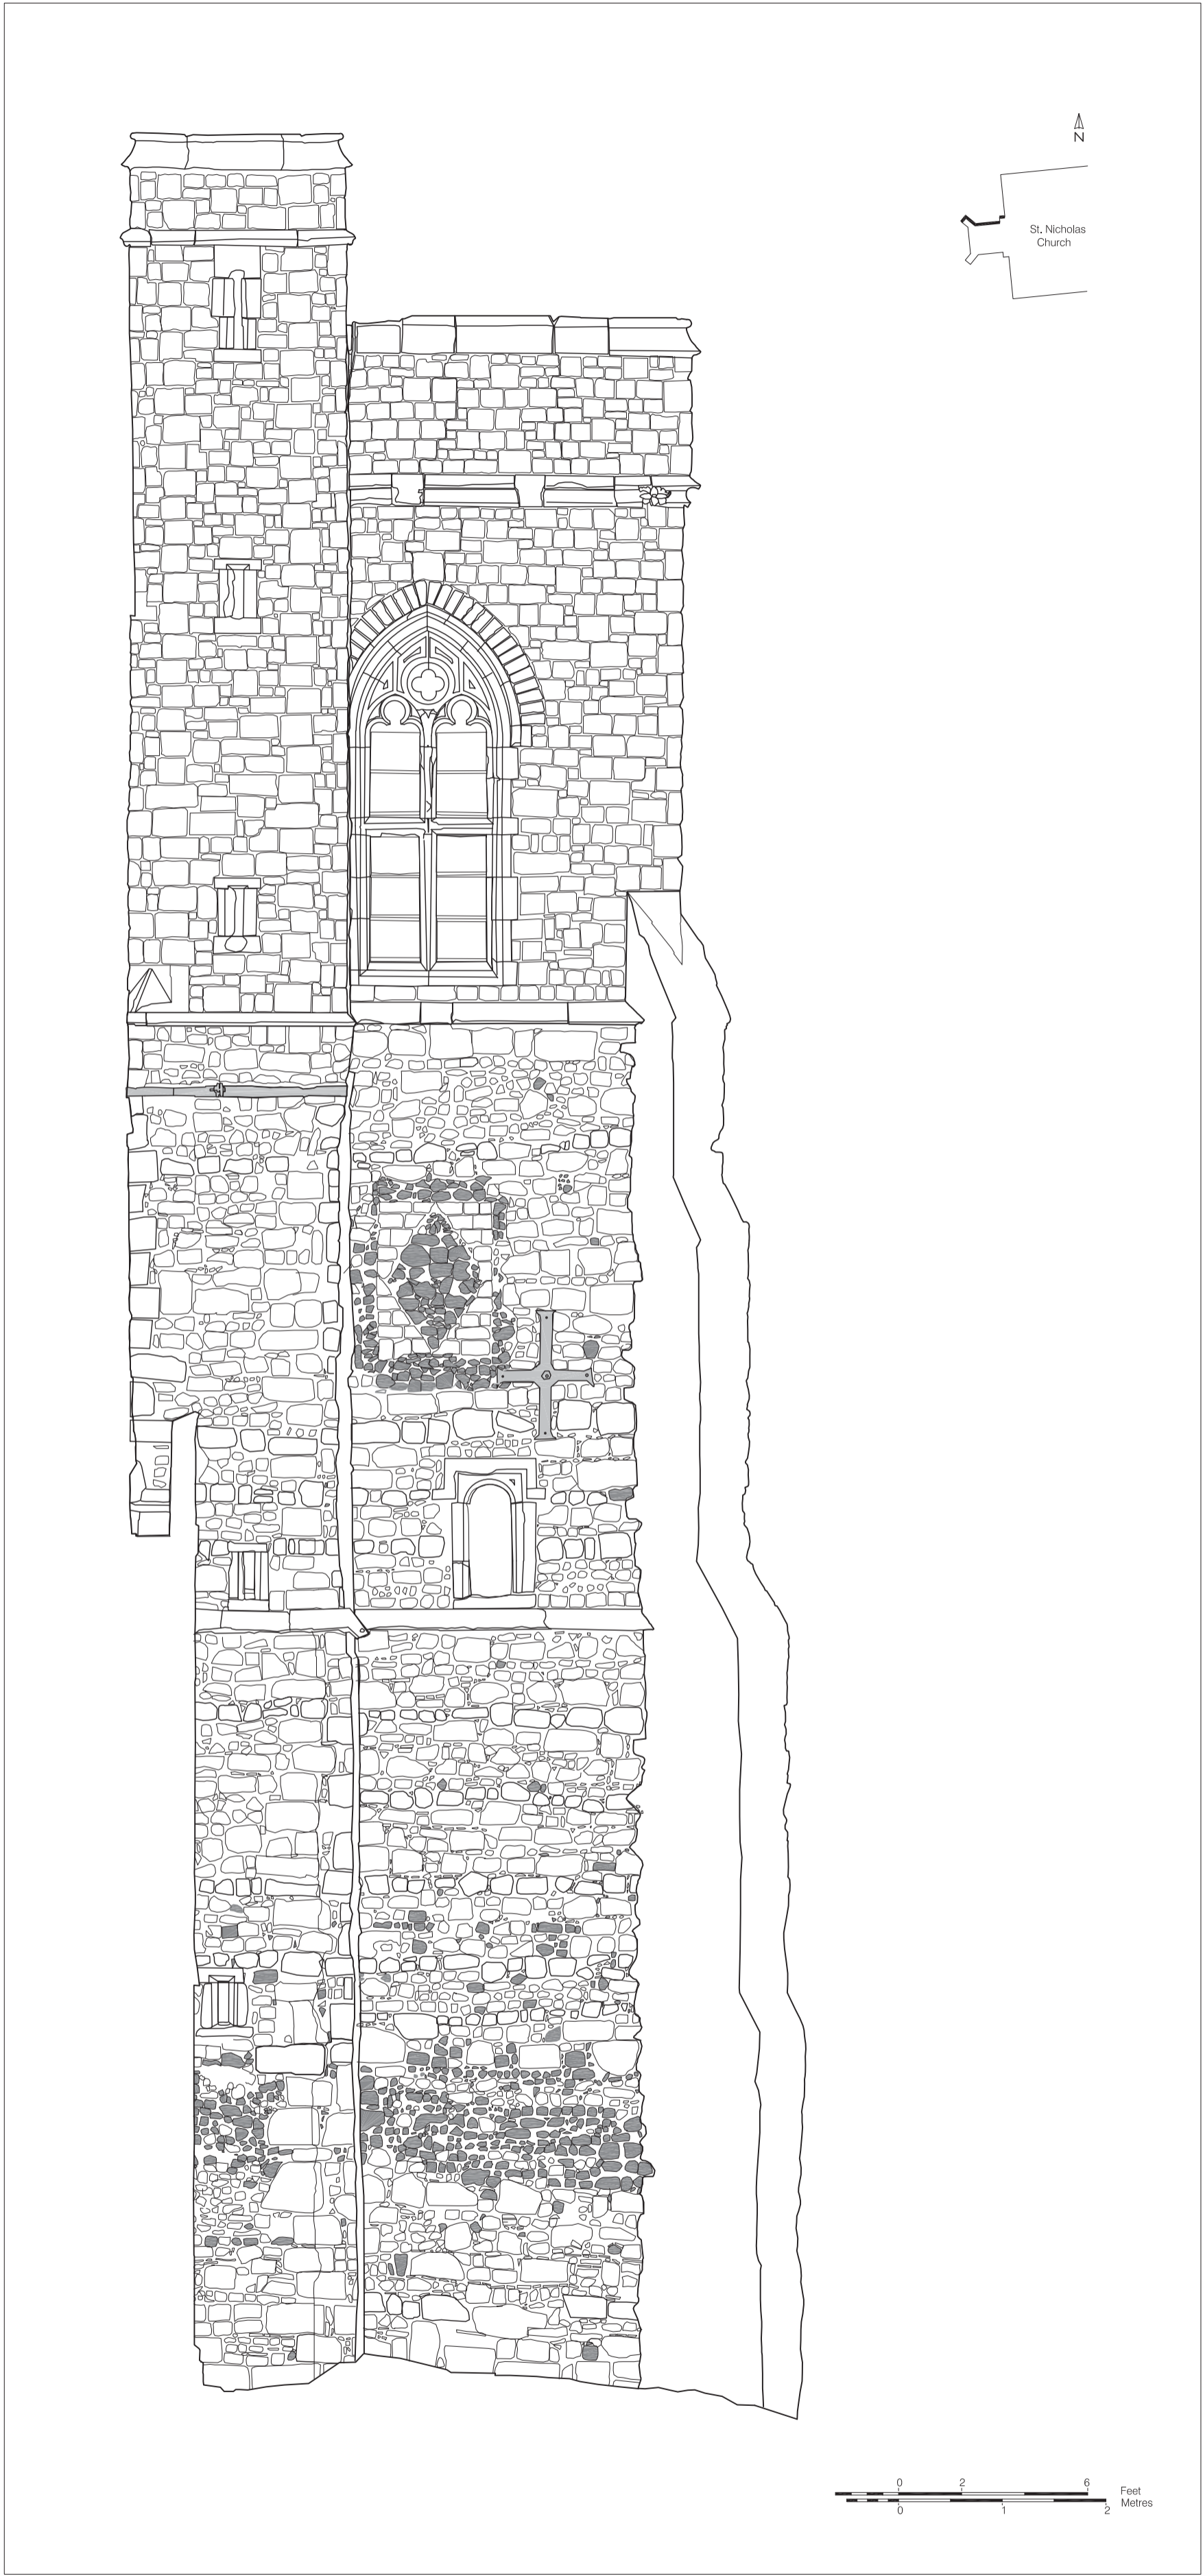
Figure 44
North elevation - historic building survey
(For key to building material see Appendix 1, Figure 16)
1:50 at A2

- 6.2.9 The north elevation of the northeast stair turret (Figure 44) has unaligned windows and two plain laminated limestone stringcourses towards the middle and top of the elevation. The lowest window is 2" away from the 1697 church wall, with the stone lintel partly obscured by the wall. The opening above the first floor stringcourse is set further away from the church wall at 0.32m. The lowest seven metres, below the first floor stringcourse in the northwest elevation of the stair turret, are different in construction and bonding, comprising large Kentish ragstone blocks across the whole of the face (Figure 60). From the ground level, a straight mortar joint extends 1.90m before flint pebbles are used to fill the mortar joint between the turret and the north tower wall. The stones of the north wall of the tower and the turret are not tied into each other until a height of 3.41m, just above the pebbles of the straight mortar joint. The quoin stones at the north west corner of the turret step in and out. The most obvious are four stones 1.65m above the modern ground level. These stones are set out from the turret wall by 0.10m, indicating that they are later than the surrounding works. They have been re-pointed with an oyster shell rich mortar.

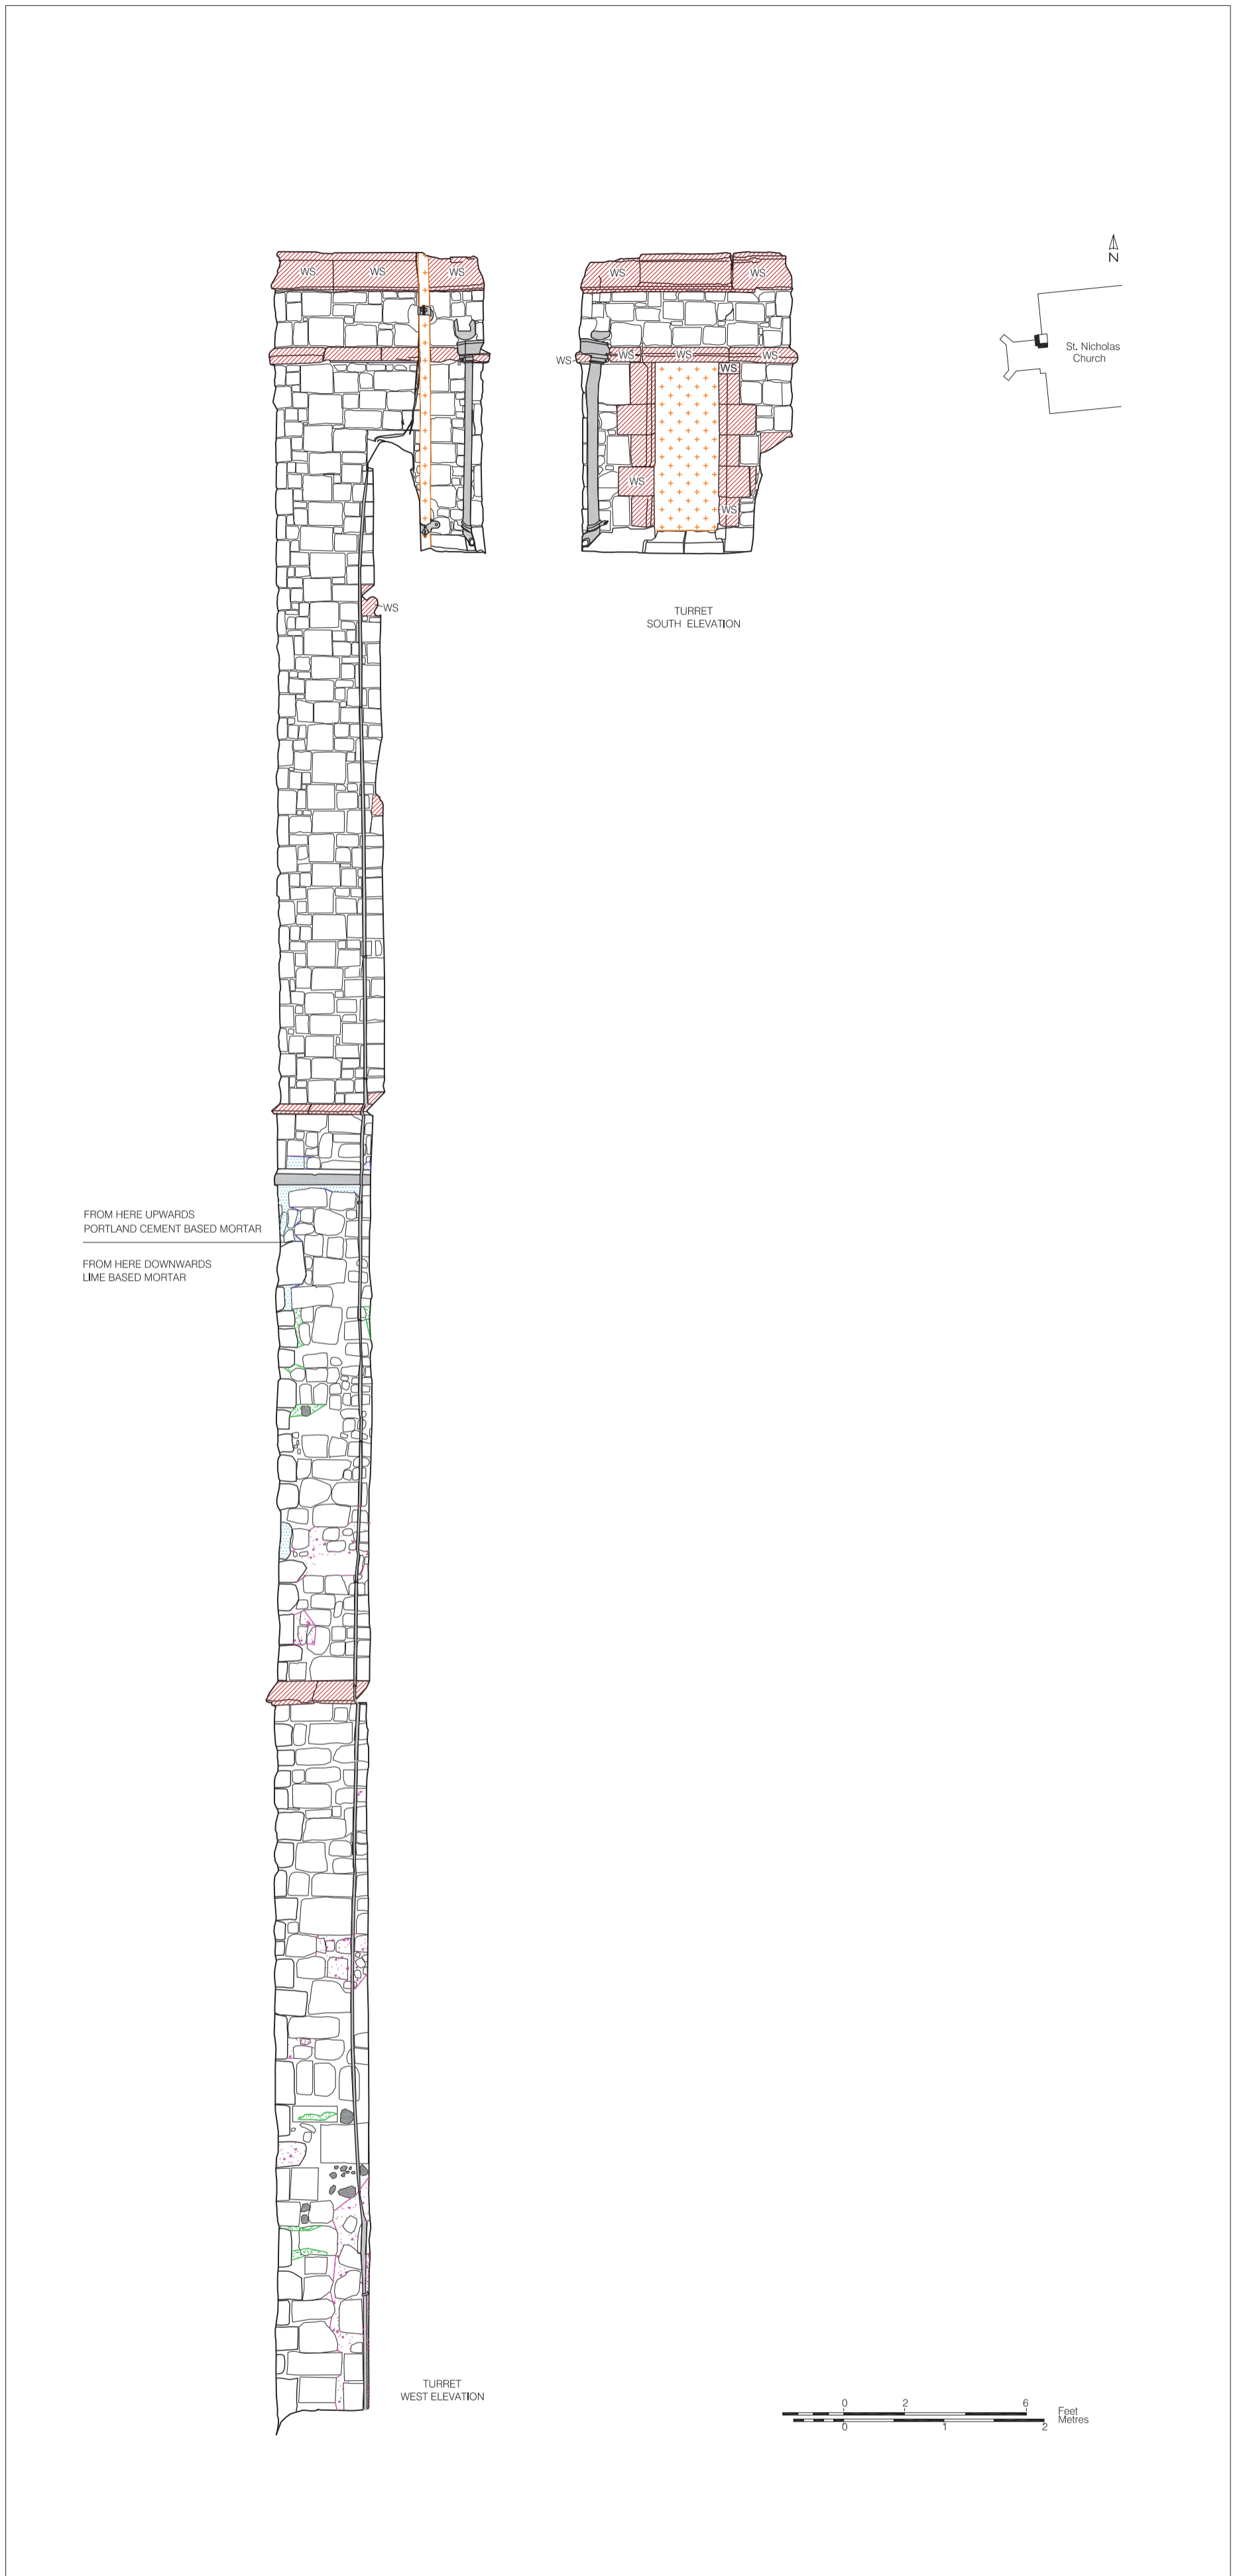
Figure 59
Northeast stair turret - pre-conservation survey
(For key to building material see Appendix 1, Figure 16)
1:50 at A2

5.1.13 The clasped buttress (Figure 59) contains the stone newell post staircase at the northeast of the tower. The 1697 brick wall abuts onto the stair turret. A vertical mortar joint adheres the northwest facing elevation of the stair turret to the north tower wall. This stair turret elevation is different in construction and bonding from the other buttresses.
