**HISTORIC BUILDING RECORDING  
OF FARM BUILDINGS  
TO THE REAR OF  
SCHOOL HILL FARM HOUSE,  
CHURCH STREET,  
FENNY COMPTON,  
WARWICKSHIRE,  
CV47 2YE**

**PCA REPORT NO: R13125**

**DECEMBER 2017**

Historic Building Recording

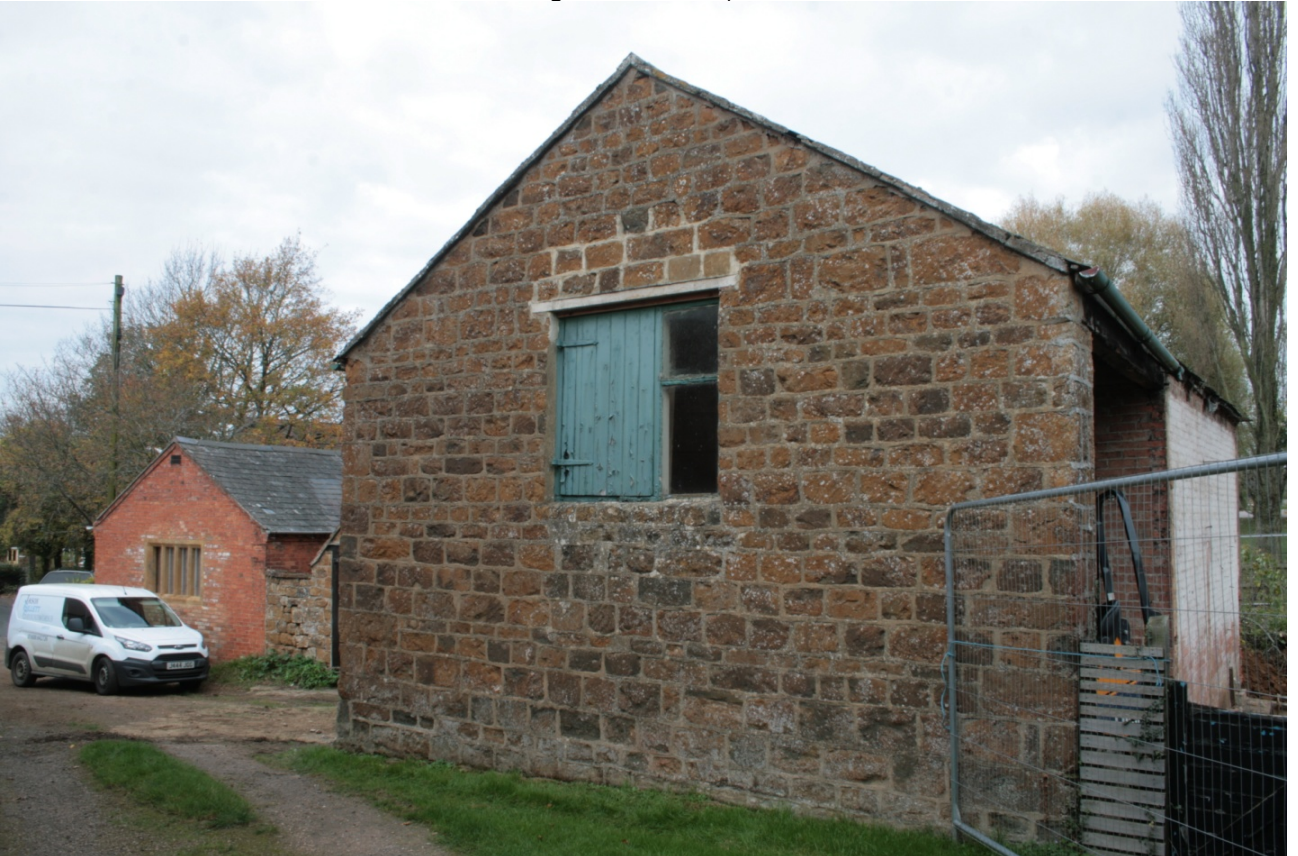
- 6.3.2 Its west, south and north external elevations were constructed entirely of coursed ironstone (**Plates 24, 25 and 29**). The west elevation has a set of large full height double doors at its south end, suitable for a fully laden hay wagon (**Plates 24 and 31**). The south elevation has a square opening at high level fitted with a fixed window on its east side and a hinged timber shutter in its west side (**Plate 25**), possibly an opening for pitching hay. The east wall was mainly constructed of brickwork in stretcher bond, which had been white washed externally (**Plate 27**), showing that it formed the internal wall of a removed building to the east. This building is shown on maps from 1887 and had been removed recently as part of the current works (**Figures 5 to 8**).

Plate 25: South gable of main barn (Building B), looking north (CSFS17 D100 (59)) (viewpoint on Figures 9 and 11)

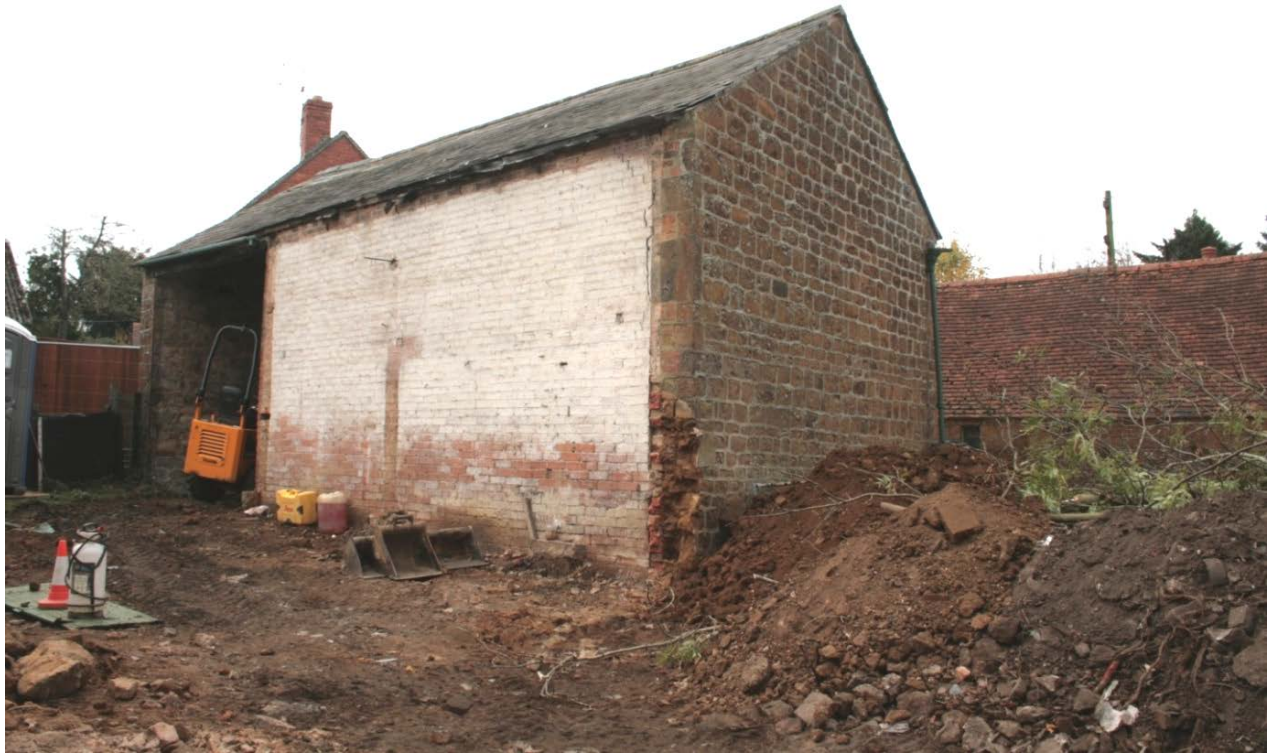
Plate 27: East elevation and north gable of main barn (Building B), looking south-west (CSFS17 D100 (64))  
(viewpoint on Figures 9 and 11)

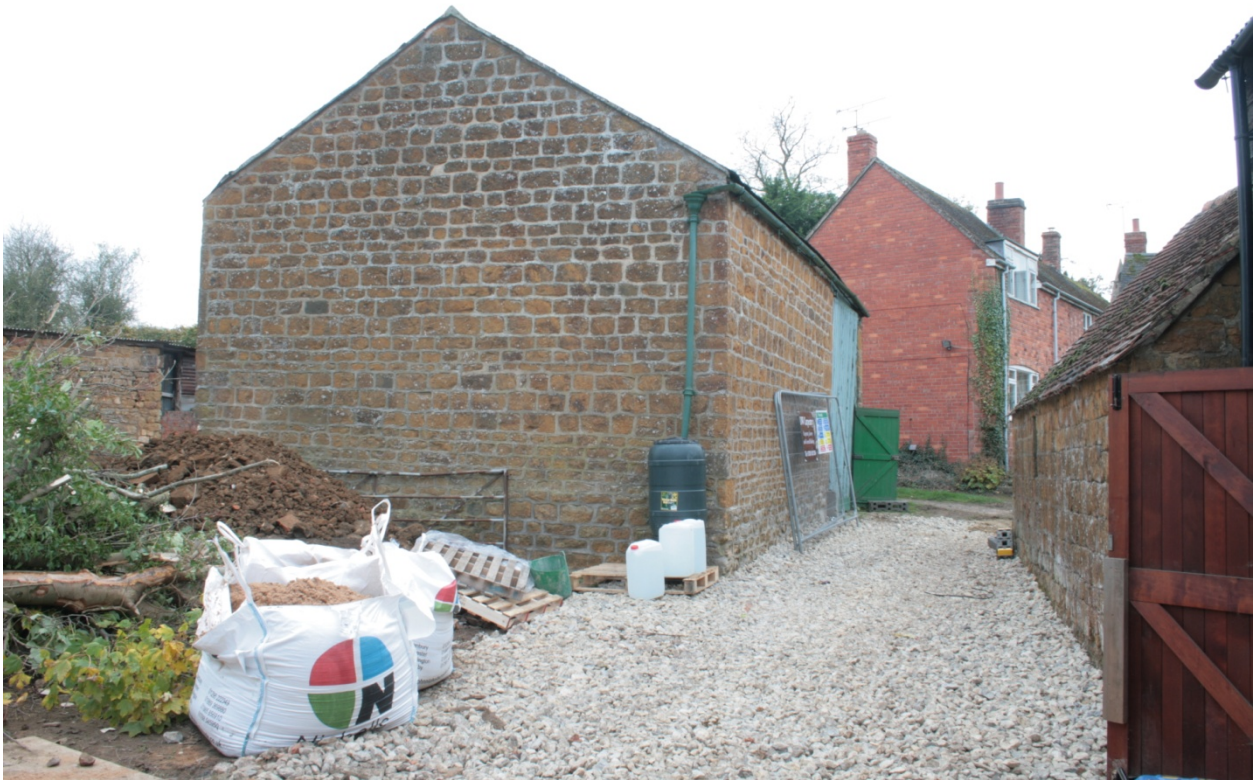
Plate 29: North gable of main barn (Building B), looking south (CSFS17 D100 (76)) (viewpoint on Figure 9)

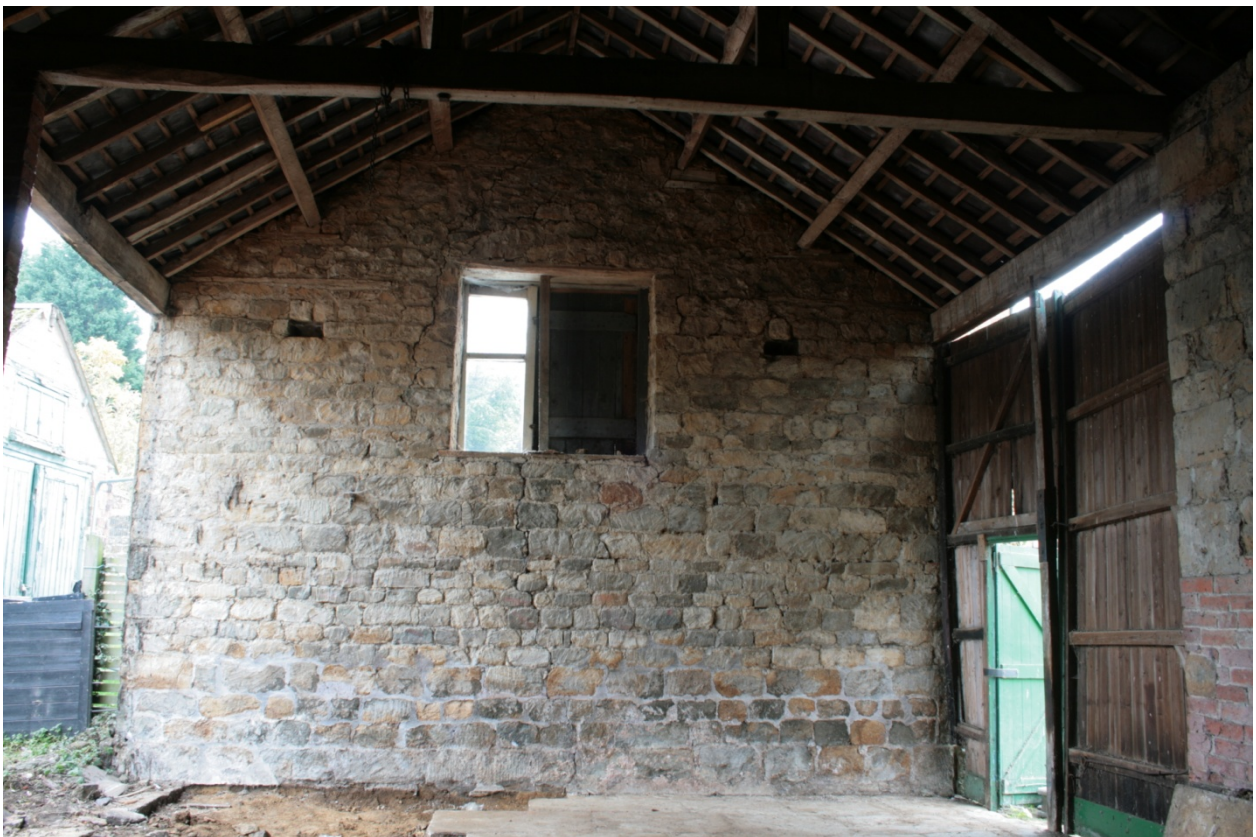
6.3.3 The south wall and upper part of the west and north walls were constructed of ironstone internally (**Plates 30 to 35**), while the lower part of the internal west and north walls of Building B were constructed of red brickwork in stretcher bond with the occasional header (**Plates 32 to 34**). This brickwork is late 18<sup>th</sup>/early 19<sup>th</sup> century in appearance. The brickwork in the east wall was different to the brickwork in the lower part of the north and west walls (**Plate 36**). The courses of brickwork in the lower part of the north wall did not line up with that in the east wall, suggesting that the latter was a later addition, although this brickwork is also late 18<sup>th</sup>/early 19<sup>th</sup> century in appearance. Internally, the floor at the south end of the building is covered with flagstones (**Plates 30 to 32**).

Plate 30: South internal gable wall in main barn (Building B), looking south (CSFS17 D100 (34)) (viewpoint on Figure 11)

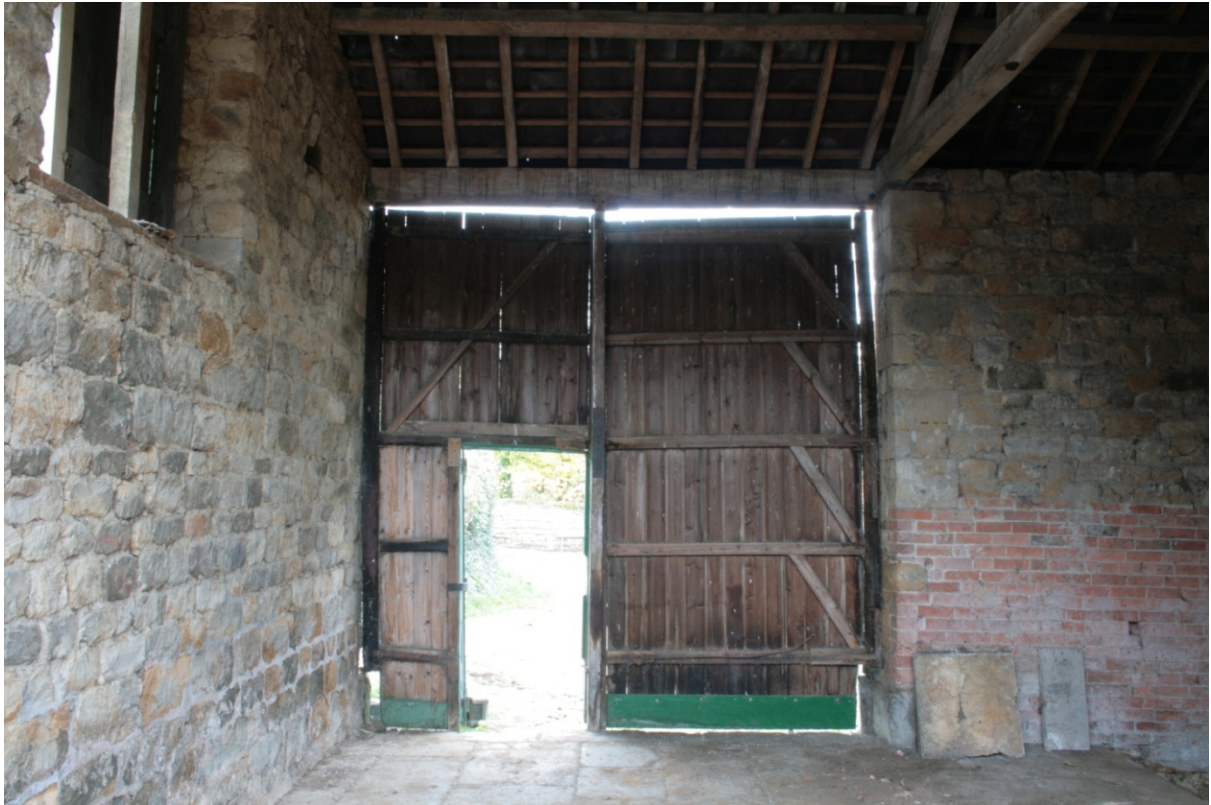
Plate 31: Front west barn door in main barn (Building B), looking west (CSFS17 D100 (35)) (viewpoint on Figure 11)

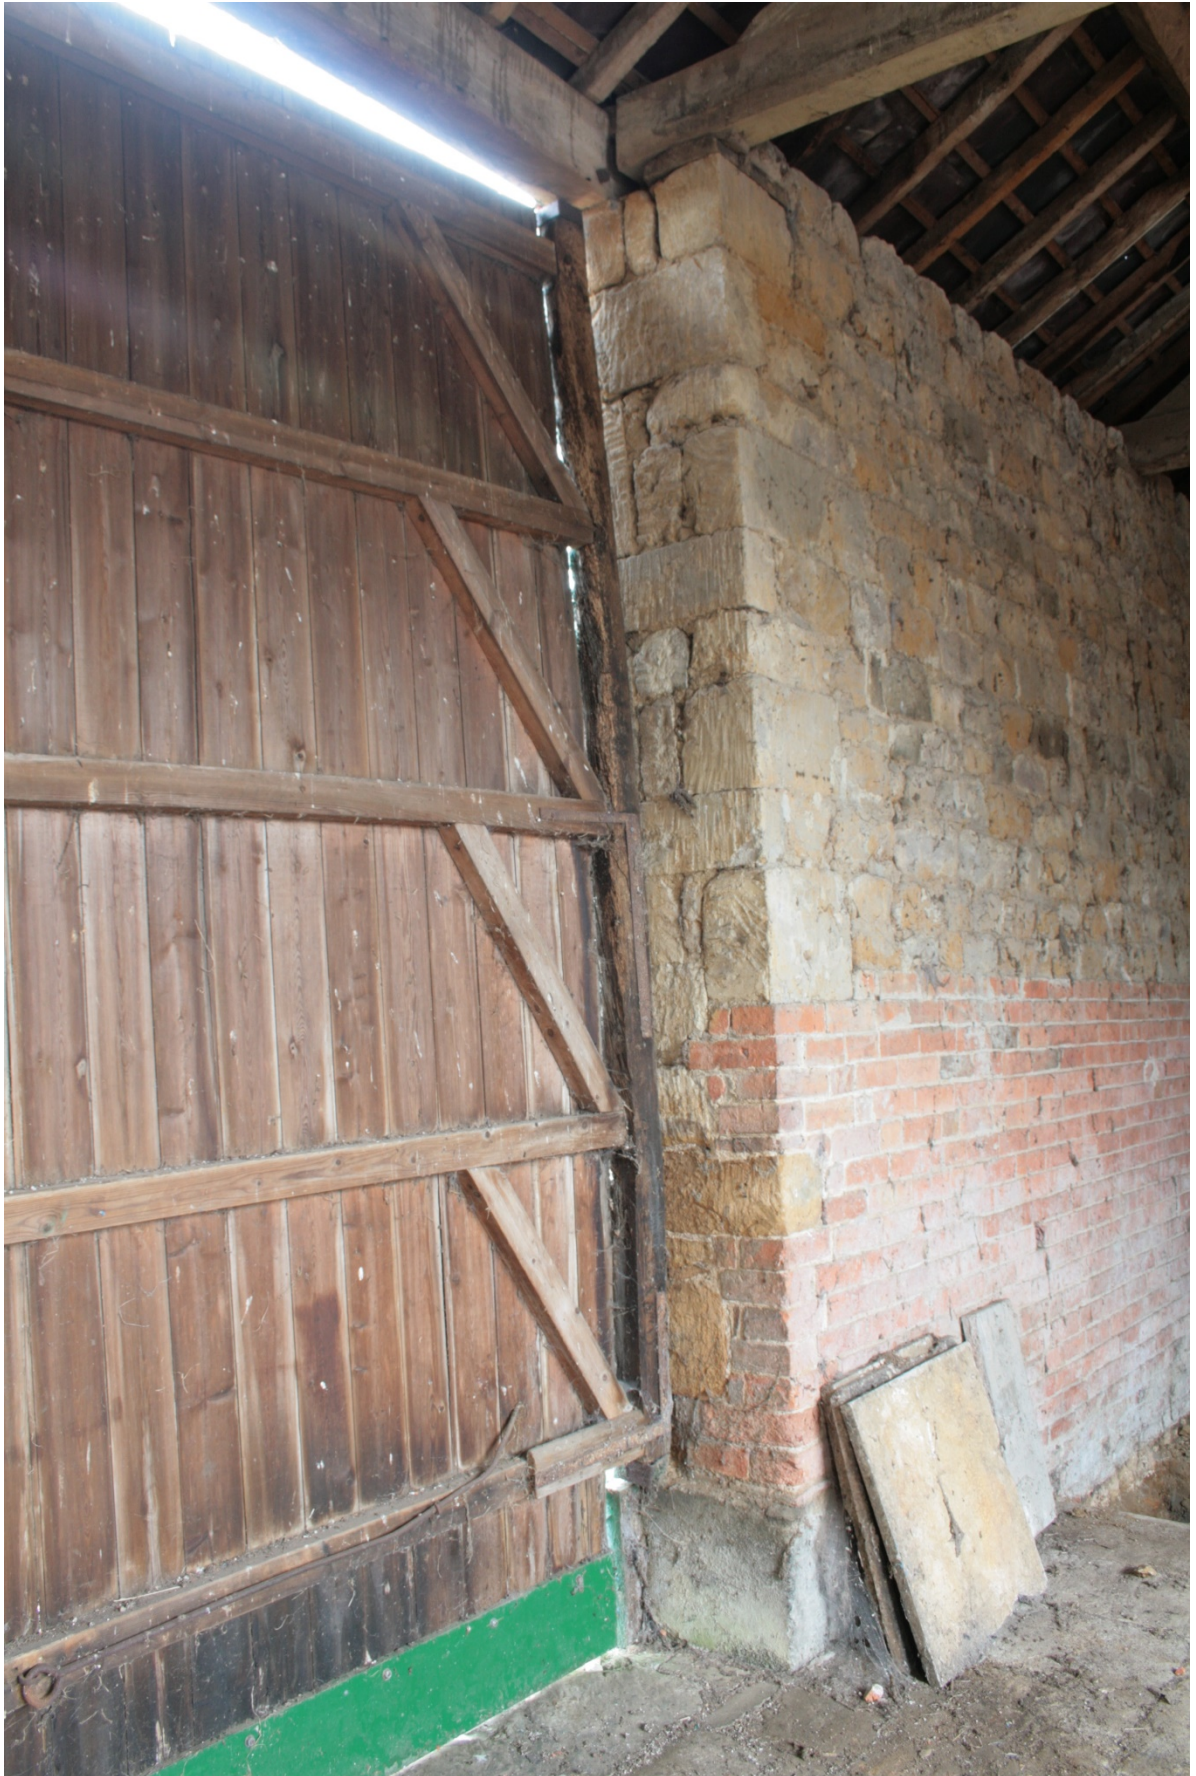
Plate 32: North side of front west barn door in main barn (Building B), looking north-west (CSFS17 D100 (38)) (viewpoint on Figure 11)

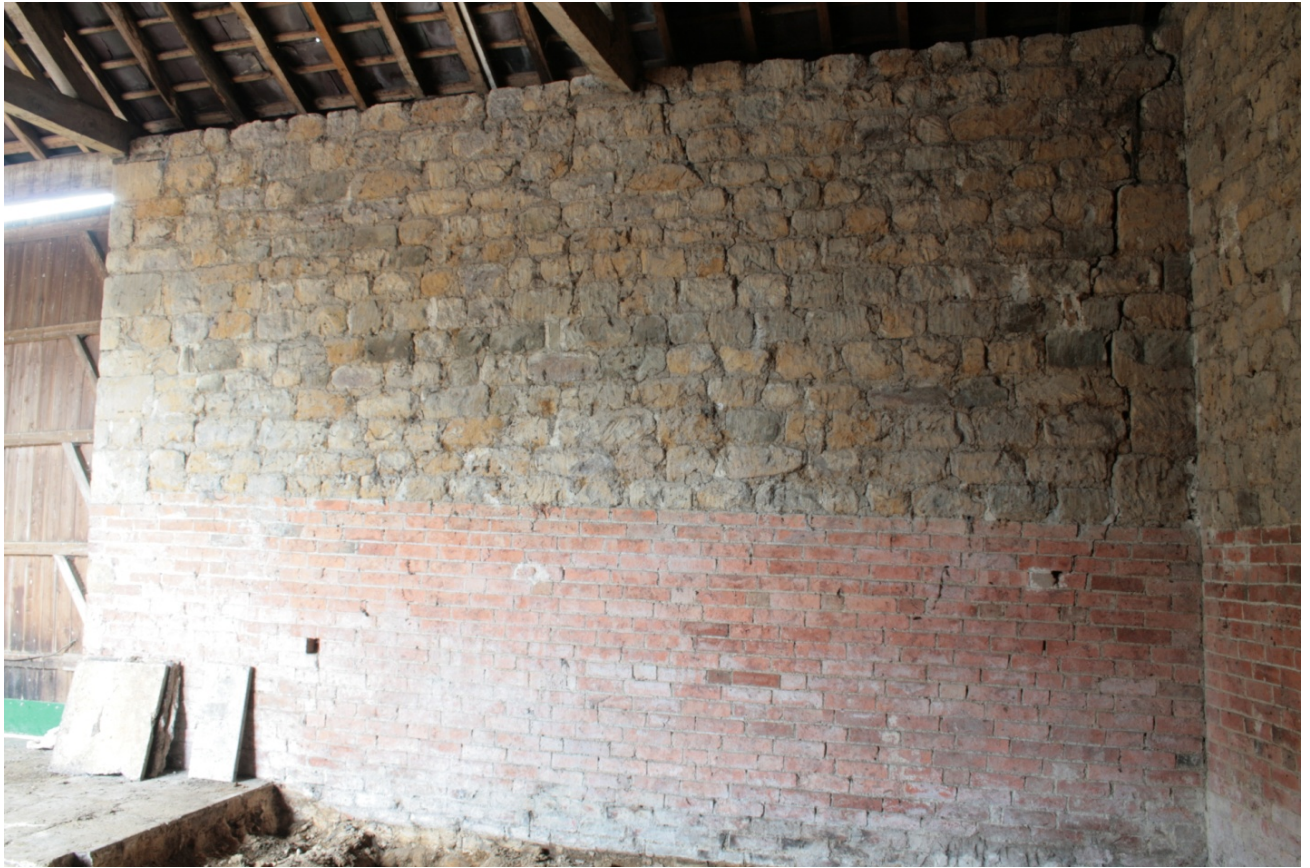
Plate 33: North end of internal east wall, looking west (CSFS17 D100 (10)) (viewpoint on Figure 11)

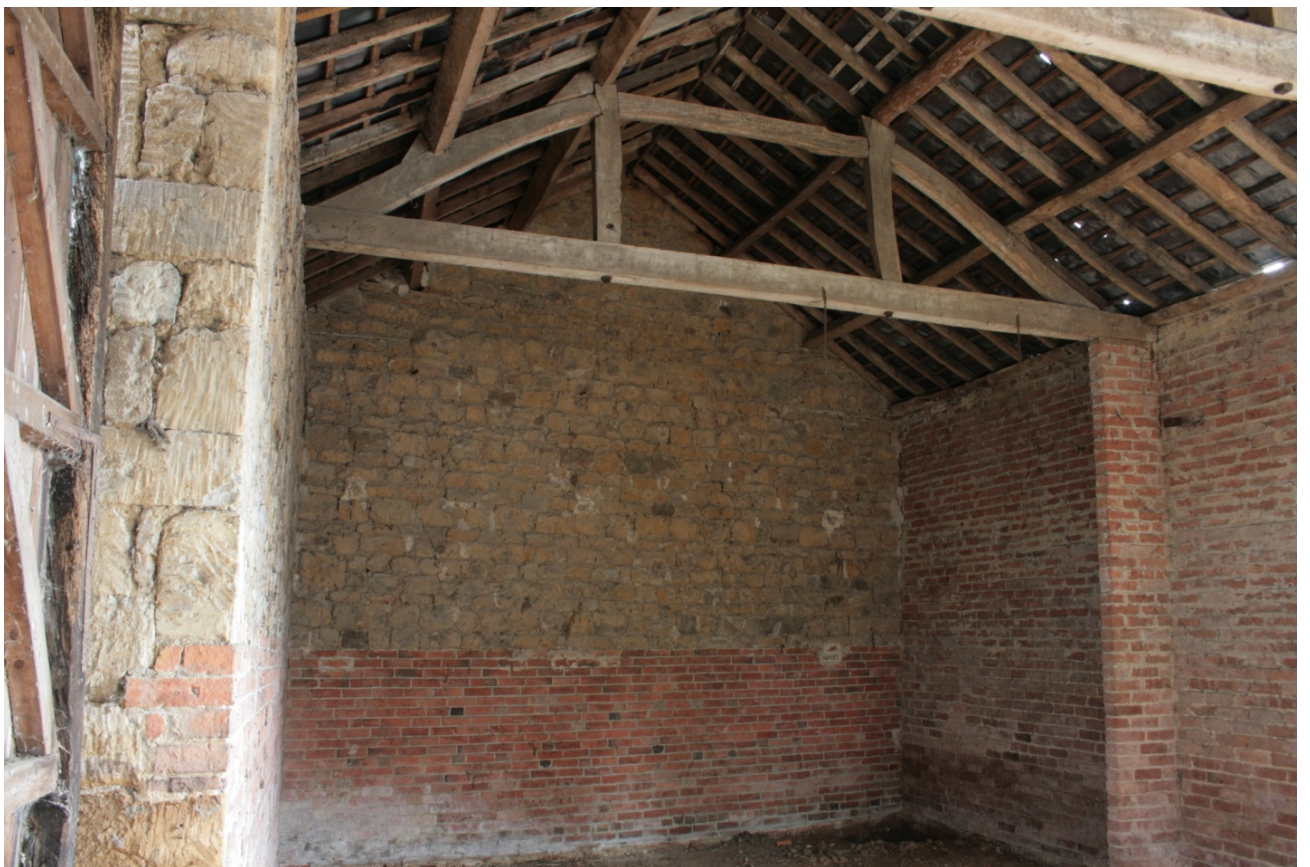
6.3.5 The building has two queen post roof trusses, which divide the building into three bays (**Figure 11; Plates 34, 38 to 40, 42, 43**). The trusses rest on the top of the west wall (**Plate 39**) and on two brick piers in the east wall (**Plates 34 and 41**). As in Barn A, wrought iron square-headed bolts are visible in the soffits of the two tie-beams, one below each queen post, and are used to pull the truss into tension (**Plates 38, 42 to 46**). Back cleats support the two purlins (**Plate 39**). A small king strut above the collar of the south queen post truss holds the ridge up. (**Plates 42 to 46**). The trusses are late 18<sup>th</sup>/early 19<sup>th</sup> century in appearance. Above the trusses, the roof has been replaced in the 20<sup>th</sup> century with purlins supporting machine-cut, softwood common rafters with a thin ridge board (**Plates 38 to 46**). This part of the roof is similar to that over Building A and presumably the two buildings were reroofed at the same time.

Plate 34: North gable of the main barn (Building B), looking north (CSFS17 D100 (37)) (viewpoint on Figure 11)

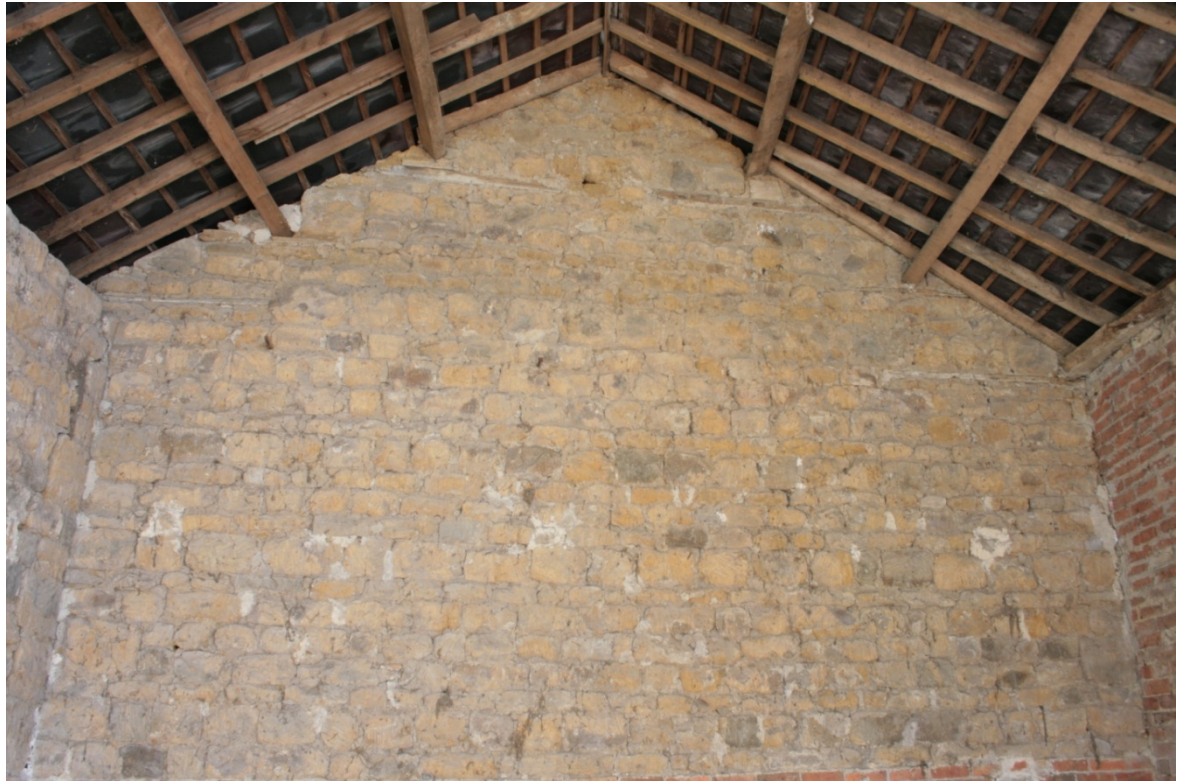
Plate 35: North gable wall in main barn (Building B), looking north (CSFS17 D100 (8)) (viewpoint on Figure 11)

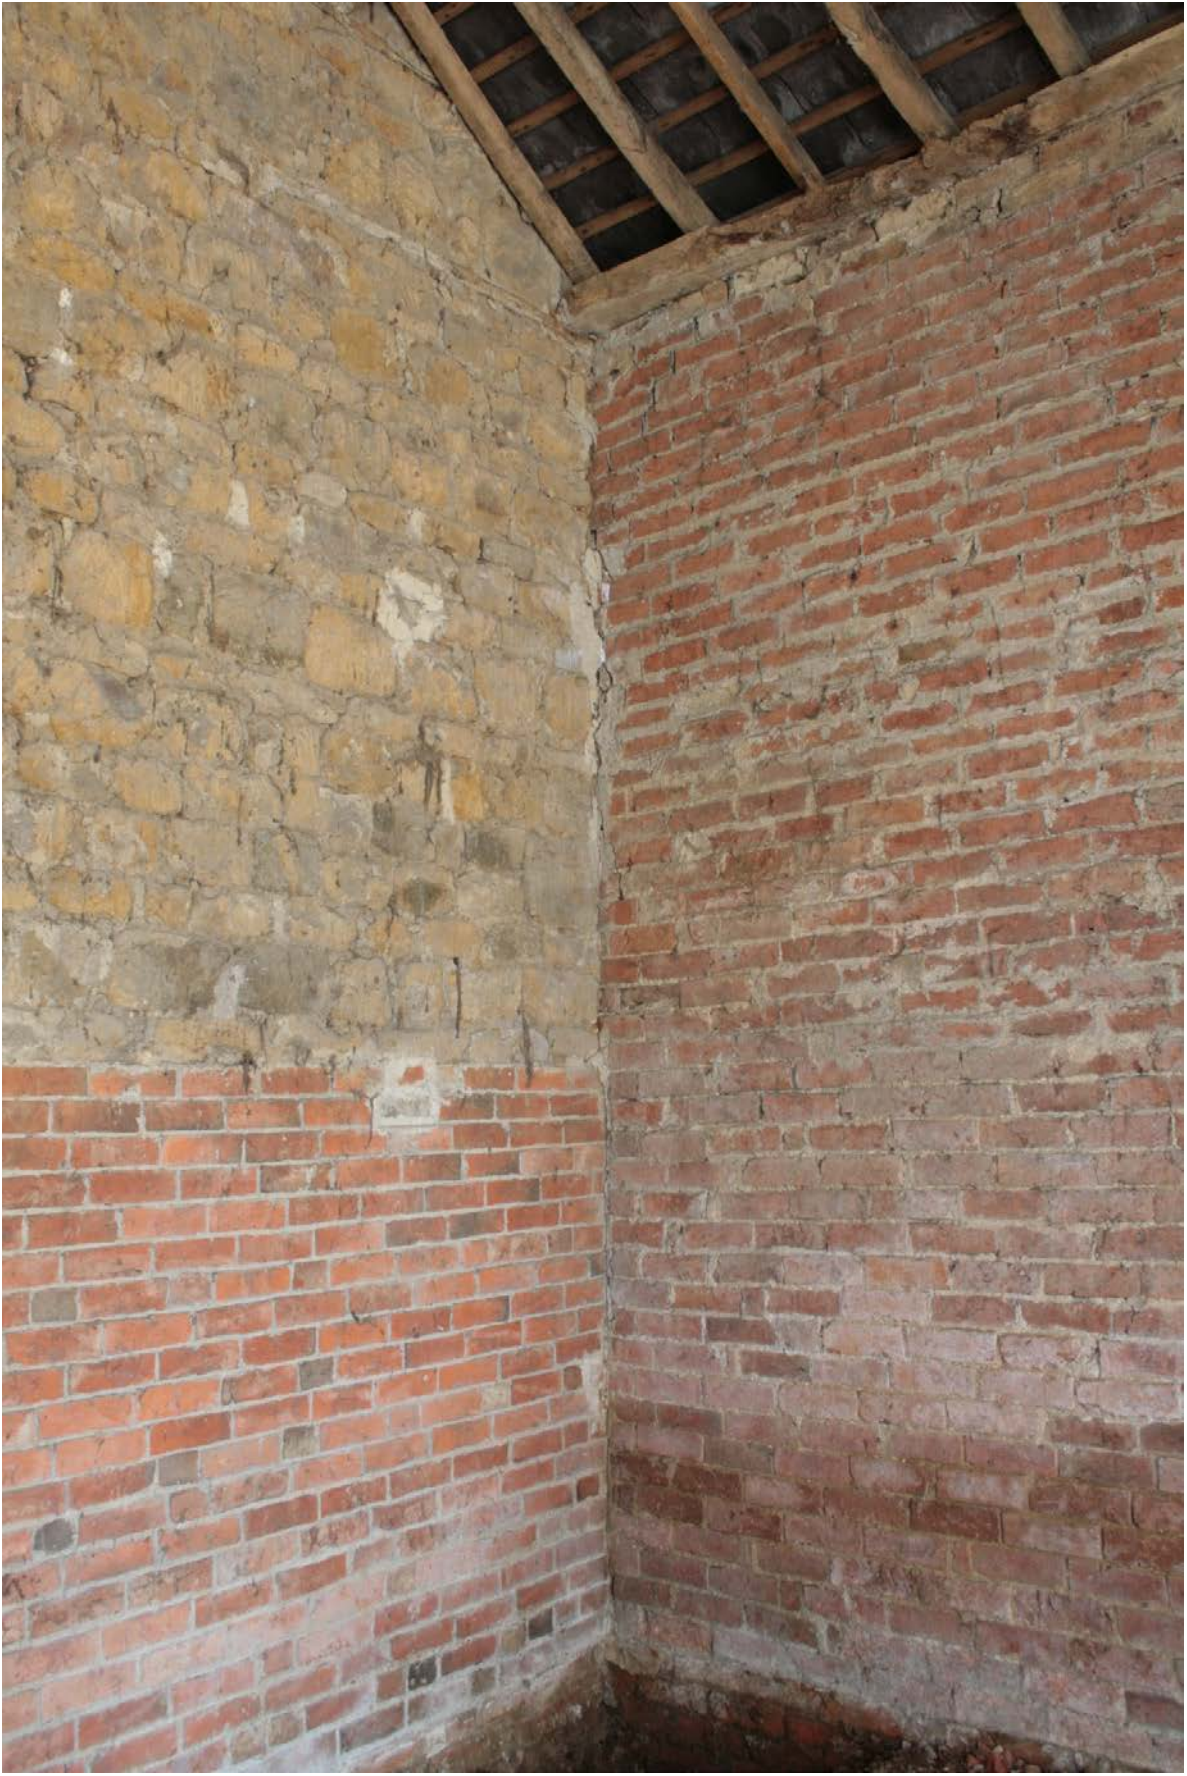
Plate 36: Corner of the north gable wall (left) and east wall (right), looking north-east (CSFS17 D100 (41))  
(viewpoint on Figure 11)

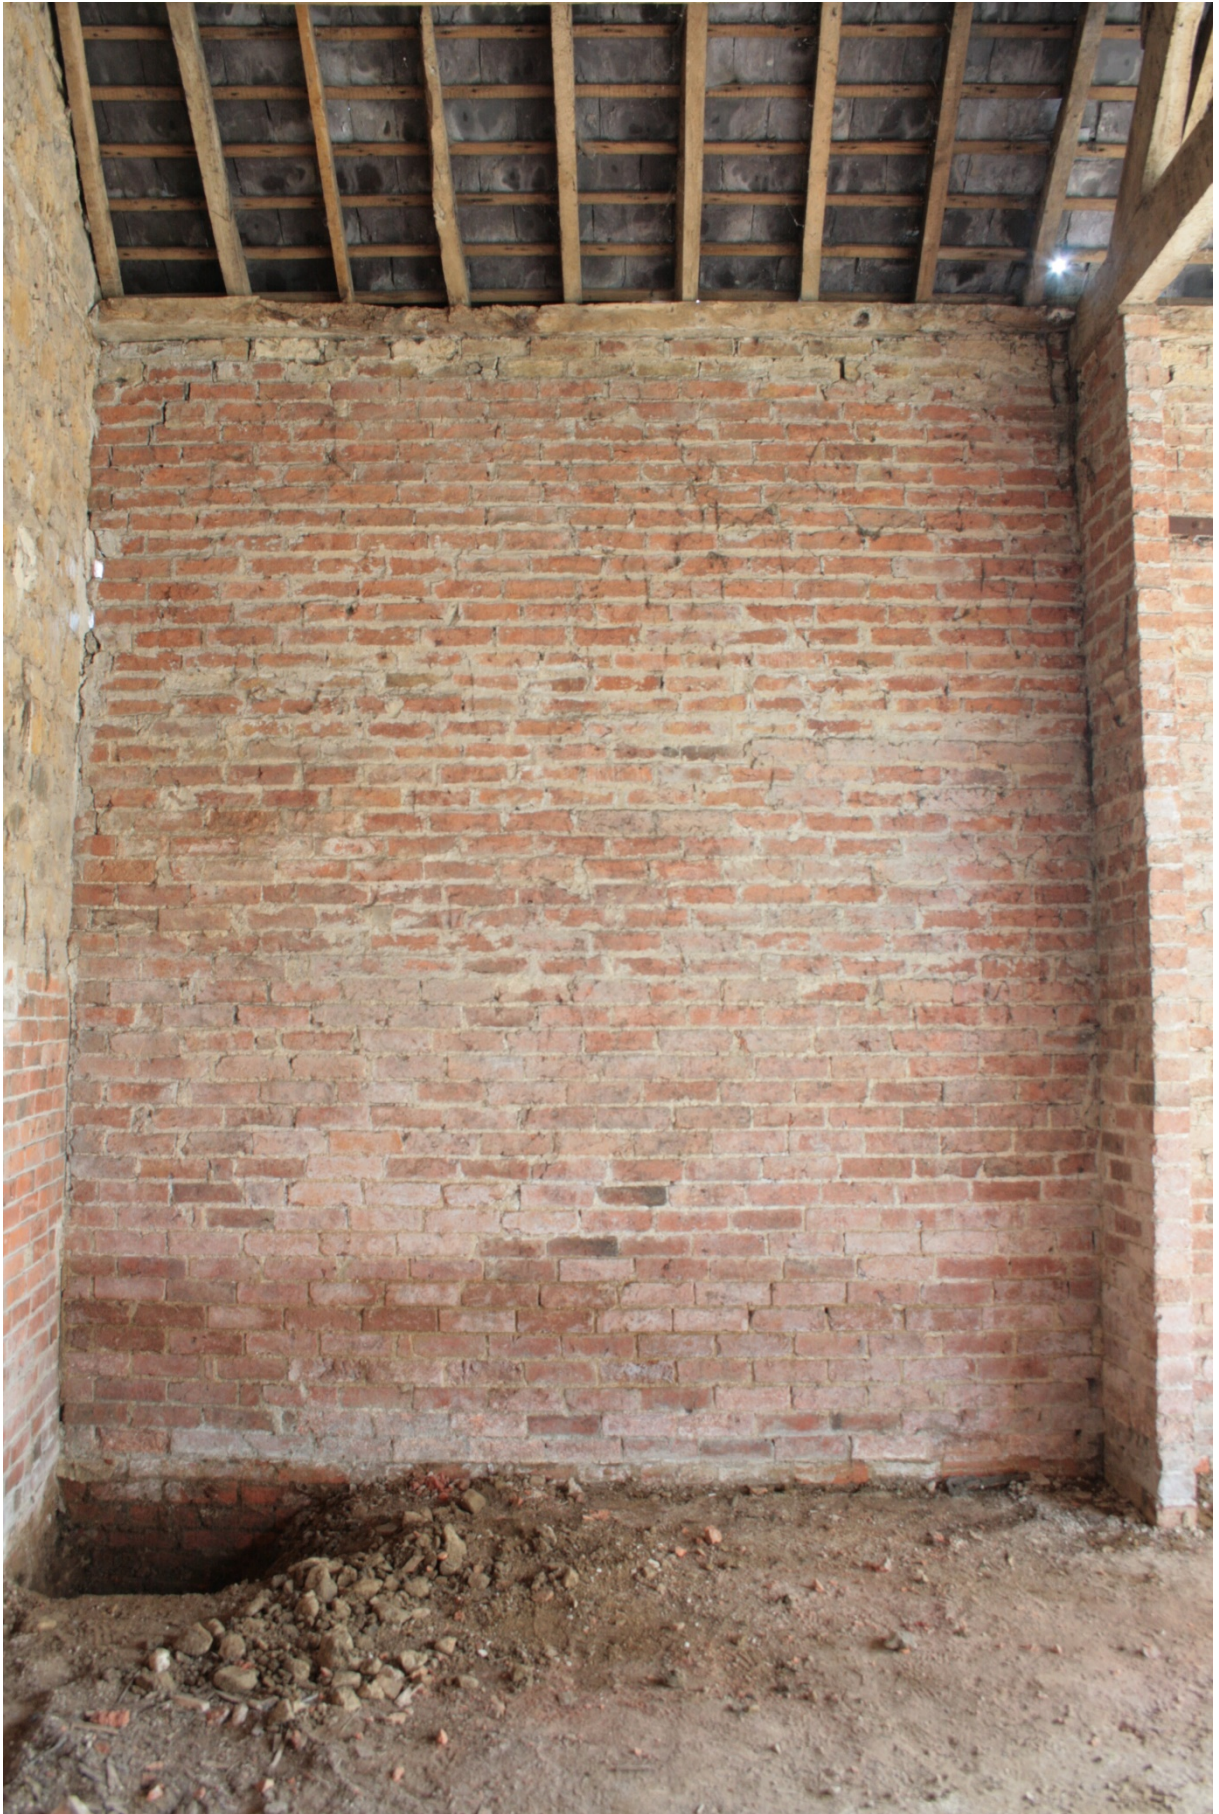
Plate 37: Northern part of the east wall, looking east (CSFS17 D100) (viewpoint on Figure 11)

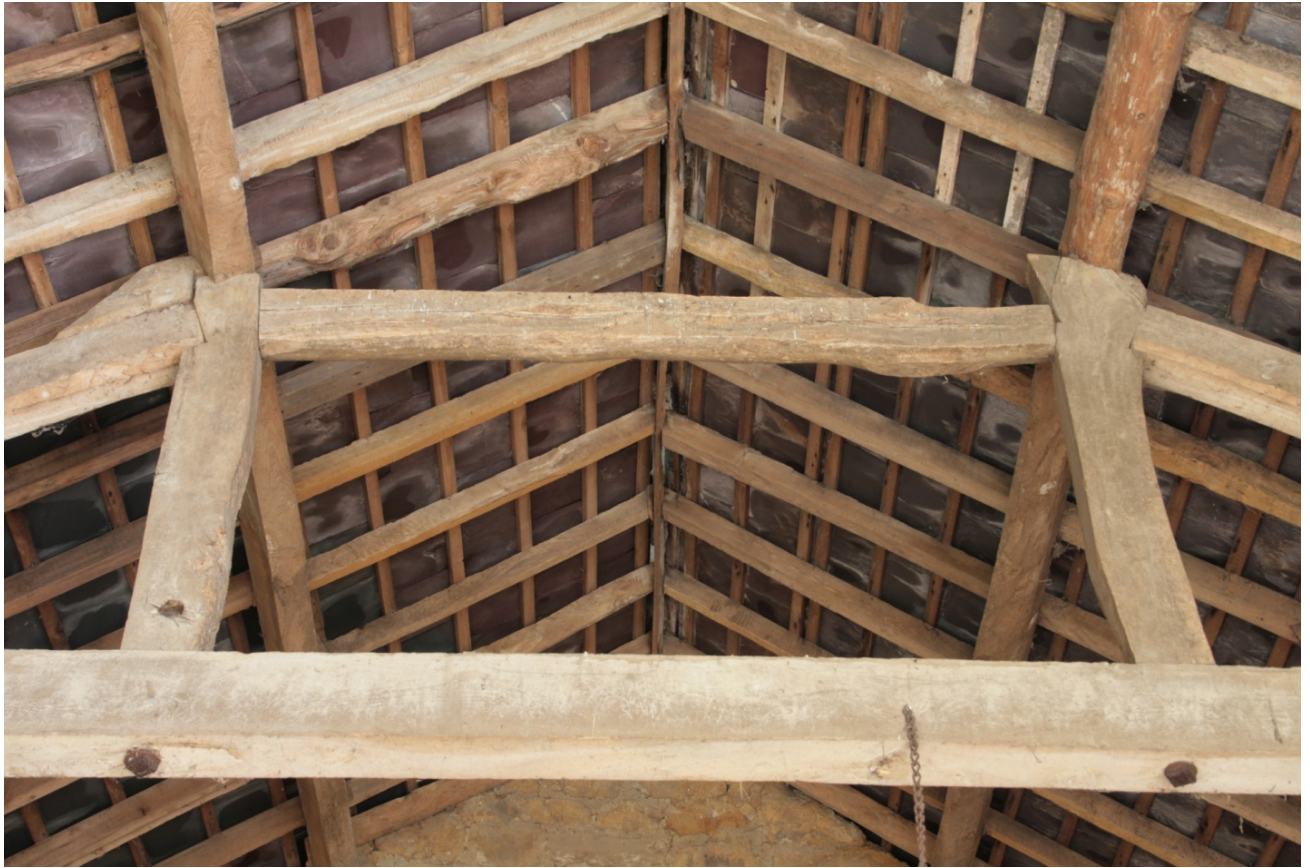
Plate 38: North queen post truss in main barn (Building B), looking north (CSFS17 D100 (4)) (viewpoint on Figure 11)

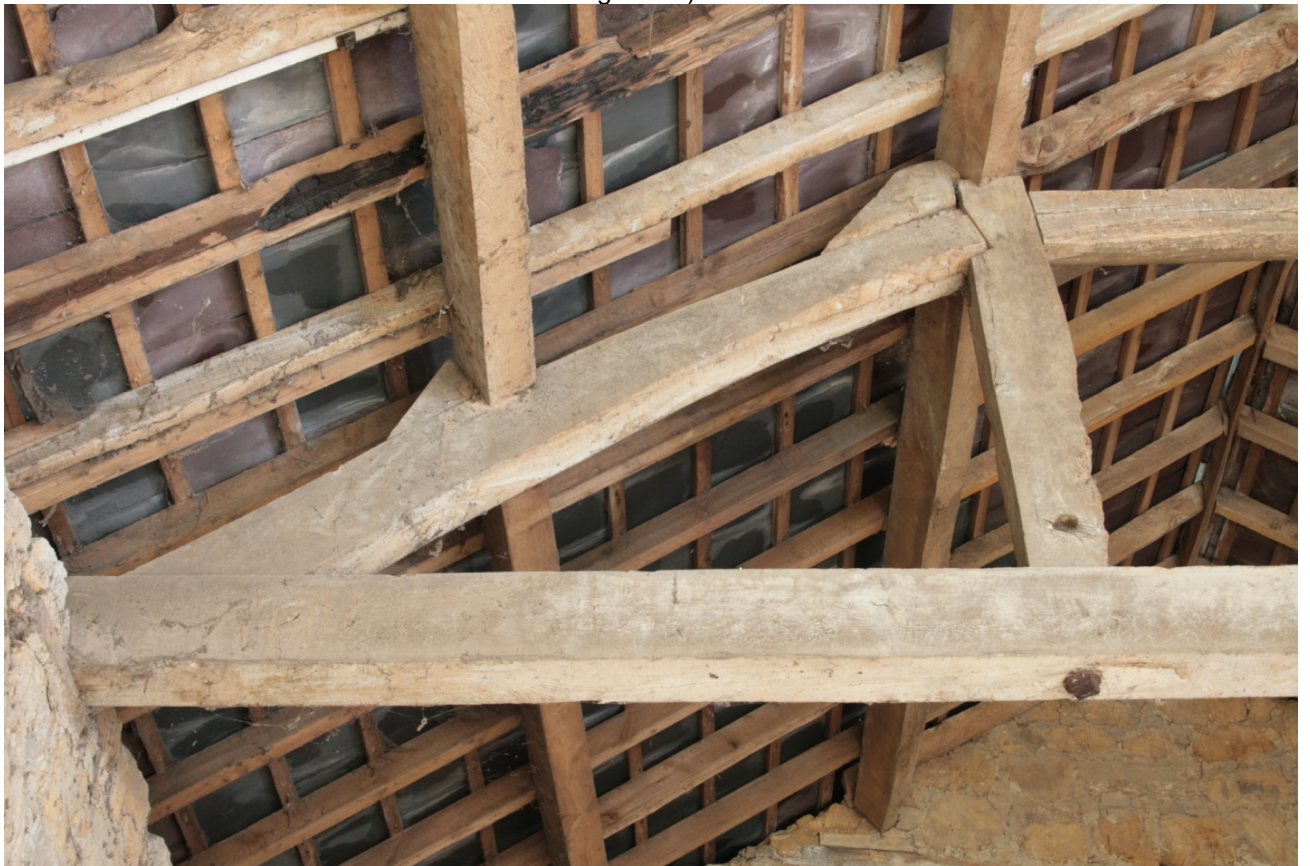
Plate 39: West end of north queen post truss in main barn (Building B), looking north (CSFS17 D100 (3)) (viewpoint on Figure 11)

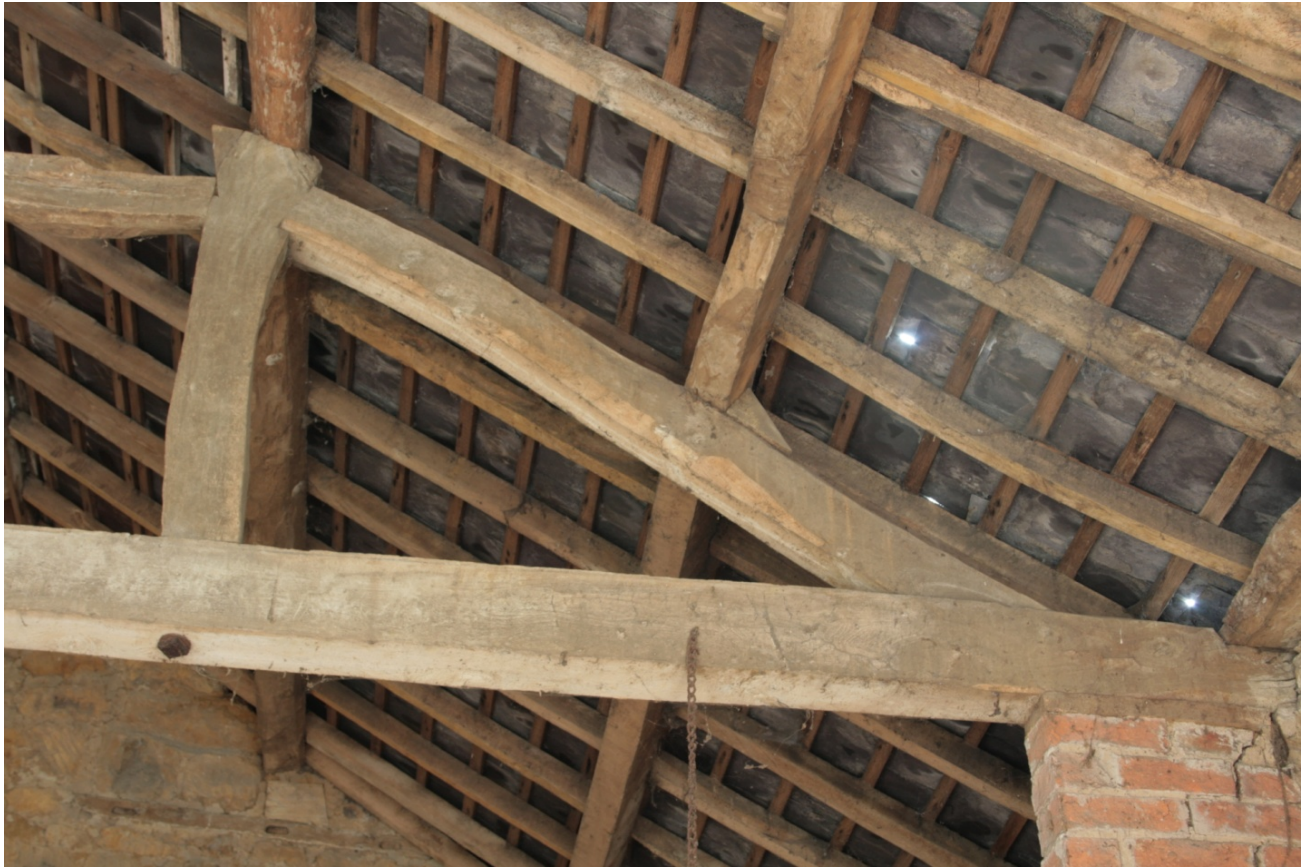
Plate 40: East end of north queen post truss in main barn (Building B), looking north (CSFS17 D100 (5)) (viewpoint on Figure 11)

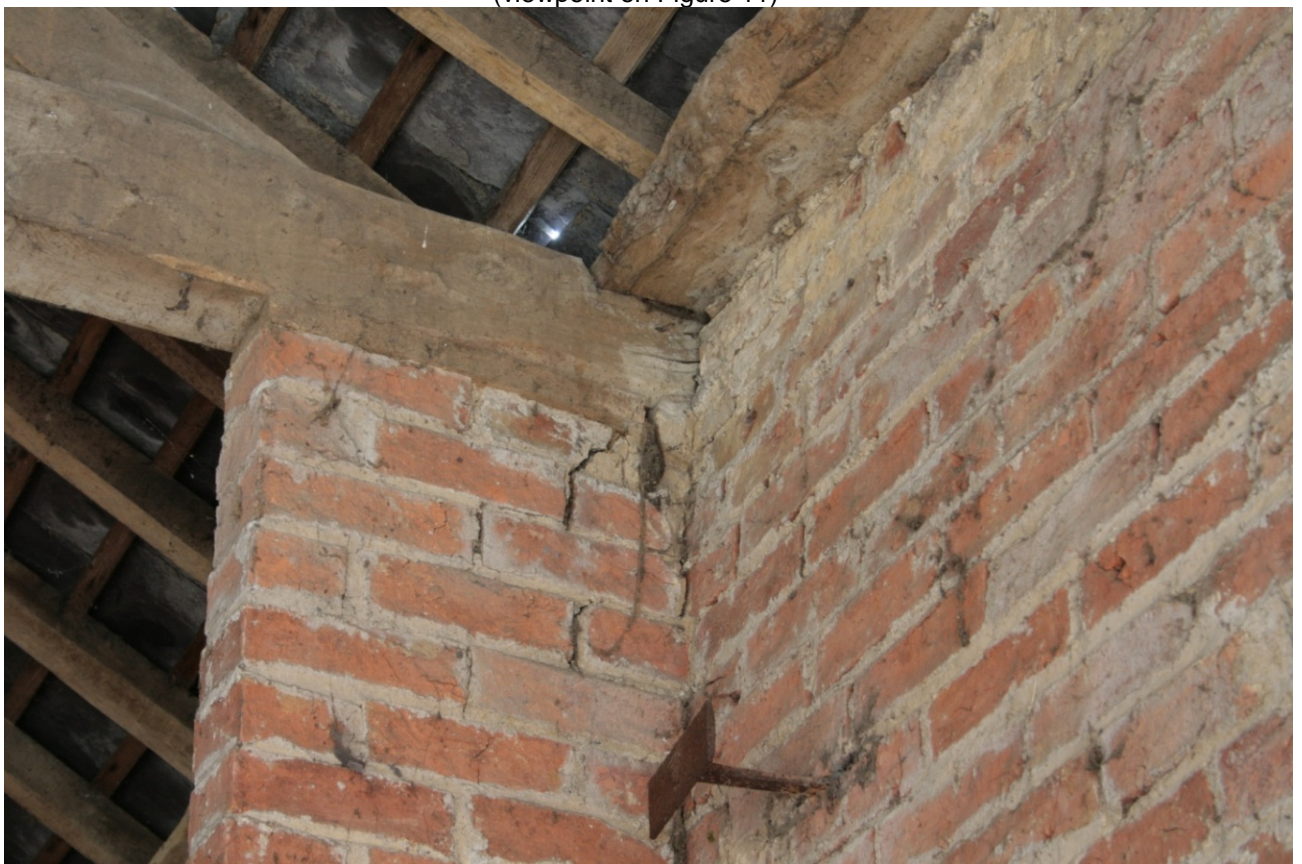
Plate 41: East end of north tie-beam in main barn (Building B), looking north (CSFS17 D100 (7)) (viewpoint on Figure 11)

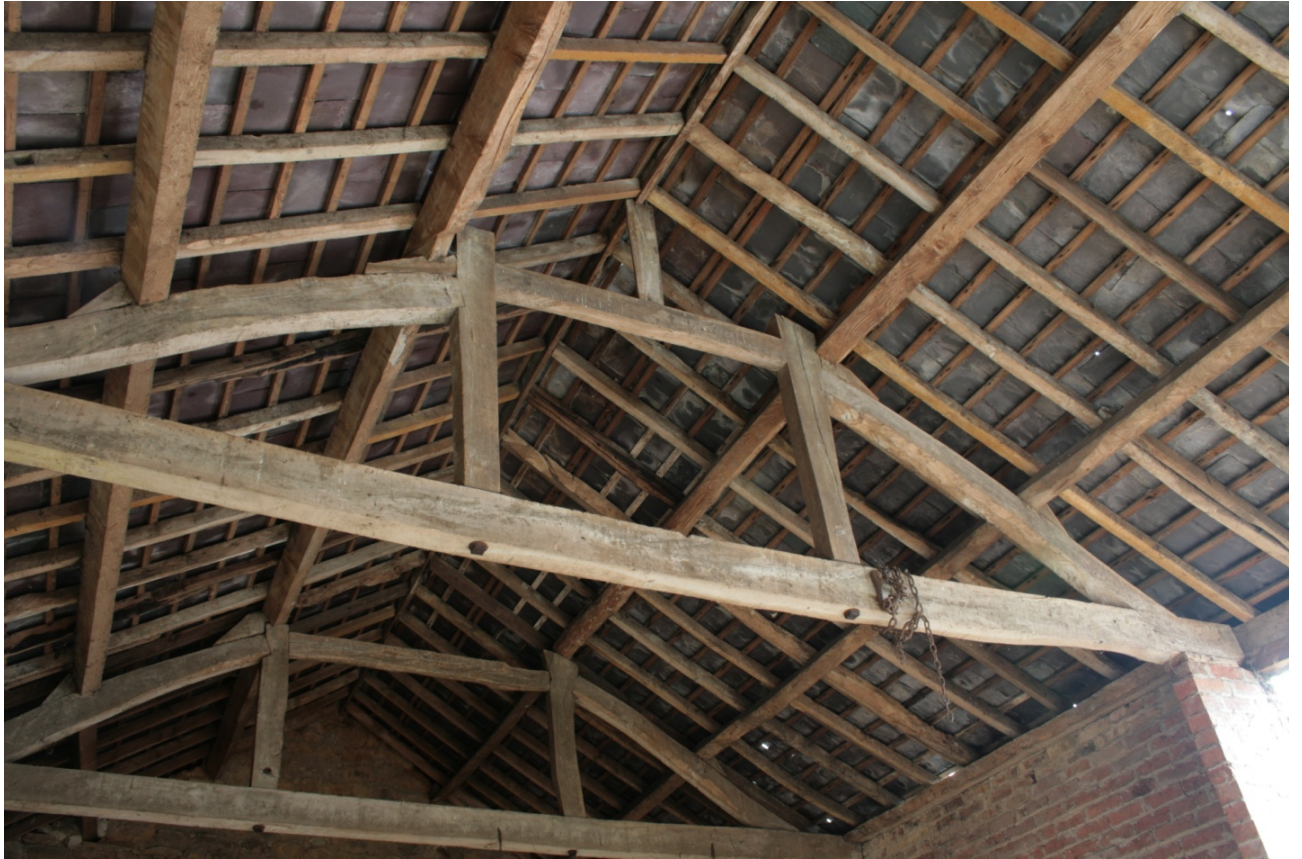
Plate 42: South queen post truss in main barn (Building B), looking north-east (CSFS17 D100 (26))  
(viewpoint on Figure 11)

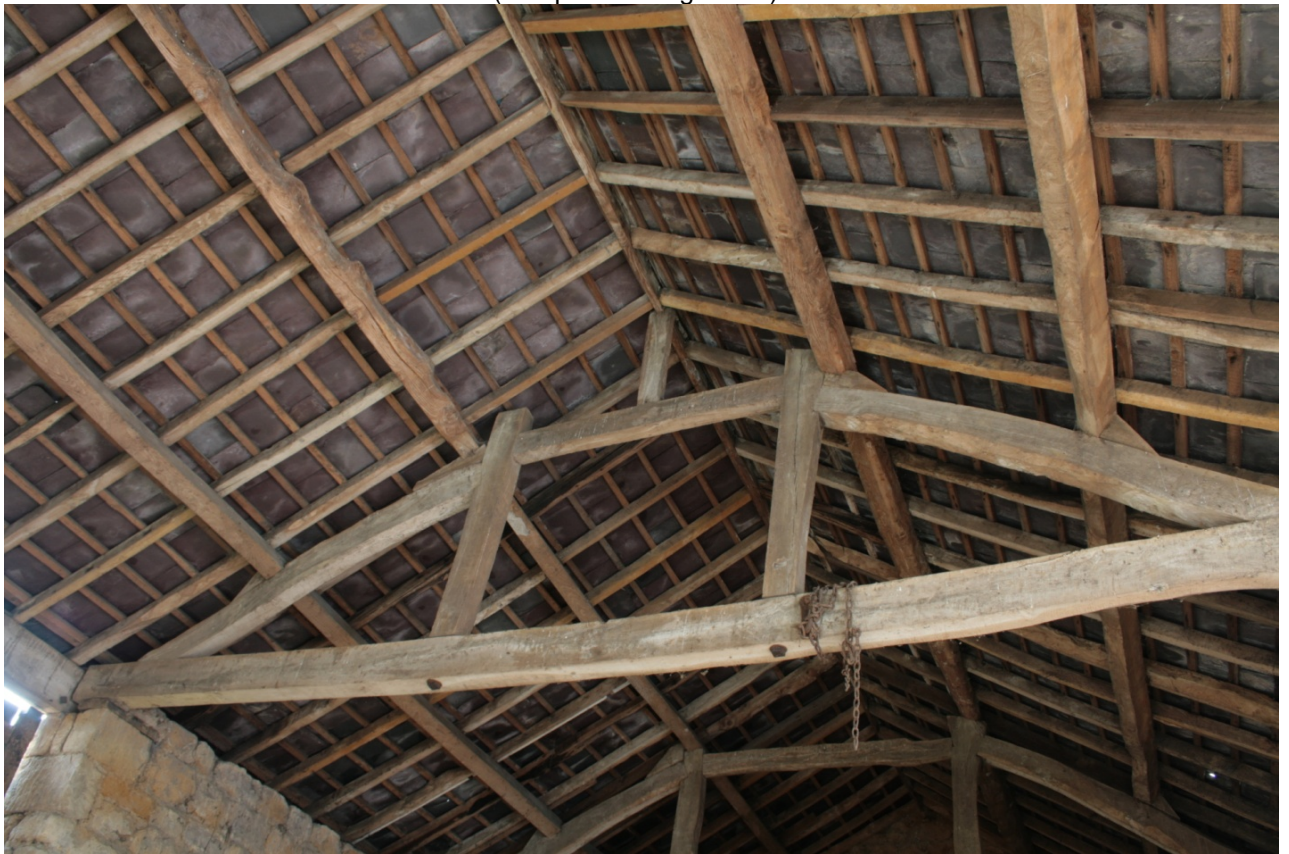
Plate 43: South queen post truss in main barn (Building B), looking north-west (CSFS17 D100 (27))  
(viewpoint on Figure 11)
