**HISTORIC BUILDING RECORDING  
OF FARM BUILDINGS  
TO THE REAR OF  
SCHOOL HILL FARM HOUSE,  
CHURCH STREET,  
FENNY COMPTON,  
WARWICKSHIRE,  
CV47 2YE**

**PCA REPORT NO: R13125**

**DECEMBER 2017**

Historic Building Recording

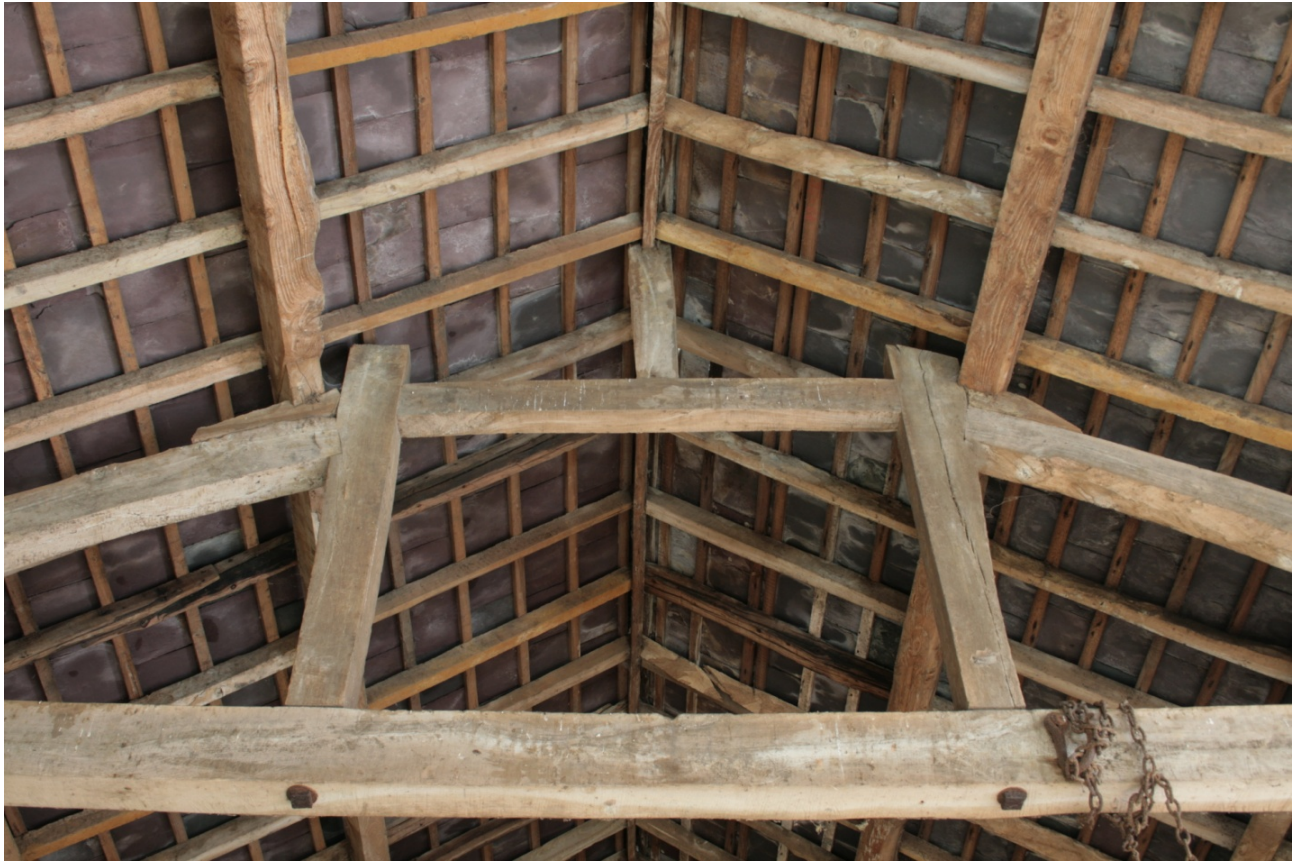
Plate 44: South queen post truss in main barn (Building B), looking north (CSFS17 D100 (29)) (viewpoint on Figure 11)

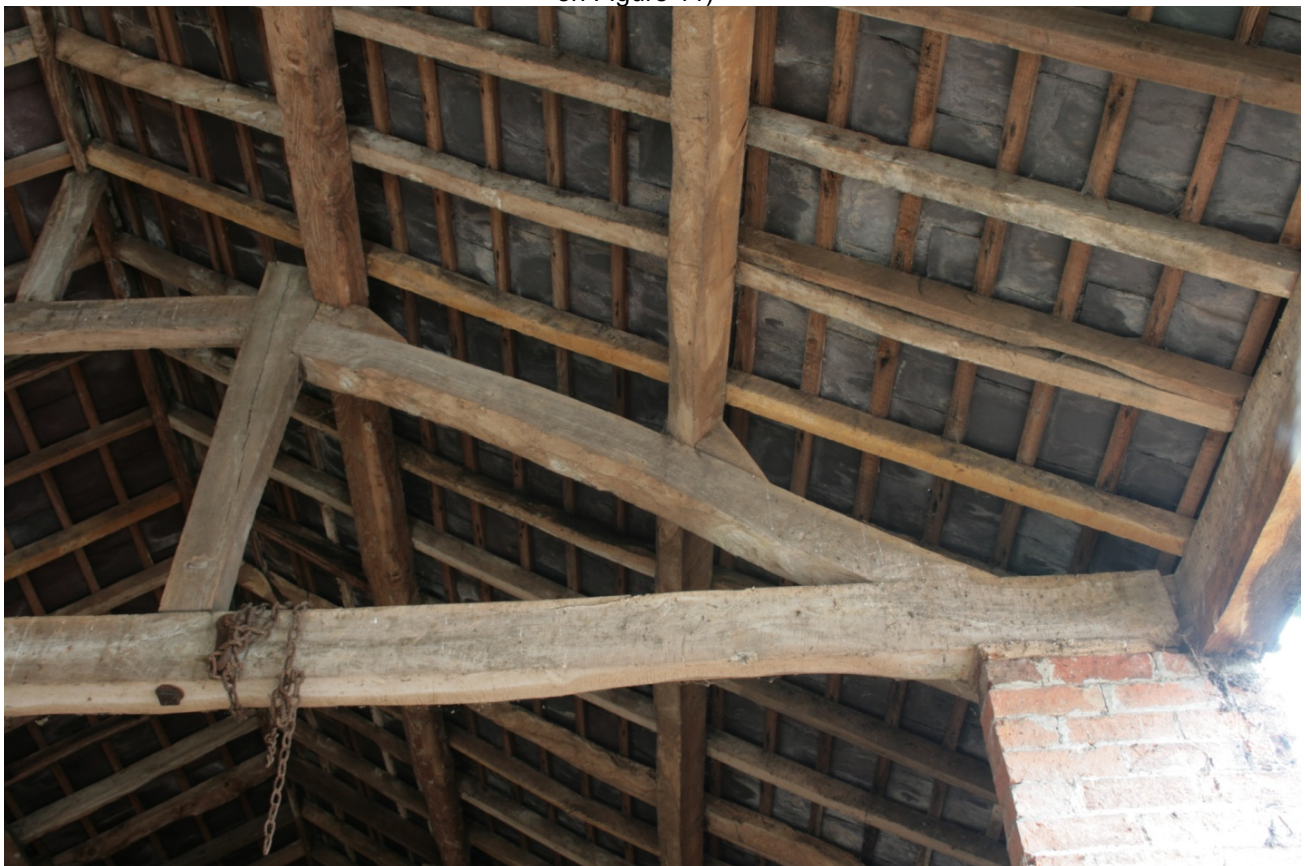
Plate 45: East end of south queen post truss in main barn (Building B), looking north (CSFS17 D100 (28)) (viewpoint on Figure 11)

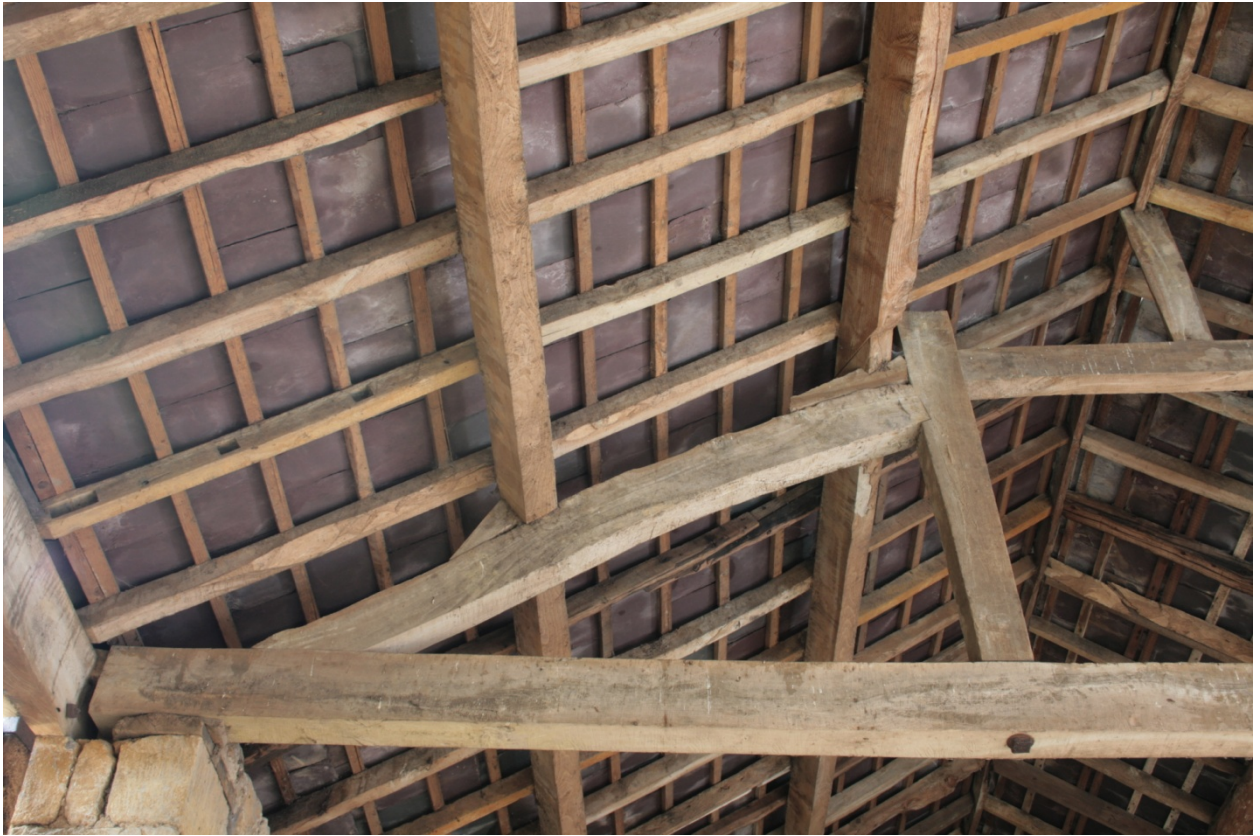
Plate 46: West end of south queen post truss main barn (Building B), looking north (CSFS17 D100 (30)) (viewpoint on Figure 11)

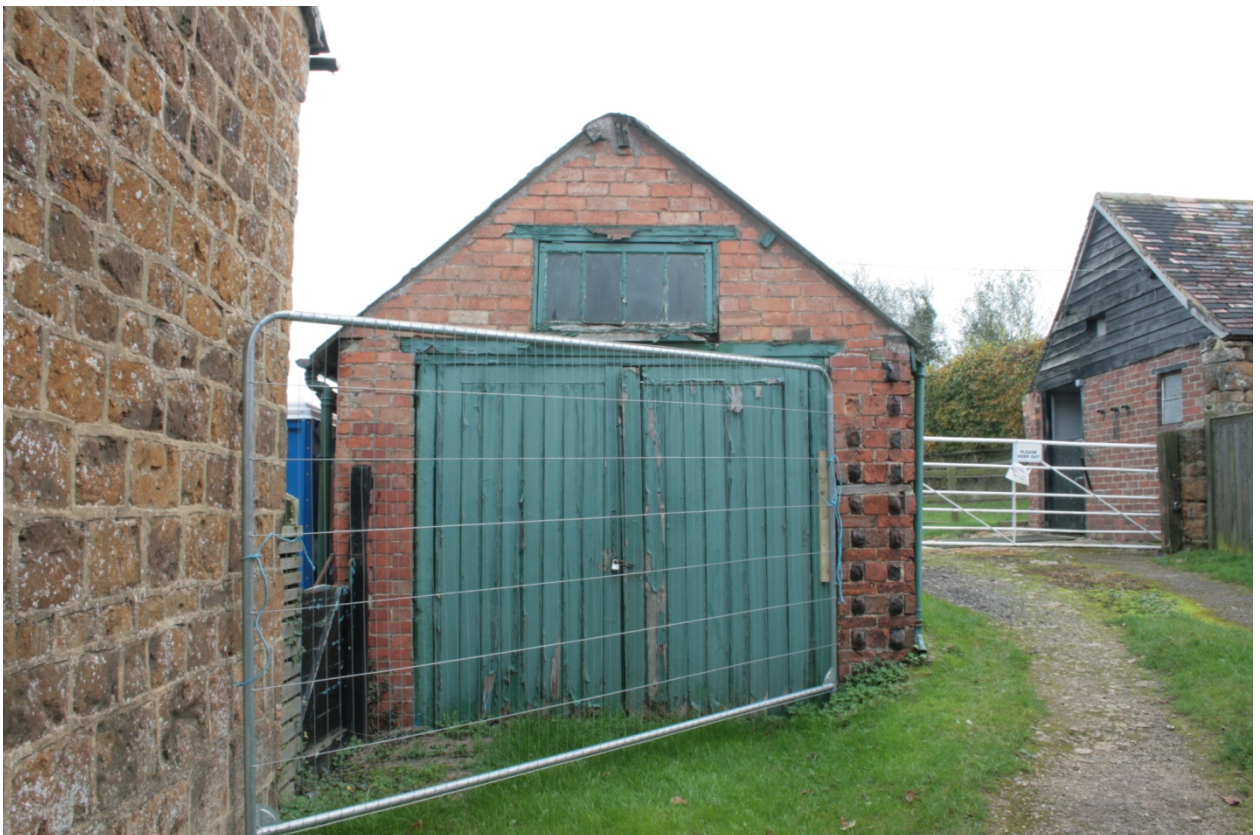
6.4.1 Building C is a small brick building, which is aligned east-west unlike Buildings A and B which are aligned north-south (**Figure 9**). Its roof is covered with sheets of corrugated asbestos. Most of the south wall and the south end of the west wall were constructed in a distinctive rat trap bond (**Plates 47 to 50**). This rare bond was used in the early mid 19<sup>th</sup> century as a cheap form of brickwork laying the bricks on edge. In contrast the north wall, the east end of the south wall and the north side of the west wall were constructed in stretcher bond with a few headers (**Plates 47, 48, 50 and 51**). The west elevation has a large perhaps mid 20<sup>th</sup> century timber garage double door with a window above (**Plates 47 and 48**). Both have timber lintels. The east wall has another window (**Figure 12**). A building is shown in this position since 1887 (**Figure 4**) and it is possible that the northern part of this building was rebuilt in the mid 20<sup>th</sup> century as a garage.

Plate 47: West gable elevation of Building C, looking east (CSFS17 D100 (60)) (viewpoint on Figures 9 and 12)

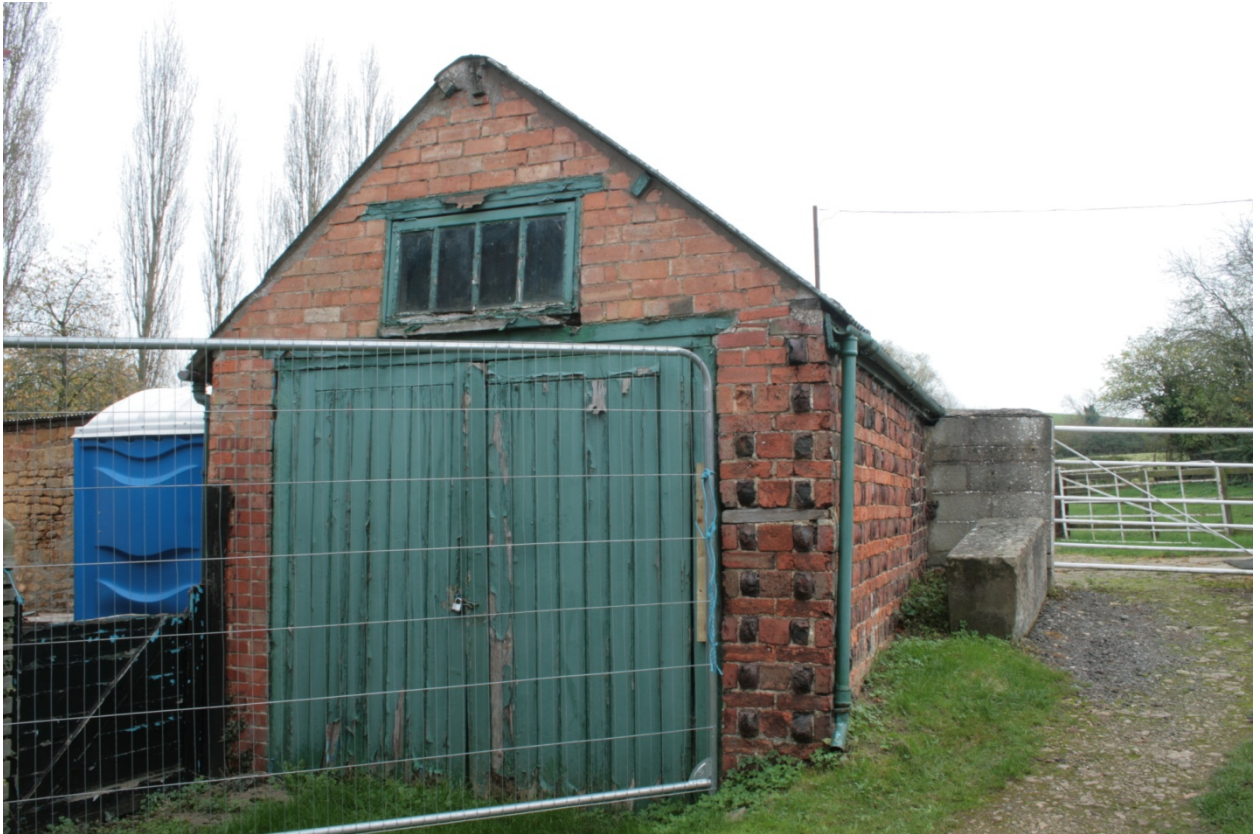
Plate 48: West gable elevation of Building C, looking east (CSFS17 D100 (61)) (viewpoint on Figures 9 and 12)

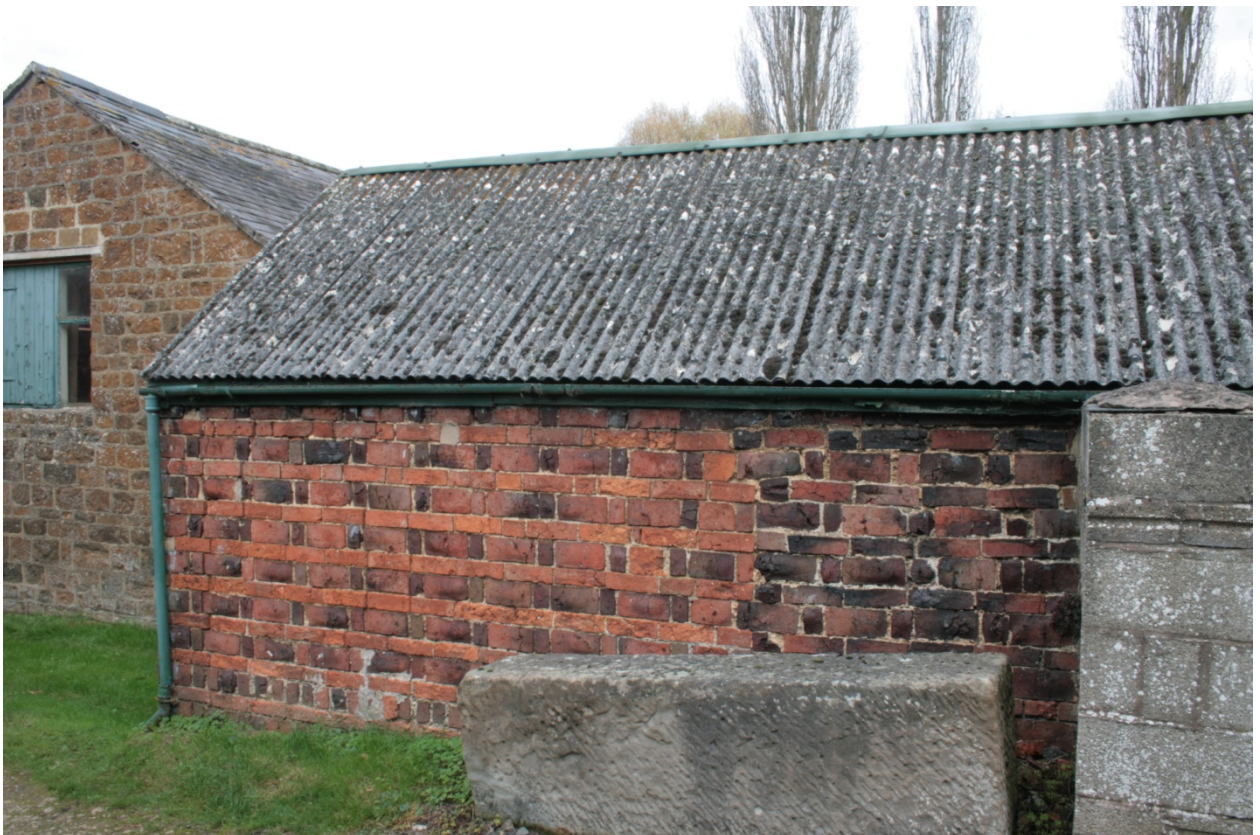
Plate 49: South elevation of Building C, looking north (CSFS17 D100 (62)) (viewpoint on Figures 9 and 12)

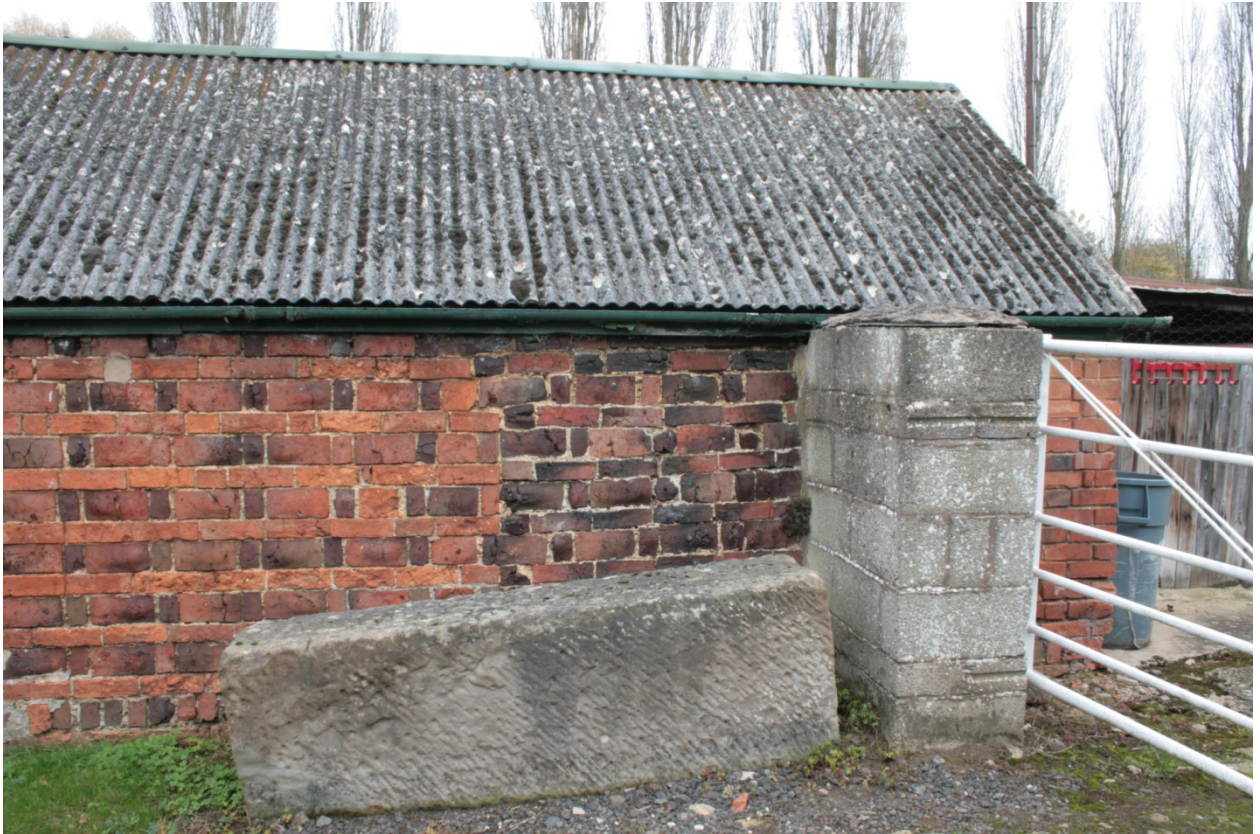
Plate 50: South elevation of Building C, looking north (CSFS17 D100 (63)) (viewpoint on Figures 9 and 12)

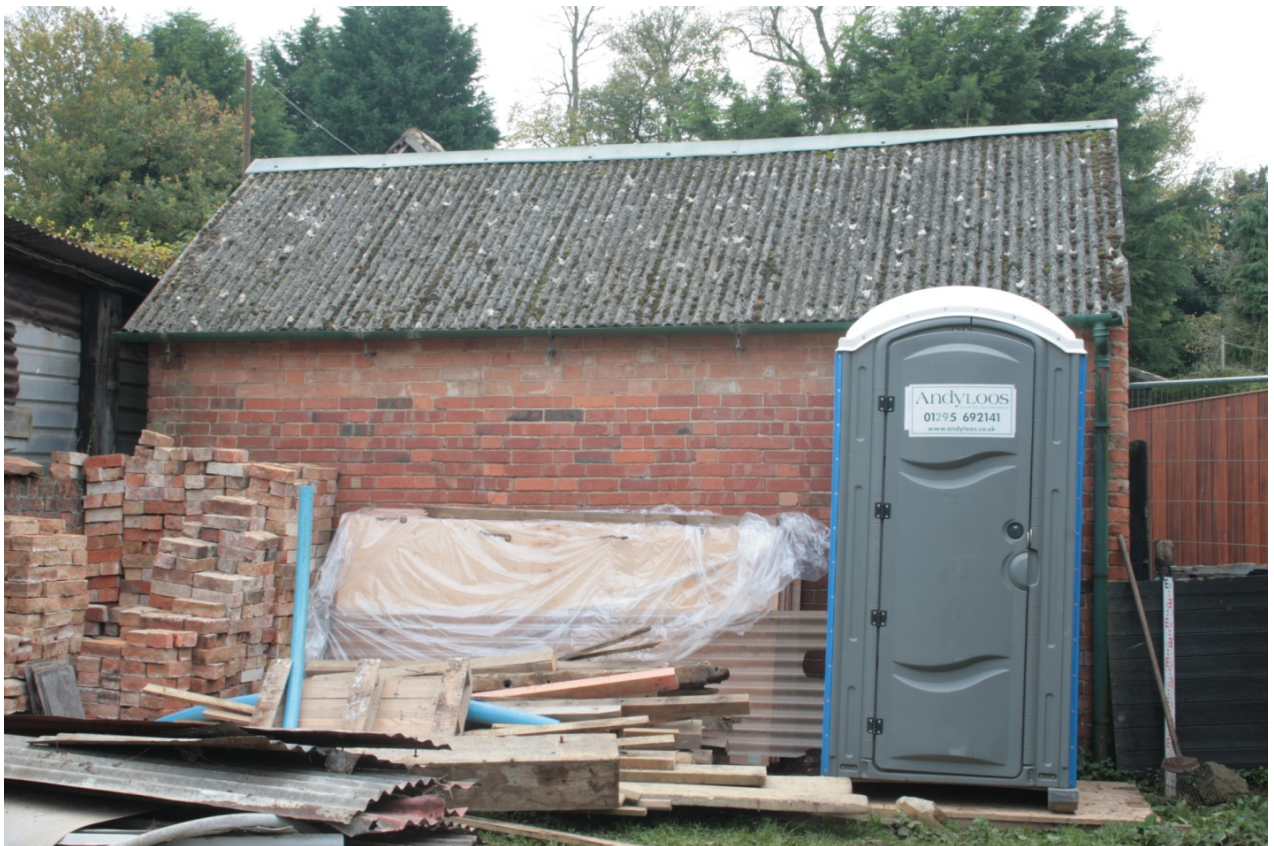
Plate 51: North elevation of Building C, looking south (CSFS17 D100 (70)) (viewpoint on Figures 9 and 12)

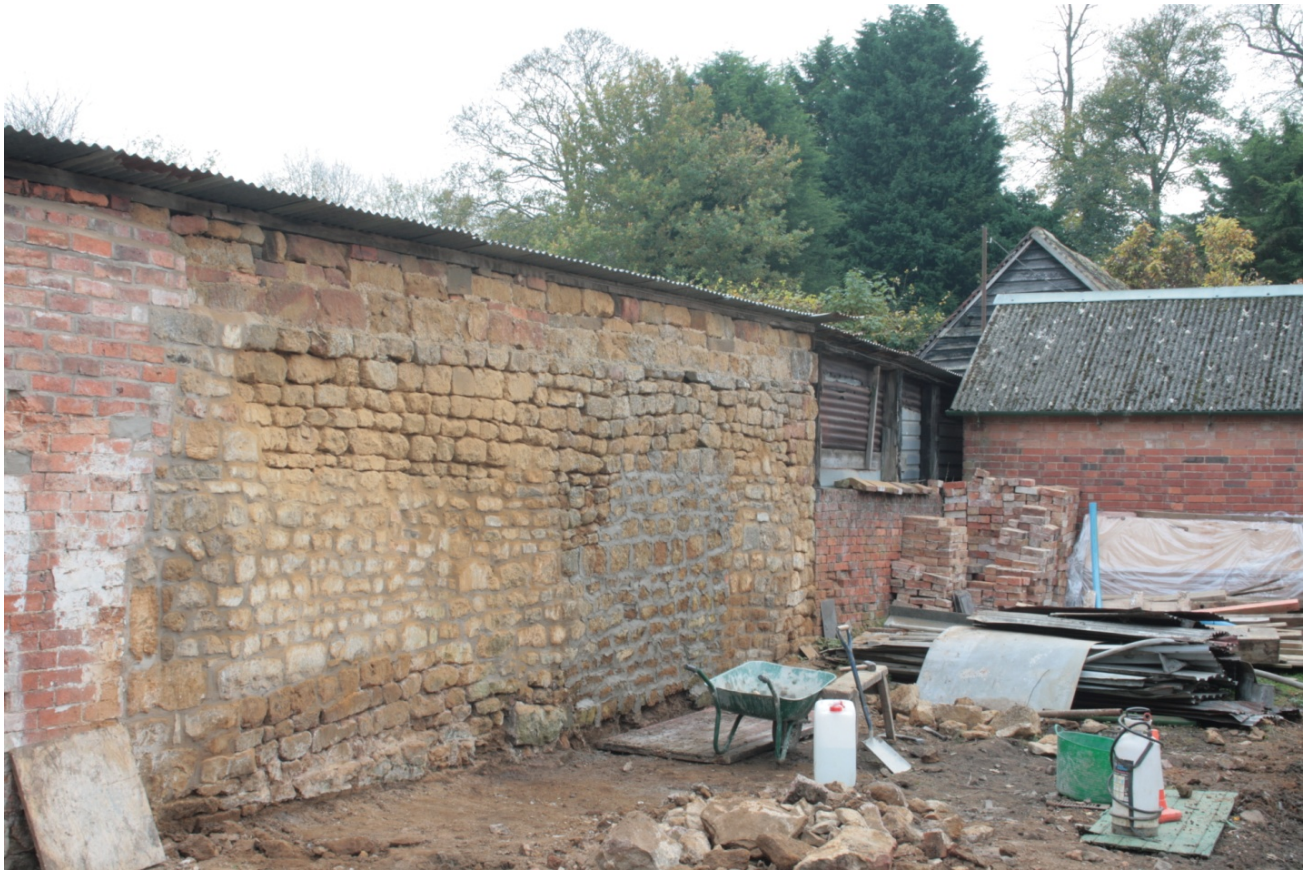
6.5.1 The west elevation of the building to the east of the Site was photographed (**Figure 9; Plates 52 to 54**). Other buildings within the Site to the west of this wall had recently been removed. The south end of this wall had been constructed in brick in the 20<sup>th</sup> century (**Plate 52**). This part of the wall is not shown on the 1887 and 1905 maps (**Figures 4 and 5**) and is shown on the 1971-72 map (**Figure 6**). The rest of the wall is constructed of ironstone and brick and is shown on the 1887 and 1905 maps (**Figures 4 and 5**). Two straight construction joints are visible in this part of the wall indicating the position of a former doorway that has since been infilled with brickwork (**Plate 53**). The north end of the west elevation was constructed of ironstone (**Plate 54**).

Plate 52: Building C (right) and west elevation of buildings to the east, looking south (CSFS17 D100 (71)) (viewpoint on Figure 9)

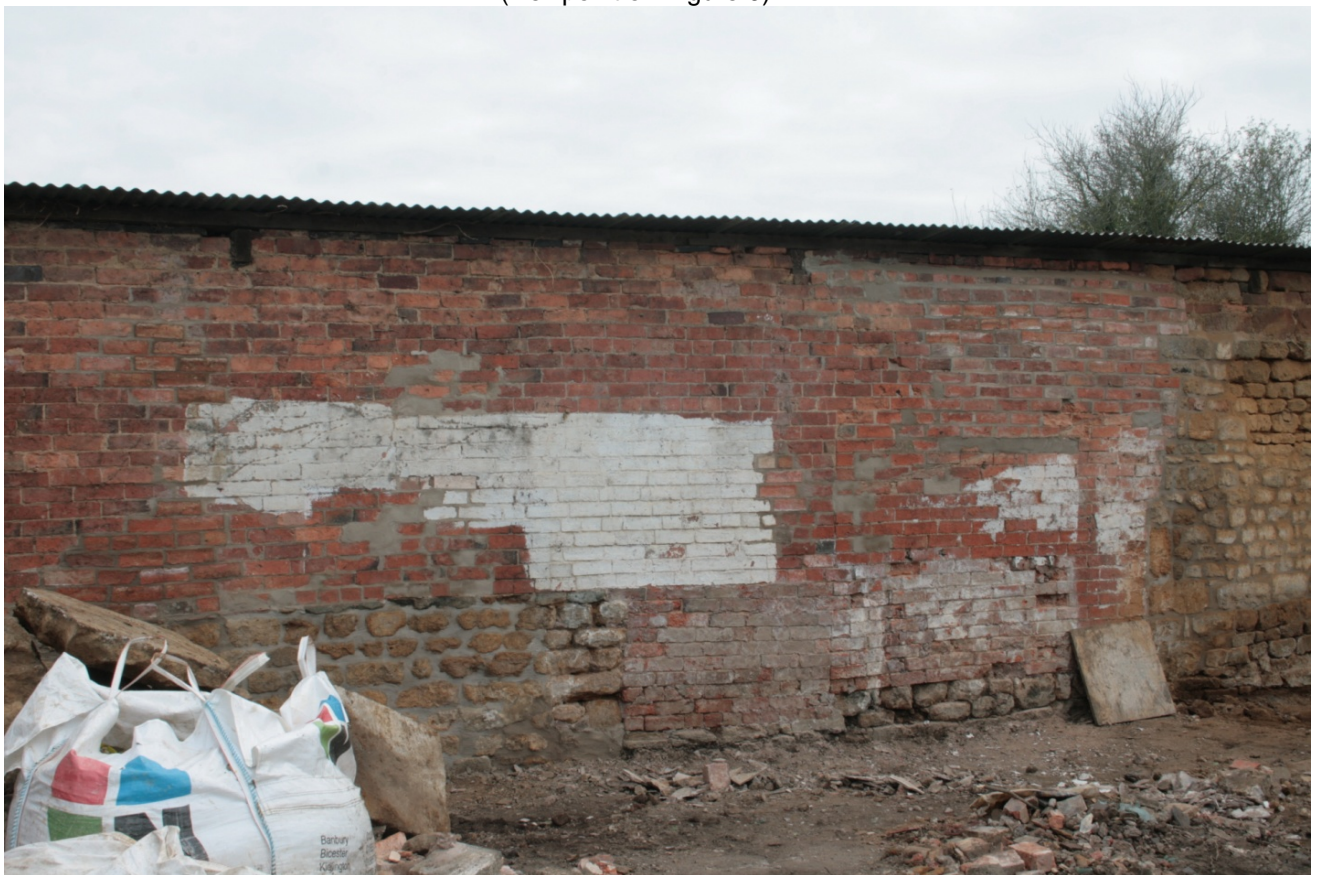
Plate 53: West elevation of the building to the east, looking east (CSFS17 D100 (73)) (viewpoint on Figure 9)

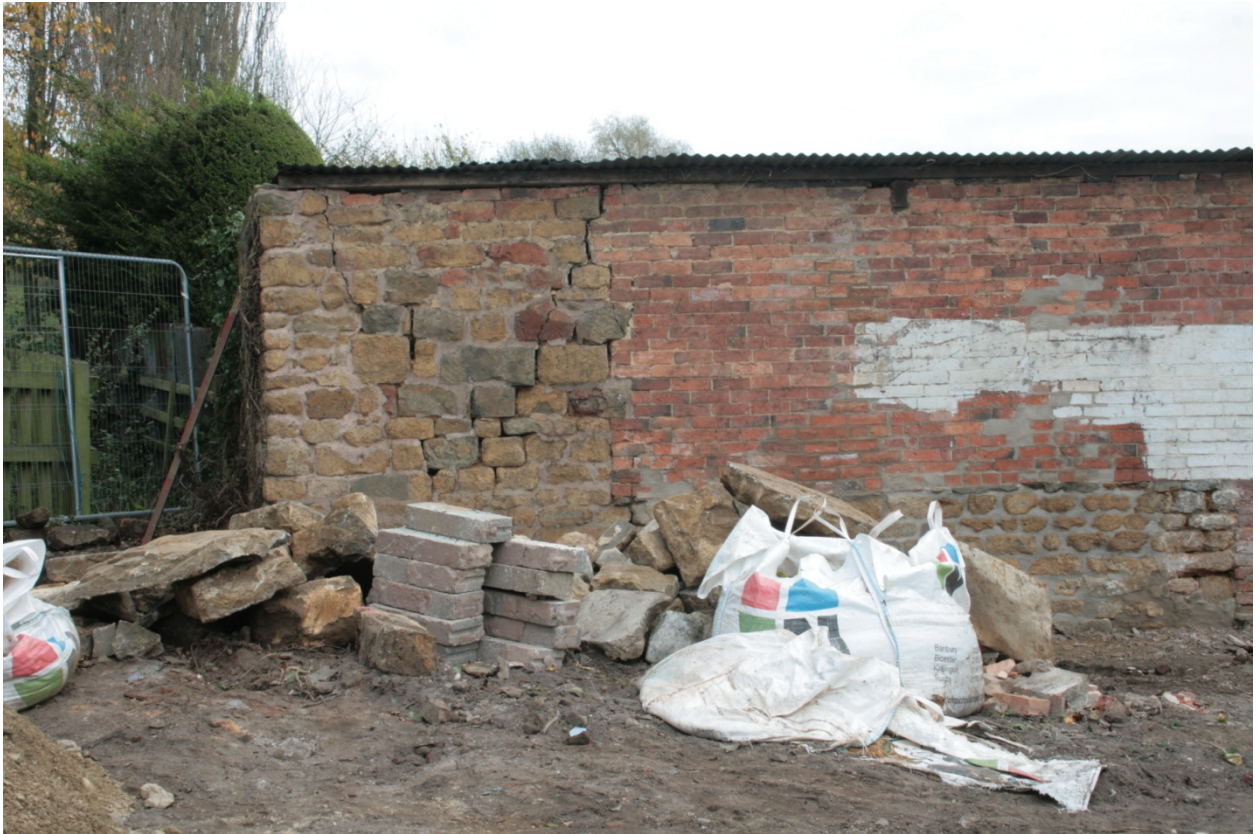
Plate 54: North end of the west elevation of the building to the east, looking east (CSFS17 D100 (74))  
(viewpoint on Figure 9)
