**NORTHERN OUTFALL SEWER
AND ASSOCIATED STRUCTURES**
Greenway Bridge over the River Lea
Greenway Bridge over Marshgate Lane
and Pudding Mill Lane
Pedestrian Subway
Abbey Lane Pedestrian Bridge
Pedestrian Bridge Spanning the Channelsea River
Viaduct of the Northern Outfall Sewer
London E15

A standing building survey report

November 2008

Site Code: OL-02507, OL-04507, OL-04607, OL-04707, OL-02207, OL-02307 and OL-04107
National Grid Reference: 53710 18390 to 53920 18310

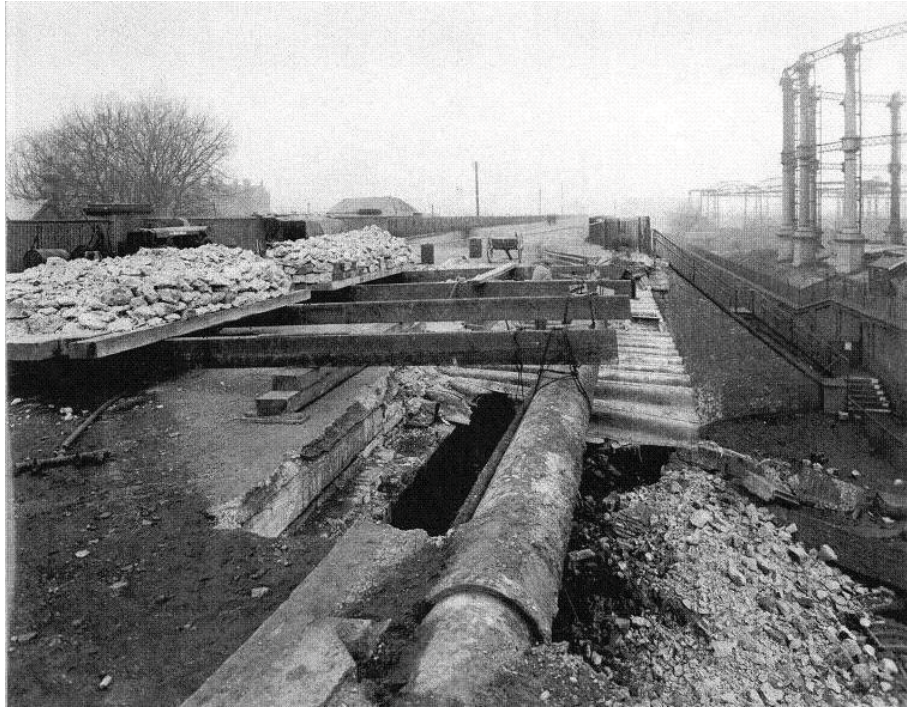
Plate 13 View of bomb damage affecting Abbey Lane Pedestrian Bridge, looking west, 1940

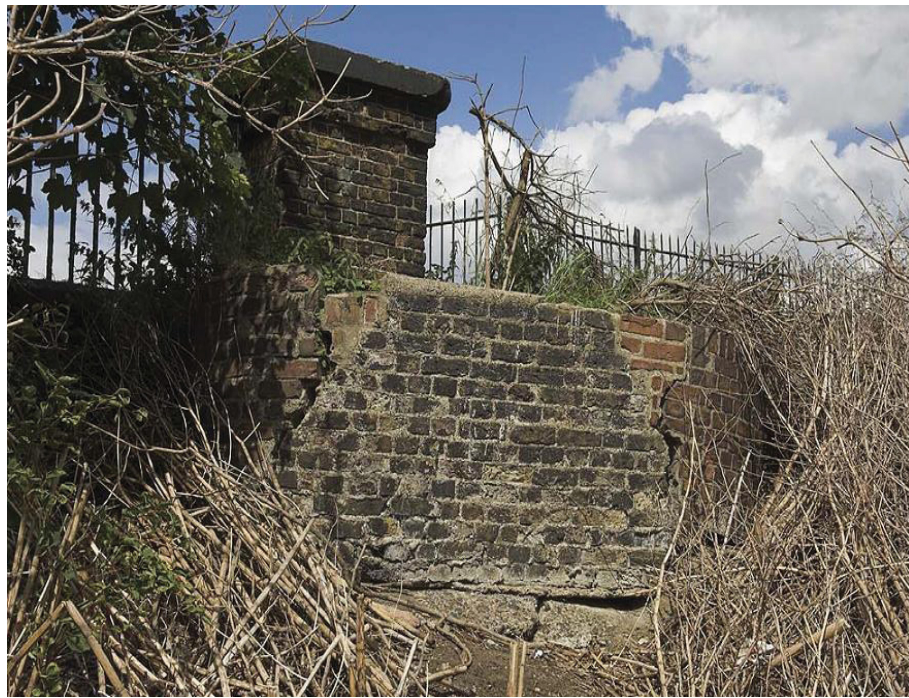
Plate 41 View of damage brick built platform on south embankment of Greenway looking north

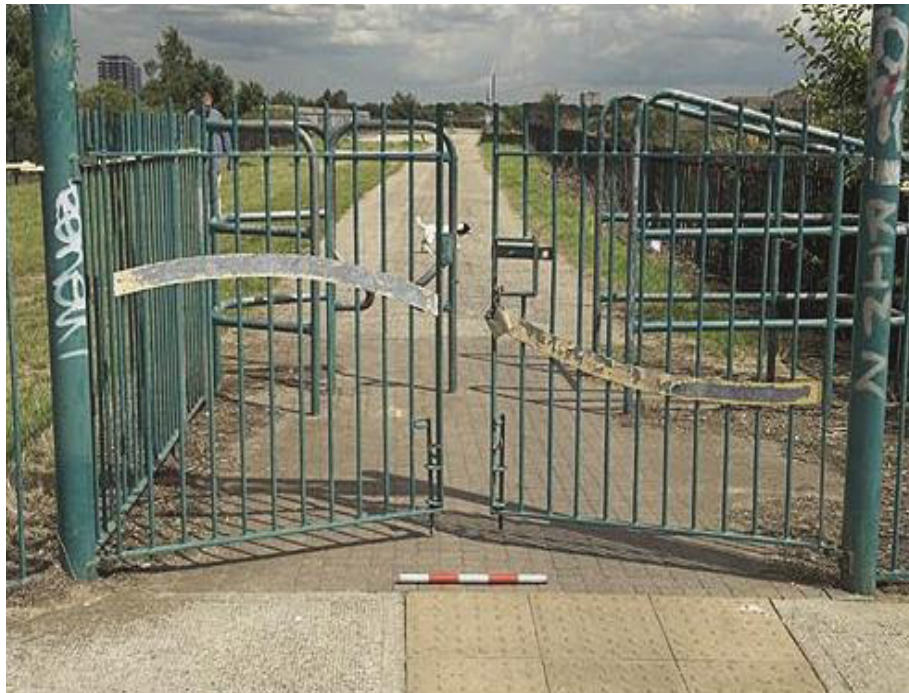
Plate 57 View of Canning Road crossing the Greenway looking east

Canning Road crosses over the Northern Outfall Sewer east of the Pudding Mill River. The east and west sides of the road have been marked with green and yellow signs, and have lockable gates (Plates 57 and 58).

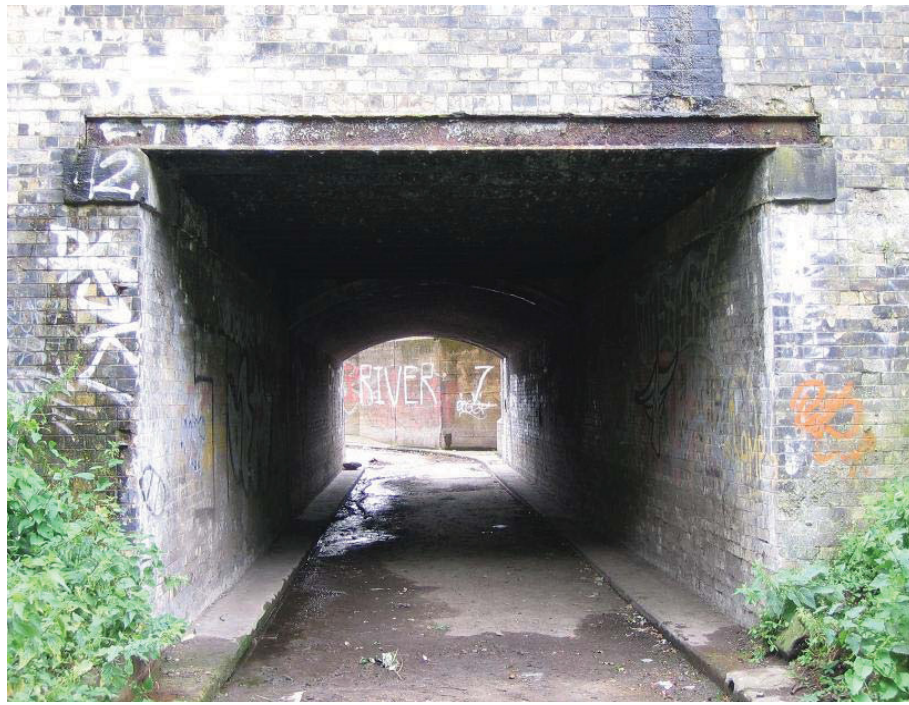
Plate 72 View of brick abutment on east side of Marshgate Lane and Pudding Mill Lane Bridge looking north-east

The central pier has a red brick structure at its base, on the western side of the Marshgate Lane footpath (Plate 72).

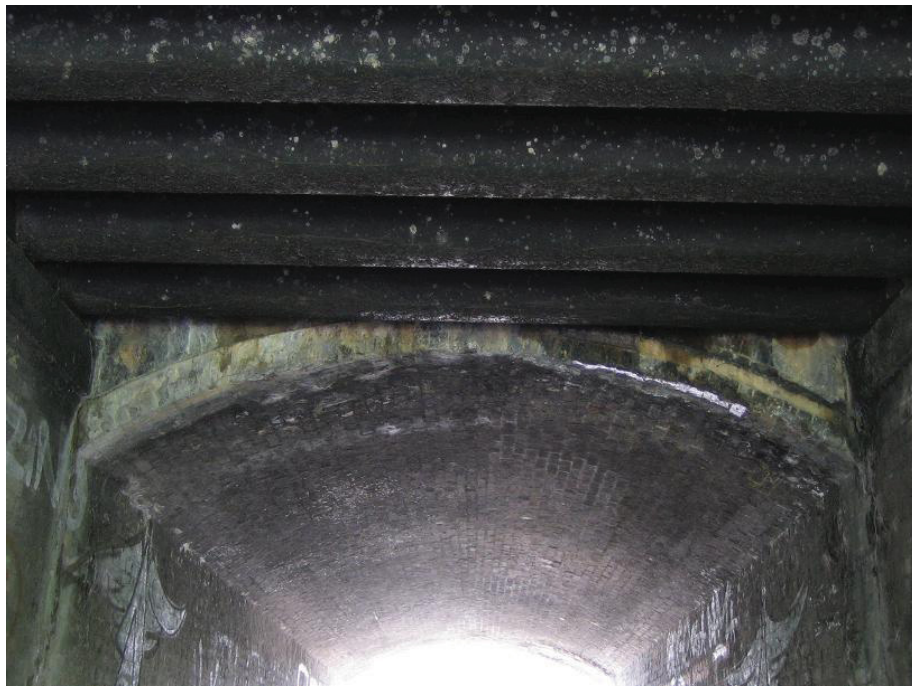
Plate 80 Detailed view of Larssen type sheet piling

The southern half of the subway has a barrel roof constructed of yellow stock brick with grey/yellow mortar in stack bond pattern. The roof at the northern end of the subway is constructed from Larssen type steel piling (Plate 80). At the junction between the barrel roof type and the steel roof type at the midway point in the subway, a north-facing arch can be seen which has the same brick, mortar and bond pattern as the arched entranceway in the southern elevation. Only two brick courses of this were visible, as cement render and the

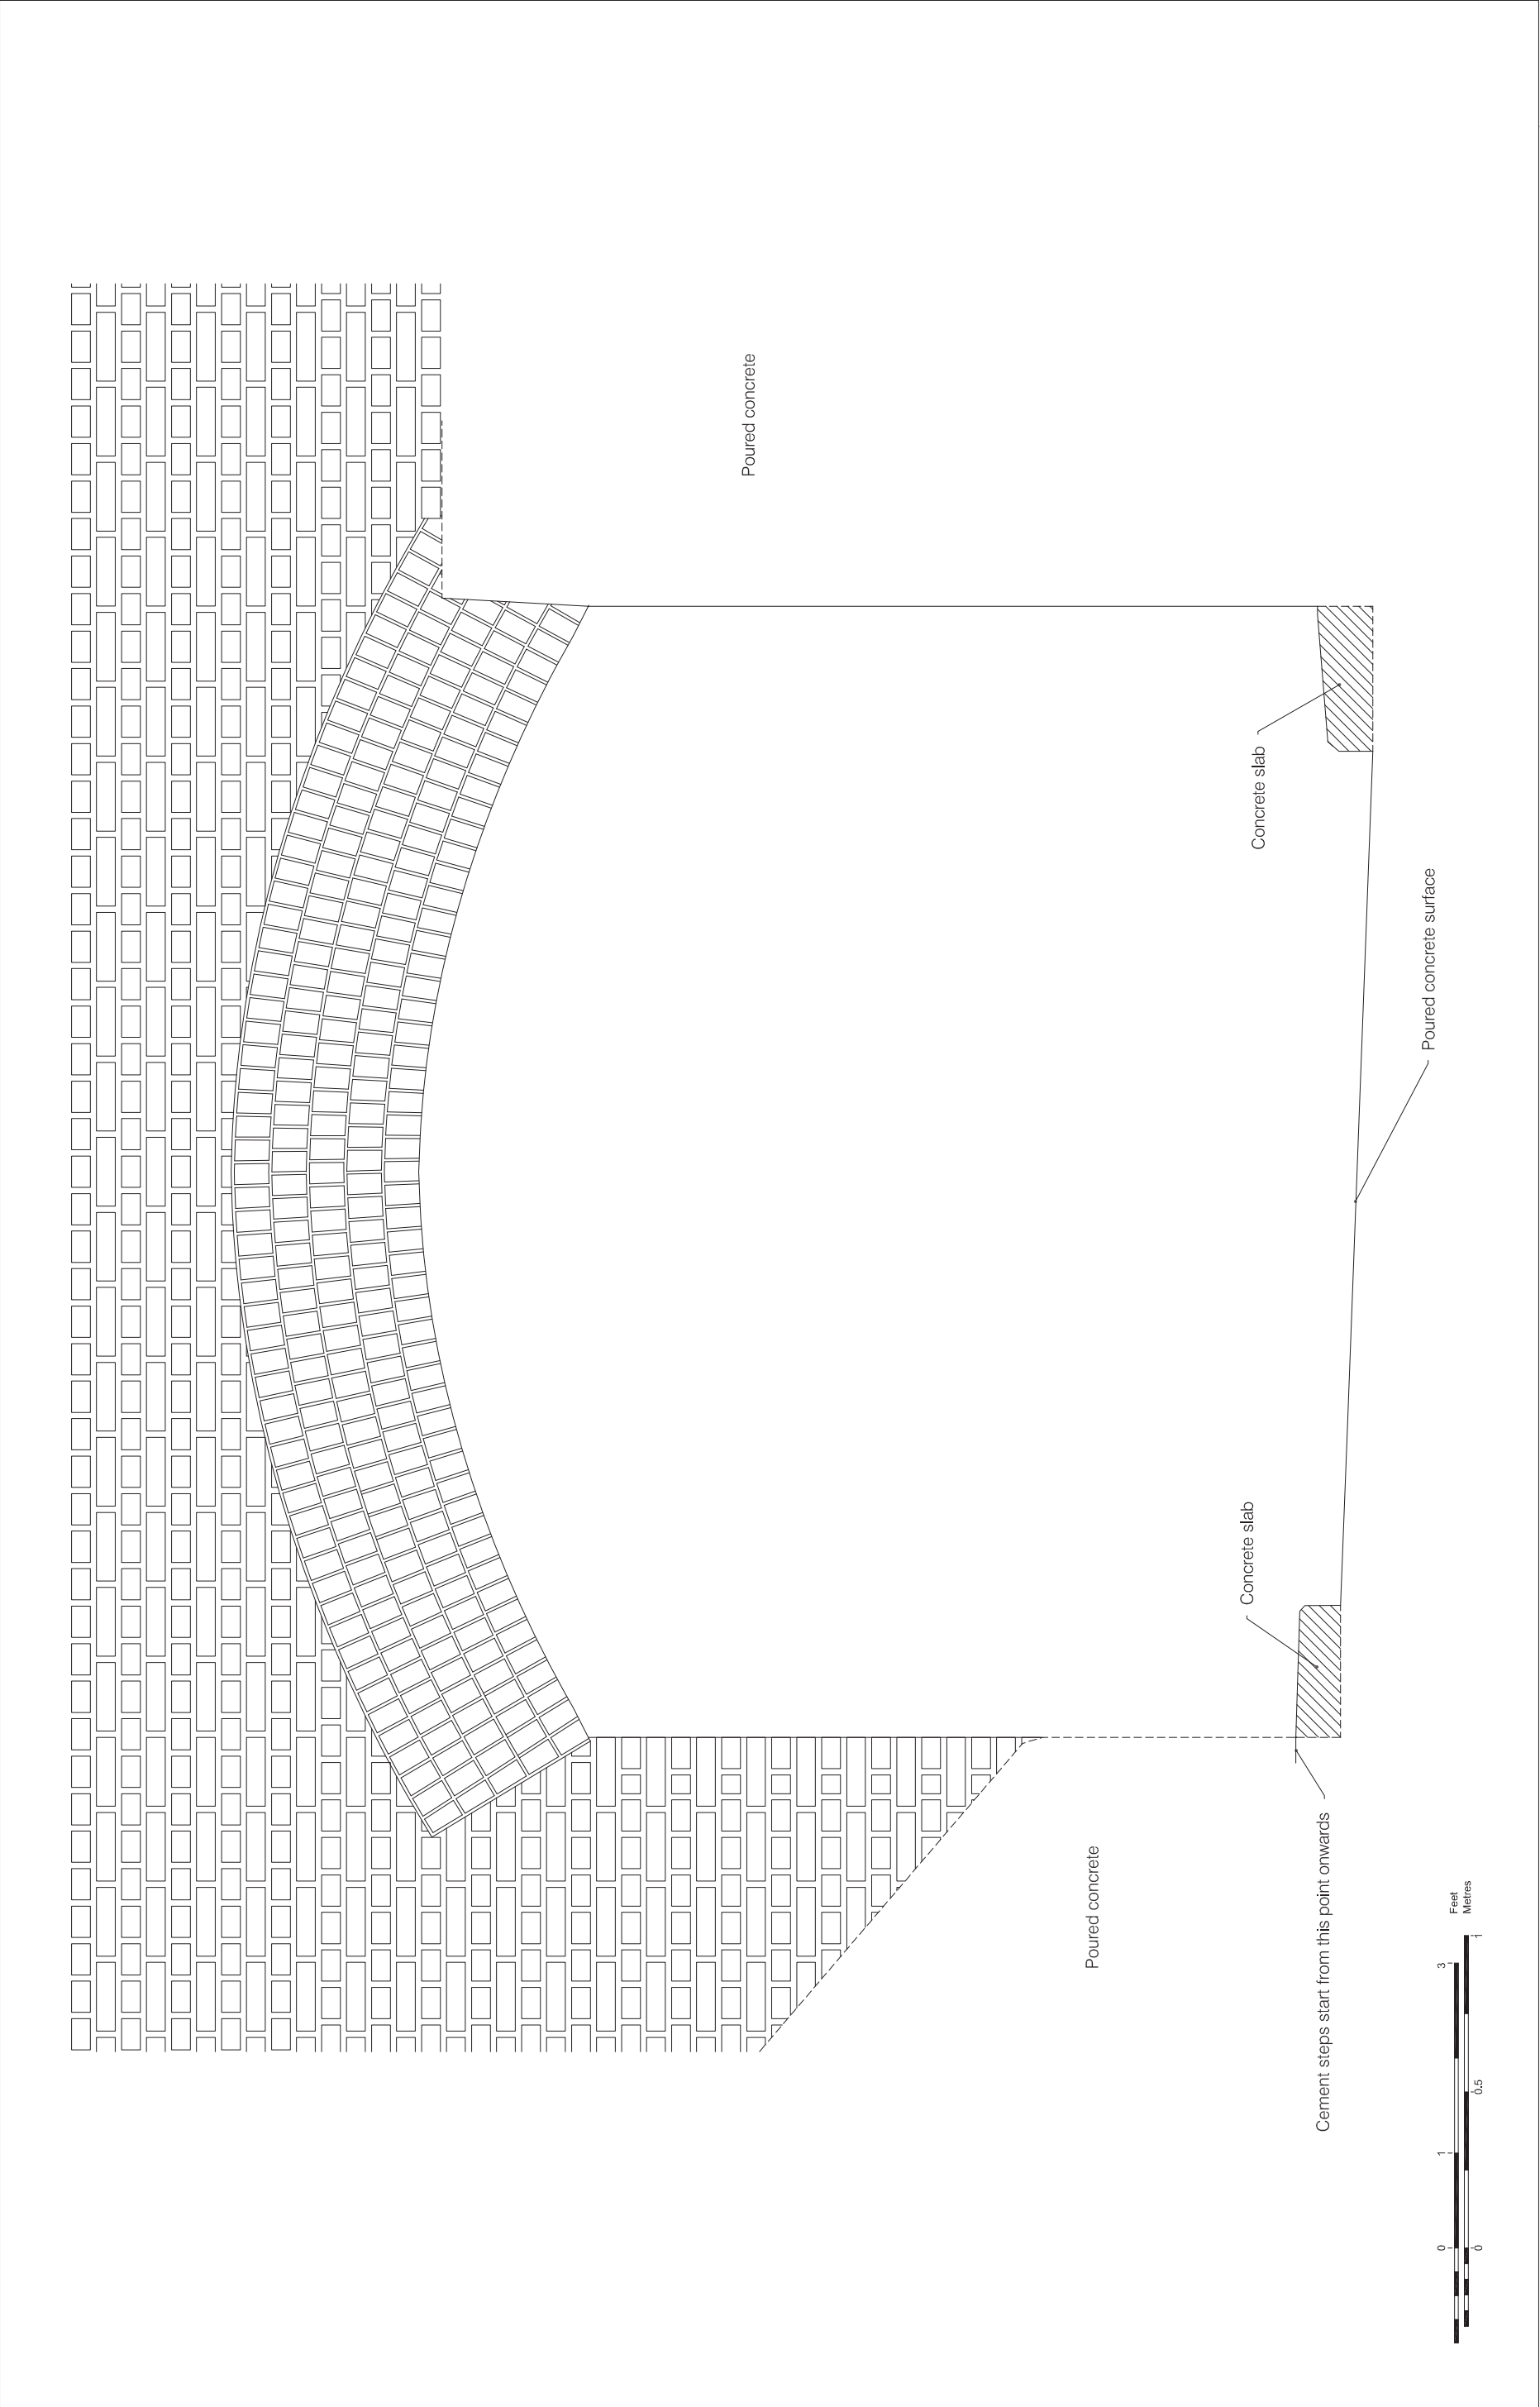
Figure 76
South-west elevation of Pedestrian Subway: OL-04107
Pedestrian Subway
1:20 at A3

The south elevation (Figure 76) is constructed of yellow stock brick set in English bond pattern, with grey/yellow fine mortar. The mottled appearance and general state of the brickwork indicates that the south elevation is older than the north. The opening to the subway tunnel has a segmental brick arched head formed of five courses of rowlock bond brickwork (Plate 77). The eastern side of the opening has been partially obscured by a later concrete structure, which follows the line of the Outfall Sewer’s southern elevation until it reaches the Waterworks River (Plate 78). On the western side of the opening are modern concrete steps which give access to the City Mill River (Plate 79). The cement has a high percentage of aggregate inclusions, which typical of 1930s Portland cement. The stair access to the City Mill River was constructed in the early 1930s as part of the Stratford Back Rivers scheme.

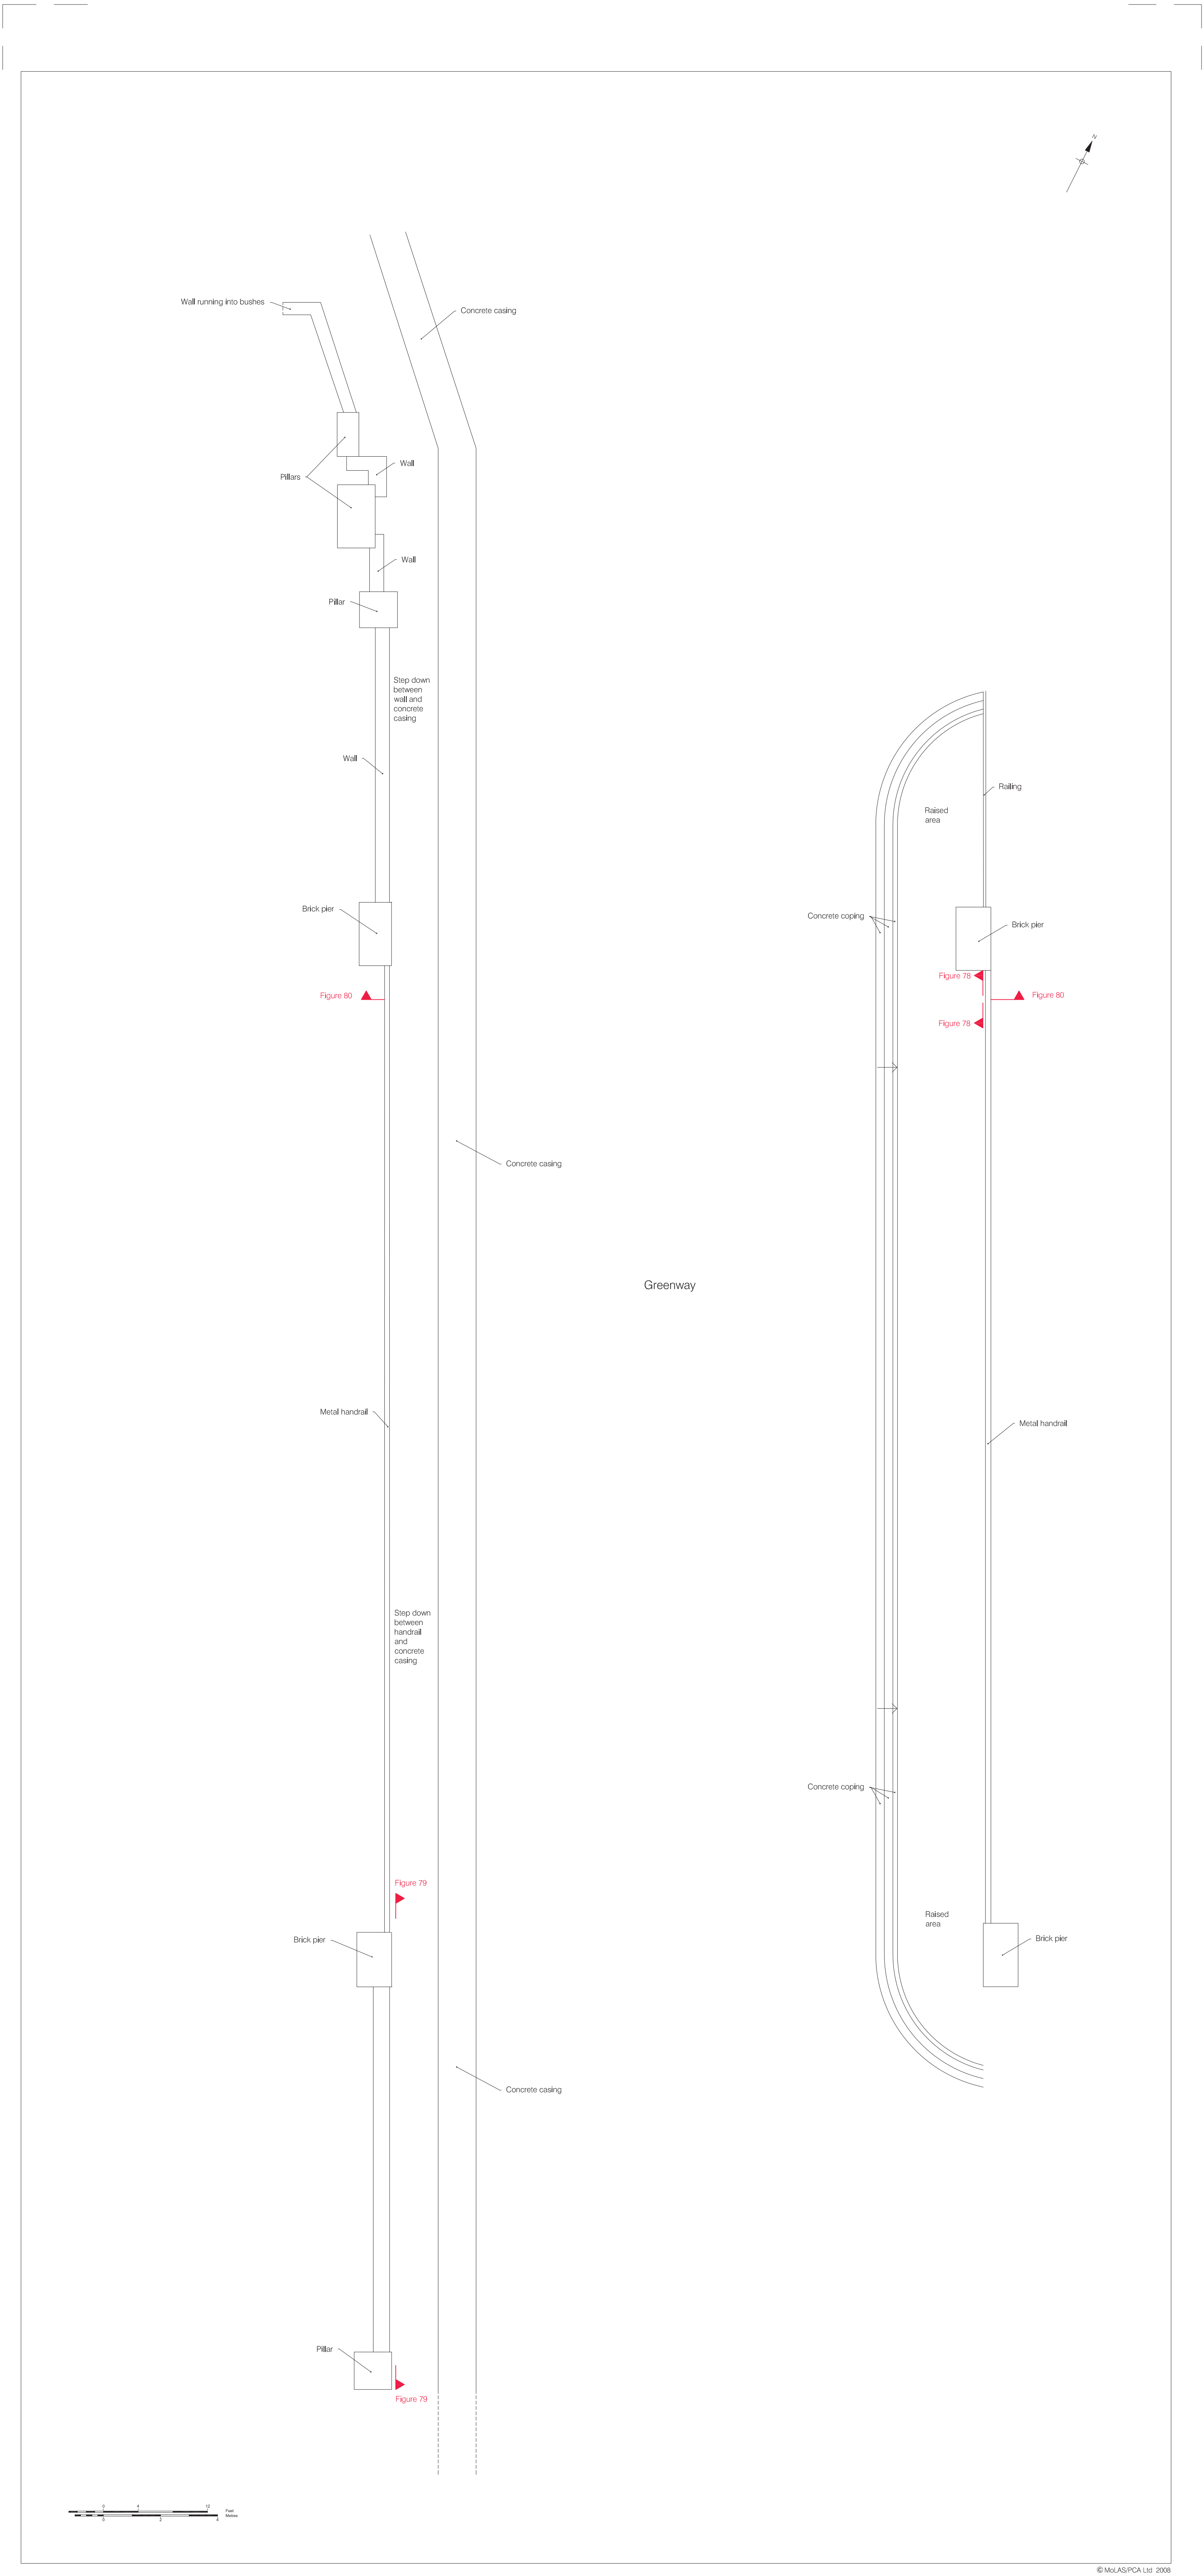
Figure 77
Plan of Channelese Bridge: OL-04607
Pedestrian Bridge spanning the Channelese River
1:100 at A0

This bridge was built to carry the Northern Outfall Sewer pipes across the Channelsea River and is constructed on a northwest-southeast axis (Figure 77, 78, 79 and 80; Plate 91). The bridge deck, or superstructure, of the Greenway is covered with a modern asphalt surface. The substructure is constructed from sections of riveted steel plates forming the outer skin of five large sewer pipes (Plates 92 and 93).
