ROYAL FESTIVAL HALL WATER TOWER

HISTORIC BUILDING RECORDING

# **Historic Building Survey of the Water Tower Between the Royal Festival Hall and Hungerford Bridge**

**Pre-Construct Archaeology Ltd, February 2005**

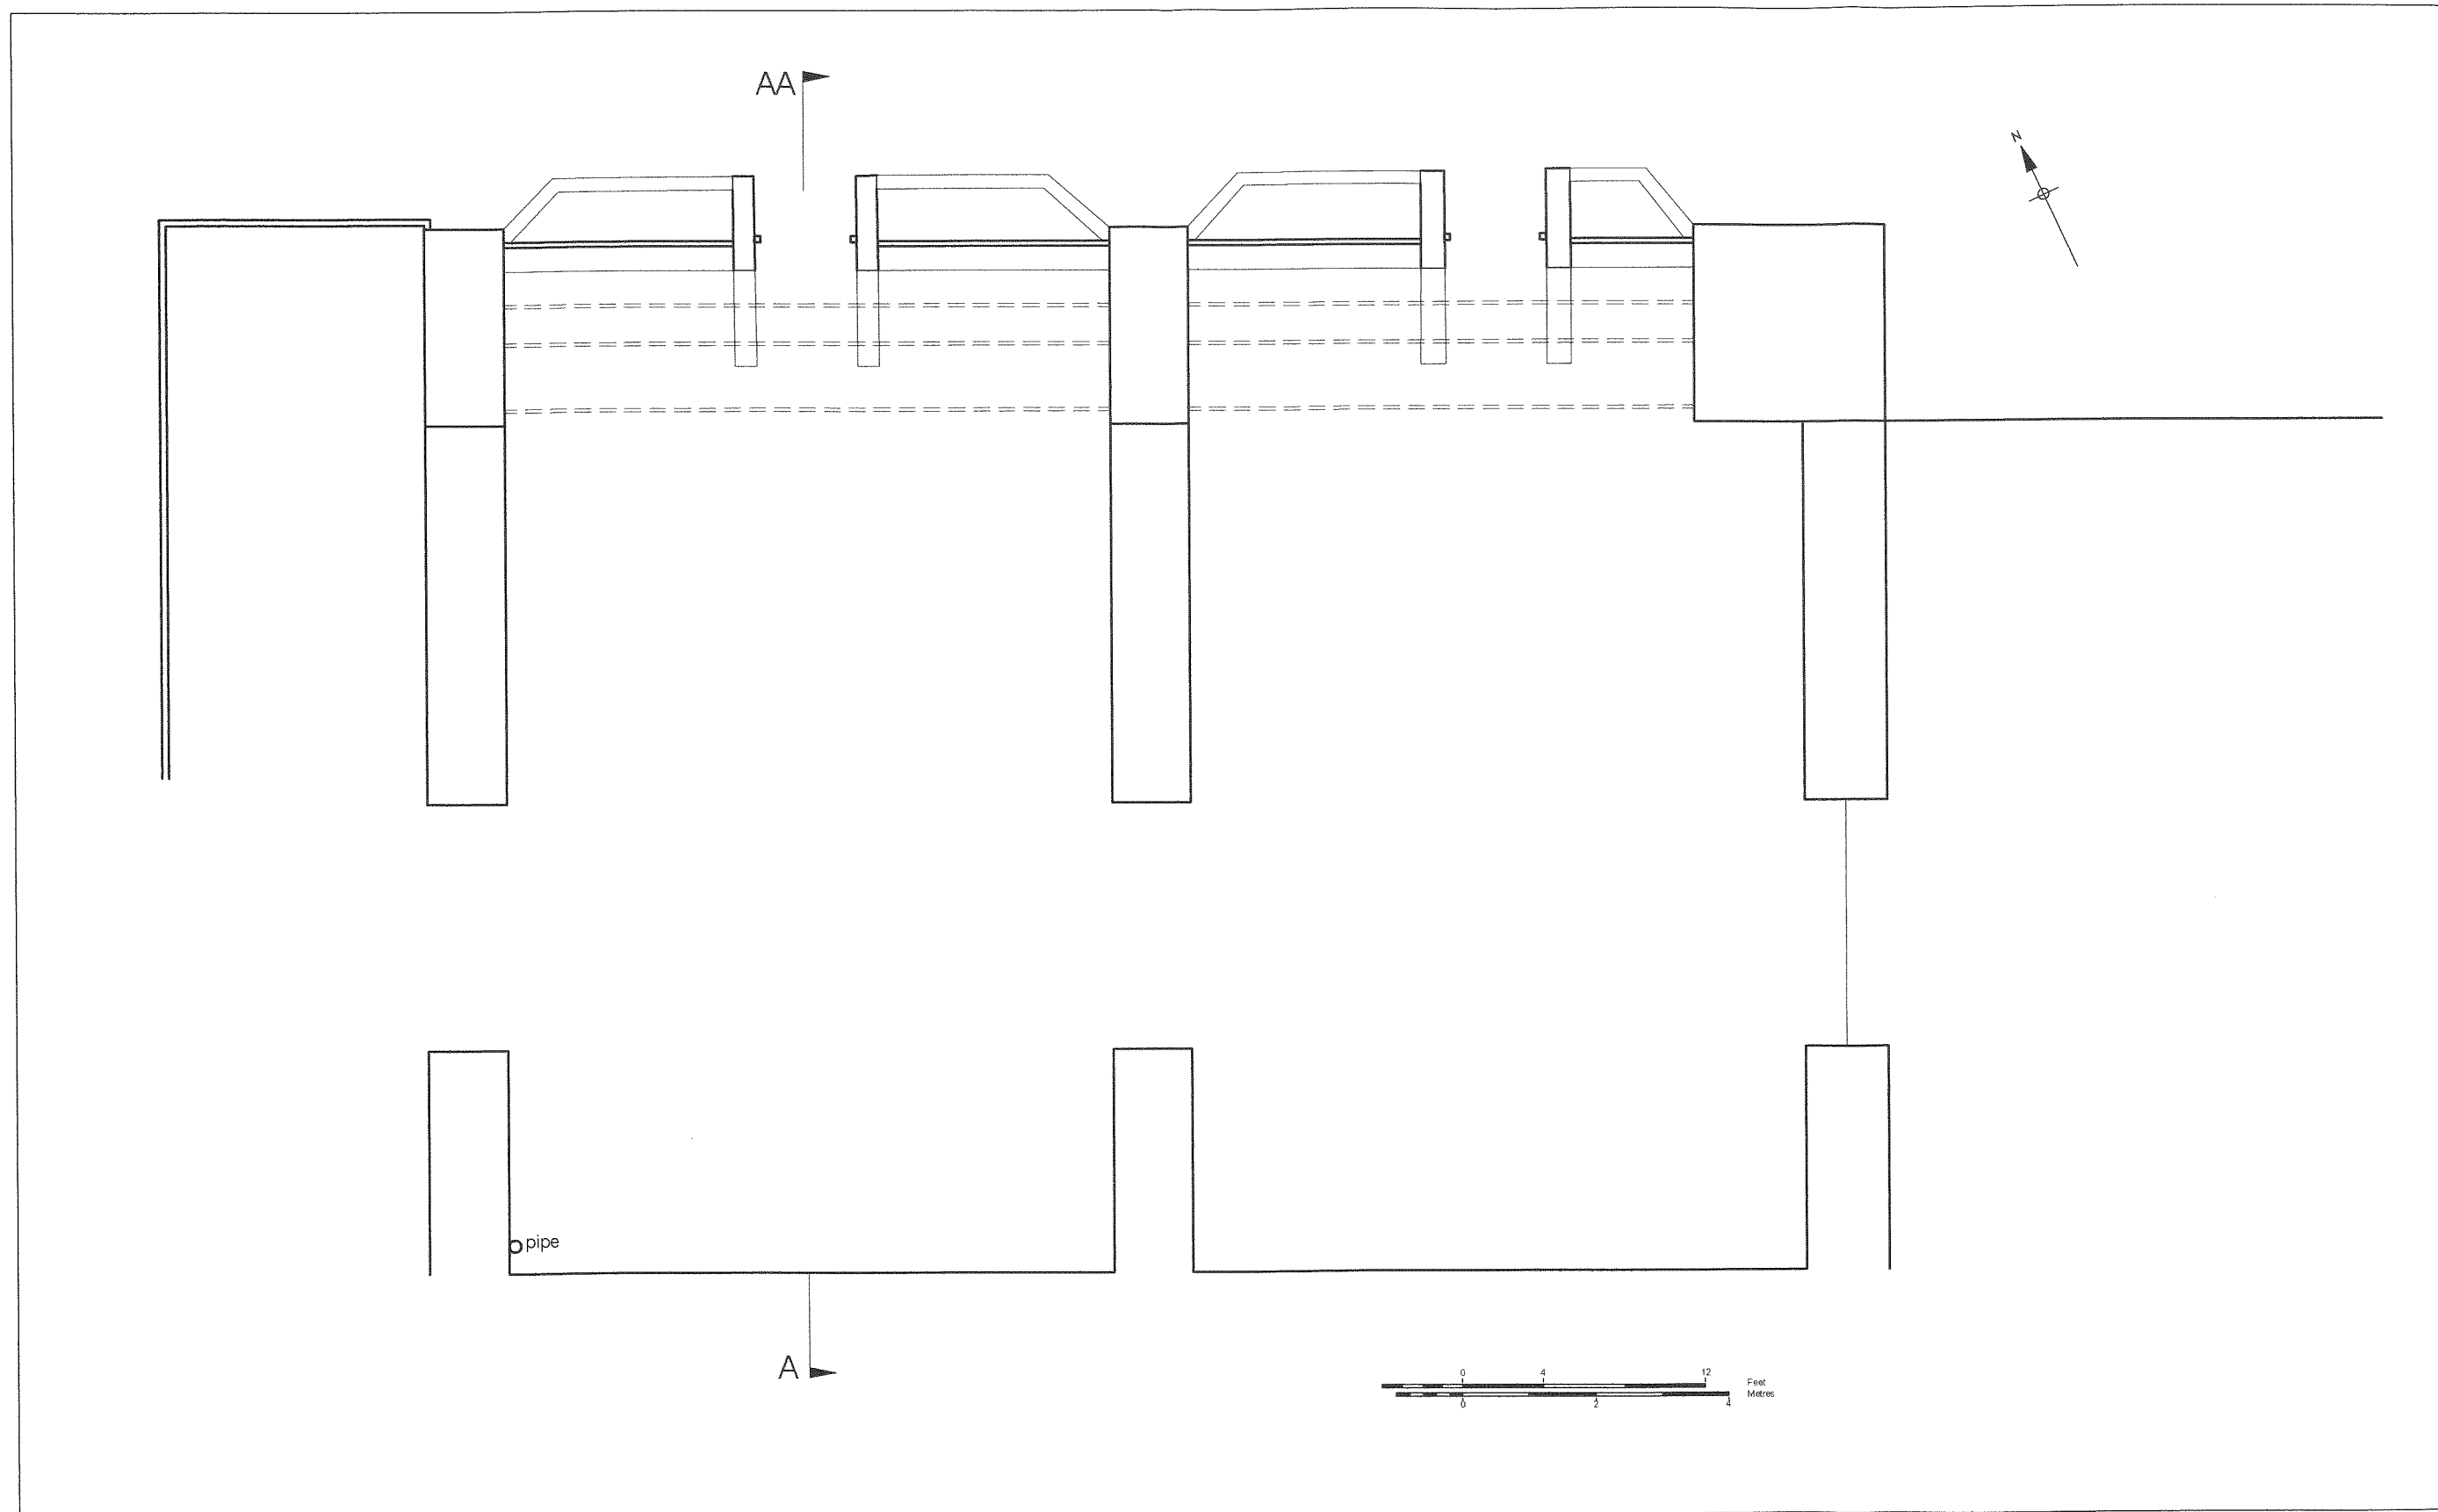
Figure 5  
Plan of lower level arches  
1:100

5.2.1 The water tower was a narrow brick structure built on two levels (fig 7). Its lower level consisted of two broad segmental headed arches positioned against the arches of the railway viaduct to the south. The western arch matched that of the viaduct while the eastern arch had a narrower span. On demolition, the abutments were seen to have been tied to the masonry of the railway viaduct. They were of solid brick, although there was a stoneware downpipe built into each abutment, that was hidden within the structure and drained below ground.

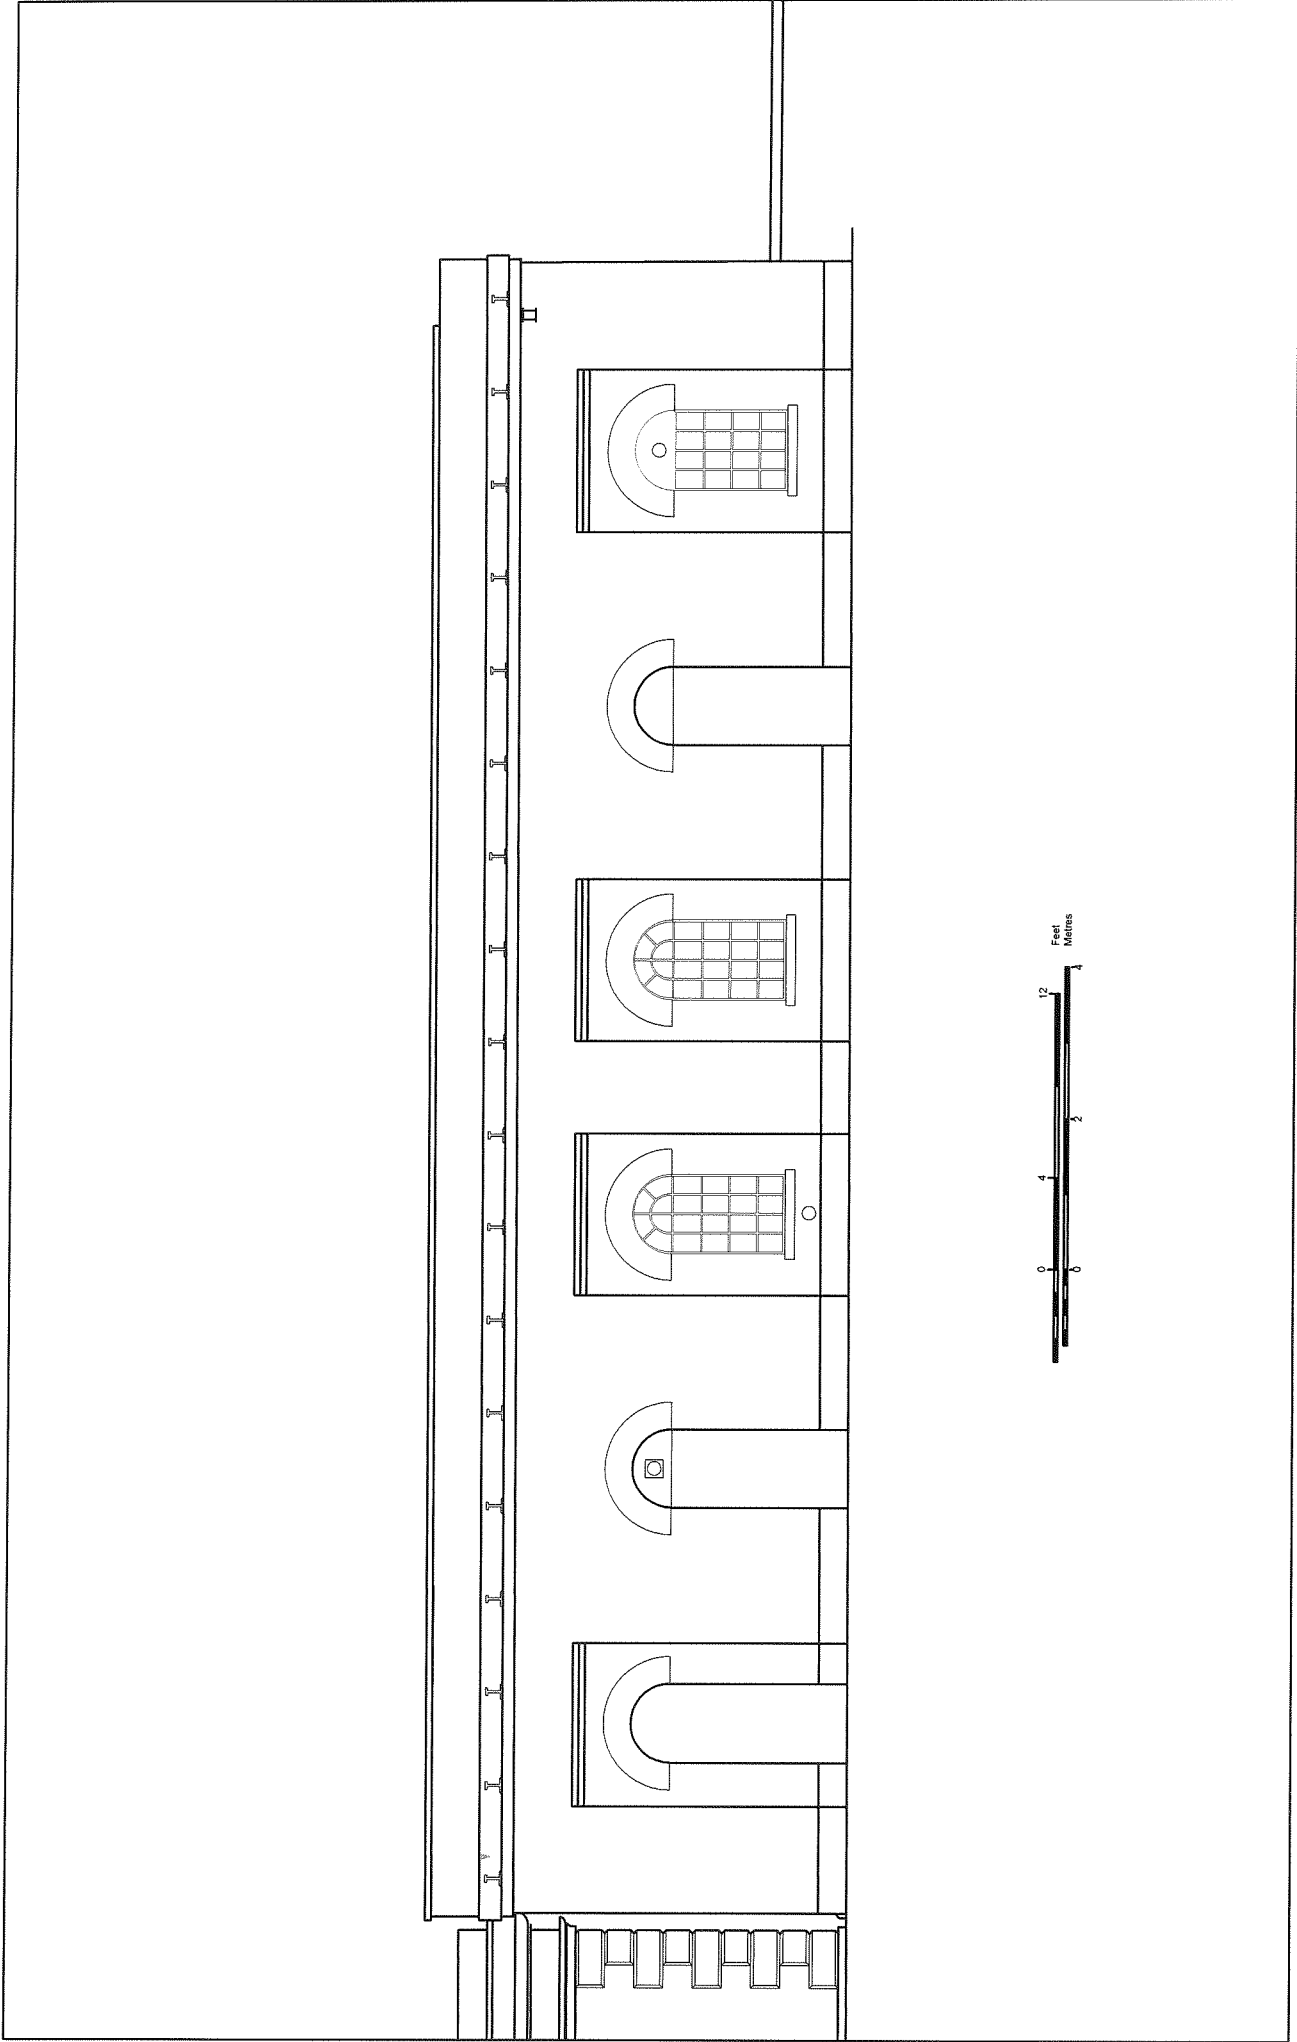
Figure 9  
South-west (track-side) Elevation  
1:100

- 5.2.3 Externally, a string course separated the upper and lower levels. Just below window sill level on the upper level the brickwork stepped in to form a chamfered plinth. The openings on the north elevation (Plate 1) were set into six recesses. On the south elevation (fig 9) there was no chamfered plinth (Plate 2). The upper level rooms were accessed via two doors that opened onto the railway track. Three of the original four windows on the south elevation survived, set into recesses, as on the north elevation (in the middle two bays and the eastern bay). The doorway inserted in the western bay was set into recessed brickwork, while the doorway in the second bay from the east and the blocked opening in the second bay from the west were not recessed. The windows had sandstone sills and cast iron frames and mullions (fig 11). The window glass was unusually thick (7mm thick), designed to endure the vibration caused by railway traffic.
