Church Farm Barn The Street Thorndon Suffolk Historical Building Survey

February 2010

Archaeological record

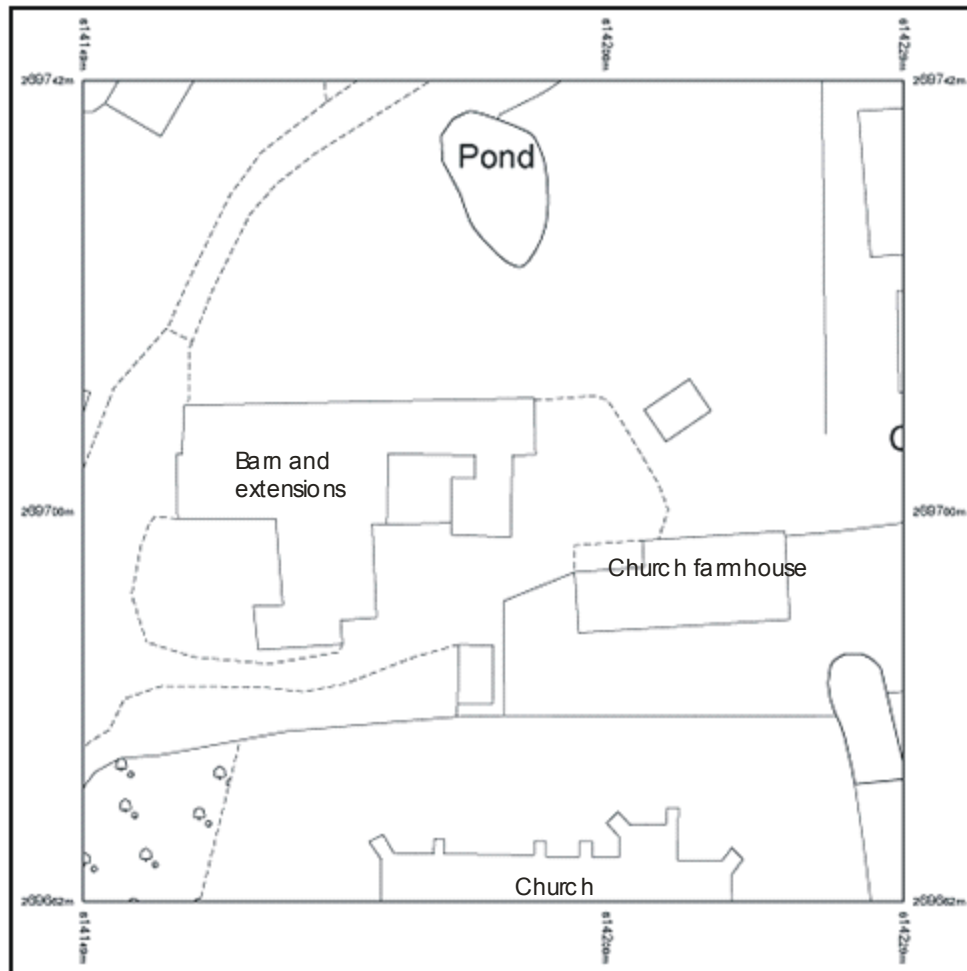
Figure 7: Block plan of Church Farm Barn
(geo-referenced for scale)

The origins of the main barn (2) are likely to be c. late seventeenth-early eighteenth century. This can be evidenced by the mixture of nail fixings for the scantling and peg joints for the main box frame, and suggests a cross-over of the two jointing methods seen in buildings of this date. Remains of the original lathe and plaster infill were noted, and are also typical of this period, with cut willow vertical poles retained by twine and covered with a daub render. Further evidence that the barn was either refurbished or completely rebuilt over an existing barn structure was seen from the archaeological monitoring report for this site. The report showed that a stone course, possibly an earlier footing, was recorded below the connecting range, also an organic deposit was recorded in two areas of the footings, which could be evidence for an earlier building being used for stock holding.
