Archaeological Monitoring Report. Lartington Hall, Co. Durham.

For John and Shona Harper-Wilkes January 2020

AE0106-2020

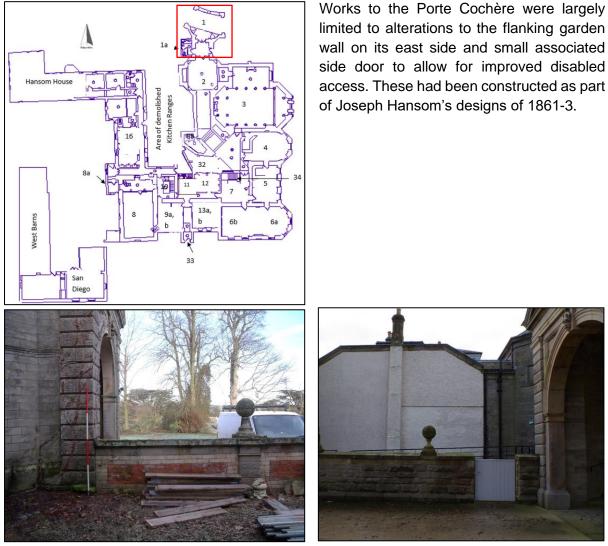
Plate 2. Flanking wall to the east of the Porte Cochere prior to works (above left and seen looking north) and in 2020 following works to facilitate improved access (above right and seen looking south). The new gate leads to a level access ramp (plate 3)

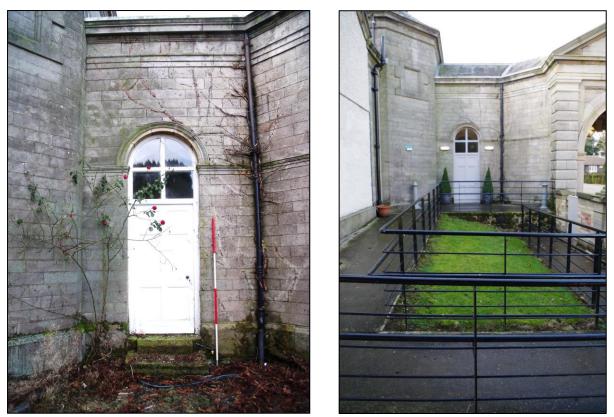
Plate 3. Personal door on east side of the Porte Cochere prior to works (above left) and following works to facilitate improved access (above right)

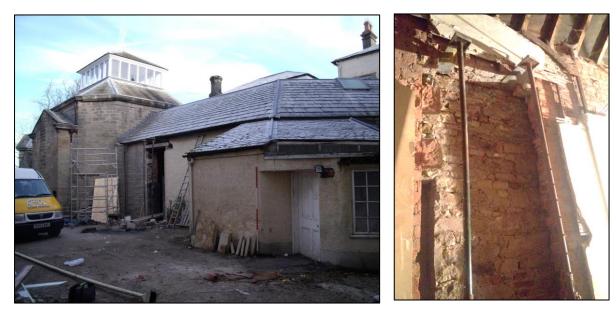
Internally the late 20th century suspended ceiling of the Grand Corridor was removed and new timberwork introduced to replace the lost arched form of the original design, which also included glazed roof lanterns to allow natural light to illuminate the corridor. With the suspended roof removed the construction of the structure could be better understood and was clearly in brick with iron bracing (plate 5b).

Plate 4 (4a above left), Looking north-east at the outside west wall of the Grand Corridor constructed in 1861-3 showing new opening to access the new toilet block. (4b above right), Opening up works for the new entrance seen from the inside and (5c far left), outside wall at the same point showing brick internal construction with outside facing in sandstone.

Plate 5. (5a Below left) Looking south with work in progress to the Grand Corridor following removal of late 20th C suspended ceiling revealing original brick, iron reinforced arch of 1861-3 in the foreground with new timberwork beyond. (5b Below right); Removal of the 20th C ceiling also revealed the SW corner of the Museum/Ballroom (room) G3, prior to 1861/3 an outside wall and clearly in part adapted by Hansom to accommodate the Grand Corridor.

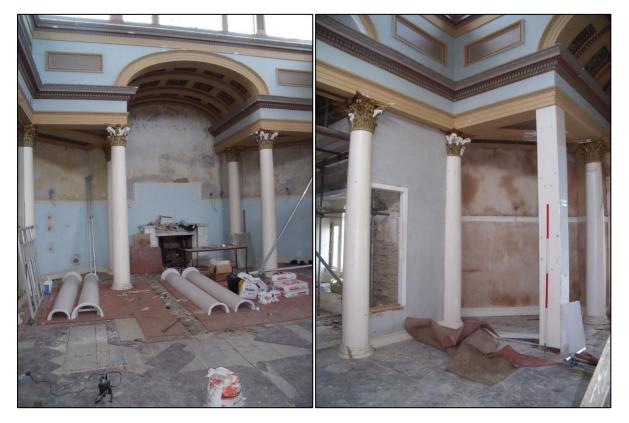
Works to the former Museum of 1832 built for Henry Witham to the design of Ignatius Bonomi and then later used as a Ballroom, were largely concerned with repairing the roof and in particular the decorative plasterwork damaged when the room was converted into a recording studio in the 1990s. Scaffolding inserted for these works also allowed closer photography of the decorative schemes. In addition to images reproduced here a wider selection are contained in the photo archive.

Plate 13. Room G3, (left above) Northern Atrium ceiling and clerestory under repair in 2012; (below left) West wall and fireplace under repair, not replacement column sections wating for insertion 2012; (below right) looking north-east, room under repair, note the white plaster repair sections to the column capitals previously damaged by insertion of a 20th century recording studio.

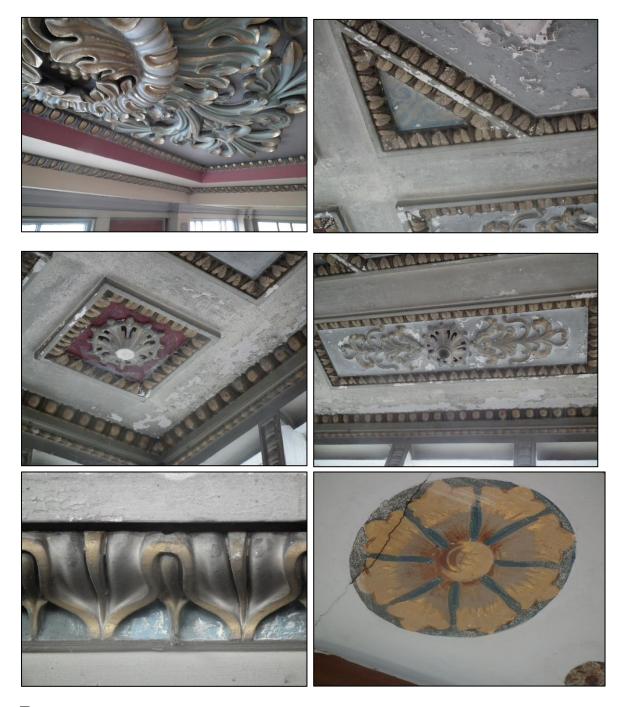
Plate 14 (following 9 images). Room G3, the former Museum and later Ballroom. Details of plaster ceiling decoration prior to restoration.

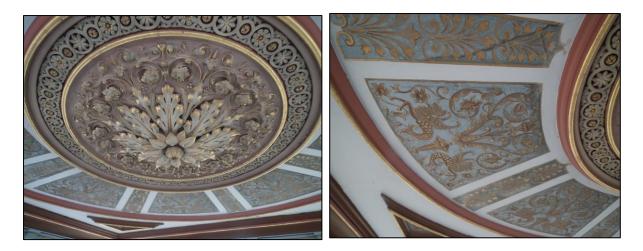
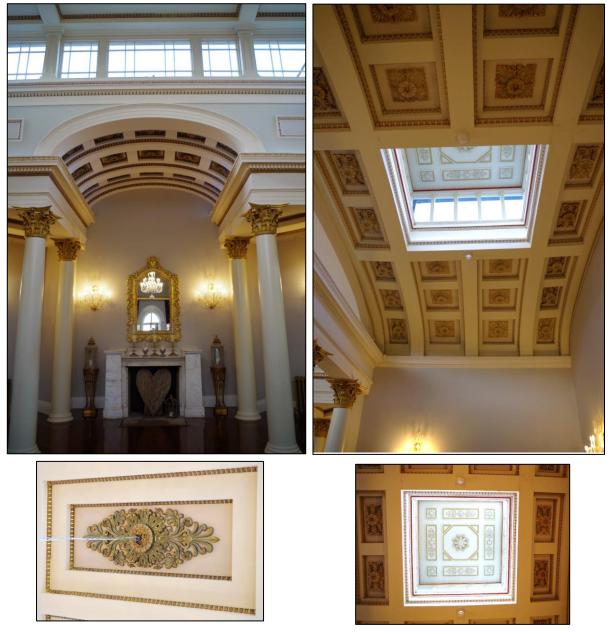
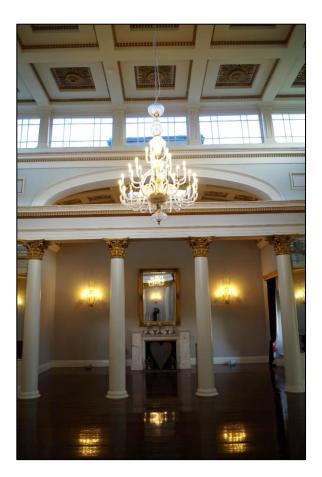
Plate 15 (following 5 images). Room G3, the former Museum and later Ballroom after restoration in 2020. (top right) west wall; (top & bottom right) North Atrium Ceiling; (bottom left main room ceiling; (following page) North Atrium arch and fireplace.

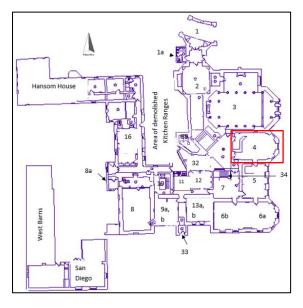
Plate 16 (right). Room G4 decorated cornice prior to restoration in 2012.

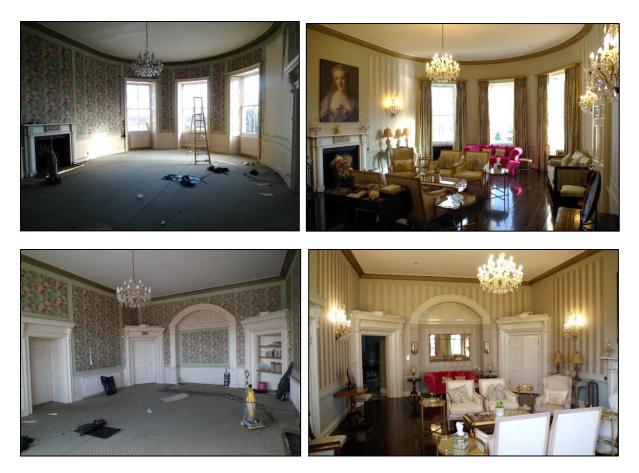
Plate 17 Room G4. (above left) prior to restoration in 2012; (above right) After works in 2020.

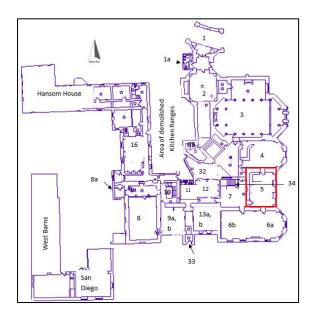
Plate 18 Room G5, the mid Georgian entrance Hall in use as a kitchen prior to restoration in 2012.

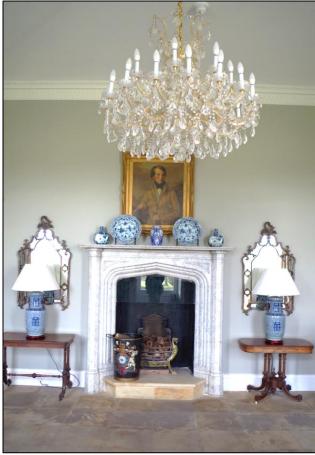
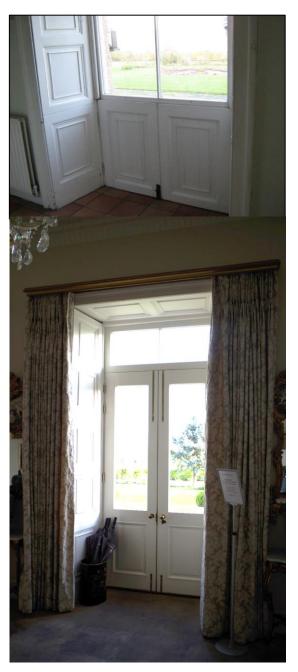
The Hall, later used as a library was added to the building as part of the major mid-18th century remodelling of the Hall which changed its principal elevation to the east. Works to this room involved removing a suspended ceiling and a stove installed into the west wall chimney opening as part of the use of the room as a late 20th century kitchen.

Plate 19. Room G5, the mid Georgian entrance Hall. (top left) in 2012 with suspended ceiling removed showing Georgian cornice; (middle left) in 2020 after removal of range cooker and insertion of stone floor; (top right) The former Georgian half-window/lower split door arrangement in 2012, this was replaced by a more conventional and usable double door to suit more regular use as a wedding venue accessing the gardens (bottom right in 2020). Removal of the suspended ceiling 18th revealed century decorative plasterwork, a cornice (left), which has in due course been restored as part of the recent works. The quarry tile floor was also removed and a new sandstone flagged floor laid. The range/cooker was also removed and the fireplace restored. The former Georgian half-window/lower split door arrangement was replaced by more conventional and usable twin doors to suit more regular use as a wedding venue accessing the gardens.

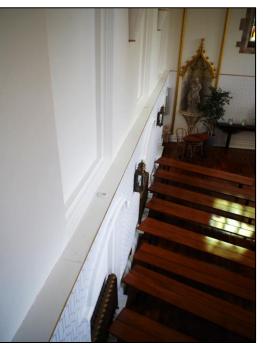
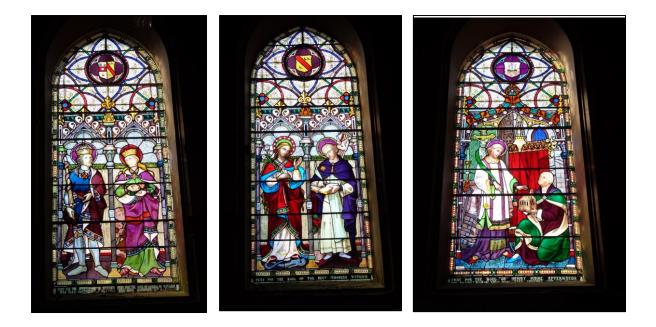
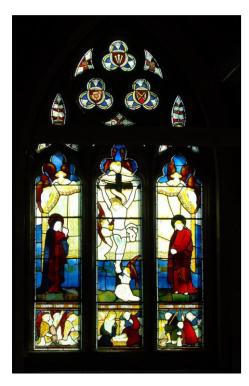
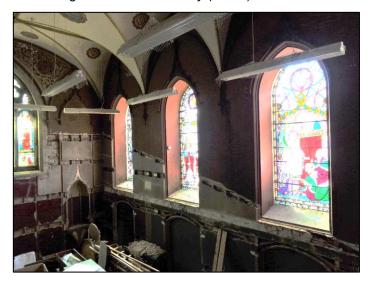
The Introduction of the squash court structure into the chapel in the late 20th century had caused significant damage to the existing decorative scheme with many projecting plaster work finishes hacked off or mutilated. Nevertheless the scheme was still very legible and consisted of late and plaster battened walls covering over the stone walls of the Chapel which showed no sign of earlier decoration or plasterwork save from some iron clamps along the east wall which may have had an earlier function of supporting and retaining panelling (plate 24). The lathe and plaster walls were covered with a painted and stencil decoration of repeated geometric shapes in red and green with white, gold and silver detailing and highlighting.

Plate 26. 19th century stained glass revealed by the removal of the squash court structure in the chapels west wall (above from south to north) and above the altar at the south end (left). The angled scar left by the squash court can be seen in the view looking SW from the balcony (below)

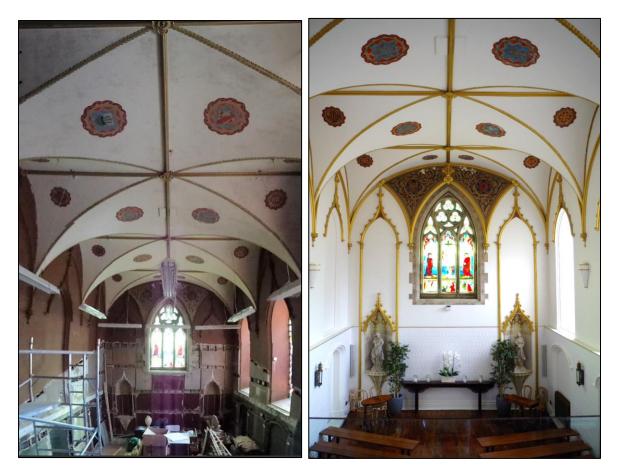
Plate 27. The Chapel room G8, looking south from the balcony at the north end. (above left) in 2014 following removal of the late 20th century squash court; (above right) after building and conservation work in 2020.

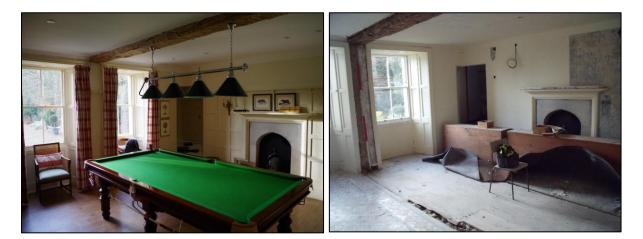
the current scheme of works revealed the major N-S centrally placed beam holding up the first floor. On the underside of this beam were the markings of lathes (plate 28) indicating the presence of earlier plasterwork around the beam. No evidence was present as to the complexity, detail or date of this decoration.

Plate 28 Room G9, formerly a principal room of the 17th C Hall. (Clockwise from top left) looking SE showing floor scar left by removal of the later N-S partition wall, with 19th C encaustic tile floor to the east. (Above right), detail of the encaustic tile floor. (Right) scars from earlier lathe and plaster to the central supporting beam. (below right) view of room in 2012 prior to building works looking SW showing 18th C fireplace and steps to the chapel (Below left) view of the room in 2020 after building works.

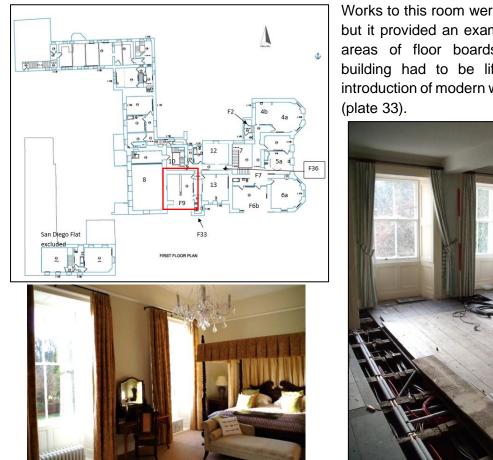
Works to this room were largely cosmetic but it provided an example of how many areas of floor boards throughout the building had to be lifted to allow the introduction of modern wiring and services

Plate 33. (above right) room F9 during building works in 2012 looking SW and showing how modern wiring and services were accommodated. (above left) the same room and view following conservation works in 2020.

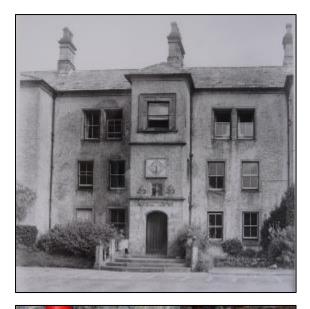
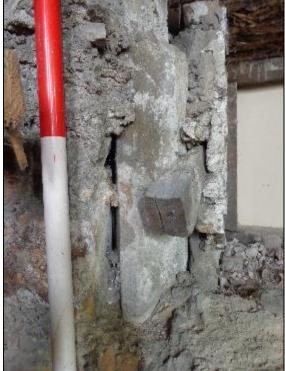
The discovery of the mullion and transom window and associated plinth course in the east wall of the Chapel (plate 34 bottom left), which is also the outside west wall of the pre-1800 hall, is exceptionally helpful in identifying the size and ground plan of the 17th century building and its subsequent evolution. The design and form of the blocked window is identical to the blocked window on the Hall's projecting entrance turret (plate 34) and which is dated to 1635. This had previously been obscured by a later sundial and vegetation. Similarly the plinth course is also identical to that found on the south elevation of the Hall either side of the stair turret, strongly suggesting this is all of one contemporaneous build.

Plate 34. (above) 17th C mullion & transom window on the entrance tower previously concealed by the sundial dated 1641 (top left). The central transom is identical in form to that exposed in the east wall of the Chapel, the former west wall of the Hall (left)

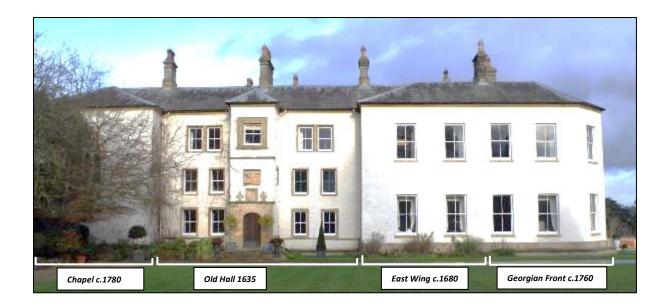
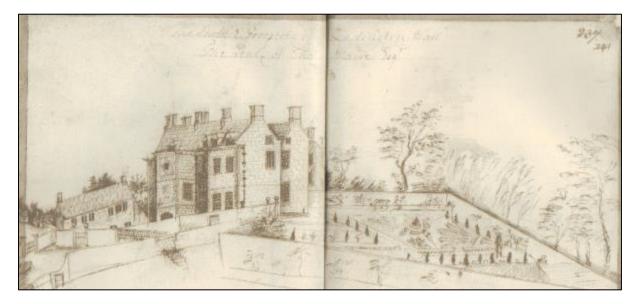
Plate 36. The South elevation of Lartington Hall in 2020 at the completion of works showing phases of construction and extension. Comparison with the Samuel Buck drawing of 1720 (below) also shows how as well as the extensions, the roofline of the Hall has also been altered to a shallower pitch without dormers the whole being unified by a moulded sandstone course running around the whole of south and east elevations. This seems likely to have been part of the significant Georgian work of c.1760 which altered the principal elevation of the Hall from the south to the east to look over the newly laid out landscape parkland.
