**Coldrach Farm Steading, Drymen:  
Historic Building Recording Survey  
Project 3646**

## **Coldrach Farm Steading, Drymen: Historic Building Recording Survey**

**Project Number:** 3646

28/03/2013

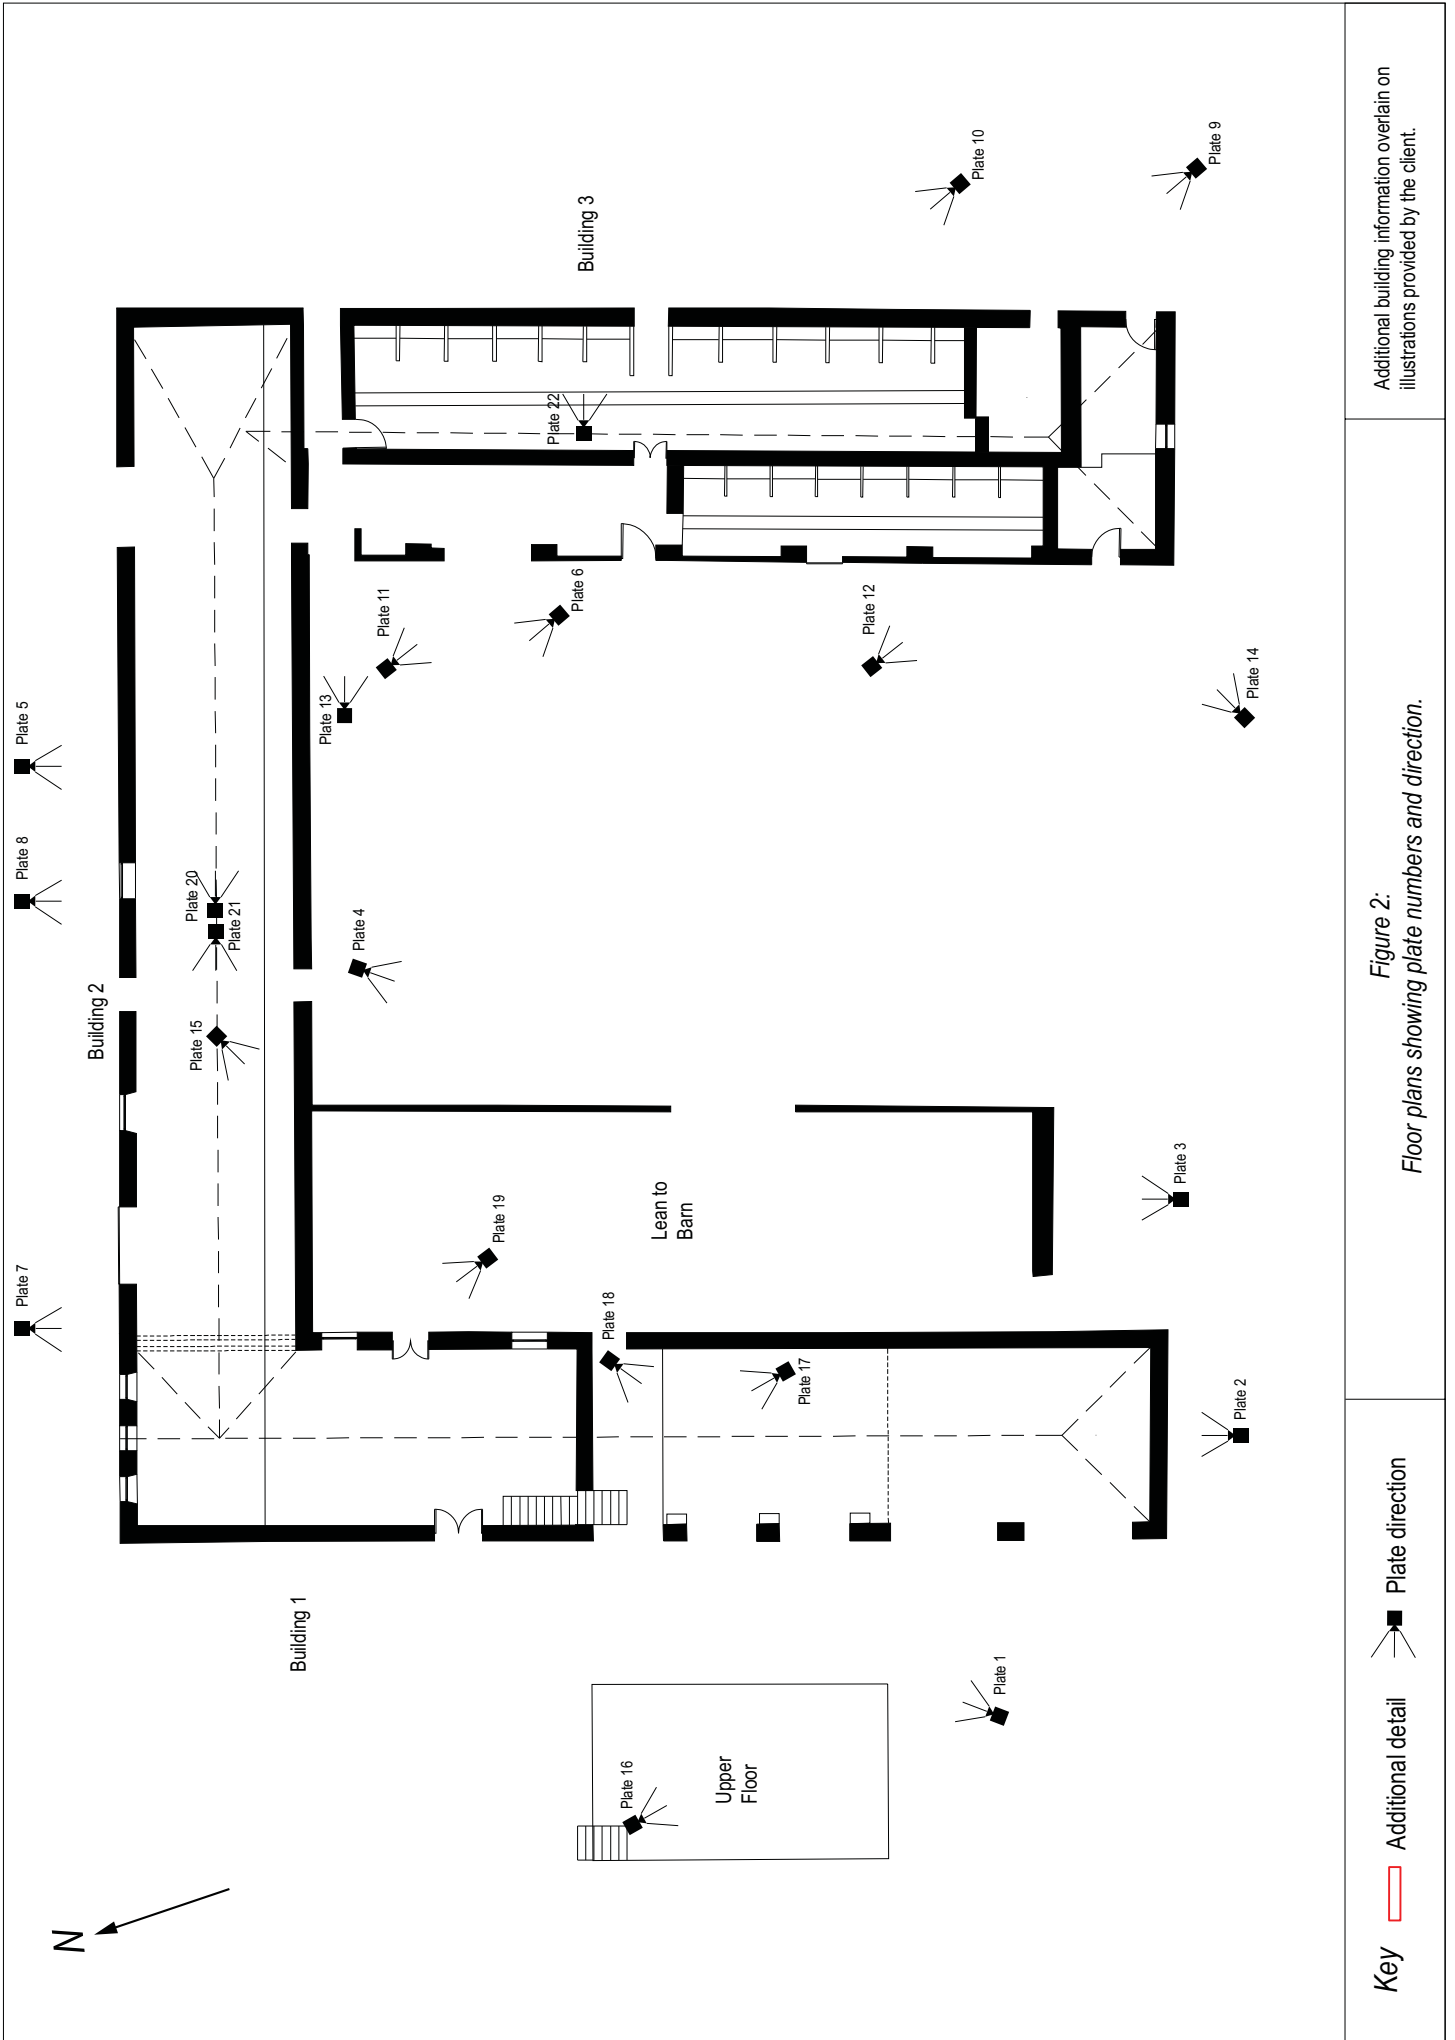
Figure 2:  
Floor plans showing plate numbers and direction.

- 7.15 This building has concrete floors throughout and is sub-divided into three areas, the southernmost of which was boarded-up on the interior and exterior and was inaccessible (Figure 2). The northern area had, at one time, been partitioned-off from Building 2 but, at the time of the survey, was open (Plate 15). All of the interior stone walls, with the exception of that within the lean-to animal shed, are whitewashed/limewashed.

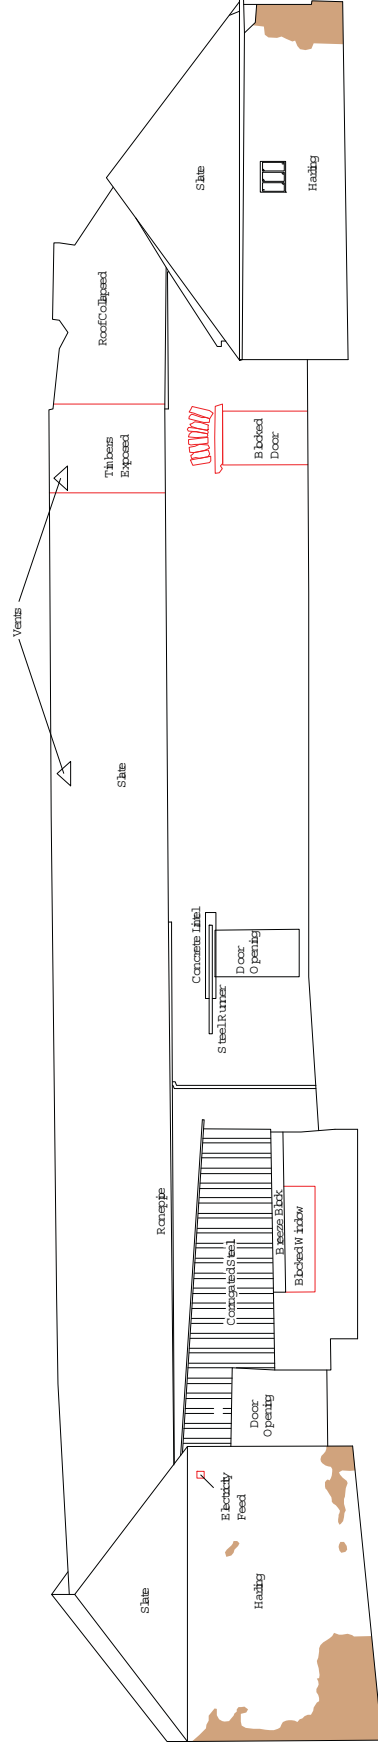
Figure 3:  
South Facing Elevation

- 7.8 The building is of bonded stone with five entrances from the north exterior, two of which are now blocked-up (Figure 5; Plate 5), and two from the courtyard, one of which is blocked-up (Figure 3; Plate 6). On the north elevation are two sliding-track barn doors with wooden lintels, one sliding-track door with a wooden lintel, one block-up sliding-track door with a wooden lintel and one blocked-up door with stone lintel and splayed stone headwork. From the courtyard, one entrance has a wooden lintel and the other, which is blocked-up, has a stone lintel and splayed stone headwork.

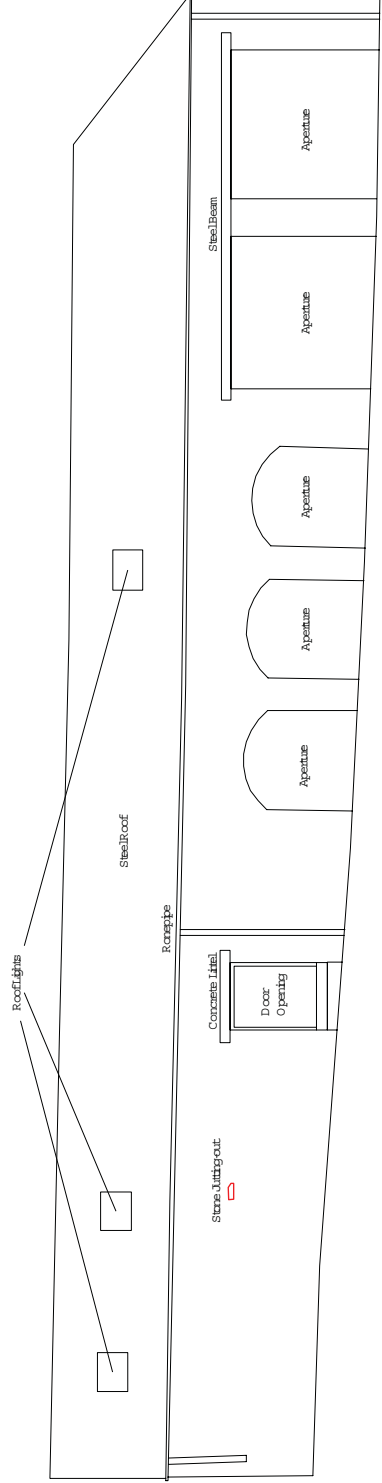
Figure 4:  
West-facing elevation of Building 1.

- 7.4 The west facing exterior of the building was bonded stone with six entrances to the interior. A timber double-door entrance provided access to the storage area at the north of the building. Three cart-arches are in the central section (Figure 4; Plate 1), and two further entrances at the south-west were also probably cart-arches, but had been enlarged to accommodate modern farm machinery; these were boarded-up, making the south interior inaccessible.
- 7.5 The harling on the south and east facing elevations was relatively intact, although patches were missing from both walls (Figures 3 & 8; Plate 2), and a vent had been created on the upper portion of the south-facing wall for the electricity supply.

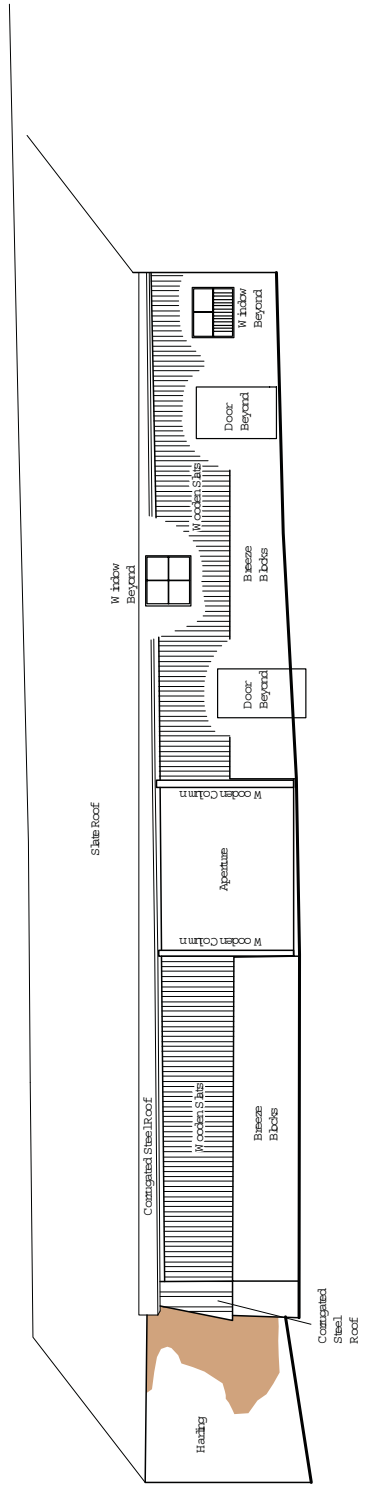
Figure 8:  
East Facbg elevation of Building 1

- 7.6 A modern lean-to animal shed of breeze-block, timber and corrugated steel construction adjoined the eastern side of Building 1 (Figure 8; Plate 3), and incorporated an existing stone wall that formed its southern limit. A window or gap on this earlier wall had been blocked-up and capped with breeze-block (Figure 3; Plate 4). The lean-to shed has one gated entrance from the courtyard.
- 7.7 The roofs on the west side of the building and on the modern animal shed were of corrugated steel, and were in a good state of repair. Graded slate roofs on the east and south sides of the building were found to be in a reasonable condition, with slates missing only from the first few rows from the bottom edge.
