Walled Garden and 8 Acre Field, Edmonstone Estate Data Structure Report Project 3955

Data Structure Report

On behalf of: Wintertree Software Inc.

Project Number: 3955

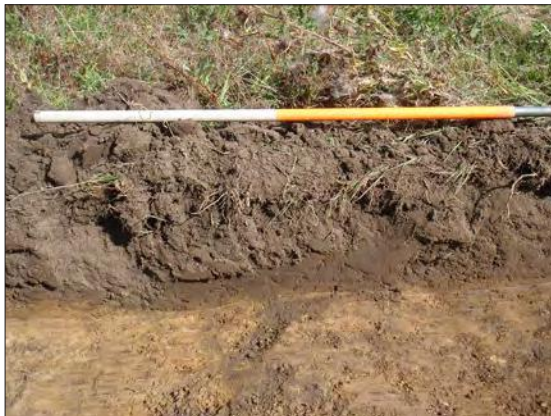
Plate 12: South-west facing section of trench 8.

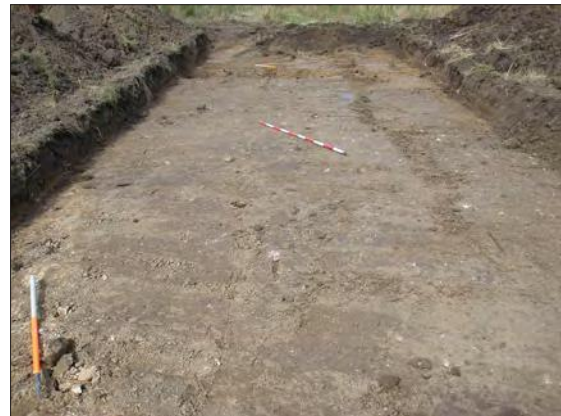
Plate 13: Wide furrow within trench 7.

7.13.1 A furrow (7004) was investigated within trench 7 as representative of the east/west system of furrows seen across the 8 Acre Field area (in addition to the truncated (6004)), in order to establish the full width and depth (Plate 13). This had a brown silty clay fill with frequent coal and sandstone flecks and occasional small oyster shell fragments, and was 0.25 m maximum depth in section within a shallow cut. A total of 14.9 m in length was revealed within an area expanded to the north of the trench, and the width was 4.8 m.

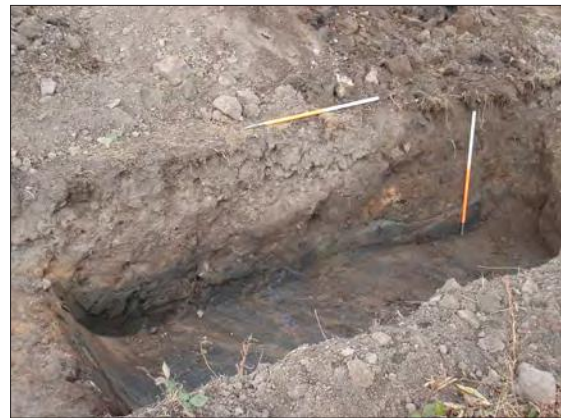
Plate 19: North-east facing section of ditch (oblique from the north).

7.15.3 A ditch (13007)/[13008] was present immediately adjacent to the south of the wall [13006], and as in trench 6 the wall appears to be set into the northern extent of this. This seems likely to be a further extent of [6006]/(6007) however is more substantial here at 1 m in depth cut down into a blue shale clay, with a gently sloping cut to the south, and terminating at the wall to the north (Plate 19). The fill (13007) is a mostly dark brown sandy silt with some mottling of lighter grey brown.

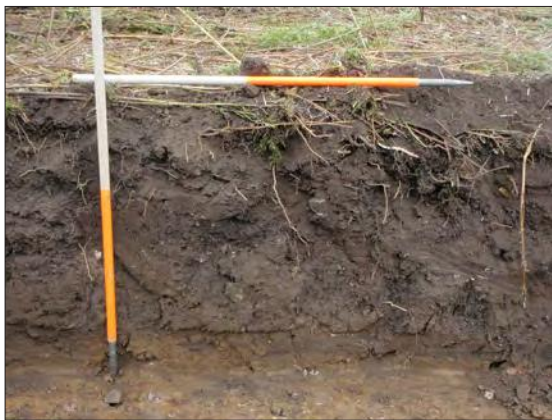
7.16.2 Topsoil across the Walled Garden area was a dark organic rich grey brown silt with frequent small stones and roots, and varied in depth from 0.25 m – 0.42 m (Plate 20). This overlay a deep intermediate plough soil deposit consisting of moderately compact mid brown silt clay with frequent mixed sandstone and dark mineral flecks, varying from 0.18 m – 0.4 m in depth. Subsoil was a light beige orange mottled grey clay with sandstone and dark mineral flecks.

Plate 20: South-east facing section, trench 24.

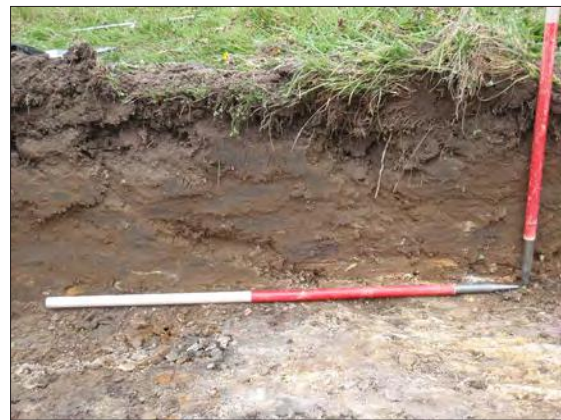
Plate 21: Furrows in trench 22 from the south.

7.16.4 A very ephemeral series of furrows was present across several of the trenches, concentrated more towards the east of the garden. These were shallow at 0.13 m depth or less where surviving, and were 0.68 m – 1.39 m in width, 2-3 m apart, orientated east-west (Plate 21). The fill was mid orange sandy silt, with frequent sandstone and dark mineral flecks and occasional oyster shell fragments visible; a representative sample was retained from feature 32004. These were cut into the subsoil below the intermediate ploughsoil at depths of up to 0.8 m below existing ground level, representing an agricultural system pre-dating the construction of the Walled Garden. No material culture was recovered to indicate date.
