**Halbeath, Dunfermline, Phase 1,
Heritage Statement
Project 5211**

On behalf of: Geddes Consulting

Project Number: 5211

Report by: Maureen C. Kilpatrick

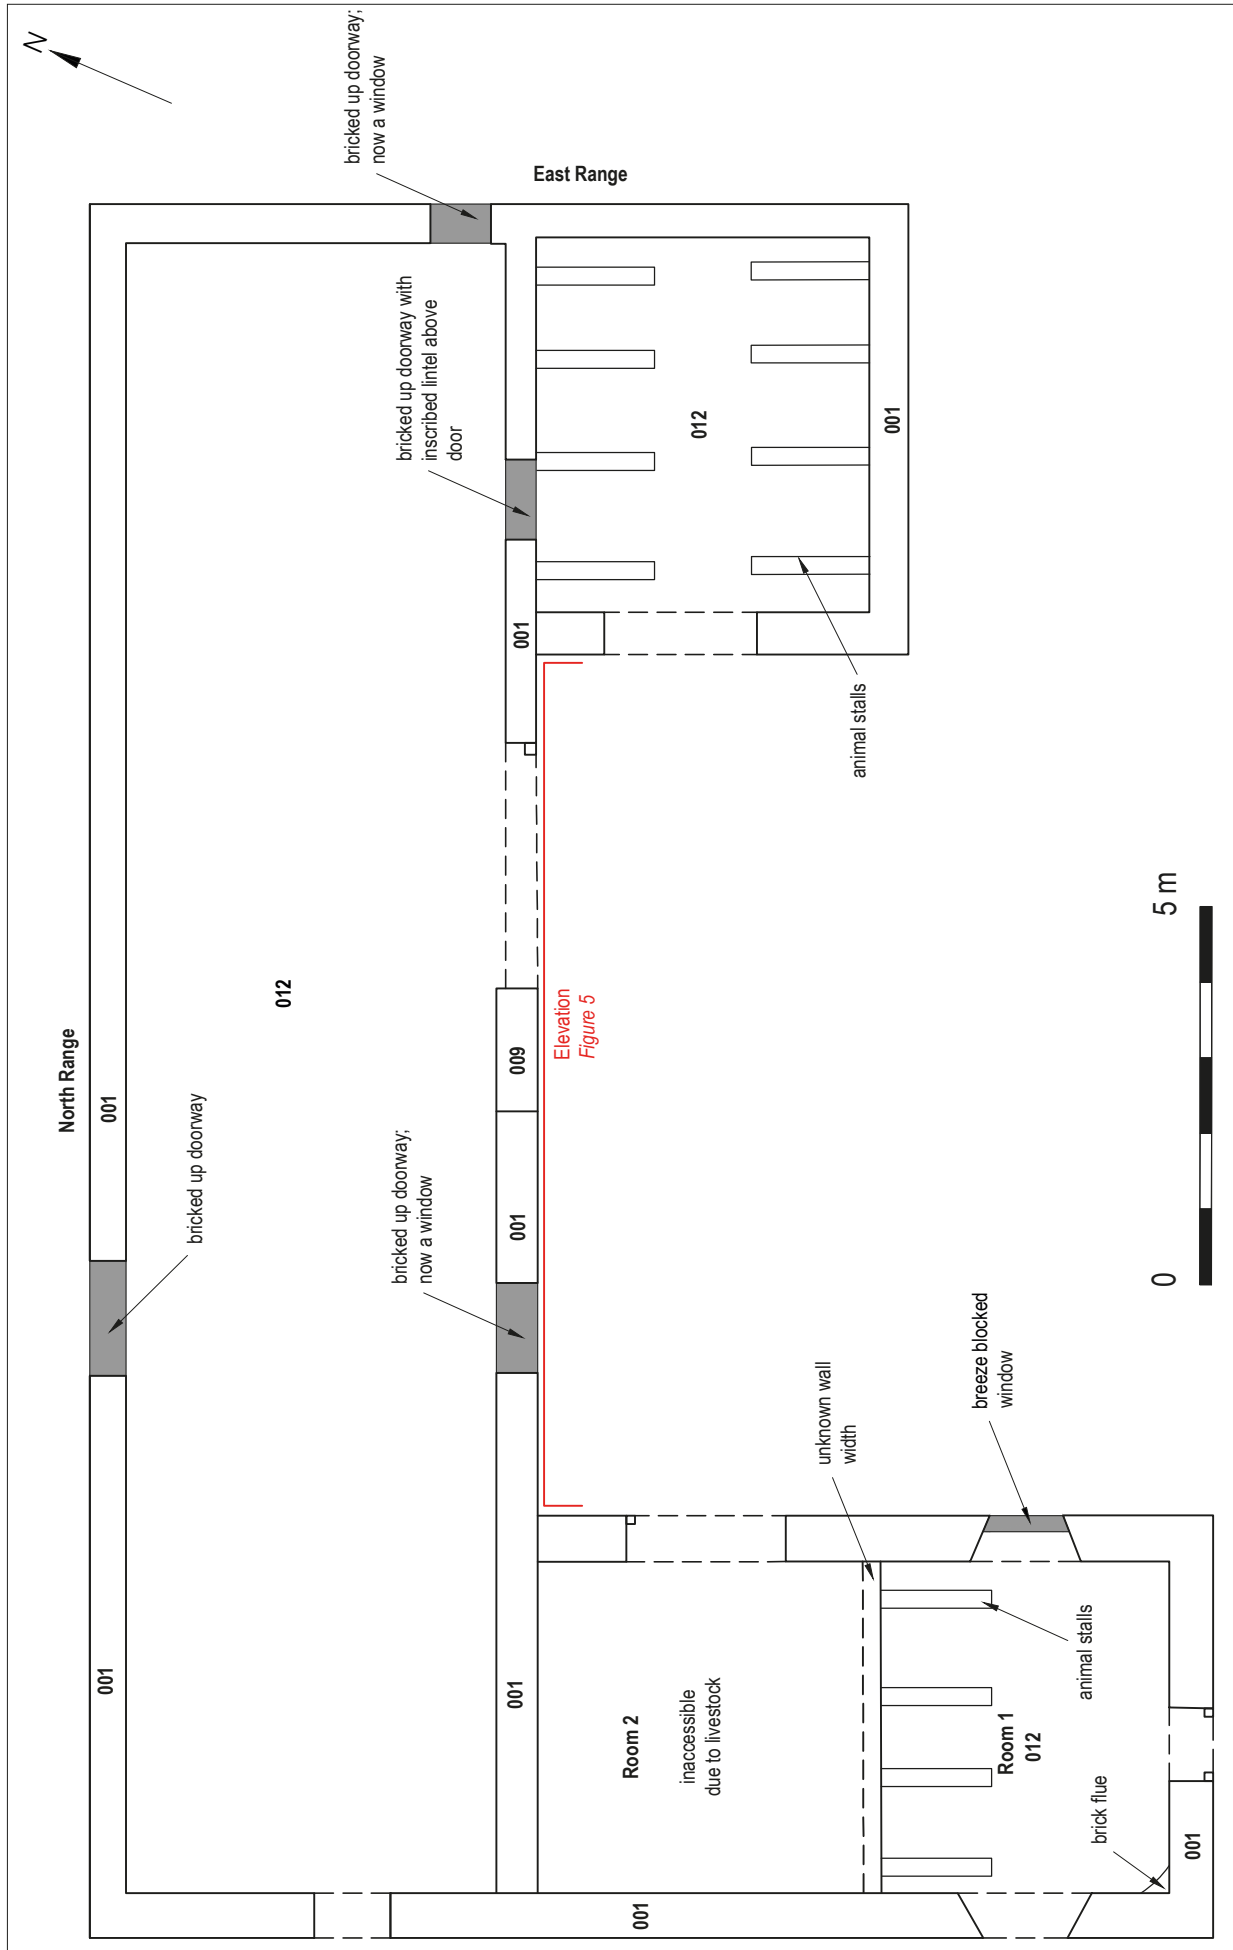
Figure 4: Plan of Building 1 (The Steading)

7.1.1 The steading was a C-shaped building comprising a single storey set around a courtyard area (Figure 4, Plate 1). It was constructed of roughly rectangular yellow/brown sandstone blocks 001 with larger, dressed sandstone quoin stones 008 at each corner (Plate 2). Many of the external stones had surface weathering and spalling, with degraded and missing mortar noted in several areas. The stones in the lower courses of the West Range adjacent to a drainage gully were particularly badly affected (Plate 3). In several areas of the building, eroded mortar had been patched using cement. Several areas of the external walls had collapsed, with masonry missing at North Range elevation 4 (Plate 4), where one section had been partially repaired using bricks, and elevation 6 of the East Range where there were obvious gaps in the stonework. North Range elevation 8 contained a large crack on its external masonry.

- 7.1.2 The North Range measured 23 m in length, the East Range 11 m and the West Range 15.5 m externally. The exterior walls were 0.56 m thick and between 2.1 m and 2.6 m high.
- 7.1.3 The steading's hipped roof was covered in concrete tiles (003) with half-round ridge tiles held with strips of lead. Cast iron sheet valley guttering overhung the eaves of the roof and drained into water butts below. Several tiles were missing, particularly in the North Range elevation 4 exposing the wooden lintel below (010). The roof had notable sagging in several areas and moss covered many tiles. In several sections of the West and North Ranges, the tiled roof had been replaced with corrugated sheeting (Plates 4 and 5).

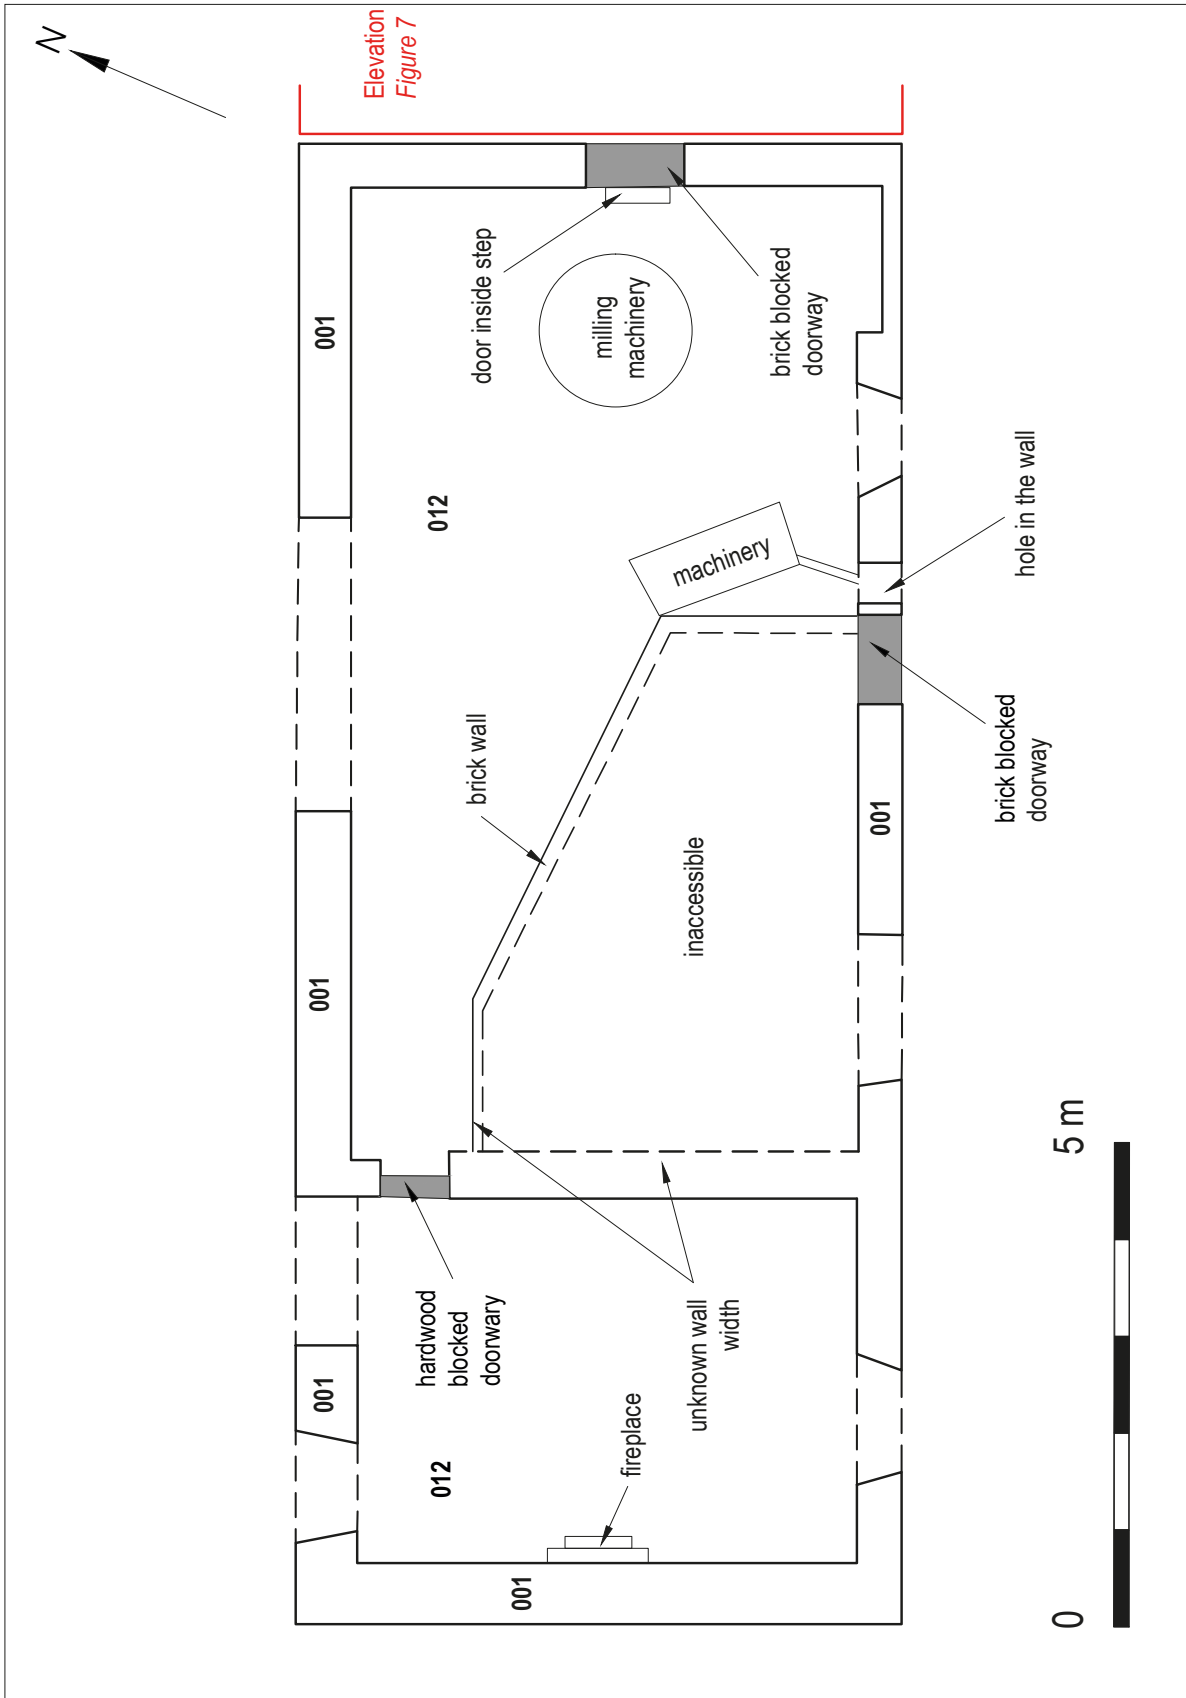
Figure 6: Plan of Building 2 (Farmhouse)

7.2.1 The farmhouse was axially related to the steading on its southern side and was also a single-storey building (Plate 17). It was rectangular in shape and measured 15.5 m by 6.5 m externally and comprised two rooms (Figure 6). The walls were of similar construction to the farmstead, comprising yellow/brown sandstone 015 with mortar. Externally, much of the wall surface was covered with pebble-dash concrete render 011. The render was degraded in several areas, revealing the underlying stone.

7.2.3 The larger room measured 10.2 m by 5.2 m internally with the walls being 0.54 m thick. Internally, the room had been much adapted and was now used as a milling shed. A large hole in the south wall led to the grain silo situated outside (Plate 18). A modern brick wall (Plate 19, Figure 5) divided the room in its south-west end. This area could not be accessed as it was being used to store farm machinery. This brick wall obscured the fireplace, a blocked window and a bricked-up doorway. Both the window and doorway could only be observed from the exterior (Plate 20).

7.2.4 The smaller room measured 4 m by 5 m internally. A fireplace on its western wall was partly obscured by a later fire surround and modern heater (Plate 21). The walls were plaster and the ceiling comprised the remains of plaster and lath. Sash windows with wooden surrounds and deep recesses were located on the north and south walls; these measured 1.58 m by 1 m. An external doorway on the north wall was 2 m high and 1.2 m wide.
