SUMMARY

1. INTRODUCTION

Cumbria County Council Historic Environment Service (Development Control) was consulted by West Cumbrian Rivers Trust regarding the demolition of a series of former bridge abutments and piers associated with the former Cockermouth and Workington Railway near Camerton, Cumbria (figure 1).

The study buildings are located at three locations; NY 039 307, NY 046 306 and NY 049 303.

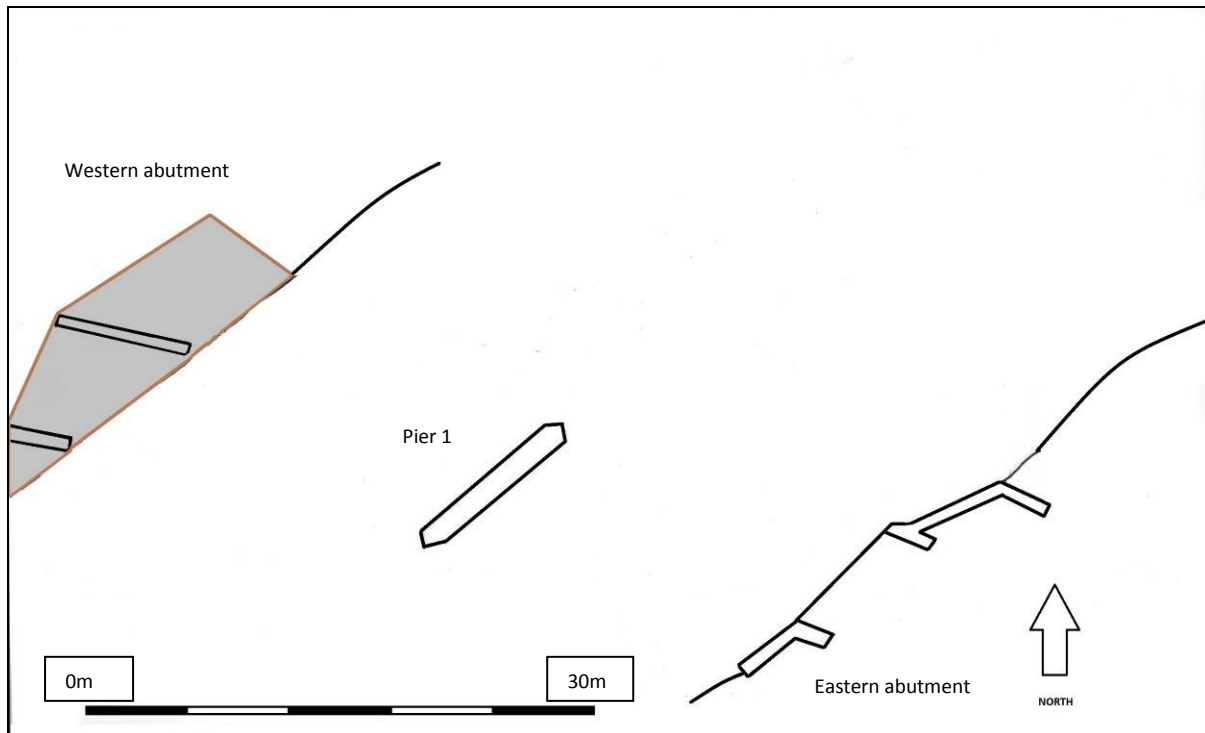
Figure 10. Plan of Ribton High Bridge (No. 20). Grey outline denotes area lost to river erosion.

Ribton High Bridge (No. 20) displayed three extant structural elements, namely the eastern abutment, Pier 1 and the western abutment (figure 10). The condition of these elements is discussed below.

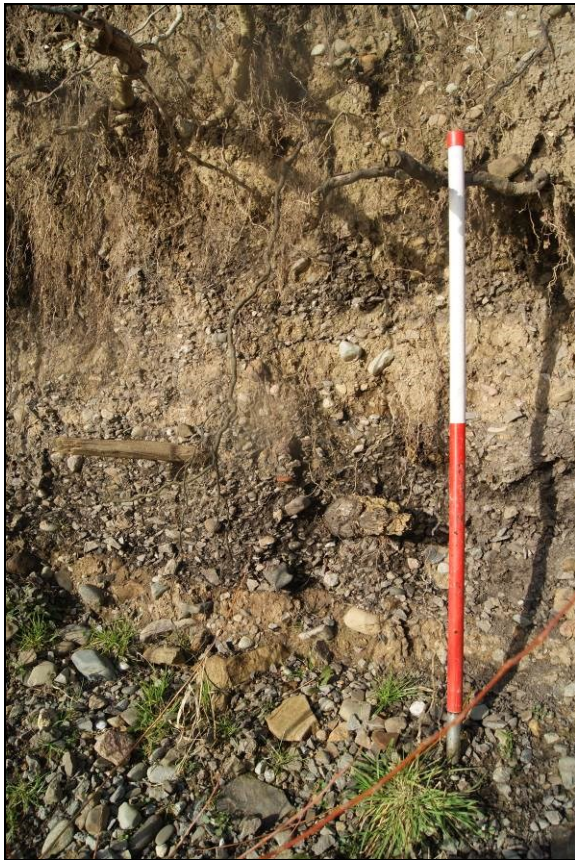
Figure 15. Buried wood in ground make-up

Further north, traces of wood was found embedded in gravel (figure 15), suggesting that some of the overlying clay was indeed ground make-up.

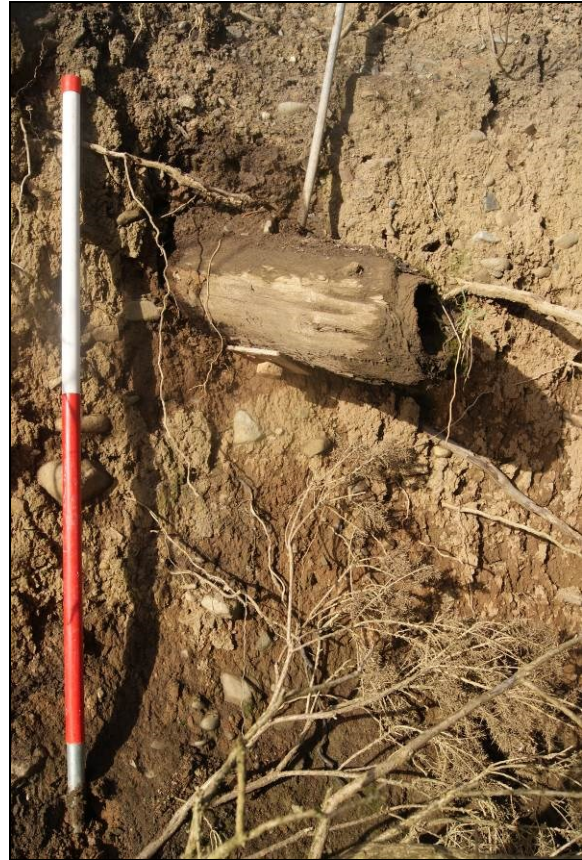
Figure 16. Stanchion base for telegraph pole

A timber stanchion base for a former telegraph pole (figure 16) indicated the northern limit of the course of the railway line.

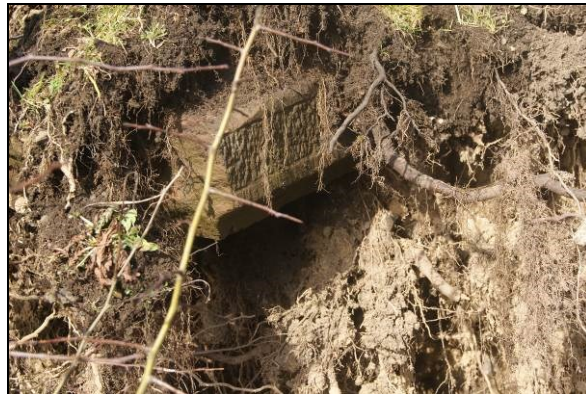
Figure 17. Neatly dressed stone block

The destructive force of the river appears to have been a significant issue in the past. A neatly dressed and incised stone block was (figure 17) was found embedded in the side of the bank, a structural element assumed to have emanated from the bridge abutment.

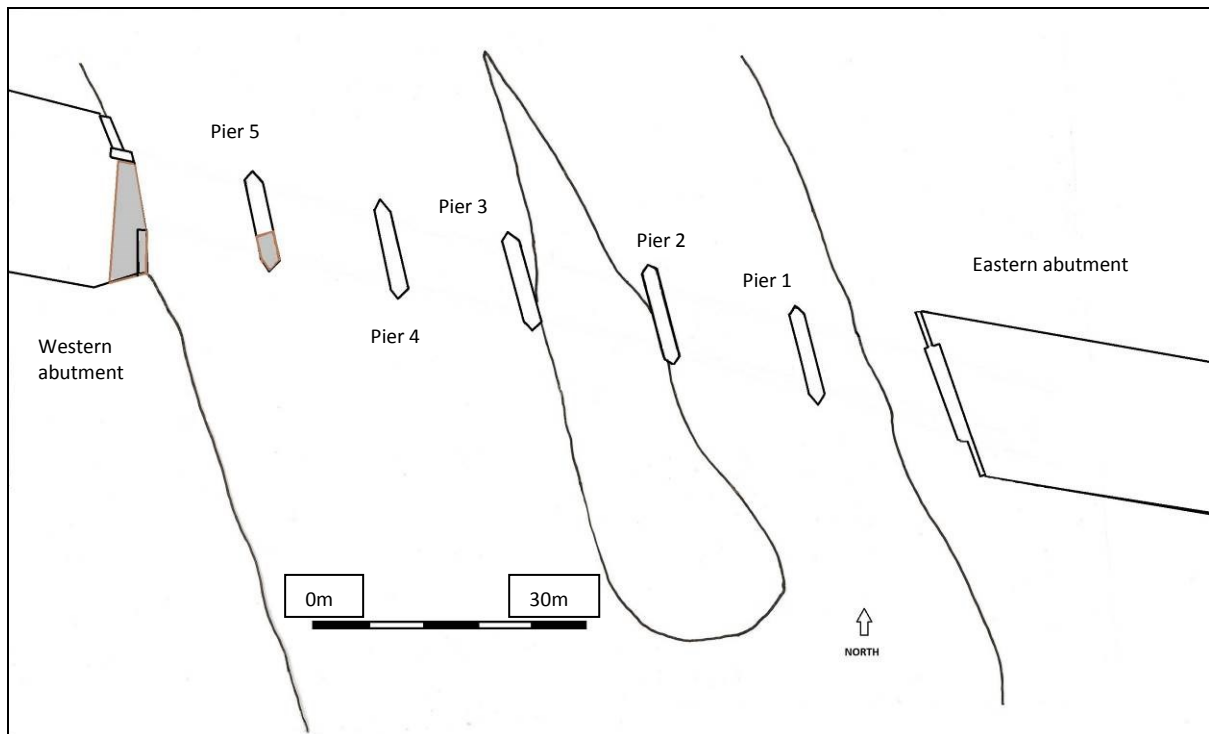
Figure 18. Plan of Ribton Bridge (No. 22). Grey outline denotes area lost to river erosion

Ribton Bridge (No. 22) consists of an eastern abutment, five stone piers measuring approximately 12.00m in length, 2.00m in width and 3.50m in height and a western abutment described below (figure 18). These stone blocks varied in size, the largest being 1.20m x 0.60m and 0.36m in height (Pier 5).

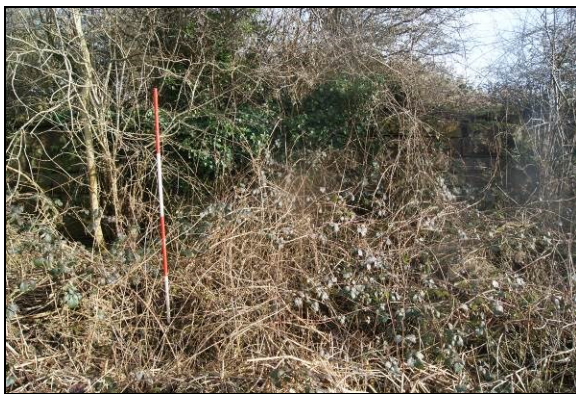
Figure 19. Eastern abutment Ribton Bridge

A low former railway embankment lead to the eastern bridge abutment (NY 04653 30490) that comprised of a low, rough-hewn, red sandstone wall, flush with the river, that stood to a maximum height of 1.75m (figure 19).

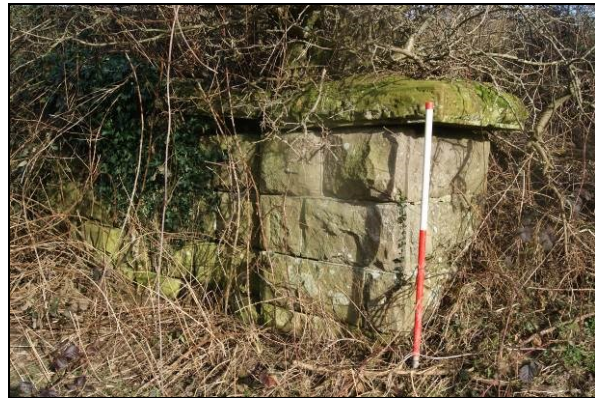
Figure 20. Pier at southern end of east abutment

The wall was surmounted by a stone coping with two small rectangular piers at each end. Both piers were four courses high, surmounted by low pyramid-shaped copings (figure 20) with raked-back sandstone buttresses. The area was heavily overgrown with brambles and largely inaccessible.

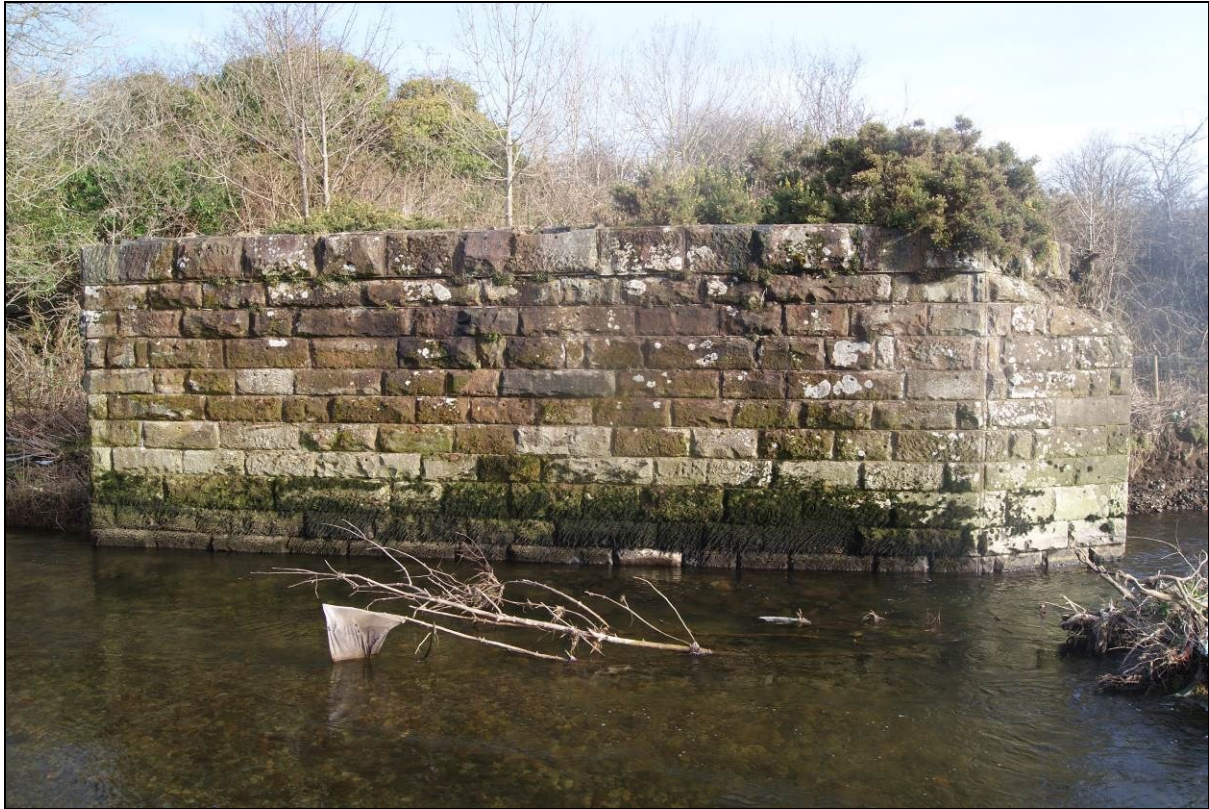
Figure 21. Western elevation illustrating Pier 1

Pier 1 was partially situated on the river bank, the western elevation being within the river channel. The pier was constructed from concordant, rough-hewn, red sandstone blocks and was complete, measuring approximately eleven courses in height (figure 21).

- The northern end possessed a blunt face.
- The southern end possesses a chisel-face, deflecting water into the channel between Piers 1 and 2.
- There was no architectural embellishment present, nor any evidence for masonry marks.

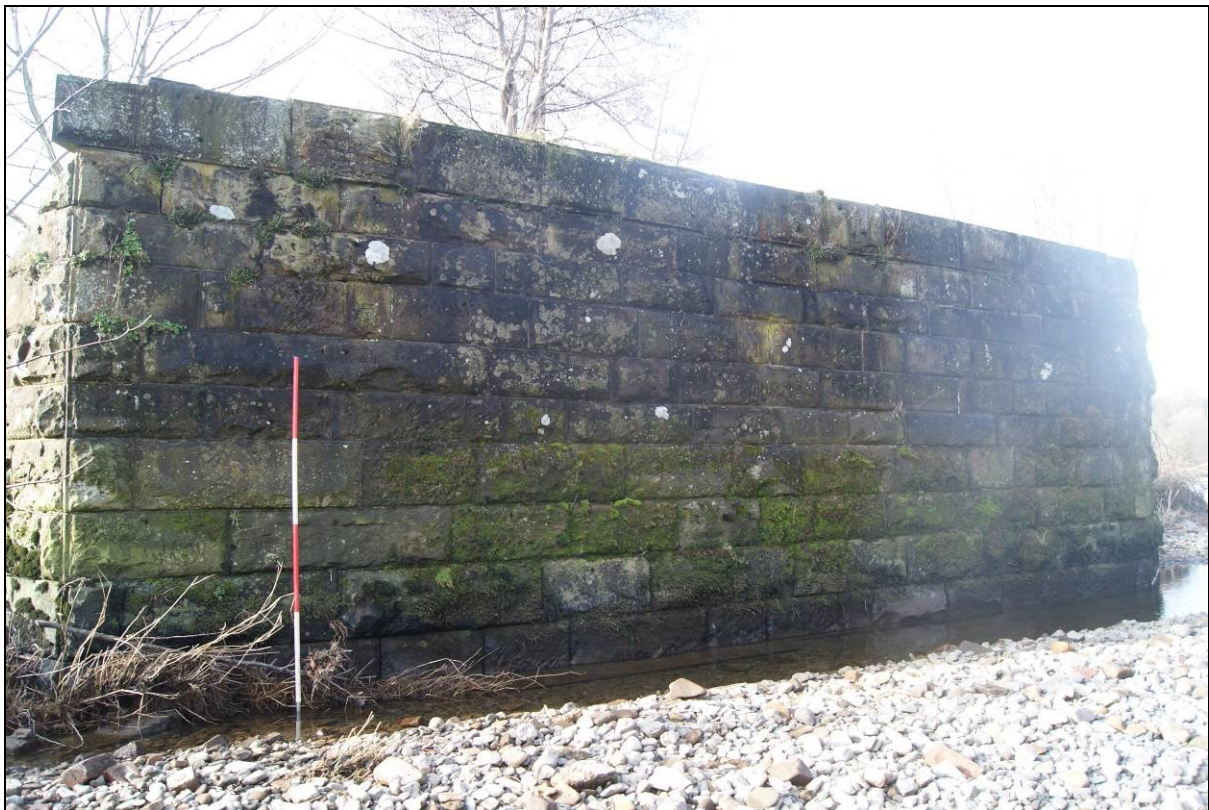
Figure 22. Pier 2 showing the eastern elevation

Pier 2 was located on gravel that formerly represented the river bed, the eastern elevation in contact with water (figure 22), the western elevation colonised by scrub.

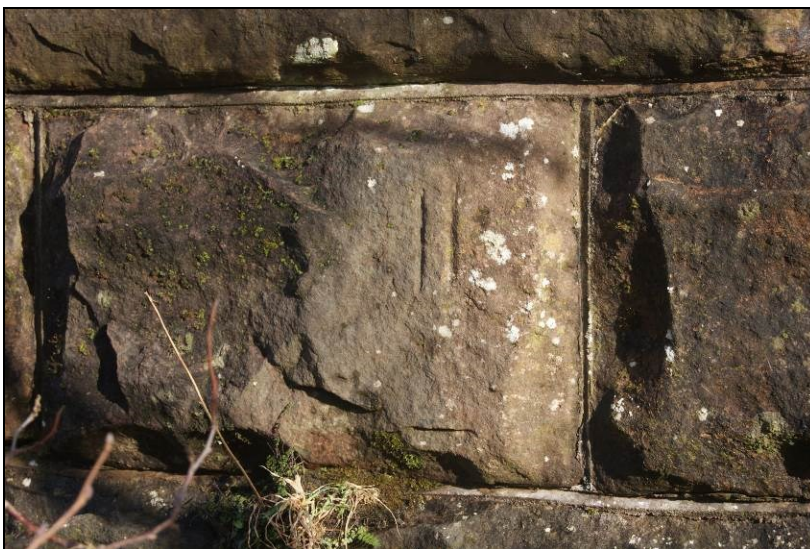
Figure 23. Masonry mark, Pier 2

- Both northern and southern ends possessed pointed faces facilitating the efficient flow of the river.
- The top course comprised of dressed stone blocks.
- There was no architectural embellishment present.
- The stonework had been repointed (Figure 23)
- A masonry mark comprising two upright incisions was visible on the western elevation (Figure 23).
- Below the water line was an offset stone plinth upon which the pier had been constructed

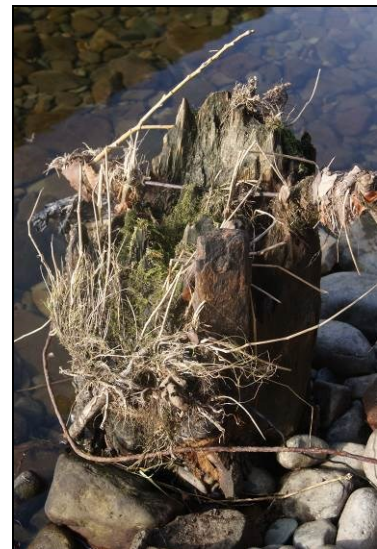
Figure 24. Timber pile

These square plan timber piles (0.30m x 0.30m) were tipped with a wrought iron sheath (figure 24) held in place by a large nail or bolt, that had assisted the pile through the gravel. It appears highly plausible that these four piles represented a trestle for the earlier timber bridge built in 1847 and replaced by the stone piers currently in place.

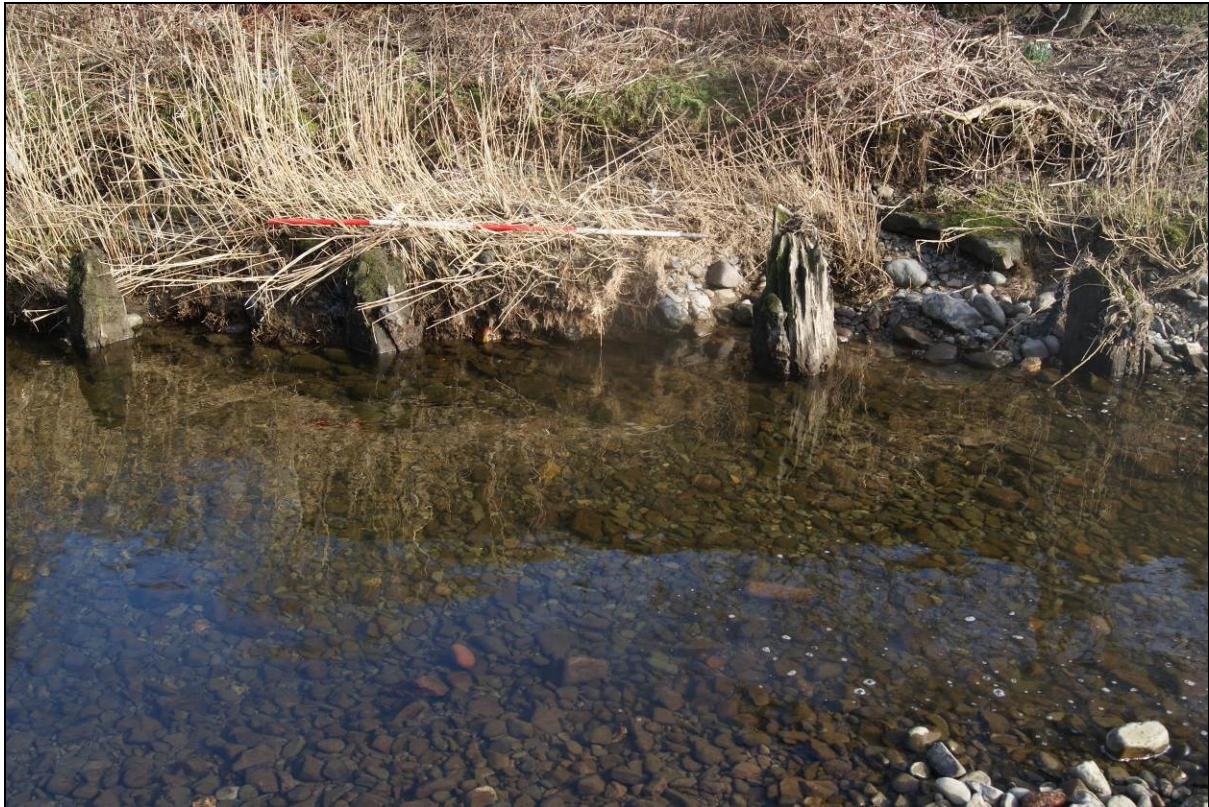
Figure 25. Alignment of four timber piles representing the earlier bridge

Midway between Piers 2 and 3 were four timber piles that formed a linear alignment parallel to the stone piers (figure 25). These piers stood to a height of approximately 0.50m and were heavily denuded above the water-line.

Alternatively, these piles could represent a repair undertaken c 1857-1858 prior to construction of the stone piers.

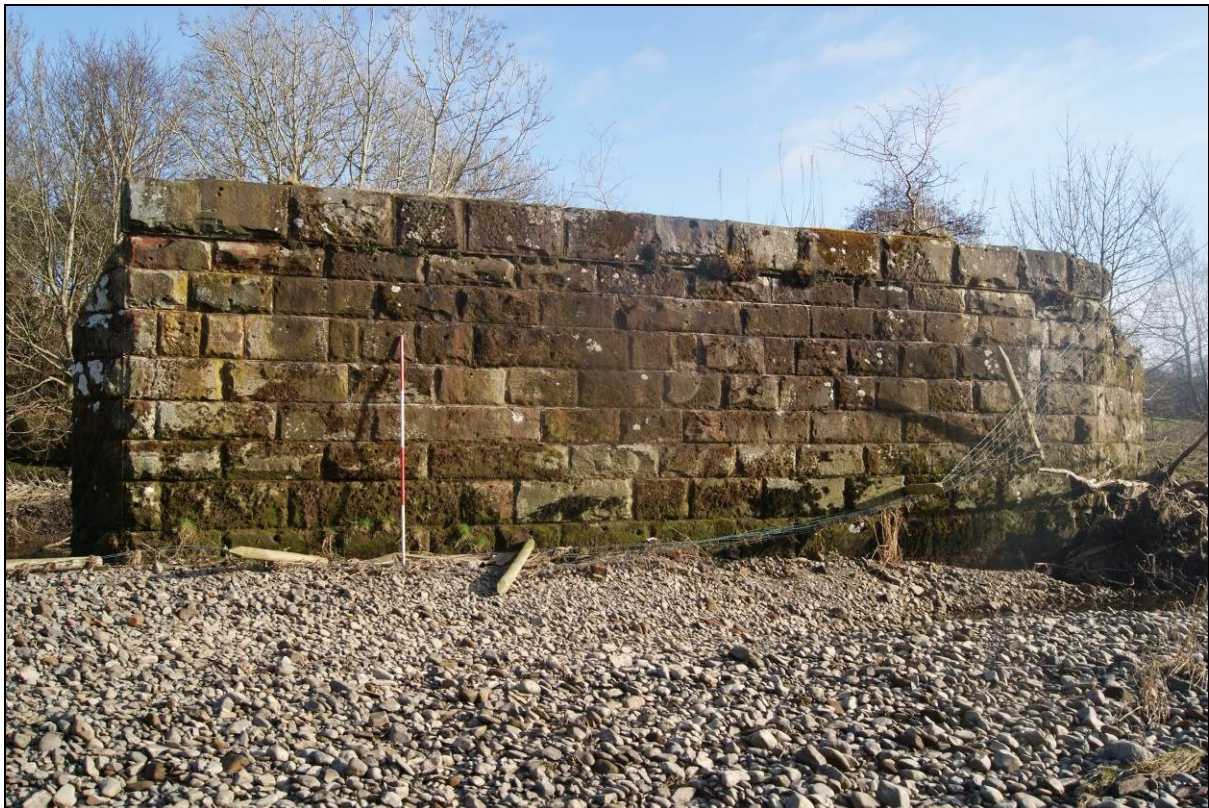
Figure 26. Western elevation of Pier 3

Pier 3 was located on a gravel bar that formerly represented the river bed, the eastern elevation just in contact with water (figure 26), the western elevation free of scrub.

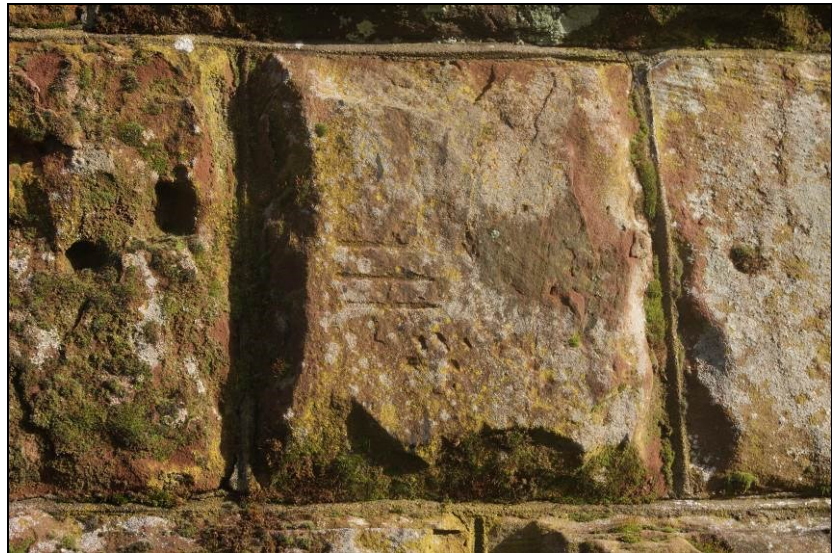
Figure 28. Masonry marks on western elevation on Pier 3

- Both northern and southern ends possessed pointed faces facilitating the efficient flow of the river (figure 27).
- The top course comprised of dressed stone blocks.
- There was no architectural embellishment present.
- The stonework had been repointed (figure 28).
- A masonry mark comprising three horizontal incisions was visible on the western elevation (Figure 28).

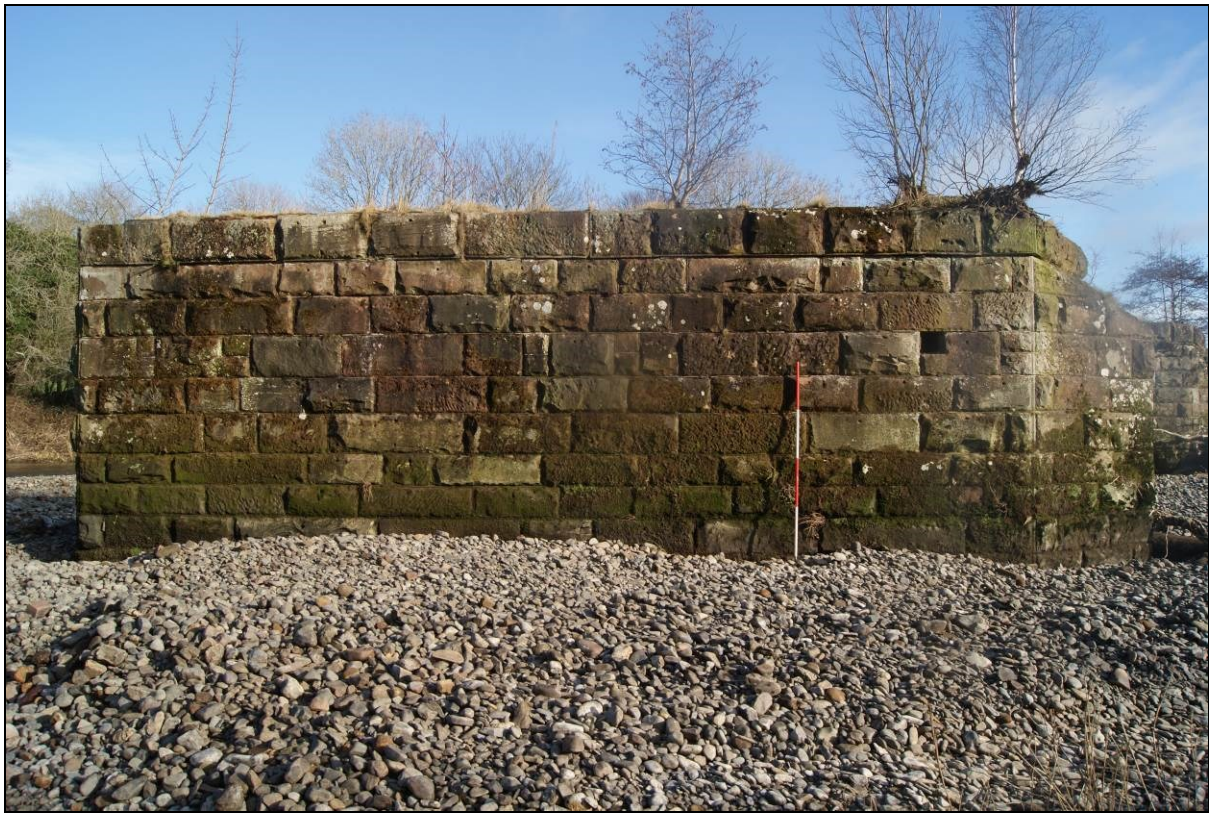
Pier 4 was located on a gravel bar that formerly represented the river bed, the eastern elevation and the western elevation free of scrub (figure 29).

Figure 29. Western elevation of Pier 4, the masonry marks are dead centre

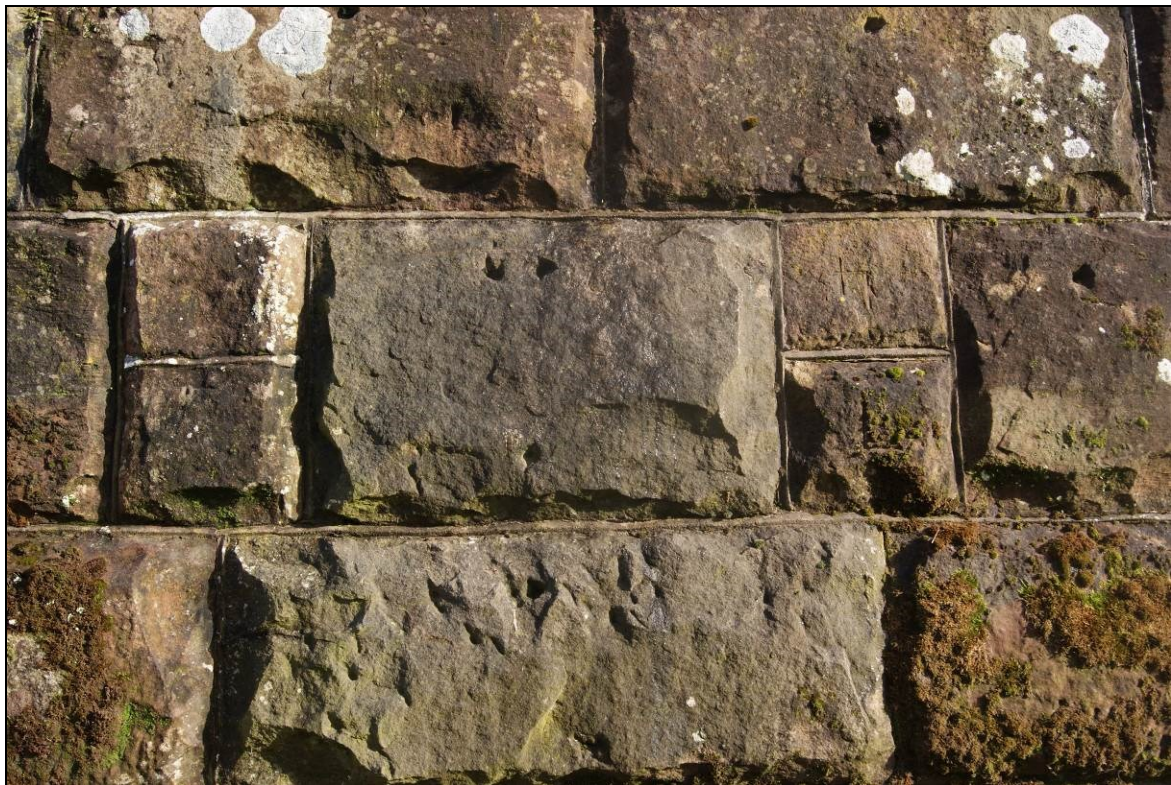
Masonry marks comprising an inverted “open four” and a capital L was visible on the western elevation (Figure 30). This graffiti appeared to be set within a symmetrical stone arrangement comprising a central stone flanked by pairs of square stones (figure 30).

Figure 30. Mason’s marks showing an inverted “open four” and a capital L

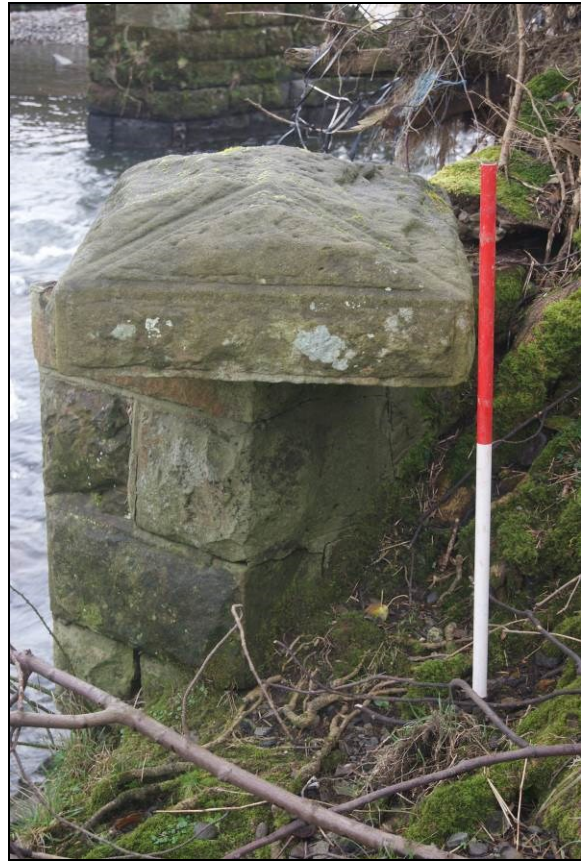
Figure 33. Surviving flank of western abutment

The western bridge abutment (NY 04570 00508) had largely been swept away, a small portion of the bridge abutment surviving to the north-west. This stone wall possessed a stone coping that has become dislodged (figure33).

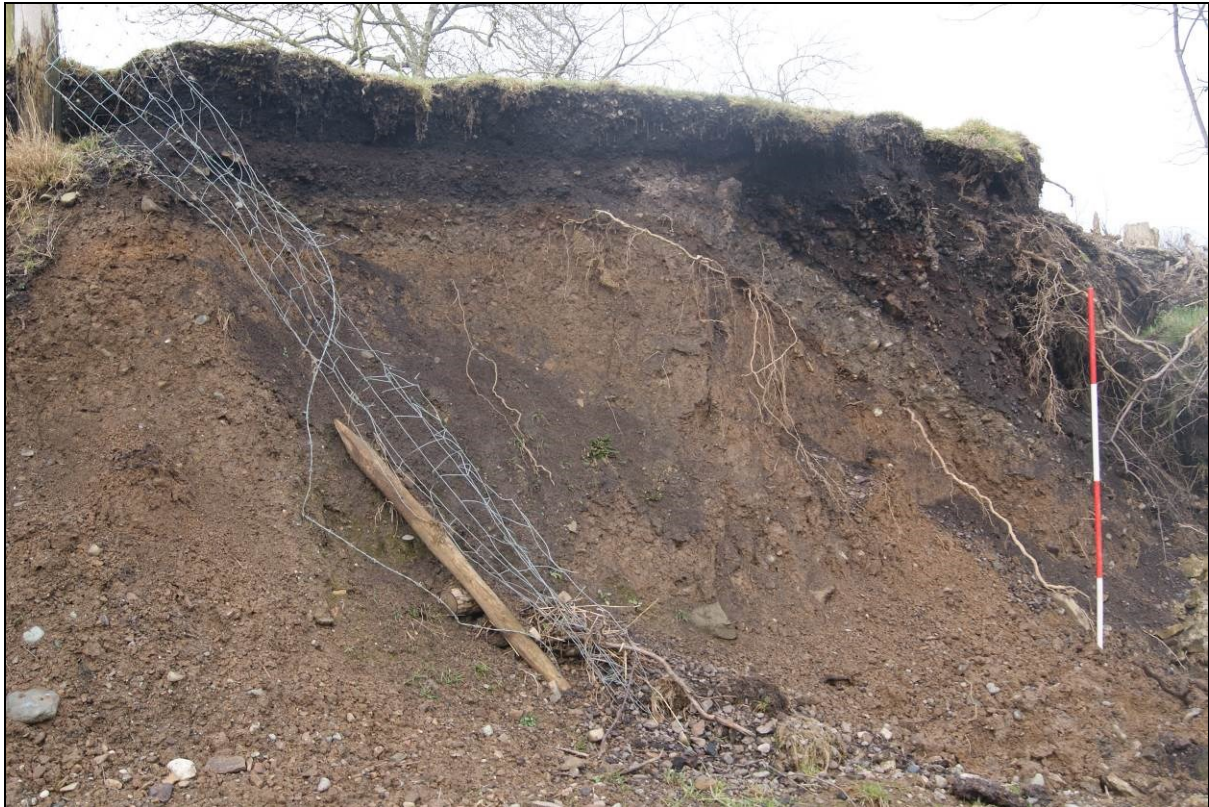
A linear upcast of light brown clay standing to a height of approximately 2.50m sealed to the north by a membrane of grey clay 0.40m in thickness that conjoined a bed of dark brown compacted gravel, possibly a former track bed, forming a level plane approximately 6.00m in width. The embankment possessed a 45 angle of repose, approximately 12.00m in width at its base (figure 36).

Figure 36. Section through the embankment showing the original embankment to the left

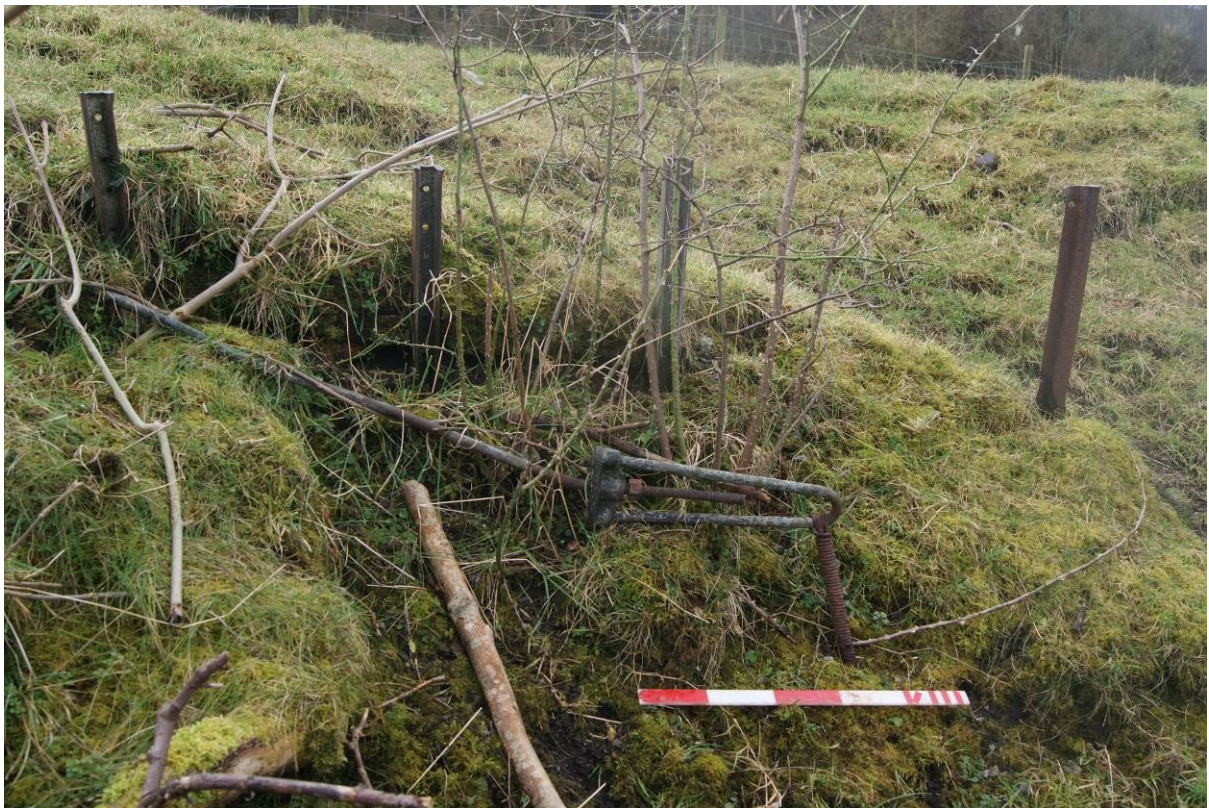
Figure 37. Telegraph stanchion and iron fence posts

On the north side of the embankment was a stanchion formerly supporting a telegraph pole and a series of four low iron posts probably forming a fence established when the railway was in use (figure 37).

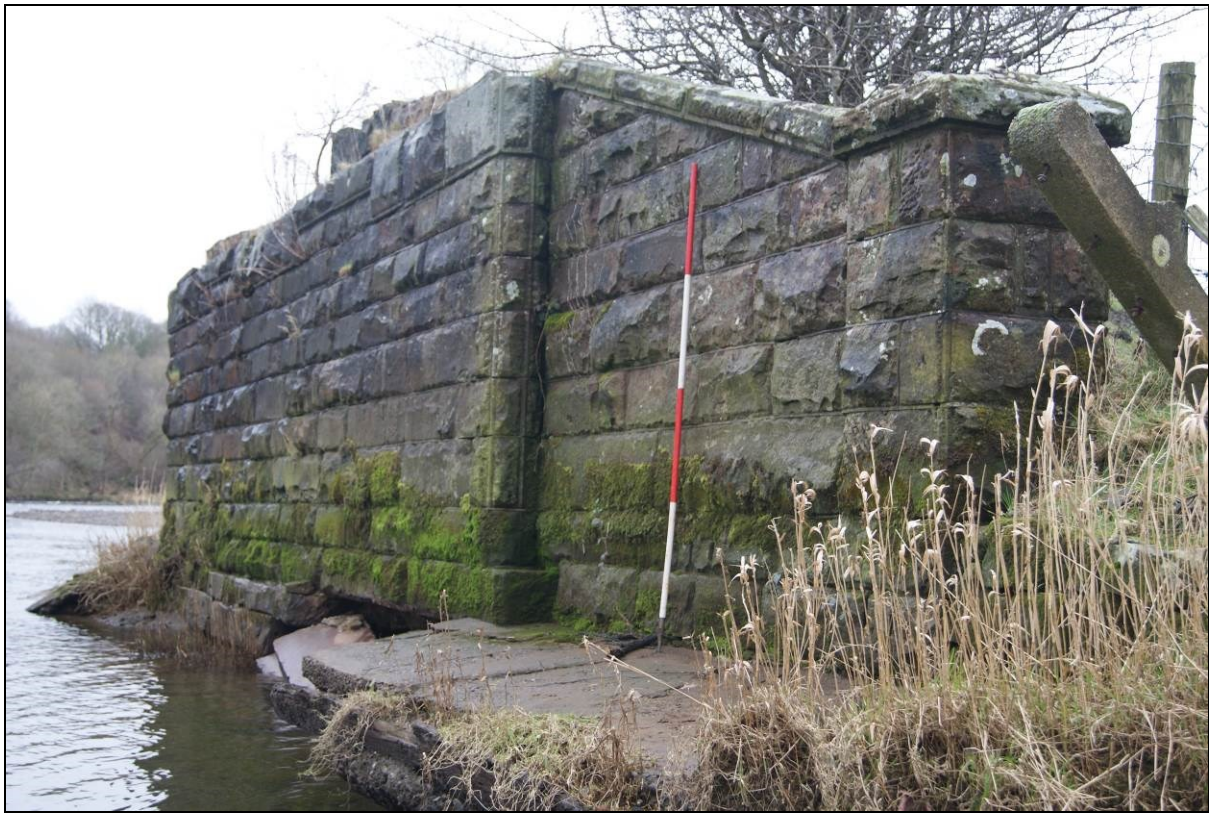
Figure 39. Western elevation forming the eastern bridge abutment.

The abutment had been formalised by a red, rough-hewn sandstone retaining wall partly dressed, standing to a height of 3.00m and formed from blocks measuring approximately 0.75m x 0.36m and 0.50m in thickness

The abutment was outlined by a thin rebate, possessing flanking stone wings defined by terminals of stone pillars with a low pyramidal coping stone (figure 39). Copings surmounted the flanking wall up to the track bed.

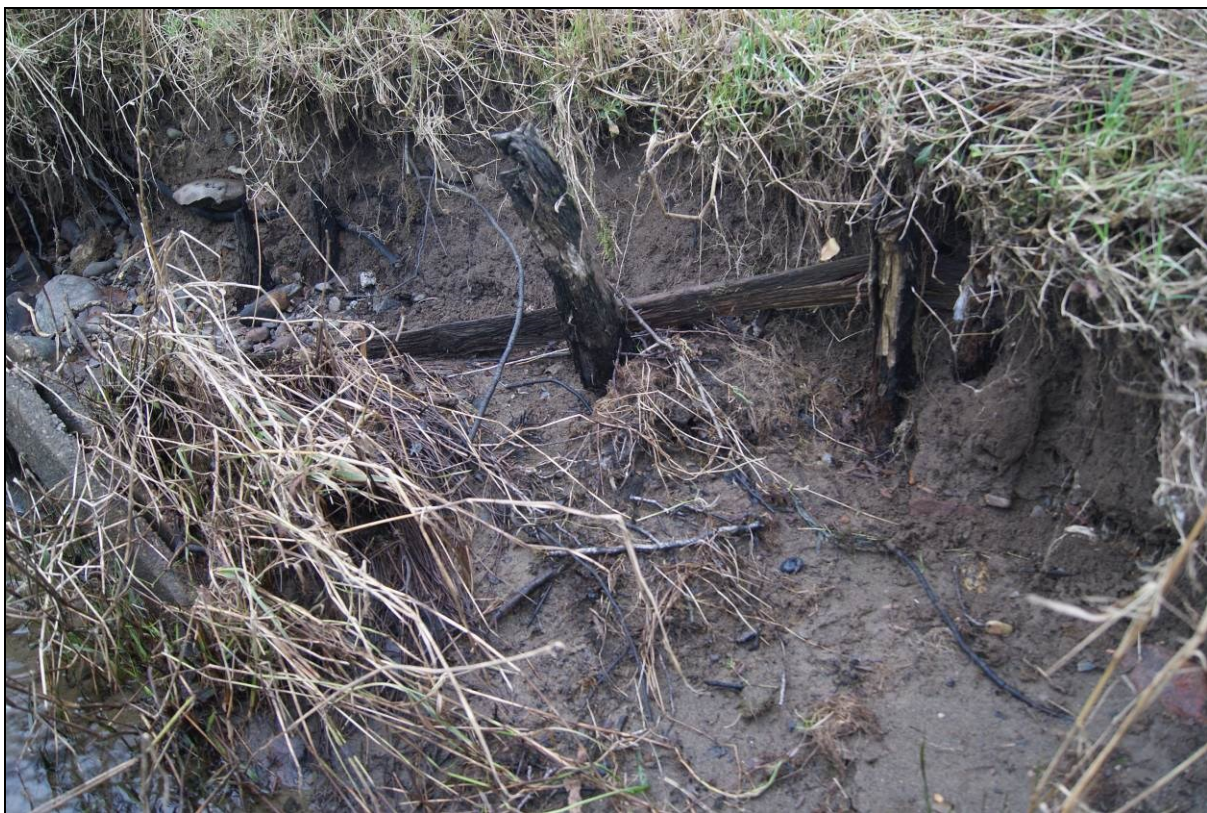
Figure 43. Timber posts and cross member indicating probable earlier timber bridge abutment

Exposed by the scouring of the river just to the south of the abutment were a series of upright timber posts or piles with at least one retaining plank (figure 43). These timbers probably indicate

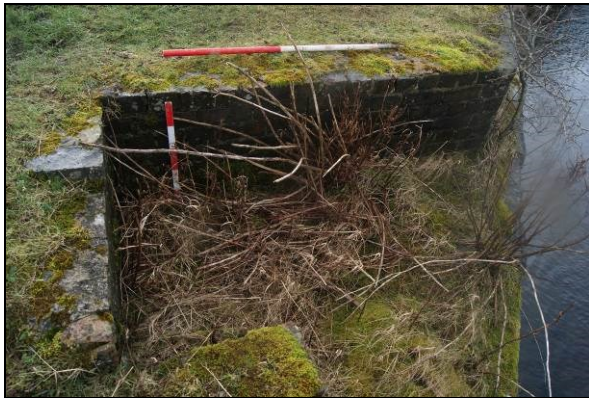
Figure 44. Reception pit or recess

A small rectangular plan reception pit measuring 2.00m x 0.93m and 0.50m in depth was outlined in vitrified brick (figure 44).

Both features possessed sufficient margin that would allow the iron bridge to expand in hot weather and contract when cold, thereby avoiding structural stress in the bridge fabric.

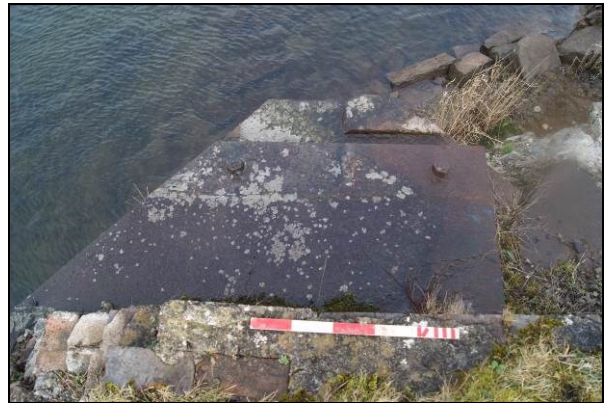
Figure 45. Iron plate on bridge abutment

On the extreme north side bolted to the top of the abutment was an iron plate (figure 45).
