## SUMMARY

### 1.1 Project origins

Permission is being sought by the executors of the estate of the late David Burnett for the demolition of a Grade II listed barn whose structural condition has rapidly deteriorated in the last four years.

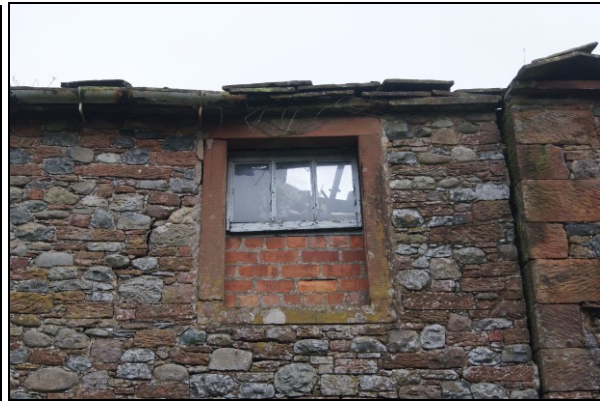
Figure 13. Window (2) within annex

2. The window within the annex possessed a plain red sandstone surround 0.11m in thickness. The bottom part of the window had been filled by bricks but the upper half of the window consisted of three glazed lights (0.40m x 0.20m) within a timber frame (figure 13).

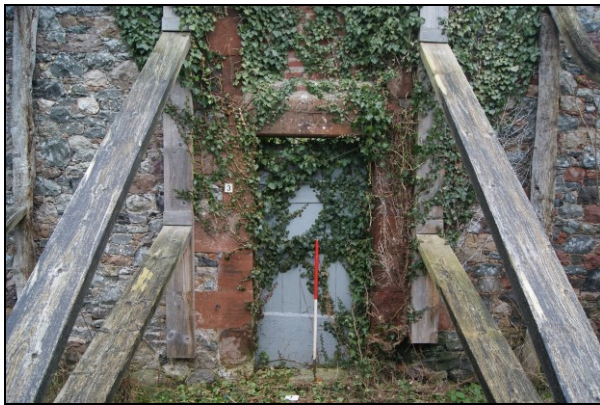
Figure 14. Doorway (3) into Room 2

3. A door measuring 1.90m x 0.98m provided the only access into Room 2. It could not be opened whilst the jamb was obscured by timber props. However, it was clearly defined by red sandstone quoins with a red sandstone lintel. The door was made from tongue and groove planks and sat in a slight rebate that could not be clearly viewed (figure 14).

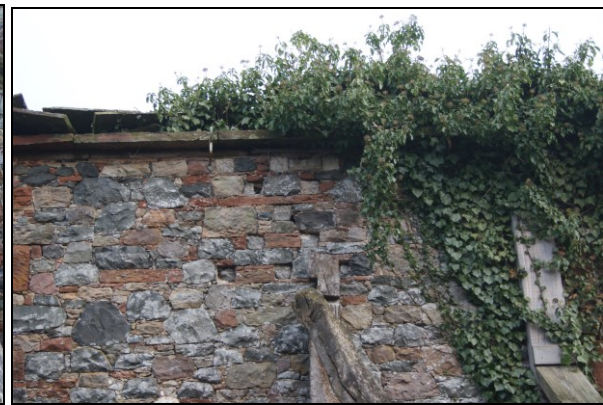
Figure 15. Air vents (6), Room 2

6. Eight square plan voids approximately 0.15m x 0.15m were located just to the west of window (4). These voids were arranged in rows of three, two, one and two and probably provided ventilation for animals kept in Room 2 (figure 15). The slightly inconsistent order of these voids suggests that they represent a later adaptation.

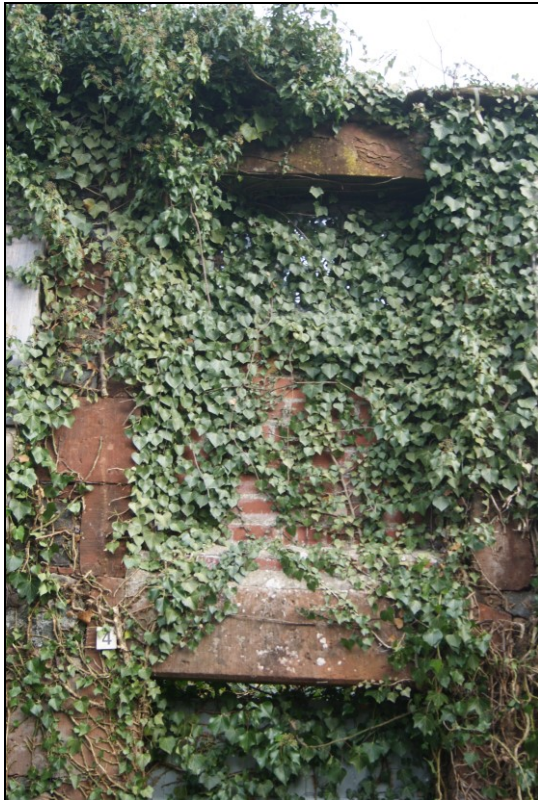
Figure 16. Window (4), above Room 2

4. An upper window was almost totally obscured by ivy. This window possessed a red sandstone sill and lintel, the surround formed from red sandstone quoins producing a symmetrical design. The opening measured 1.65m x 1.05 and was largely filled with brick although a timber window frame bearing three glazed lights (0.40m x 0.20m) was present beneath the lintel. This aperture was probably originally used as a door for a hayloft within Room 2 (figure 16).

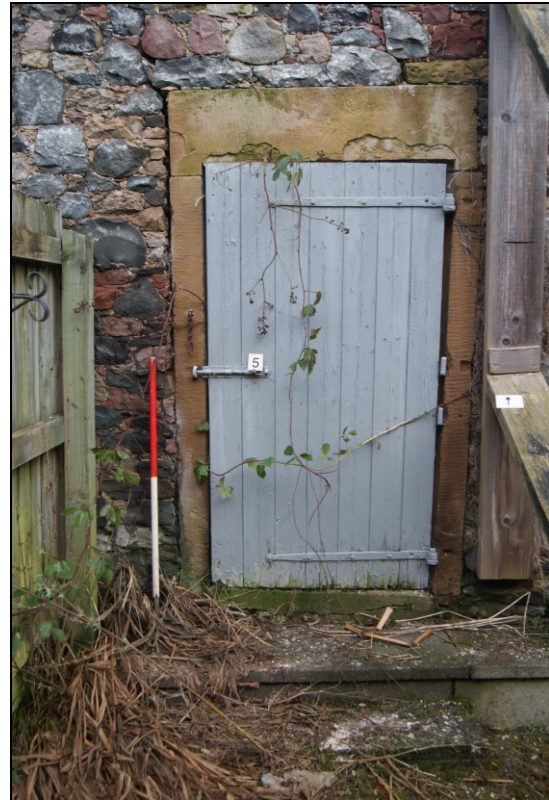
Figure 17. Door (5), rear access into Room 1

stone lintel 0.20m in thickness. The eastern jamb possessed four small recesses that bore either former hinges or bolt-holes. It appears highly likely that this stone has been re-used from an earlier provenance (figure 17). Moreover, the door is not in keeping with the buildings prevalent architectural style suggesting that this ingress is a later amendment, probably a back door providing easy access to the Manor house.

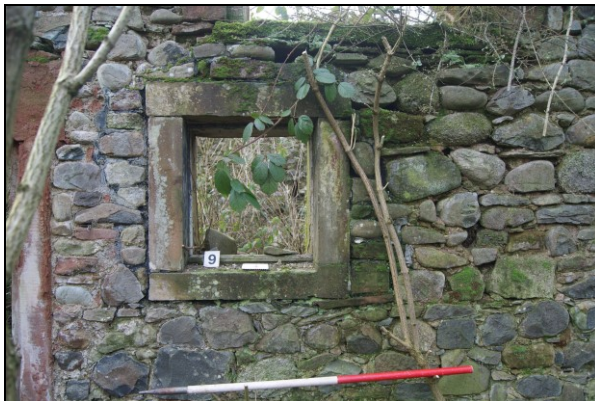
Figure 24. Window (9), Room 2

9. An eastern window lighting Room 2 measuring 0.75m x 0.80m formed from an assortment of red sandstone masonry. The sill may have been cut from a larger piece of stone as the western limb had a slight return whereas the eastern end was flat. The undecorated lintel and uprights were uniformly 0.15m in thickness producing a light measuring 0.50m x 0.50m (figure 24).

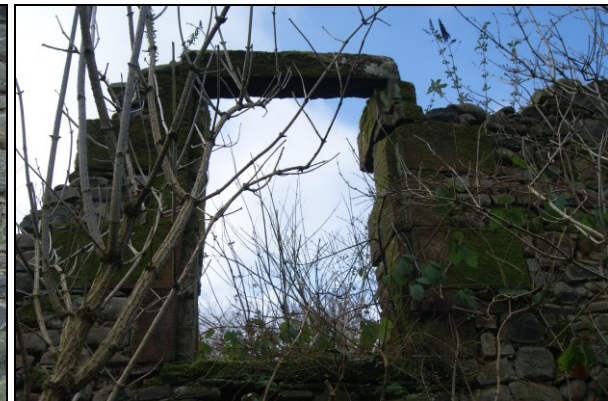
Figure 25. Window (10), Room 2

10. A window or more likely a small door served the upper storey of Room 2. This aperture measuring 1.55m x 0.95m was highlighted through a series of concordant symmetrical red sandstone blocks with a small rebate to accommodate a door. A red sandstone lintel surmounted this arrangement (figure 25).

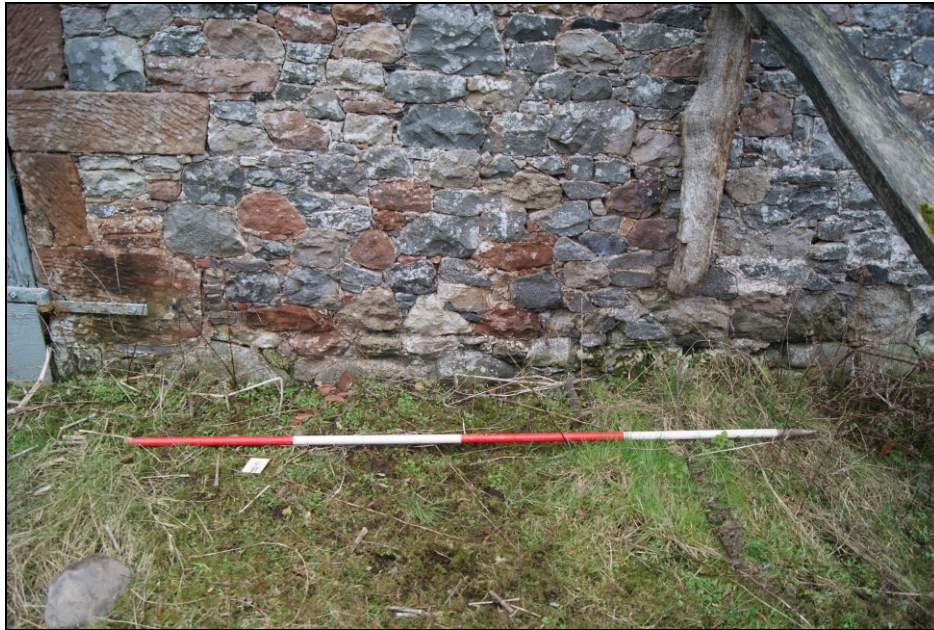
At the base of the stone-work on the southern elevation were some large rounded stone boulders out of keeping with the regular face of the barn (figure 33).

Although featured on the tithe map, this depiction does not necessarily have to represent the current structure; a clay dabbins building intimated by remnant boulders could have been an earlier structure. However, the similar dimensions strongly suggest that the extended barn was fully constructed by 1831.

Figure 33. Rounded boulders that may have formed an earlier foundation
