Historic Buildings Survey

**FARM BUILDINGS AT BUTTERFORD,
NORTH HUIISH, DEVON**

By R.W. Parker

REPORT No. 2011.04

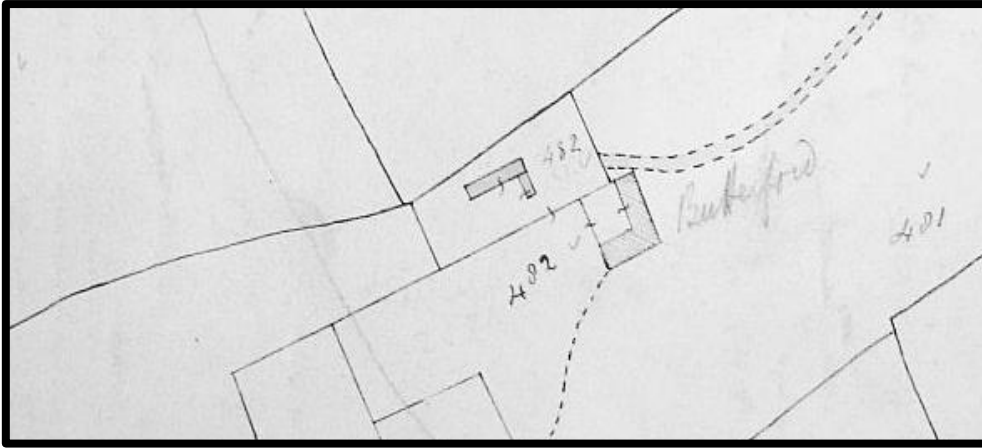
- The North Huish tithe map, surveyed in 1839 (Fig. 2), shows an 'L' shaped mansion with a footprint markedly different from, indeed, the reverse of, that of the 18th-century mansion as known from later mapping and historic photographs. The farm buildings are also shown in a different position than those now existing.

Fig. 2 Detail of the 1839 North Huish Tithe Map. This map shows the house as a left-handed 'L' Shape which cannot be reconciled with the form of the house as rebuilt c.1790. The footprint may have been derived from an earlier estate map.

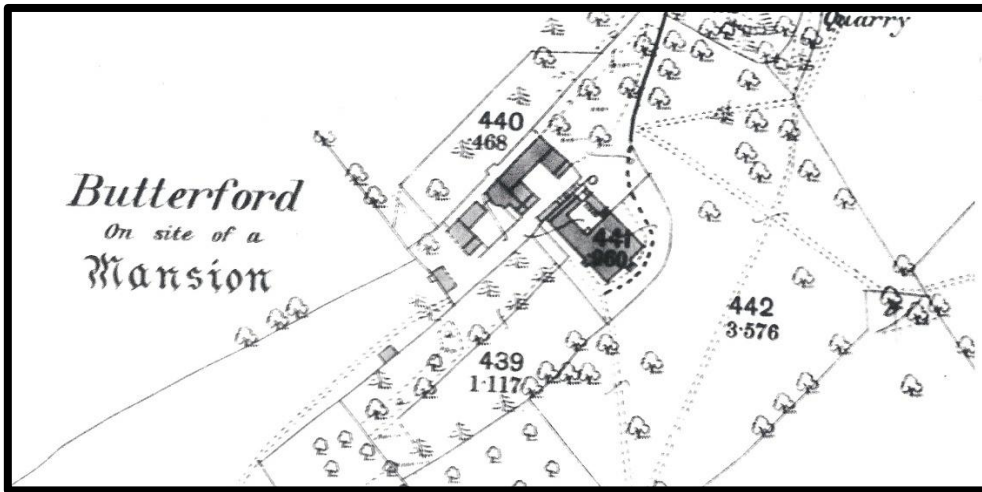
The OS 1st-edition Map of 1887 (Fig. 3) shows the farm buildings in their fully-developed form, with a large, 'U'-shaped building lying to the rear of the mansion framing three sides of the north-eastern yard. Both of the projecting wings of this range have an identical internal layout. The formal layout of these buildings strongly suggests a structure with architectural pretensions, such as a stable and coach house block associated with the 18th-century mansion. To the south west the small 'L'-shaped building shown on the tithe map may have been rebuilt or extended to enclose the south-western yard. This yard had a gateway though its northern corner to an access road running at a high level along the rear of the buildings. A rounded element in the structure, near this gateway, may represent a horse-engine house, which survives in ruins at the junction of barns 1 and 2. This may reflect later 19th-century farm use and the decline of the status of the mansion.

Fig. 3 Detail of the OS 1st-edition 1:2500 map Devonshire Sheet CXXVI.I, surveyed in 1887, showing the buildings at Butterford with fully-developed agricultural ranges, including a formal 'U'-shaped range, perhaps representing stabling.

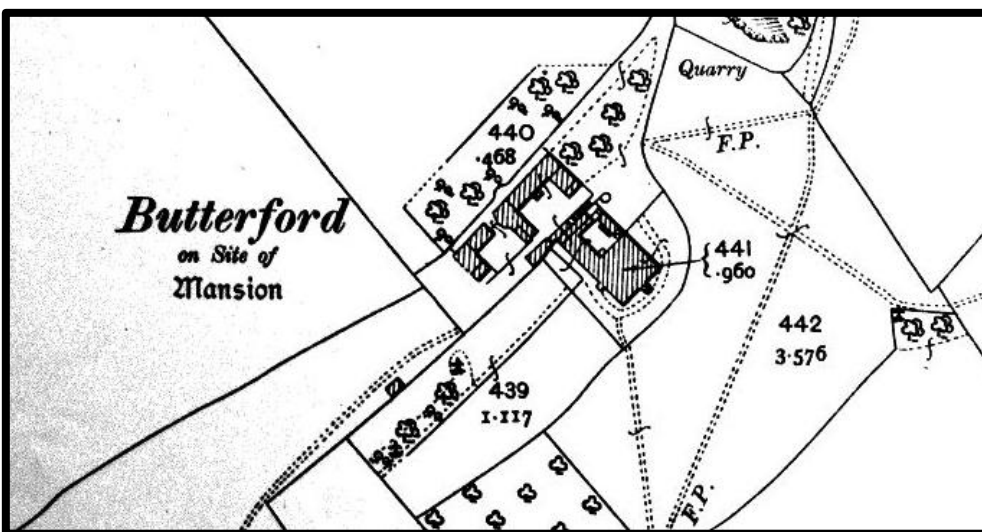
Comparison with the OS 2nd-edition map of 1906 (Fig. 4) reveals some slight differences: the south-western wing of the presumed stable range appears to have been demolished and the north-eastern yard has been enlarged and extended across its site. The south-western yard appears unchanged, though a narrow structure has been added to the south-western façade of its north-eastern wing. These alterations may reflect late 19th-century changes to the earlier structures.

Fig. 4 Extract from the OS 2nd-edition map Devonshire Sheet CXXVI.I, surveyed in 1906, showing slight alterations to the footprint of the buildings, including the apparent enlargement of the north-eastern yard, possibly by the demolition of one of the projecting wings.

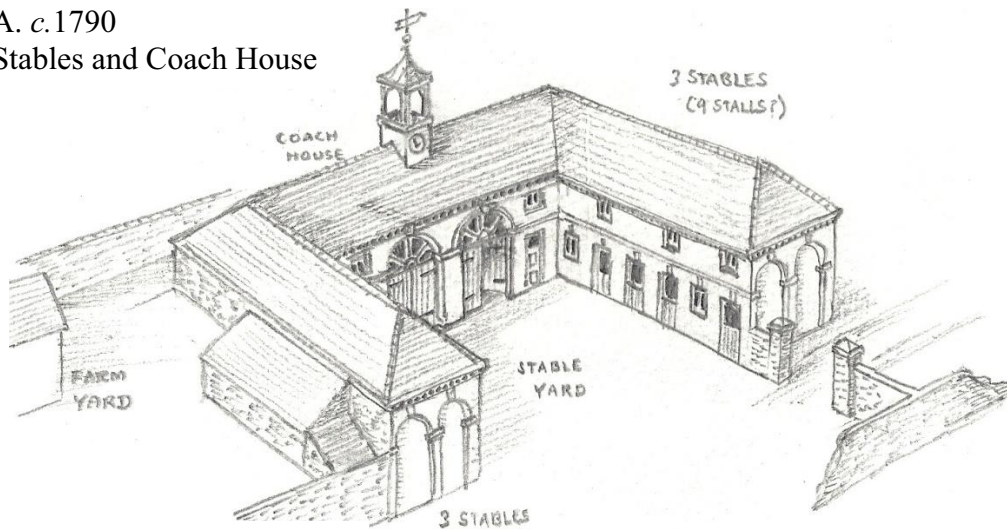
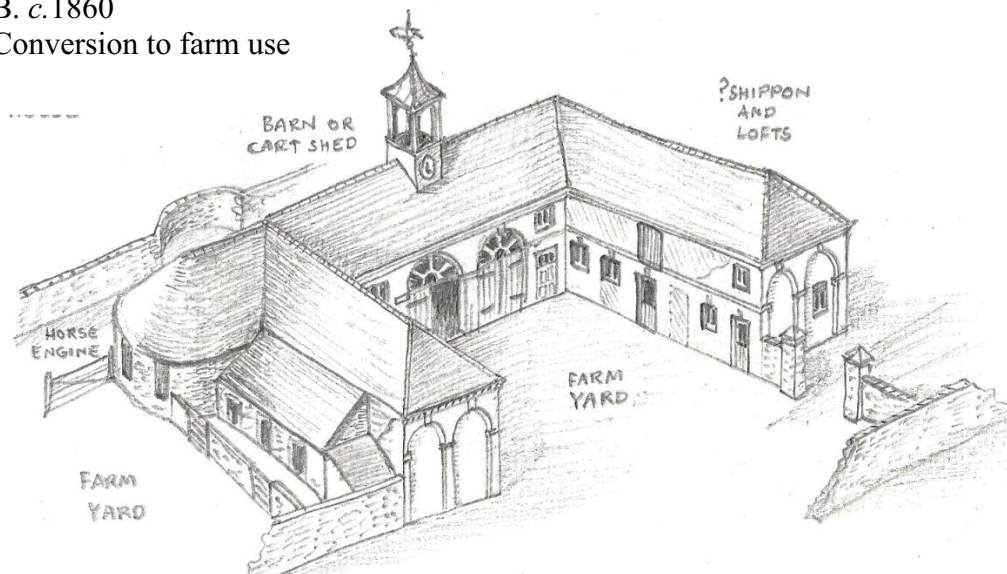
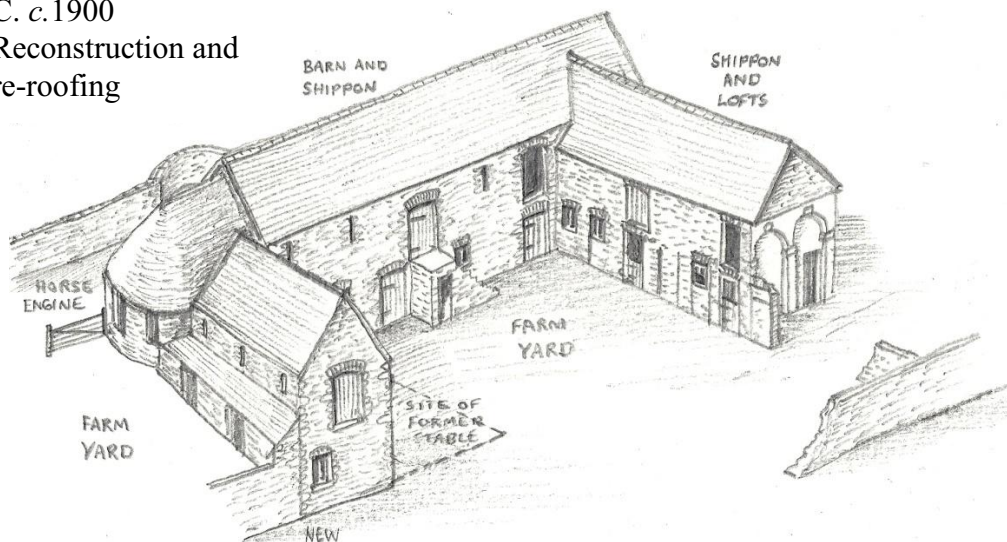
Fig. 15 Sketch reconstruction drawings by the author showing three of the probable phases of development of the farm buildings at Butterford.

A. c.1790
Stables and Coach House

B. c.1860
Conversion to farm use

C. c.1900
Reconstruction and re-roofing

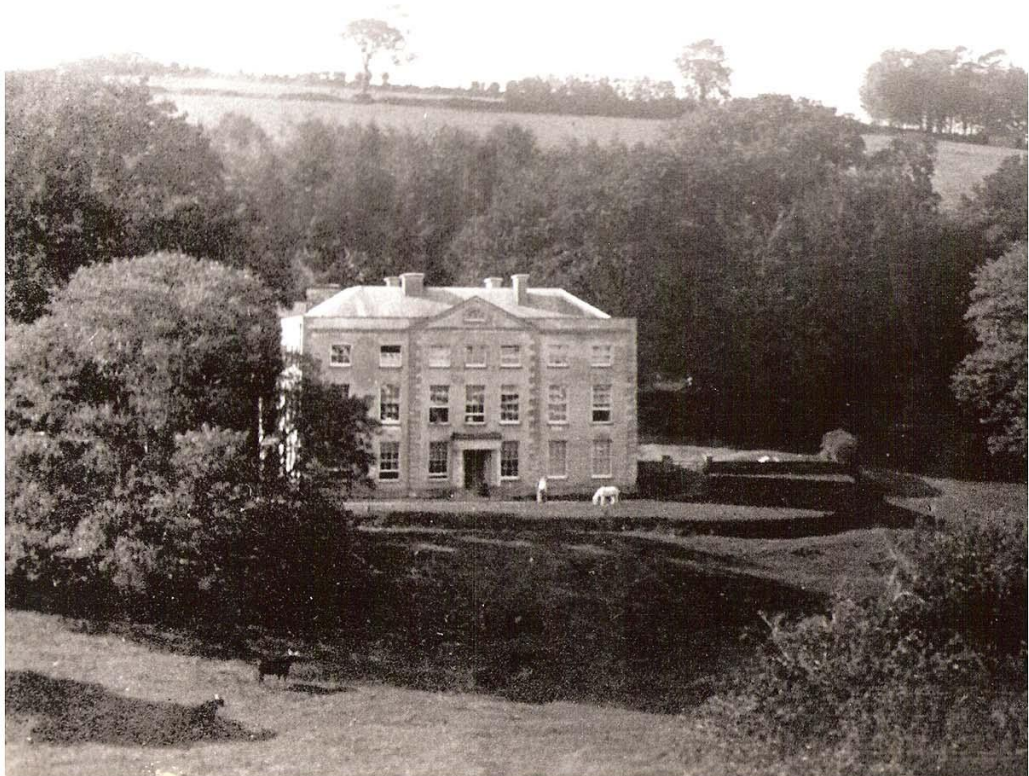
Plate 1: Butterford House, circa 1935

The plain design of the house is most evident in this view from the south; the only extant photograph known of the house before its demolition. Note the imbalance of chimney sizes, not followed in the reconstruction drawings. This is due to the irregular layout of the ground floor fireplaces. Note also the plain facade, without the window surrounds and stringcourses to be seen in Plate 2.
