Historic Building Survey
Of
ROOF STRUCTURES
AT
KILLERTON HOUSE, BROADCLYST, DEVON,

**With an Account of a Watching Brief
on Trenching in the Forecourt of the Mansion**

By R. W. Parker

REPORT No. 2020.03

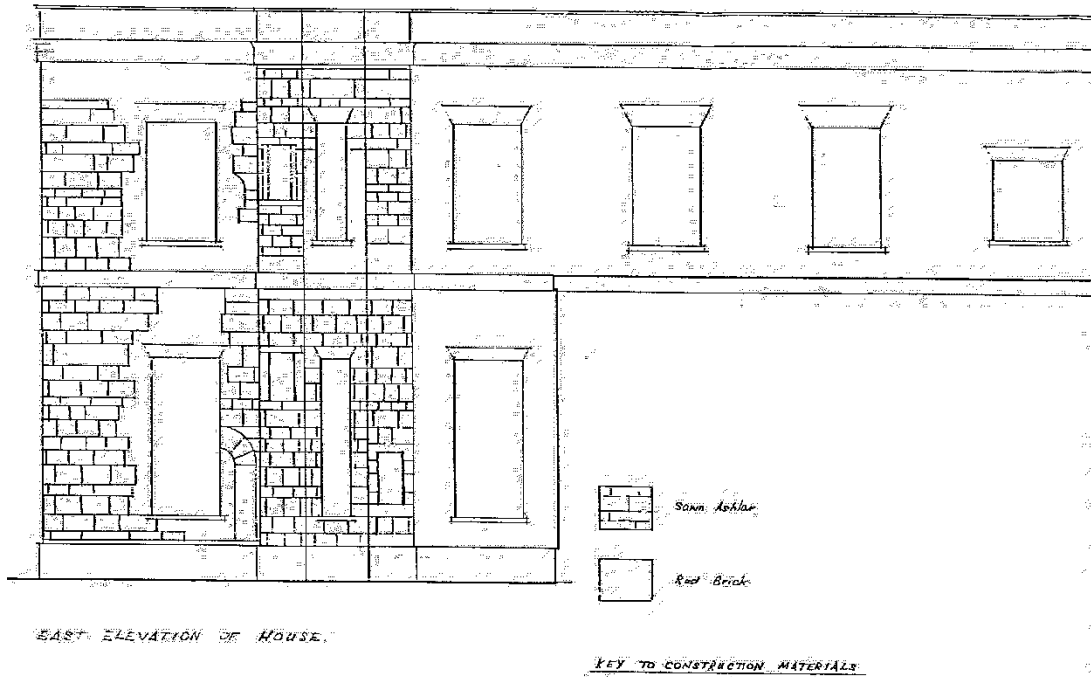
In 1987 the rendering of part of the main south range of the house was removed for repairs, exposing an area of earlier masonry which clearly pre-dates the existing structure. The fabric was recorded at the time in an elevation drawing (Fig. 14) by N. Marsland (Marsland 1987, NT Drawing KI:06:PL:200–207). Marsland's drawing shows the southern part of the east wall of the south range with the polygonal turret rising against it. The turret and the area immediately south of it were recorded as being constructed of 'sawn ashlar', with intrusions of red brick forming irregular areas surrounding the present sash windows. Marsland depicted the stone-built areas with ashlar jointing. This convention probably represents blocks of Killerton or Silverton volcanic stone laid to irregular courses, some very deep and others shallower, including very narrow bands at approximately half the height of each storey. These might conceivably represent the remains of string courses, though whether these had been dressed off flush with the wall is not recorded.

Fig. 14 Drawing by Nick Marsland made in 1987, showing the fabric of the east elevation as exposed during alterations at that time (NT Drawing KI: 06:PL:14)

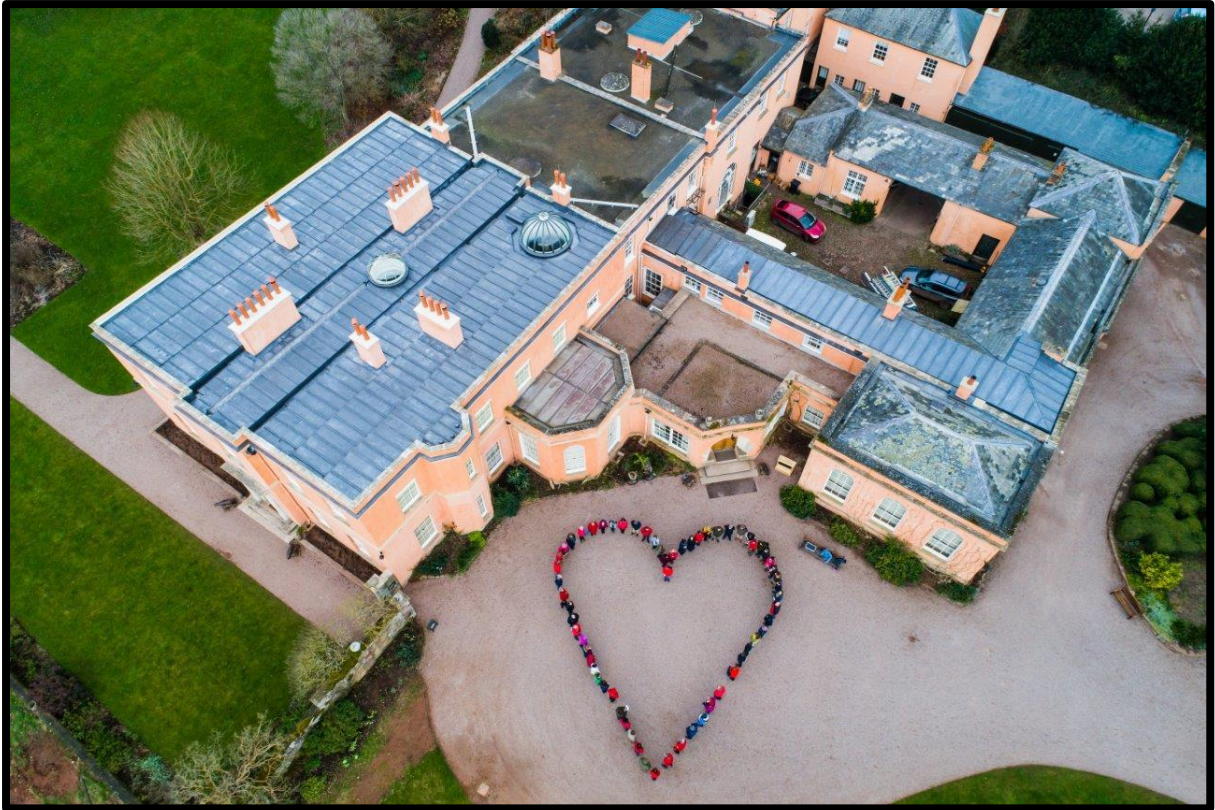
Fig. 19 Aerial view of the new roof structures at Killerton House in 2019 (possibly by Malcolm Jarvis for PCA Consulting engineers and the National Trust), showing the new lead flats, rebuilt chimneys and domes, and expressing the fond hope of Killerton staff and volunteers that this solution will endure for a little longer than its predecessors.

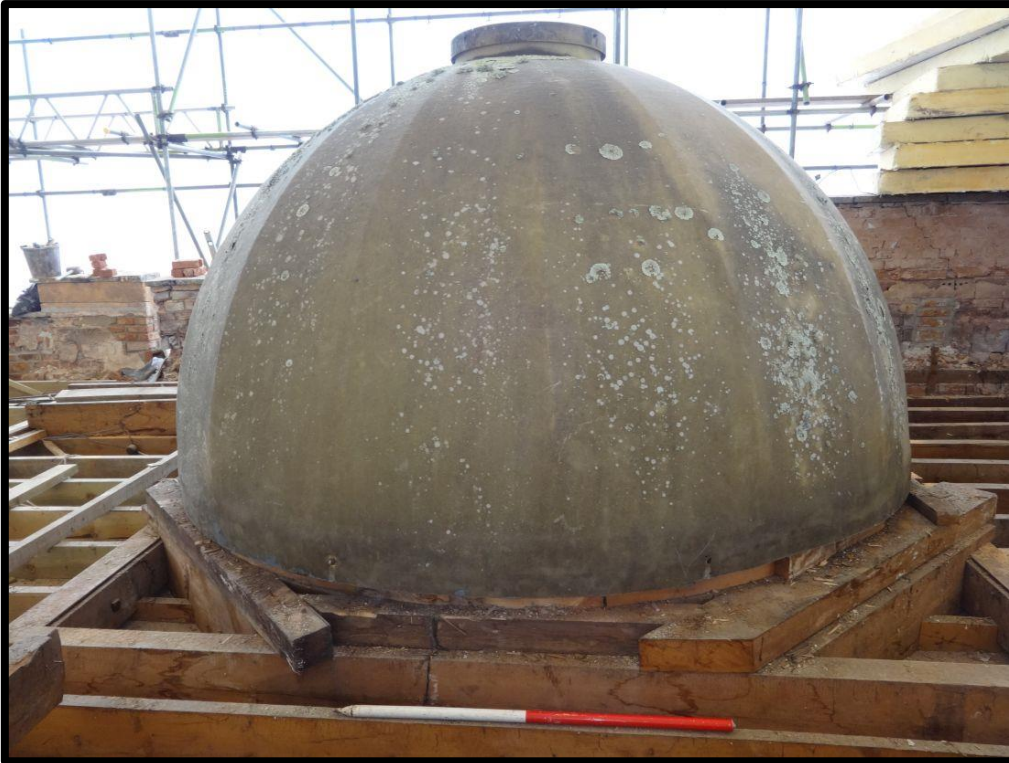
Fig. 25. It is probable that the dome was added when the staircase was removed here in the 1820s

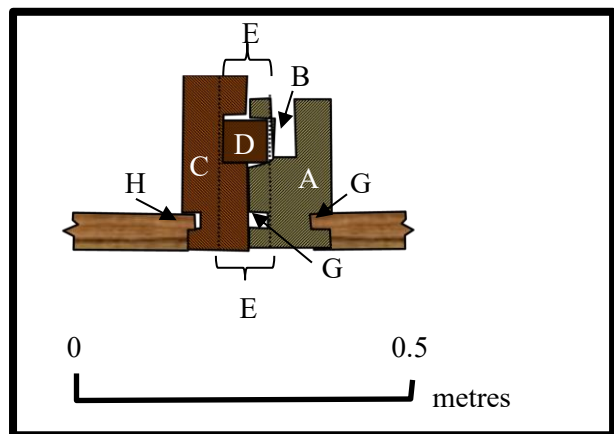
Fig. 36 Scale drawing of the assembly showing the original tie beams (A) with the mortices for the ceiling joists at the base (G) and for the principals at top (B), the secondary fillet cutting the face of this beam (D) and the additional tie encompassing the fillet (C) with the replacement ceiling joists in their mortices (H).

The waisted timbers thus appear to have been the lower ends of vertical ties designed to prevent the tie beams from sagging by securing them at a higher level, either from a continuation of the rafters on the east and west sides of the roof to a new, higher apex, or by introducing a ‘Mansard’ style structure with two distinct pitches (Sampson 2007, 4). Alternatively, a horizontal compression beam may have been added between the king posts near their apex, to prevent the ridges of the paired roofs from folding together, and the ties may have been hung from these, in which case the roof may have taken a trapezoidal form, with a flat apex between the former ridges.

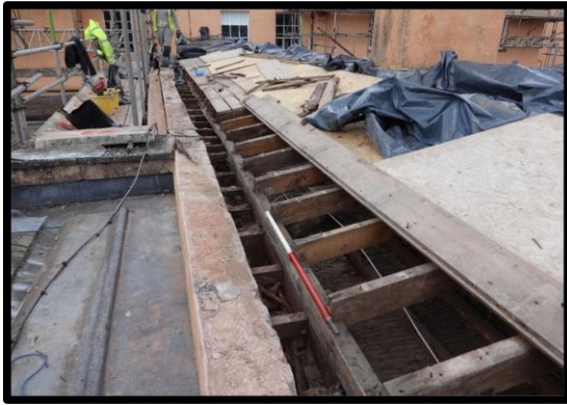
The roof of the southern range of the service range was stripped of slates in March 2017 exposing the timber work. This part of the roof is asymmetrical in profile, with a steeper pitch to the north and a shallower pitch towards the south (Fig. 37); however, this appears to be an alteration, since the sawn-off ends of several timbers are visible rising from the south wall at eaves level, bird's-mouthed over a timber plate resting on the wall top (Fig. 38). Although the eaves detail may always have been different on this side, the timbers may represent the remains of truncated principal rafters, from an A-frame roof of more conventional type.

Fig. 37 The shallow pitched section, forming the southern side of the service range roof, seen from above the roof of the Billiard room, looking west

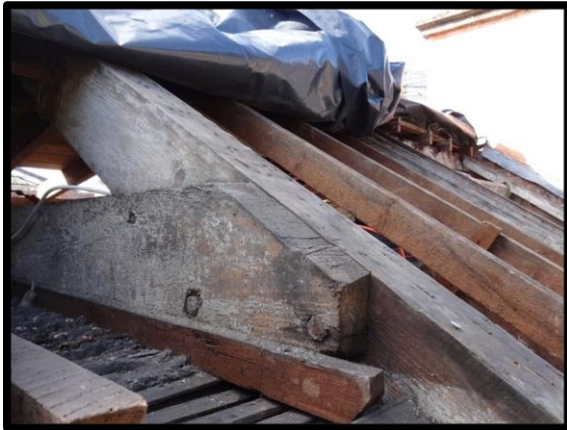
Fig. 39 The end of one of the collars showing the method of securing with large metal spikes.

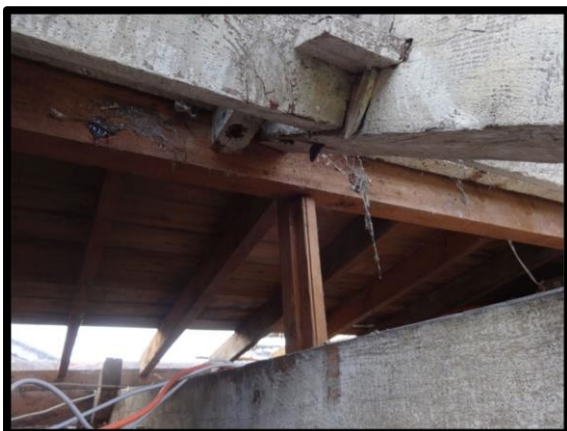
Fig. 41 The whitewashed surfaces of the timbers of the northern side and also the tusk-tenoned and wedged peg of one of the purlins.

The present ceiling has been inserted below collar level and is supported on subsidiary rafters inserted below the originals (Fig. 43). The box gutter behind the southern parapet appears to have been constructed by laying horizontal timbers across the backs of the original principals and inserting short trimmers between these and the parapet wall. The new gutter being higher than the old one necessitated a change in the pitch of the roof in order to ensure a proper stepped fall to drain the water. The new, shallower roof rested on these horizontal timbers. Its beams and rafters are not whitewashed and it is probably contemporary with the existing inserted ceilings (Fig. 41).

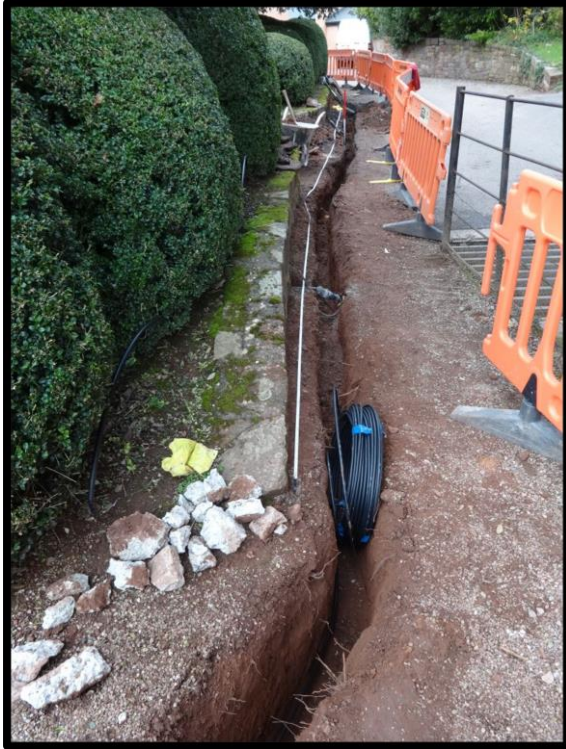
Fig. 45 The south part of the trench extending from the gate of the forecourt towards the service yard (looking north).

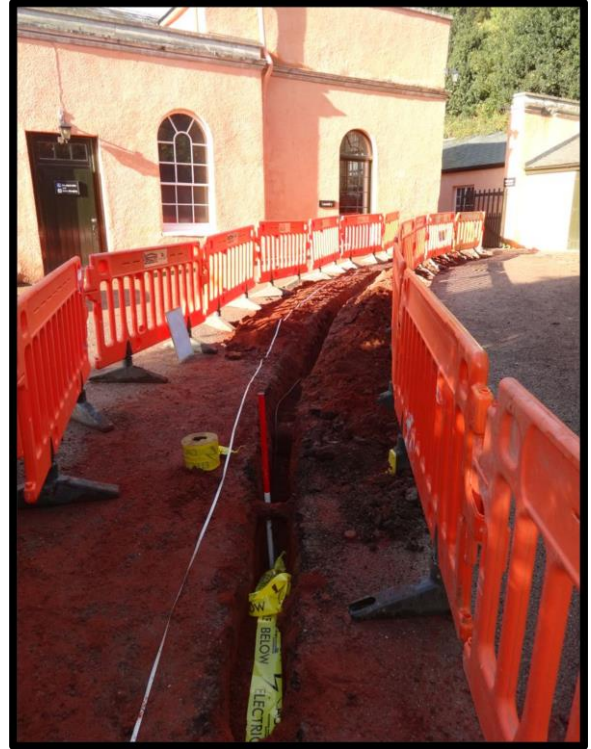
Fig. 46 the northern part of the trench curving towards the angle of the service range and the rear service court.

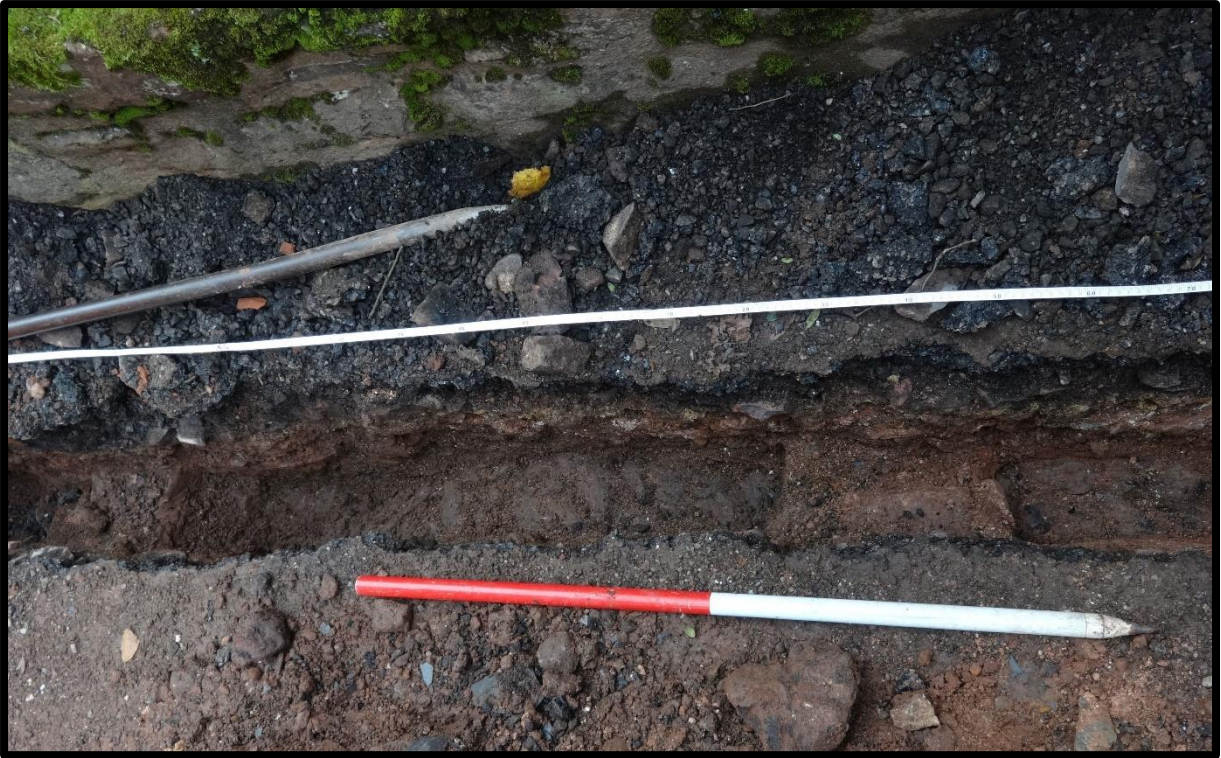
Further north, at about 8.7 to 9 m, the excavations exposed a feature which resembled a narrow wall or footing 0.4 m wide and 0.23 m below the existing ground surface (Figs 51 and 49). Part of this feature was constructed of small volcanic blocks bonded with a bright red clay mortar. Alongside this was a narrow drain 0.2 m wide and, north of this, an area of volcanic rubble resembling well-worn cobbling or footings. This part of the feature was about 1.4m wide, but just over 0.2 m of its northern edge was overlaid by another narrow wall or footing identical with that described above, flanking a narrow drain of approximately the same width (Figs 47, 49). Above this surface, beneath the garden soil, was a thin layer of demolition materials including slate, mortar and oyster shells.

Fig 49 The stone feature observed in the electrical trenching.

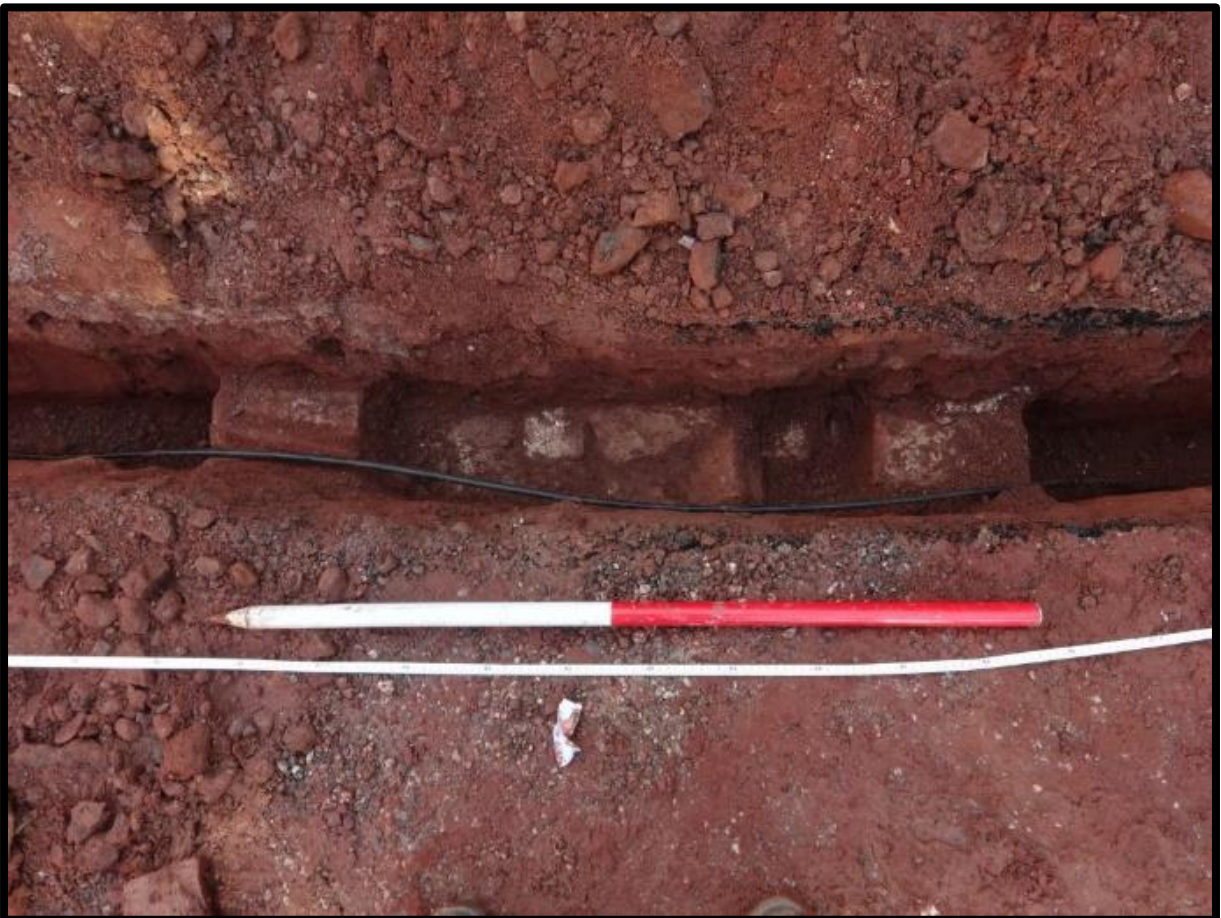
At about 17 m to 18.2 m the red sand was cut by a brick and stone feature which appears to have been trench- built within the red sand (Figs 48, 50, 52). No distinction was seen between the garden soil or make up material overlying this sand and the fill of the trench surrounding the feature. The nature of this feature is uncertain as it was not disturbed, the new electrical cable being simply laid over it. The feature seems to have masonry side walls surrounding an area of rougher masonry (Fig. 52) which might be interpreted as the top surface of a crude vault, or rubble infilling of some form of walled channel. The feature might be a culvert, conduit or drainage channel, perhaps bringing water from a well or a spring higher up the hillside to supply water to the service wing of the house.

Fig. 50 The possible culvert with masonry sides and a central channel, observed in the electrical trenching.

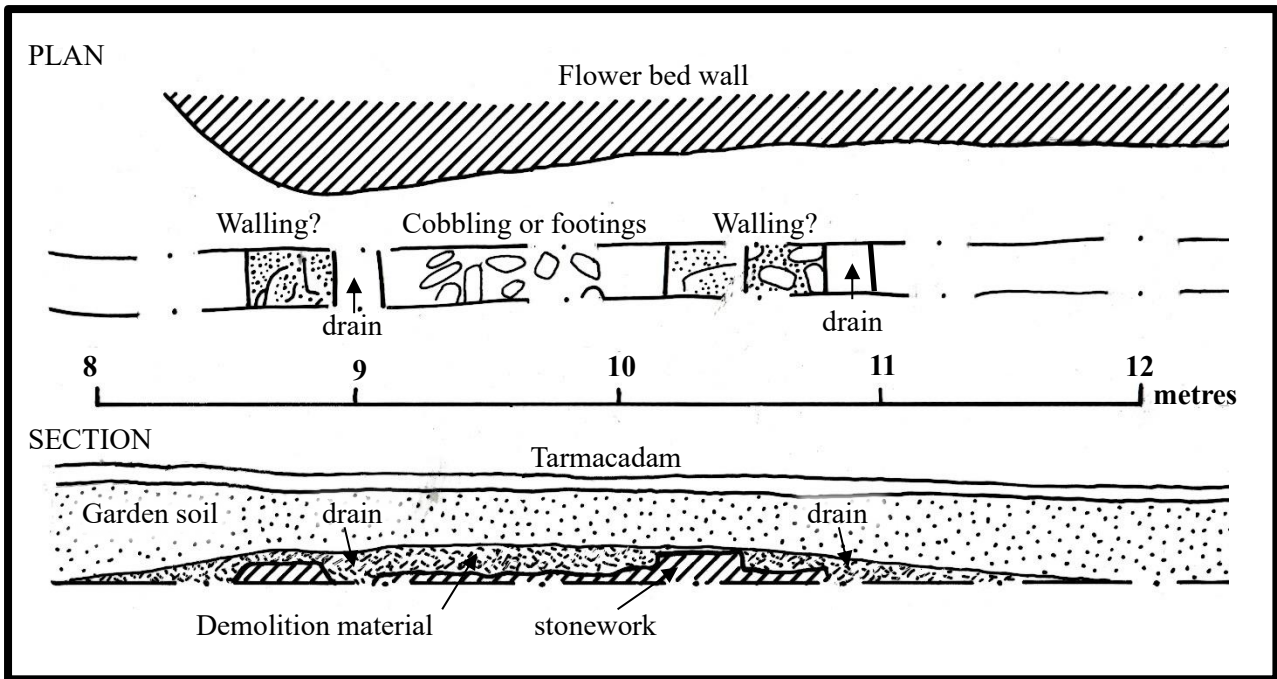
Fig. 51 Plan and section of the stone feature observed in the southern part of the electrical trench east of the house.

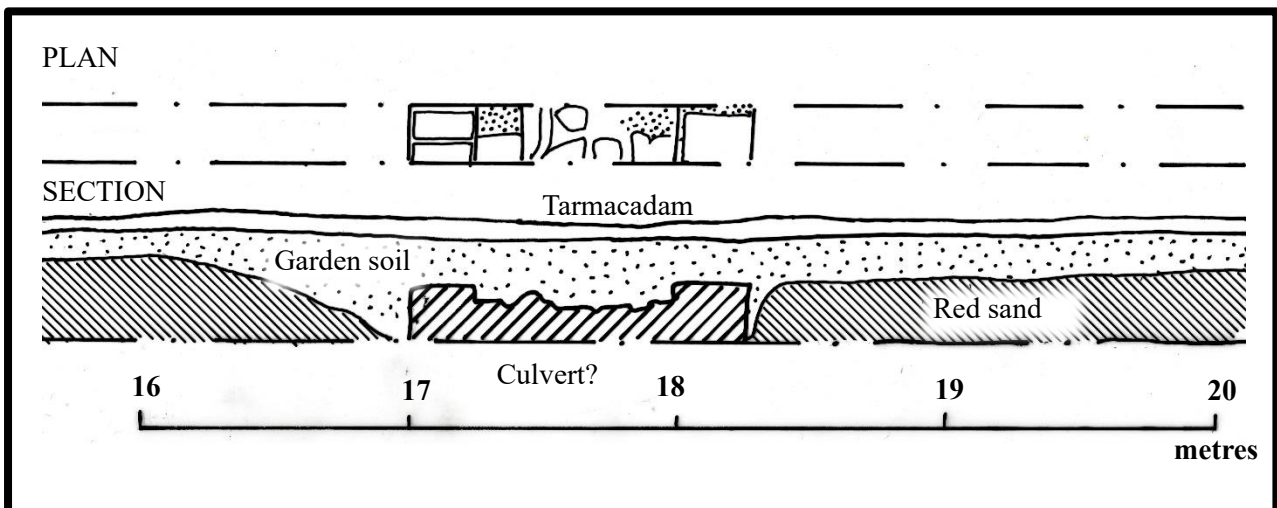
Fig. 52 Plan and section of the possible culvert observed in the northern part of the electrical trench east of the house.

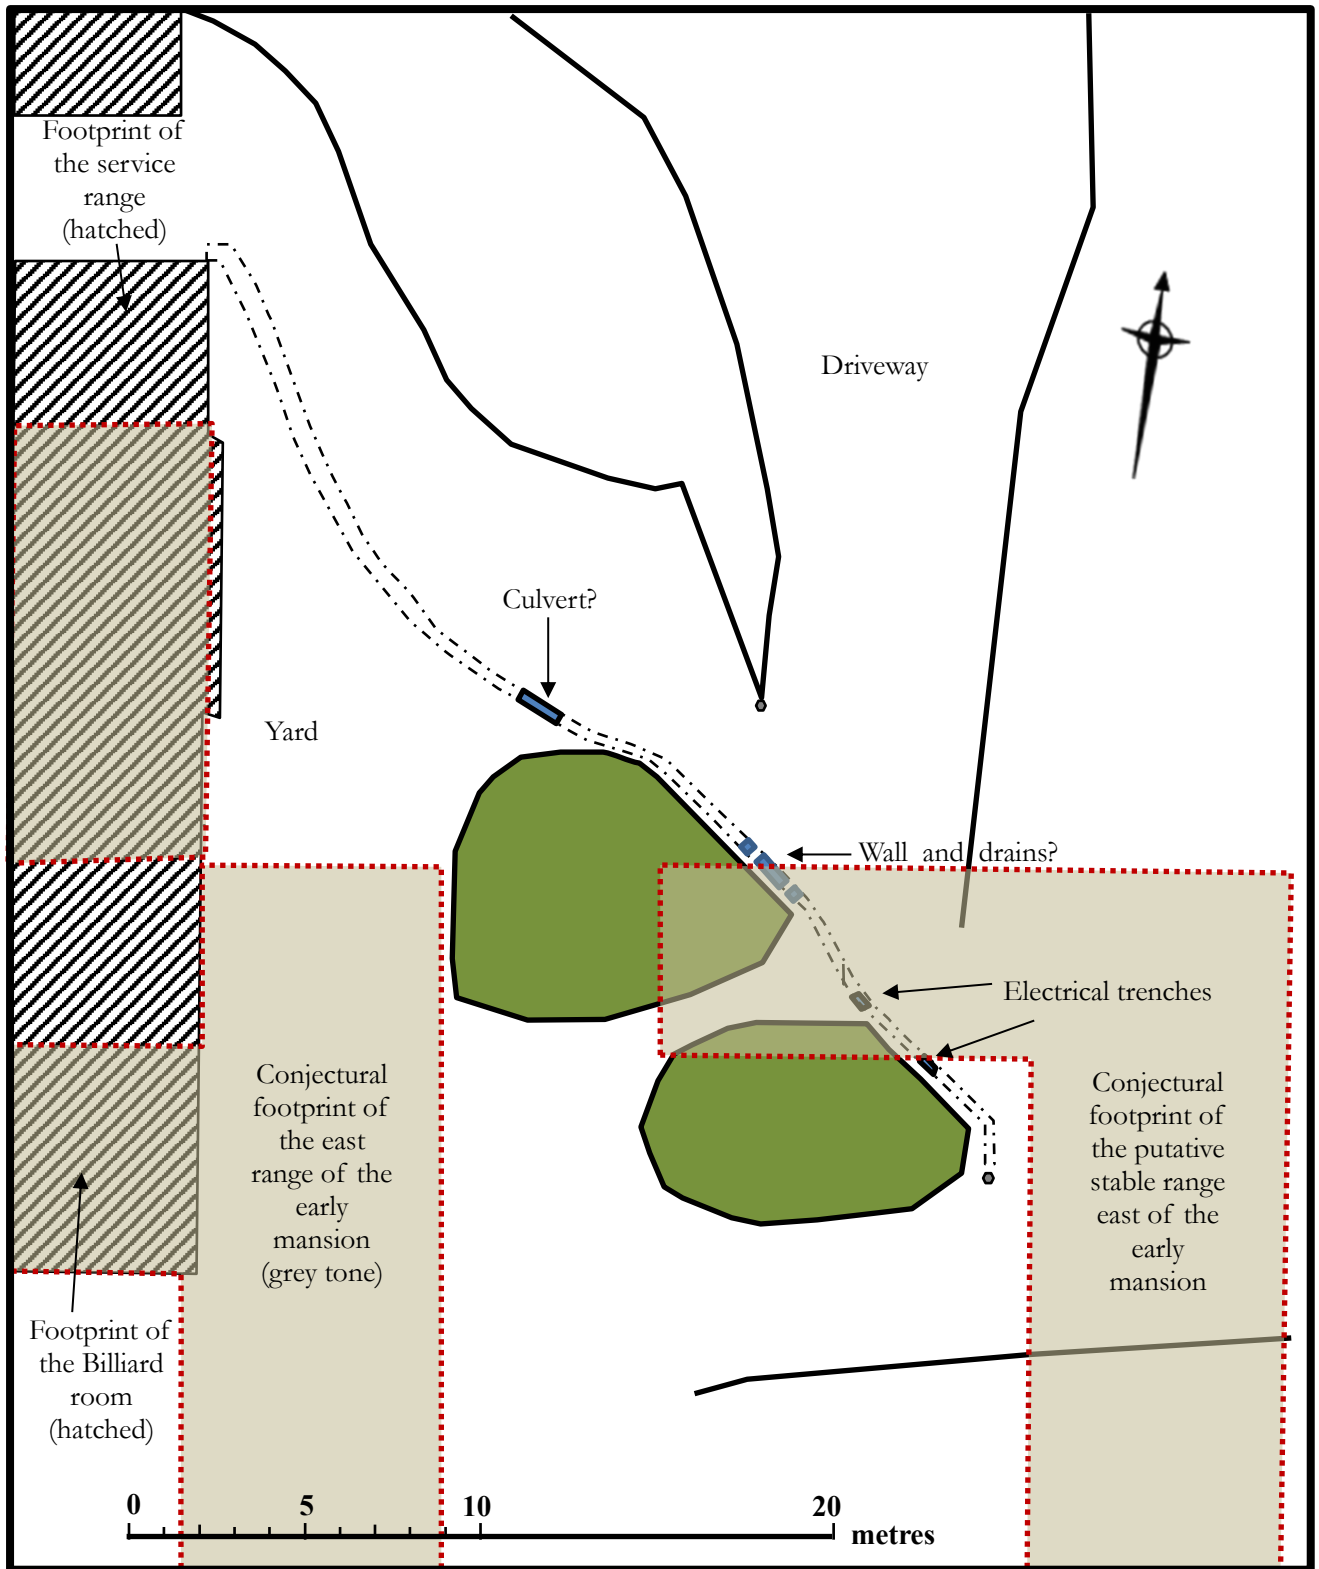
presumed footprint of the ‘U’-shaped building defining the putative stable yard to the east of the house (Fig. 53). This coincidence raised the possibility that both masonry features were in fact the footings of demolished walls, perhaps cob walls on stone footings, with drains at their bases. Given the ‘keyhole’ nature of the trenches and the impossibility of determining the alignment of these features this must remain speculation, but the trenching has at least demonstrated that there are archaeological features lying to the east of the present mansion and that there is a strong chance that these do relate to the demolished Elizabethan or Jacobean mansion.

Fig. 53 Plan of the area to the east of the house based on existing surveys, overlaid with the line of the electrical trench and the presumed footprint of the Elizabethan or Jacobean buildings shown on the early 18th-century estate map. The masonry features observed in the southernmost electrical trench and the supposed cobbles lying north of this appear to coincide more-or-less exactly with the position of the north and south walls of the presumed stable range.

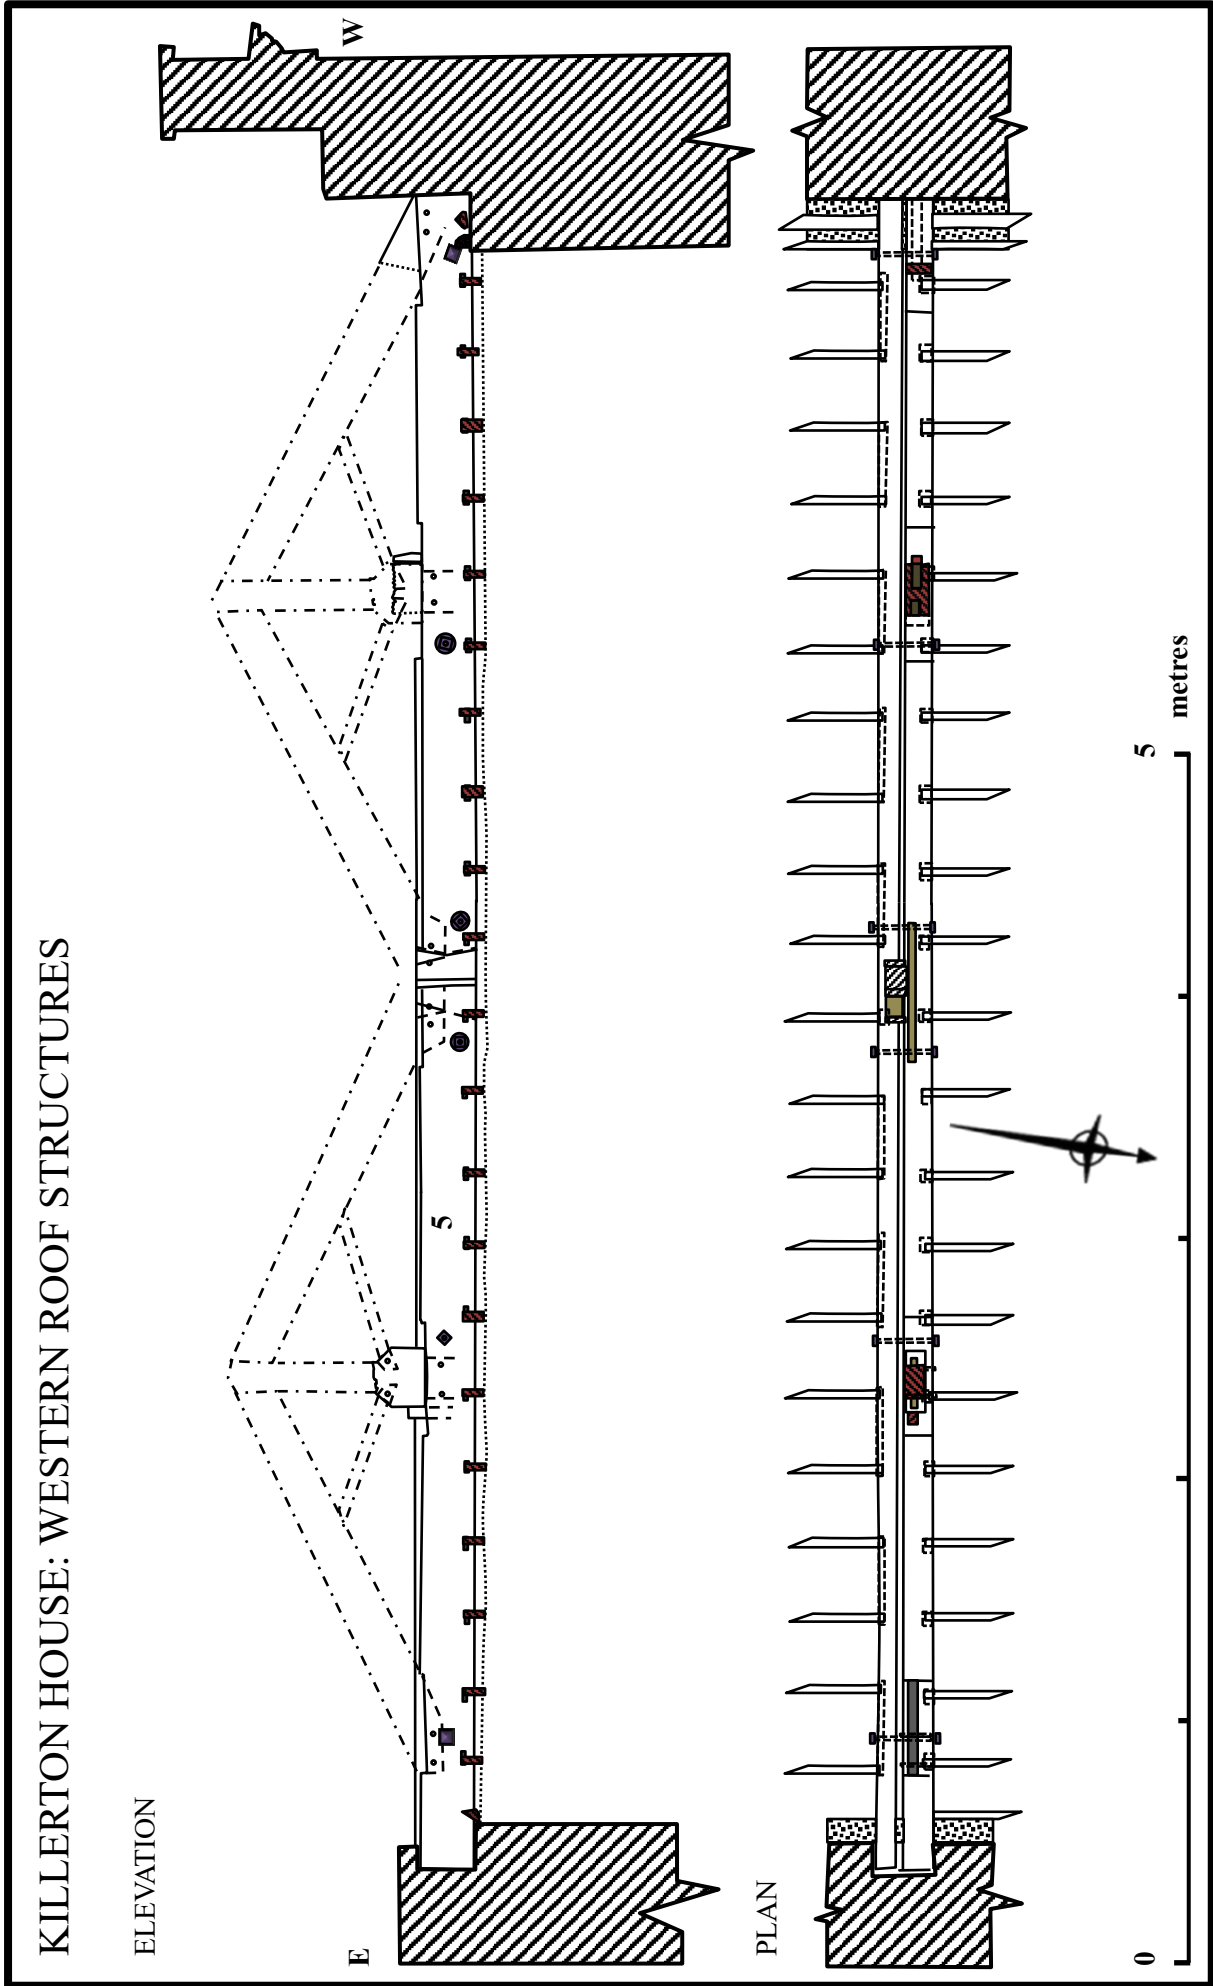
Over the western part of the building the present ceilings formed part of a late 18th-century roof structure divided into a ridge and furrow pattern of two pitched roofs running from north to south, supported on king-post trusses aligned from east to west. This was very feeble and poorly designed, the double-pitched trusses supporting the entire weight of the roofs, roof coverings and ceilings and strongly inclined to fold together in the middle and sink into the bedrooms.

Fig. 54 Elevation and plan of one of the late 18th-century trusses over the western part of the house with the missing elements of the original design restored.

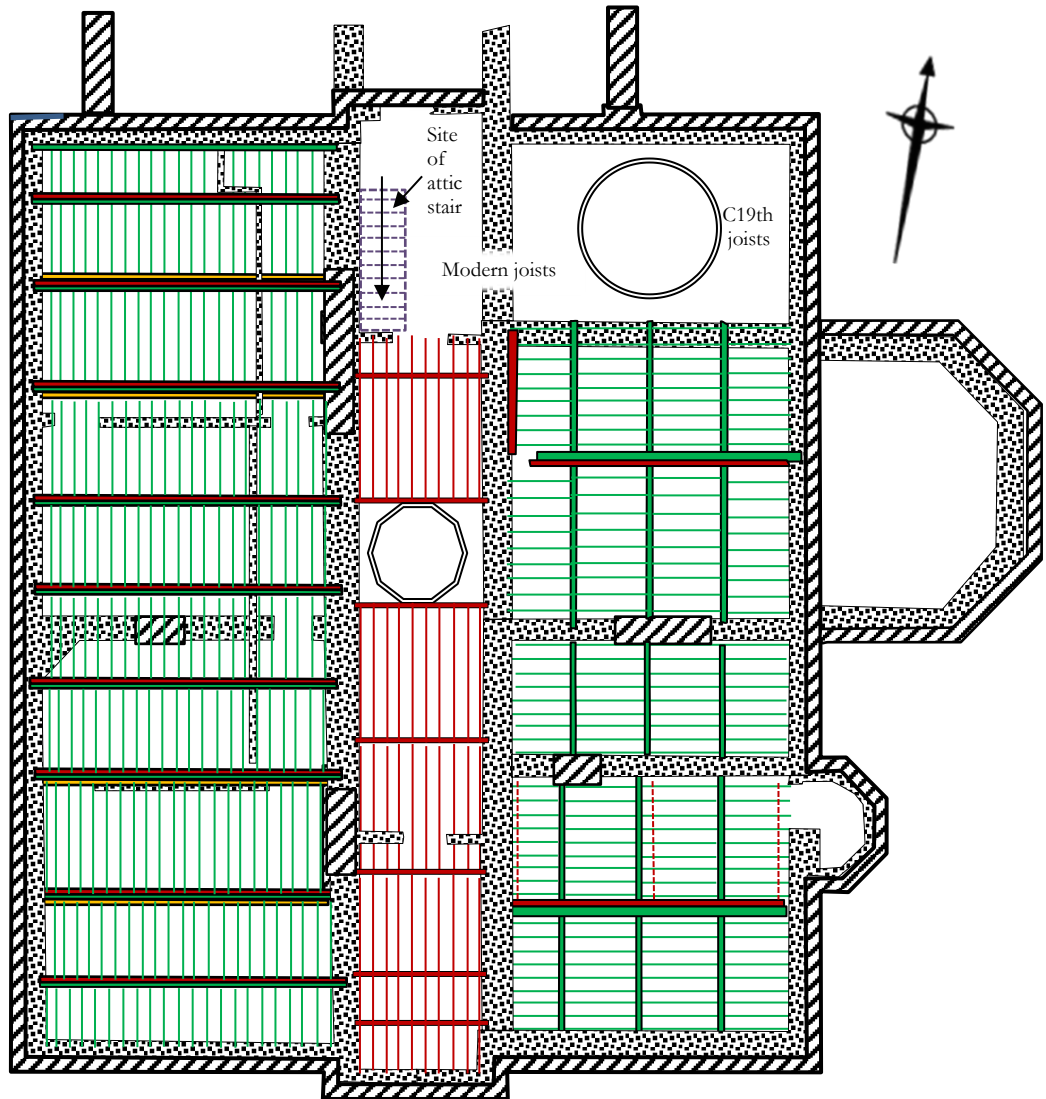
Fig. 55 Plan of the south range at roof level showing the probable phasing of the roof timbers
