**Haden Hill Park  
Rowley Regis  
Sandwell**

**Report on a programme  
of archaeological work**

May 2004

*Marches Archaeology Series 277*

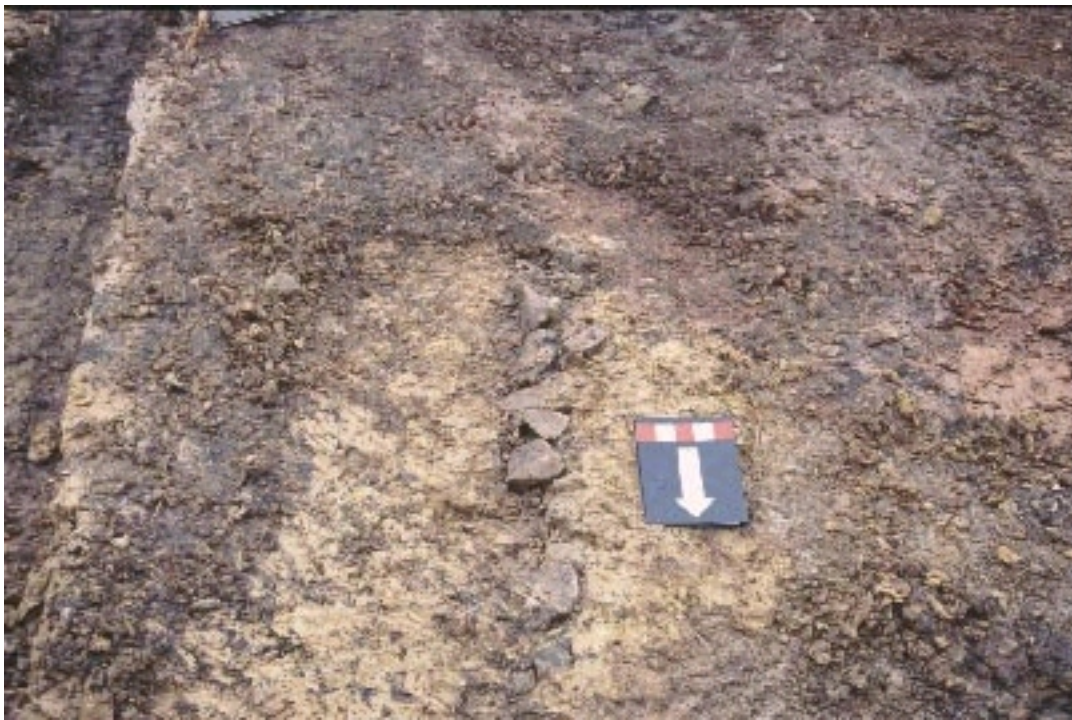
**Plate 26 The foundation utilised by the existing steps, looking west**

The existing steps were demolished down to the brick foundation. The existing steps had utilised an existing foundation that could have been part of the original steps shown on the 1888 25" Ordnance Survey Map (Morriss, 2002, 60) (Plate 26). The foundation was left *in situ* with the intention to incorporate it into the new design.
