# Shildon engine house and mine workings

Shildon by Blanchland, Northumberland

## *Archaeological recording during conservation works in 2010*

Data Structure Report

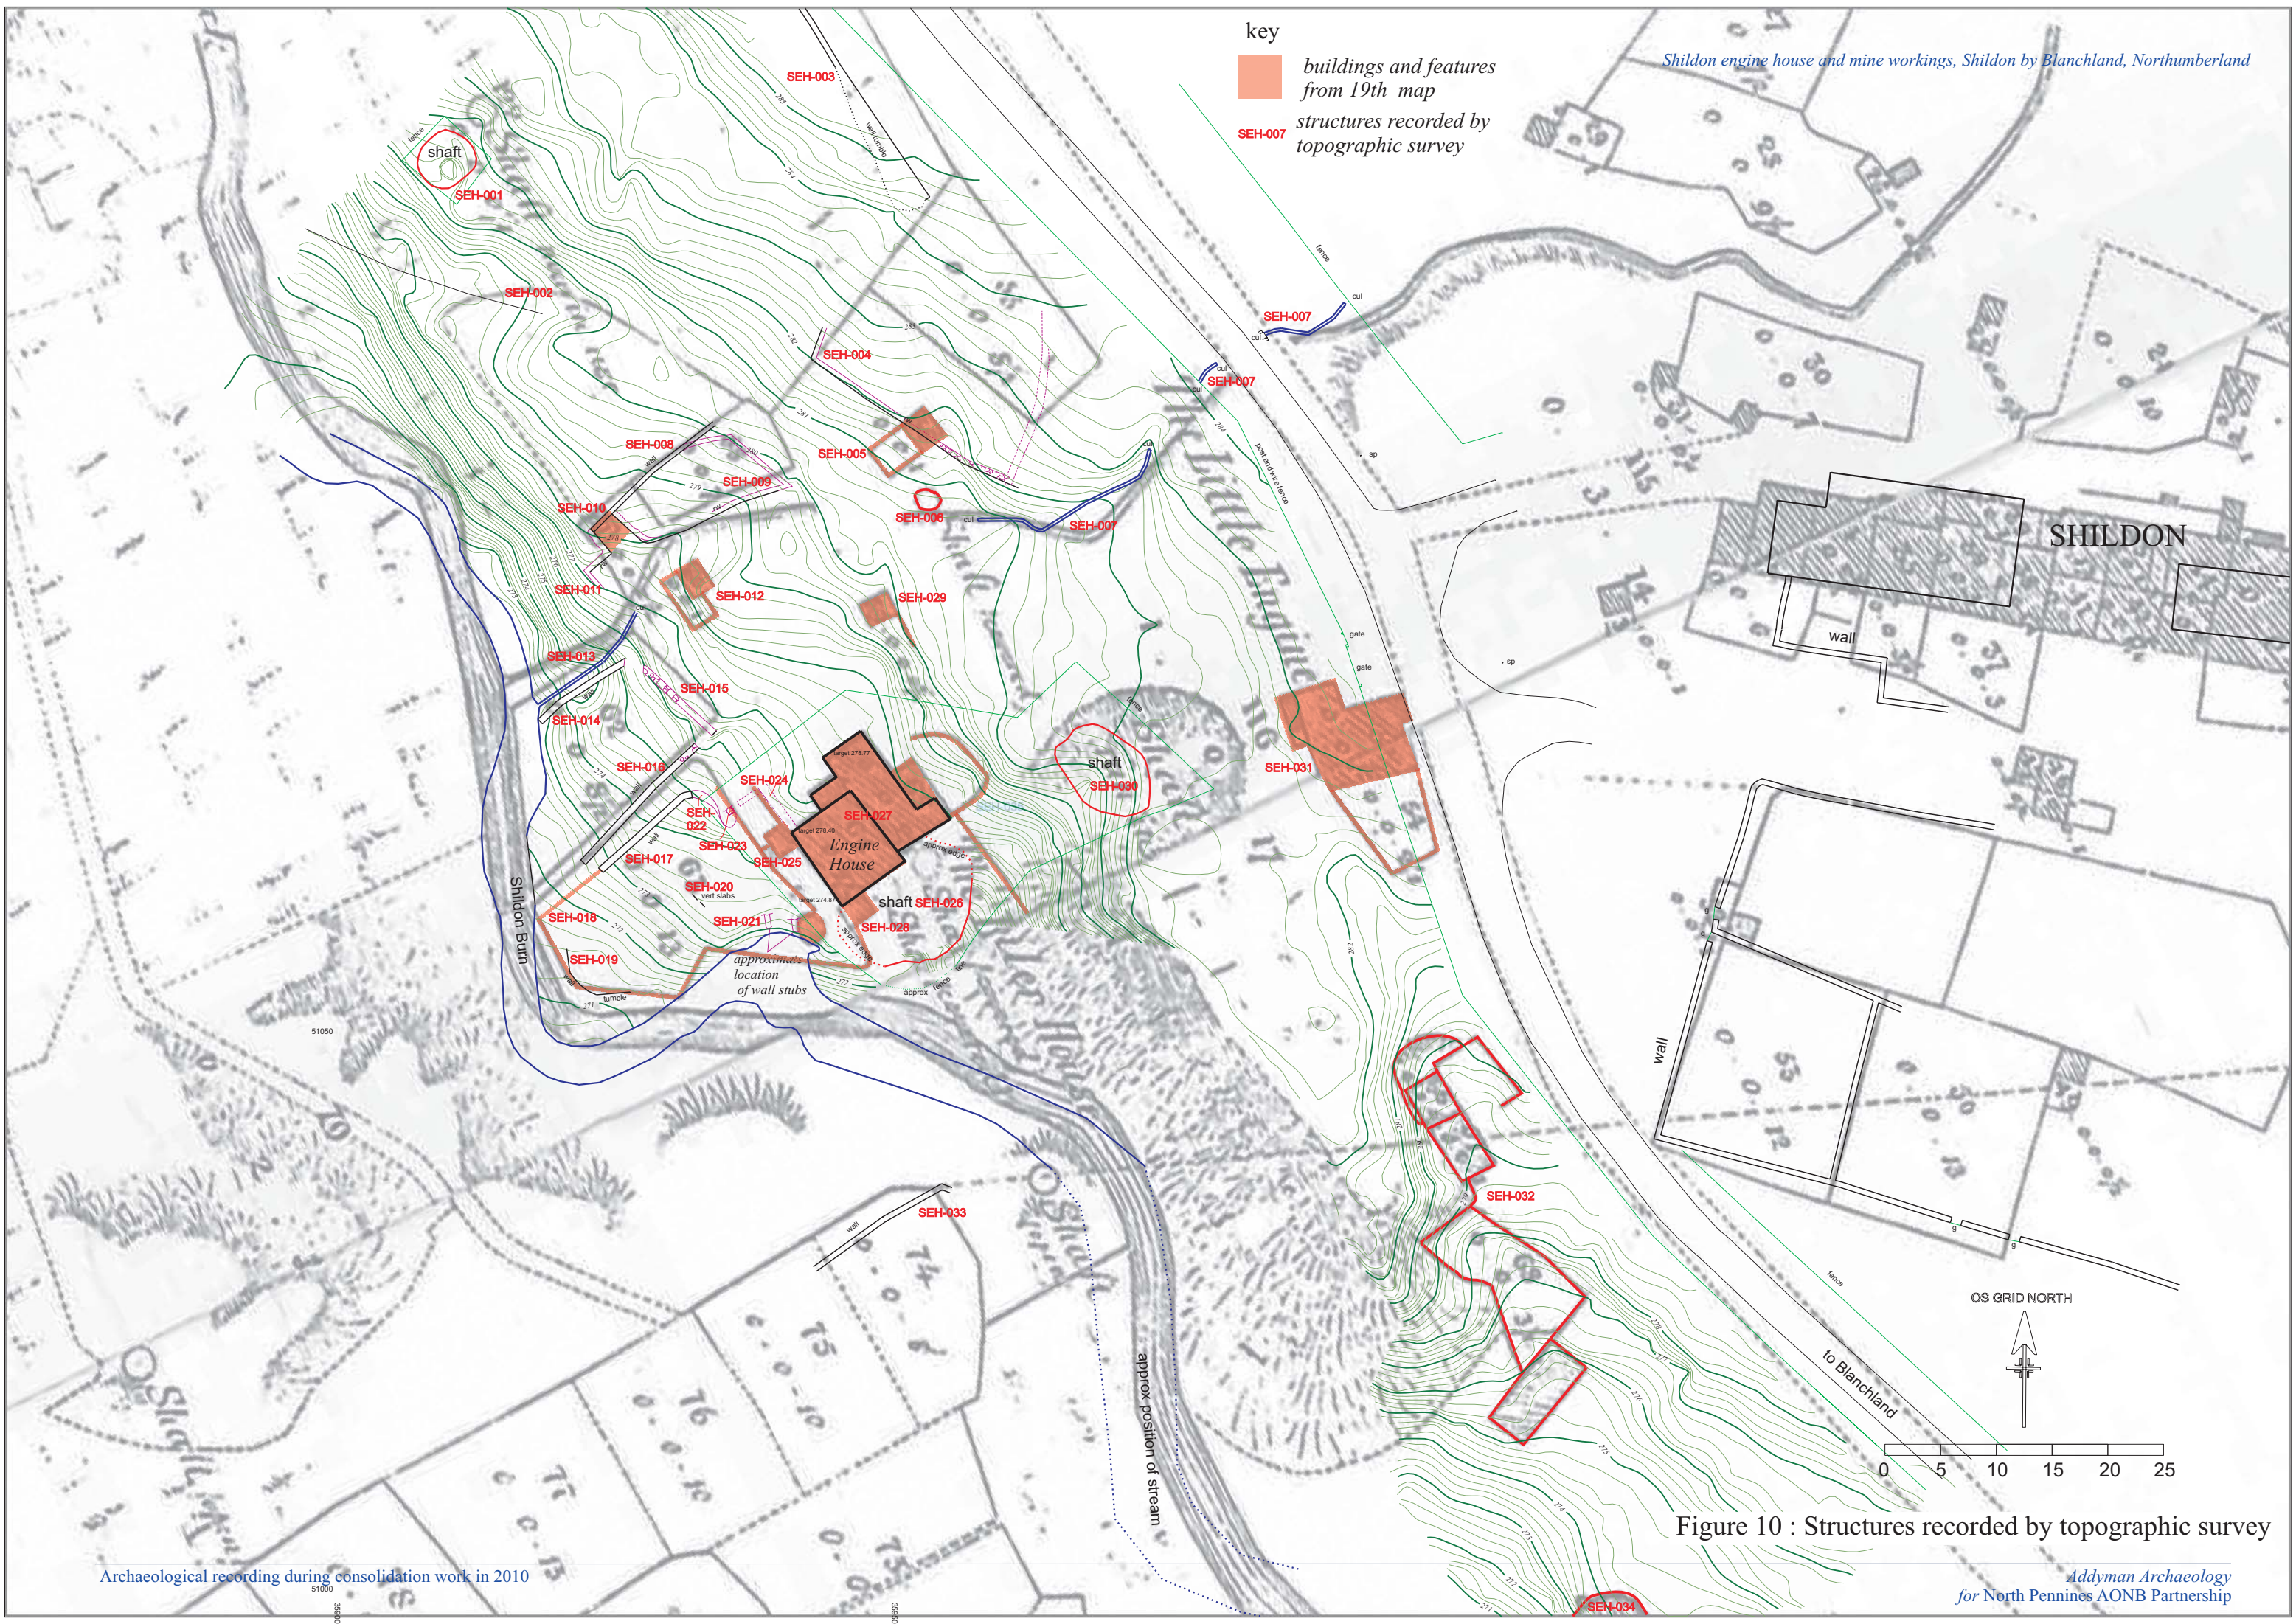
Figure 10 : Structures recorded by topographic survey

SEH-008	Wall running NE / SW forming N side of rectangular enclosure SEH-009	<i>Alignment does not fully coincide with position marked on 19th C estate plan</i>
SEH-009	Rectangular enclosure to NNW of main engine house, rubble wall	<i>Alignment does not fully coincide with position marked on 19th C estate plan</i>
SEH-010	Small building with square plan, to SW of rectangular enclosure SEH-009	<i>Only NE and SE walls survive</i>
SEH-011	Rubble wall remains to SW of building SEH-010, continuing from SE corner of SEH-010 SE-wards to meet the culvert	
SEH-012	Small rectangular building to NNW of main engine house, SE of SEH-010 with small rectangular enclosure wrapped around its SW elevation and S corner	<i>No visible remains above ground</i>
SEH-013	S end of 19 <sup>th</sup> century line of culvert for minor stream to N of main engine house where it meets the burn to W of site; compare SEH-006	
SEH-014	Wall to SSE of culvert SEH-013, following its course to the burn; wall forms NW side of large rectangular enclosure incorporating SEH-015 and SEH-016

SEH-015	Remains of walling containing blocked openings, probably of disused building, later incorporated within large rectangular enclosure consisting of SEH-013 and SEH-016

<b>Site No.</b>	<b>Description</b>	<b>Comment or photograph</b>
SEH-016	Wall forming SE side of rectangular enclosure consisting of SEH-013 and SEH-015 (W side of enclosure is built directly against E scarp of burn	
SEH-017	Wall to SE of SEH-016 on similar alignment; together they appear to form a small road or track leading from the engine house down to the burn; NW side of large angular enclosure SEH-018, SEH-019, SEH-022, SEH-025	
SEH-018	Wall line continuing from wall SEH-017 forming NW corner at burn; dilapidated	<i>No visible remains above ground</i>
SEH-019	Wall at S corner of angular enclosure SEH-017, SEH-018, SEH-022, SEH-025; tumble	
SEH-020	Vertical upright slabs, aligned NW / SE, set in the centre of the large angular enclosure SEH-017, SEH-018, SEH-019, SEH-022, SEH-025	<i>Not marked on 19th C estate plan</i>
SEH-021	Pair of two wall stubs revetted into the slope, aligned N / S, on the N scarp of the burn, immediately W of the subcircular feature (as part of SEH-025)

SEH-022	Wall at N corner of angular enclosure SEH-017, SEH-018, SEH-019, SEH-025; dilapidating to NE	
SEH-023	Masonry stump protruding from built-up ground to W of engine house; possibly related to SEH-024	
SEH-024	L-shaped remains of walling to NW of engine house consisting of a relatively thin stretch running E / W, against a thicker wall running roughly N / S and possibly continuing N of the re-entrant angle of the E / W cross wall	
SEH-025	Complex of thin wall footings, aligned NW / SE and connected to a square building in its N part and subcircular structure to S (photograph; compare SEH-021); NE part of complex forms NE wall of large angular enclosure SEH-017, SEH-018, SEH-019, SEH-022	<i>No visible remains above ground</i>

SEH-027	Main engine house building also comprising boiler house, chimney and small lean-to structure	
SEH-028	Small rectangular building against S corner of main engine house	
SEH-029	Small rectangular building, perpendicular to a relatively steep part of the sloping ground, to N of engine house; a small stretch of wall continues S-wards from the building's E wall	<i>No visible remains above ground</i>
SEH-030	Mine shaft to E of engine house	<i>Marked as ruinous on 19th C estate plan</i>
SEH-031	“Little Engine” house to E of main engine house, small complex of structures with a main rectangular block and extensions to N and E; small long rectangular building against W wall; angular enclosure against S wall	<i>No visible remains above ground</i>
SEH-032	Large complex of buildings and enclosure walls to SE of main engine house	<i>No visible remains above ground</i>

SEH-033	Small stretch of walling forming N-most line of enclosure walls of field system to S of main engine house	
SEH-034	Mine shaft at S edge of site	
SEH-035	Semi-oval enclosure wall against NE side of boiler house, part of main engine house complex	<i>No visible remains above ground</i>

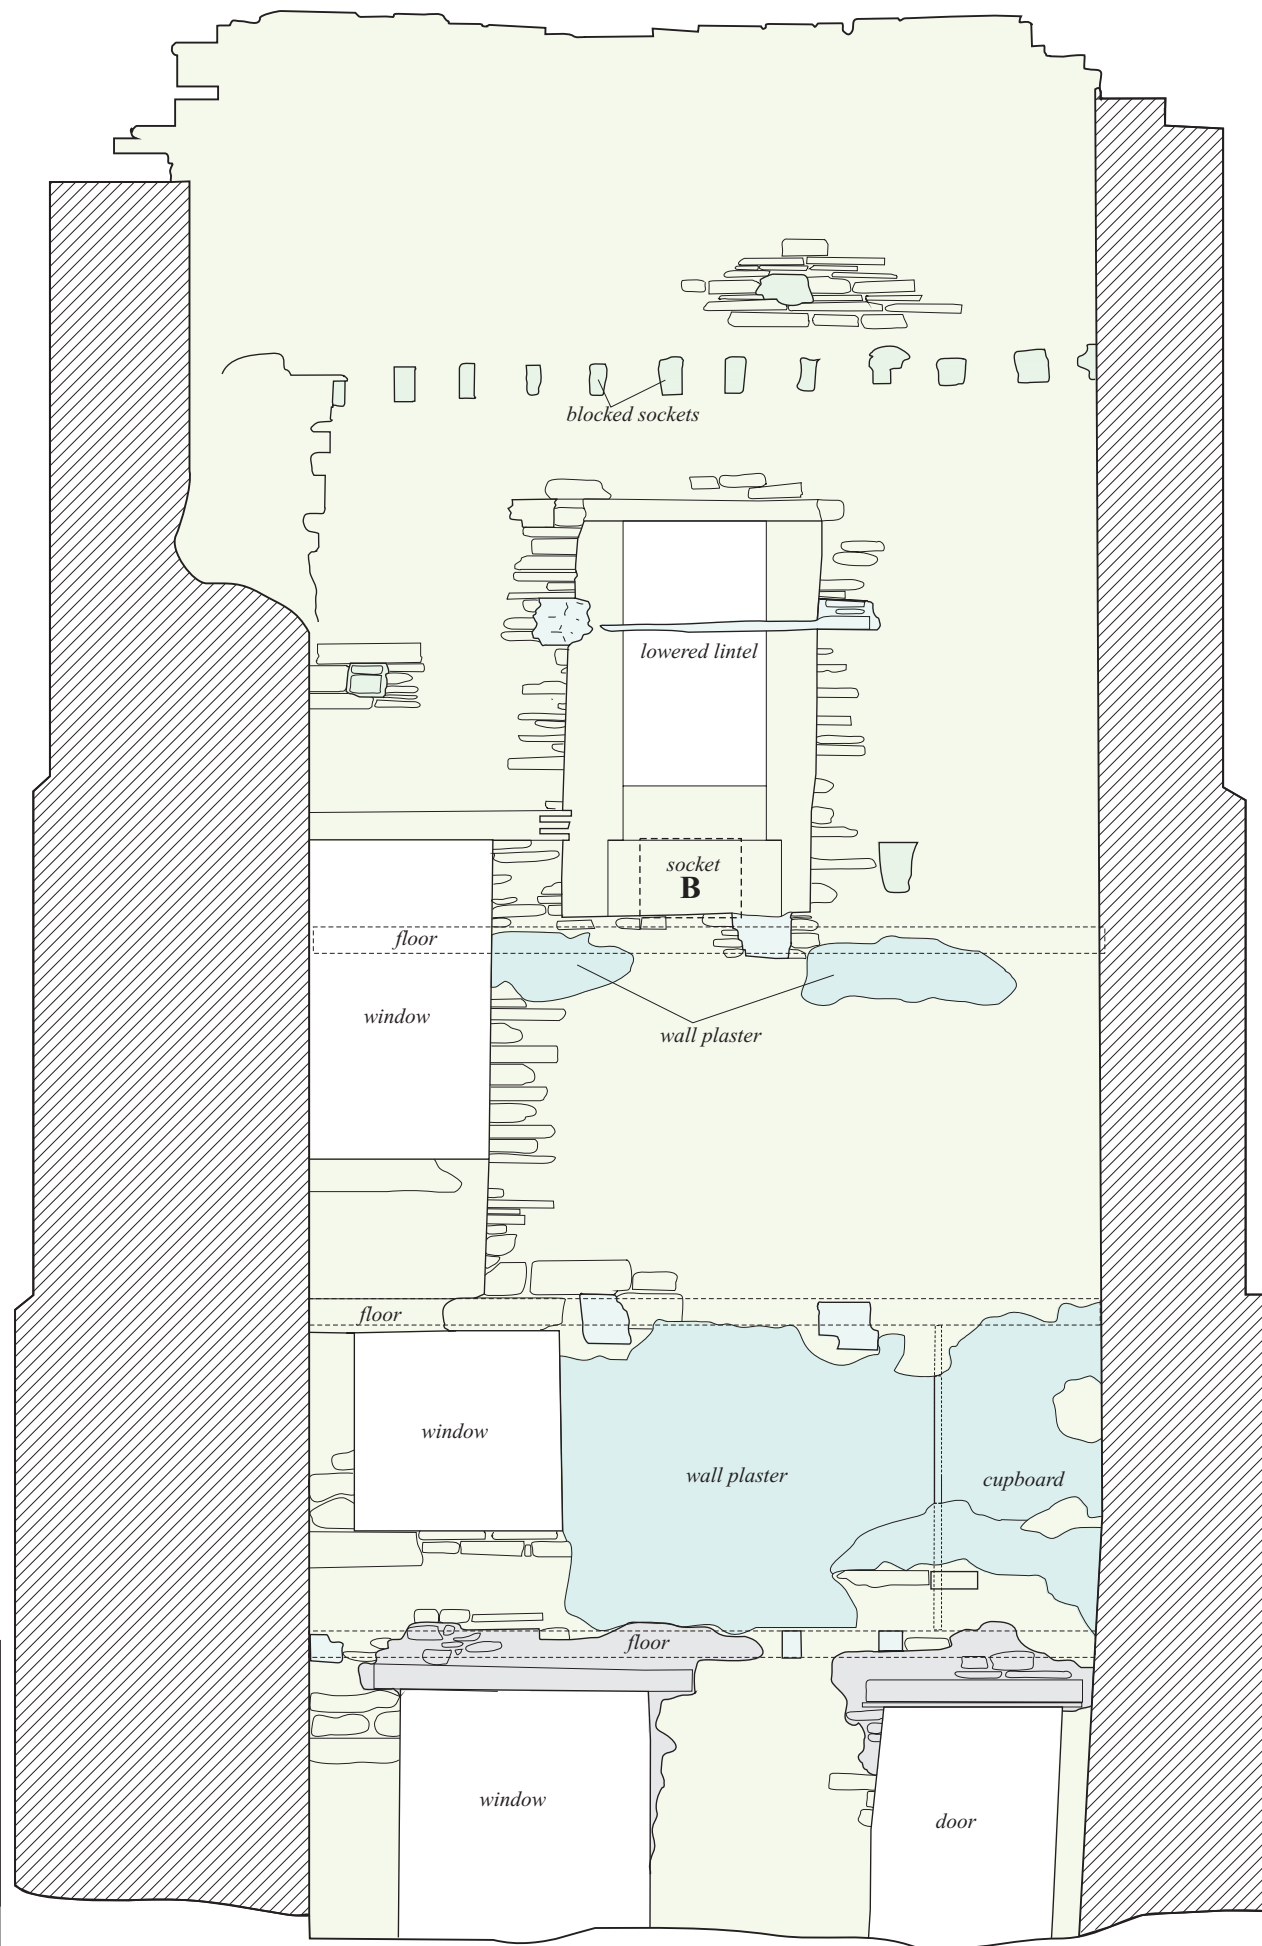
Figure 16 : Shildon Engine House South Interior phased

A central splayed window sits above this opening just described, the lower part of which is likely to be a later alteration of a major socket “B” that can be seen on the exterior and matches the position of another socket on the north elevation. Above this window exists a row of blocked joist sockets; these are likely to represent a floor or gallery around the machinery of the beam providing access for control, maintenance and repair to the engine.
