29-31 High Street, Jedburgh

Historic Building Survey and Archaeological Monitoring : October 2012 – February 2013

Data Structure Report (AA.2013)

The Scottish Borders Council

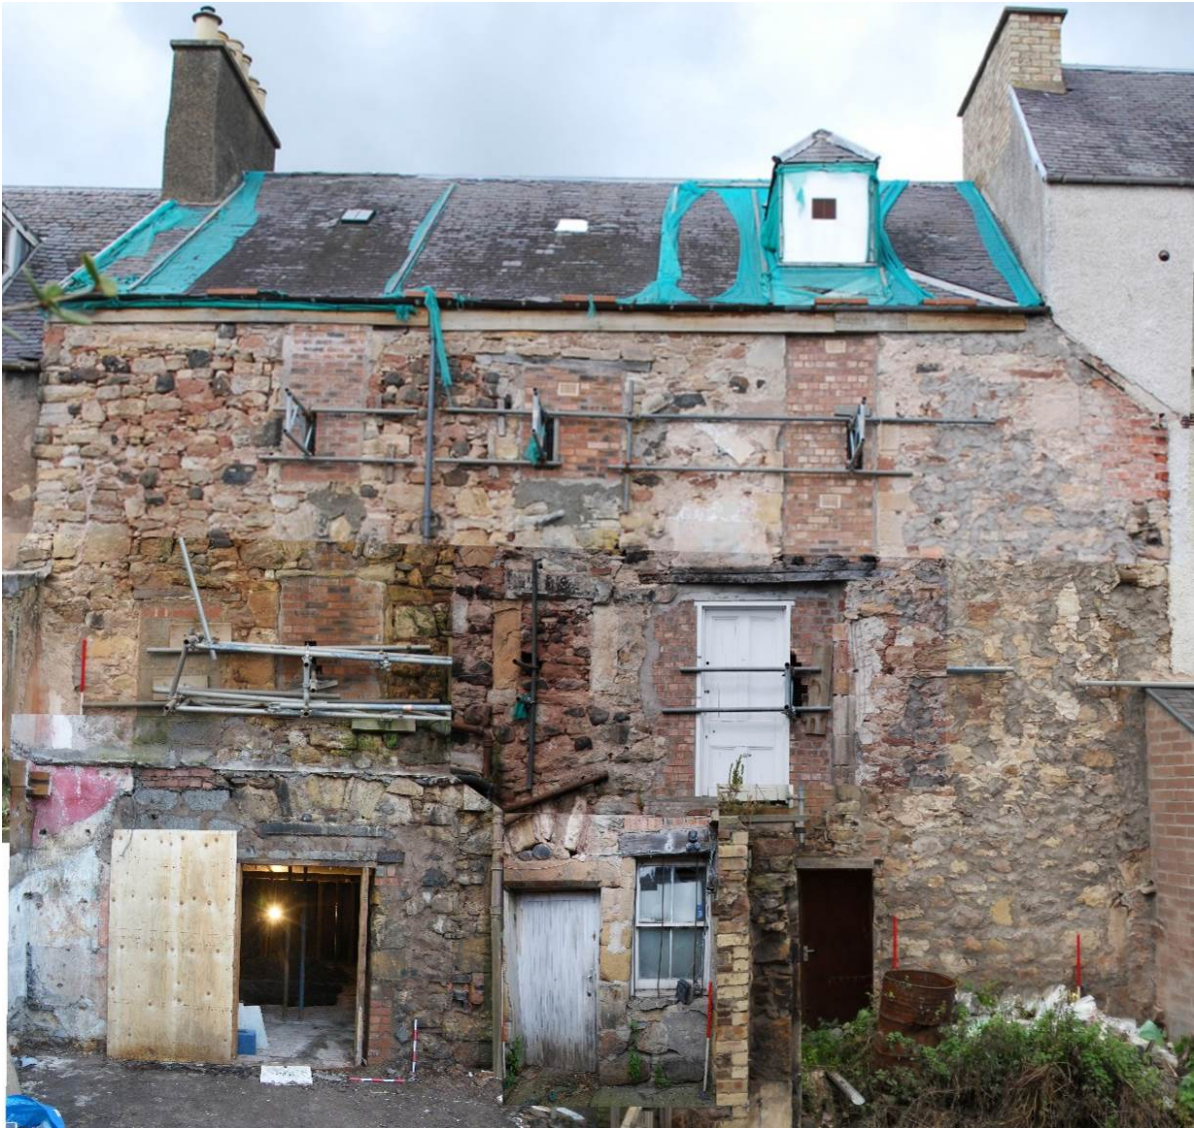
Plate 7 Composite view of the rear elevation

At the mid-point of second floor level the phase II masonry terminated, evidently at its original wall head level. Interrupting this were the lower parts of two former windows that had evidently broken the wall head to form dormers, (139) and (140), these detailed with a chamfer. The remains of an inserted entrance in to a rear wing survived further to the NE, (147), this opening possibly superseding an earlier dormer.

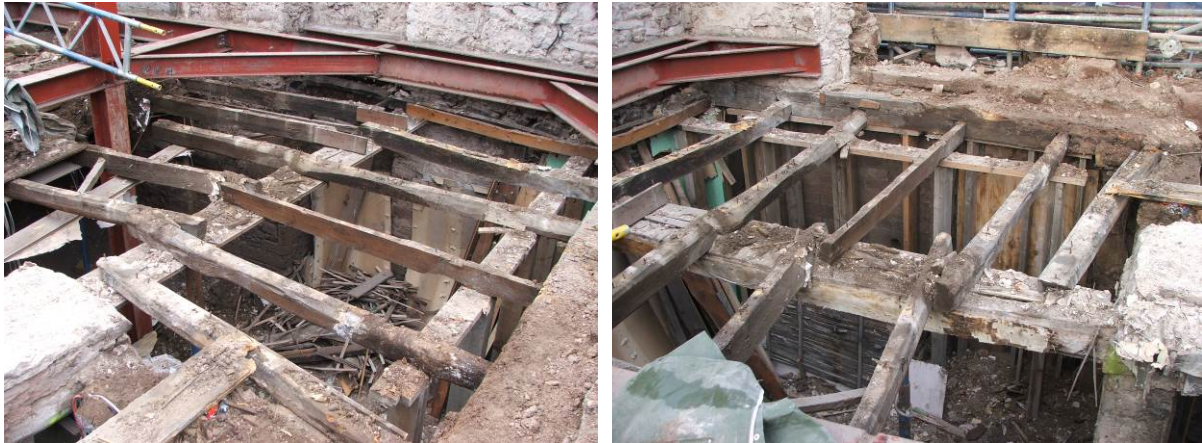
The first floor floor structure consisted of thirteen common joists within the rear panel (040 - 052) and two further short joists sections spanning between the rear wall and the chimneybreasts in the gable walls (151 and 152), and one from the SW chimneybreast to the principal joist (155). With the exception of one of the latter all of these were of pine, set at approximately 0.65m centres. One of the two original principal joists remained, this on the up-slope (SW) side of the pend (063). To the NE of the pend a secondary principal joist had been inserted at later date (072) this further back from the frontage than its predecessor. The front panels of flooring consisted of a sequence of six common joists to the SW of the pend (057 - 062) and a further five of an original six common joists to the NE of the pend (067 - 071). The frontage common joist panels were of mixed pine and oak. The ceiling of the pend was supported by a single common joist towards the frontage (153); behind this the

Plate 11-12 The first floor floor structure, showing the shorter panels of common joists extending to the street frontage

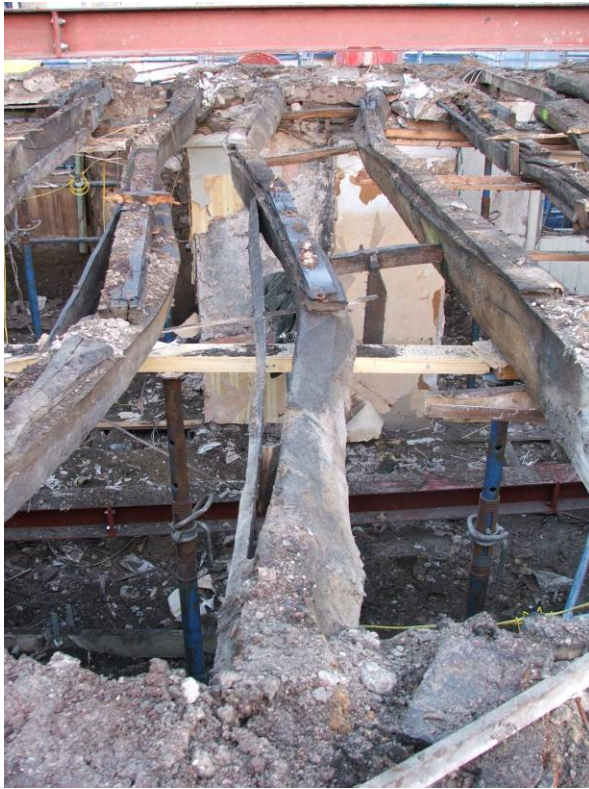
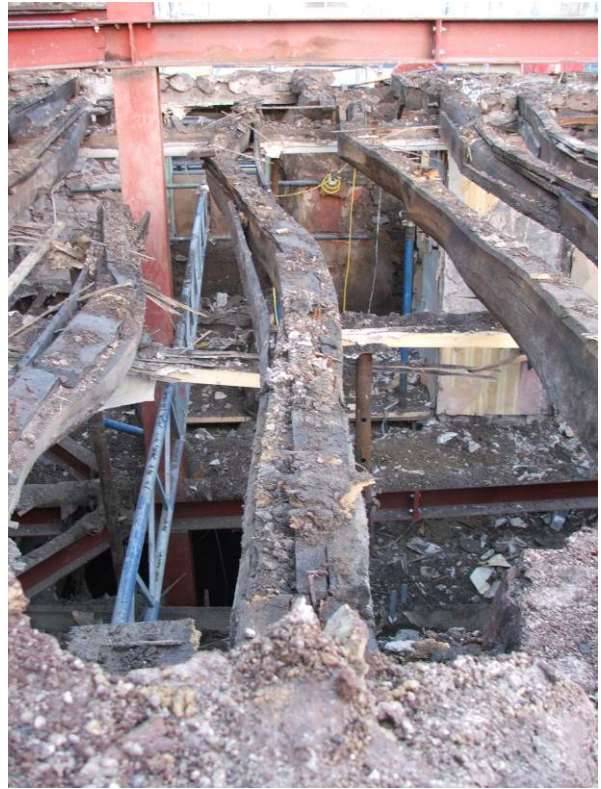
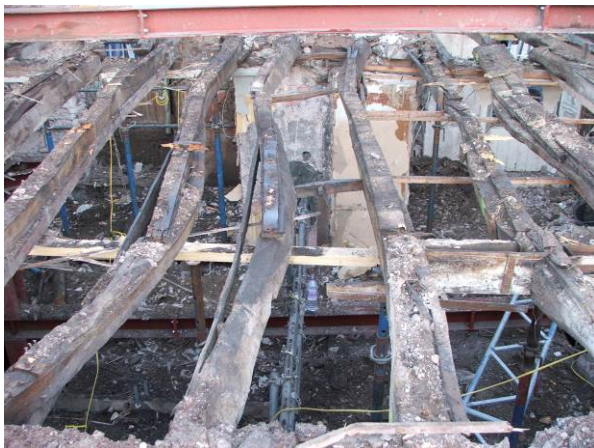
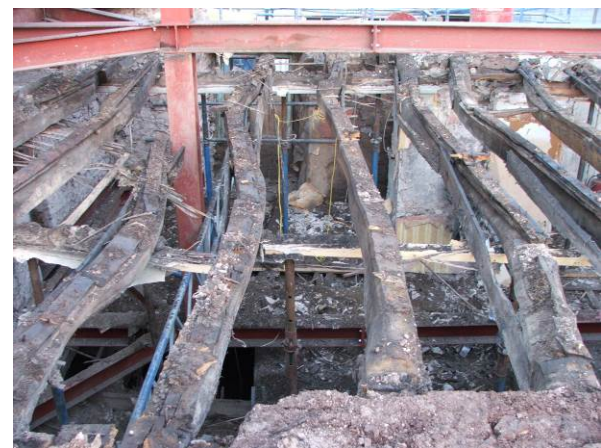
The second floor floor structure was of similar general arrangement as that on the floor below, consisting of a panel of longer common joists to the rear and a panel of shorter to the front, these all set at approximately 0.60m centres. The rear panel consisted of thirteen full length common joists, all of oak (009 - 022), with further shorter sections spanning top the chimneybreasts (008, of pine, and 023 - 024, of oak). The frontage panel consisted of two groups of six common joists on either side of a gap over the area of the pend two floors below (group to SW - 025 - 025, of pine, and 027 - 030, of oak; group to NE - 033 - 39, all of oak). The panels are supported by principal joists (031, of squared pine, probably a secondary replacement, and 032 of oak), these extending out from a masonry pier that rises from the arched feature within the pend. These panels of common joists were particularly notable for their sinuous lines, limited working and poor quality - all retained much sapwood and some individual timbers relying upon branched ends to ensure the correct lengths were achieved.

Plates 13-16 Second floor floor structure – note the sinuous and unworked nature of the timbers employed, including branched ends, plates 17-18, below

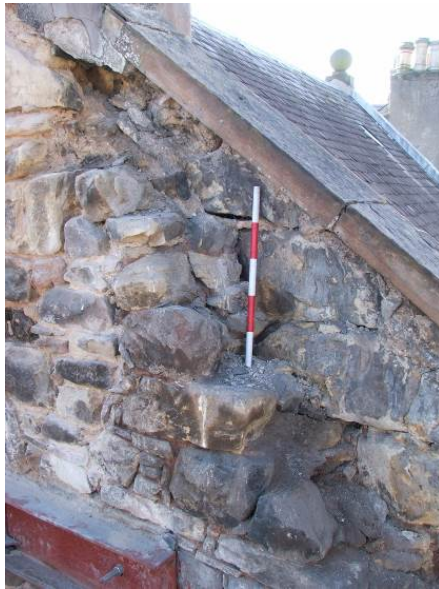
At points the parts of the original gable heads were traceable as diagonal breaks in the masonry construction or even surviving extant - (112) and (101). This was particularly evident to the SW where embedded crow-steps were even visible at points on the street frontage pitch (*plate 19*; also see *plate 6*, above) and visible externally on the rear pitch. The roof had clearly been notably steeply pitched.

Plate 19 (left) Remains of the phase II wall head revealed as an off-set; embedded crow-steps can be seen behind the scale pole.

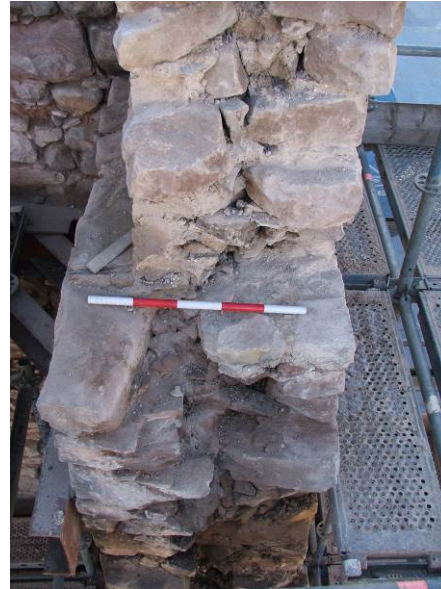
Plate 20 (right) The scale lies upon the wall head of the phase II frontage, as exposed during demolition

The wall heads of the phase II front and rear elevations survived intact, embedded beneath later masonry. The frontage wall head was signified by an off-set seen internally, *plate 20*. The rear wall head, at the same level, was defined as a construction break; of note were a series of early low-fired terracotta bricks seen at the wall top towards the NE end.

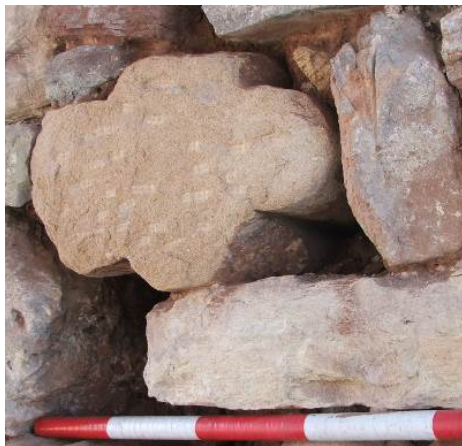
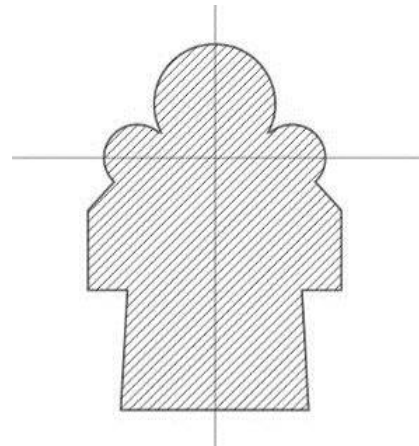
Further carved stones were recorded elsewhere, particularly within the fabric of the front and rear elevations and within the pend walls, see *plate 9*, above. Within the masonry of the street frontage a similarly early moulded window mullion section, also of ecclesiastical character, was recorded (*plate 39, figure 7*). Also of medieval date was a large jamb stone, this displaying early tooling. These earlier stones were all cut from a warm honey-coloured sandstone, generally fine-grained.

Plate 39, Figure 7 – ecclesiastical mullion section

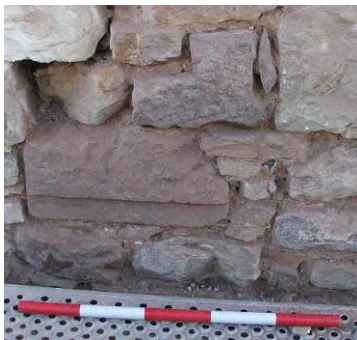
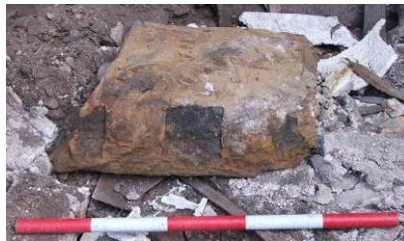
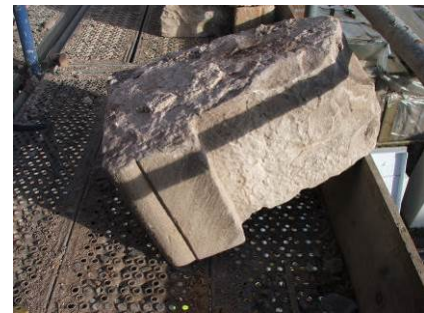
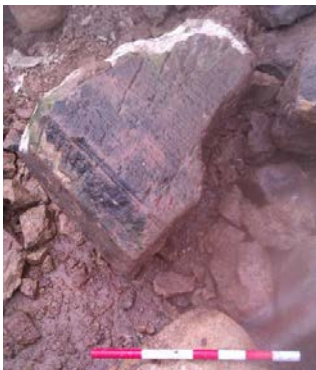
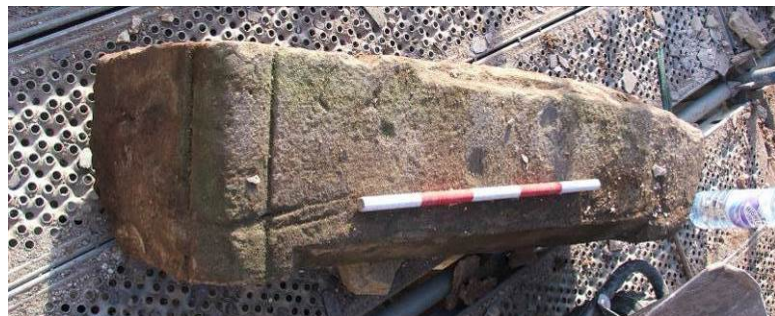
A number of stones were clearly architectural elements but were either not extracted or were too damaged to determine their former function. Also present was a group of stones of later date, likely of the 16th century and perhaps from the predecessor building on the site; these included jamb stones with angle rolls, lintels, etc. The later stones were of varying sandstones – some were of the honey-

Plates 40-44 Recycled stones bearing carved architectural detail revealed in or recovered from the phase II construction

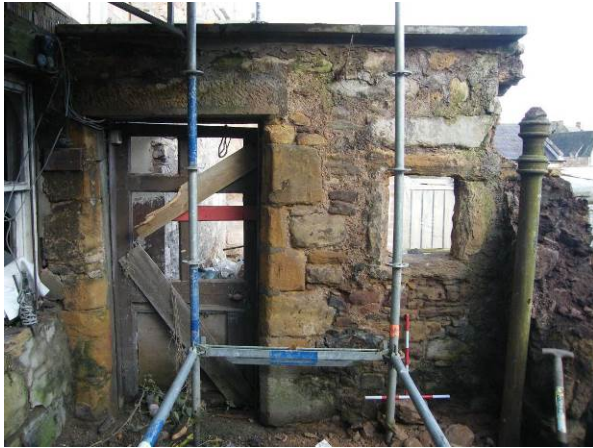
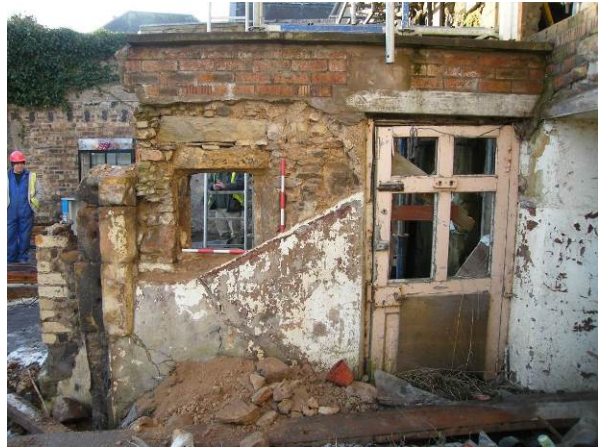
The first section of walling contained a large entrance and, on its NE side, a small window, *plates 45-46*. The dressings of both of these features was detailed with chamfered inner arises (excepting the entrance lintel, which was secondary). The abovementioned step-out formed a corner that had been built using large sandstone quoins; the NE end of the walling return preserved the remains of the jamb of an entrance whose dressings were detailed with a chamfer, see *plates 46-47*. Demolition demonstrated that the intervening walling section had abutted this corner and was thus likely to represent secondary infill – a short linking building between the frontage range and the rear range within the close, *plate 47*.

Plate 45 Exterior side of rear wing fragment

Plate 46 Interior side of rear wing fragment

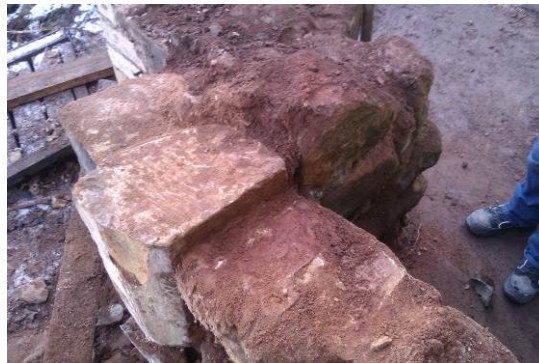
Plate 47 Junction of link (foreground) and main walling rear range

The dating of the rear wing and link building remained uncertain although the general characteristics of their construction suggest them broadly to be of similar date to the frontage range and thus of phase II, of the second half of the 17th century. That they may be nearly coeval is suggested by the absence of a stair to the upper levels within the frontage range at phase II – it seems likely that the link building contained the stair, as it certainly did at a later date (see phase III).

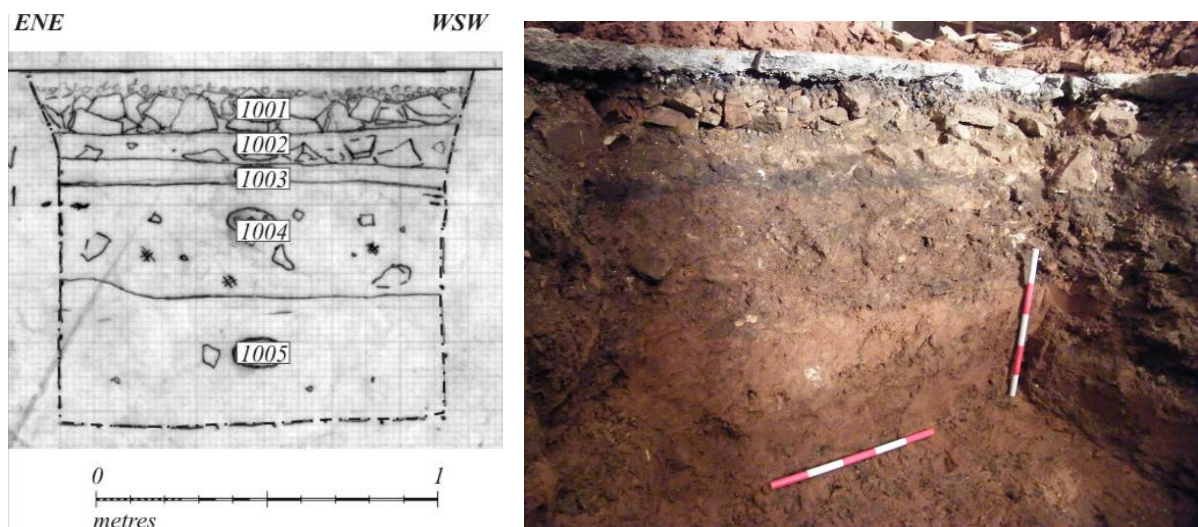
Trench 1 revealed a clear old ground surface (1003) overlain by a modern levelling layer upon which the existing concrete floor sat. The ground surface comprised moderately compact dark brown-black fine grained silt, clearly a much dirtied beaten earth floor.

Below (1003), a deep deposit of very mottled and mixed silty clay (1004) seems to represent an accumulation mixed deposit, possibly a levelling layer. Directly below this, undisturbed natural subsoil (1005) was encountered.

Figure 9 NE facing section of Trench 1 – annotated field drawing
Plate 52 Oblique view of the NE facing section of Trench 1 (Photograph 328)

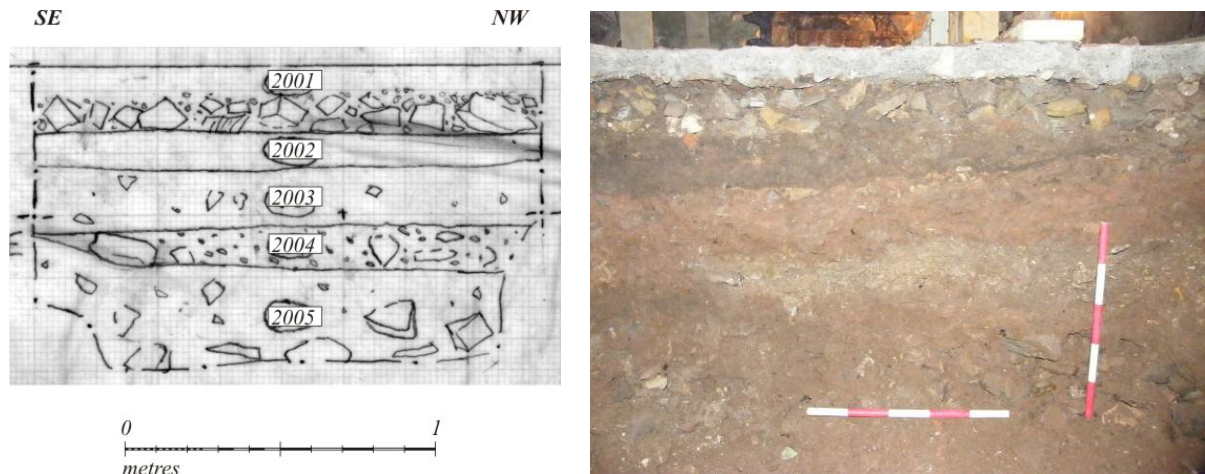
Figure 10 NE facing section of Trench 2 – annotated field drawing

An old ground surface (2002) was located, presumably the same as (1003), but unlike in Trench 1, undisturbed natural subsoil was not encountered. This may indicate deeper archaeological deposits in this area, or a conscious levelling out of the existing natural topography at some point in the past. Below (2002) a series of clear levelling deposits were recorded, the first of which (2003) was clearly a very clean band of natural material re-deposited from elsewhere.

Plate 53 NE facing section of Trench 2. The quality of the image is obscured by the volume of stoor created in the building by the demolition team (Photograph 332)

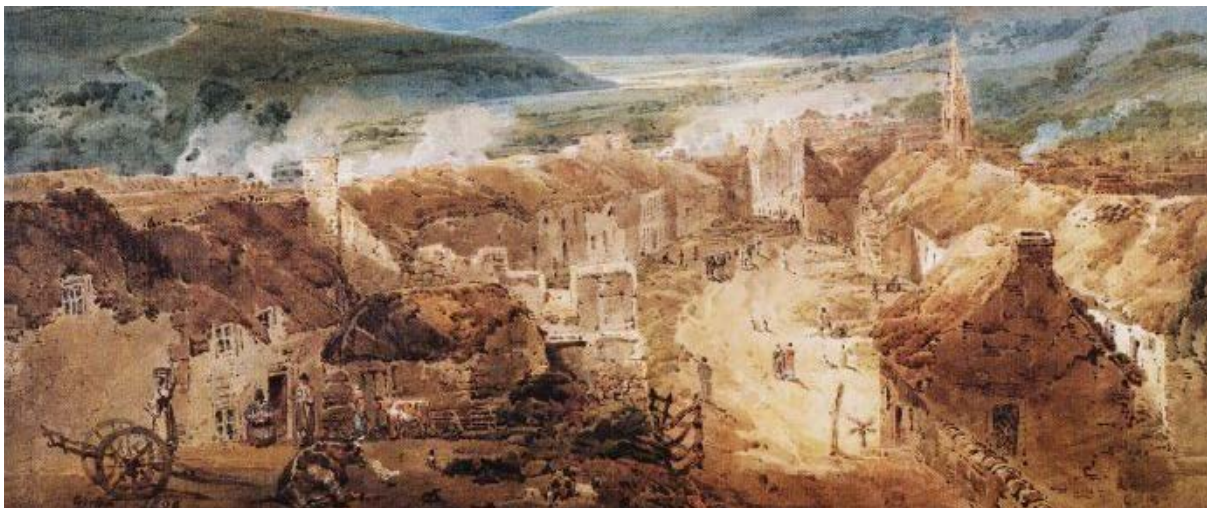
*Figure 10 'The Village of Jedburgh, Roxburgh', by Thomas Girtin, post-1796
(National Galleries of Scotland - D 5175)*

While the survival of roof members was unexpected, more remarkable was the preservation both of batons for affixing thatch and residues of the thatch itself, of cereal straw. This evidence accords well with historical sources, which suggest that the roof-scape of Jedburgh was predominantly thatched as recently as c1800, see *figure 11*.

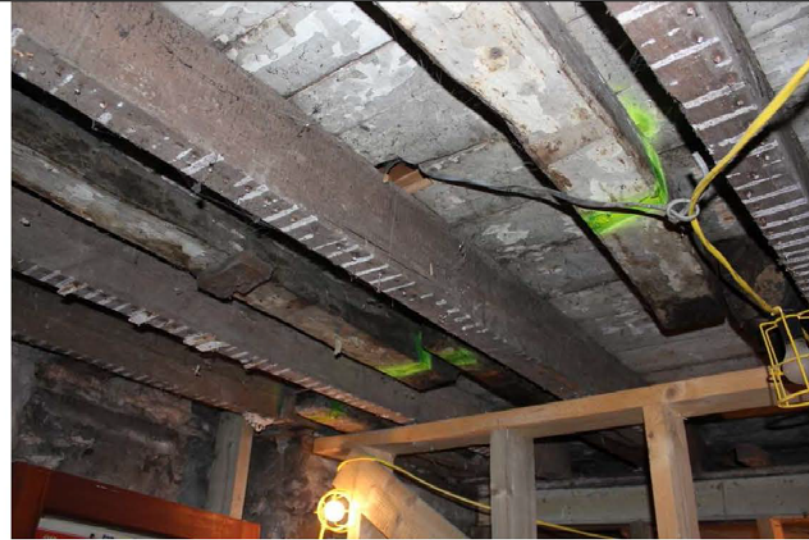
3 Hewn, roughly square conifer joists in ground floor ceiling (in between more regular rectangular joists assumed inserted later) running from the main block forward into the front extension at the NE side of the central pend. Photo: C Mills

The hewn conifer (probably pine) joists in the ground floor ceiling (exposed in the NE side) are roughly 15 x 12 cm in cross-section, and assumed to be earlier than the deeper, regular rectangular (18 x 7.5 cm cross section) milled pine joists inserted much more evenly spaced between them. The hewn timbers have overlapping (but not usually jointed), often slanted ends, which seems unusual, and some have paint finishes suggesting they were once exposed. I counted 40-60 rings on a couple of them towards the pend wall - which is marginal for dating - and so we need to maximise the sample numbers. I have marked up the 11 exposed examples for sampling, but a lot more would be advisable once the rest of this ceiling is exposed - assuming some may survive on the other (NW) side of the pend. That area was not yet revealed at my visit.

I have marked up the revealed 6 oak joists for sub-sampling, and would seek at least an equivalent number from the other half of the ceiling (yet to be revealed) to make for a decent assemblage size to select from; some may have to be excluded if too few rings. It would be best to sample all of the oak joists at this floor level. The sequence lengths may mean we have to reject some for analysis.

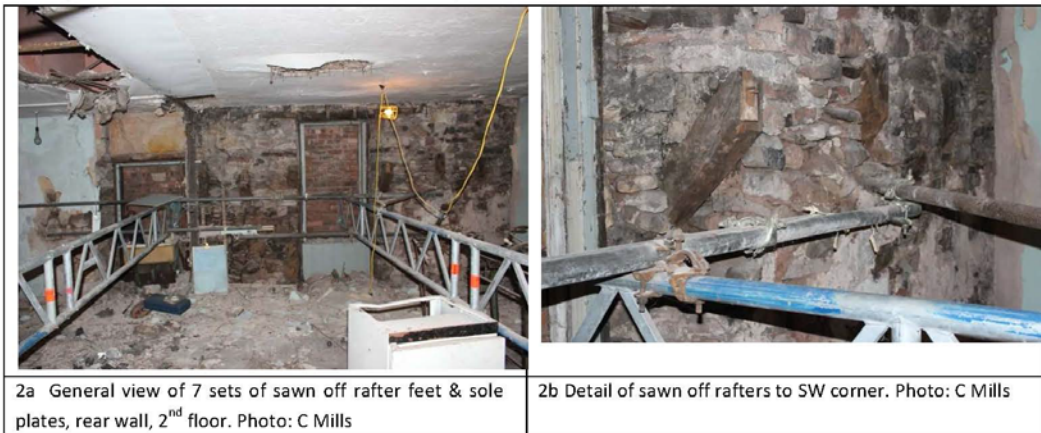
2a General view of 7 sets of sawn off rafter feet & sole plates, rear wall, 2nd floor. Photo: C Mills

2b Detail of sawn off rafters to SW corner. Photo: C Mills

While there is a redundant mortise in one and a peg in another, this doesn't necessarily mean every element is re-used. They are quite variable in cross-section form (Photo 2b), and the survival of more fragile sapwood / bark edge on some might indicate that some are not re-used. So it is possible that we will obtain a date for this roof construction as well as for any earlier structures from which some timber was recycled.

Twigs and small branches resting on the upper outer surface of the rafters in places may be the remnant of thatch and could be subject to species ID and characterization to inform us on the nature of that thatch. That would be doubly interesting if a dendro-date for the structure was obtained.

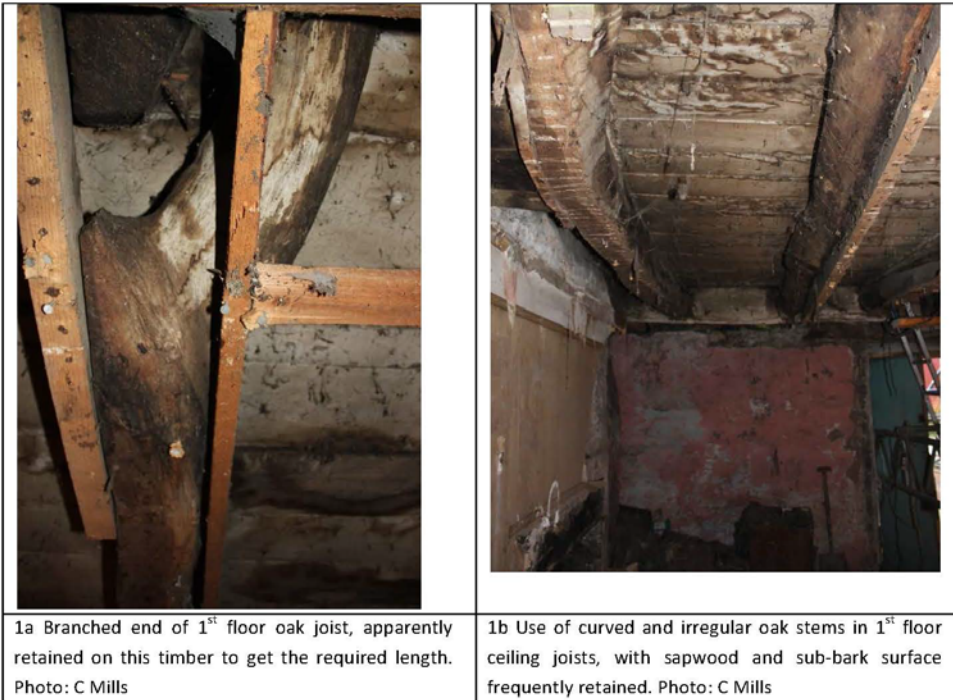
Group 1: Irregular hewn oak joists in 1st floor ceiling

This is a very exciting group of timbers. This is probably a very rare survival of a late-medieval or early post-medieval *native* oak structure. This very irregular set of hewn oak joists has characteristics suggestive of being the poor quality end, or last gasp, of a local timber supply. In general, native oak is dwindling across Scotland from the 15th C, and there are very few dated native oak structures after 1450 (Mills & Crone 2012). This could well be one of them. The dimensions are highly variable, as is the type of conversion. Some are roughly halved timbers, but they are so wiggly I think they were cut by hand and eye to extract the maximum length, with little regard to form. Hence a branch has been left on the end of one to maximize length (see photo 1a above). The largest scantling is 27cm x 15 cm, smallest about 15 x 15cm – so all quite chunky - but they are highly variable. There is no sign of re-use on the timbers so far revealed (in the NW half of the 1st floor ceiling) and most of them have the sub-bark surface intact which is very promising in terms of obtaining a precise felling date, assuming they have sufficient rings for dating. We will have to await their removal and sub-sampling to check that for the group as a whole, but one sample already provided by Tom Addyman has 74 rings, and if the others are similar than there is good potential for dating the group. As well as the dendro-work proposed, the forms of these timbers would be worth recording in more detail as they will be informative regarding the nature of the source woodland and its management.

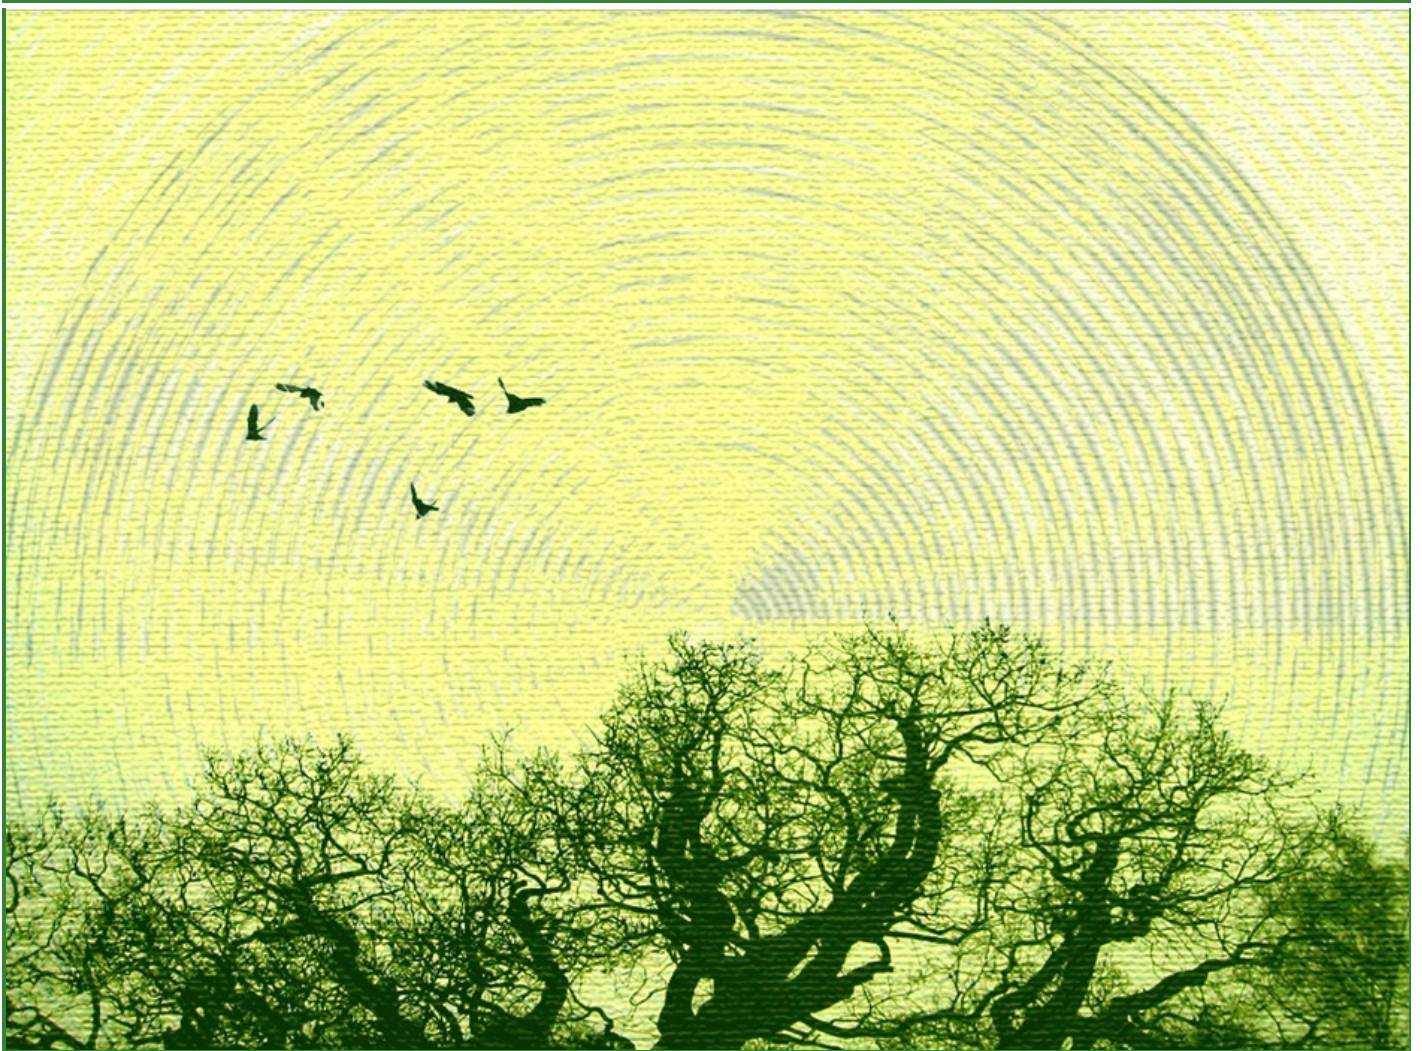
Plate 1 Group A Joists of crooked and branched oak revealed in 1st floor ceiling; potentially a very rare native oak structure of late medieval or early post-medieval date. Relicts of Jed Forest perhaps?

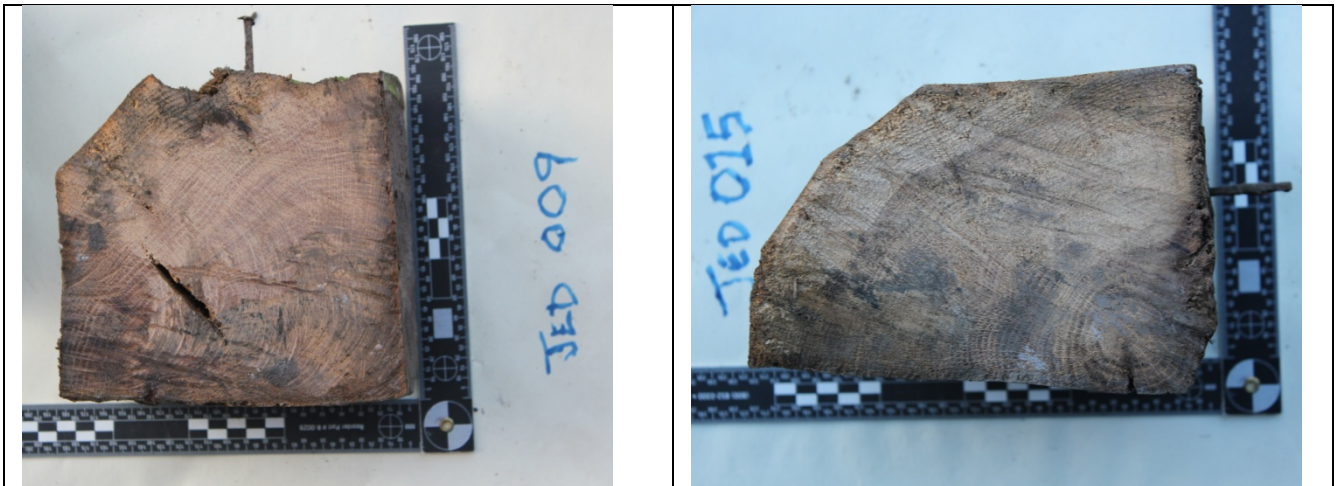
Plate 2 Group A Typical cross-sections of oak joists from the first floor, with either complete sub-bark surface, or a lightly adzed edge close to sub-bark surface. They have the potential to give very precise felling date information.

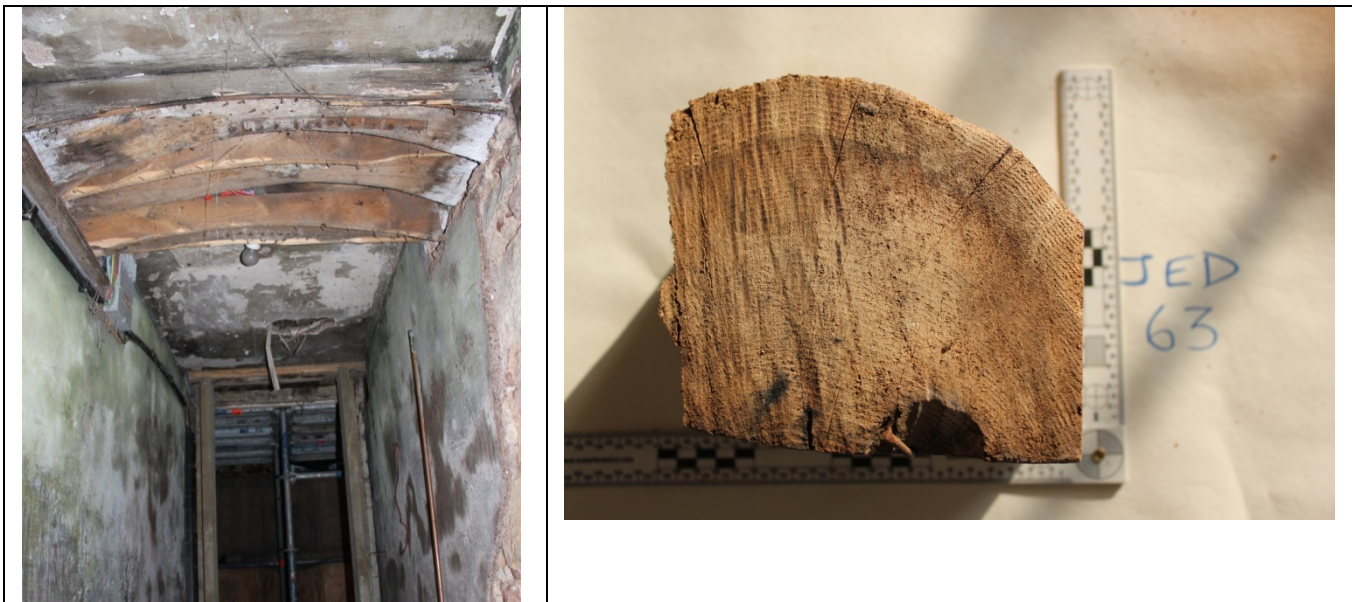
Plate 3 Some of Group B timbers: (L) The curved oak elements forming an arched ceiling to the central pend on the ground floor; (R) sample of F63 the principal oak joist in the ground floor ceiling, on the old frontage line in the NW part of the building

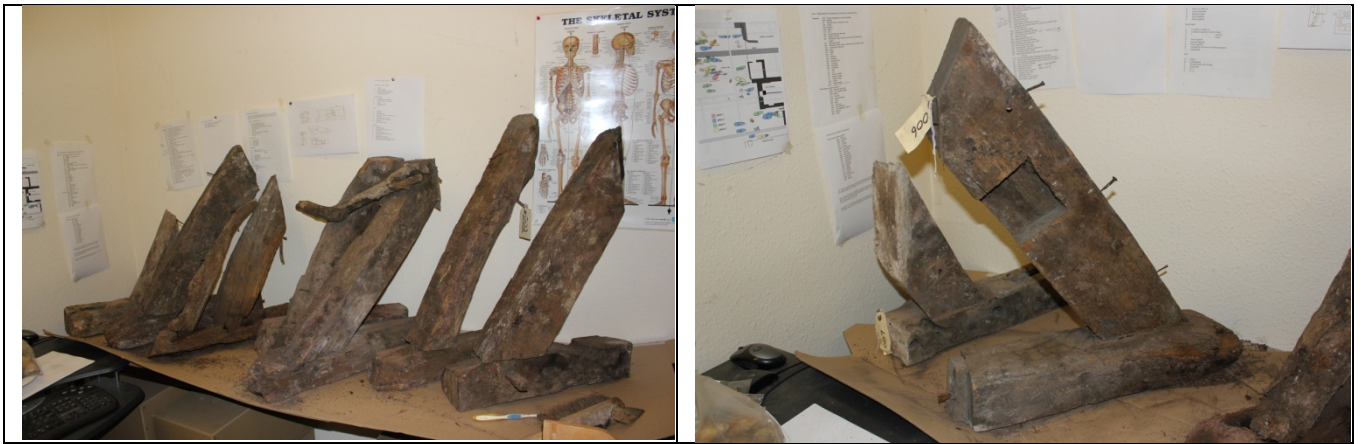
The other key issue to consider is re-use. There is little obvious evidence of re-use amongst Groups A and B, the structural oaks in the 1st floor and ground floor ceiling structures, but there is definite evidence of re-use on some (but not all) of the rafter feet assembly elements (Group C) which may be a mixture of re-used and original elements; dendro-analysis should be able to tease this out.

Plate 4 Group C (L) The oak rafter feet assemblies from an earlier roof, some elements with clearly redundant features, like (R) this slot on Rafter 006 which may be a sawn-through mortise slot or a former cross-lap joint. However some of the elements have no sign at all of re-use and there may be a mix of re-used and original timber, which should become evident in the tree-ring results.

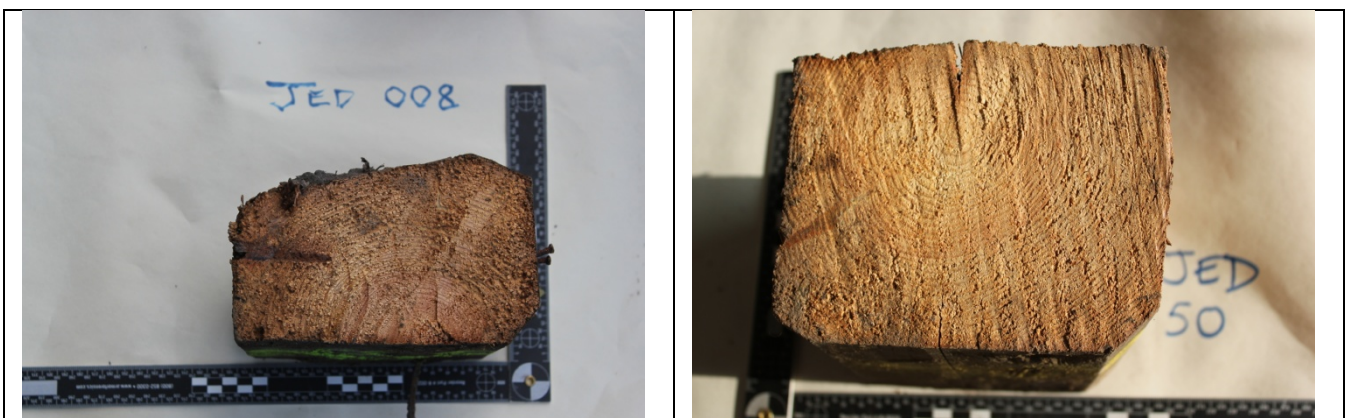
The smaller assemblage of pine timber (Group D) comes mostly from the ground floor, but with a few samples from the first floor, and includes some clearly re-used elements (eg F08, in the rear SE corner of the first floor ceiling, with regular drilled holes through it), but also many young timbers with no obvious evidence of re-use (such as the main ground floor common joists, F40-F52, which have between 35 and 60 rings). Of the already extracted 20 pine samples, there are only eight timbers with more than 50 rings (1st floor F25 & F26, ground floor F40, F42, F45, F49, F50, F151), the longest of which has an estimated 70 rings (F26); getting results with short sequences is analytically more difficult for pine than it is for oak, and the potential for replication is quite limited, so this is far from guaranteed to work. There are a few huge rectangular sectioned long-lived pine beams in the shop frontage wall, with high ring-counts, but these are probably much later, looking very like 19th Century imports, and at time of writing not yet extracted from the building, as they are within the front wall buttresses retained while stabilization work is carried out. Thus, overall, the pine is a rather diverse set of material, with mostly very young timber in the more useful contexts, and which is more marginal in terms of dating potential than the main groups of oak (A, B and C).

Plate 5 Group D Pine timbers (L) F008 from the first floor ceiling, a short re-used element

(R) F50, pine timber with an estimated 52 rings, a typical example of the young pine used for the common joists in the main block at ground floor ceiling level

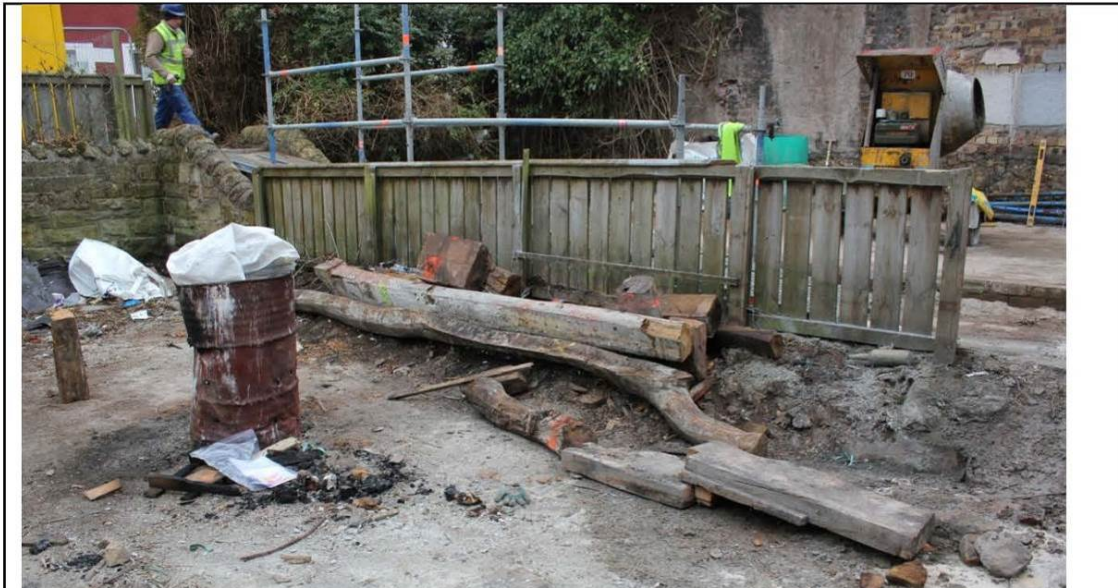
The timbers found retained in yard on 10th April; some of these have been previously sampled or were previously retained for the museum services to consider taking. All useful dendro samples have now been extracted. Photo by Coralie Mills

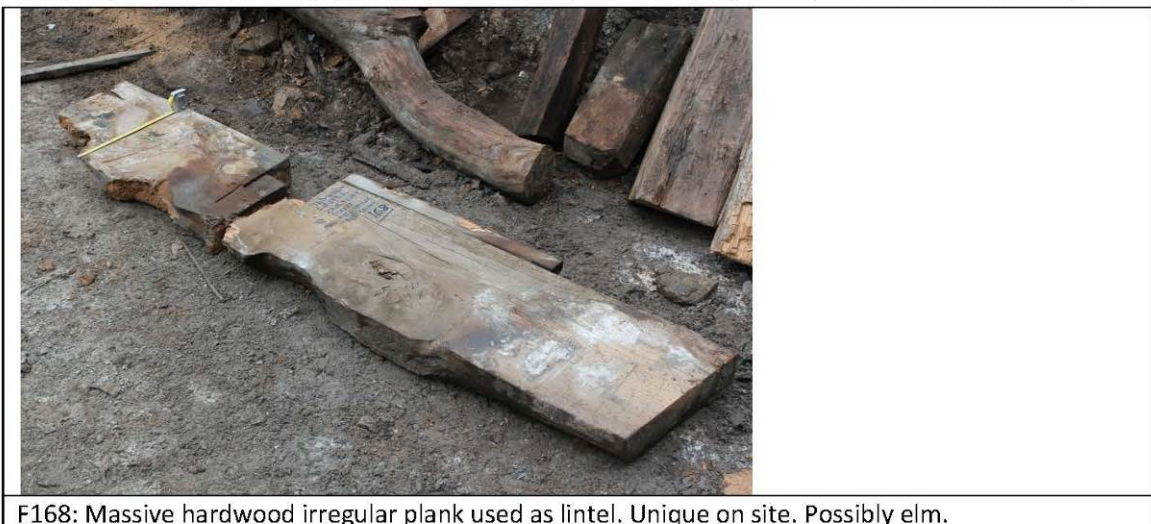
F168: NEW FEATURE not previously assessed. Unlike anything else on site. A large thick irregular hardwood plank which contractors say was a window lintel on 2nd floor street frontage in NE area. CM took a section from one end, as too large to bring it all. It had already been chain-sawn into 2 big sections by the contractors. It has a wavy edge on one long side, the sub-bark surface, and a straight edge on the other long side. It has irregular growth & many branch scars, so not good quality timber. Dimensions roughly 34 cm wide by 9 cm deep by c. min 1.85m length (combined length of the 2 surviving parts which do not join neatly). One face has clear irregular near vertical saw marks roughly 2mm apart, possibly hand sawn. It has a firm pencil line along the long axis a few cm inside the irregular edge. I suspect this was drawn on in 'antiquity' when the timber originally being prepared - a guide for removal and squaring of the waney edge – but it never was removed, presumably because the irregular face was going to be hidden and the law of least effort prevailed! The species is interesting – neither oak nor pine; I need to clean up the section to check species and ring count, but I think it is probably elm.

F168: Massive hardwood irregular plank used as lintel. Unique on site. Possibly elm.
