The Temple, Dumfries House Estate by Auchinleck, East Ayrshire

Historic Building Survey and Analytical Assessment

for The Great Steward of Scotland's Dumfries House Trust

March 2014

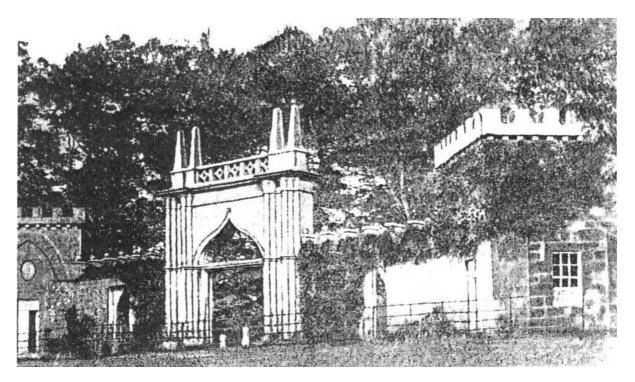
Plate 1 Early photographic view of the Temple from the SE (MSA)

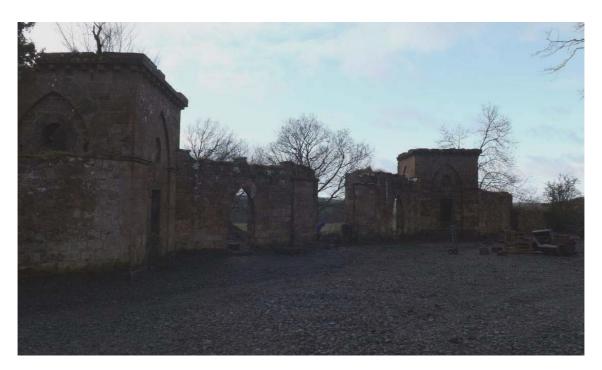
Plate 2 General view of The Temple looking SW showing the new hard-standing area (Photograph 210)

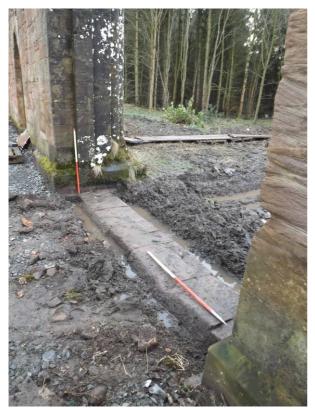
In 2014 the threshold area of the arched entrance was mechanically excavated and the threshold itself cleaned off by hand (*Plate 6* and *Plate 7*). The threshold was revealed to have been formed of seven substantial neatly dressed, tight-jointed ashlar blocks. The outer two were integral to the pier bases on either side. Each of these latter preserved the remnants of an iron gate pintle, set within lead, indicating paired gates and further confirmed by the presence of a bolt socket on the centre-line of the threshold.

Plate 6 Looking SE across the newly revealed threshold stone (2014 - Photograph 271)

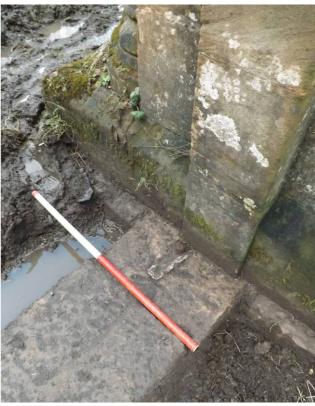
Plate 7 The westernmost lead-fast iron pintle of the gateway (2014 - Photograph 274)

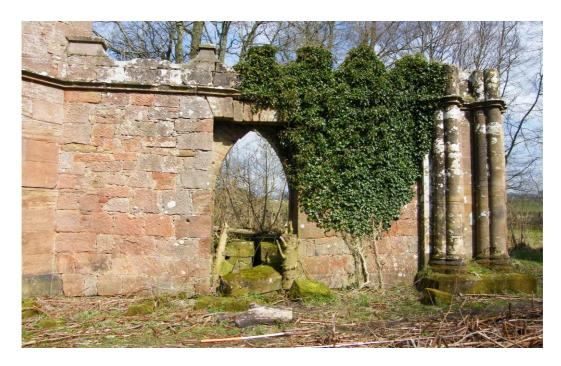
Plate 9 – Western flanking wall, (2008 – Photograph 076)

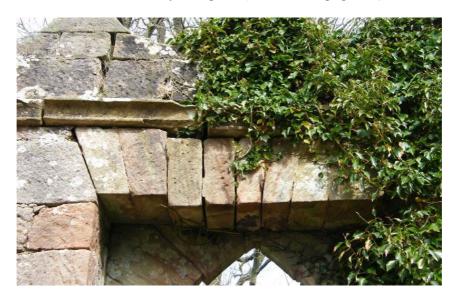
Plate 10 Detail of dropping flat arch on eastern flanking wall , (2008 – Photograph 080)

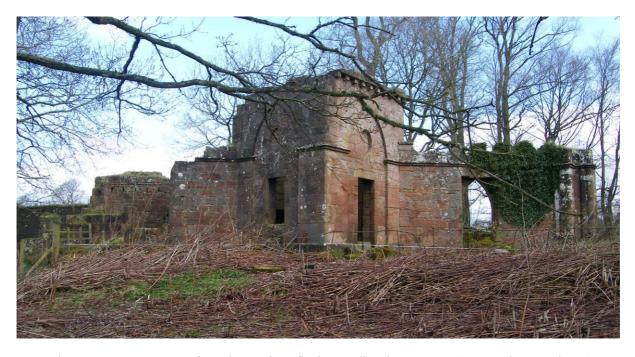
Plate 12 Western section of temple: pavilion, flanking wall and west wing, (2008 - Photograph 013)

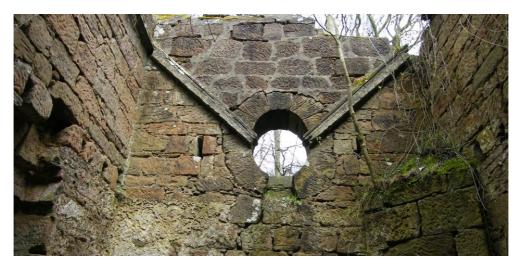
Plate 14 Eastern pavilion interior, evidence for roof structure, (2008 – Photograph 134)

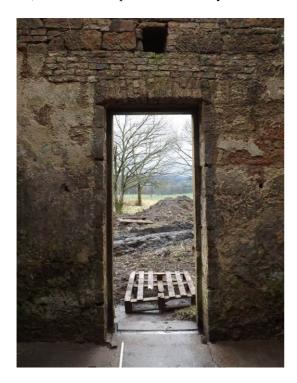
Plate 18 NE facing internal elevation of East pavilion (2014 – Photograph 429)

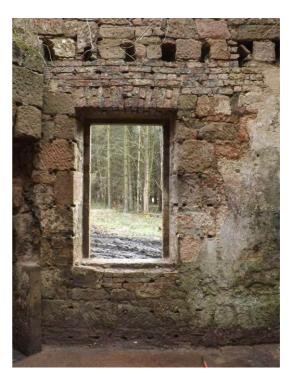
Plate 19 NW facing internal elevation of East pavilion (2014 – Photograph 430)

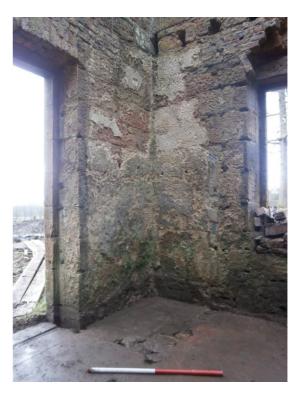
Plate 21 The W corner of the East pavilion (2014 – Photograph 326)

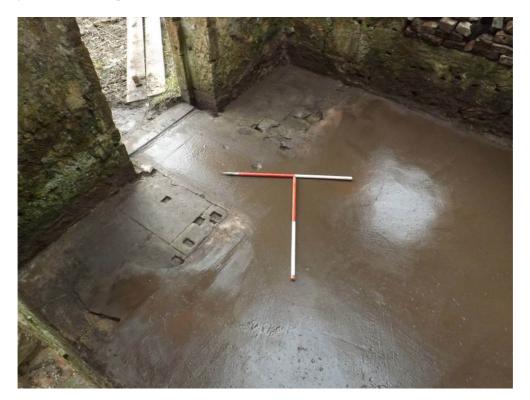
When the floor of the pavilion was revealed it was shown to comprise a red concreted surface. This may have been installed during the military occupation of the site in the 1940s (*Plate 22*). Only in the southern and western corners did any details survive to provide any indication as to the nature of the pre-existing surface. As discussed above, the assessment of the documentary evidence and the walls

Plate 22 Post-excavation view of the East Pavilion looking W (2014 - Photograph 404)

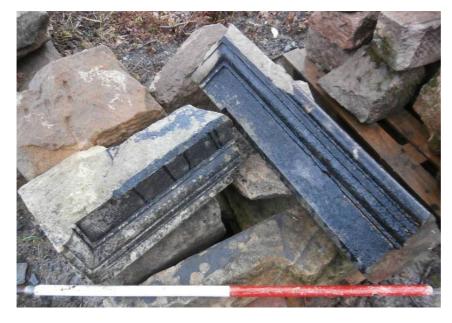
Entering by the principal entrance to the SE one faced a centrally positioned fireplace opposite to the NW. Although this is damaged and the lintel has fallen, the inner jambs of this fireplace still remain *in situ*. In 2008 *ex situ* fragments that appear to relate to it were noted close by - a handsomely moulded and delicately detailed surround, including a rounded bolection, a fillet, a quarter *ovolo*, and a further fillet within. These were removed to storage prior to the archaeological involvement in 2014 and recorded there, *plate 23* and *figure 3*. The flue of the fireplace runs up diagonally within the wall to appear at the wall head at the W corner of the structure. Unfortunately the wall head at this point is broken down and no chimney detail survived.

Plate 25 Ex situ fireplace lintel from the West pavilion (2014 – Photograph 518)

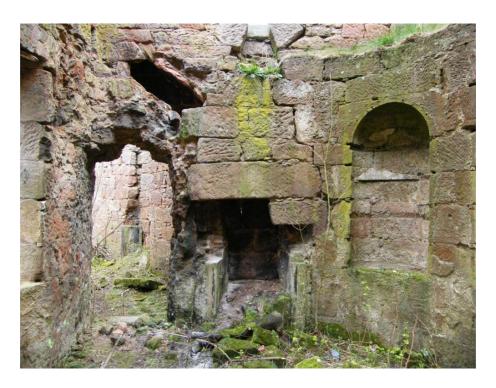
Occupying the cardinal points of the pavilion the thickness of the wall contains semi-circular niches with semi-circular arched heads. Inside these there are plaster residues. This is most evident in the northernmost niche/alcove, where there is clear evidence for plaster respecting shelving (*Plate 26*). There had almost certainly had been a niche to the W, with this being clawed away where a new entrance was broken through to the wing beyond (*Plate 26*). The window openings and the niches all retain dooks indicating architraved surrounds. Although it is probable there was originally a cornice within the circular chamber no direct evidence for this remains *in situ*.

Plate 26 Western pavilion interior, looking NW showing the, fireplace, secondary entrance in to the wing and alcove with shelving evidence, (2008 – Photograph 048)

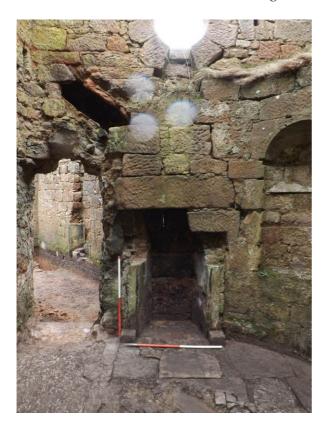
Plate 27 General view of the fireplace following clearance; note the outer hearth stone and adjacent flooring flags (2014 – Photograph 460)

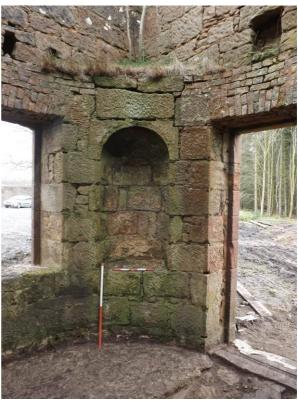
Plate 28 View of the eastern alcove/niche (2014 – Photograph 468)

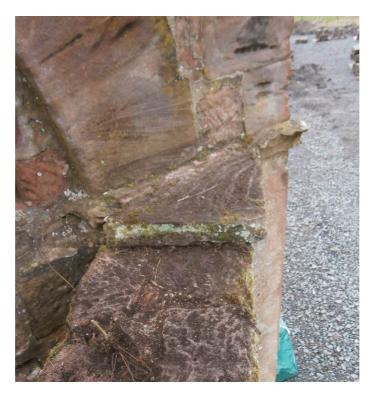
Plate 30 Cope detail on the north wall of the east wing (2014 – Photograph 354)

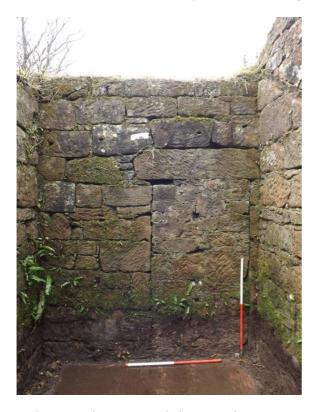
Plate 31 W facing internal elevation of East Wing (2014 – Photograph 414)

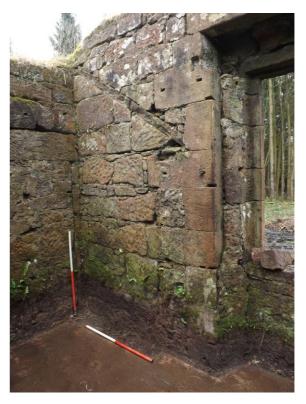
Plate 32 Oblique view of N facing internal elevation of East Wing, E end (2014 – Photograph 416)

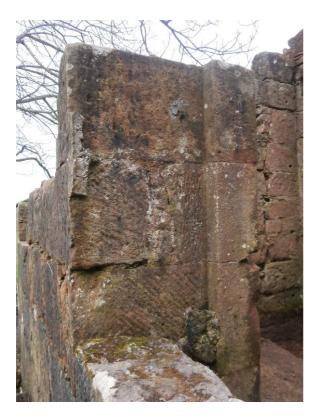
There is a principal entrance in the centre of the south side and a further entrance within the west wall, the details exactly mirroring those in the east wing. The secondary infill within the entrance to the south has partly fallen away to reveal the rebate of the original opening; here there are lead-fast wrought iron fixings for a timber frame.

Plate 33 Details of the jambs of the early entrance into the west wing looking NW (2014 - photographs 499)

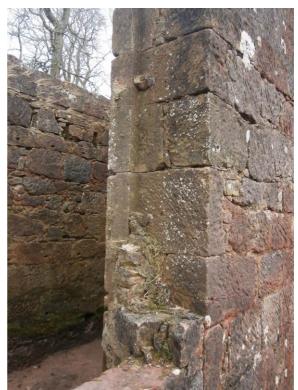
Plate 34 Details of the jambs of the early entrance into the west wing looking NE (2014 - photographs 500)

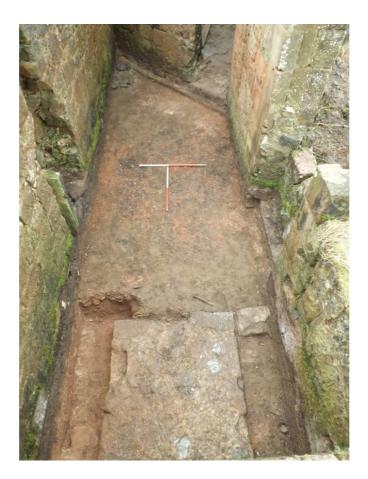
Unfortunately, no direct evidence remained to indicate the nature of the flooring in the West Wing. From the Western Pavilion, the ground dropped significantly and during the removal of the overburden, it very quickly became clear that only a sandy bedding material survived. This comprised a mixed and mottled orange brown, mid brown and dark brown sand upon which at one point the floor surface would have sat (*Plate 35*).

Plate 35 Post-excavation view of the West Wing looking E (2014 – Photograph 391)

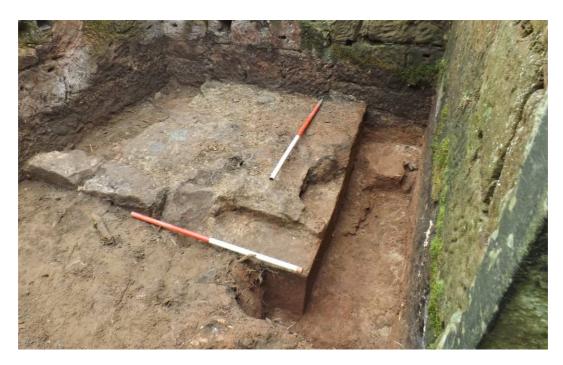
At the west end of the west wing, a large masonry footing or foundation was uncovered. The function of this is unclear. The band of bedding sand between the masonry and the N wall was excavated to expose the natural subsoil, revealing the base of the feature to contain a finely carved sandstone block, with fine tooling and still sharp edges. Why such a finely dressed stone was used in a foundation is unclear. The mortar bonding atop the feature seemed to lip up against the E facing elevation to the W, indicating it to be secondary.

Plate 36 General view of masonry footing (2014 – Photograph 393)

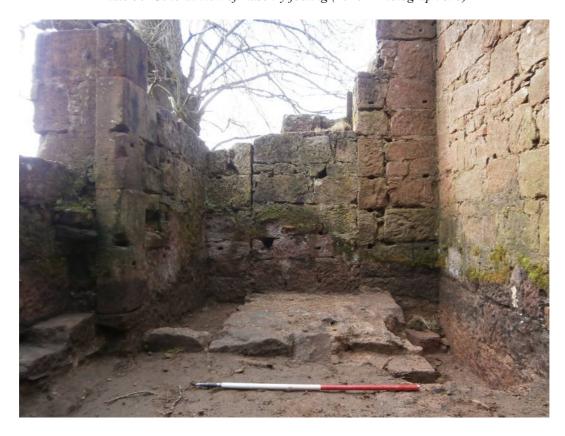
Plate 37 General view of the W end of the West Wing (2014 – Photograph 533)

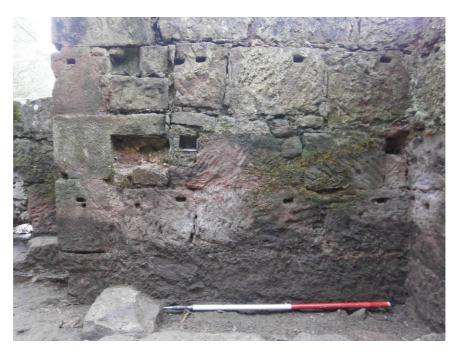
Plate 38 Detail of the N facing internal elevation of the East Wing, eastern end (2014 – Photograph 386)

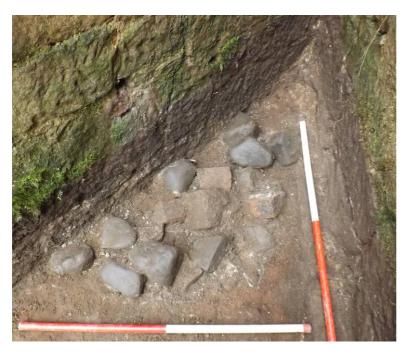
That early floor surface may have been cobbling was indicated by a small spread of medium rounded stones in the NE corner of the room, in the acute angle formed by the junction of the west wing and the west pavilion. Although much disturbed, here a small number of cobbles seemed to sit in an organised manner directly atop the bedding sand. In addition, a number of loose cobbled stones were recovered from this area. No other such cobbles were recorded during the clearance of the remaining structure.

Plate 39 Pre-excavation view of cobbles in NE corner of West Wing (2014 – Photograph 395)

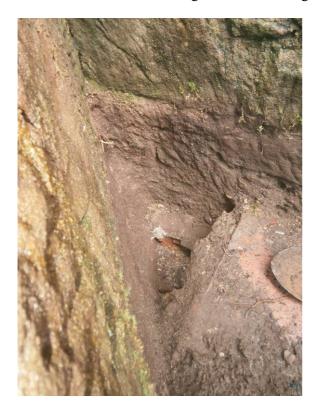
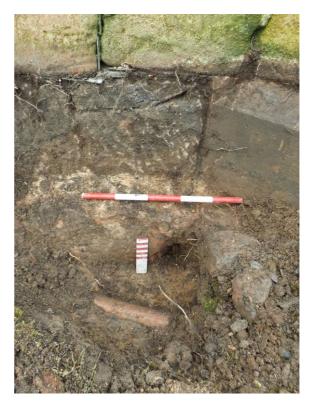
In the East Wing, ground clearance in this area revealed a hole in the concrete, and while this may have housed a drainage pipe, no indications for this were found. External excavations (*Plate 42*) revealed a possible hole through the wall (it was not clear if this went the whole way through), but this did not seem substantial enough to hold a drainage network.

Plate 41 Mid-excavation view of NW corner in East Wing (2014 – Photograph 305)

Plate 42 Post-excavation view of external excavation of NW corner in East Wing (2014 – Photograph 485)

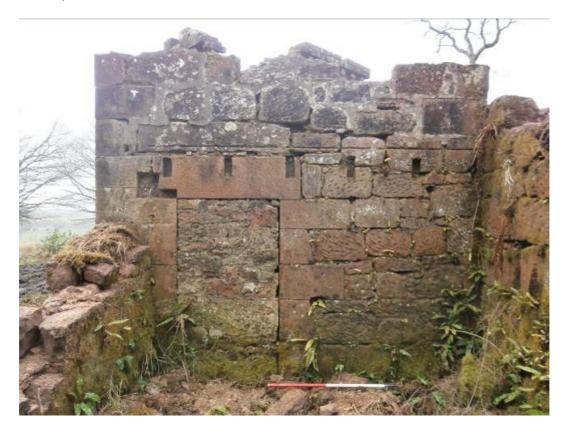
Abutting the exterior of the east wing at its E end is a lean-to structure of which only the S wall remains standing. From the raggle in the end wall of the wing it's clear that this had had a single pitched roof structure sloping gently down to the east, supported by multiple rafters. The structure seems to have been opened on its east side. The roof structure was apparently supported by a single wooden lintel, the socket of which can still be seen to the N.

Plate 43 E facing external elevation of East Wing, showing the secondary lean-to structure (2014 – Photograph 493)

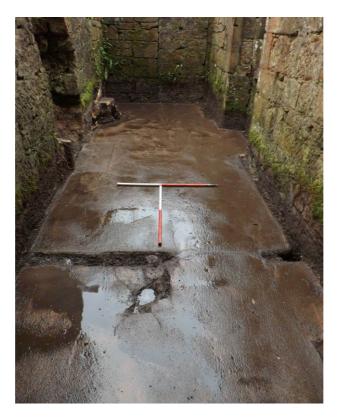
The existing floor across the east wing corresponds to that recorded in the east pavilion, with a red concrete surface extending much of the way across virtually the entire structure.

Plate 44 Post-excavation view looking E along the floor of the East Wing (2014 – Photograph 406)

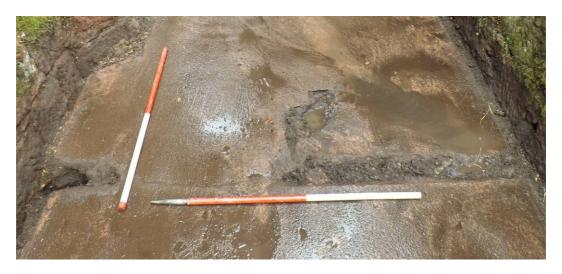
The only features of note in this floor surface were a setting for the pre-existing fireplace midway along the N wall, and the silhouette of a north/south aligned partition wall where no concrete extends; this contained an entrance off-set to the south. The partition may have pre-dated the concrete floor.

Plate~45~Detailed~view~of~the~features~in~the~floor~of~the~East~Wing,~looking~W~(2014-Photograph~409)

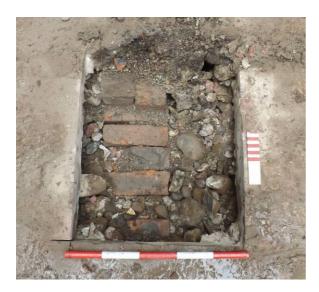
It was anticipated that the concrete surface may overlie an earlier stone floor and a test pit was excavated through this (*Plate 46* and *Plate 47*). The test pit revealed a large W-E running sleeper wall of unfrogged red bricks. This was presumably first built to hold a timber floor, but the area around it had since been packed with a loose collection of small to medium rounded pebbles and gravel to provide the flat surface for the concrete flooring. This flooring was seen to be up to <0.15m deep. Below the pebbles, the undisturbed natural subsoil was visible.

Plate 47 Post-excavation view of trial pit looking W (2014 – Photograph 478)

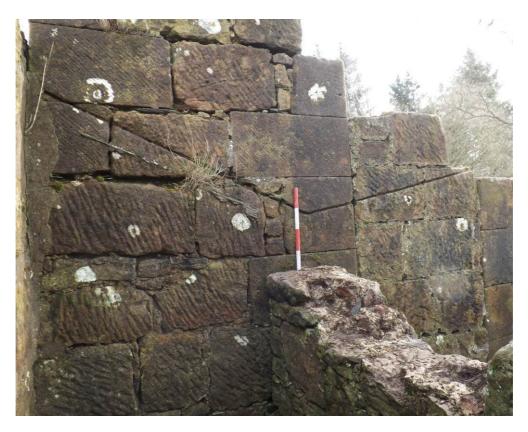
Built up against the W wall of the wing and abutting it externally are the remains of a small lean-to type structure, perhaps a privy or coal house. This may have been built around the same time as the interior was remodelled. Raggles within the end wall of the wing indicate two single pitched roof structures running down to a valley (*Plate 49*). This also indicates the lean-to building and the abutting building had two chambers and there is certainly a cross wall within and two entrances to the W. These structures were built of mortared rubble, sometimes incorporating what are apparently re-used dressed stones.

Plate 49 Detail of the raggle for the lean-to (2014 – Photograph 477)

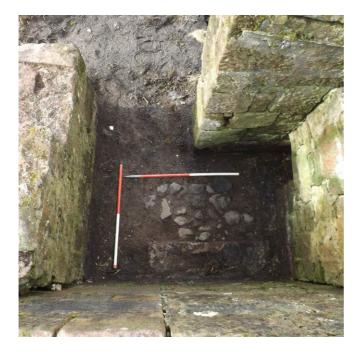
The removal of the rubble collapse and overburden within the secondary lean-to revealed differing floor surfaces. The larger, more southerly of the two contained a large concentration of compact coal ash, beneath which a small collection of sub-angular cobbles indicate the former floor surface (*Plate 50*).

Plate 50 Post-excavation view showing cobbles in the southerly of the two lean-to structures at the western end of The Temple (2014 – Photograph 475)

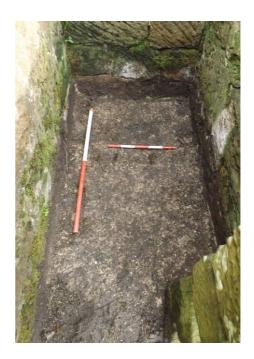
The floor surface in the smaller, more northerly of the two lean-to structures consisted of lime concrete flooring of a similar nature to that in the East pavilion. There is no indication as to the function of this smaller room.

Plate 51 Post-excavation view showing cobbles in the northerly of the two lean-to structures at the western end of The Temple (2014 – Photograph 476)

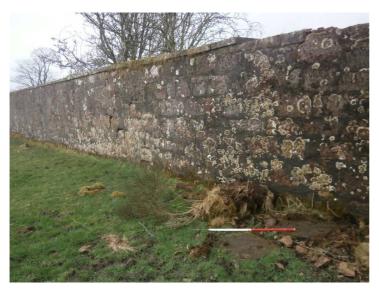
Extending outwards from the east and west wings are sections of tall boundary wall; these rise up to slightly below the height of the wings. The walls had been coped with a simple plain copings. The eastwards-running wall is relatively poorly preserved, only rising up to wall head height in one or two places. The copes are all now fallen and probably many robbed. The western wall however is very well preserved and is complete up to its wall head and the copes are mostly in place all the way to its far termination. The west wall is almost exactly 100m in length. Thereafter the wall is of lime bonded rubble construction but of about half the height and far more coarsely built. The coped section of walling is of roughly squared sandstone rubblework, built to a height of about 2.5metres or 8 feet.

Plate 52 The westwards running boundary wall (2014 – Photograph 501)

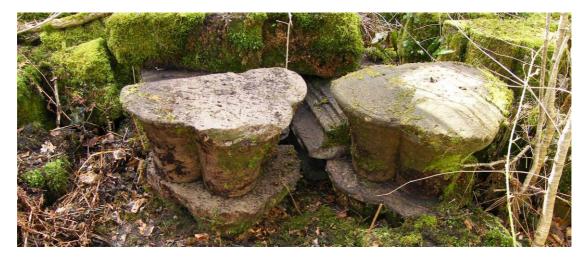
Prior to 2014, the stack of stones remained and in general the stones are in good condition though with much new moss growth. However, there had clearly been some physical damage to them during the

Plate 55 Dismantled arch stones, detail, (2008 – Photograph 093)
