Panmure House

Canongate, City of Edinburgh

Historic Building Survey and Analytical Assessment

for Edinburgh Business School

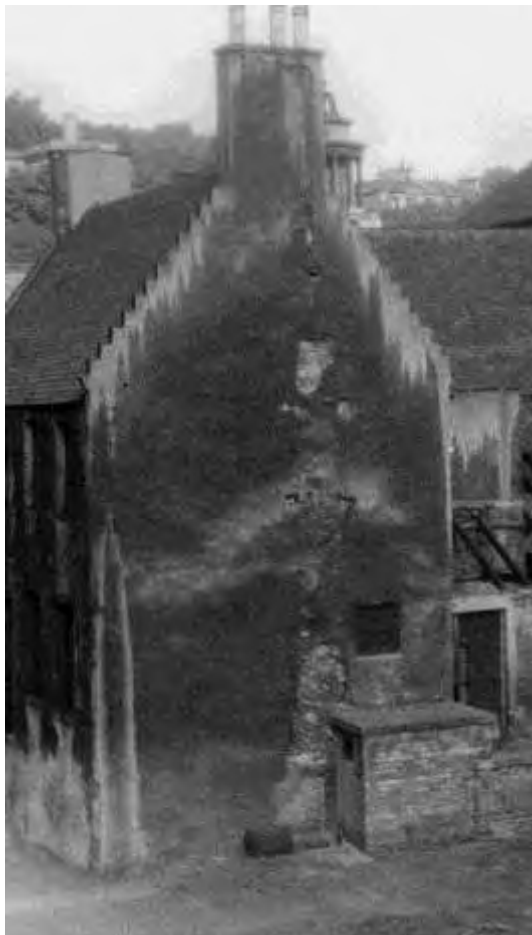
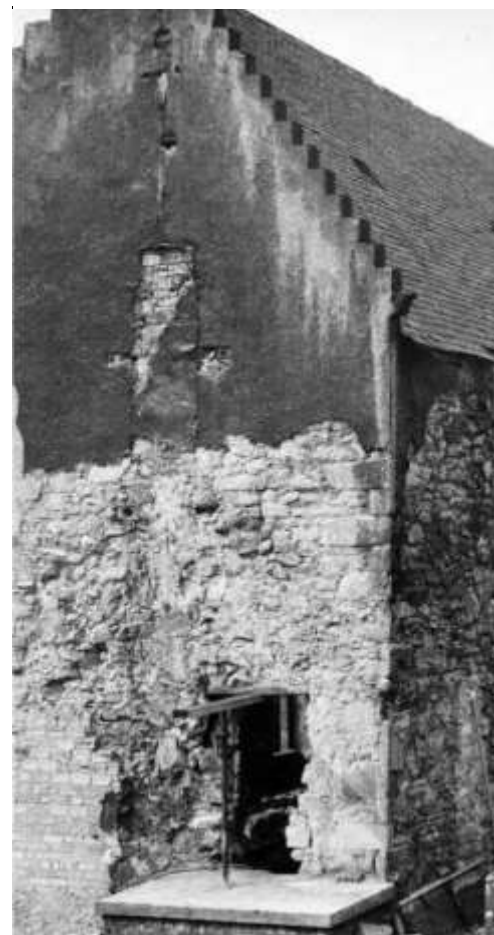
Surviving early and mid-20th century photographic evidence suggests the southern gable wall of the principal range incorporates what appears to be a large area of pre-existing walling of an inferior build compared to the surrounding lime-bonded masonry of the upper and western parts of the wall, *plates 1 and 2*. The latter areas are clearly part of the late 17th century main build of Panmure House. The earlier masonry appears to consist of the internal side of the gable of an earlier building that had extended southwards or, perhaps, a flue-supporting cross-wall within a pre-existing range. The apparent wall head profile indicates a roof-line a full storey lower than that of the existing Panmure House.

Plate 1 View of Panmure House from the SW, c1921 (RCAHMS)

Plate 2, right, during the of works of c.1957, with the re-facing of the lower left wall area in progress

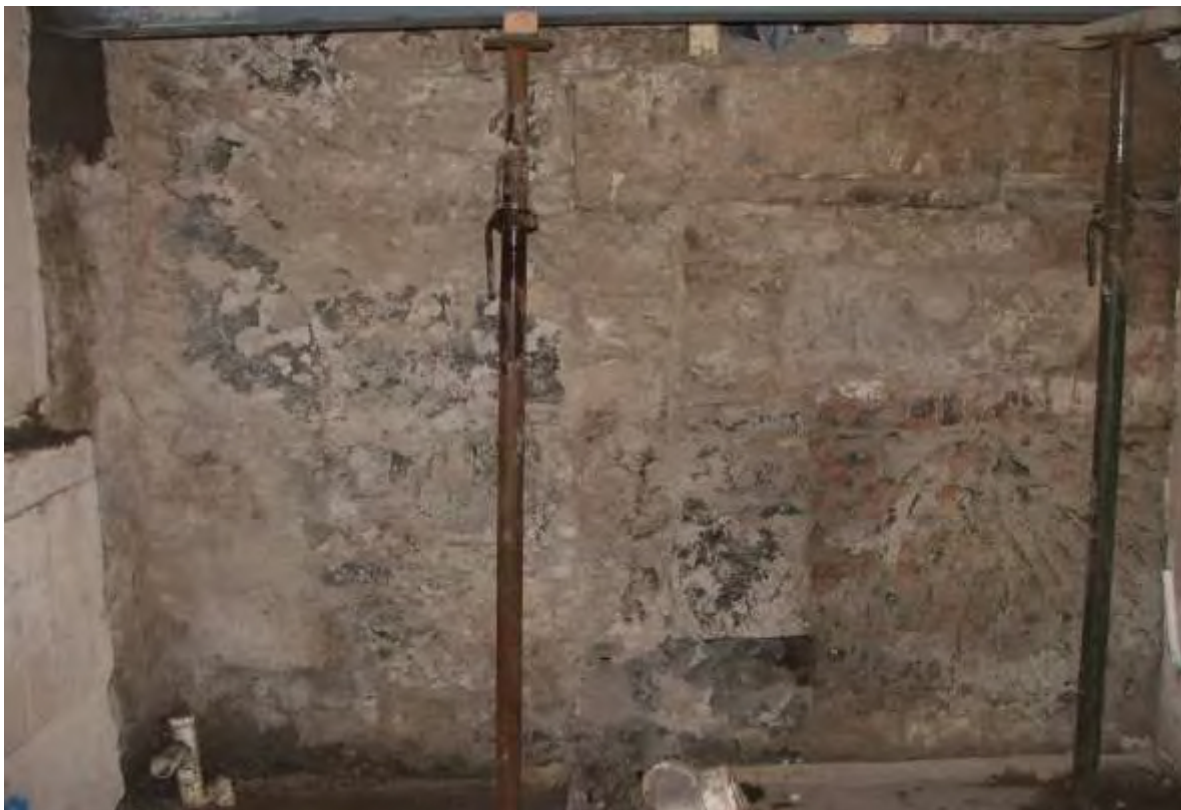
Probably inserted into the former boundary wall within the basement was a 2m wide large fireplace. This sat central to the east range and likely related to the 1690 phase of construction. The jambs were of rough rubble stone and the lintel was a massive reused block of sandstone with a roll mould running down one edge stopped to the right and the roll mould returns to the left.

Plate 3 Inserted fireplace to right

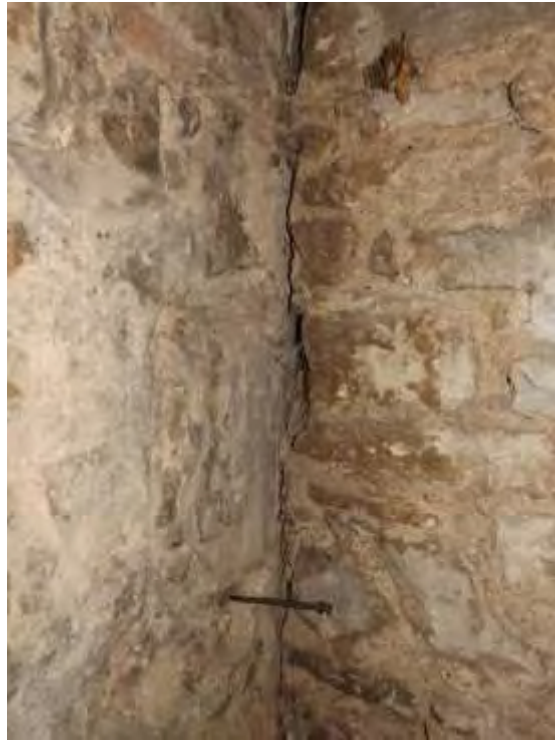
The east wall of room 1 contains a number of openings, mostly entrances. The north and south ones, 232 and 236, were slappings of the 1950s. Elsewhere evidence survived for two pre-existing entrances, both blocked, 167 and 168. These were located in the middle part of the east wall; one had given in to the jamb, and the other evidently to the exterior close to the re-entrant angle of the jamb and the main range. These appear to be original to the masonry of this elevation. On their interior side within room 1 their entrance jambs were formed of rubble and plastered, each opening approximately 1m in width. To their exterior (east side, within rooms 4 and 3 respectively) they are detailed with fine chamfered pale orange-yellow sandstone quoining. The exterior face of these was plastered over with a thin lime washed plaster coat, 173, this surviving trapped behind the masonry of the south wall of the east jamb, 172, which clearly abuts the masonry of the main range at this level.

Plate 5 thin render/plaster, 173, on face of main range (left) trapped behind eastern jamb (right)

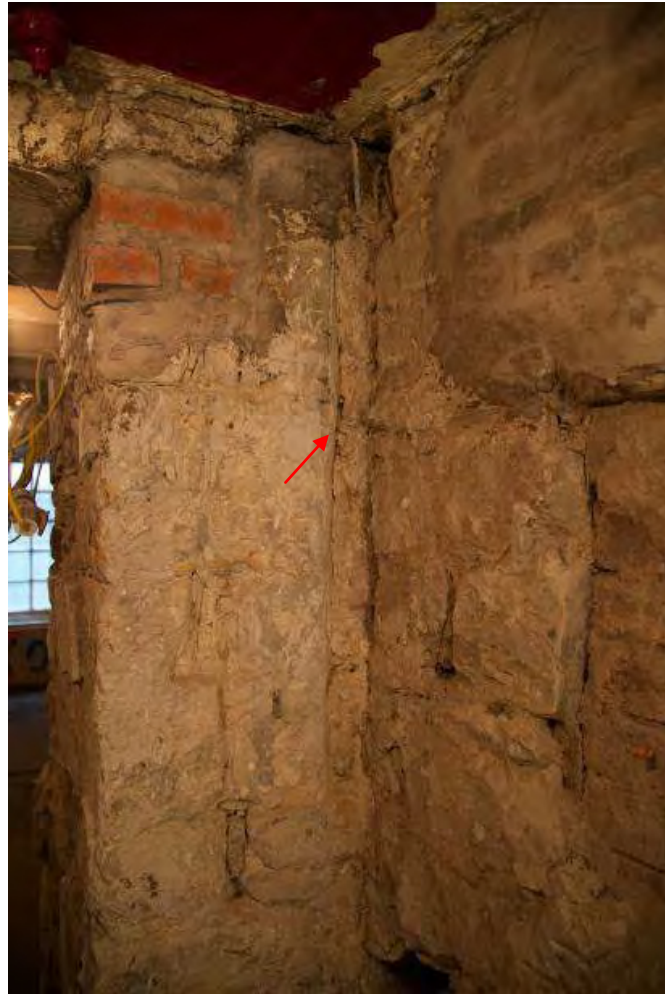
The former exterior side of this wall area is mostly hidden behind a later brick skin belonging to the existing flat-roofed extension of the 1950s that extends to the south. However further west the western jamb of the westernmost opening, 166, was partly visible; the opening itself was blocked up and overlain by the masonry of the abutting east wall of the secondary stair tower, 176. This had a fine chamfered sandstone surround covered with a thin coat of lime render running over the jamb and into the opening. A small patch of brick blocking was exposed on the interior in the area of the

probable centre window, 165, but no edges to the blocking was visible because of the obscuring plaster overlying this area.

Plate 6 detail of the exterior side of window 166 (indicated), looking north

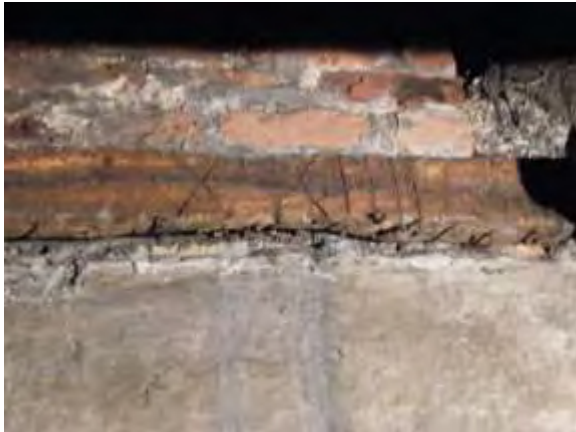
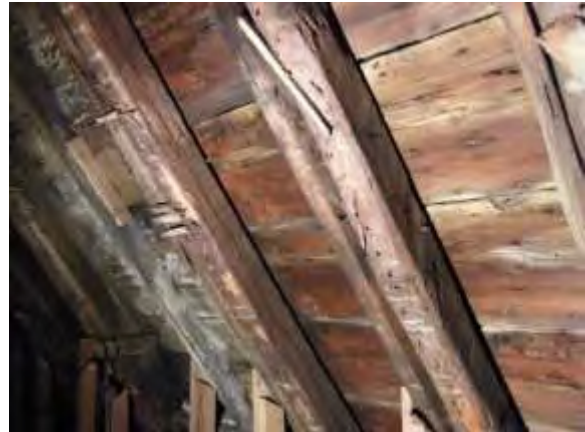
Though there has been some modification and replacement of early structural elements, particularly at the valleys where the early jamb ran in from the east, the principal range roof is essentially well-preserved and *in situ*. This is confirmed by surviving carpenters' laying-out marks which remain in their correct sequence that had evidently run from north to south, their upper (marked) sides facing south. Significantly the most northerly surviving early frame is numbered *XXIII* (24) – *plate 9*; the sequence continues southwards, the most southerly surviving early frame being numbered *XXXVIII* (44), (001- 022). There was room for a further rafter pair to the north, now missing - frame *XXIII* – that would have corresponded to the position of the cross wall (existing N gable). The implication is that there had existed a further 22 frames to the north of the cross wall; this would suggest the missing northern part of the range had been precisely the same length as the existing.

Plate 9 the carpenters' assembly mark on the northernmost surviving frame collar (for frame 'XXIII')

Plate 10 assembly marks on rafters of the principal range

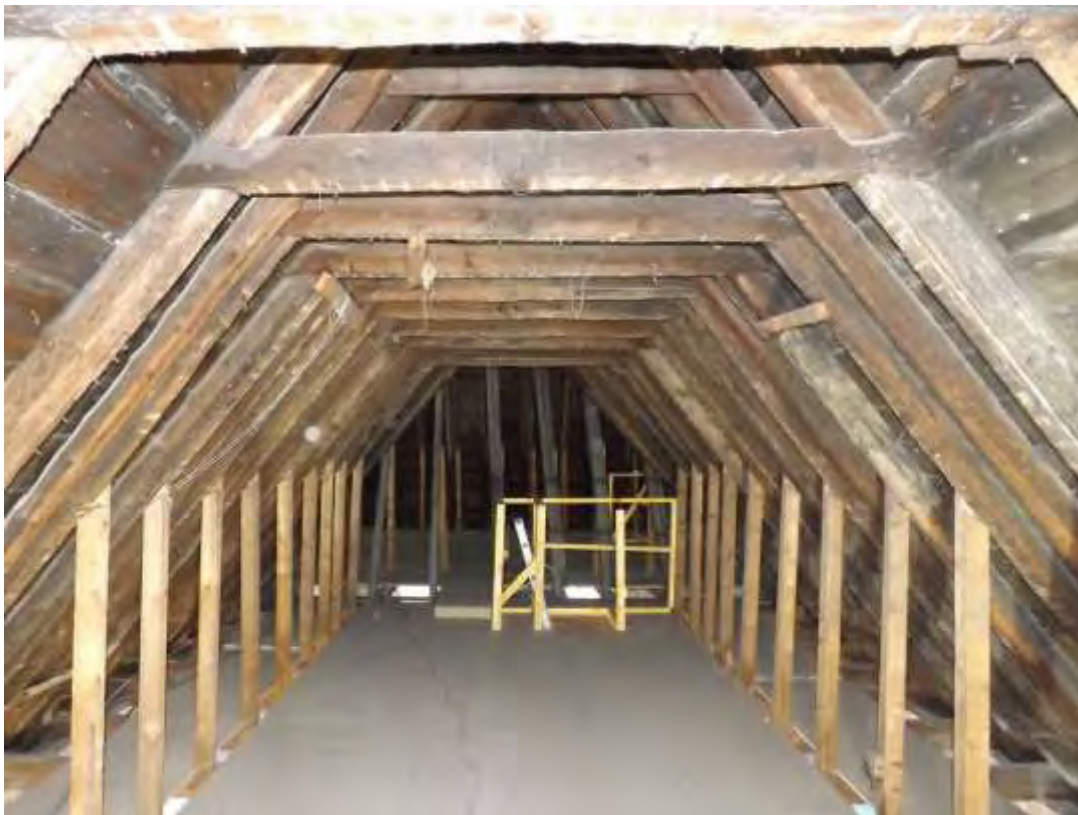
The original roof structure of the eastern jamb is of similar framing detail to that of the principal range although its overall span is considerably less. A number of the original cross frames survive, these in numbered sequence of marks from *I – XIII* from east to the western surviving frame, these cut onto their western sides *063 -076*.

Between frames *072* and *074* on the north pitch there was evidence for a dormer, *078*, of the same construction detail as on the roof of the principal range. And upon the rafter of frame *065* on the southern pitch there was evidence for a further dormer, although the rafter itself may be reset as the northern joist is numbered '*III*' (correctly) but the southern '*IIII*'. The rafters at the east end of the south pitch are generally a bit muddled and only a few survived, but the evidence showed that there was definitely formerly a dormer on frame '*III*' presumably running to the now-lost rafter of frame '*V*' on this pitch.

Plate 13 east jamb roof structure

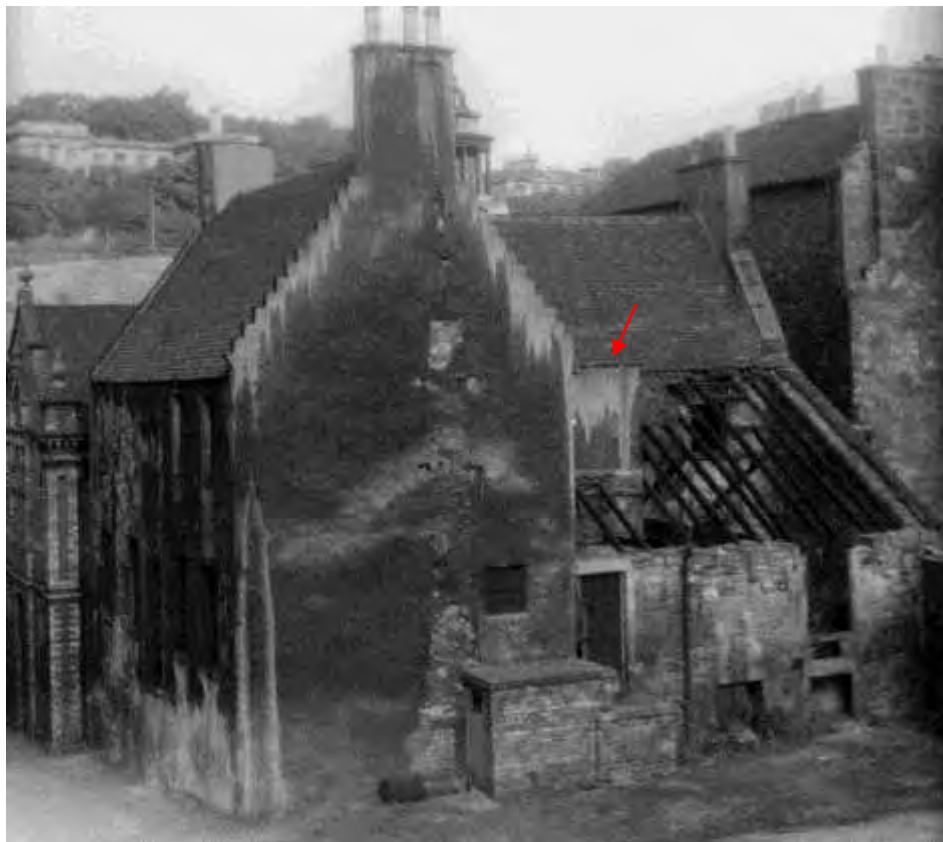
About the end of the 18th century or the beginning of the 19th a substantial three-storied stair tower was constructed within the re-entrant angle of the main range and the east range, 175. This was masonry-walled, of lime-bonded sandstone rubble with walls 0.30m thick. The structure now only survives intact within the basement level, but its upper parts can just be seen in some early photographs, see *plate 14*. In the latter the tower is surrounded to the south and east by a lean-to structure. The exterior of the tower was harled and this can be seen in the photograph where it rises above the lean-to structure. The roof appears to have either been flat or very low-pitched and detailed with a low stone-coped parapet.

Plate 14 Photograph of c.1921 looking NNE; the upper parts of the stair tower can just be seen at the re-entrant (indicated), this in turn surrounded by a large mono-pitched lean-to infill structure.

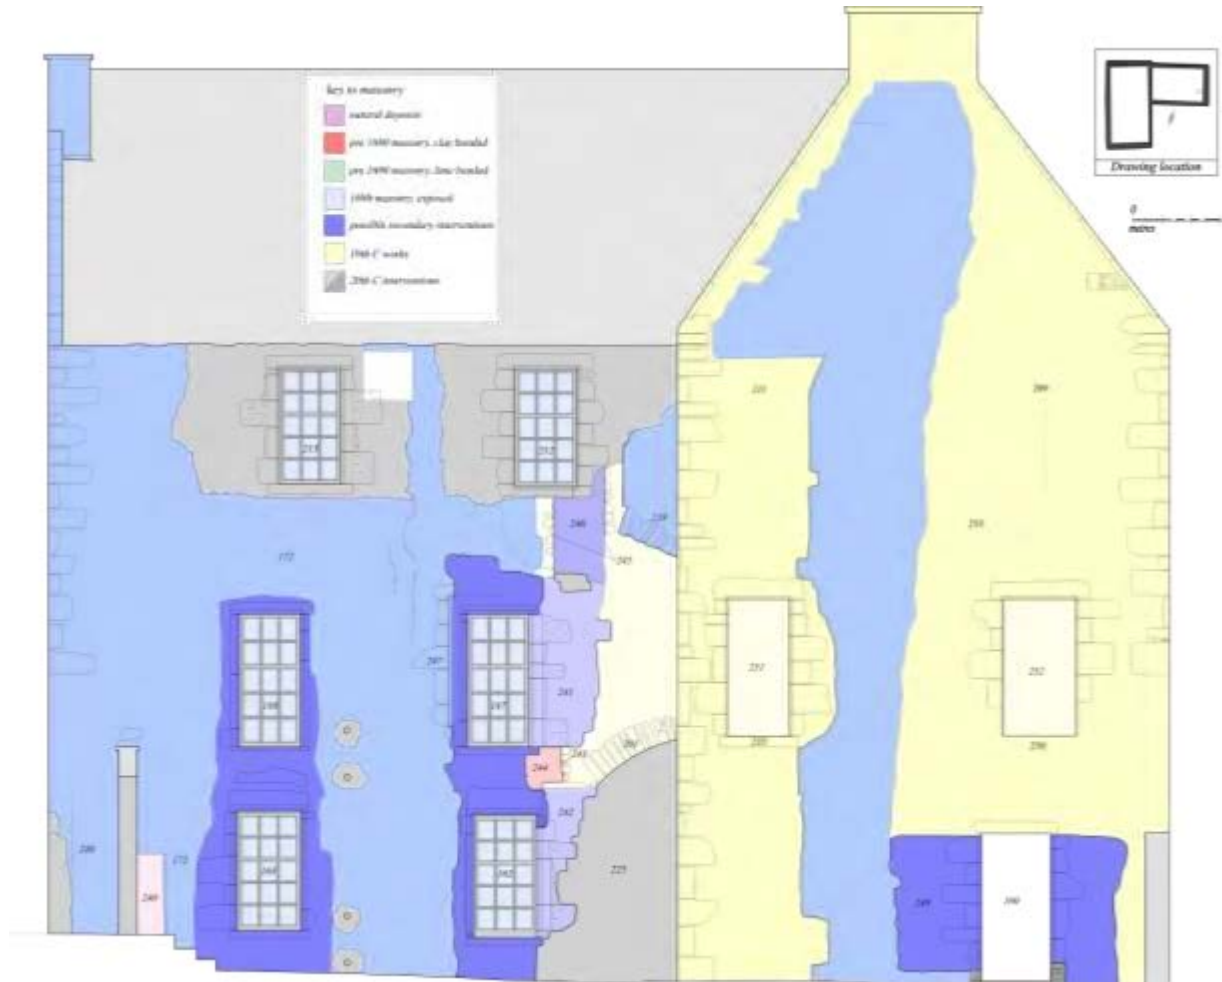
The north exterior of the building is the most complex and has clearly seen many alterations. The most significant of these was the demolition of the northern range and refacing (253) the former internal cross wall to form an external face this also involved the insertion of quoins down the corners.

Figure 7 phased north exterior elevation

On the gable of the truncated north range, at the first floor level doors/ press recess into the lost range have been blocked up. The ground floor doors/press recess have been formed into windows with a chamfered surround 235, and 250. It is not clear if these were formed open or blind originally but they are currently blocked with rubble 251, 252. This rubble is dissimilar to the rubble skin of 253 and may postdate this perhaps indicating they were made blind at a later date.

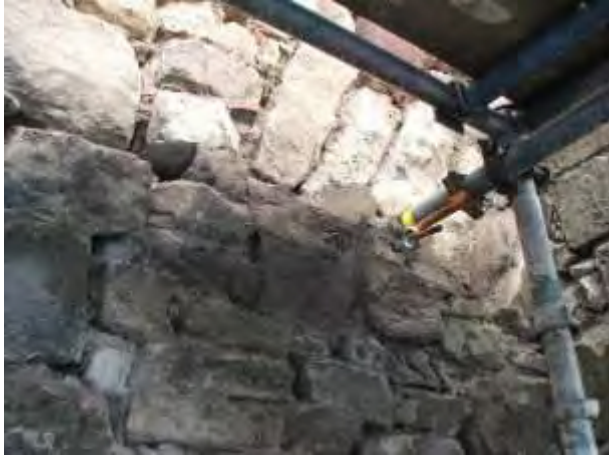
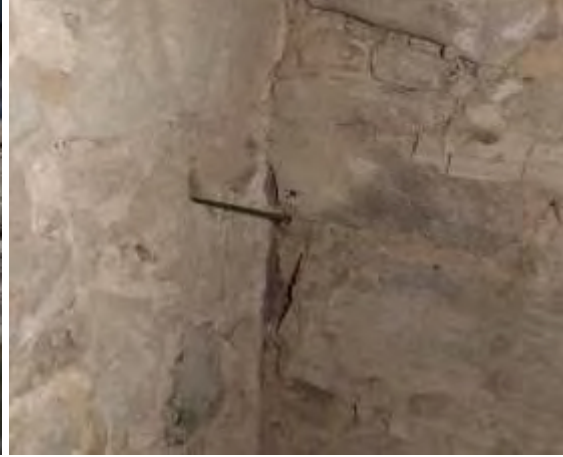
The only potentially original features visible are 228 and 247. 228 is the truncated remnants of a relieving arch similar to those over the windows on the west elevation, any former features below this

have been lost and its eastern half has been cut away for a later opening. It is not clear if this is part of the original phase or a later inserted feature due to the limited survival of early masonry around the arch. However the later rubble infill 196 below the arch abuts wall plaster against the west jamb and this plaster 194 survives trapped within the former opening indicating it to have been well plastered and painted green?

Plate 17 arch 228 with jamb 245 cutting through

Plate 18 plaster 194 trapped behind rubble infill 196

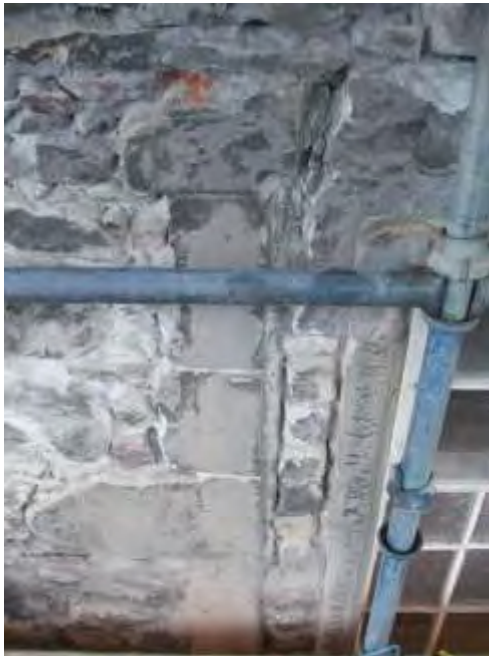
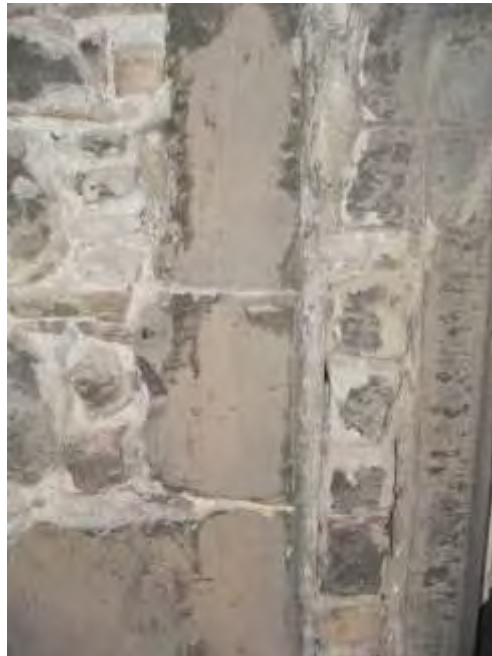
247 is the surviving eastern jamb of an original ground floor window apparently in situ. The stub of the lintel and sill survive and give a full internal height of the window of 1.75 m but the rest has been removed in a slapping to form window 187. The jamb of the 247 window is formed from polished blond sandstone with a chamfered edge the same as the other original windows seen elsewhere on the building.

Plate 19 window 247 at left, lintel stub at top with later window 187 within

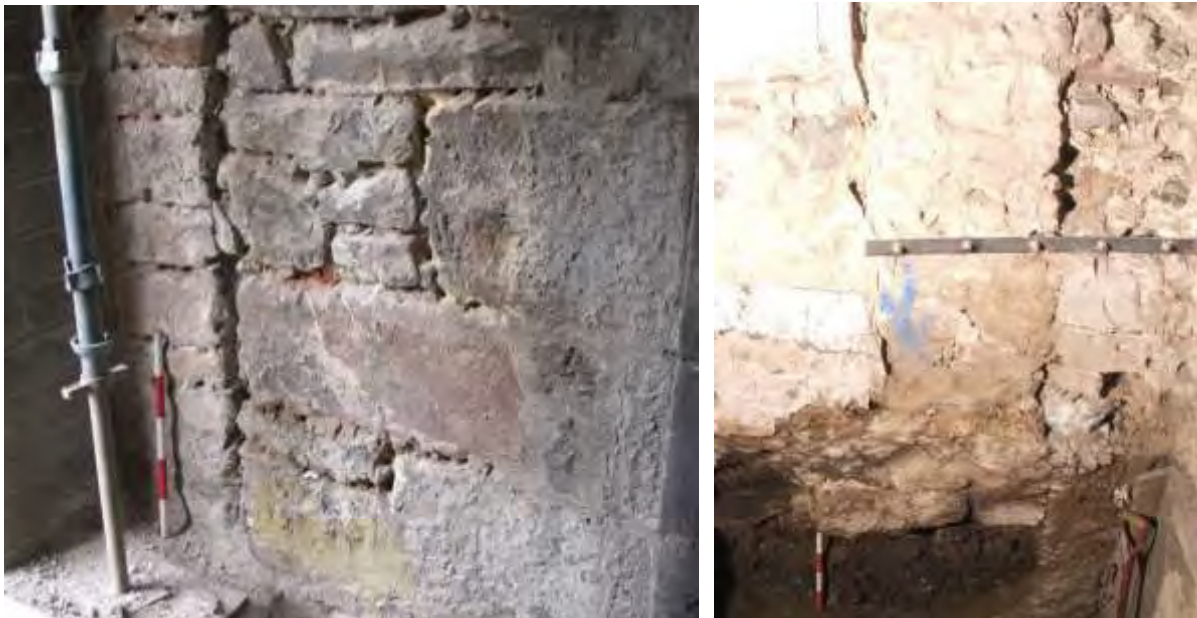
An isolated feature 240 appears to be a vertical rubble jamb surviving for 1.1 m on the exterior but appears to be the full height of a door? Internally. The original masonry of 172 may have been built over this and it may relate to a structure abutting the earlier boundary wall to the east. Alternatively it was a secondary opening into the building, the relationship between this and the 172 masonry is largely lost (to the west by cut for window 163) or obscured to the east behind a late 20th C blockwork wall built against the 172 masonry. However the jambs being of rubble stone rather than polished ashlar as elsewhere indicated that it was not part of the original c1690 (172) design

Plate 20 jamb 240 exterior looking east; Plate 21 jamb 240 interior looking north (jamb to left of metal strap)

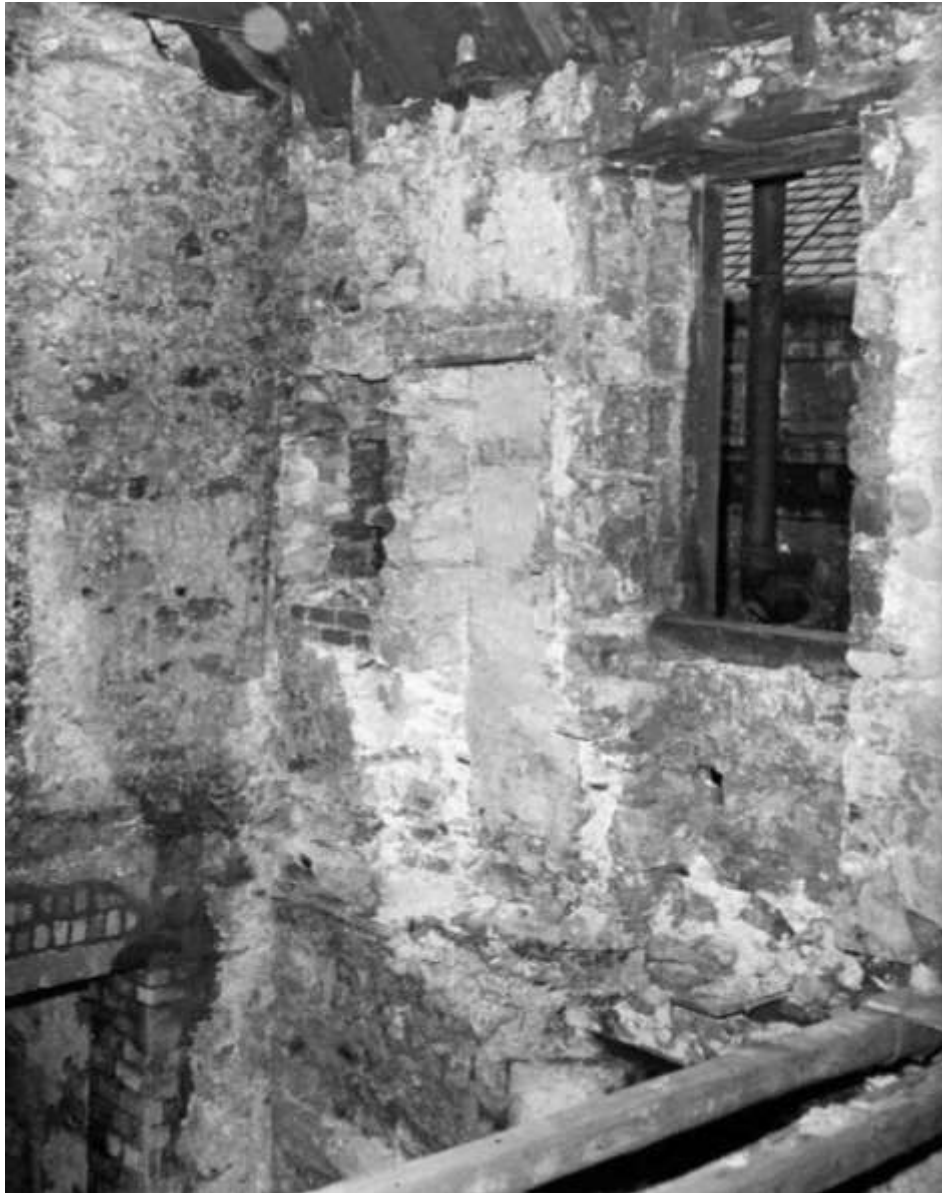
Plate 22 interior of 245 between window and wall return (Scran)

The opening appears to be approximately 2 m high rising from floor level and linteled over with a timber lintel on the interior. The slapping through the arch 228 is clear on the historic photo. The opening had been blocked into a recess with a plastered back prior to the 1950s. During the 1950s works it appears that window 212 has been shifted approximately 0.50m to the east removing the upper parts of the feature.

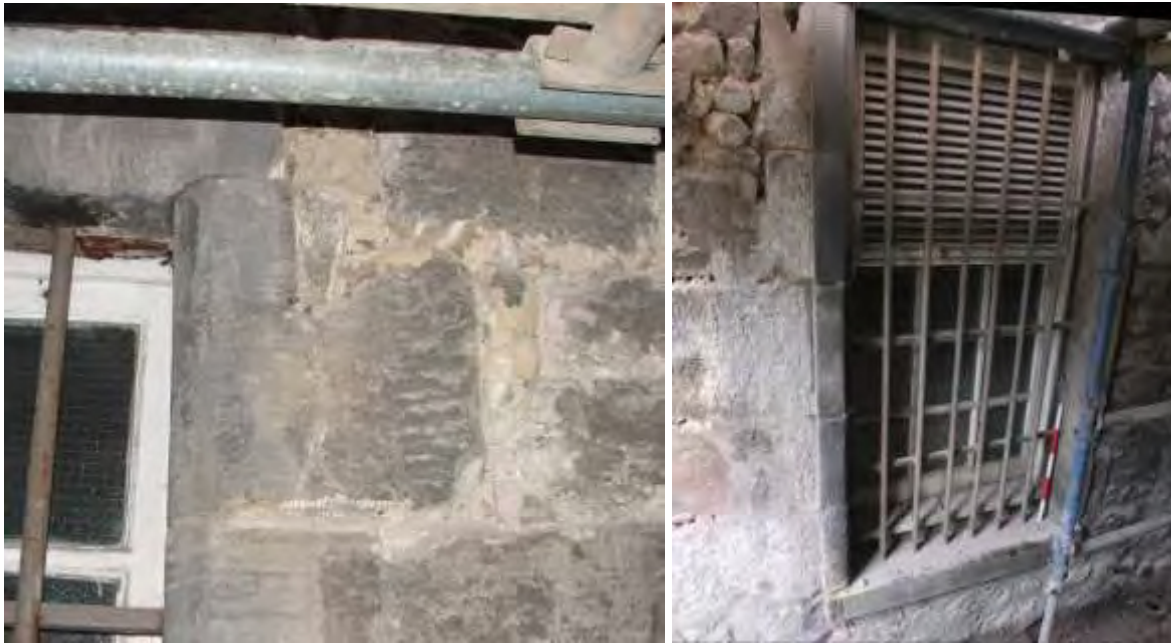
Plate 24 Window jamb 242 with window 162 cut in at top Plate 25 window 163 shows raised margins

The eastern jambs lintels and cills 187, 162 of windows 241 and 242 are of a different moulding with a noticeably narrower raised margin. The top quoin of the west jamb to window 162 is cut into the top quoin of 242 indicating it is likely a secondary replacement.

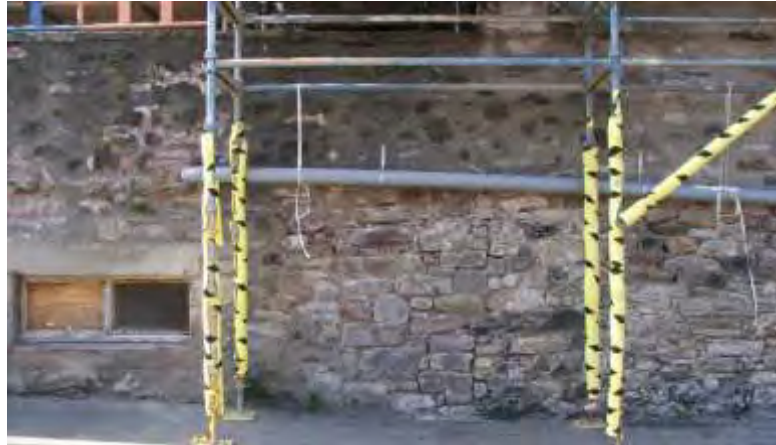
The only feature noted on this elevation was a roughly formed rubble jambed opening 254, possibly a door slapped through the early boundary wall at the junction of the east range and the infill structure within the courtyard. This was latterly infilled with lime bonded rubble 255. This was of uncertain age but could relate to 19th C occupation of the building

Plate 26 opening 254 and infill 255

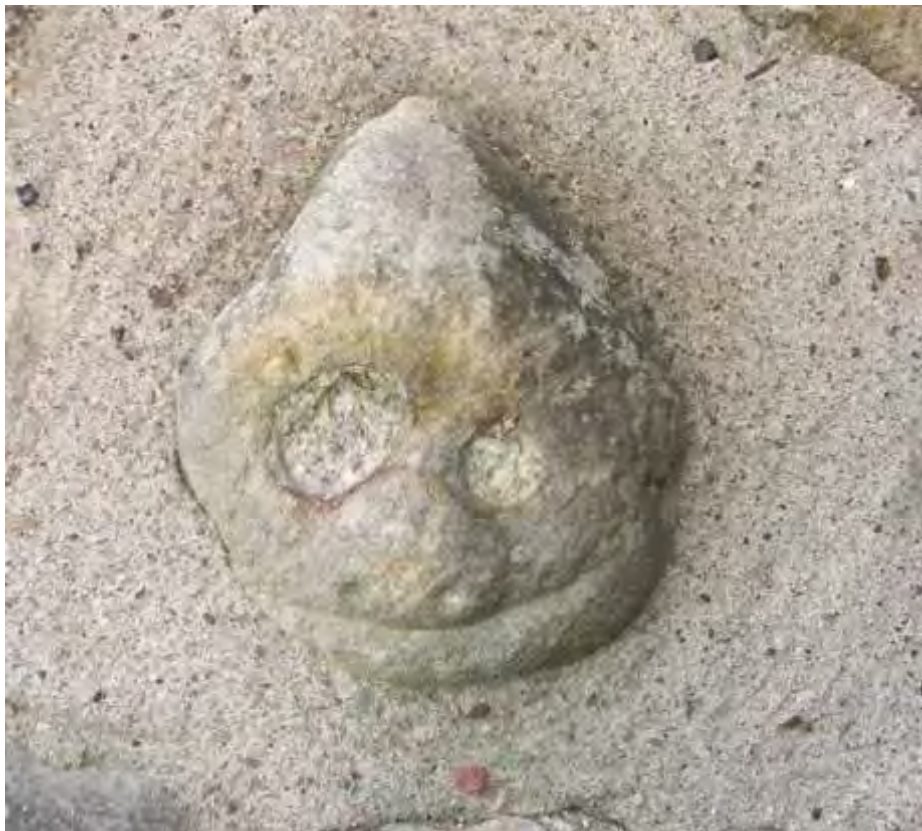
Plate 27 carved face on exterior

One feature of note was a partially carved face utilising a stone with natural depressions as eyes and a slightly carved mouth and nose

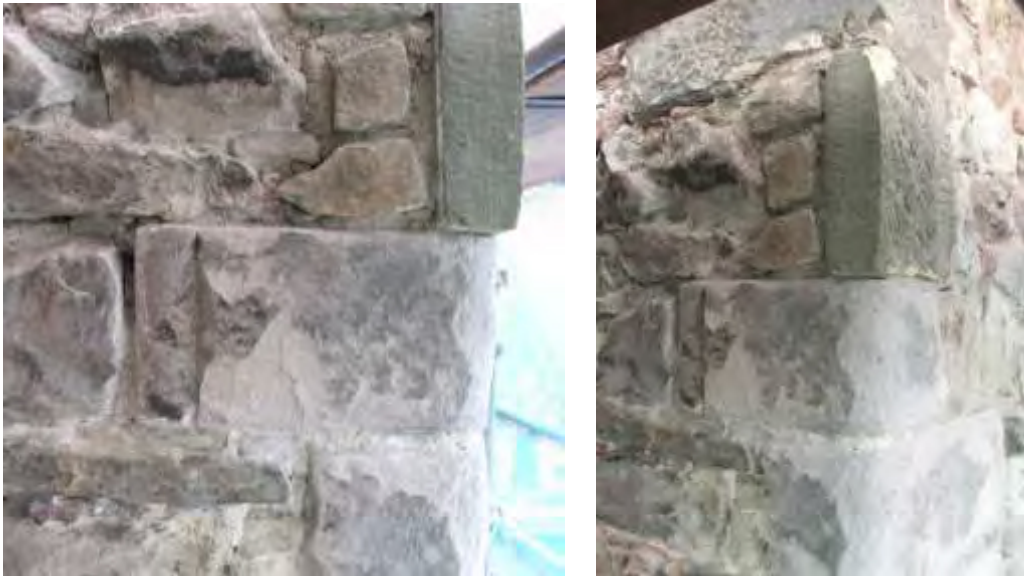
On the eastern corner some of the corner quoins are clearly reused masonry including a number of soft pinkish sandstone blocks 1 of which shows a roll moulding

Plate 28 and Plate 29 reused stones reused as quoins

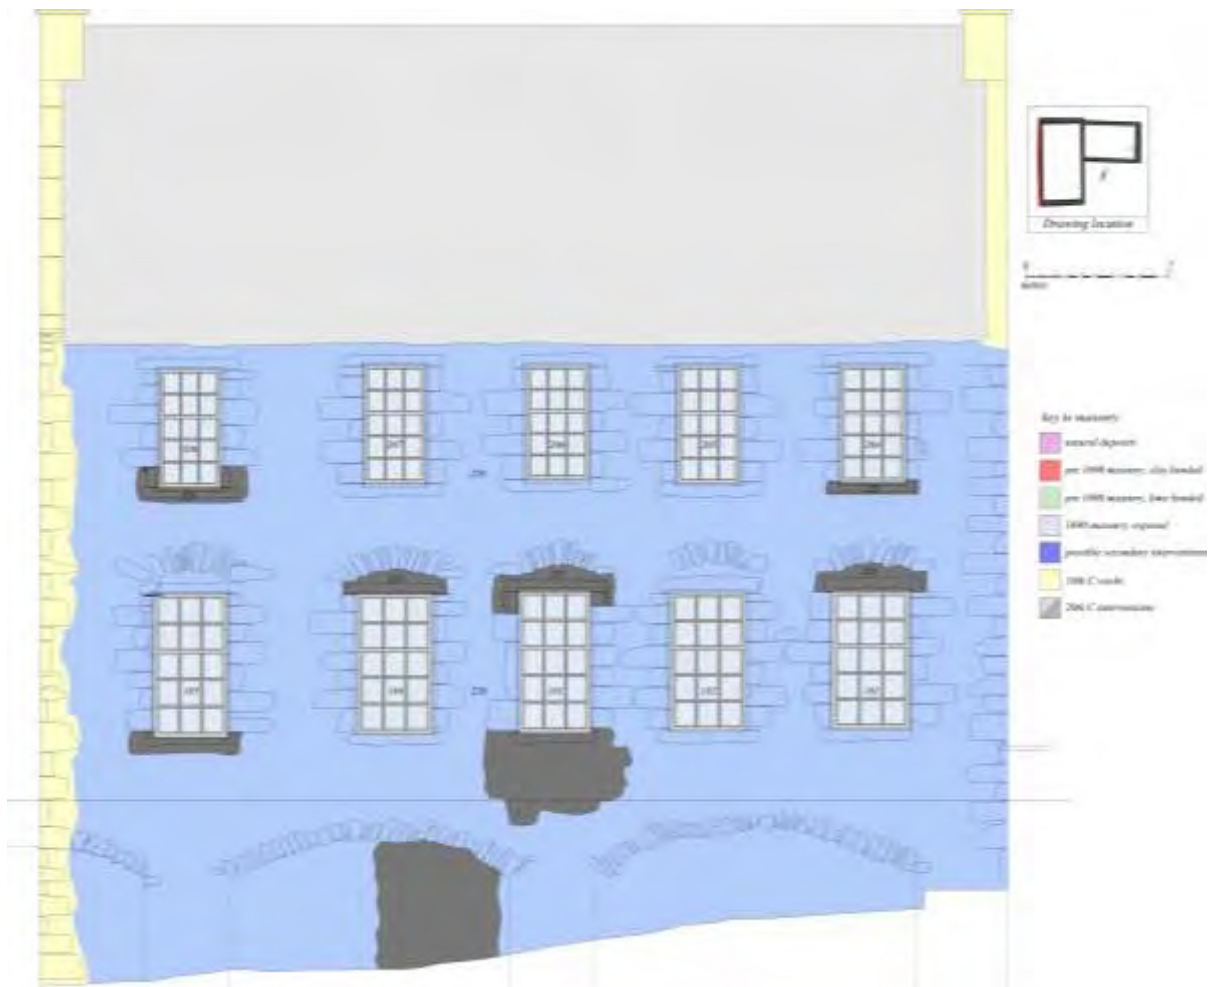
This elevation is largely intact as originally designed in c1690 except for the demolition of the northern half of the elevation as well as the vaulted forecourt to the west in the 19th C. the demolition of the forecourt has exposed the last remnants of the vaulting within the lower part of the elevation represented by 2 ½ vaults the 2 complete ones are approximately 3.90 and 4.45 m wide. The masonry blocking the arches is integral to that between them so they were not open into the house basement a door sized blocked opening was seen in the masonry blocking the middle vault and represents the access between the basement and the vaults . This door was visible in the interior as a plastered jamb but on the exterior any jambs have been lost and the hole patched up with rubble leaving little trace of the opening, this blocking may relate to 1950s works. A number of lintels and cills were replaced in the 1950s works.

Figure 10 phased west exterior
