Fluthers Cottage

Earlston, The Scottish Borders

Historic Building Recording and Archaeological Evaluation :

Job number 2117

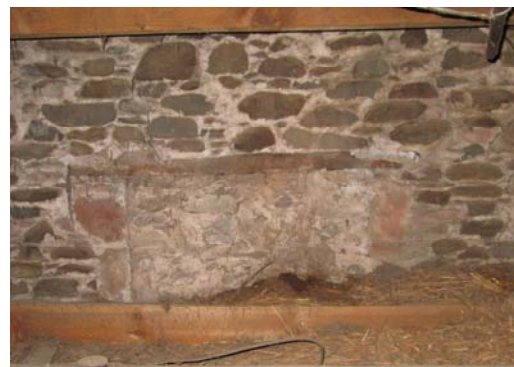
Plate 7 Blocked attic window interior (155)

A second window (*018*), now blocked (*019*), was partially visible in the centre of the gable at attic level (*plate 6*). The lower squared sandstone jambs and a thin timber sill were all that could be seen due to the covering of harl. Further evidence for this window could be seen on the interior, where the upper sandstone jambs and timber lintel were visible (*plate 7*). The height of the window in relation to the current roof structure suggested that the present ceiling must have been added after or at the same time as the window was blocked.

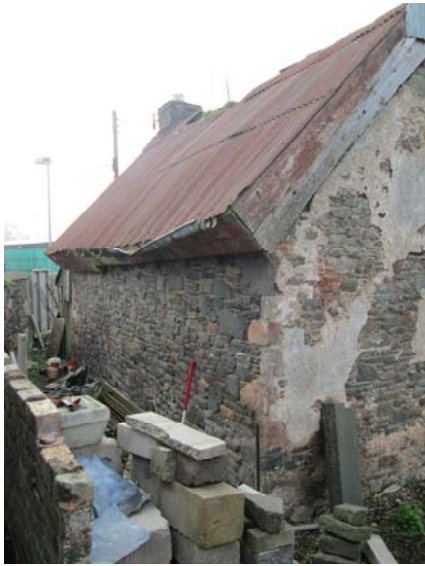
Plate 8 General view of north elevation (016)

The north elevation, at the rear of the building was almost entirely featureless (*plate 8*). The masonry was identical to the rest of the building but there was no evidence of harl on this face. It would seem likely that this face was also harled but it has been removed, although it is possible that only the more visible frontage and gables were harled. The rear wall of the timber lean to structure was built from vertical railway sleepers, presumably salvaged from the former railway to the south of the cottage. The track, which was part of the Berwickshire line, was still in use by freight trains until 1965; therefore the sleepers must have been salvaged when replacements were made during maintenance of the line. The shadow of the fixings for the track can be clearly seen on the sleepers, showing that they had been used. The upper part of the wall was made from vertically laid thin planks, and a small window (017) with a timber frame had been cut through (*plate 9*).

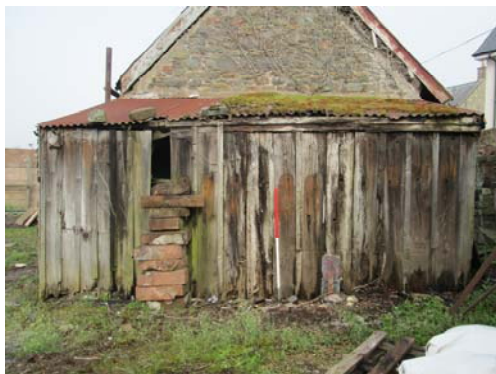
Plate 10 East elevation of timber lean to (019)

The base of the east gable was obscured by the timber lean to; the exposed masonry was identical to that observed elsewhere in the building, and there were only very slight traces of harl visible (*plate 10*). The base of the chimney as seen on the exterior was built from squared sandstone. The upper part of the chimney had been rebuilt in brick, similar to that used in the blocking and wall head rebuilding in

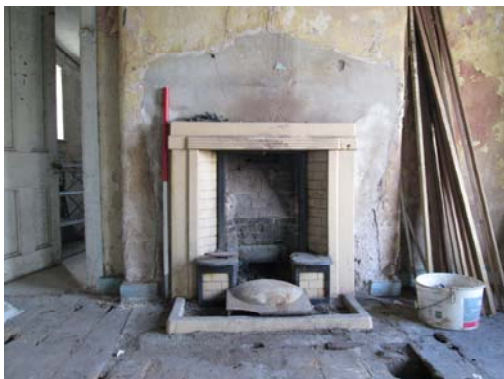
Plate 13 East elevation main room (034)

A six panelled timber door to the right led to the main room of the cottage: a large sitting room with a fireplace set in the centre of the east wall lit by a large window with internal splays in the south elevation (*plates 13 and 14*). The timber lining which formed the ceiling was largely missing exposing the inside of the thatched roof above. The floor and window sill were timber. Revealed in the plaster around the fireplace (*036*) was patching for an earlier surround (*037*) which had been removed and replaced by the current fireplace, which dates stylistically to the early 20th century. The interior retained some of the original lime plaster (*038*). A four panelled timber door (*044*) to the left of the fireplace accessed the timber lean to, to the east.

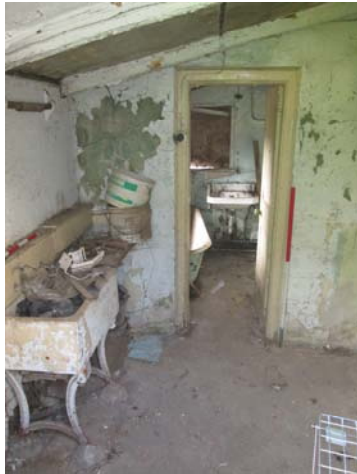
Plate 15 Looking south in kitchen (032)

The lean-to was constructed to house the kitchen and bathroom and had been sub divided into two rooms by a brick partition; both rooms had a concrete floor. The first room entered was the largest and was presumably the kitchen; a sink and an additional set of taps survived, but there was no evidence for the cooker (*plate 15*). It is likely that the original fireplace contained a range later replaced by the more decorative fireplace. The kitchen had a small timber framed window in the north wall. The bathroom was entered through a timber doorway in the south wall and still contained the fixtures and fittings; the small window in the south wall had been boarded up (*plate 16*).

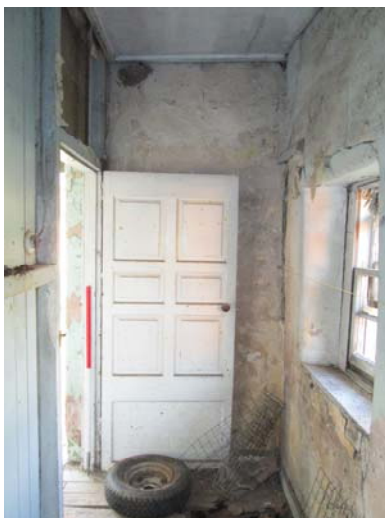
Plate 17 Bedroom looking south (050)

The bedroom was a long narrow room at the west end of the cottage. The timber door had six panels in pairs of different size over a single large panel at the bottom (*plate 17*). There was a small timber framed sash and case window in the west wall. The south end of the east wall was of timber planking adjacent to the hall; tongue and groove had been applied to the remainder of the lower half of the east wall, whilst elsewhere the walls were plastered. The paint and patching (*049*) in the plaster on the west and north walls indicated the position of what was presumably a box bed (*plate 18*).

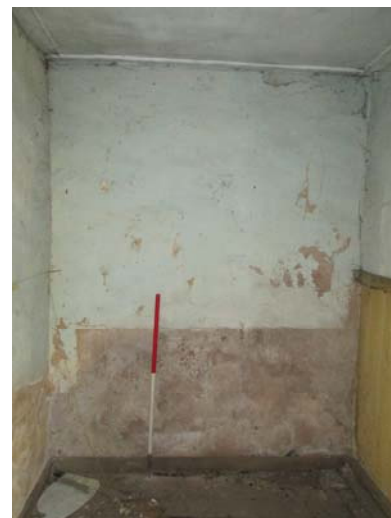
Plate 18 Bedroom looking north (052)

The window of the bedroom was reduced in width with brick and rubble, perhaps to improve the temperature. The chimney stack was replaced in brick; the poor quality of the sandstone had likely failed.

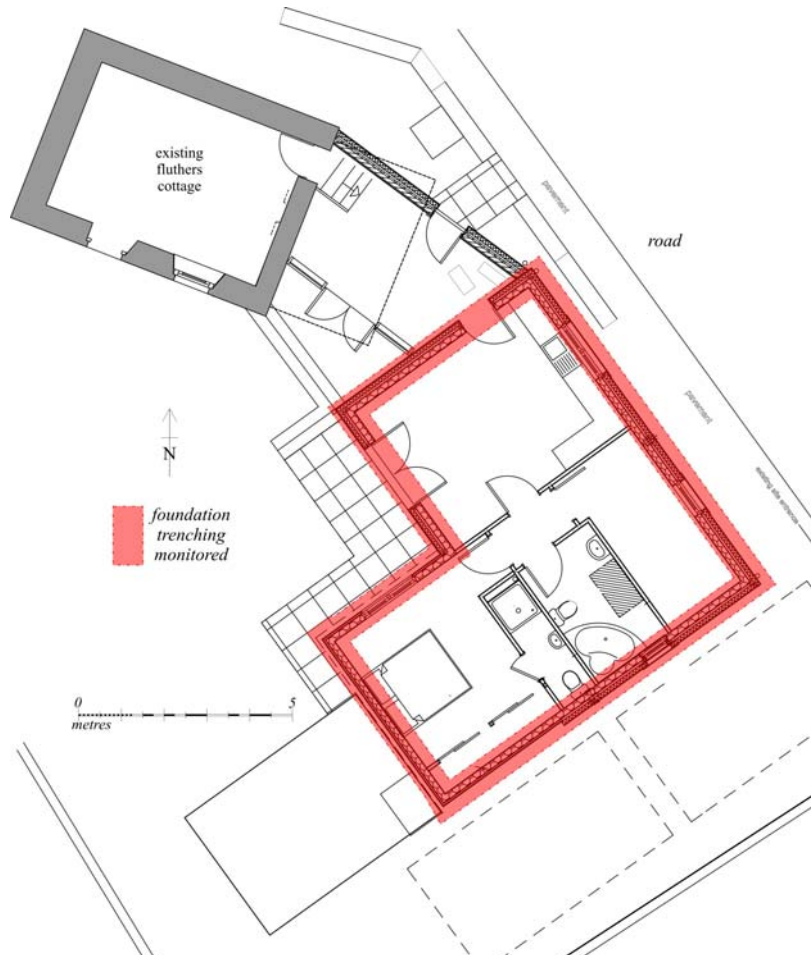
Figure 6 plan of trenching

Foundation trenching for a new southern extension to Fluthers Cottage was excavated by a Wacker Neuson 6003 mini digger under archaeological supervision (*figure 6*). The trenching was started on the 8th August 2015 and supervised by J Morrison; however, lack of storage space for spoil on site meant that excavation was stopped until spoil could be better managed. The depth of the trenches required to reach solid natural was considerably deeper than originally envisioned and the quantity of spoil was accordingly large.

The trenches were excavated down to solid natural deposits to form a secure base for the foundations. The natural deposits varied in depth from 0.50m to the north down to approximately 2.0m at the SE corner (*plate 25*).

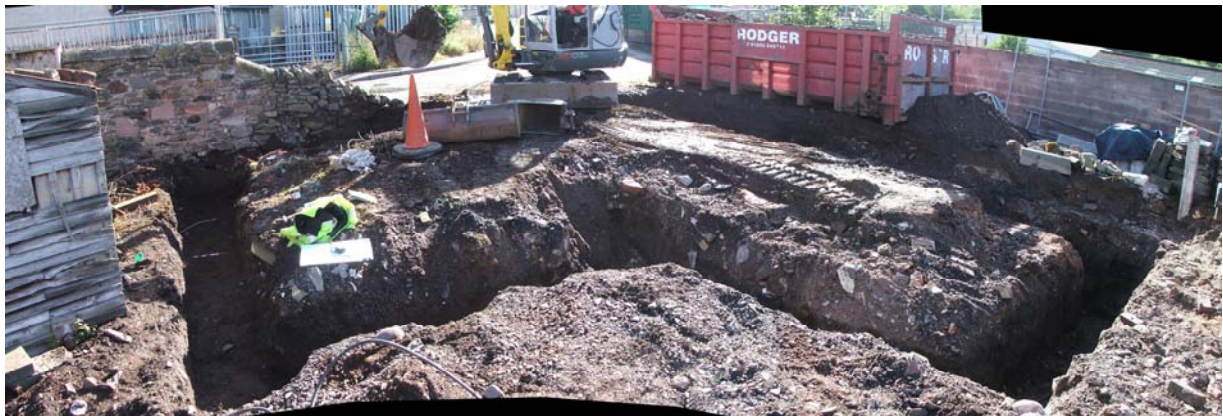
Plate 27 general view of trenching

The stratigraphy was simple and generally consistent across the site. The lowest deposit exposed was compacted gravelly/sand natural (061) sloping down to the SW from the north and following the former general slope of the surrounding area.

The upper deposit was a deep spread of modern building debris (059) dumped and spread across the site in recent years. This sloped from 0.20m deep in the north to 0.90m deep in the south, further levelling the site.

At the SE corner of the trenching the underlying soil deposits had been historically removed down to solid natural and replaced with large quantities of concrete blocks and rubble. This was most likely relating to strengthening the entrance for heavy vehicles.
