The Gates, Durham

Historic Building Assessment

April 2015

Nathaniel Litchfield & Partners on behalf of Milburngate Durham Ltd

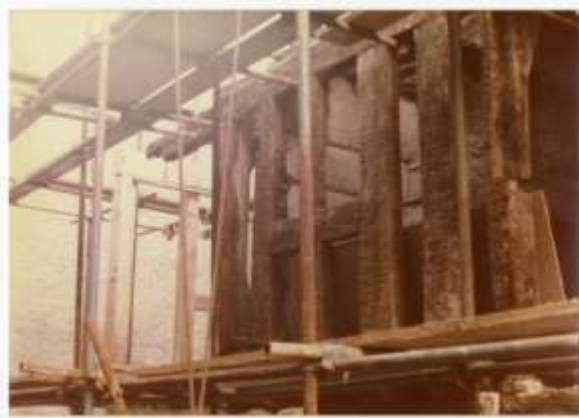
Plate 21 The upper part of the west frontage (DCC) Plate 22 The NE angle of the rear range (DCC)

The original framing of much of the upper wall survives on the street frontage on the west side, this mostly complete between the remaining cross-frames (the central bay as existing), *plate 21*. The early wall plate extends further southwards, beyond frame *V*. The well preserved section between the two original cross-frames retains an early window opening, later blocked. The southern jowl-post (the northern side of the existing southern window) displays multiple peg-holes that suggest the former presence of a bracing element.

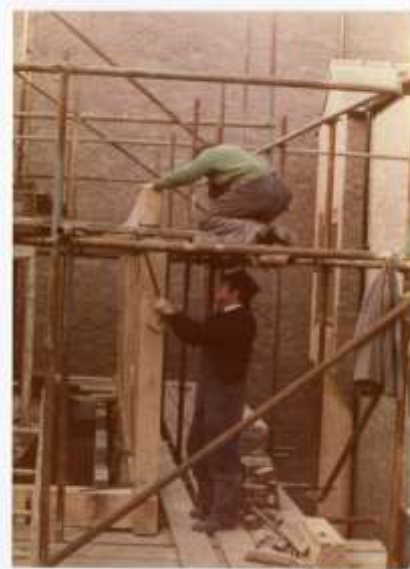
*Plate 23 assembling the framing of the new north gable wall (DCC)
Plate 24 re-roofing No.5 in progress*

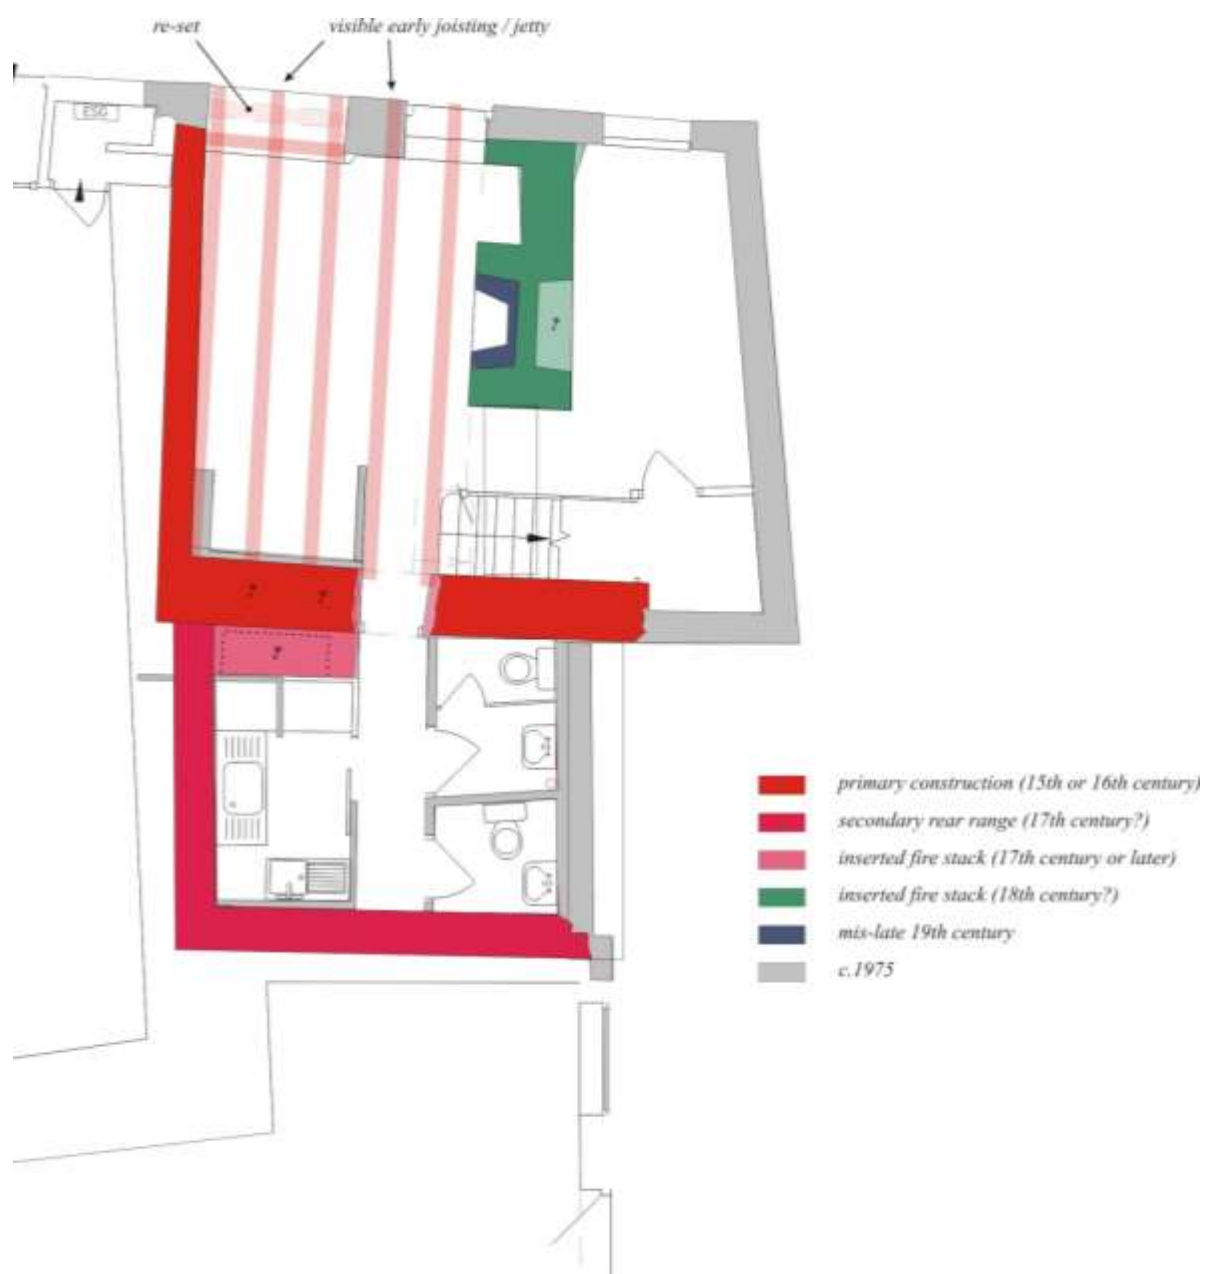
The frontage range originally faced westwards on to Milburngate, running parallel to it. Today only the southern half of the range survives and this, as noted, in a much-mutilated form. While externally all of the visible lower walling of the structure is modern, it is the heavily restored half-timbering above that signifies this to be an historic structure, *plates 19 and 20*. Internally some of the lower walling to the rear, internally and to the south are likely to be partly or mostly of early construction, *figure 5*.

Figure 5 Plan of ground floor of No.55 showing suggested phasing (this remaining to be confirmed by investigation)

It is thus recommended that a general historic building survey of No.5 in its as-existing state be carried out. An investigative exercise could be very usefully undertaken at an early stage to inform the project of the possible extent of further historic fabric within the building. This would involve opening up certain areas, such as the rear wall of the frontage range internally, the south gable wall of the frontage range internally at both levels, revealing parts of the floor structures of both the frontage range and rear range; determining the nature of the lower level walling of the rear range and the possible extent of surviving early fabric. A programme of dendrochronological (tree-ring) dating of the remaining early would be regarded as highly desirable and would be an important addition to the corpus of timber-framed structures dated in the NE and in County Durham in particular.

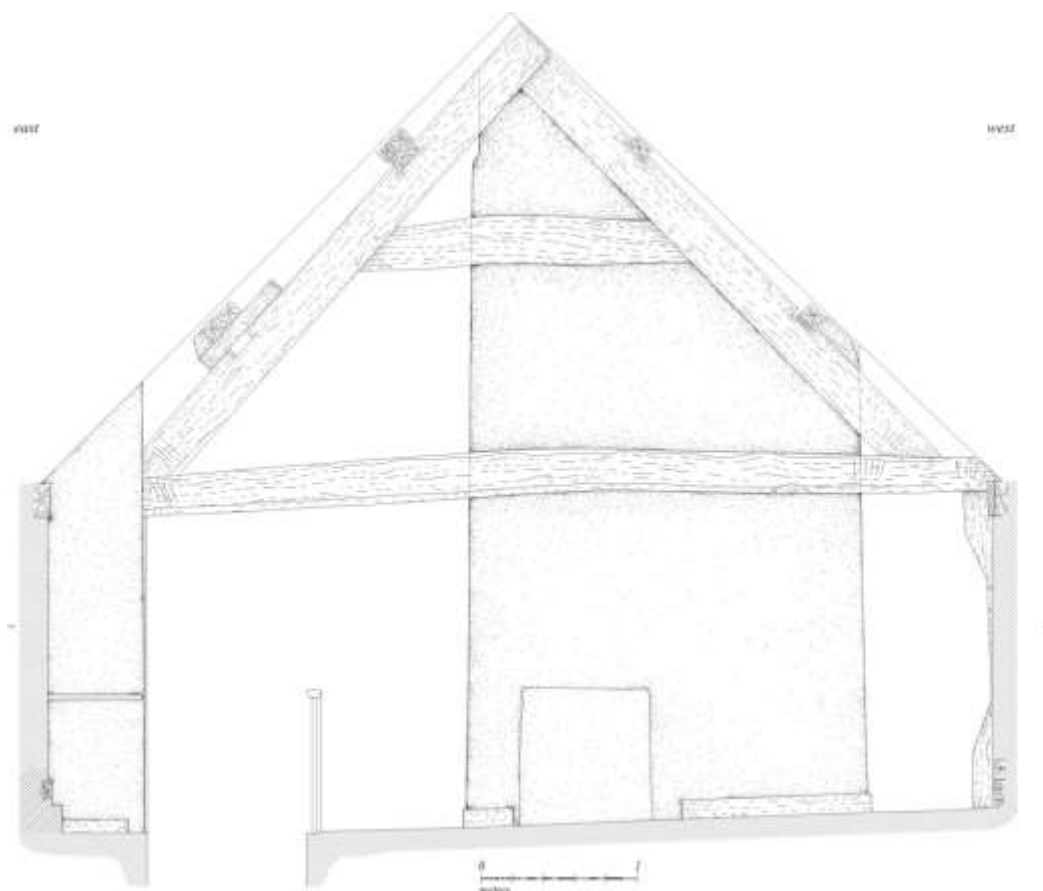
Figure 6 Principal range roof structure – northern surviving truss (truss III), upper (north) side

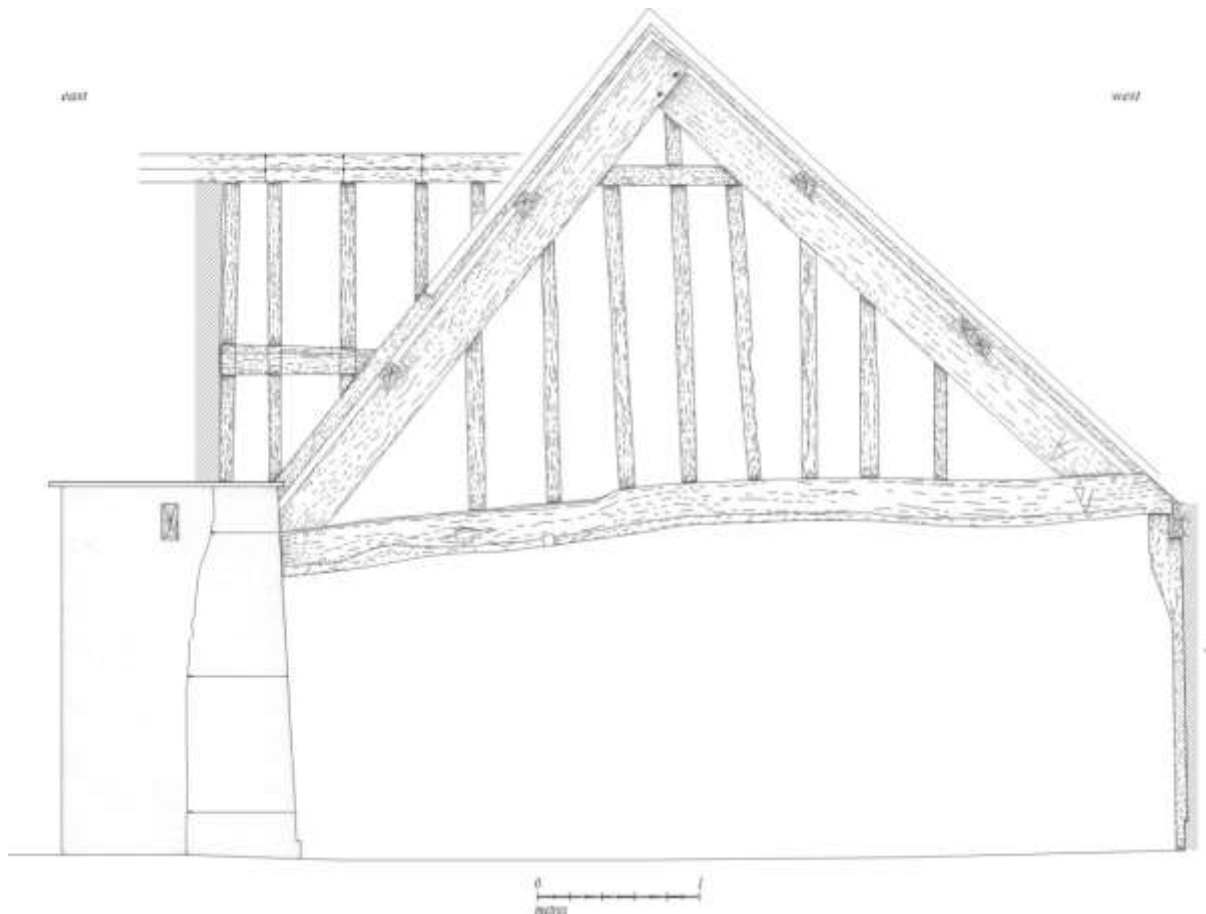
Truss *V* preserves vertical studs rising from the tie-beam, these for a wattle and daub partition. Mortice sockets on the south side of the tie indicate the former presence of a floor structure, probably of the original phase of construction, on that side.

Figure 7 Principal range roof structure – northern surviving truss (truss V), upper (north) side, showing rear range roof running in
