# Woolsington Hall

*Woolsington, Tyne and Wear*

Post-fire recording works, clearance and materials recovery

Project AA.1964

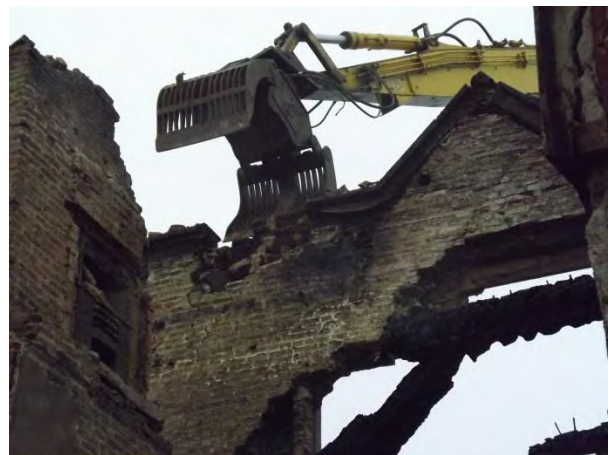
*Plate 7 South-east gable during dismantling*

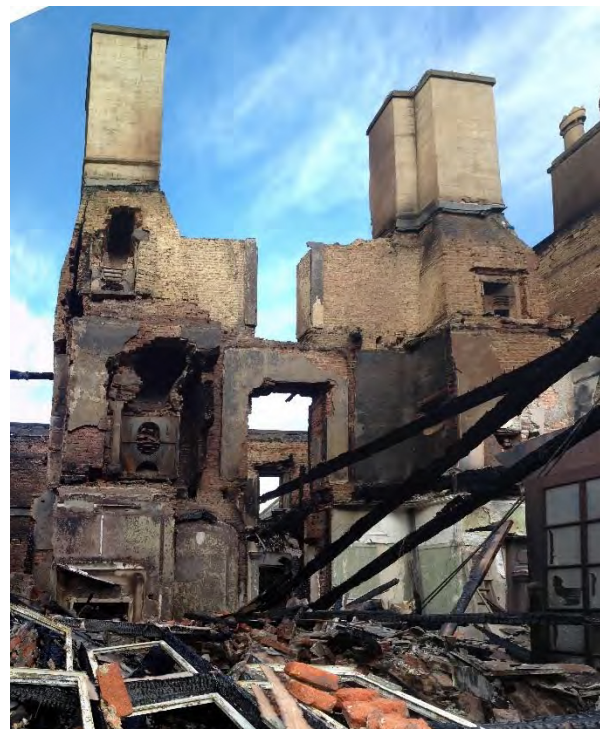
*Plate 12 composite photograph of central spine post-fire*

Following the building being made safe for initial access, clearance of the interior by MGL Demolition commenced. During these works the vibrations of the clearance made further parts of the masonry unstable, the central spine wall especially. This was consequently reduced down to first floor ceiling level. Later further localised demolitions were also undertaken to maintain access safe during clearance.

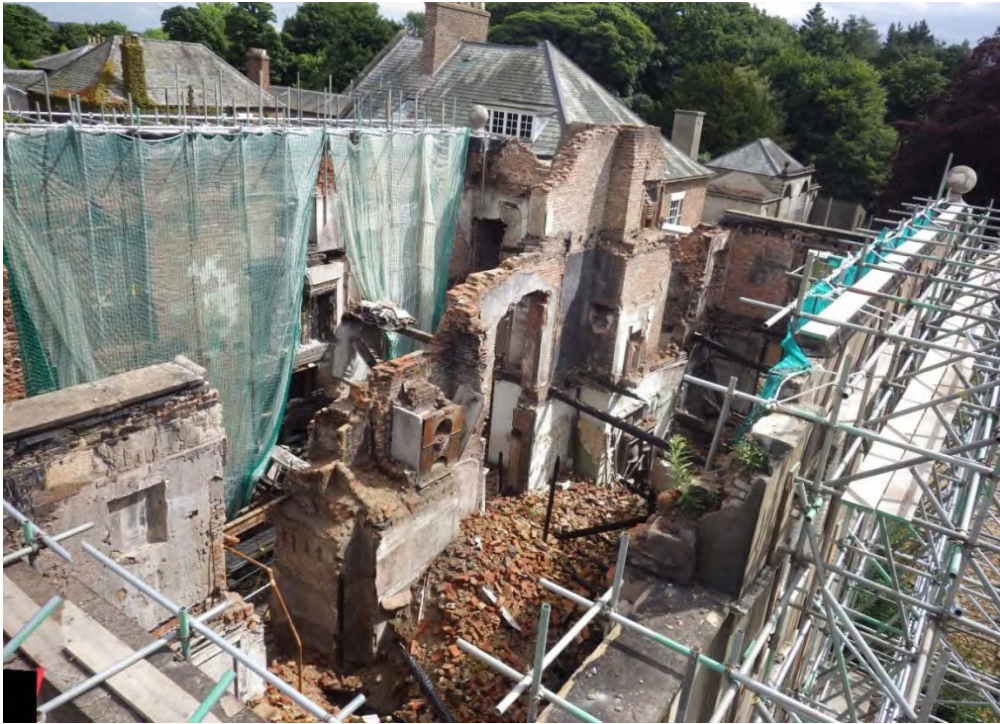
Plate 13 The masonry of the spine wall after the first stage of demolition

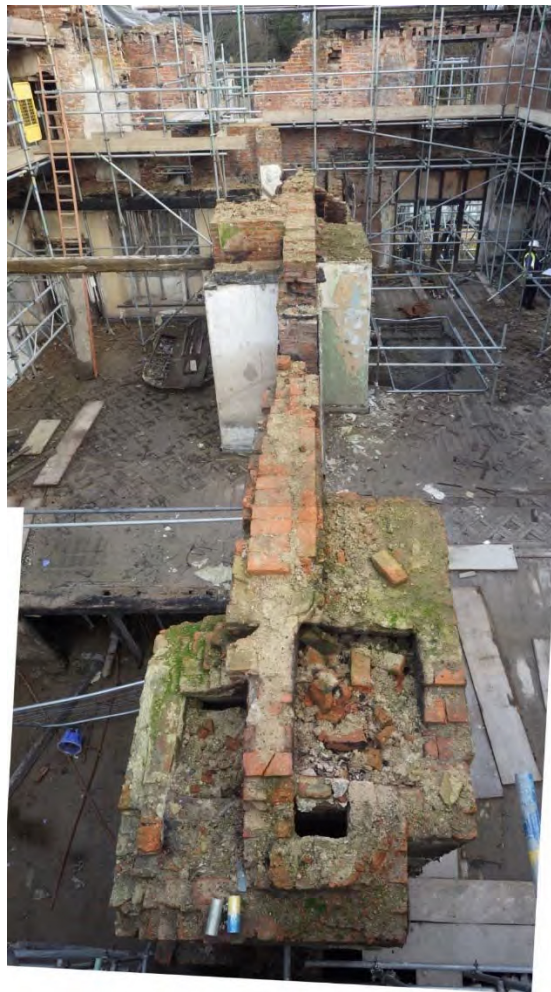
Plate 14 The masonry of the spine wall following further reduction

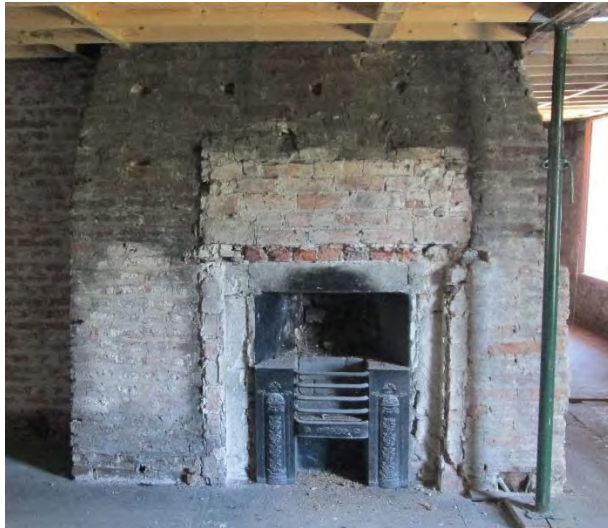
Plate 20 S09 fireplace in situ

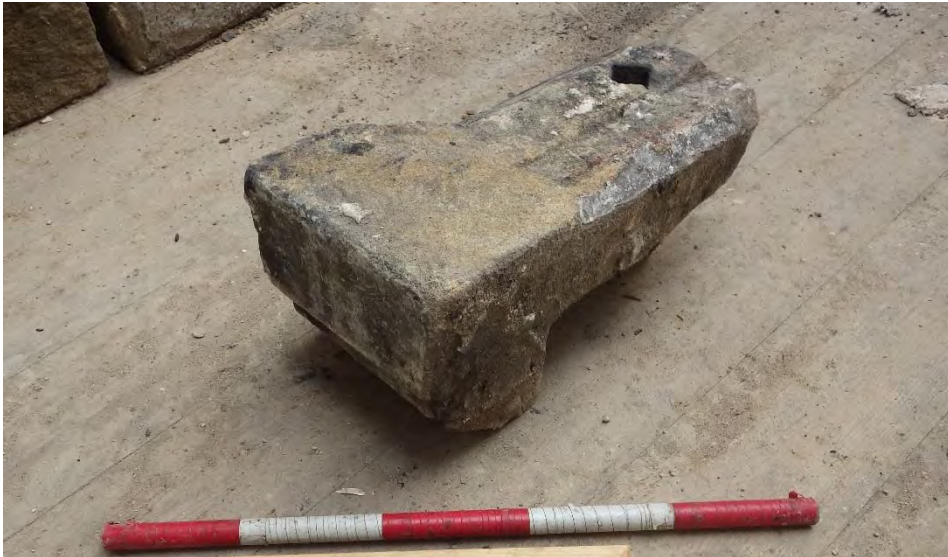
The stonework of the window surround in the east wall was largely recovered in pieces, all fire-damaged but enough to identify this (and the other attic windows) as not having the same detail as the surviving early windows on the floors below. Unlike those the window was not mullioned and may have been replaced (or modified) when the roof configuration was adjusted in the 18<sup>th</sup> century; evidence for this can be seen where one of the jambs was cut down from an early sill with matching profile to the original windows.

Plate 23 Room S09 - jamb stone showing evidence of reuse, cut down from an early sill (find no 106)

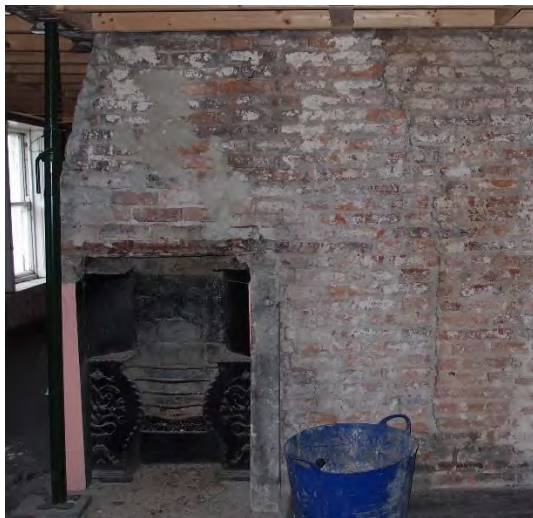
The cast iron fire within the earlier fireplace was partly overlain by an even later plain polished stone surround; the lintel of this had fallen or had been removed prior to the fire. Heavily fragmented remnants possibly of this surround were noted in the debris but not enough to reconstruct it or comprehensively identify them as the surround for this fireplace.

Plate 24 S08 fireplace in situ

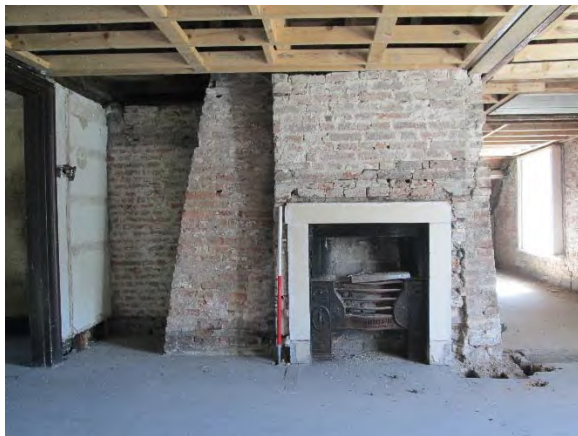
This fireplace within the stack on the south side of this area sat within a plain polished sandstone surround; again this surround was very fragmented and only partially recovered. The fireplace ironwork was recovered in tact during controlled demolition (find 007).

Plate 28 S07/6/5 fireplace in situ

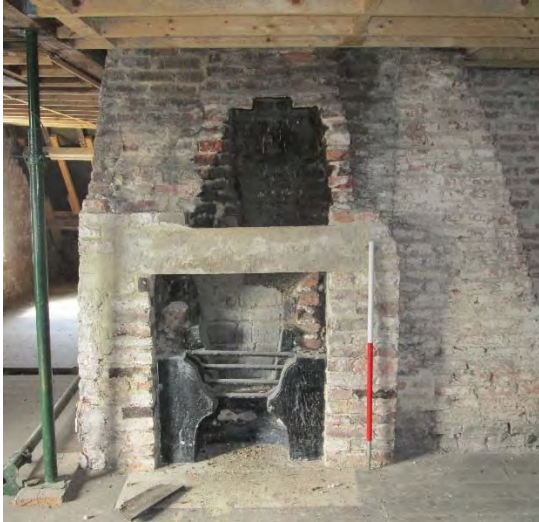
The fireplace within the stack on the north side of this room was fronted with carved stone in to which the iron work sat. The stone shattered into small pieces as seen in post-fire photography prior to demolition and was not recovered, but the ironwork of the hob-grate (find no 081) survived and was recovered. The masonry of the window within the gable wall to the west was mostly recovered, though again heavily heat affected and shattered; the feature was reassembled and recorded.

Plate 30 S04 fireplace in situ

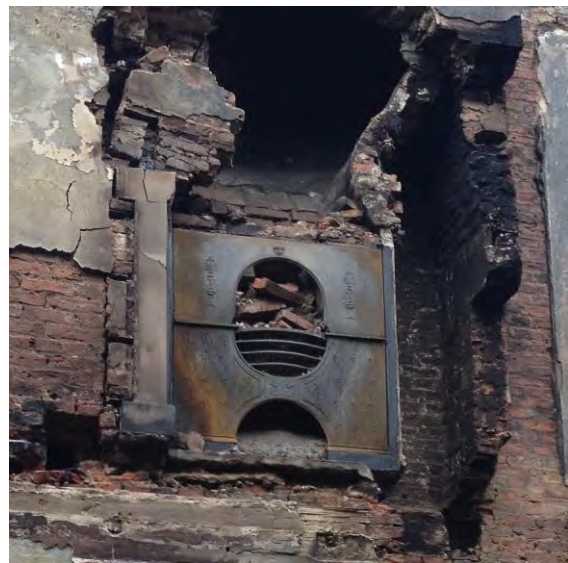
The timber surround of the fireplace on the north wall of room F04 had been lost but much of its polished stone surround was recovered in fragments (find 096); the cast iron fire grate (find 020) was also recovered, in two pieces, during the demolitions, as were most of the jambs and lintel.

Plate 35 room F04 fireplace and surround in situ post fire

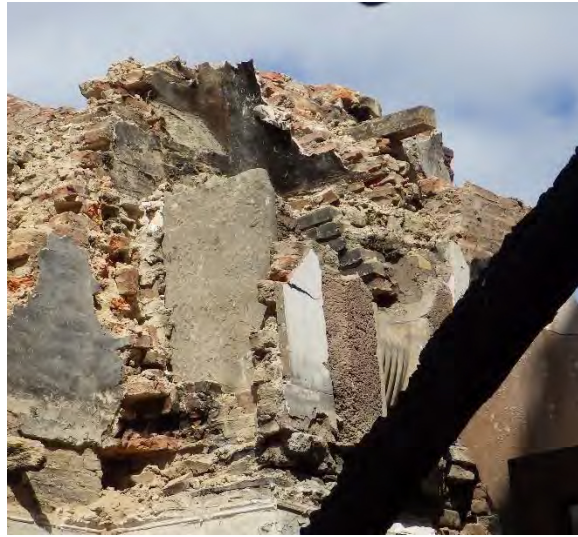
Before the fire the surround of the fireplace on the north wall of room F09 had already been removed; but it was clear from what remained of its interior that this must have been of 20<sup>th</sup> century date. During demolition this later work proved to be an infill within an original fireplace opening; the large side slabs of the original revealed still to be *in situ*.

Plate 51 F09 - fireplace under demolition, revealing rear of side slab of original

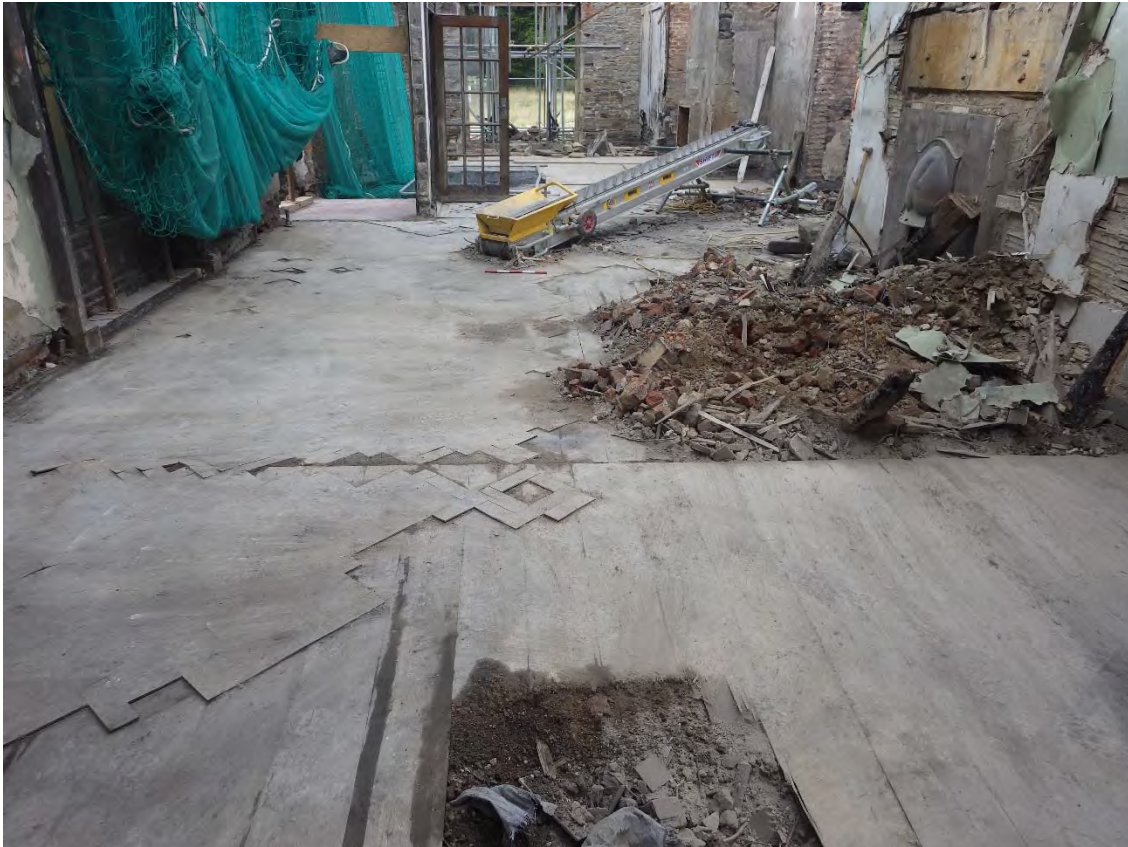
*Plate 56 Room G09 flooring as exposed*

Much of the flooring remained intact throughout the ground floor level, though with the exception of parts of rooms G03/4 and G09 and the complete loss of the floor in G05. The floor was covered with 0.3m + of cinders and collapsed/ melted plasterwork representing the remains of the floors and roof above a deep deposit of brick and masonry; on top of this was the result of the demolitions.

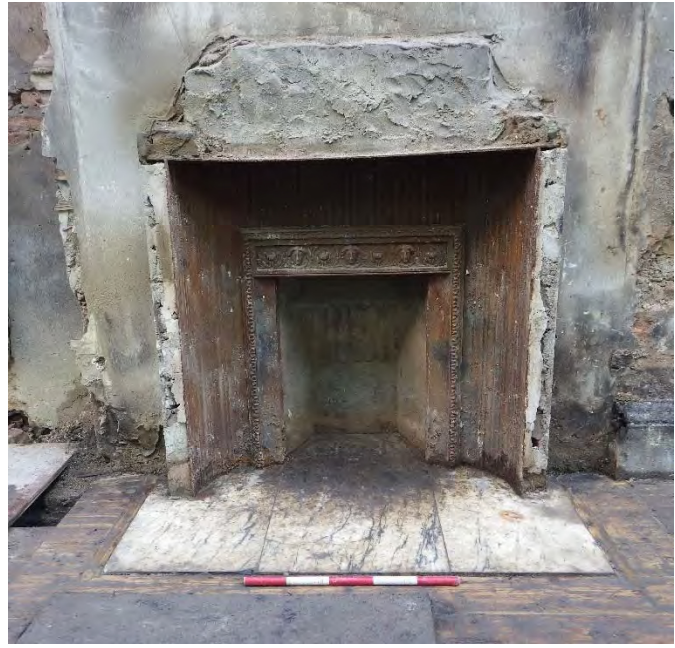
Plate 58 G03 fireplace post fire

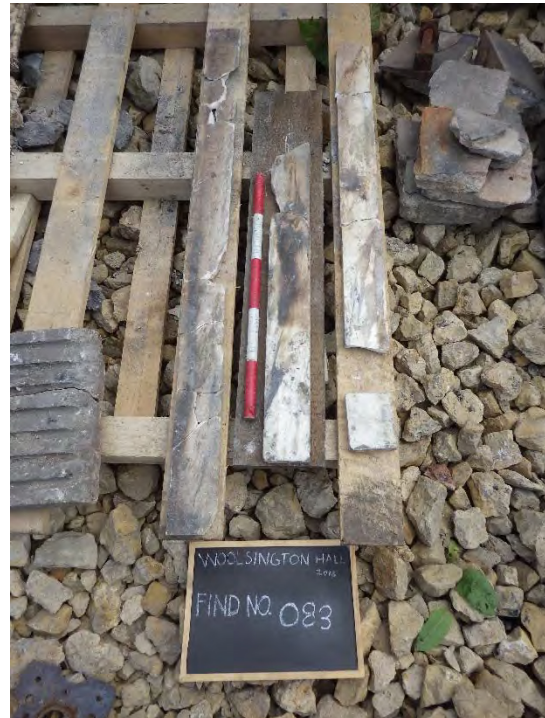
Plate 60 room G03 remnant of marble surround (find no 083)

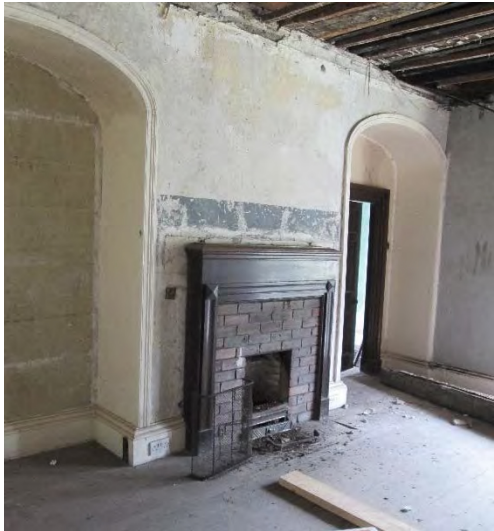
Plate 64 room G06 fireplace

The large fireplace to the south remained intact, although some small cracking was noted on the lintel and in the brickwork.

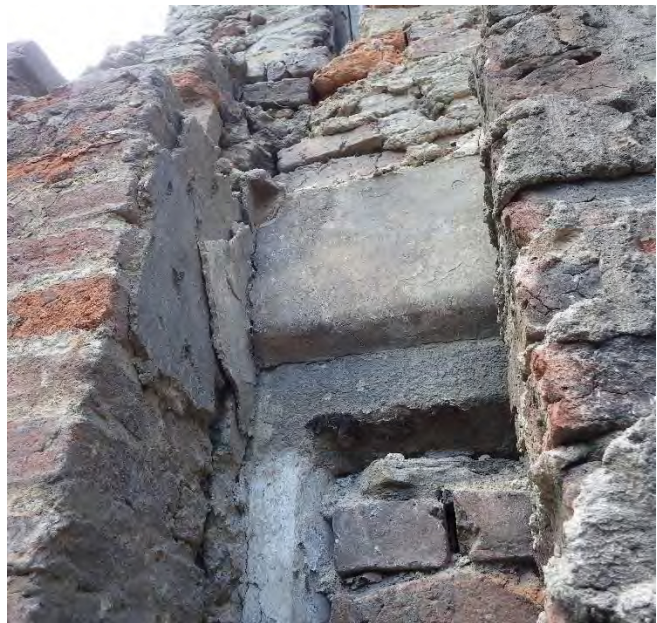
Between room G03 and G05 the width of the chimney stack would have formed a corridor with doors either end into the rooms. This corridor was lighted by an original window, which was latterly blocked with brick and covered with cement on the exterior. Service channels for pipe work were formed within the blocking on the interior. The window was partially exposed in the demolitions and clean up; on the exterior the cement ran up to the corner downpipe which had melted, leaving a jamb exposed. On the interior, removal of piping partially exposed the plastered ingo and soffit of the window; this showed two coats of plaster on the square ingos, with the earlier pecked for grip. The window jamb also showed no evidence for a transom, showing it to have been an open window.

Plate 67 early window G03/G05 detail of plaster

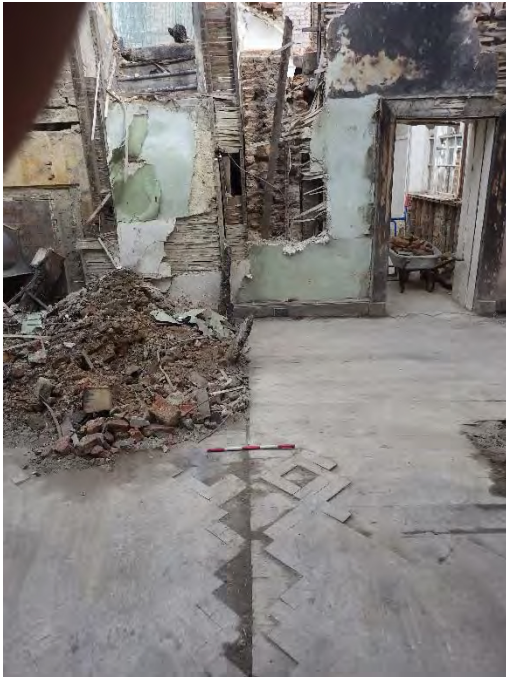
Plate 70 room G09 shows earlier flooring to west stopping on line of former gable

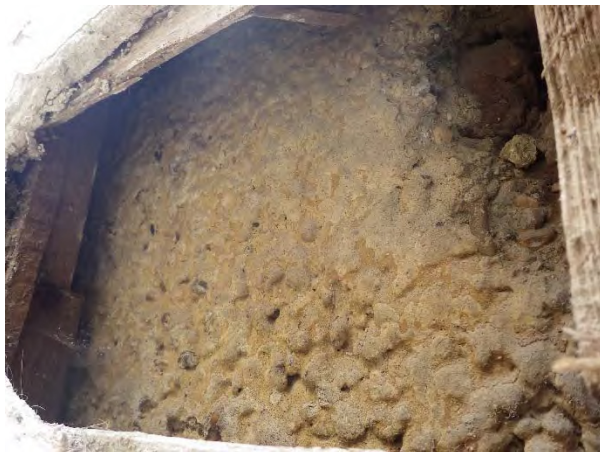
Within this room a number of earlier wall finishes were noted; on the west wall, the former exterior of the original building, a large amount of a lime washed render was visible behind the existing lath and plaster.

Plate 73 room G10 original exterior finish

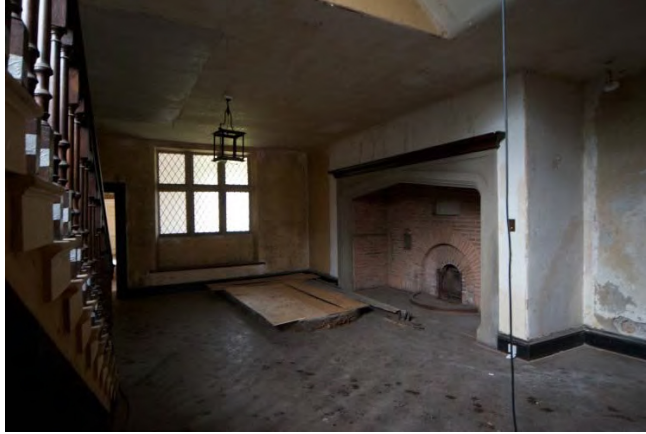
Plate 75 room G06 pre fire

Much of the eastern part of room G06 survived the fire, including parts of the ceiling structure and its floor structure. However the remaining ceiling timberwork, and a mass of overlying collapse material, had to be dismantled and removed to enable stabilisation of the structure.

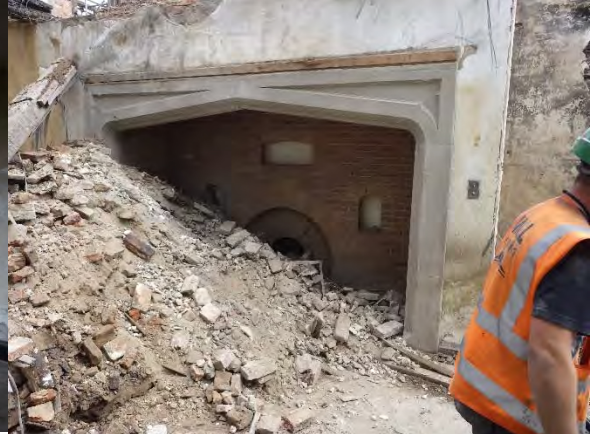
Plate 76 room G06 fireplace under excavation

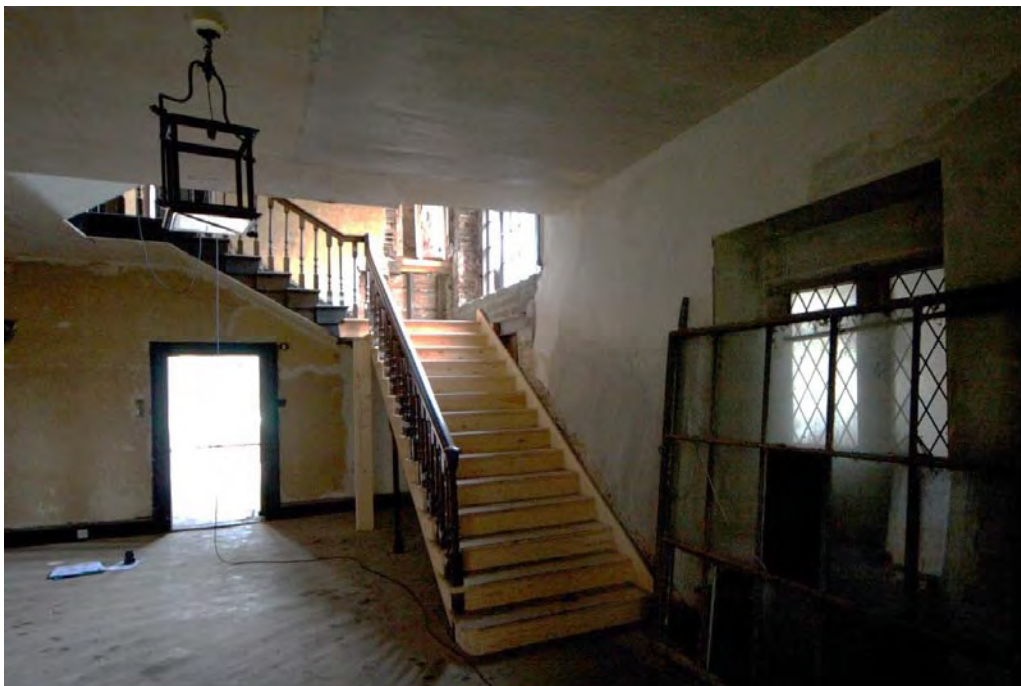
A major loss was the stairwell and staircase. The stair was a very elegant structure of mid-late 18<sup>th</sup> century date occupying the entirety of the central bay on the north side of the building. It had seen secondary modification at ground floor level when its eastern partition wall was removed and the lower flight re-aligned to descend eastwards rather than to the south – into the amalgamated chamber, room G06.

The timberwork of the stair was almost entirely consumed, with only a few parts of the lower flight recovered. A complete single turned baluster was recovered but most others were fragmentary and badly charred at best.

Plate 77 Stair hall, room G6, looking WNW towards the stairwell, showing re-alignment of the lower flight

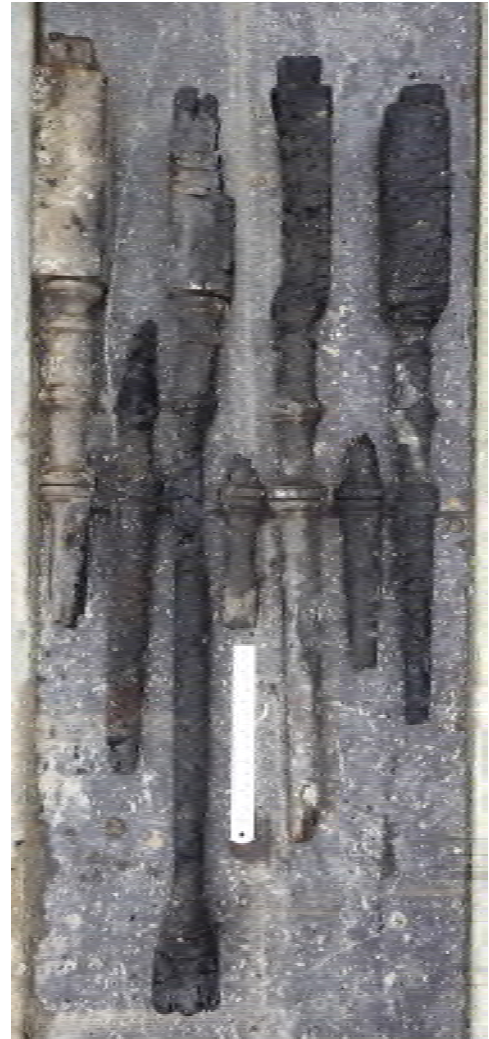
Plate 79 Remnants of the stairwell find no 013

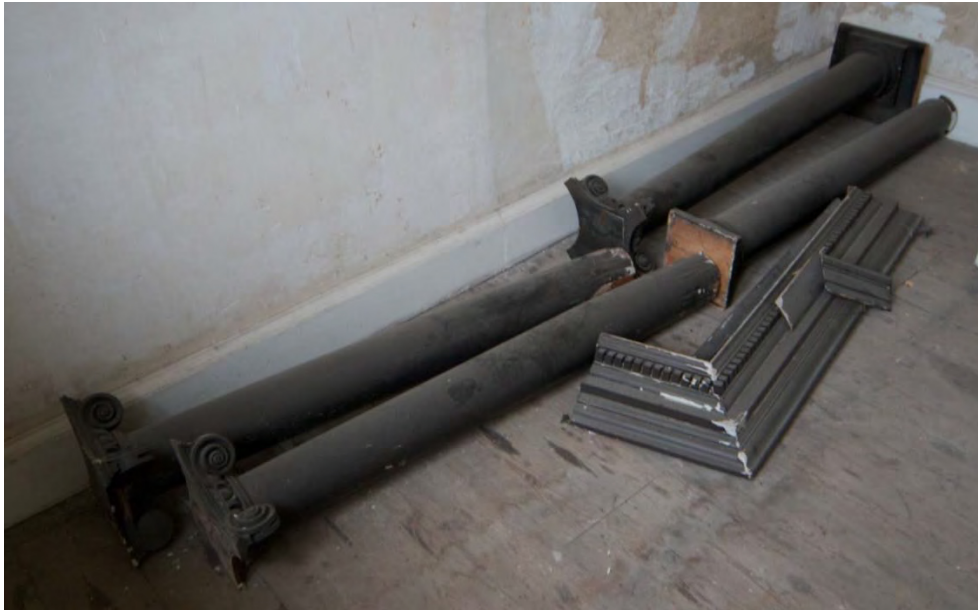
The stairwell was particularly notable for the presence of a tripartite ‘Serlian’ window at what had been the landing level between ground and first floor. To the interior this feature had been enriched with a well formed architrave with good moulding detail and paired turned timber column shafts with naively executed ionic capitals. Before the fire the decorative timberwork had been largely dismantled to allow for damp repair, and stored elsewhere in the building. While these pieces were wholly destroyed, the remaining *in situ* parts of the architrave remarkably survived the fire.

Plate 83 Stair window – ex situ sections of woodwork – destroyed in the fire

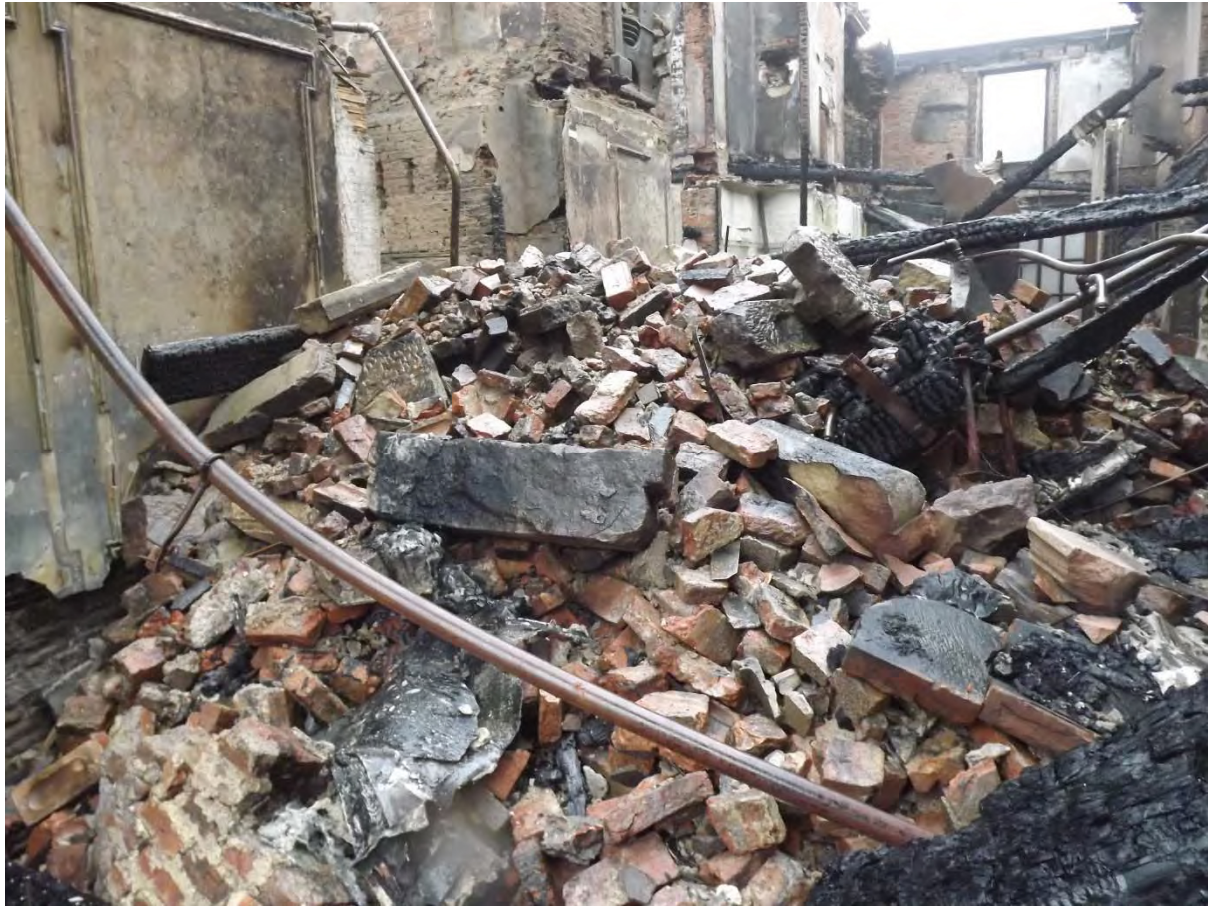
*Rubble collapse within Woolsington Hall*

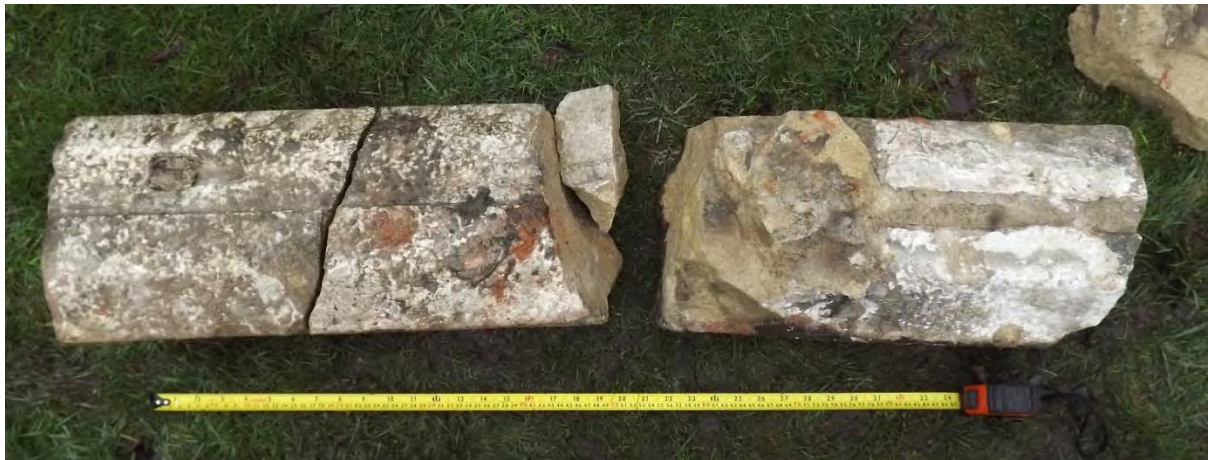
*Example - initial identification, recovery and laying-out of shattered dressed window elements, prior to recording labelling and storage*
