Lady Well Dumfries House, South Ayrshire

Excavation: June 2017

Report date: August 2017

Job number AA: 2196

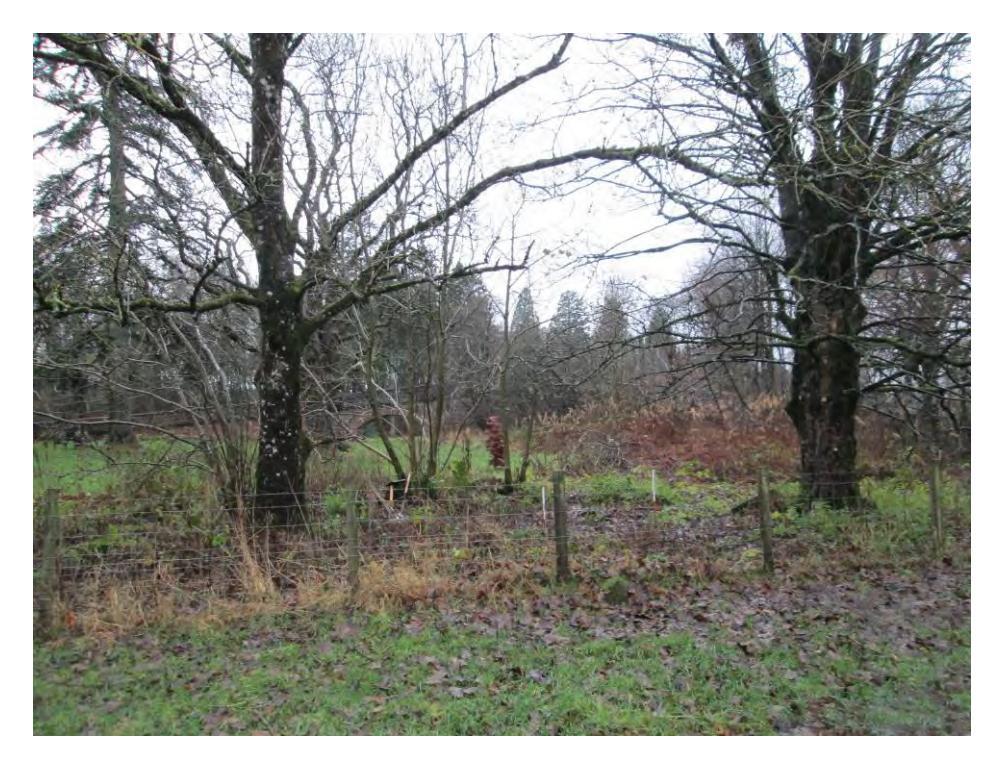
Plate 3 pre excavation view of the well, the Lady's Well sits between and beneath the 2 large trees and stumps

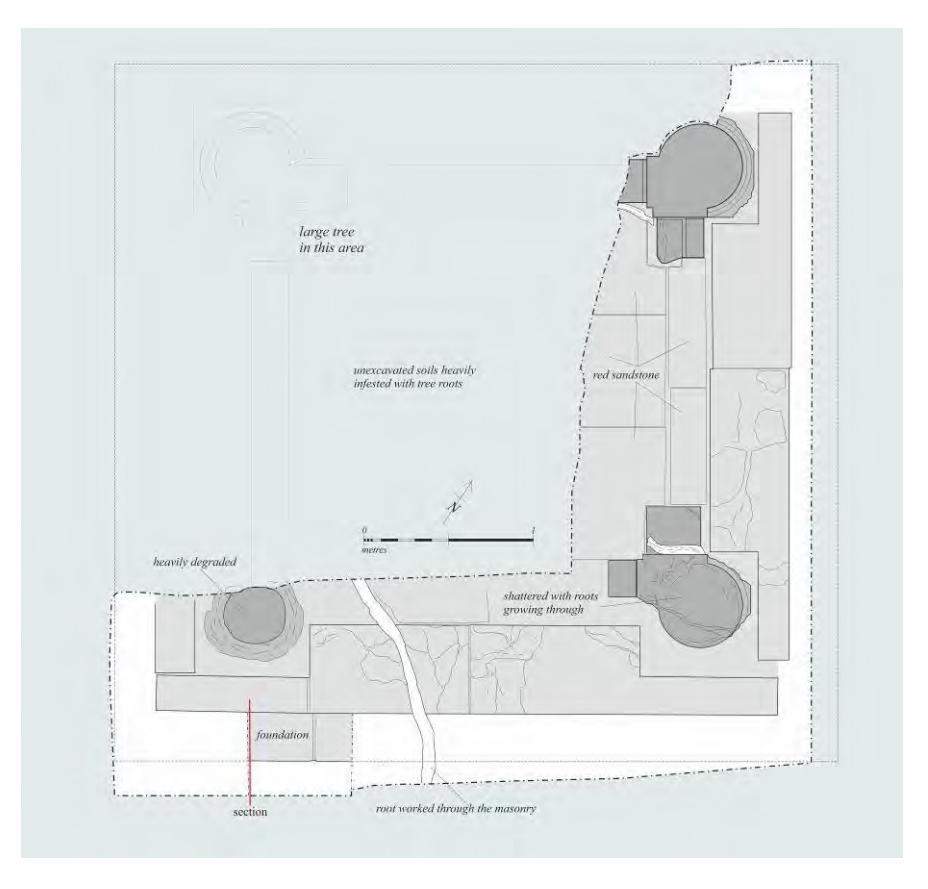
Figure 4 evaluation trench showing exposed masonry

The initial evaluation was successful in that it accurately located the footings of the Lady Well (Morrison & Macfadyen 2015). Three of the four corners were uncovered and the full extent of two sides exposed to the east and south (*figure 4*). The north-west corner of the structure remained situated under a large tree, making it impossible to excavate this area until the tree was felled and the stump removed. While the stonework forming the base of the structure had seen some distortion, overall, it consisted of a square platform of about 3.5m - 3.65m square (approximately 12').

The red sandstone slabs were considerably fractured and delaminated; it was thought possible that this damage was caused in part by the explosives used to destroy the building. Some of the outer slabs were also heavily damaged; however, it was not possible to tell whether this was the result of an explosion or the slower process of damage by ground water and penetrating tree roots causing delamination along bedding planes.

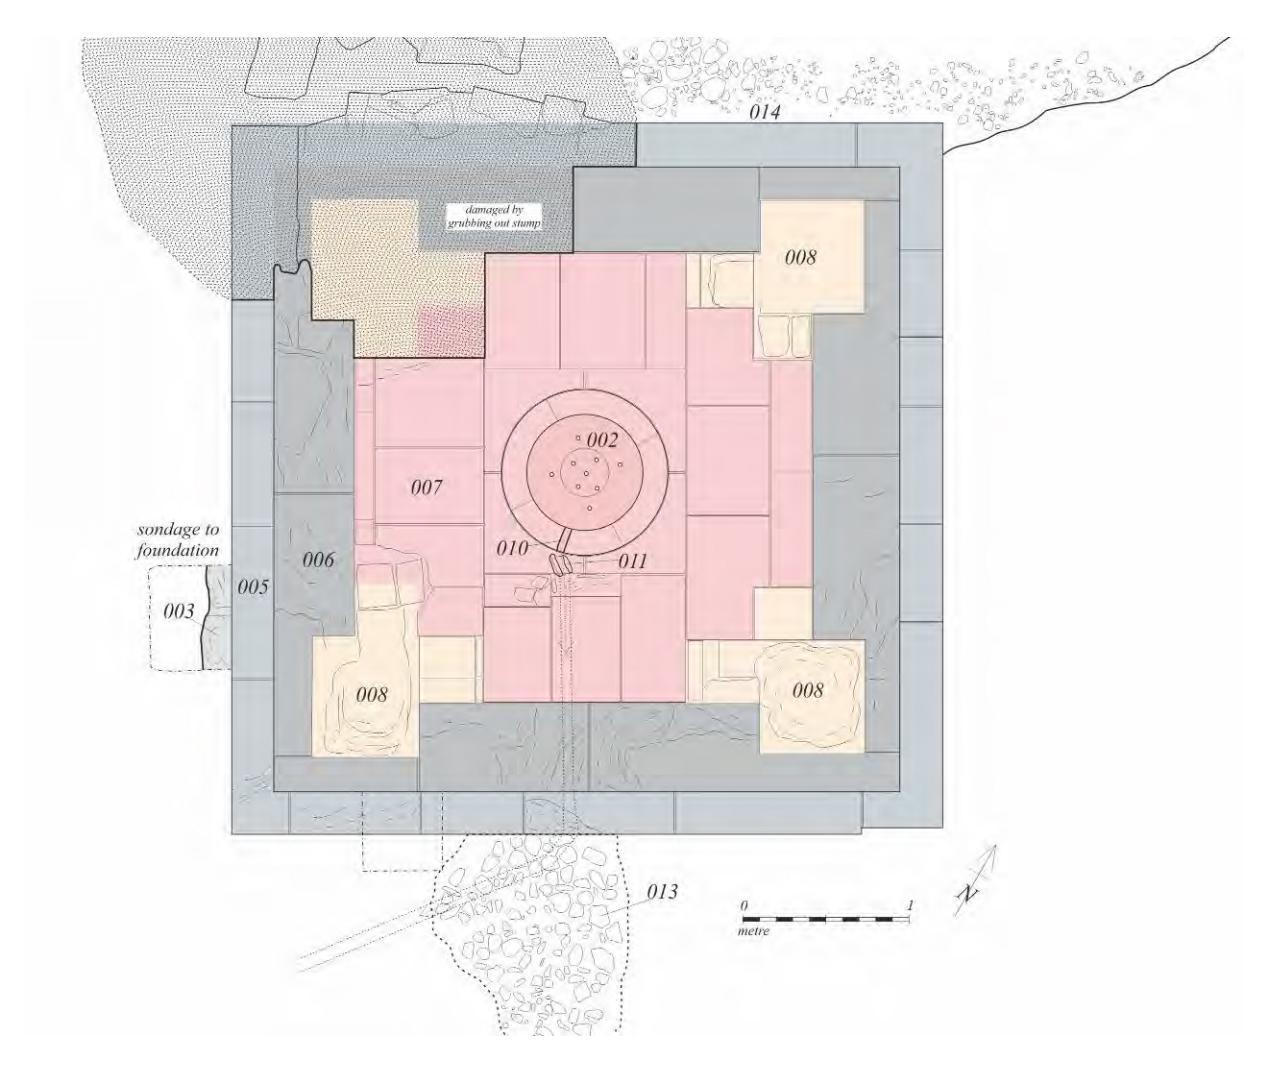
Figure 5 upper parts recorded

With limited time, the masonry was cleaned up as much as possible. This uncovered the round wellhead for the first time. This was 0.70 m in diameter internally and formed in red sandstone the same as the surrounding flagstones; the damage to the western corner from grubbing out the large tree stump was noticeable. The general degraded condition of much of the masonry was also clear.

Next, a narrower trench was excavated around the wall foot to expose the foundations for investigation. At the same time, the badly degraded parts of the upper structure were removed to solid masonry to give a good foundation to work up from.

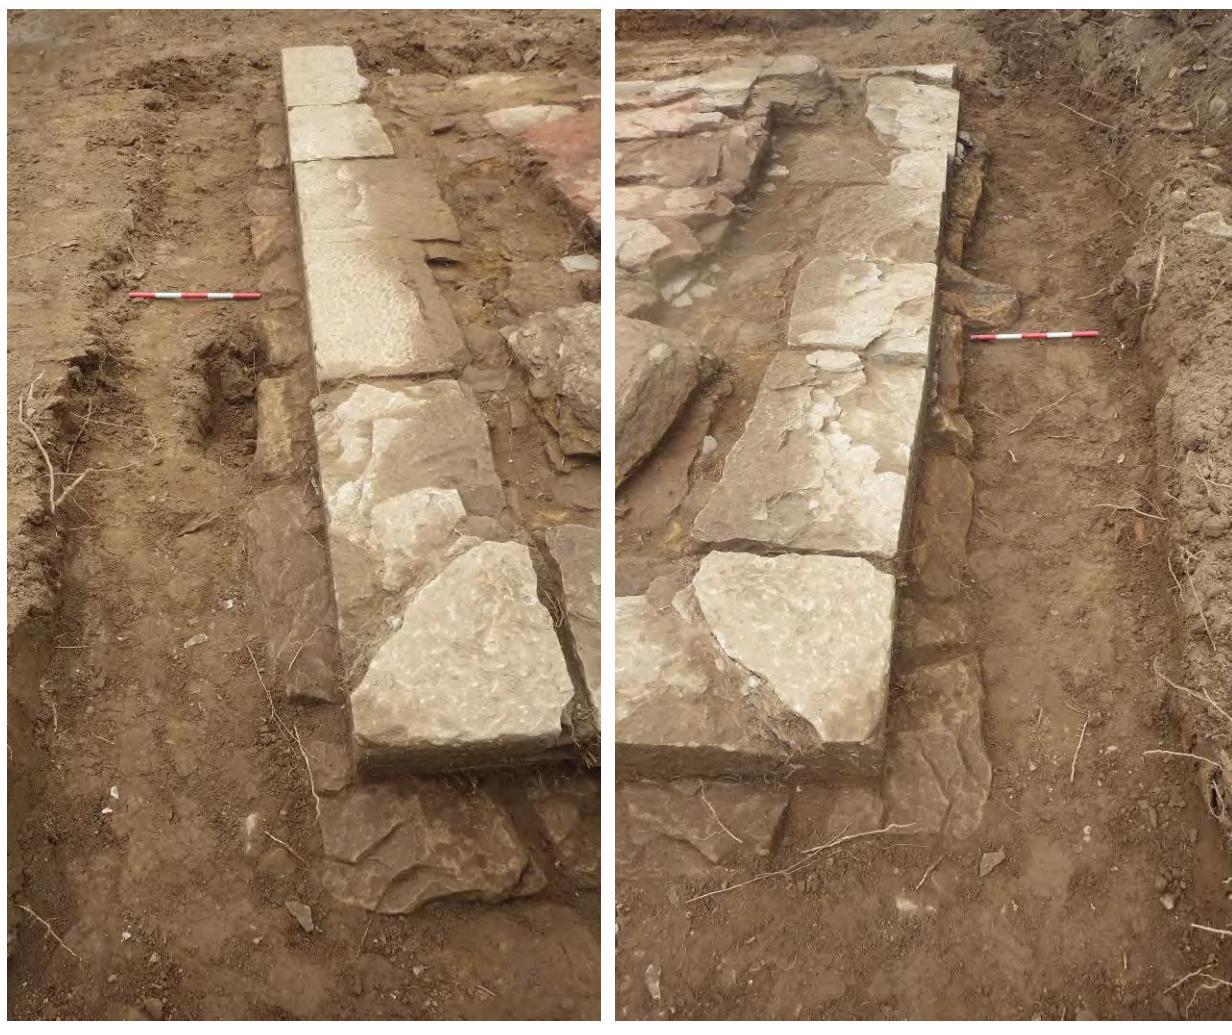
This upper foundation was bounded with a neat-tooled square kerbing 005 constructed from greyish blue sandstone of large blocks; the upper surface of these would have sat about ground level originally (*plates 11 and 12*).

Plate 11 upper foundation 005 exposed following removal of masonry on top, SW side with rough foundation 003 below

Plate 12 upper foundation 005 exposed following removal of masonry on top, SE side with rough foundation 003 below

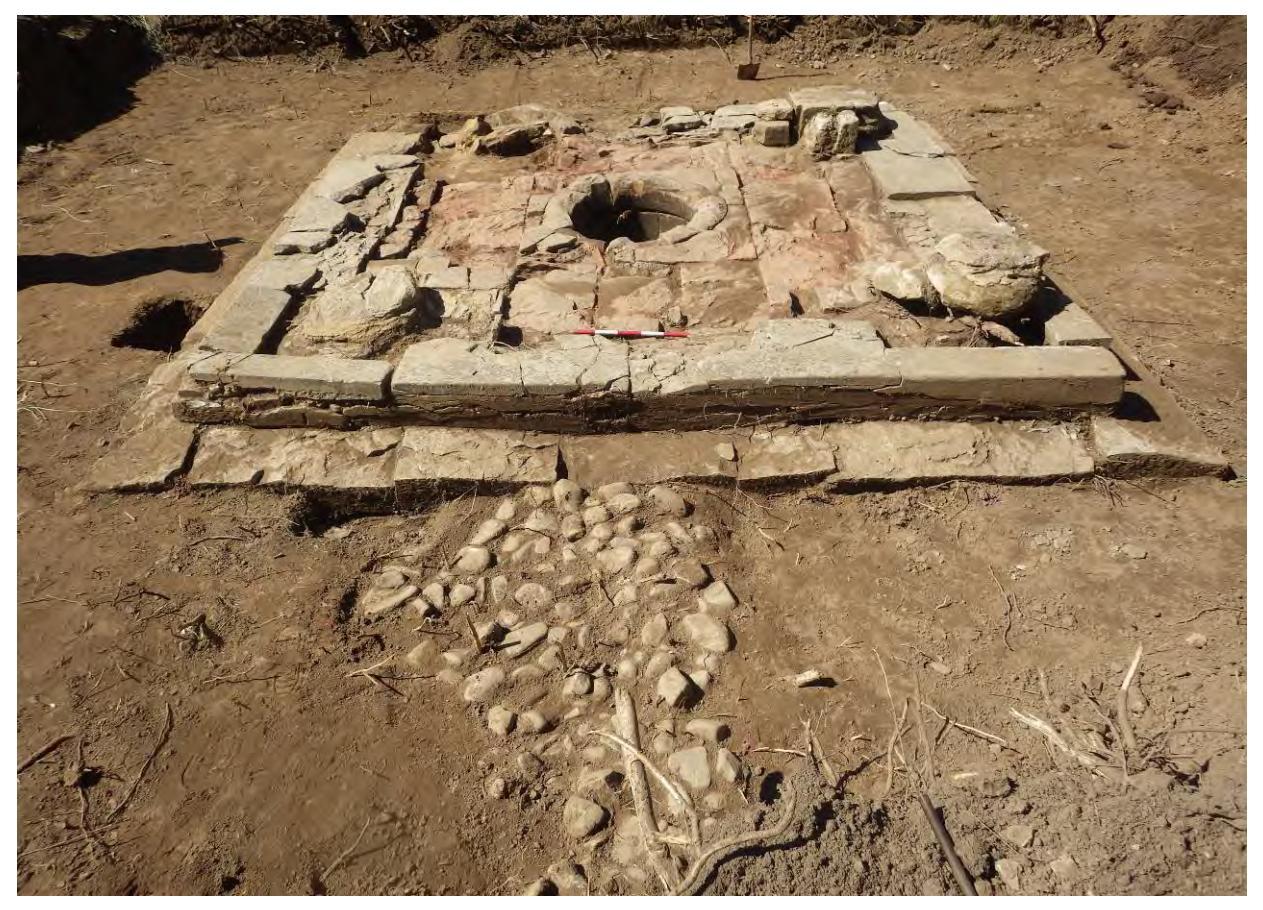
The original ground surface is evident with a cobble path 013 leading up to the structure on the southeast side, which is level with the top of 005 (plate 13). Ground level appears to have been at the level of the lower foundation 003 to the northwest where a 0.1m deep gravel metalling 014 is visible. These different levels of surfacing show the general ground level to have been sloping down gently towards the river.

Plate 13 Lady Well exposed at original ground level showing cobbled path 013 running to the structure looking NW

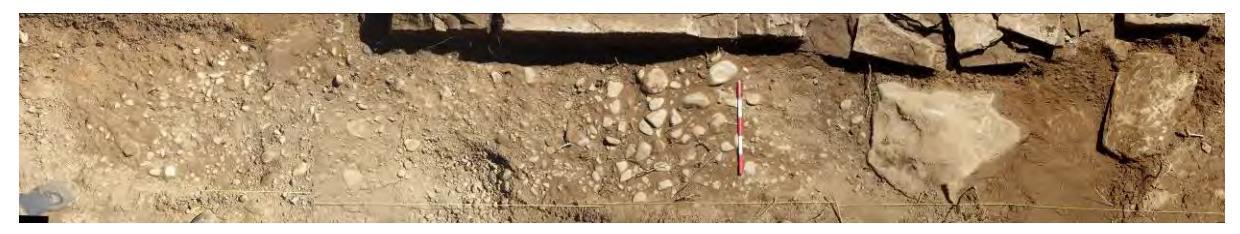
The northwest side of the structure was heavily affected by the removal of a tree. This also destroyed the western half of the metalling 014, but the eastern half-survived and a strip along the base of the structure was cleaned up and recorded prior to digging a trench to fully expose the foundations.

Metalled surface 014 was well-formed and made up from small rounded pebbles. A concentration of larger cobbles in front of the middle of the structure may show a continuation of the cobble path noted on the other side; this was flanked with gravel metalling 0.10m deep. The surface petered out to the east in a splayed form from the north corner, beyond which the working surface 004 was visible.

Plate 16 plan view of metaling 014

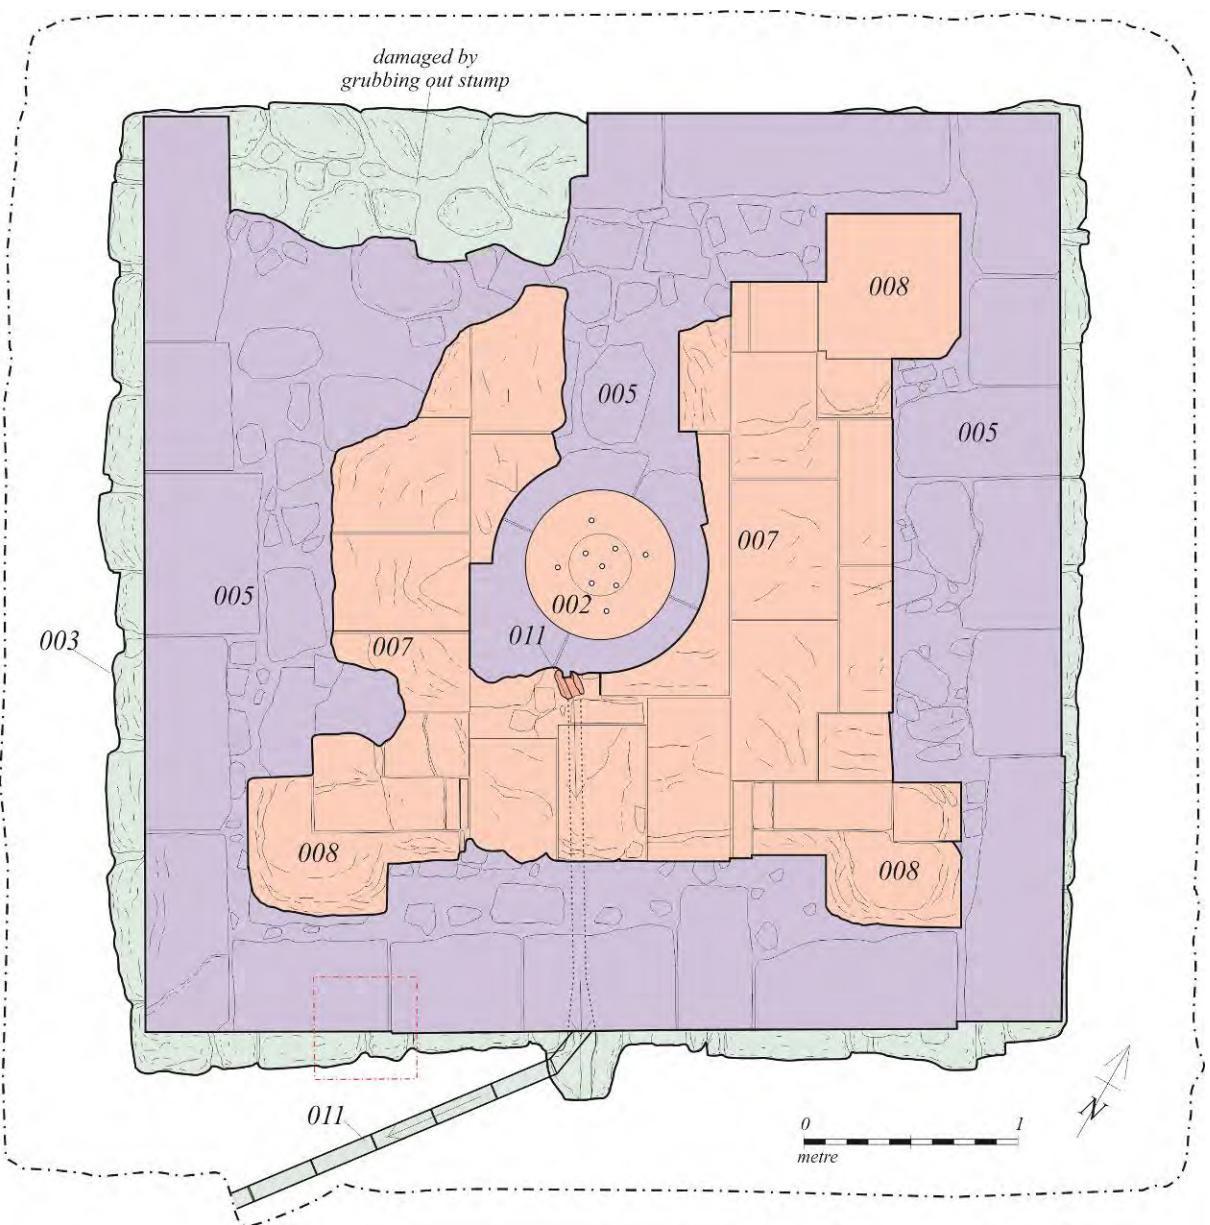
Figure 6 lower parts exposed at LOE, with the 3 levels of construction coloured

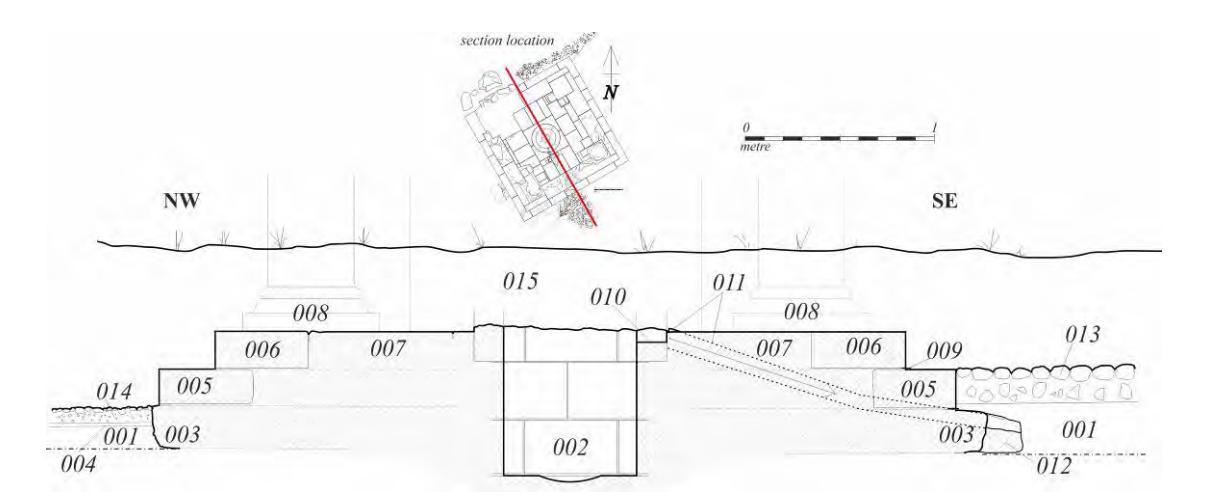
The overflow system 011 external to the structure was formed from clay horseshoe field drainage tiles running to the southwest away from the structure into the field, rather than to the river to the north (*figure 7*). This was heavily disturbed by tree roots close to the structure.

Figure 7 section across well structure showing overflow system

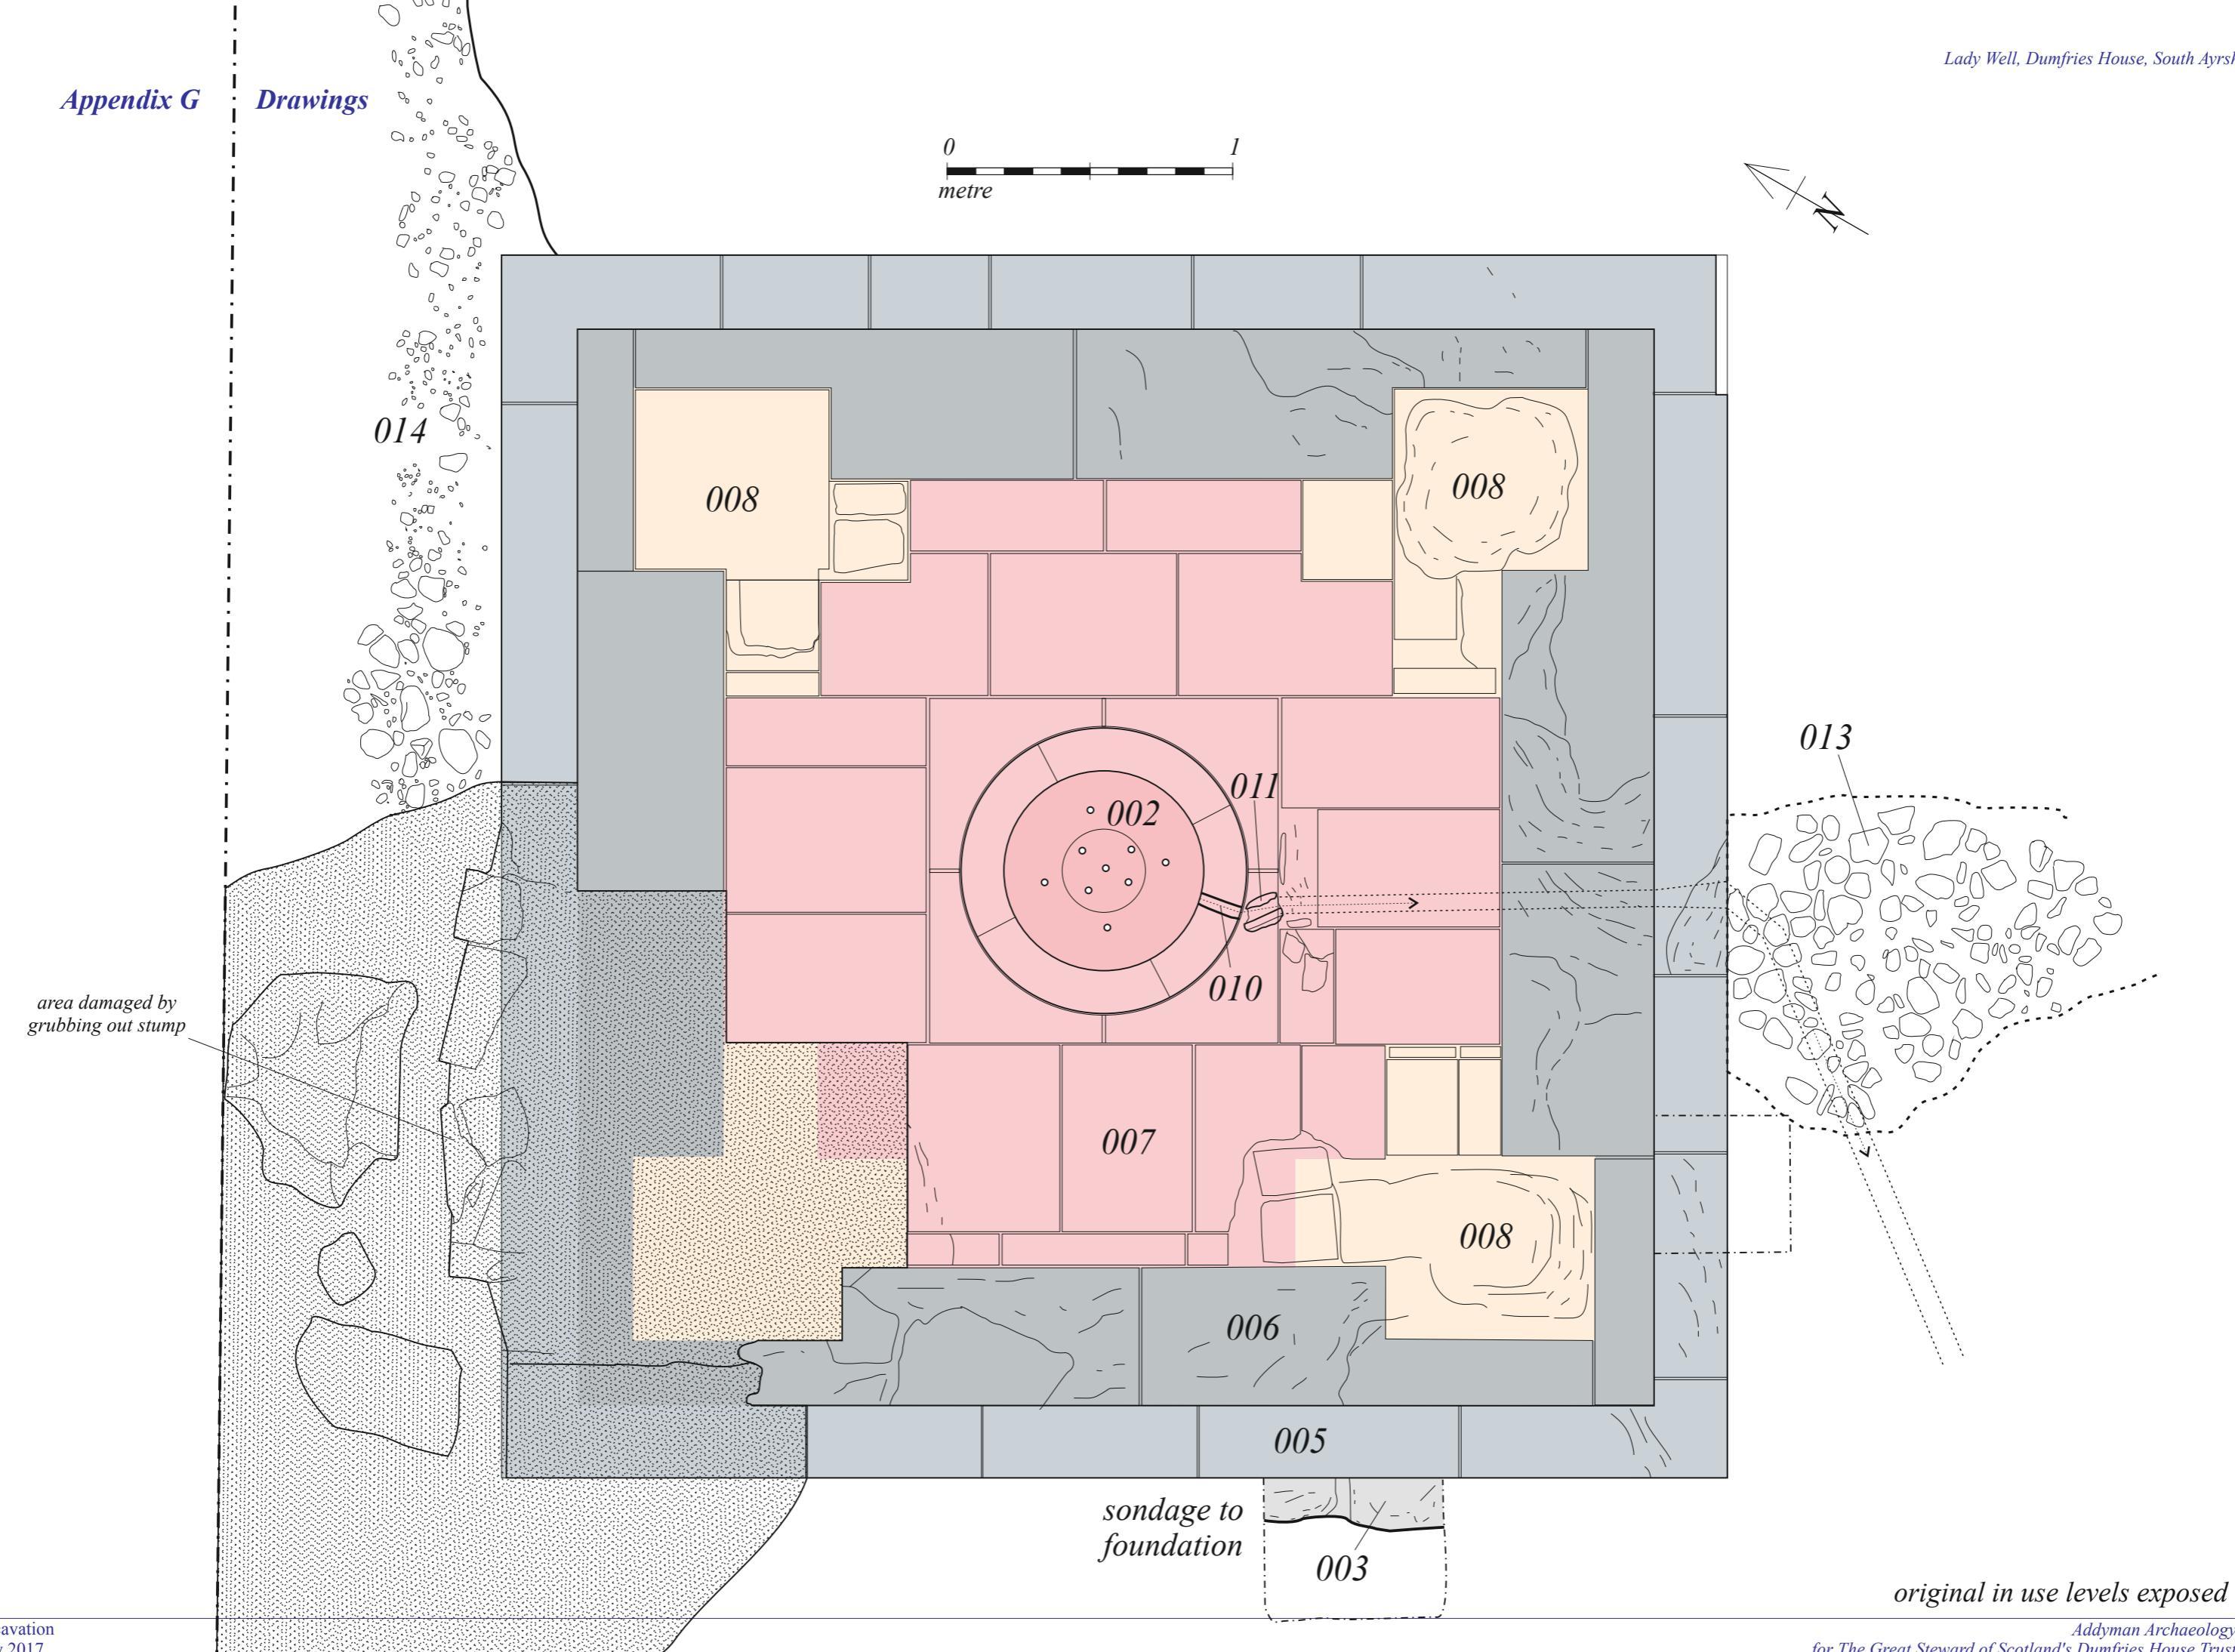
Lady Well at LOE following partial dismantling, shows the 3 main layers of construction (coloured)
