# Panmure House

*Canongate, City of Edinburgh*

Archaeological Watching Brief: works related to Demolishing and slapping of historic fabric, November-December 2016: Data Structure Report

*Project No. AA.1910*

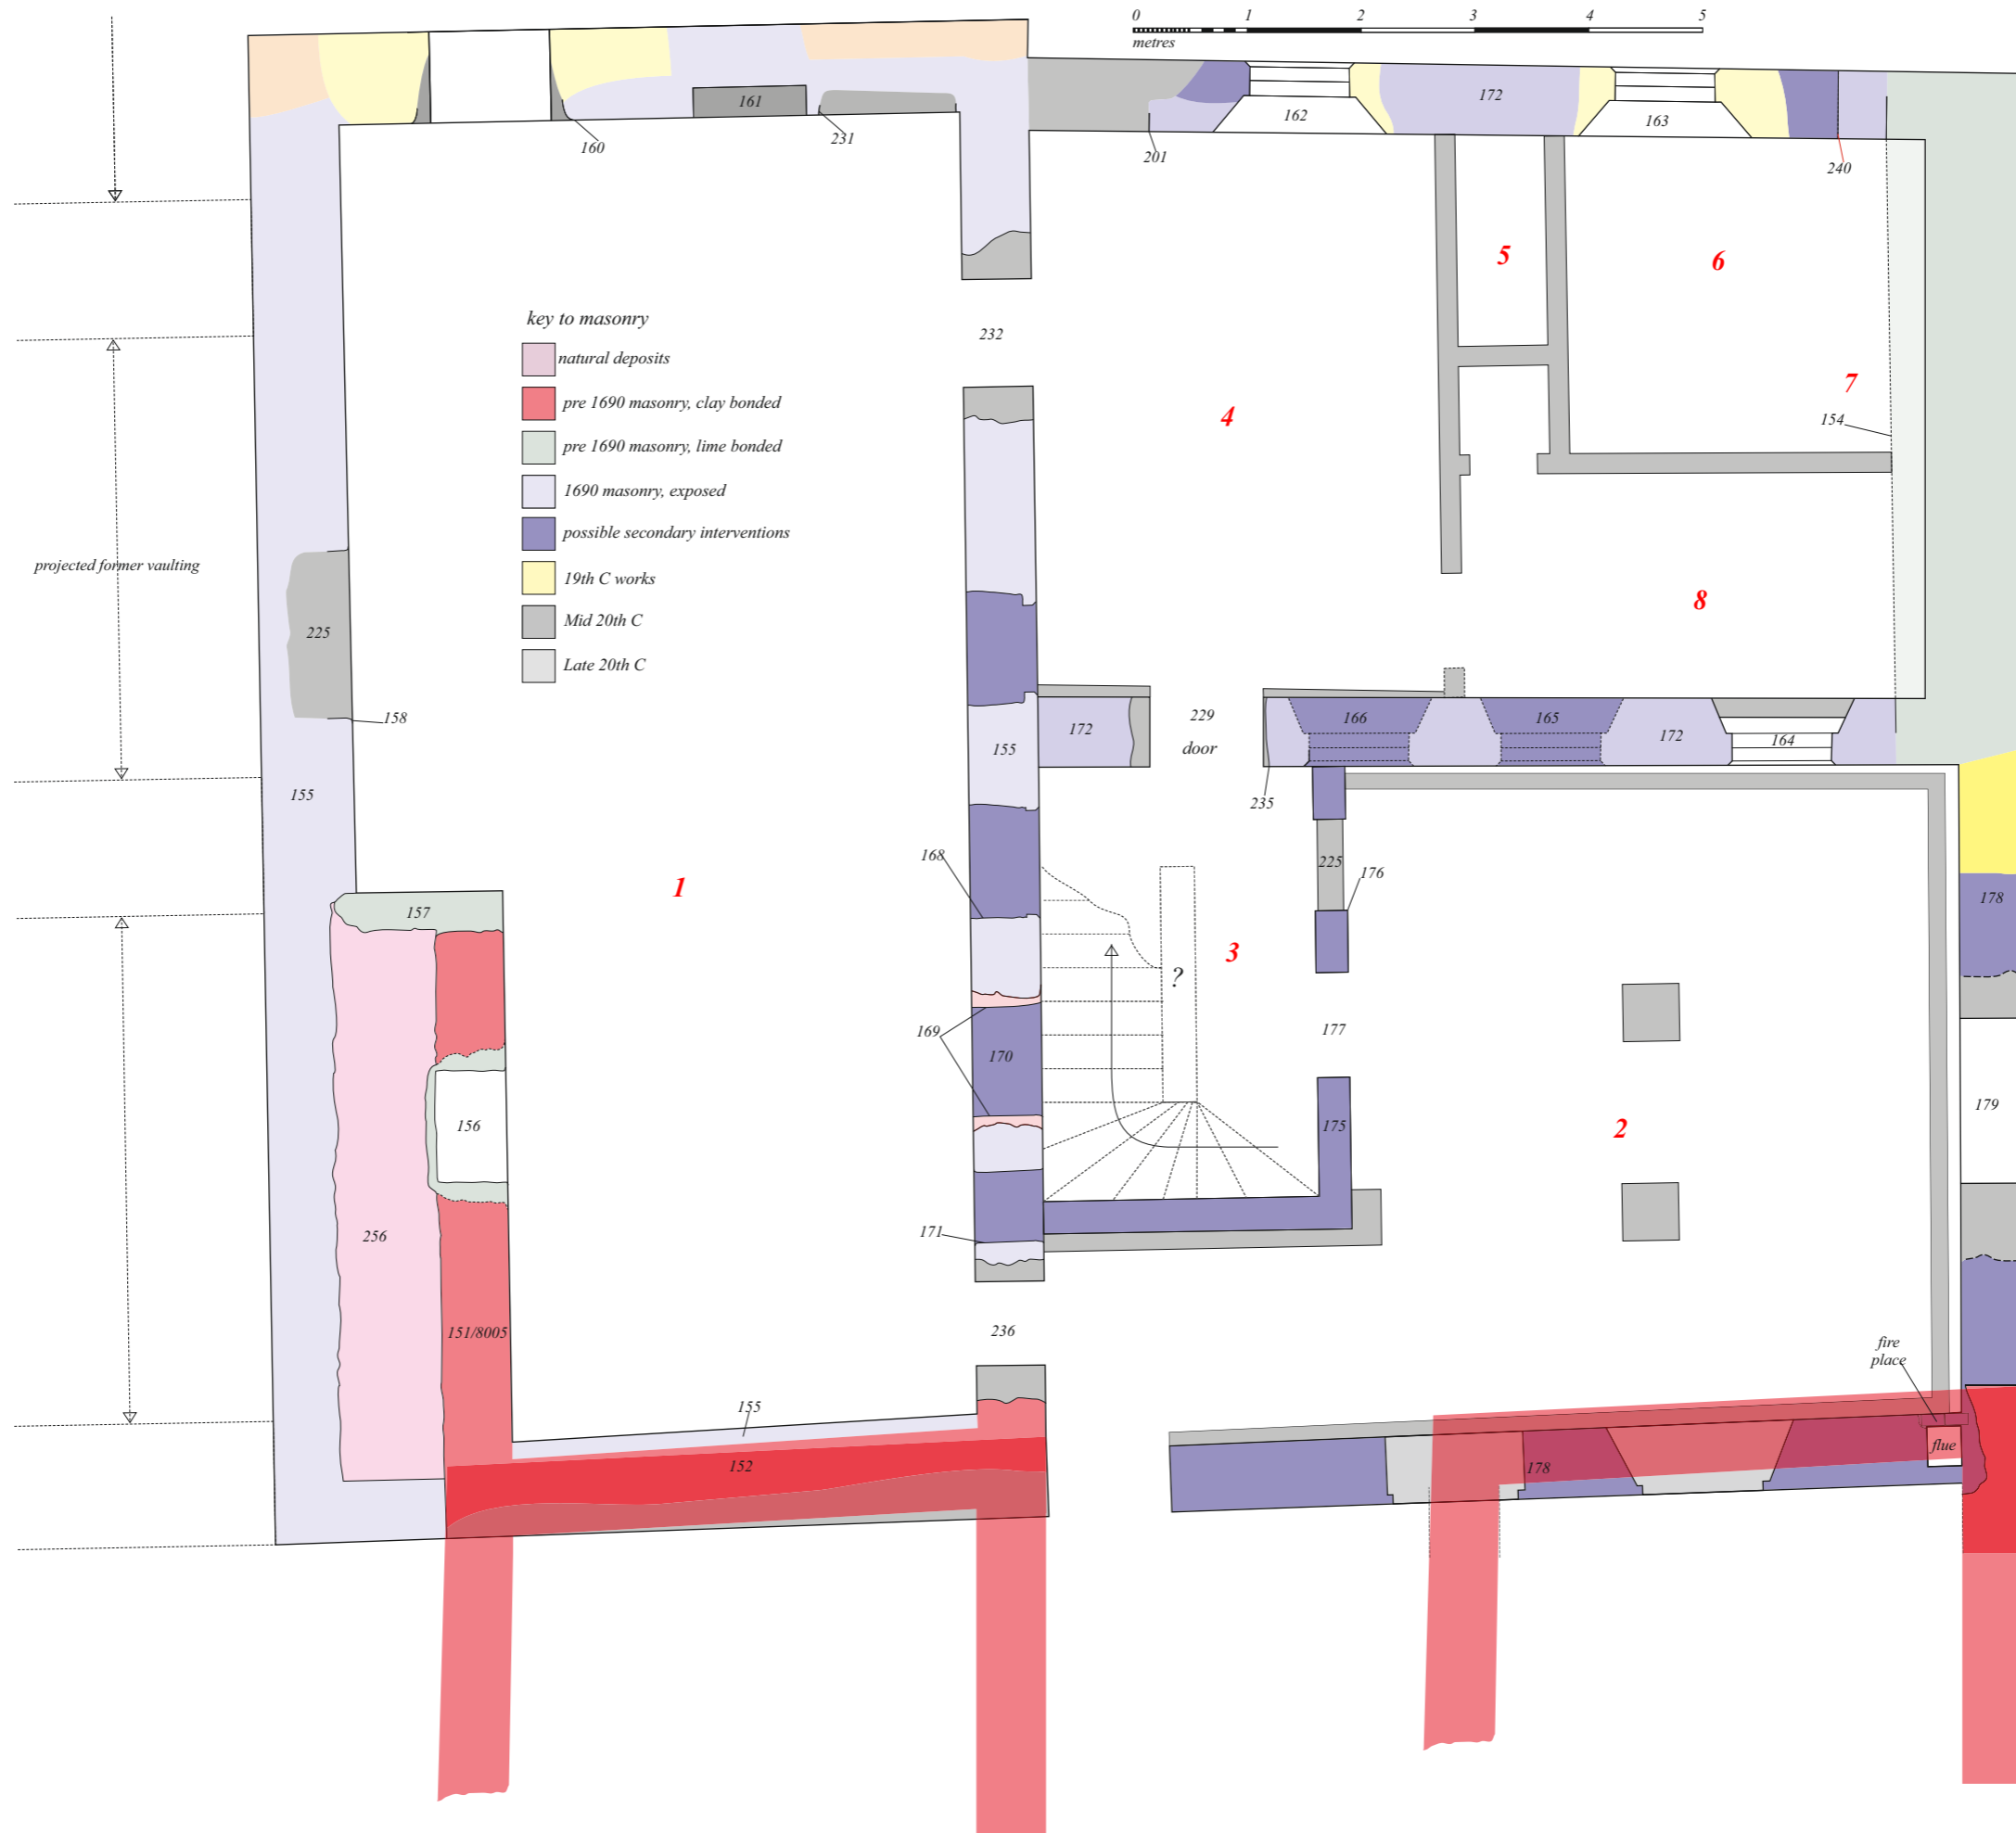
- 1: Plan of Panmure House, ground floor, showing line of early clay-bonded buildings in red
- 2: Elevations of stair tower – north, east, south
