Carsewell Steading

Penicuik, Midlothian

Historic Building Appraisal: 16/10/2017

Hope & Co Architects on behalf of Penicuik Estate

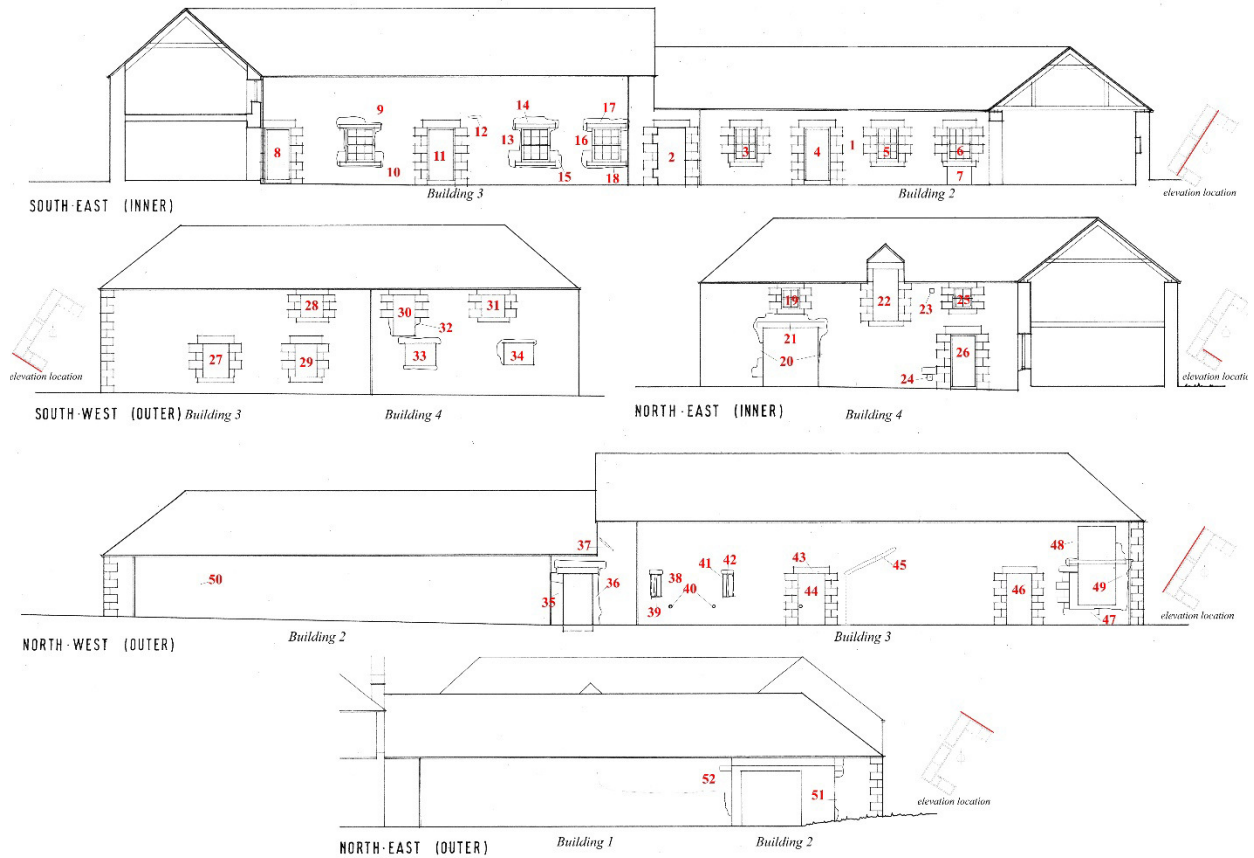
Figure 4 Elevations with contexts

On the south-east frontage elevation of the *northern room* (figure 4; plate 10) there is a door and two windows; the door (11) appears to be an original door with the same chamfer and tooling detailing as on Building 2, the north jamb has been widened. The two windows (13 and 16) are different and show evidence for three phases of use.

The southern room on its south-east main frontage has a door and a window (plate 10; figure 4); the door (08) is original with the same detailing as elsewhere but the window (09) appears to be a slapping. The window appears to have been a new slapping and formed up with cement to similar dimensions as (14 and 17) and likely at the same time. Latterly the window sill has been dropped similarly to (15 and 18).

On the north-west elevation (figure 4) originally was a door and a window; the door (46) is original and of the same detailing as elsewhere. The door is currently open and in use as a door but mortar traces on the stonework suggest it has been blocked up historically; some damaged quoins may relate to tying in the blocking or even a further phase of converting the door into a window by inserting a sill.

On the north-east elevation two windows (33 and 34) have been slapped and with no evidence for any other openings other than the large (20) opening, it is suggested this building could be a cart shed (figure 4; plate 15).
