# Newhailes House and Estate

## *Musselburgh, East Lothian*

*Flower Garden: Historic Building Record and Assessment*

### Historic Building Record and Assessment

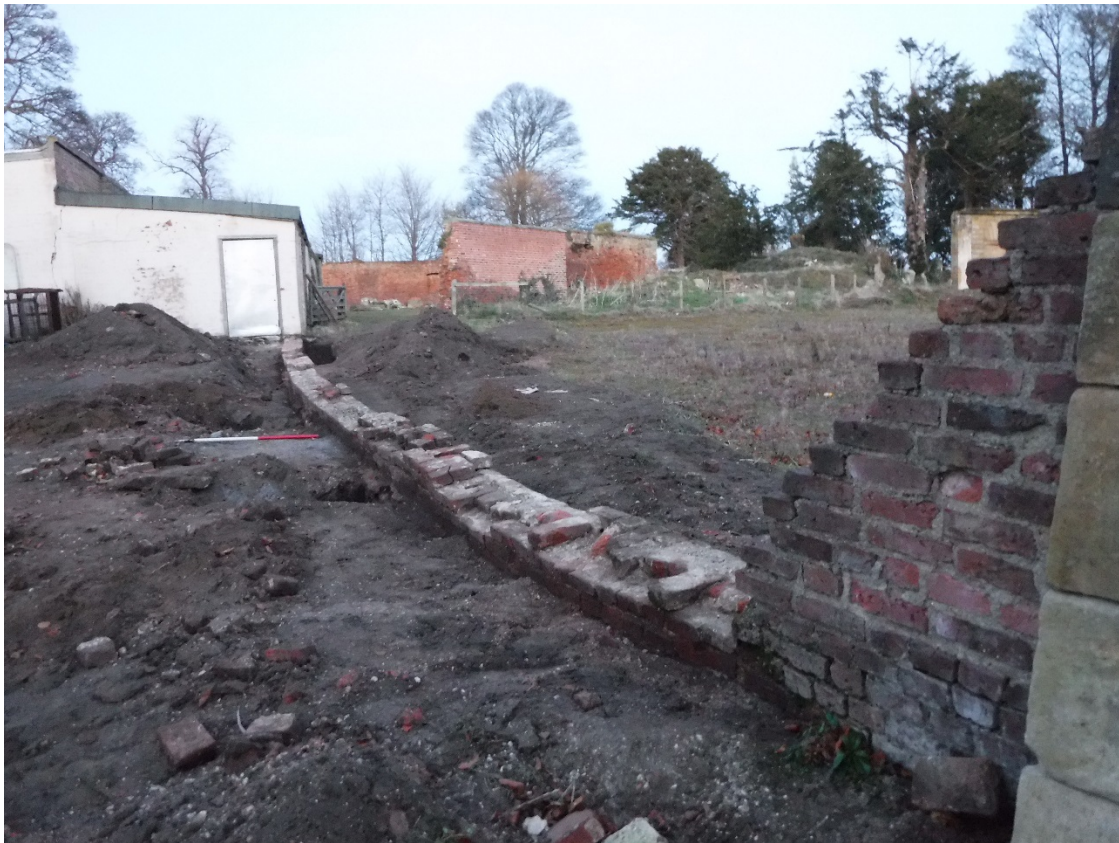
*View of the wall footing following cleaning, looking north-east*

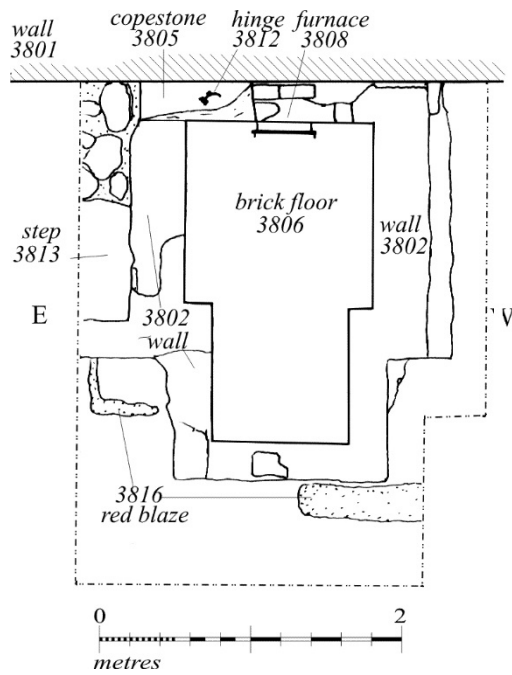
Figure 2.18 Plan of trench 38 heated wall furnaces

A furnace stoke hole was located beneath the relieving arch. This retained a cast-iron surround with part of its cast-iron door also remaining *in situ*, and part found loose. A grate within the stoke hole permitted ash to fall into an ash box below. The intra-mural flue rose into the wall just beyond the rear of the firebox.

The fill of the pit was also of considerable interest. Following the removal of an upper level of topsoil and debris, a homogenous level of dark gravel was exposed. This contained some small pieces of bricks, bones, glass, pottery and china, as well as the broken part of the firebox door and hinge, etc., already described. The lower fill consisted of a level of large pieces of cream refractory brick, many of which were fused and or coated with the residue of some form of smelting. Several bricks had impressed marks of one of two types, 'PRESTON GRANGE' or 'J. BYFORD' From amongst this fill was also recovered the base of a moulded stone urn, and its square plinth. This level overlay the deposit of coal, already described.

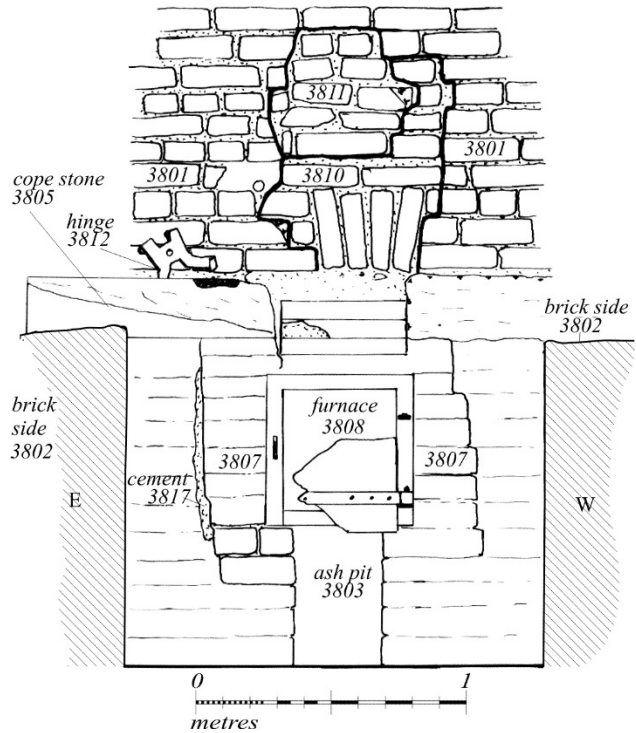
Figure 2.19 Trench 38 elevation of heated wall furnace

The mortared brickwork of the walls survives in excellent condition up to its upper part, which has been largely robbed of its coping course. Most of one coping survives and there are impressions of others. The surviving stone, at the SE corner of the pit, is neatly cut and displays a well-tooled face of distinctively Georgian character, its upper surface lies at exactly 1.2m above the floor of the pit. Significantly this block retains a wrought iron hinge pintle, counter-sunk and fixed by lead into a seating in its upper surface. A corresponding hinge band was found loose within the pit fill along with a number of perished sections of pine planking. These demonstrate that the pit had been covered in a wooden hatch that had opened upwards against the rear of the heated wall when the fire was being stoked. There may also have been an opposing hatch covering the N projection of the pit.

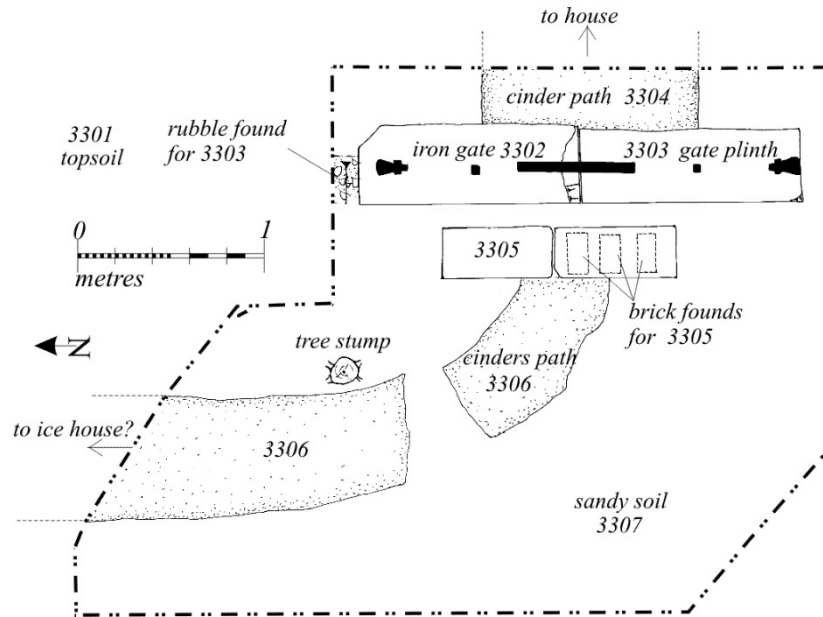
Figure 2.21 Trench 33 plan

To the W of the gate, a thick layer of topsoil 3301 covered all deposits. On removal, a 0.6m wide layer of ash and cinder 3306 was recorded, very similar in consistency to 3304. This extended from a single step formed from two rectangular stone slabs 3305, lain parallel to and slightly W of 3303, and turned almost 90° to N, continuing beyond the trench. The layer was interrupted at one point, although no discernible difference was noted between the two patches, and hence they were recorded as being part of the same deposit. The 2 part stone step 3305 had been laid on a brick footing, which was recorded due to the southern stone having been dislodged at some time in the past.

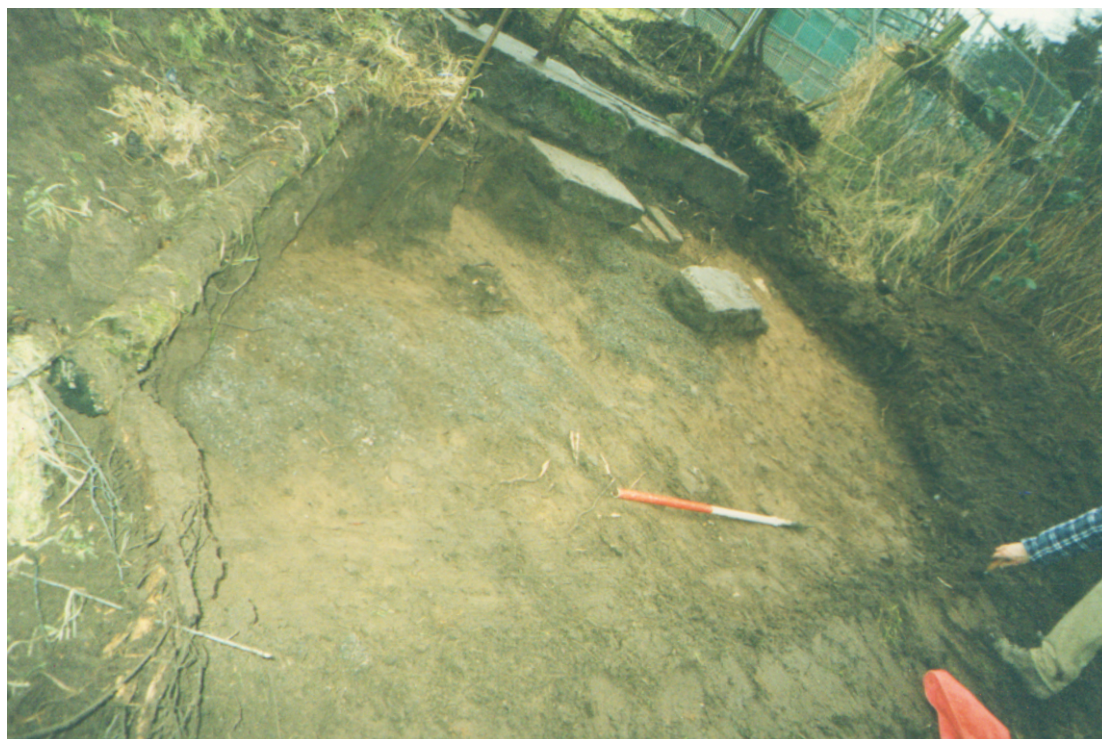
The line of the path is also different to a later fence, aligned between the seat and the northern corner of the gate, suggesting that the path predated this particular feature, and refers to an earlier scheme. The alignment of the path – moving behind other prominent garden features – suggests that it was deliberately sited in such a way as to be as unobtrusive as possible, so avoiding disturbing any vistas within the Long Garden. It is therefore quite likely that it forms an early part of the overall garden design. This is further reinforced by the evidence of the fence line, which is probably contemporary

*Plate 2.12 Trench 33, gate steps and cinder path under excavation*

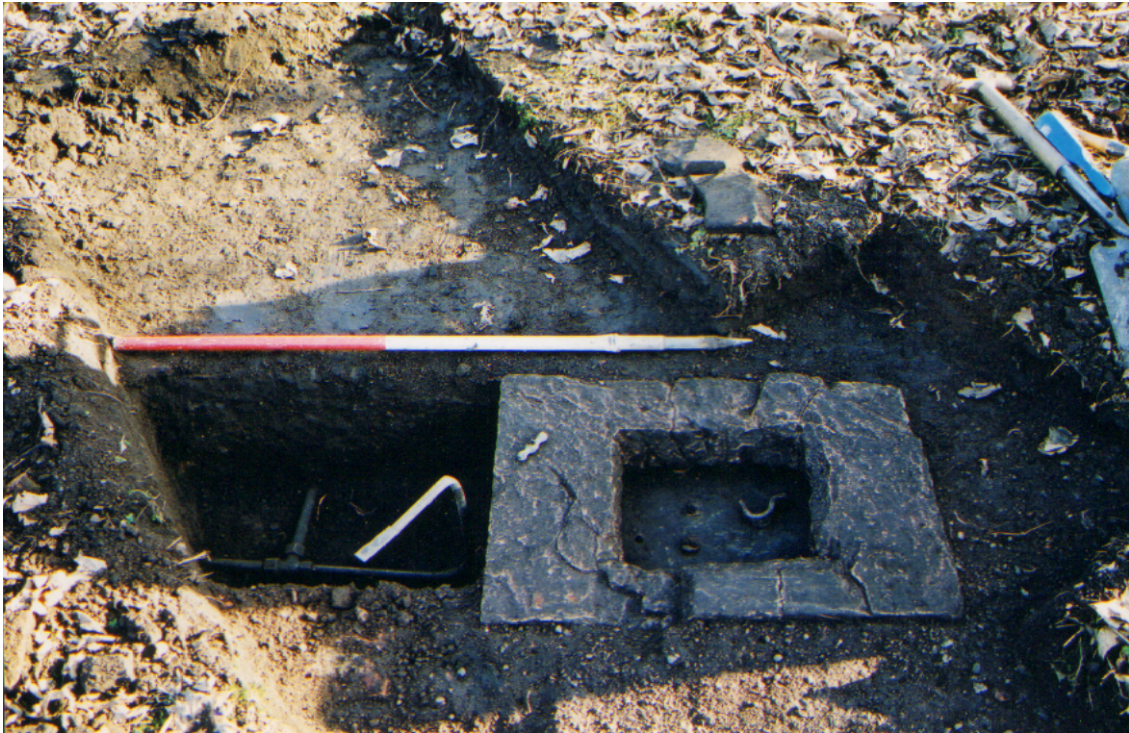
In Trench 30 a well-defined path 3002 was located 10cm below current ground level, the path was constructed from a base of compacted red blaze with a covering 4-5cm of small pea gravel. To the west and east of this path appears to be bedding. Within the east edge of the path is a sandstone rectangular ring feature 3005; this is almost certainly the base of a water standpipe and is fed from a 1 in copper pipe 3007, which runs about 35 cm below ground part of a tap was also found within the fill

*Plate 2.15 Trench 30, water stand feature*
